Advisory Visit

River Stour, Warwickshire

August 2016

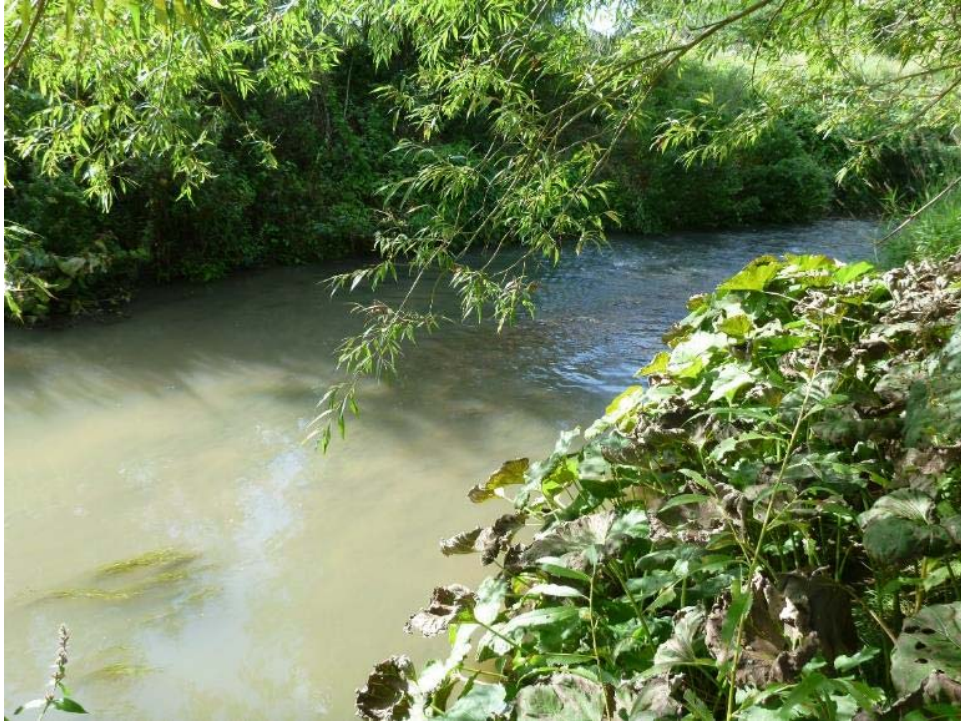
On the main river channel, downstream of the weir, the gradient is relatively steep with riffles and glides present (Photo 1). The river bed substrate is quite coarse, comprising large gravels and cobbles (fist size and above), which are not well suited to river fish spawning (too big). This may be a consequence of finer gravels being trapped above the weir and their net loss from downstream (Figure 2). It may also be a product of the relatively steep gradient found in this section of the channel, probably resulting from historic river diversion when the mill was constructed.

Photo 1 Downstream of the weir, faster flowing riffle and glide habitat with water crowfoot present.

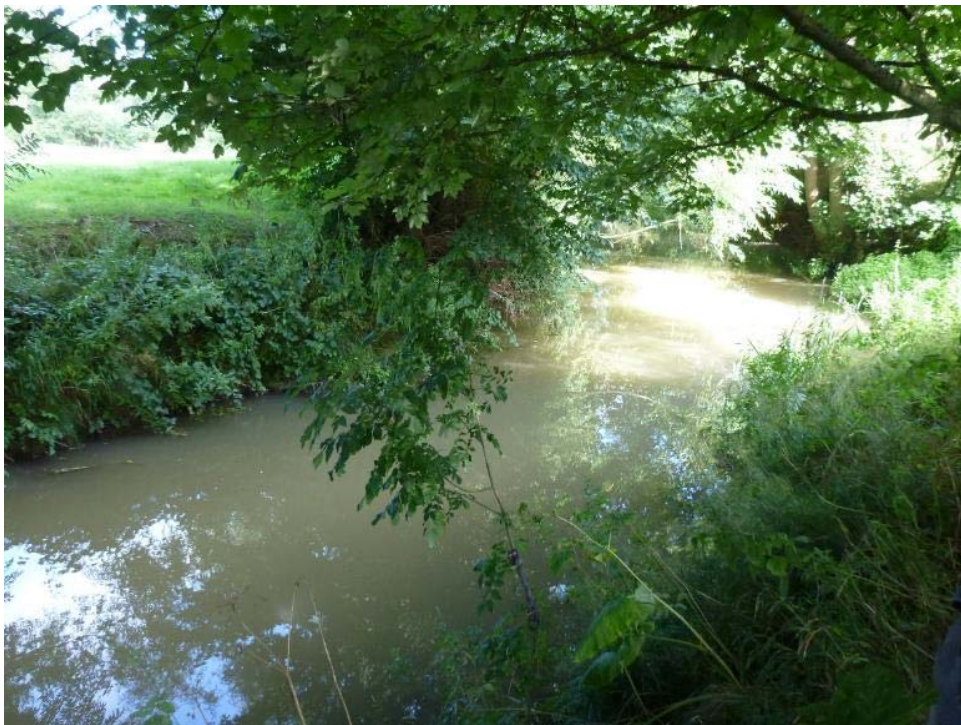
A small tributary (Pig Brook) enters on the left bank and below this, the gradient of the river lessens and the instream habitat becomes a slow-flowing glide (Photo 2). Land use on each bank is low intensity, being the grounds of the mill house on the right bank and a Guide camp on the left bank. The river has a nice balance of shade provided by bankside trees including willow, alder, ash and sycamore. Shade provides an important role in keeping water temperatures down during low flows and hot weather, an important consideration for fish such as trout which has a maximum temperature tolerance in the low to mid-twenties Celsius.

Photo 2 Slower glide section.

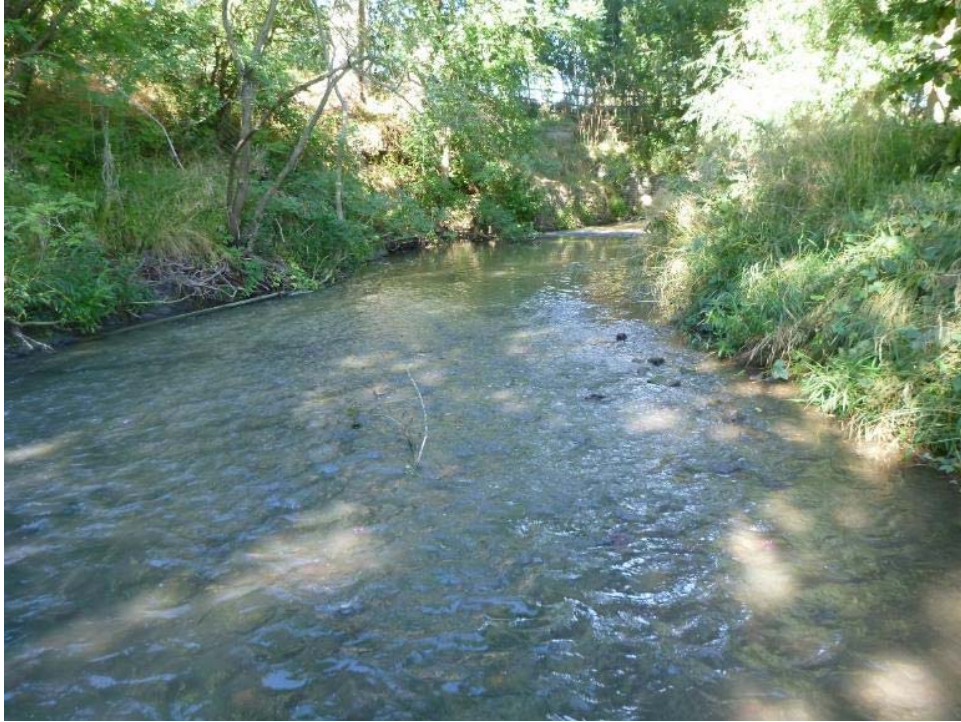
Photo 3 Downstream of the slow glide section, the gradient increases and a pool-riffle sequence establishes.

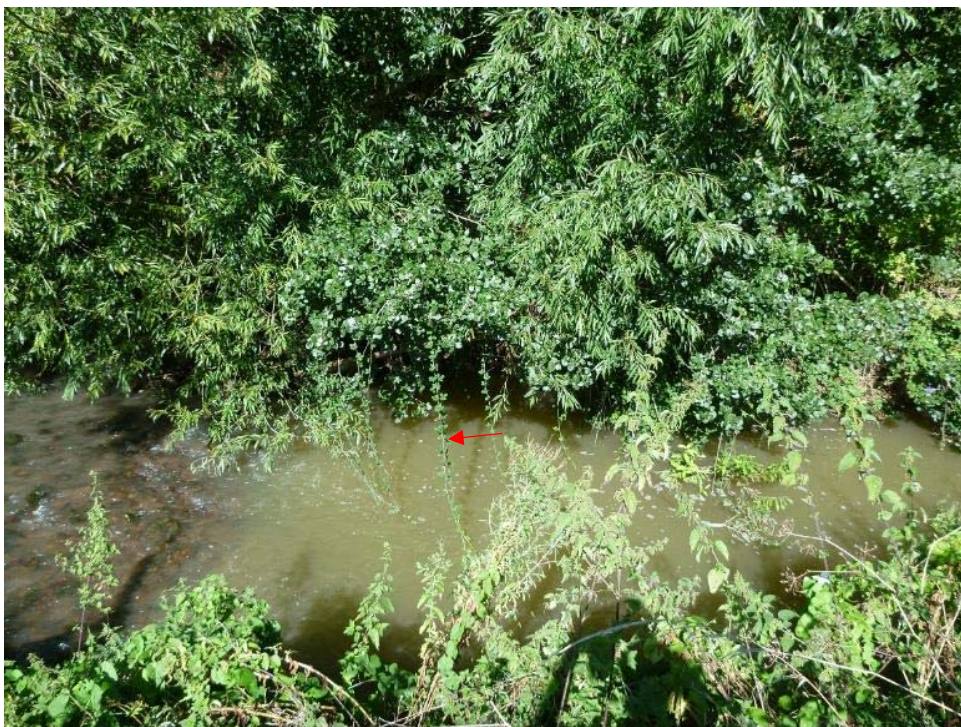
Photo 4 Good low cover over the water which should be retained. Trimming trailing brambles (arrow) to facilitate casting is not a problem, but resist the temptation to cut back the branches.

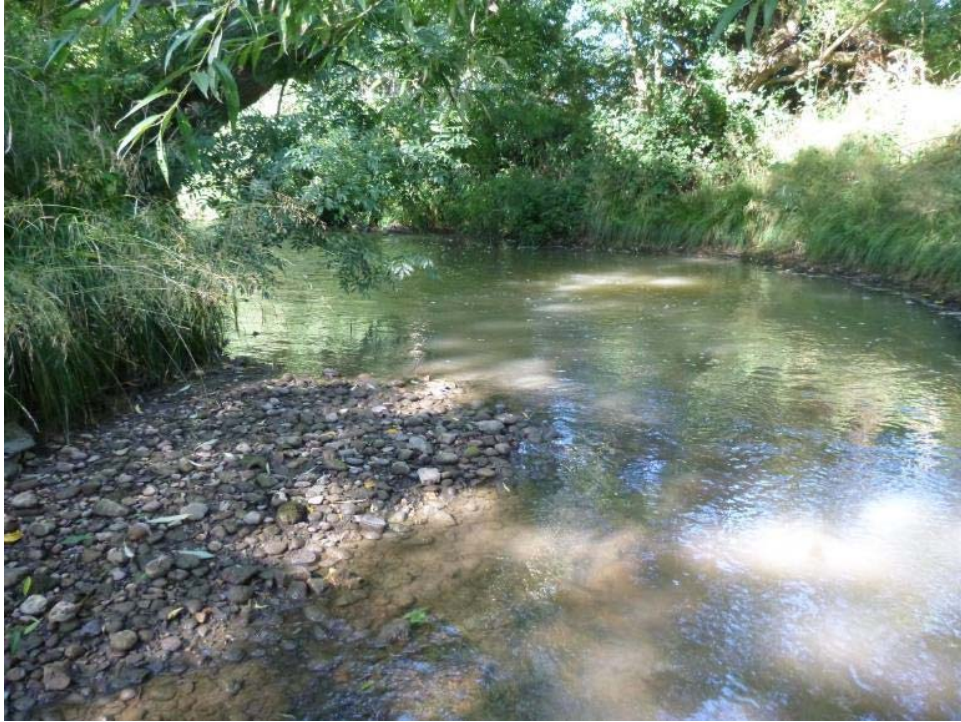
Photo 5 Nice instream habitat: a pool on the outside of the bend with a gravel shoal on the inside.

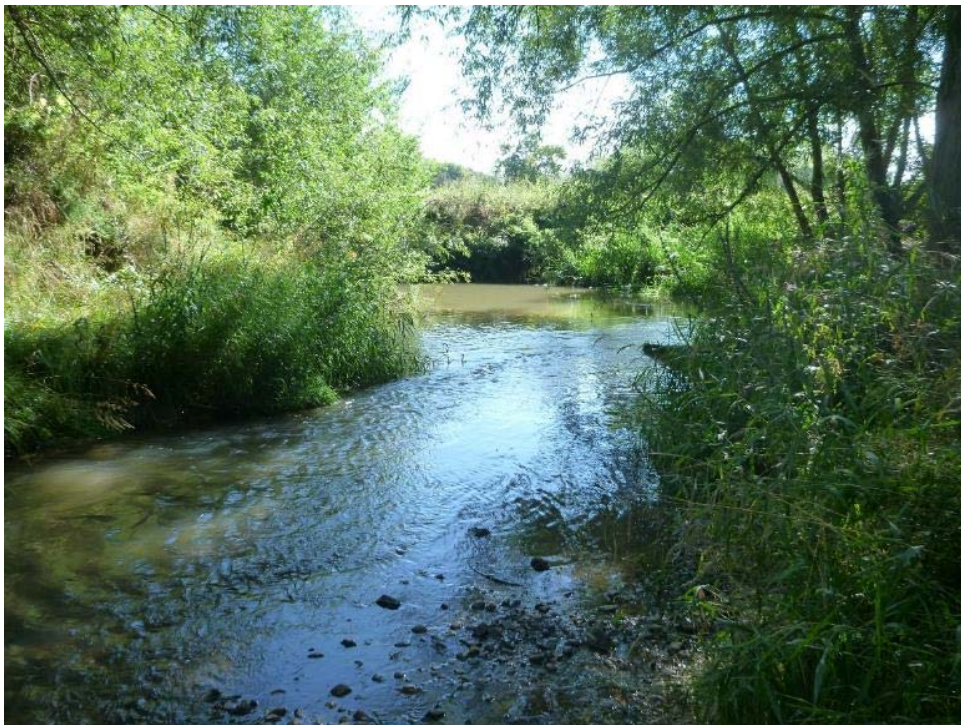
Photo 6 Another nice riffle leading into a pool on a bend.

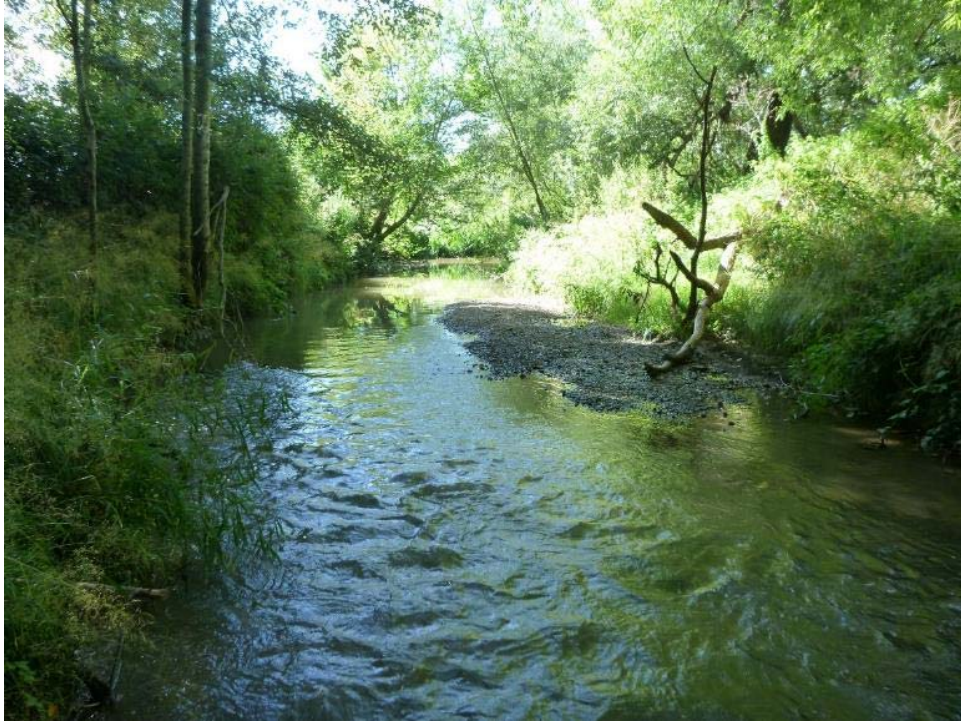
Photo 7 Gravel of a suitable size for trout spawning, towards the downstream end of the reach. Its deposition here may be a product of a less-incised bankfull channel.

Gravel of a suitable size for trout spawning (10 – 40 mm diameter) is present towards the downstream end of the reach, possibly reflecting an increase in the cross-sectional area of the bankfull channel; this increased channel capacity may facilitate the settling out of the finer gravel particles in flood flows.

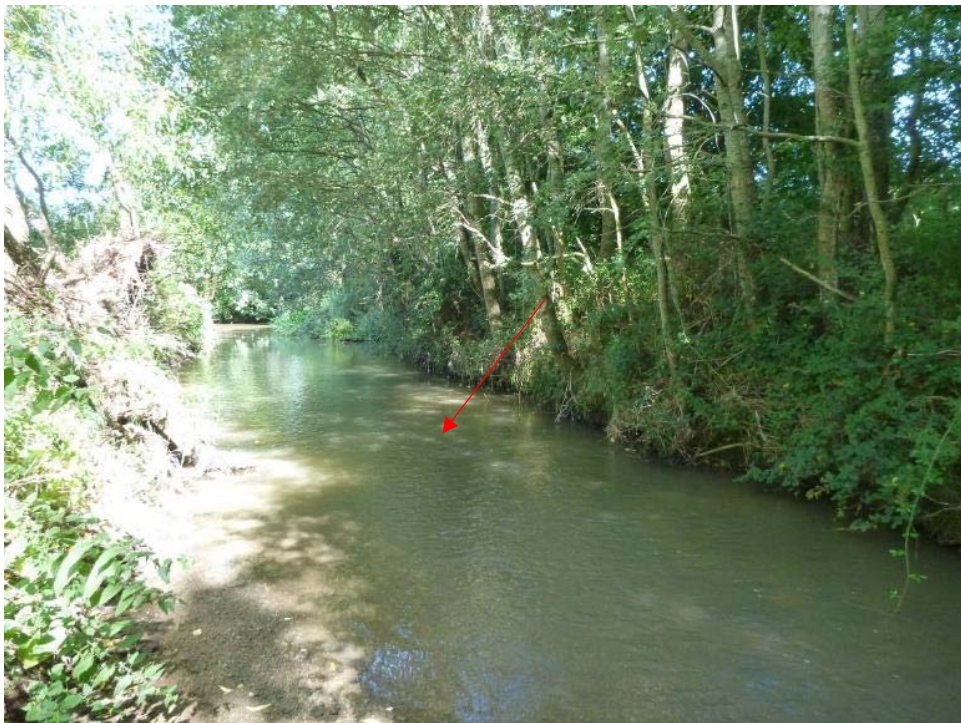
Photo 8 Shallow gravel glide which would benefit from some large woody material.

At the downstream extent of the reach (Photo 8), there is a relatively straight, shallow, gravel-bedded glide. This area would benefit from the introduction of some large woody material to diversify the flow and depth profile. There are ample trees on the right bank which could be hinged and pegged in place to achieve this (see recommendations).

- Remove the gabion dam at the downstream end of the mill leat. See if natural gravels are exposed. If not consider introducing areas of 10 – 40 mm diameter gravels.
- Retain the current level of shading of the channel. Have a light touch when it comes to tree maintenance and creating access for angling. Retain low cover over the water.
- Introduce some large woody material to the river channel in selected areas, for example the shallow glide in Photo 8. Figure 4 shows the type of effects which can be promoted by careful placement of woody material. Trees can be partially cut and hinged over into the channel (Photo 10), providing a robust anchor point. Additional fixing with stakes and wire can also be used.
