**Advisory Visit
River Terr, Nounsley, Essex
27 July 2017**

1. Introduction

This report is the output of a site visit to the lower part of the River Terr, near Nounsley in Essex, by Rob Mungovan, WTT Conservation Officer. The 3.32-km reach of channel inspected runs from National Grid Reference TL 7863410743 down to TL 79471089925. The request for the visit came from Mr Ben Norrington, Fisheries, Biodiversity and Geomorphology team (Fisheries), Kelvedon Office. Mr Norrington is keen to maximise the river's potential as a spawning ground and nursery tributary for both brown trout and coarse fish species that ultimately drop back into the River Chelmer. Angling takes places on both the navigation and the River Chelmer.

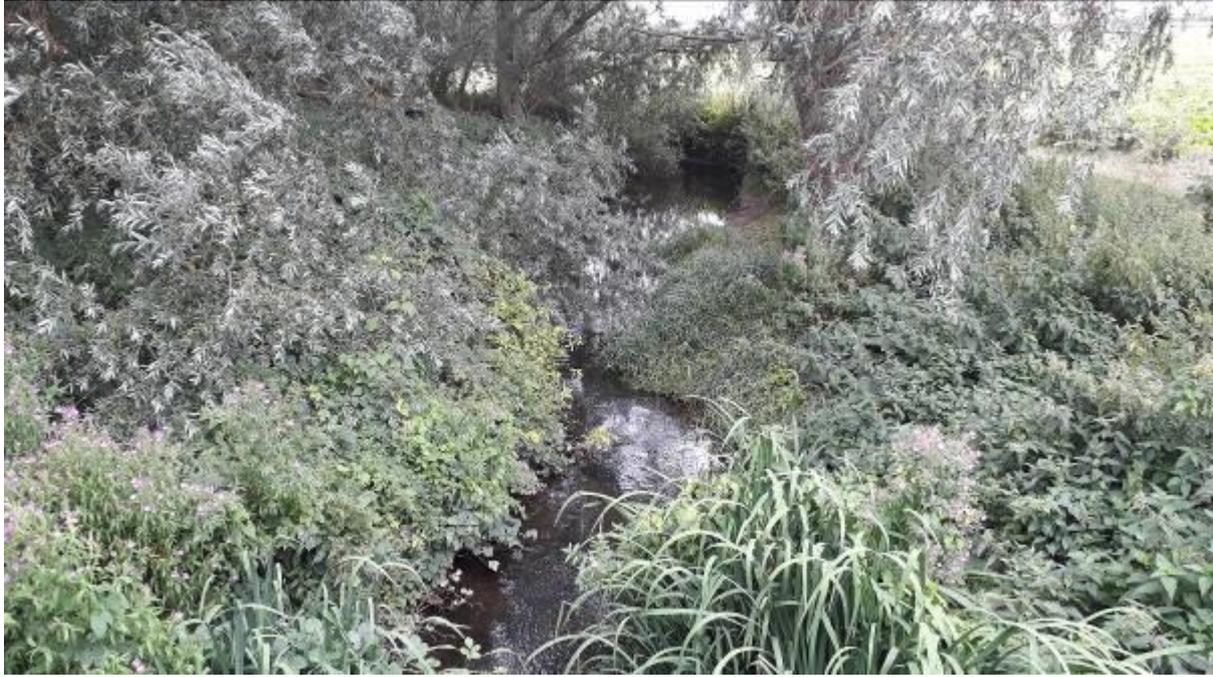
Habitat quality within the River Terr was considered to be good with a mix of gravel riffles, glides, deeper pools and shaded reaches with an abundance of fallen woody material (photo 1).

Photo 1 – The natural form of the River Terr downstream of Crabb’s Bridge; note the narrow gravel bed and marginal plants.

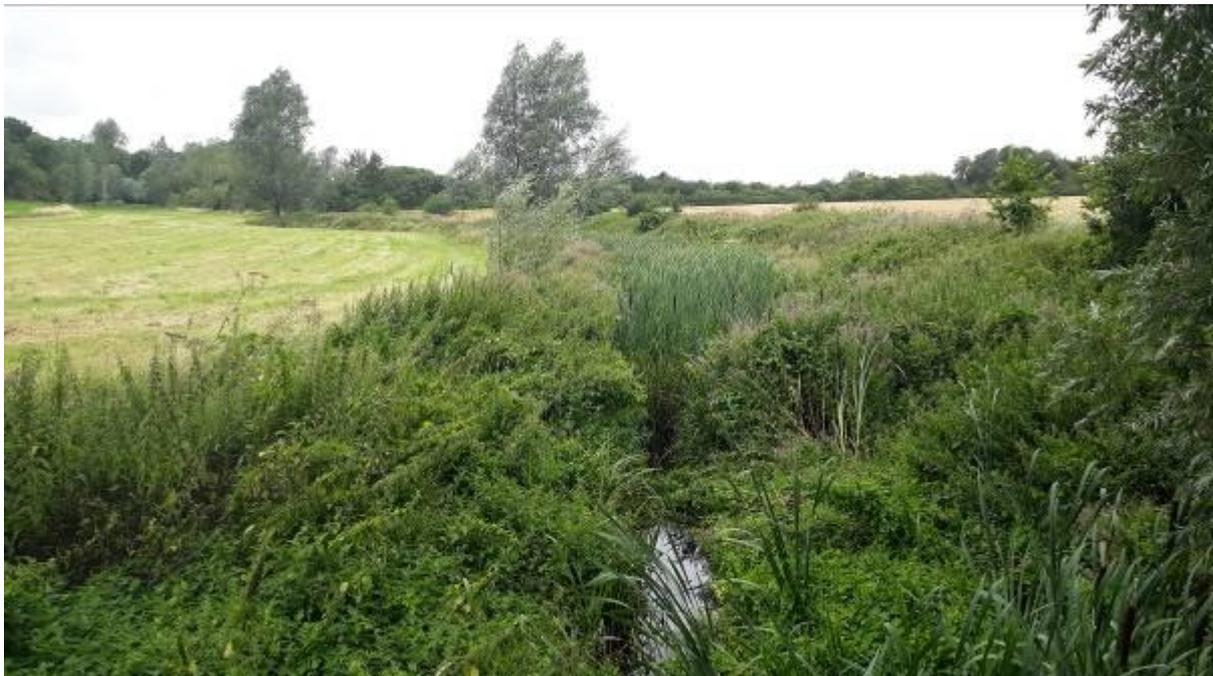
Photo 2 – View from Crabb’s Bridge looking upstream. Note the over-deep channel which is leading to the excessive growth of in-channel reedmace.

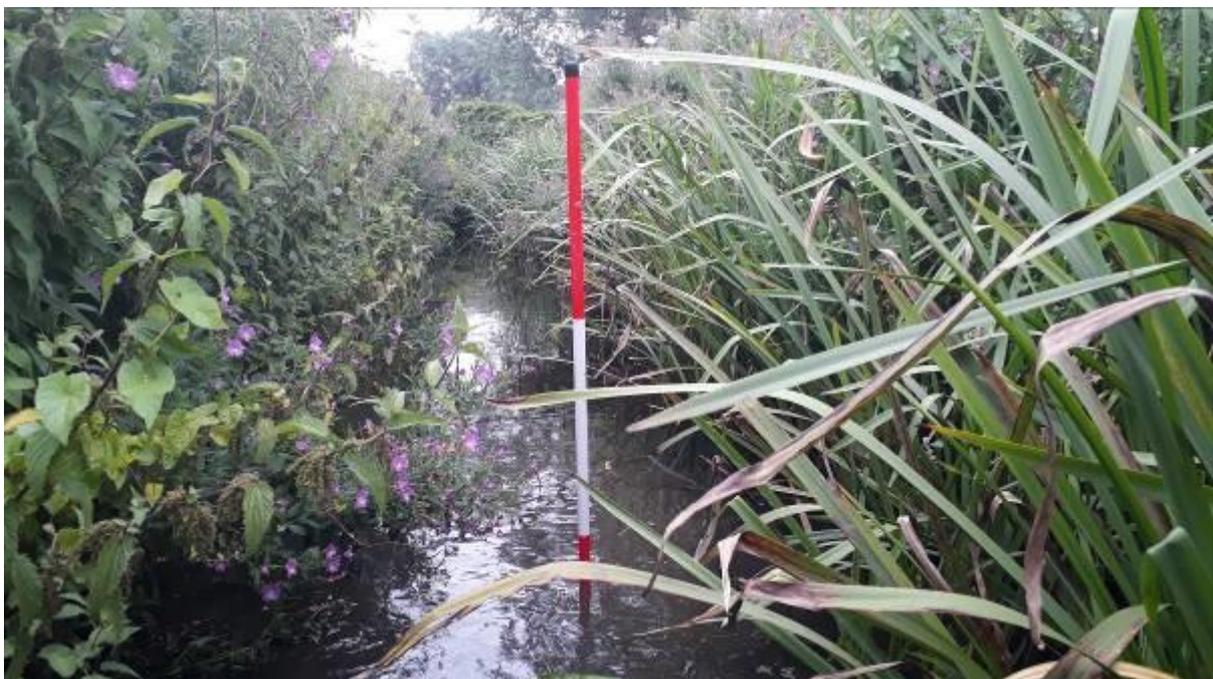
An EA gauging station is present at TL 7864010743. The structure first appeared on the 1:2500 OS Plan map dated 1965 (www.old-maps.co.uk). Comparison with an earlier map dated 1953 showed that to construct the station, the channel was realigned above it. The channel downstream of the station is significantly over-deep and over-capacity when compared to other parts of the river, this is indicative of a river that has been over-dredged. Consequently, there is now 230m of degraded river between the station and Crabb's Bridge (photo 2). The creation of an over-capacity channel has created a channel that is no longer able to naturally maintain its capacity leading to uniform deposition and the subsequent colonisation of that material with emergent vegetation. This reach of river is almost entirely overgrown with bur reed and reedmace, creating an ongoing maintenance burden for the EA to prevent the gauging station from becoming drowned-out (photos 3 & 4).

Photo 4 – Note that in places a channel is cutting a path through the dense vegetation but remains deep with fine sediment building up.

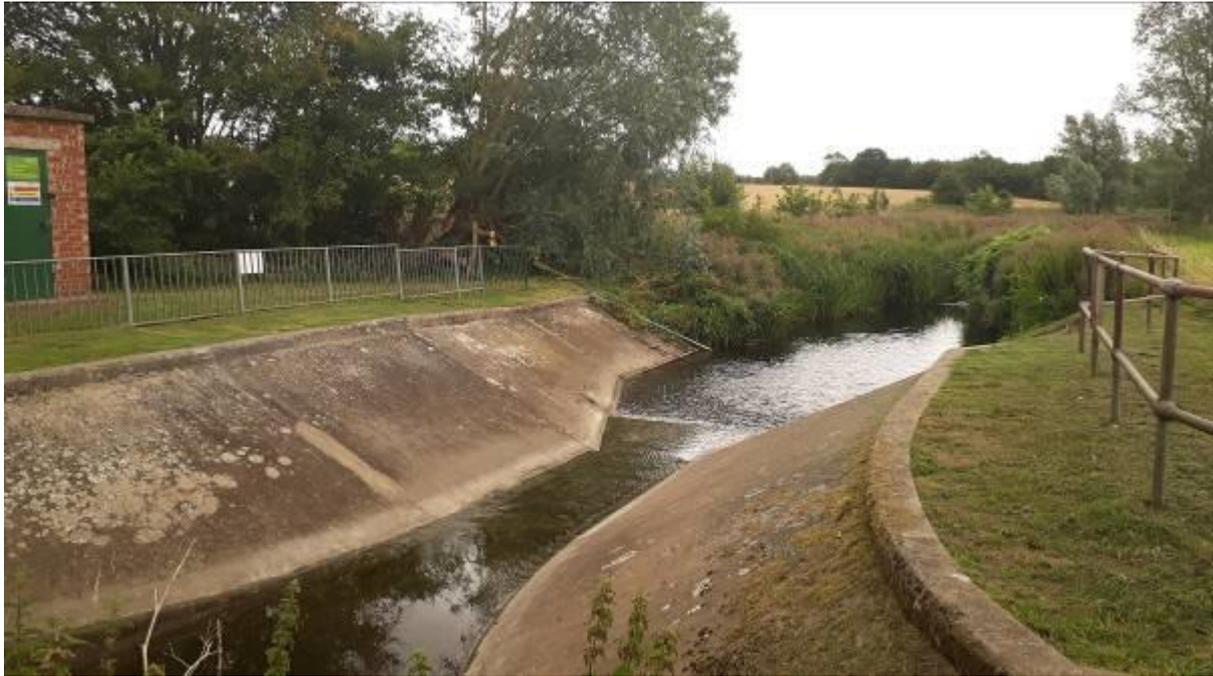
The raised, fixed cross-section created by the gauging station (photo 5) also impounds flow u/s, although the extent of this was not investigated as part of the visit. Additionally, the realignment of the channel and its impounding effect prevent the natural movement of coarse material downstream (photo 6), and hence the channel upstream of Crabb's Bridge has over 0.5m of sand and silt on its bed for much of its length.

Photo 5 – EA gauging station which degrades the River Terr and poses an obstacle to the movement of fish and prevents the natural transport of sediment along the channel.

- Address poor habitat and excessive vegetation growth at the EA gauging station. Firstly consider if the gauging station could be removed and replaced with a form that does not require a head difference (such as electromagnetic flow measurement). Secondly, seek a more sustainable solution to channel clearance, and one that also provides brown trout spawning habitat through river restoration.

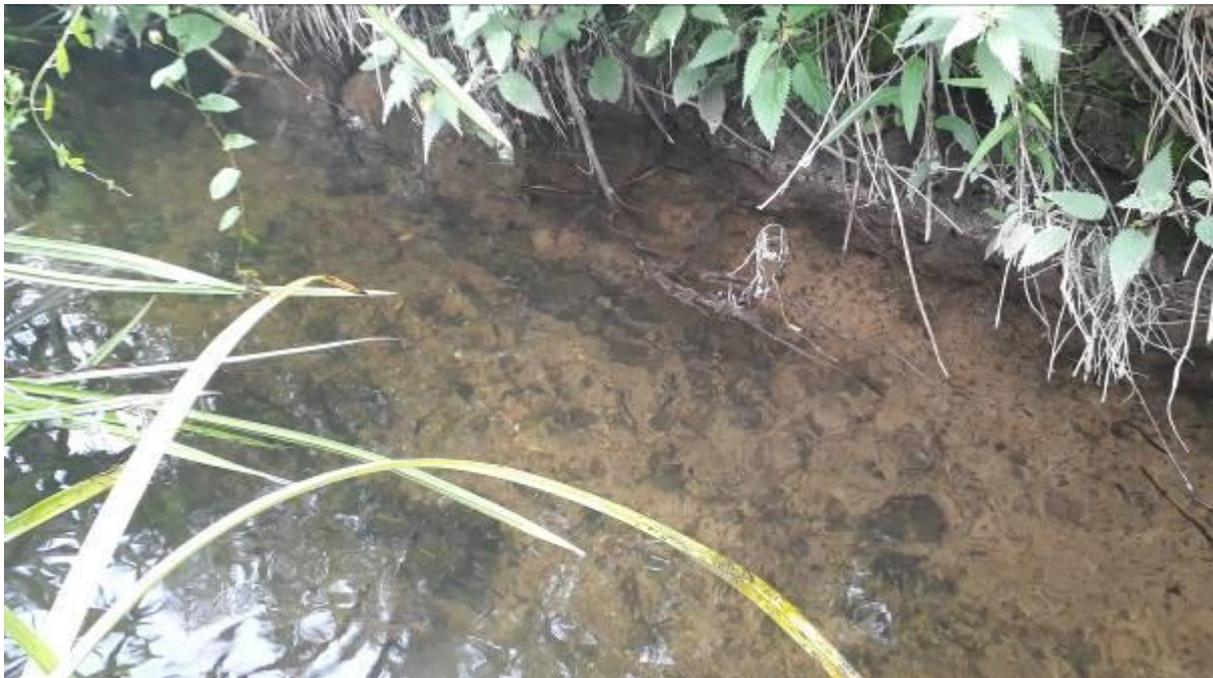
Photo 6 – Note the exposed clay bed containing very little coarse substrate. This does not present suitable spawning habitat for brown trout nor many coarse fish species.

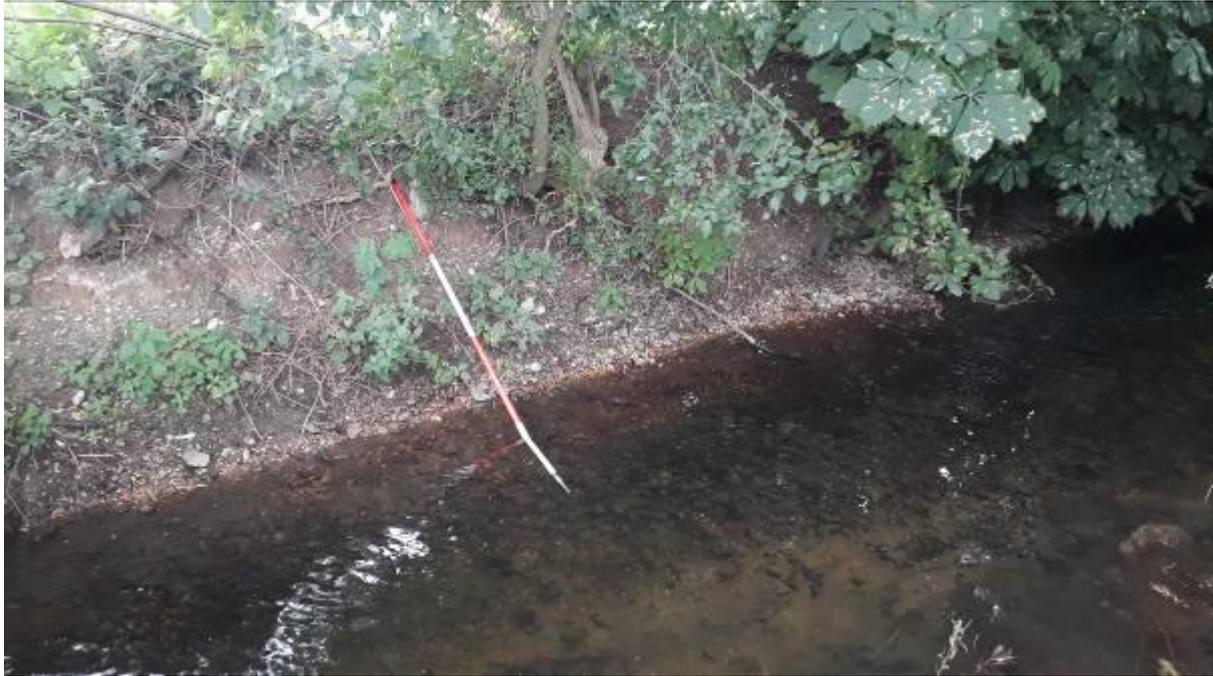
Photo 7 – Note the seam of gravel and cobbles that can be supplied to the river through the natural process of erosion. The presence of coarse material within a river's banks allows more rapid natural recovery after a period of maintenance when such material may have been removed from the river channel.

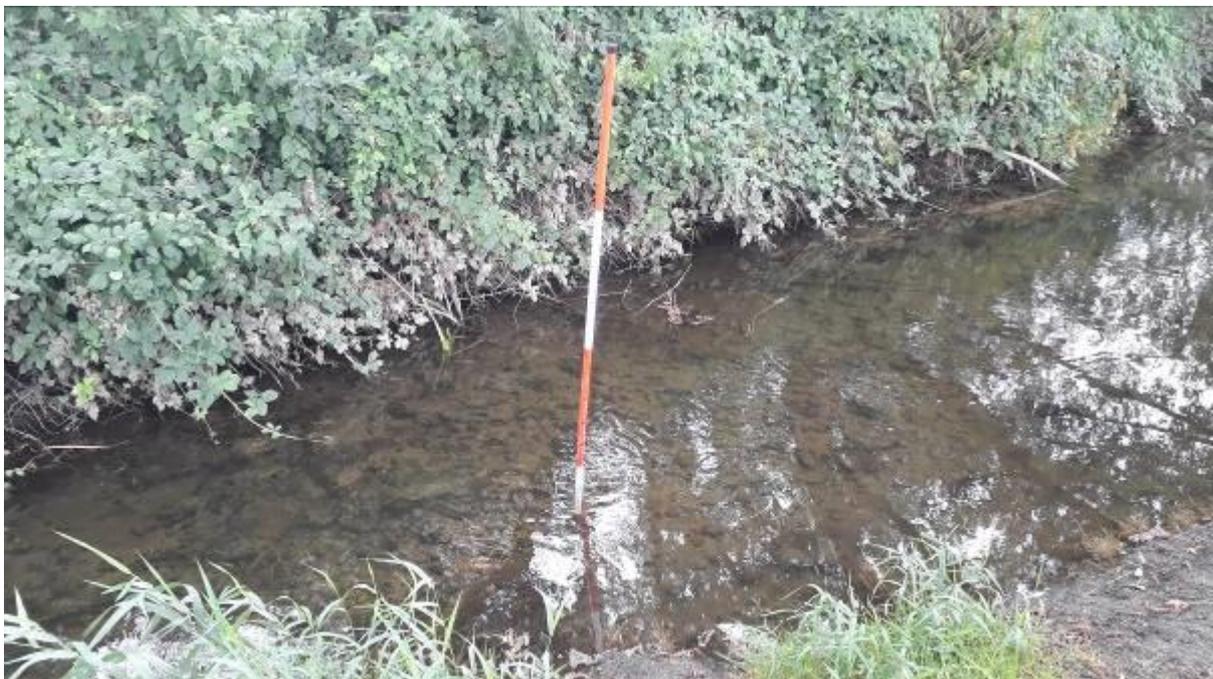
The River Terr exhibited a number of clean gravel riffles but the depth of gravel forming the riffles was often less than 0.1m; as such the success of spawning trout may be limited (especially of large sea trout) as female fish must have a suitable depth of gravel in which to cut their redds. Other gravel accumulations contained a fair amount of fines and clay particles (photo 8).

Photo 8 – Note the fine sediment starting to accumulate where the channel is over-wide for the velocity experienced. This location (with light) would be suitable for narrowing using a brushwood ledge.

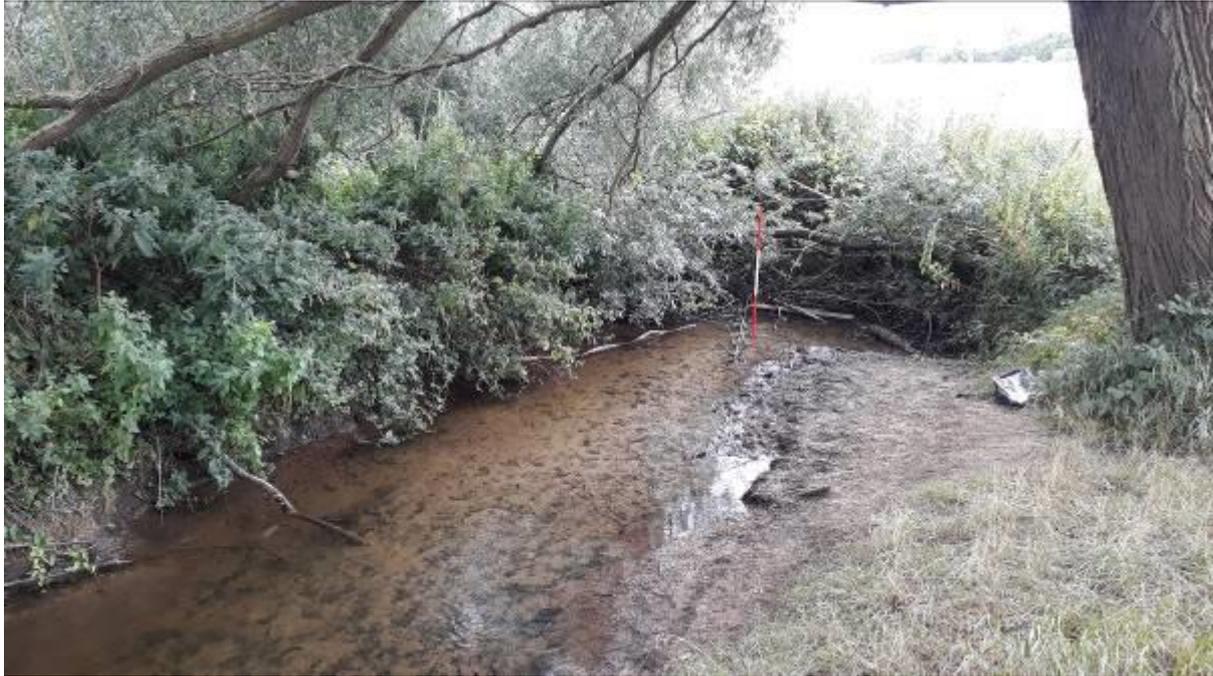
Photo 9 – Note the extent of sand and silt that has accumulated in response to the debris dam just downstream. This debris dam should be managed to ease some flow through it which in turn may draw-off some sand and silt from this impounded reach. However, measures should also be taken to address the upstream supply of sand and silt to the river thus potentially negating the need to adjust this type of feature.

Where full channel width debris dams have formed, it is recommended to cut out a narrow slot to avoid the debris dam becoming completely occluded with fine material where it may start to function as a weir. Where undershot flows are evident, they should be retained due to their value in creating natural bed scour (photo 11). A light touch is recommended and the general advice regarding fallen wood is to move and secure it if deemed a problem but never to entirely remove it from the channel.

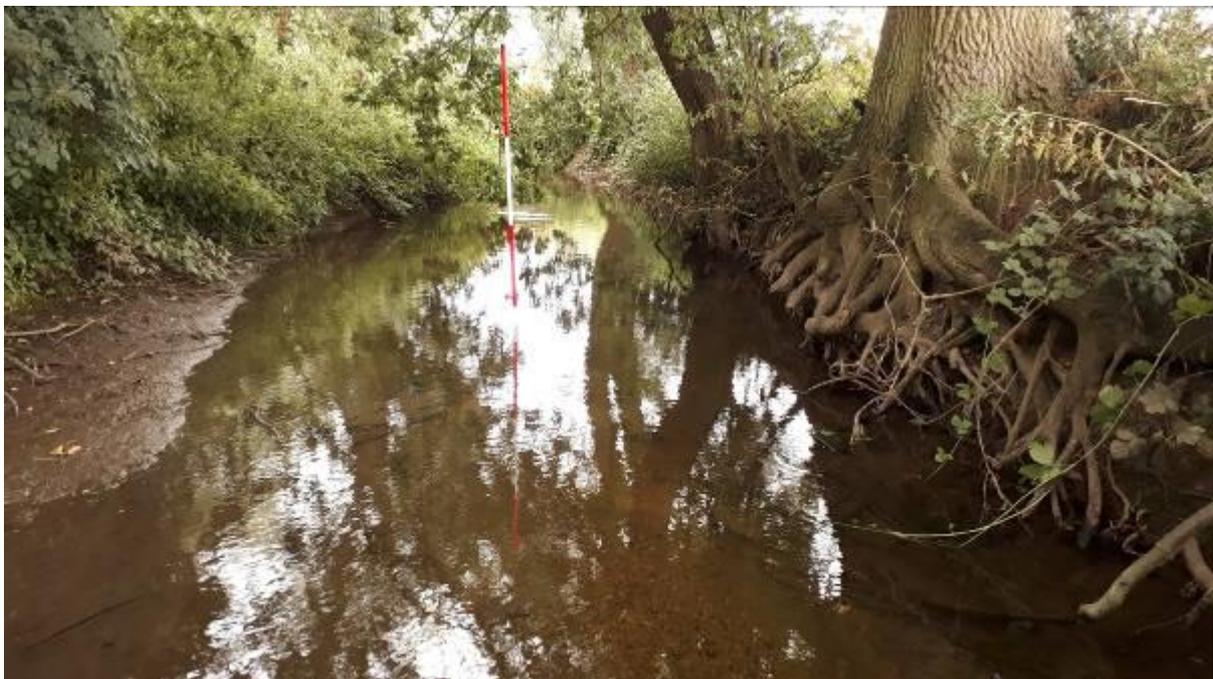
The cessation of maintenance in its entirety can bring challenges for a river. Areas that were previously deep and may have provided refuge for fish in hot periods can tend to shallow as a result of uniform infilling by sediment (especially sand in the case of the Terr, photo 9). Large woody material which is no longer removed from the channel can accumulate to form debris dams which in the case of small streams can have positive and negative implications, and the lack of tree and shrub management can lead to excessive shading of the channel, resulting in poorly vegetated banks and margins which no longer entrap fine sediment (photo 10).

Photo 10 – Note the exposed sand bar on the LB. The shade cast by the mature ash tree is suppressing riparian vegetation from colonising exposed sediments. In places a better balance should be sought. Where exposed tree roots are present they present excellent cover for fish.

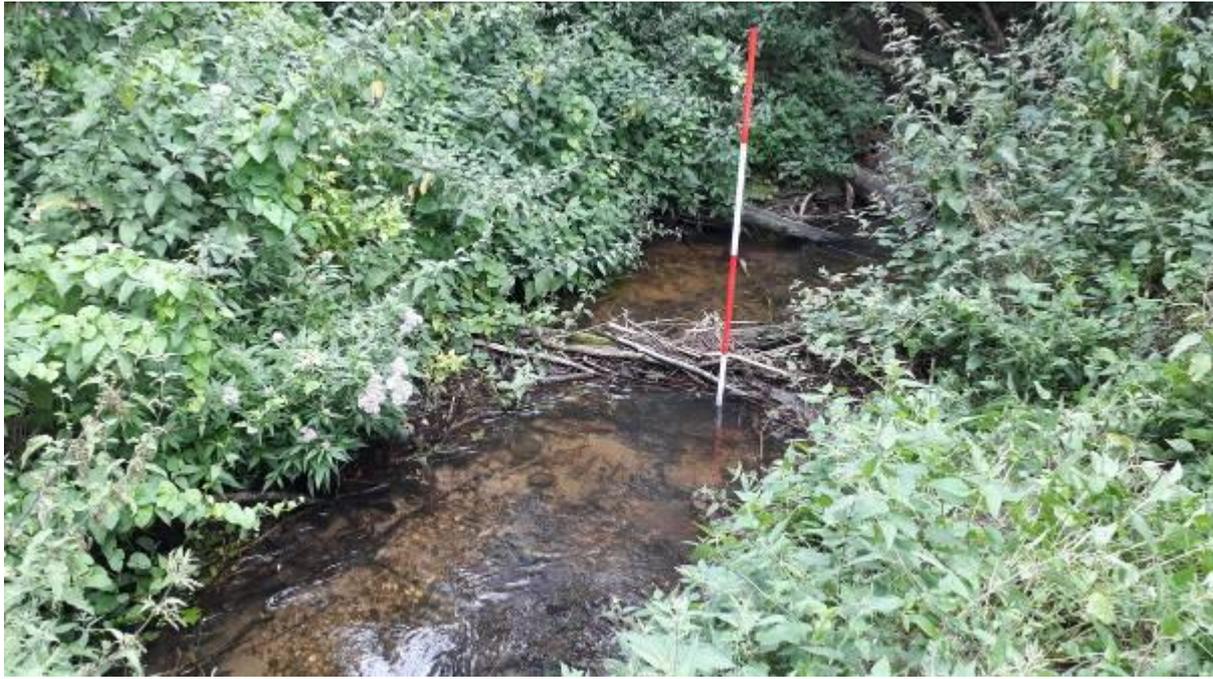
Photo 11 – This debris dam is only retaining a shallow head of water and creates an undershot flow which scours the bed downstream of it. This type of feature should be retained in its entirety.

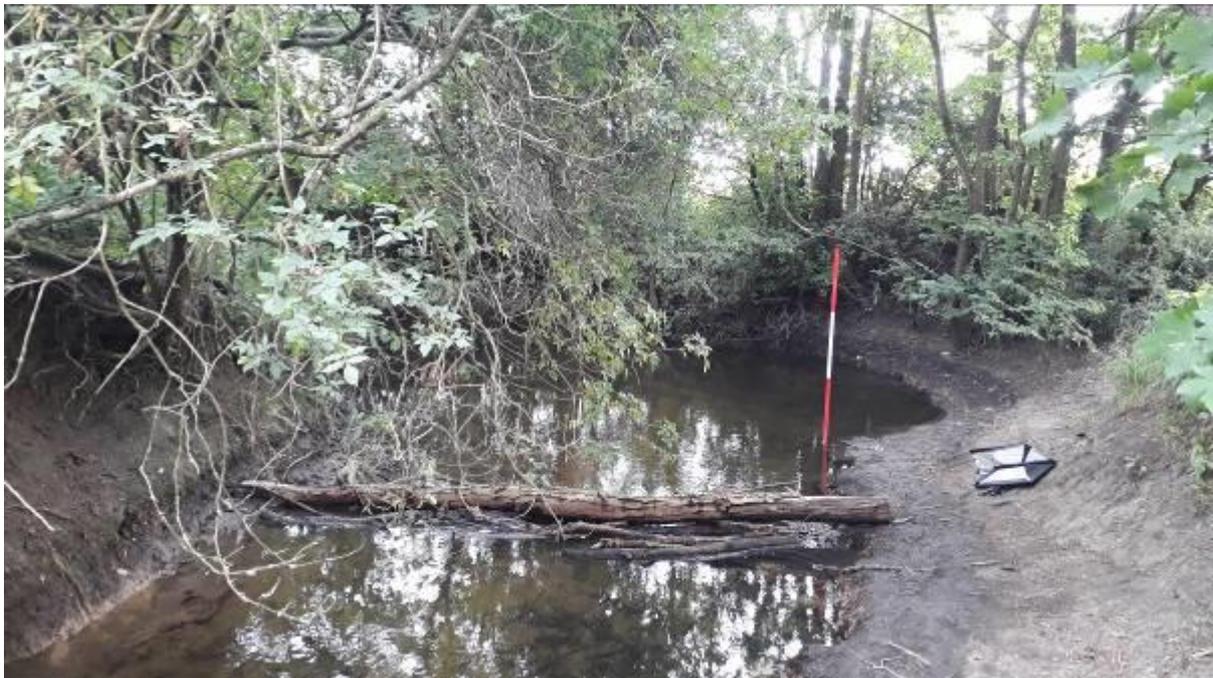
causing erosion to the banks resulting in increased levels of fine sediment entering the river (photo 12).

Photo 12 – This meander is becoming wider due to the impact of dogs and people sliding down the banks. The outside of this meander could be protected with brushwood topped with stronger timber to provide increased resilience.

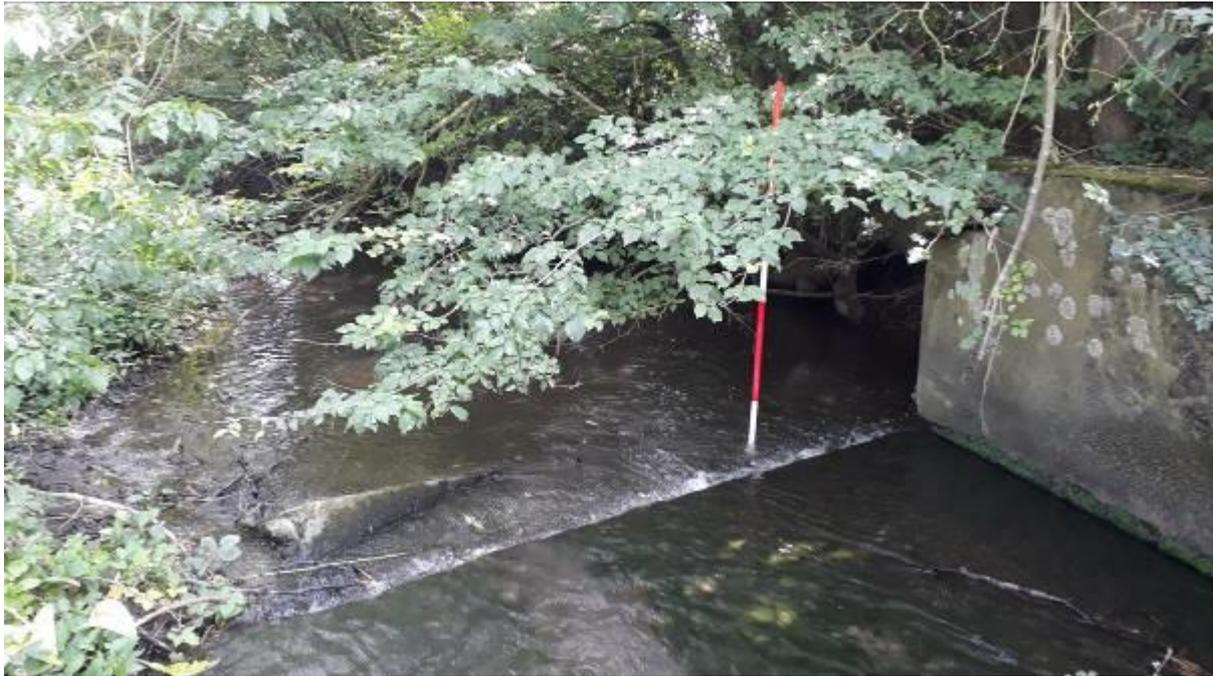
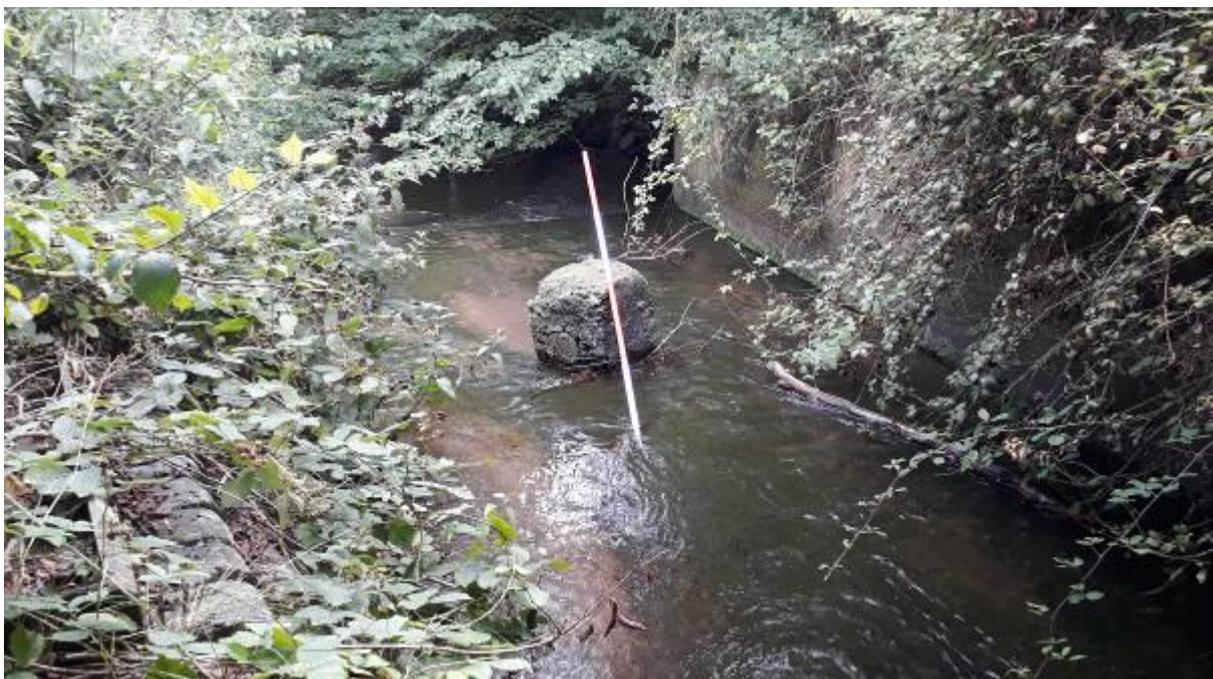
There is a weir located at TL 7926710299 and is believed to be a defunct gauging station. It first appears on the OS Plan map 1953 1:2500 (www.old-maps.co.uk). Whilst it is no longer in use, it is still holding back a head of water estimated to be ~0.15m. The concrete sill of the weir creates a smooth shallow flow which many fish species may find challenging to traverse. Conversely, on approaching the weir, a fish ~0.10m in length swam off the sill and was believed to be a juvenile trout.

The weir's form is unusual in that it turns 90 degrees making the total length of the concrete reinforcement to the bed ~8m. The downstream width of the weir was ~4.5m resulting in a dispersed flow which appears to have lacked the ability to scour any significant depth from the bed. The weir currently degrades the river (photos 13 & 14).

Photo 13 - The former gauging station weir, note the lack of any notable scour pool downstream of the structure.

Photo 14 - Due to the weir turning through 90 degrees it has a much longer concrete apron than most weirs of its size. If this weir serves no purpose then its removal should be sought.

Removal of the weir would return a natural form to the channel, ease fish movement upstream and aid the natural movement of sediment along the channel to assist the river's own natural recovery through geomorphic processes.

- Remove the defunct gauging weir.
- Undertake a detailed investigation to establish the extent of the obstacle presented by the ford to fish migration. A long-term objective should be to remove the ford and seek its replacement by a wide-span bridge thus enabling the restoration of the river beneath it. If the ford cannot be removed then modification to aid fish passage should be considered.

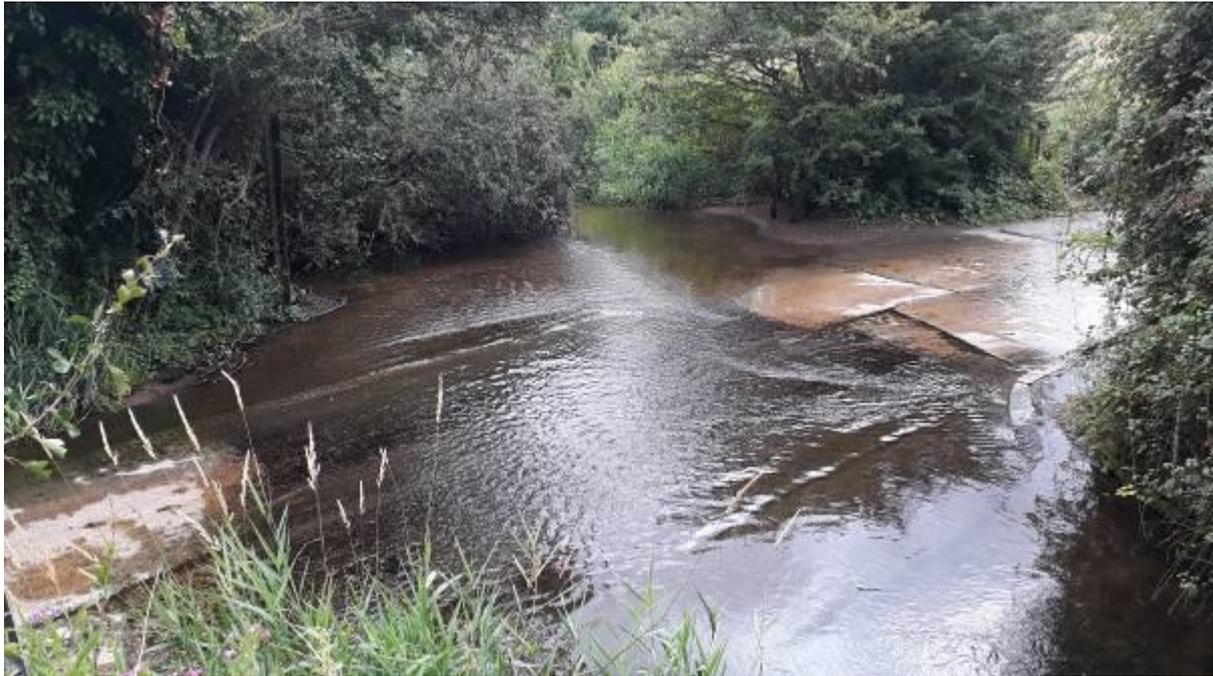
At Nounsley Road, a concrete ford crosses the river (photo 15). Fish were observed upstream and downstream of it. The visit took place during a period of low flow and it was doubtful if fish would be able to pass it. In high flows the ford may also become impassable to fish. Only at certain water levels and velocities would the ford be passable to fish. Optimal flow conditions to allow fish passage may not be experienced very often. Replacement of the ford with a wide-span bridge would enable a natural channel to be re-established.

Photo 15 – The active ford near to Nounsley village. In low and high flow conditions this ford represents an obstacle to the movement of fish. The replacement of this ford with a wide-span bridge should be a long-term objective.

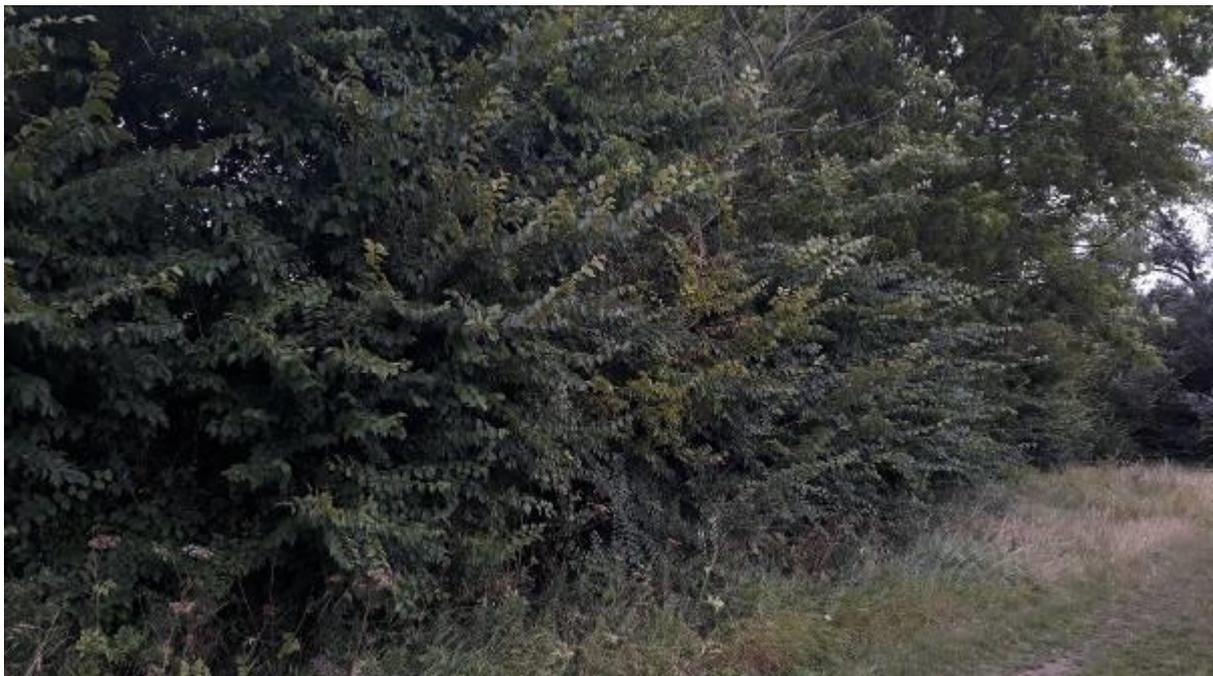
The majority of the channel was diverse in its general form but runs the risk of degrading as the tree canopy closes in (photo 16). The presence of extensive willow tree roots was clear to see at many locations (photo 17). Only one alder tree with extensive roots was observed. There is no benefit in undertaking tree planting at present unless it was with alder in very carefully selected locations. A number of mature oak and field maple trees added interest to the river. Whilst many parts of the channel were still dominated by an incised channel form, slumping had occurred in places and where light was able to reach the channel vegetated margins were forming.

Photo 16 – In places the hedgerows adjacent to the river are becoming tall lines of trees. This causes significant shading of the channel and can lead to the situation where if no one can see the river, then no one cares for it.

- Establish a tree management plan and create a coppice regime that allows light to parts of the river (ideally over the riffles whilst retaining shade over the pools). Look for opportunities to “hinge” leaning marginal trees so as to provide secure marginal cover at water level.

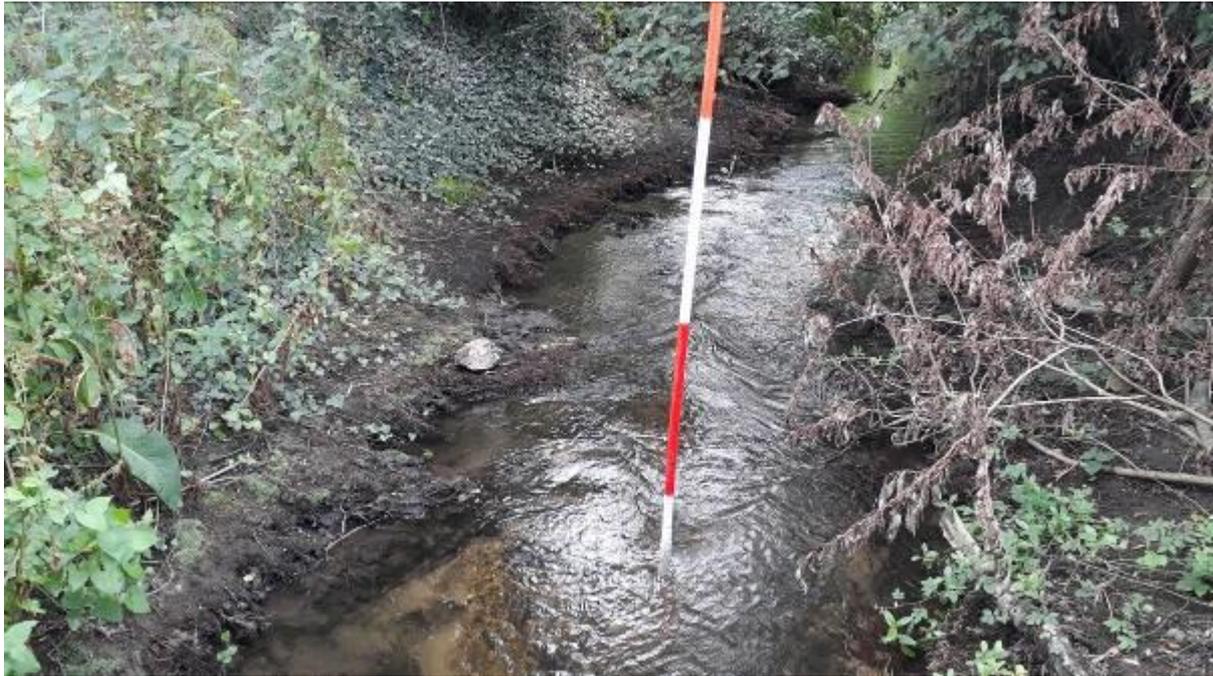
Photo 17 – Note the natural channel narrowing provided by willow tree roots. This is very useful for providing bank strength, juvenile fish cover and invertebrate habitat.

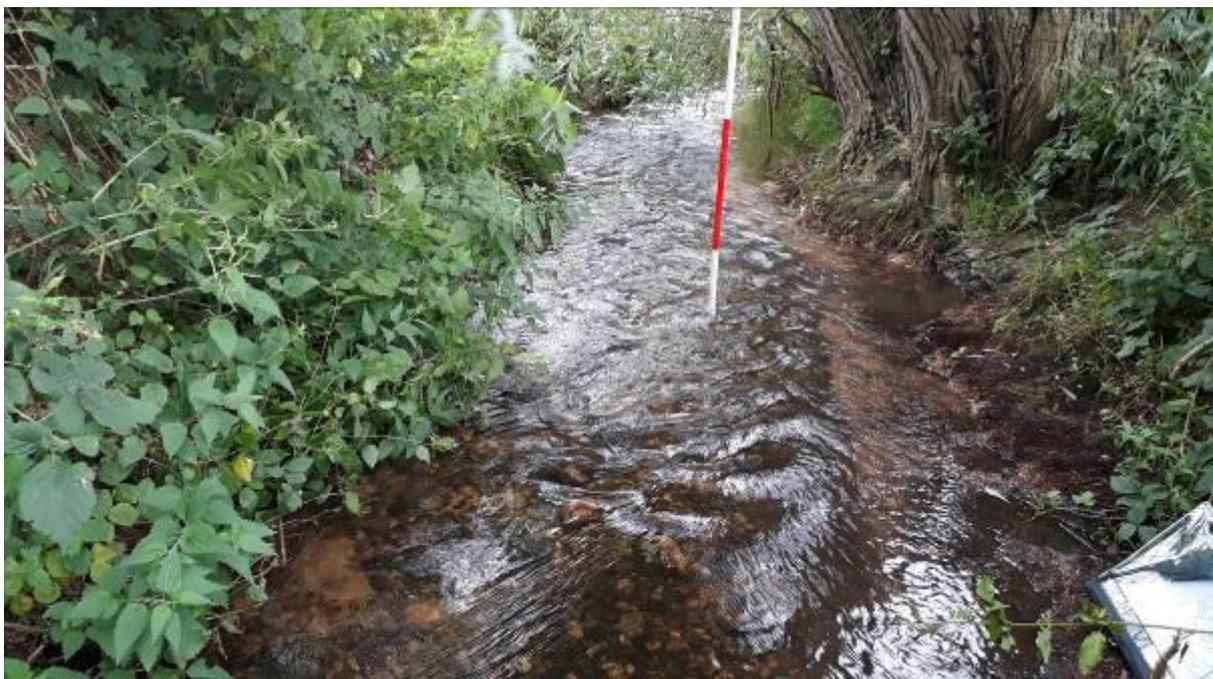
Photo 18 – This location had an excellent balance of swift flow, stable banks and an abundant coarse gravel bed substrate. This location would be suitable for brown trout spawning.

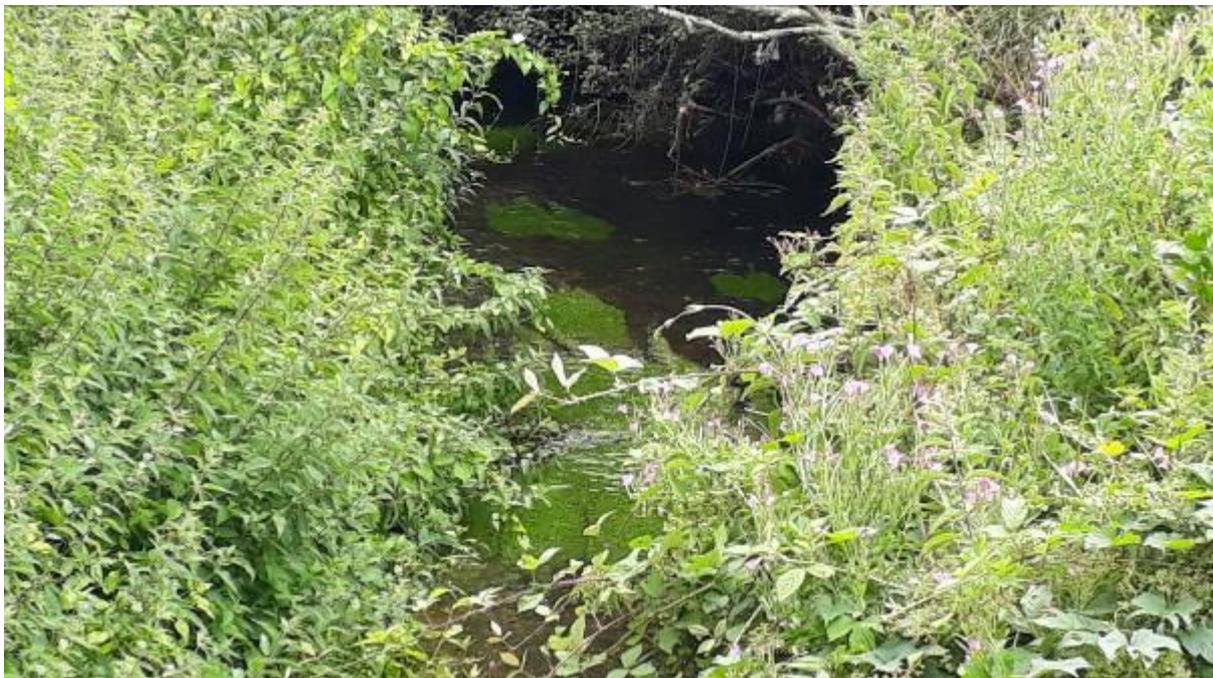
Downstream of Crabb's Bridge, the amount of in-channel vegetation was very limited. Occasional plants of starwort (photo 19) were observed, as were water lilies. The lack of aquatic plants is likely to be a combination of a firm bed substrate, high scouring flows and extensive shading. Marginal plants tended to be dominated by bur reed, greater willow herb, and pendulous sedge. There was occasional reed canary grass. These marginal plants provide important bank protection, as well as important habitat for a wide range of aquatic invertebrates.

Photo 19 – At one location the canopy was open and flow rate not too swift for starwort to be present. Other than at this point, the river had very limited submerged aquatic flora. Aquatic plants are important for water quality, fish cover and invertebrate habitat. Measures such as canopy opening should be undertaken to increase the amount of aquatic plants.

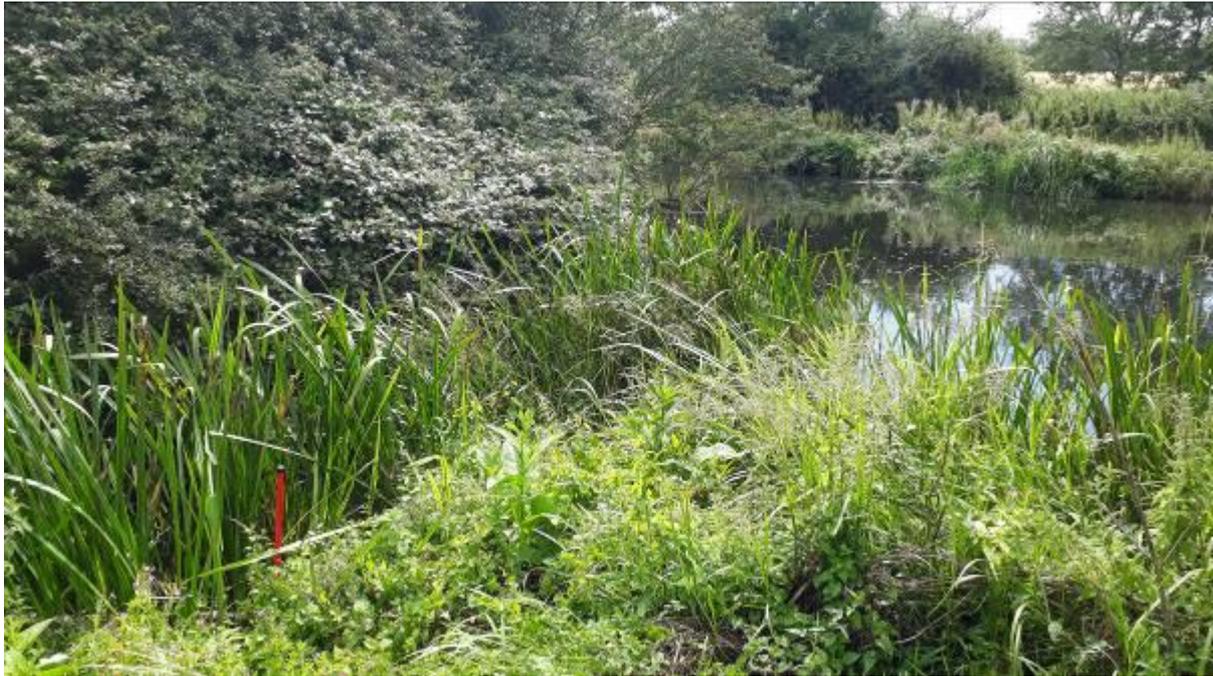
The River Terr becomes impounded due to water levels in the Chelmer and Blackwater Navigation for its last 175m (photo 20). As result of the impounded flow there is excessive in-channel bur reed growth. However, this impounded flow does not appear to restrict fish movement up into the River Terr.

Photo 20 – The River Terr immediately above its confluence with the Chelmer and Blackwater Navigation.
