Advisory Walkover
Thorner Beck, Wharfe Catchment
November 2018

1.0 Introduction

This brief report is the output of a site visit to Thorner Beck (GB104027063950), a tributary of the River Wharfe, W. Yorkshire. The visit was requested by Dr Marie Taylor (Project Officer, Yorkshire Dales Rivers Trust) for the 'Rivers in Elmet' project, and she accompanied Jonny Grey of the WTT on the walkover. A more comprehensive report has already been submitted for **Cock Beck** and the Recommendation details therein are useful also in the context of Thorner Beck.

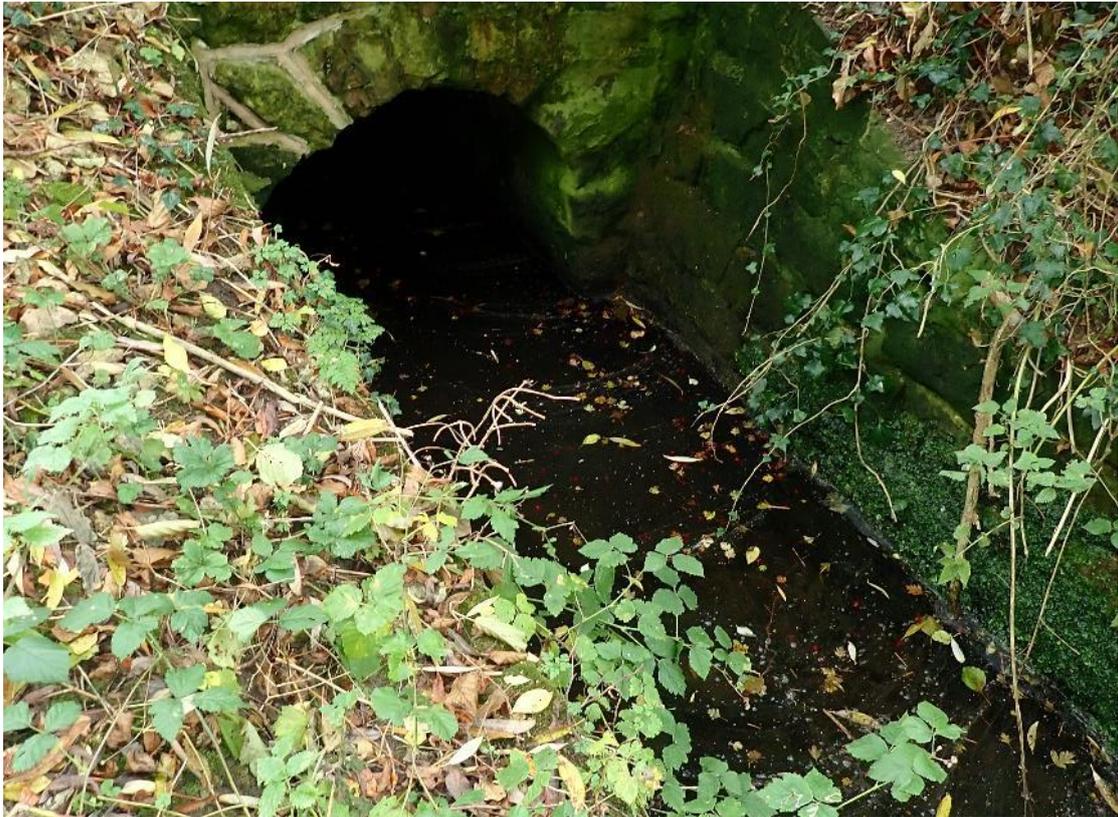
Fig 1. Thorner Beck at SE 37866 41165, where it emerges from under Milner Lane on the outskirts of Thorner village. Immediately upstream there appeared to be a series of online, (now) ornamental ponds within private residences and hence close observation was impossible. Access into and through this culvert was clear, but flow was very sluggish.

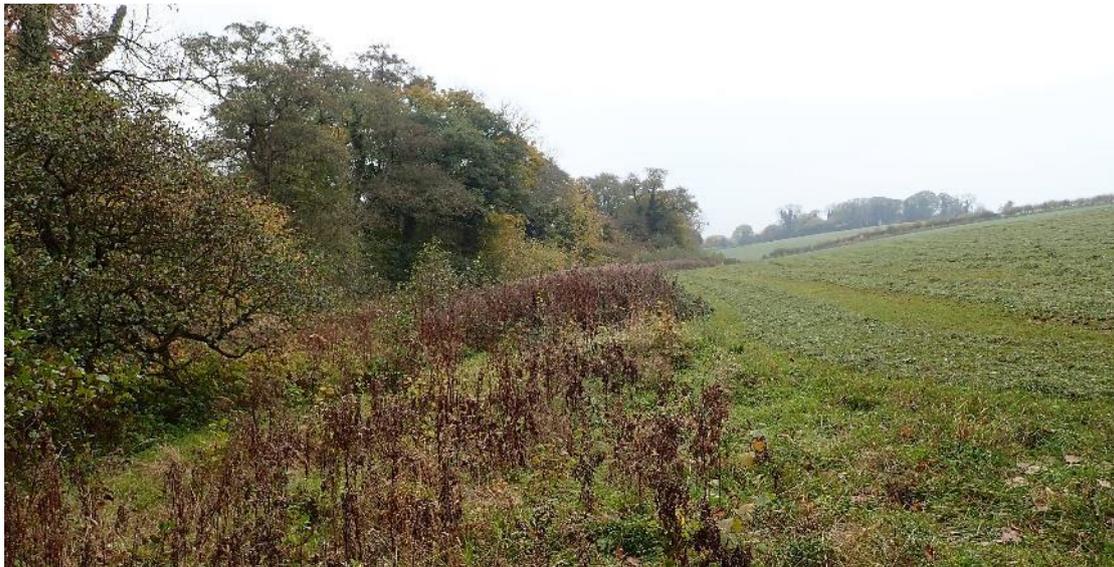
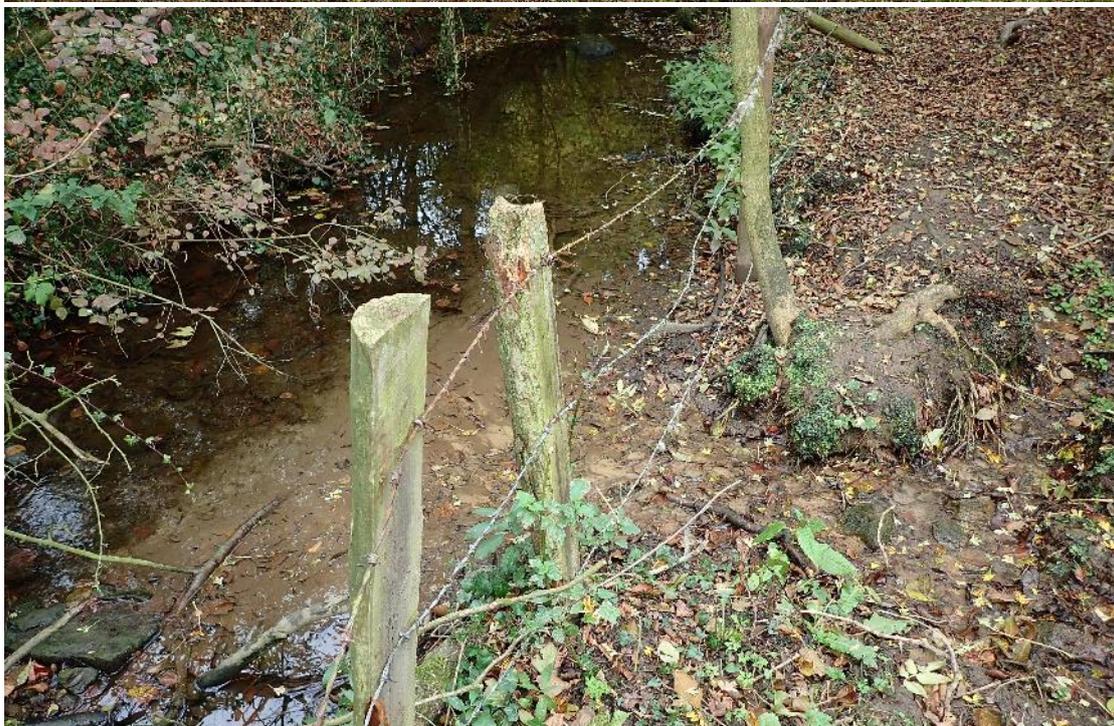
Fig 2. Opposing views of banks at SE 38082 41381. Upper panel depicts the LB, with an adequate, roughly vegetated buffer zone of 10-15m width protecting the beck from an arable field; amidst the diverse herbage were many apparently self-set alder and occasional ash saplings. Lower panel depicts a poorly protected section of RB with a dilapidated fence, in places actually within the channel, doing little to prevent fine sediment ingress from livestock (predominantly sheep) poached pasture. The fencing needs replacing to prevent any livestock access: if there is a requirement for watering, it should be adequately separated from the beck via mains, pasture pump or equivalent rather than drinking bays as the wet soils of the bank appear extremely susceptible to poaching.

- *Reinstatement or installation of riparian fencing and preferably removing the requirement for livestock drinking access by providing alternative means, or as a last resort, formalising approaches to cattle drinks / fords. Especially important on the upper & lowest sections (Figs 2, 6 & 17 but see note in legend of Fig 13). Reduces diffuse / point source soil ingress (pollution), thereby improving water quality.*

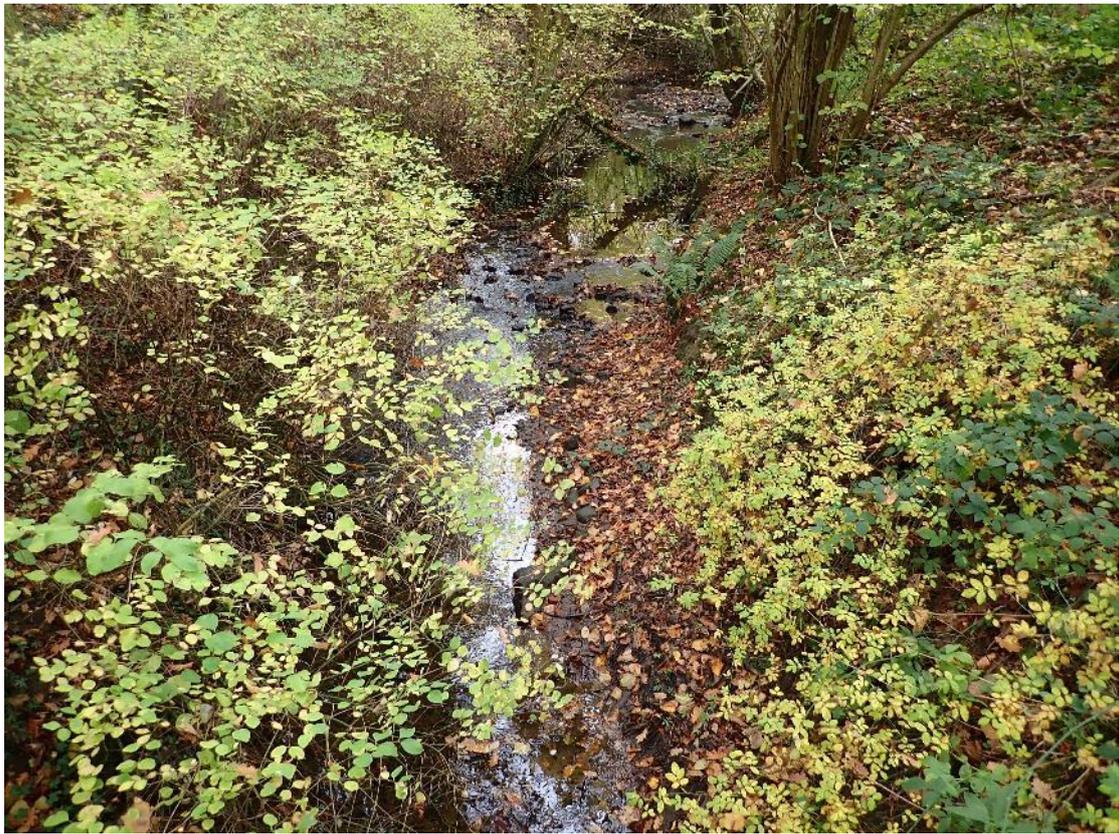
Fig 3. Where a footpath crosses the beck at SE 38292 41481, non-native snowberry was present on both banks and because it forms dense thickets preventing light penetration, it should be removed from the site.

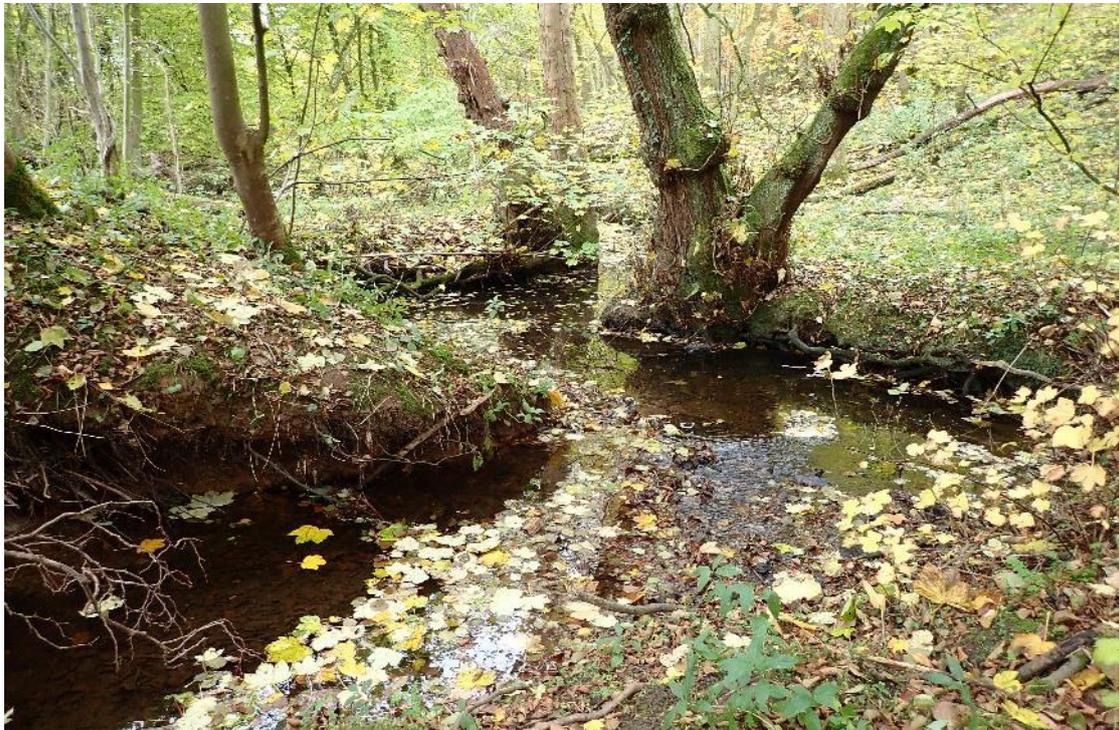
Fig 4. The channel in the wood d/s of the footbridge appears to have re-naturalised, maintaining a meandering path aided by the presence of mature trees and their root masses at the toe of the bank, and via log jams and natural woody debris. However, any lower gradient sections were smothered with fine silts, presumably originating from the arable and pasture on the RB.

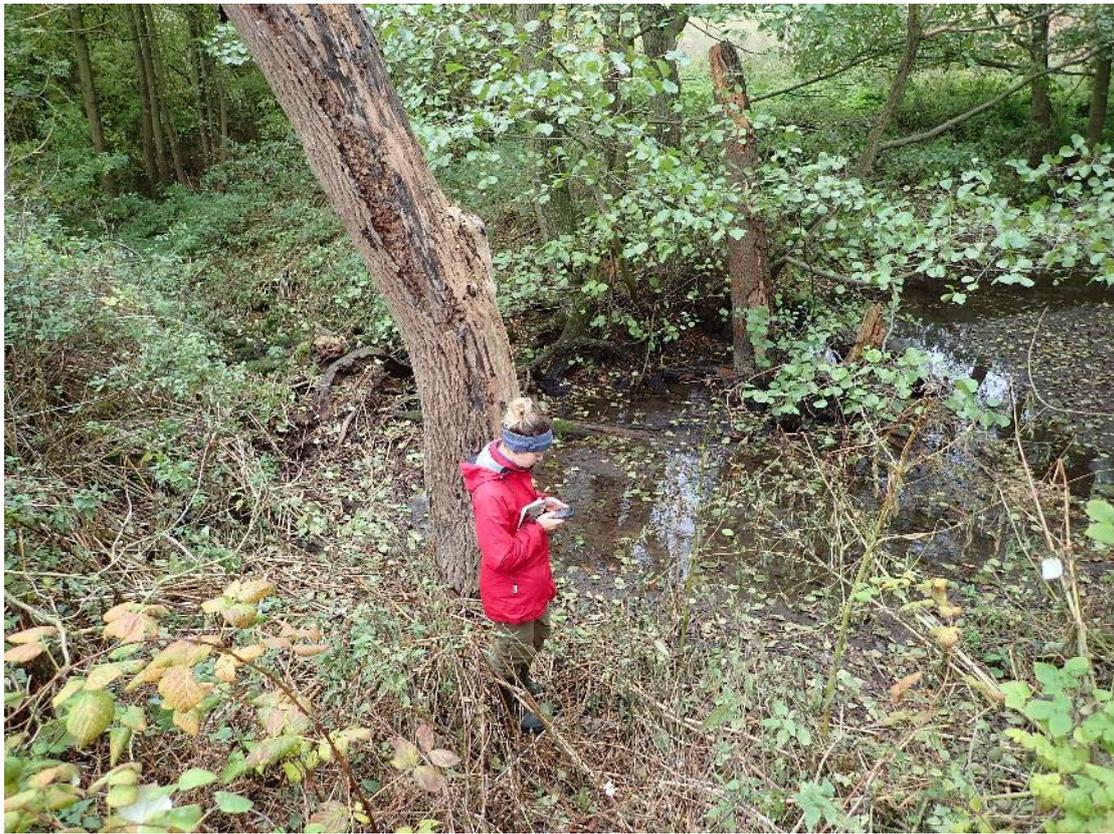
Fig 5. At SE 39182 41912, the remnants of a stone dam wall were evident which would have impounded a pool ~50m in length; the former silt bed remains very wet and mostly devoid of vegetative cover except for Himalayan balsam, raspberry, and nettle around the edges. The gradient of the beck was steep immediately d/s and large stones from the dam wall contribute to the bed substrate. More material could be removed from the wall remains to reinstate the natural gradient and better drain the soils u/s. Consultation of OS maps from 1850 onwards show kennels on the LB and a quarry on the RB, but no weir.

- *Use of the collapsed dam wall (Fig 5) and upper sections of the current water course and its natural channel (Figs 6 & 9) to formalise some leaky dams for natural flood management. The former dam is clearly still maintaining soils in a saturated state upstream.*

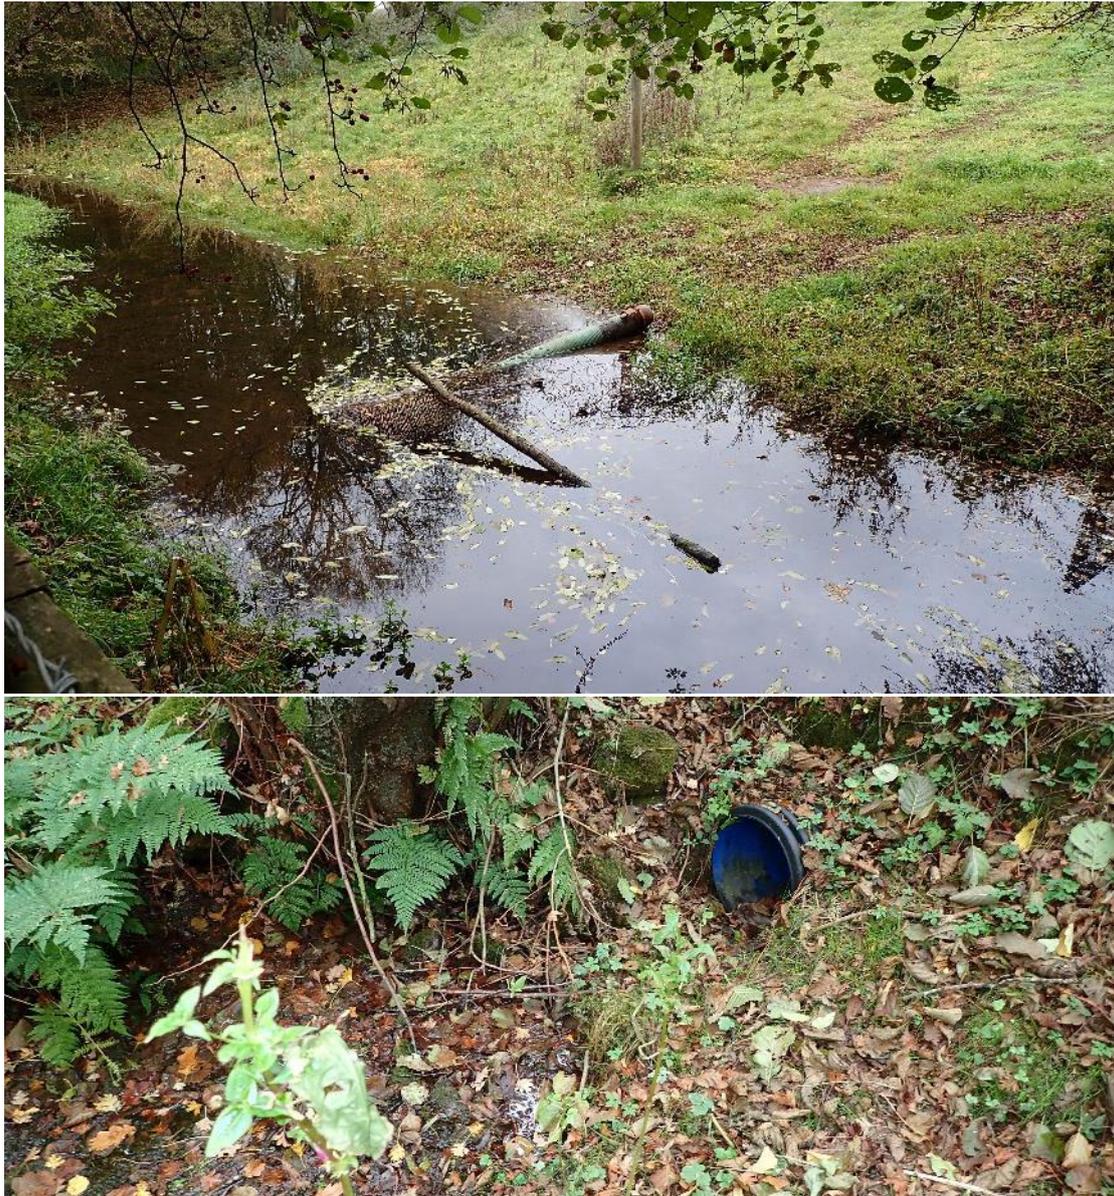
Fig 6. Further impoundment was evident \sim 120m d/s from the dam wall. The channel was pinned to the LB (upper panel) and there was pipework present which looked suspiciously like that used to flush slurry tankers (NB the agricultural building at the top of the slope – right of shot – had a manure pile outside it with no obvious bunding to prevent nutrients running down to the beck). Lower panel: a culvert pipe was found in what appeared to be the paleo-channel taking meagre overflow from the modified channel somewhere u/s. The channel appears to have been realigned prior to 1846, although clearly the culvert work is relatively recent.

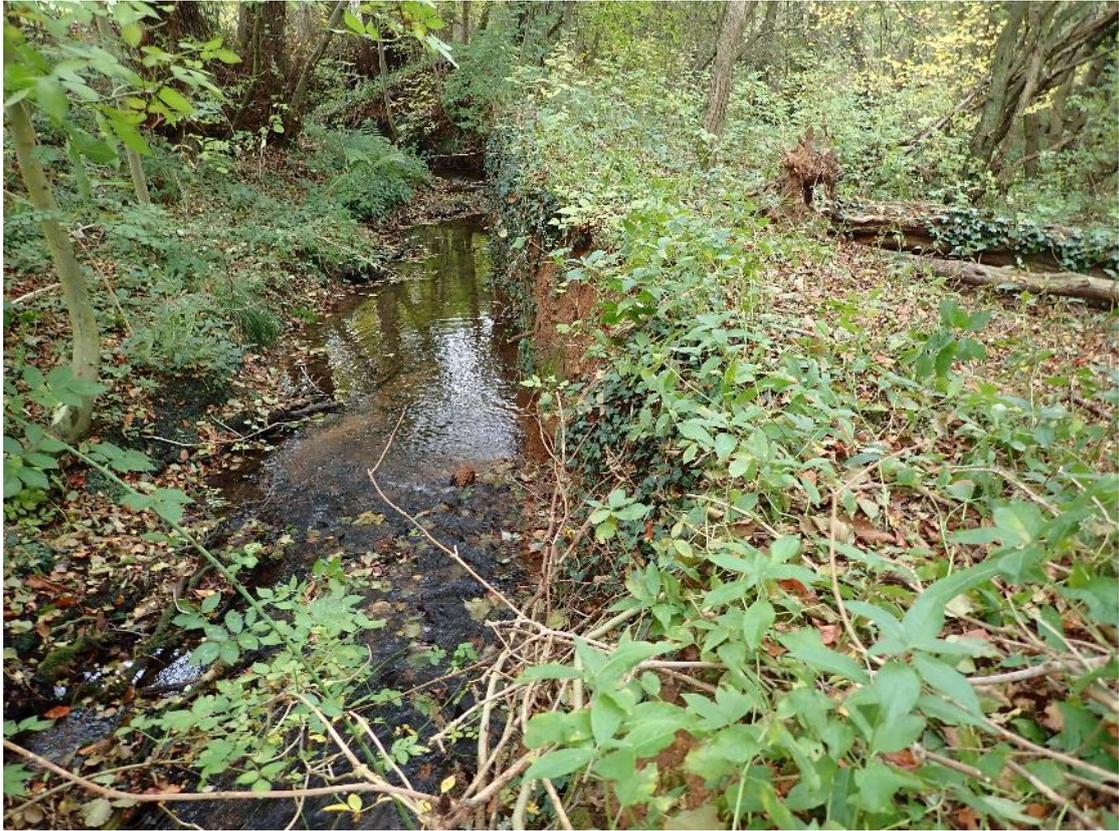
Fig 7. The channel is pinned on a straight course along the left side of the valley for $\sim 100\text{m}$, prevented from returning to its natural path by an embankment of $\sim 1.5\text{m}$ height.

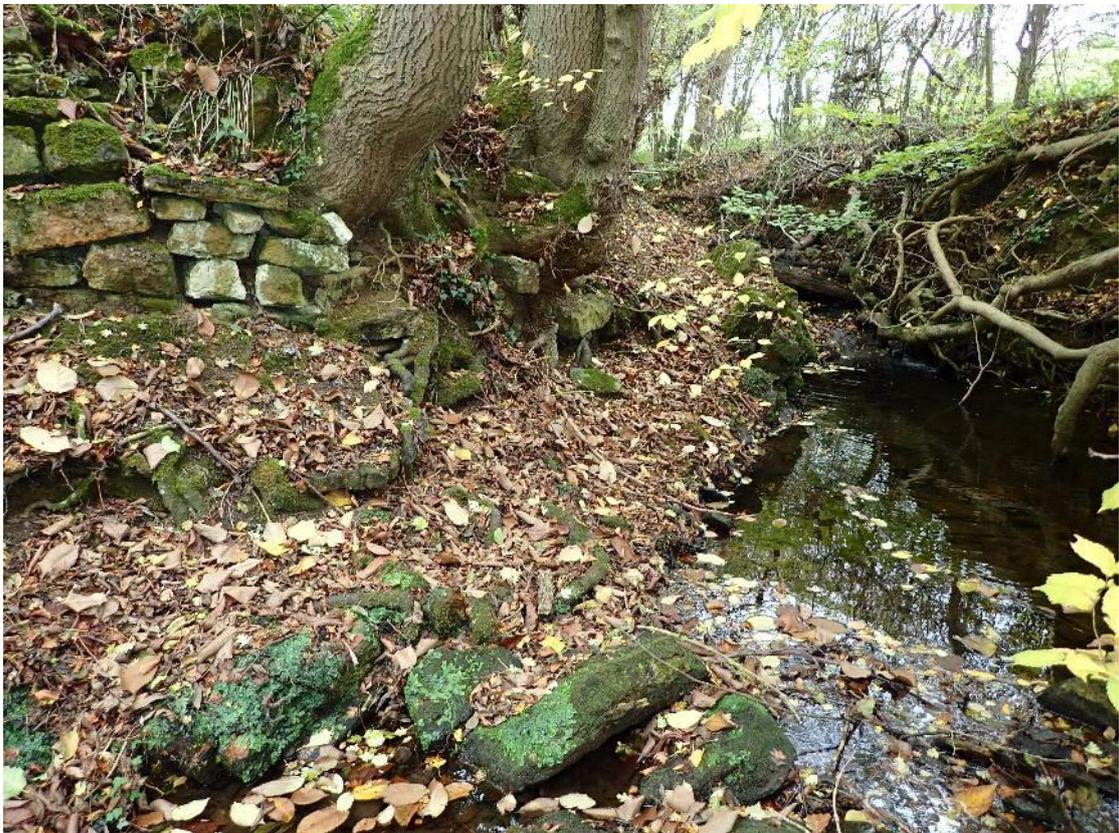
Fig 8. The 'exit' from the modified channel depicted in Fig 7. There was evidence of stone walling to hold that channel in position but few other clues as to the former structure. At this point, the beck turned sharply right to descend to the valley floor, pick up the channel from the culvert (in Fig 6), and continue through the wood.

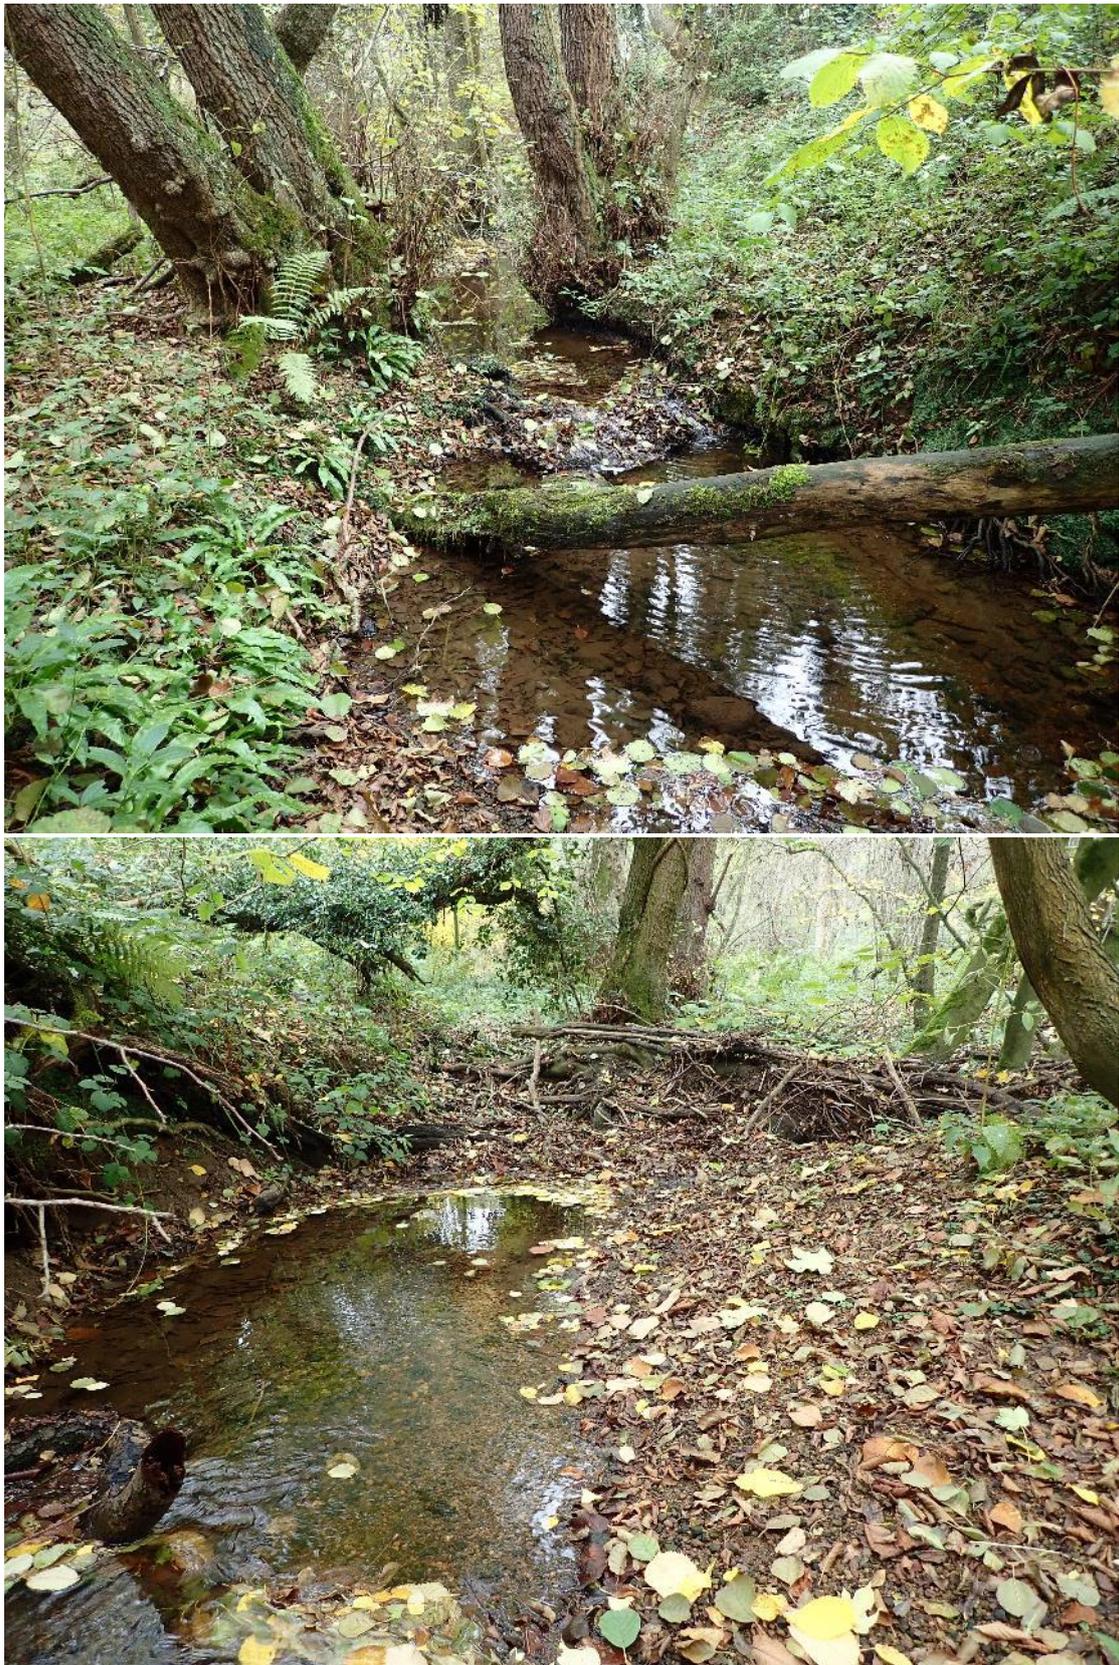
Fig 9. Root masses (upper) and woody debris (lower) forming semi-permanent and temporary leaky dams, respectively. Here, where the gradient was sufficient, relatively clean gravels were abundant, and cursory stone-turning revealed a depauperate macroinvertebrate community dominated by glossosomatid cased-caddis flies.

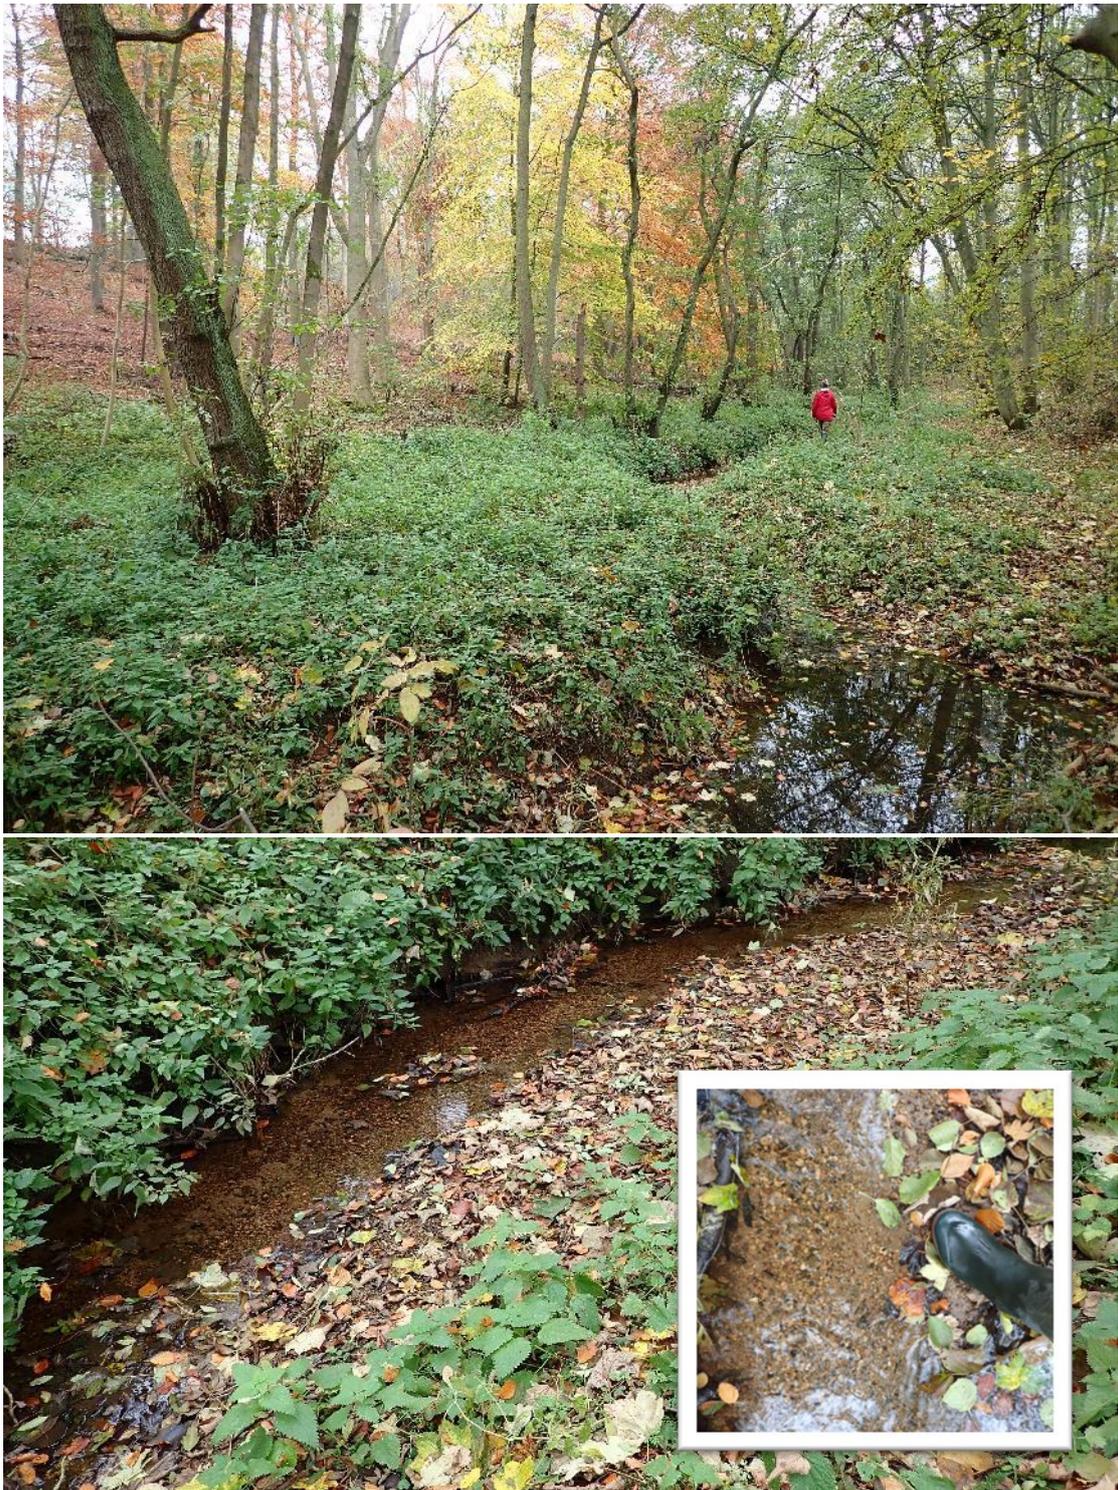
Fig 10. From around SE 39577 42009, the trapezoidal channel retained many more dredged characteristics: typically over-capacity, uniformly shallow with little sediment sorting and, where the gradient was low, sedimentation of fines (upper panel). On the occasional steeper reach, lateral bars of gravel had narrowed the wetted channel (lower panel) and the gravels were remarkably free from fines (inset).

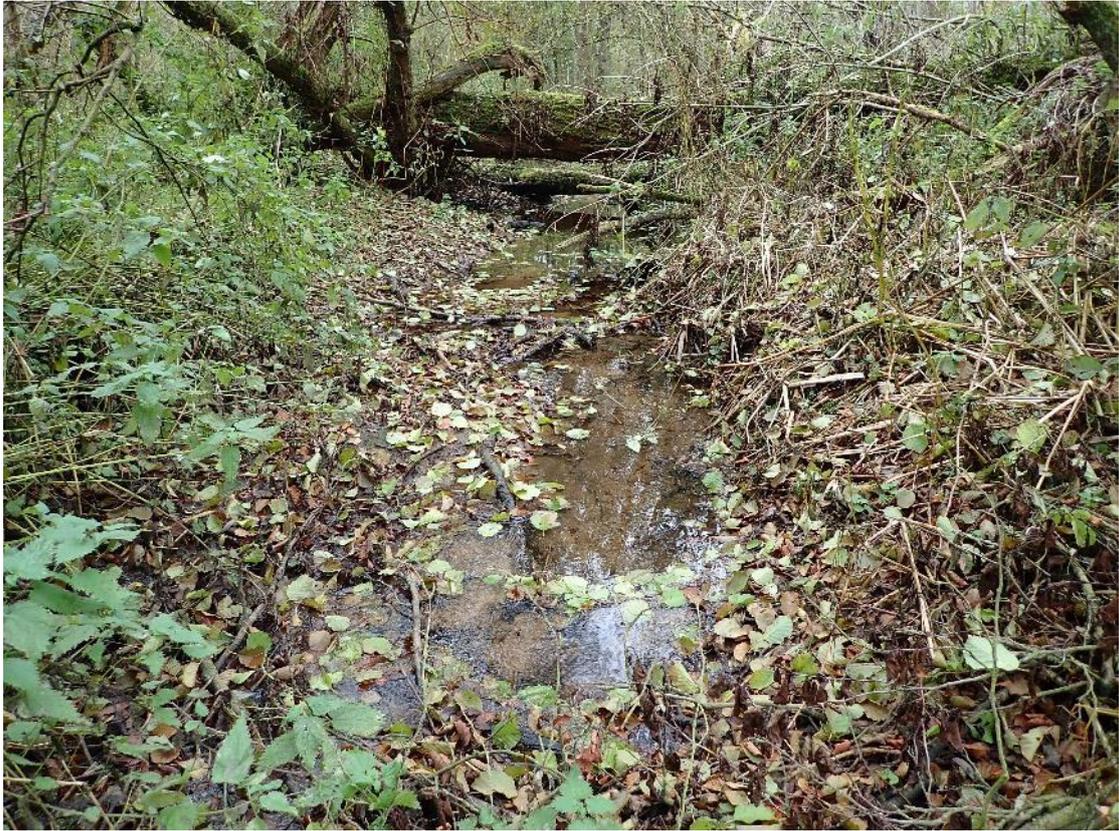
Fig 11. Saturated soils, fine sediment accumulation in the channel, and a predominance of Himalayan balsam in the understory was evident for ~230m u/s of the dam wall in Fig 12. Flow was extremely sluggish and insufficient to remove even relatively small debris jams and leaf packs. OS maps from 1846 depict this whole area as Wothersome Lake.

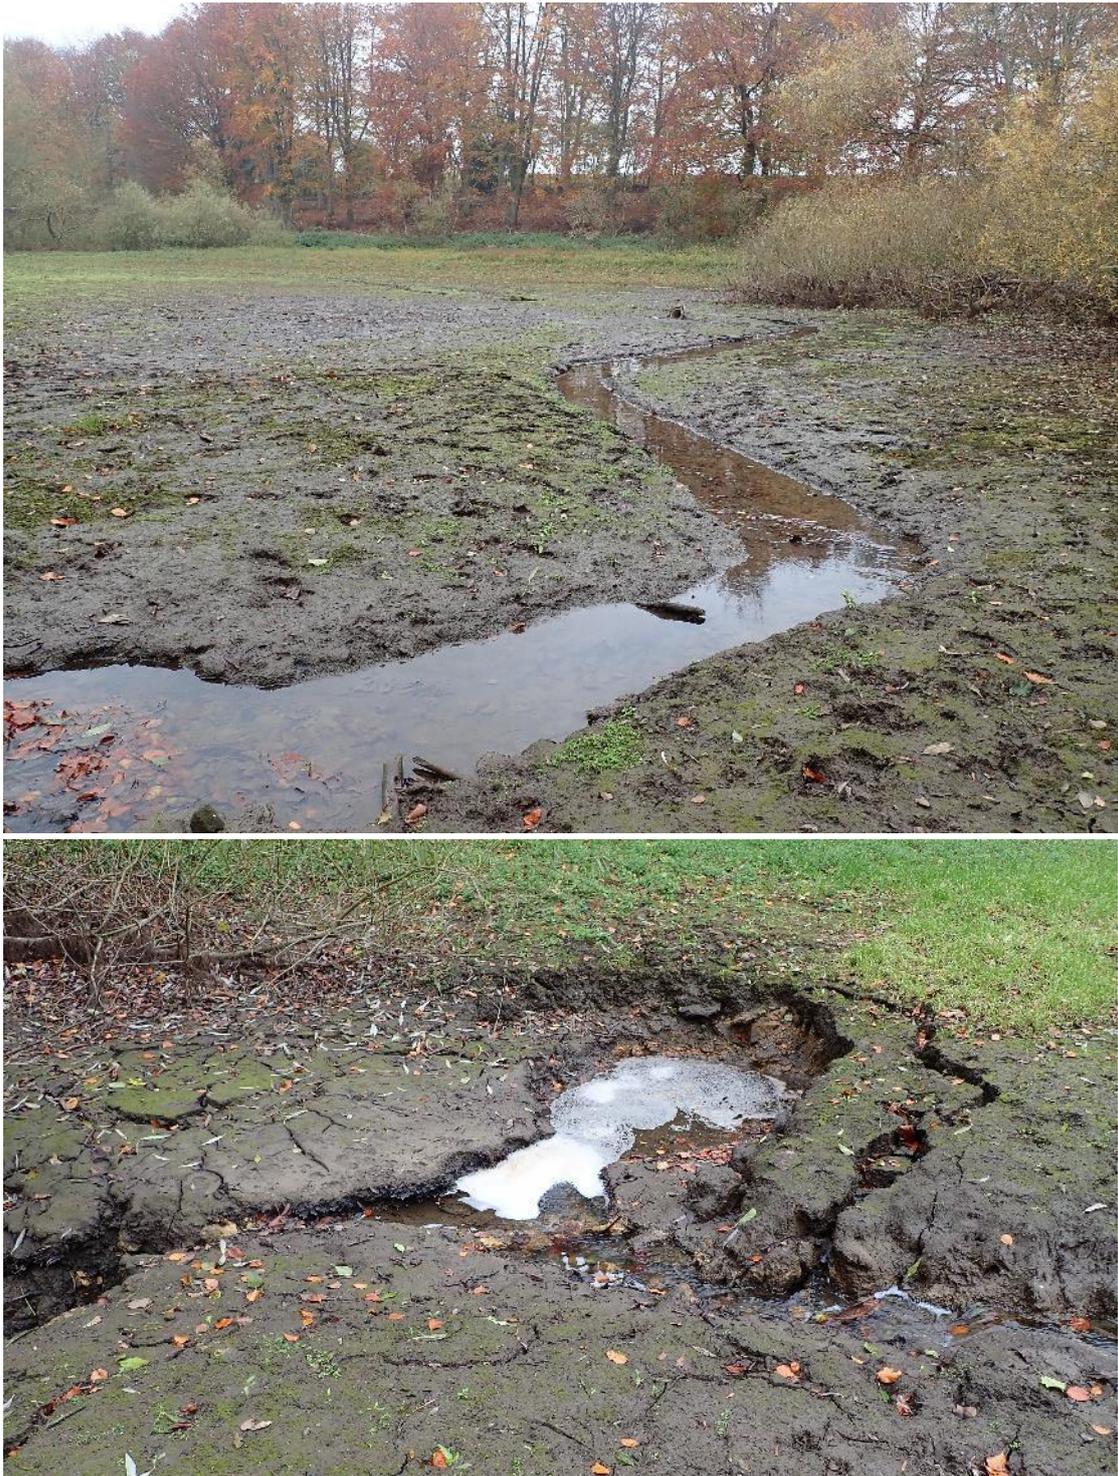
Fig 12. Wothersome Lake (depicted on maps from 1846), which should have been created by a dam at SE 40173 42243 and overflowing via a perched channel at the left side of the dam, was 'dry'. The beck disappeared into a sink in the sediments toward the right side of the dam, and resurfaced as a seep ~100m d/s. The lake would be extremely shallow as fine sediments over the last (presumably) 170 years have accumulated and marginal succession was evident with willows clearly encroaching.

- *Rehabilitation of Wothersome Lake (Fig 12) via dredging of accumulated silt (with potential to use elsewhere on the estate) and identification of drainage issue, puddling the bed with locally won clay, and allowing to refill. There is an opportunity here to effectively take this lake off-line; during the works mentioned above, create a new stream channel right bank along the left margin of the lake to the currently dysfunctional overspill channel. Under high flow conditions, the beck could overtop into the lake, providing some flood storage.*

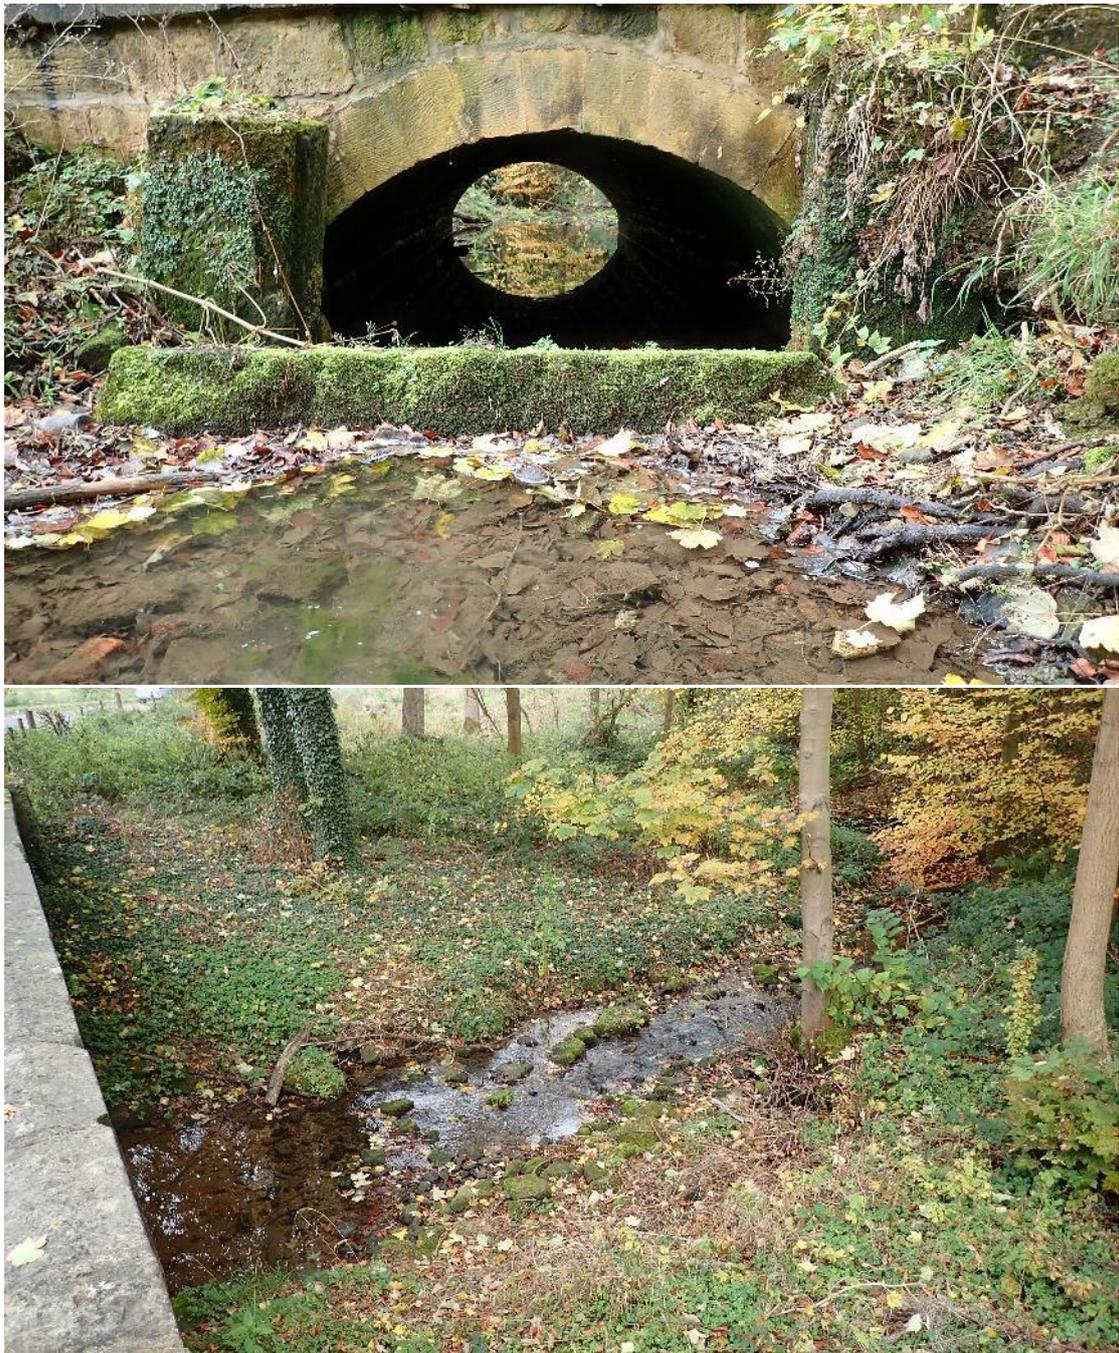
Fig 13. The beck passes under Thorner Rd at SE 40423 42435 and while the u/s side of the bridge was hindered by a former bridge component stone (which should be removed; upper panel), passage through and below was clear. The channel was more natural, both in position and cross section, and stone turning revealed a more diverse community dominated by gammarid shrimps and cased-caddis of various families, as well as heptageniids.

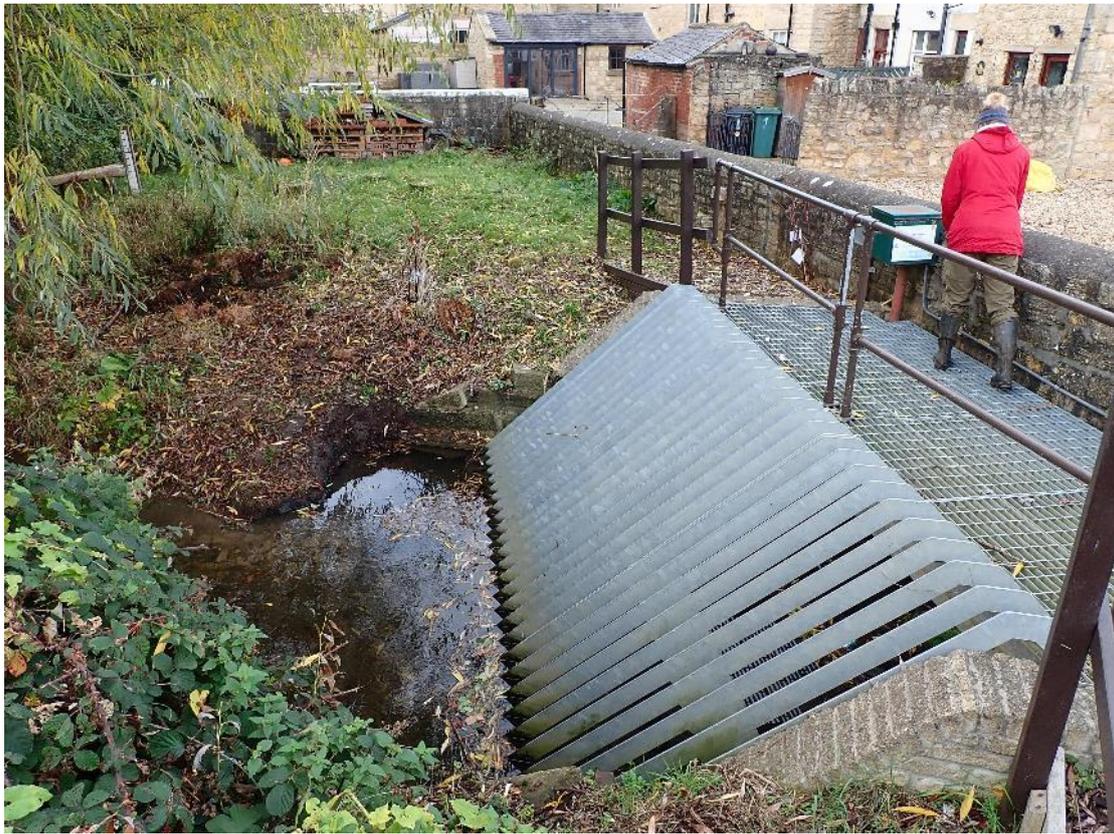
Fig 14. Trash screen at Bramham (SE 42476 42894). On the d/s side of the bridge, the beck was flowing through an over-capacity, rectangular, walled channel through the village. Fines and small gravels dominated the unsorted bed material and appeared devoid of macroinvertebrates except for one or two leeches.

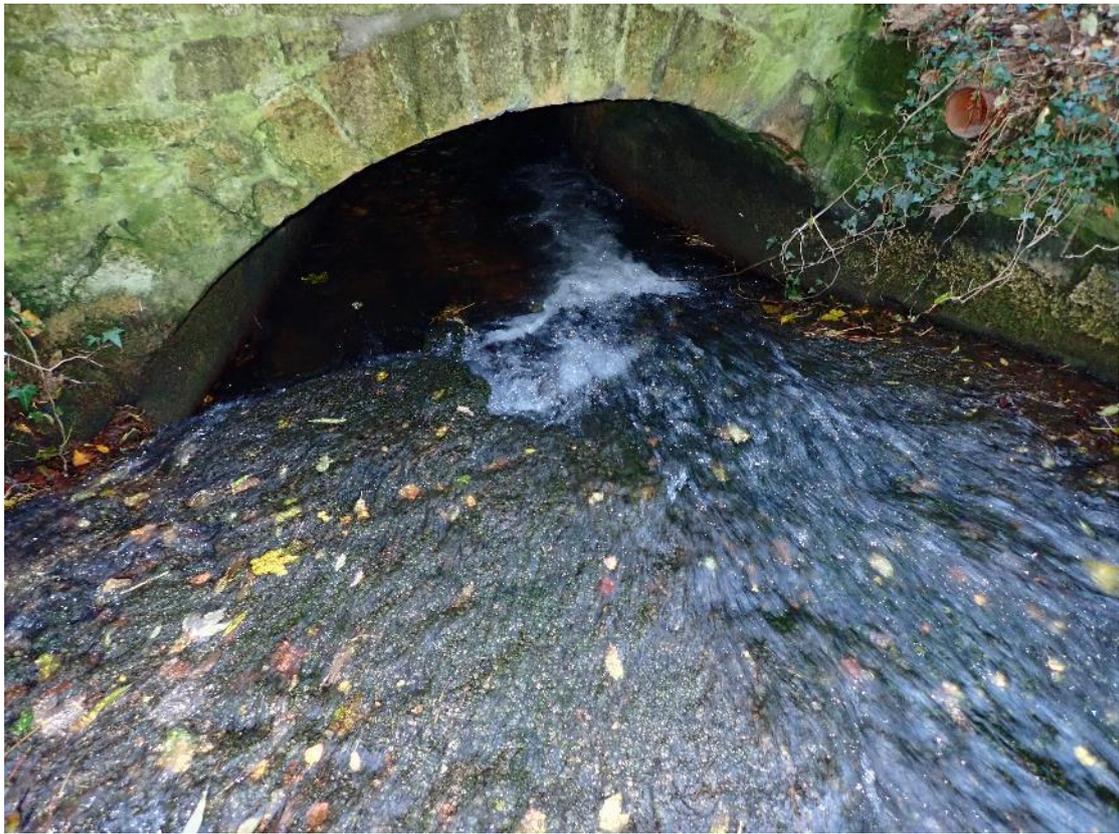
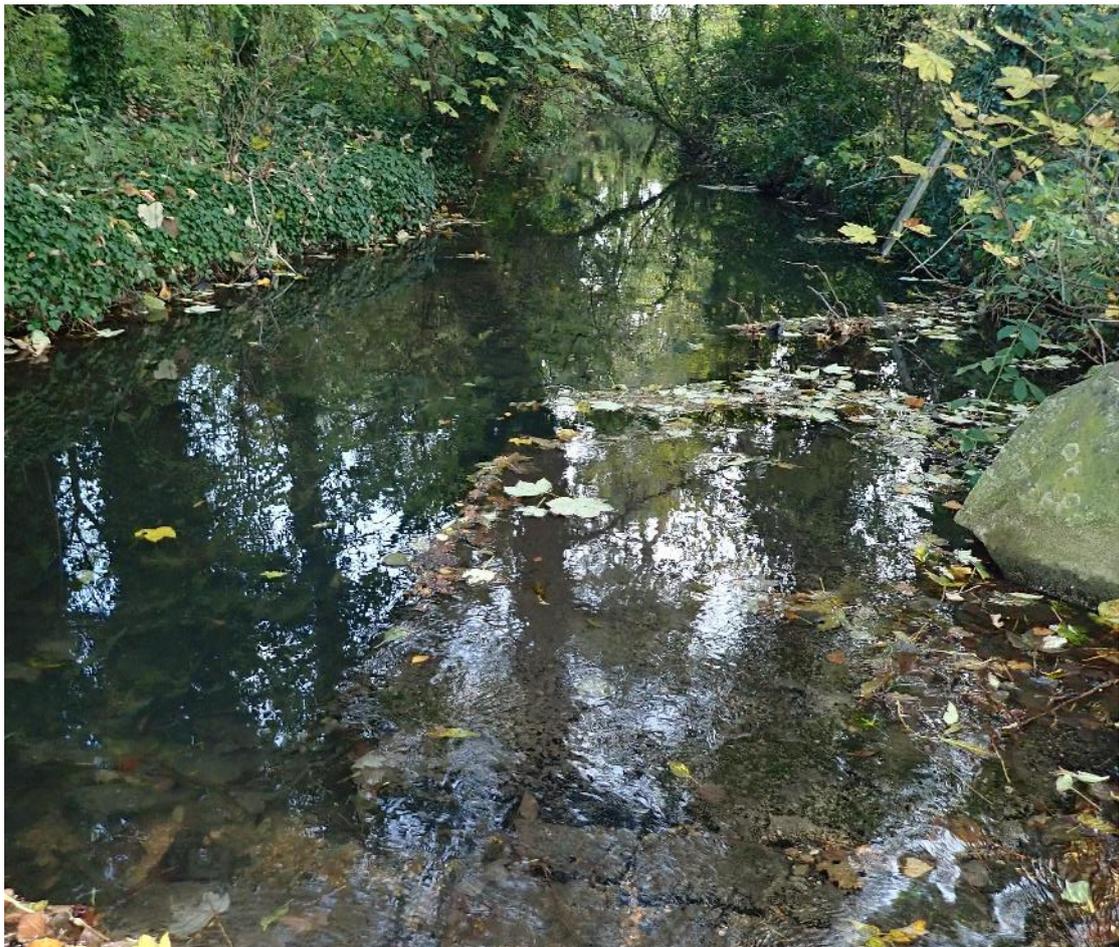
Fig 15. At Old Mill Lane (SE 43226 44167), a weir immediately u/s of the road bridge causes fish passage issues (upper) and impounds the reach (lower) as far as could be viewed. This was the only location where several fish were observed, freely rising. It would be useful to explore the ownership of this u/s reach and possibly back to Bramham as it appears to be better protected and hence offer potential for remediation work.

- *Identify ownership of the weir under Old Mill Lane road bridge and gain access for better inspection to assess mitigation options for fish passage. It would also be useful to gauge any local perceptions of flooding associated with the aperture of the bridge culvert.*

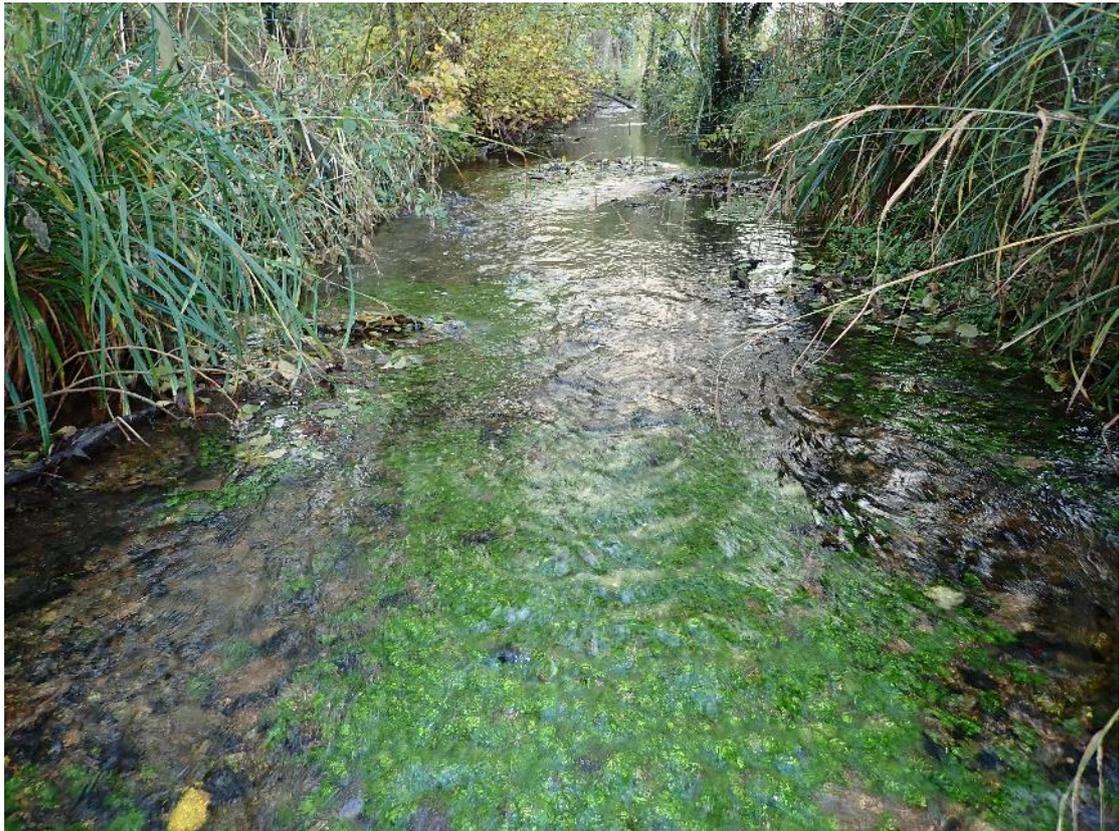
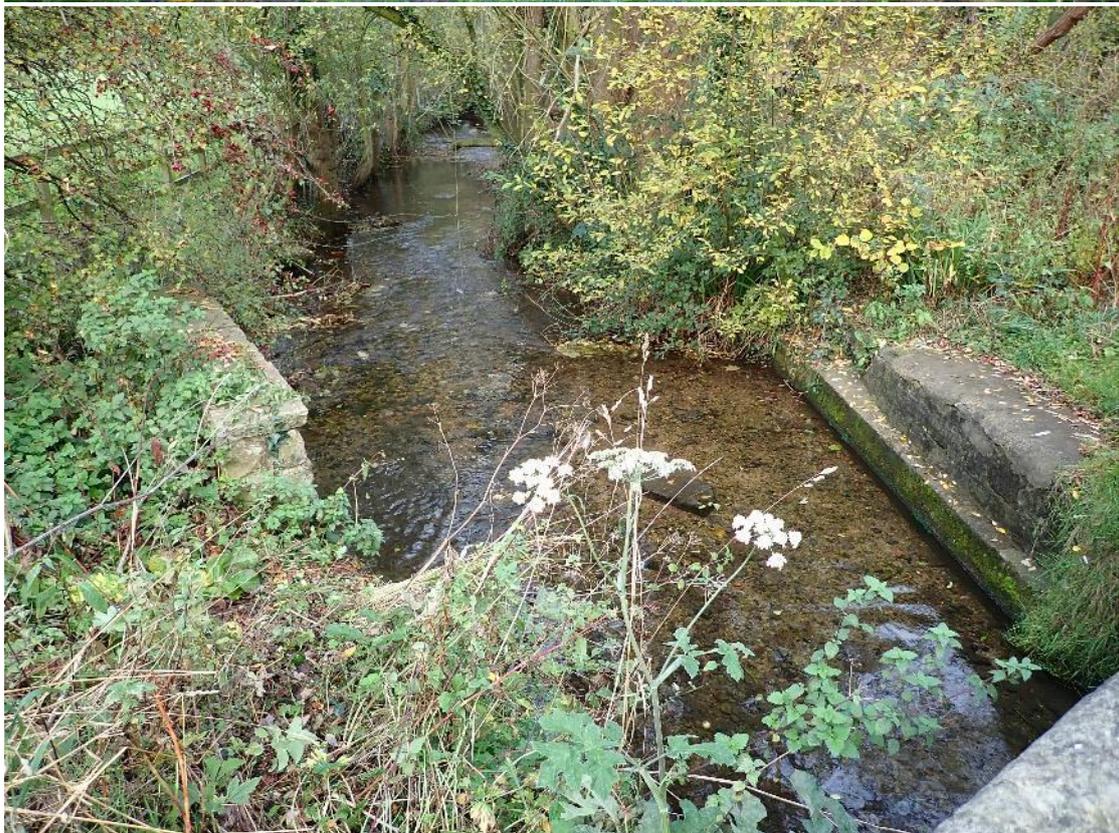
Fig 16. Views u/s and d/s from Bar Lane at SE 43566 44559. The character of the beck here was markedly different to elsewhere as submerged macrophytes imparted ecosystem engineering and the geomorphology responded accordingly with much more varied depth profiles. Despite being straightened historically, the quality and variety of the habitat was better for fish of all life-stages. A bullhead was recorded.
