Advisory Walkover
Thorner Beck, Wharfe Catchment
November 2018

1.0 Introduction

This brief report is the output of a site visit to Thorner Beck (GB104027063950), a tributary of the River Wharfe, W. Yorkshire. The visit was requested by Dr Marie Taylor (Project Officer, Yorkshire Dales Rivers Trust) for the 'Rivers in Elmet' project, and she accompanied Jonny Grey of the WTT on the walkover. A more comprehensive report has already been submitted for **Cock Beck** and the Recommendation details therein are useful also in the context of Thorner Beck.

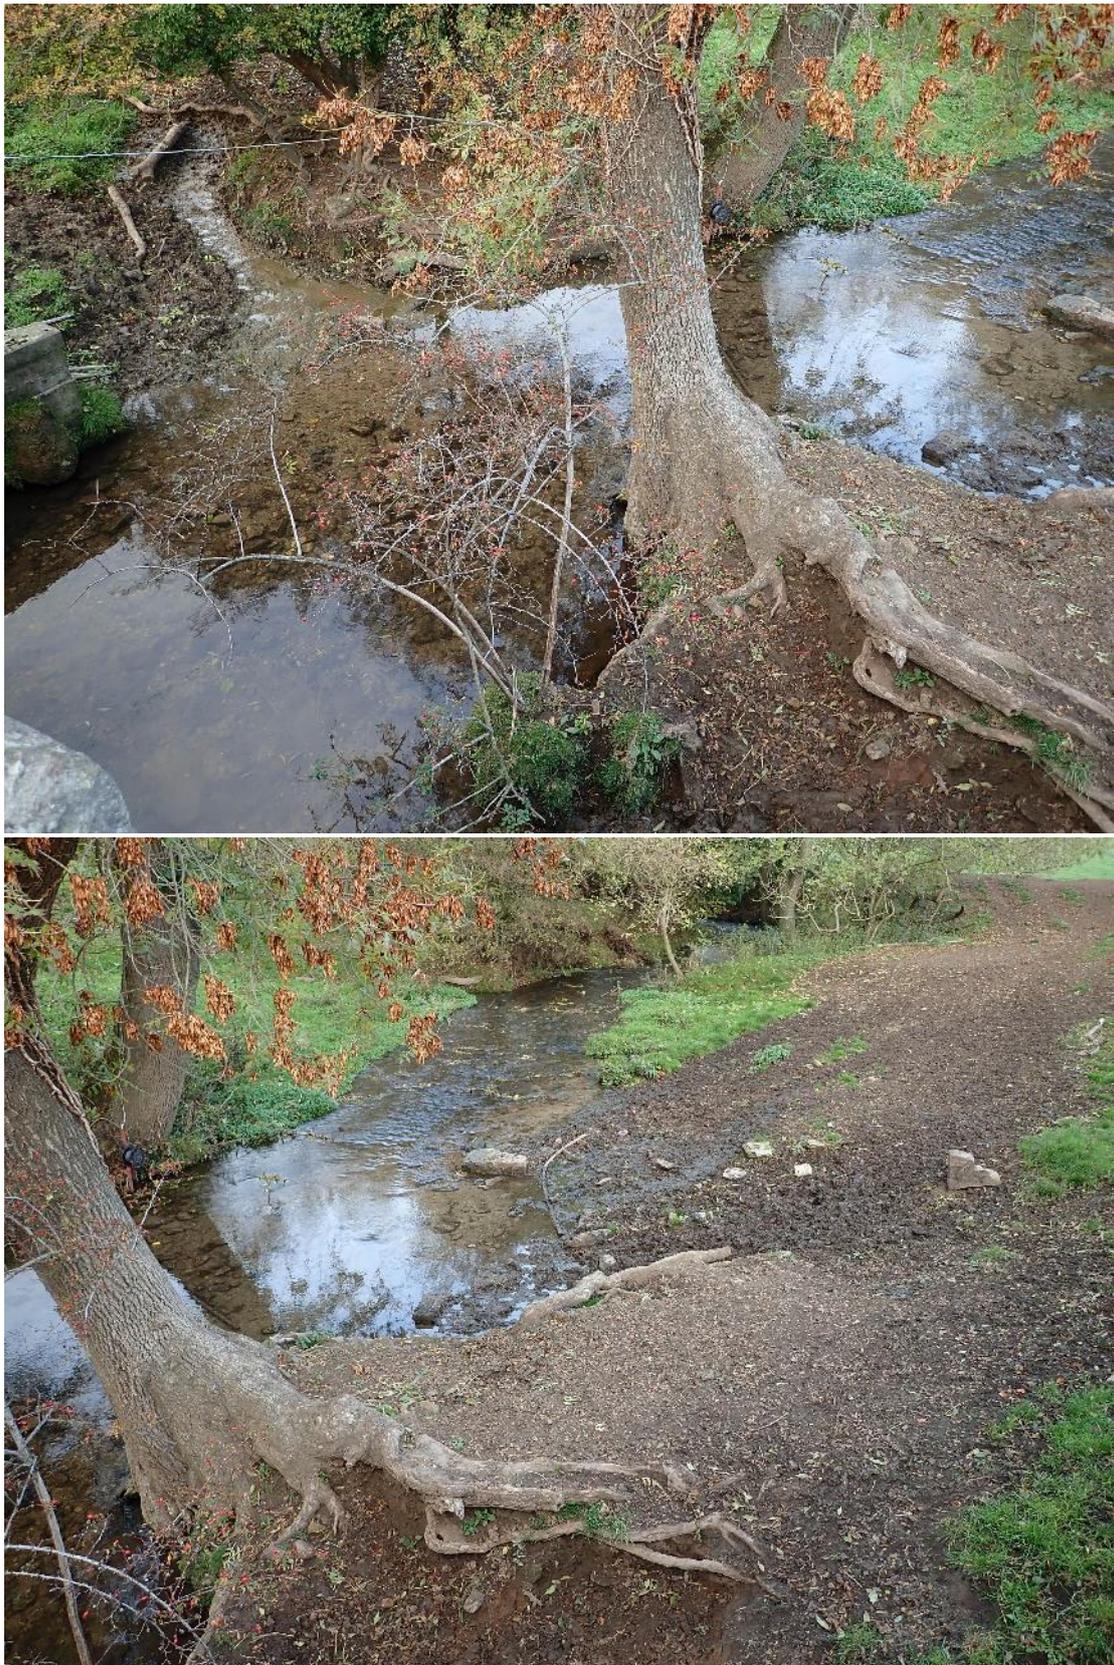
Fig 17. The last point of access was from the A659 bridge at SE 44143 45007, ~300m from the confluence with the Wharfe at Boston Spa. Immediately d/s was a serious incidence of livestock poaching and overwidening of the channel caused erosion of the banks. Fine sediment ingress was rife, a clear breach of the Farming Rules for Water brought into force in April 2018.

- *Reinstatement or installation of riparian fencing and preferably removing the requirement for livestock drinking access by providing alternative means, or as a last resort, formalising approaches to cattle drinks / fords. Especially important on the upper & lowest sections (Figs 2, 6 & 17 but see note in legend of Fig 13). Reduces diffuse / point source soil ingress (pollution), thereby improving water quality.*
