Advisory Visit to Torver Beck – River Crake Catchment
South Cumbria
February 2014

1.0 Introduction

This report is the output of a site visit undertaken by Gareth Pedley of the Wild Trout Trust to Torver Beck on the 20th February, 2014. Comments in this report are based on observations on the day of the visit and discussions with Jen Aldous and Pete Evoy of South Cumbria Rivers Trust (SCRT).

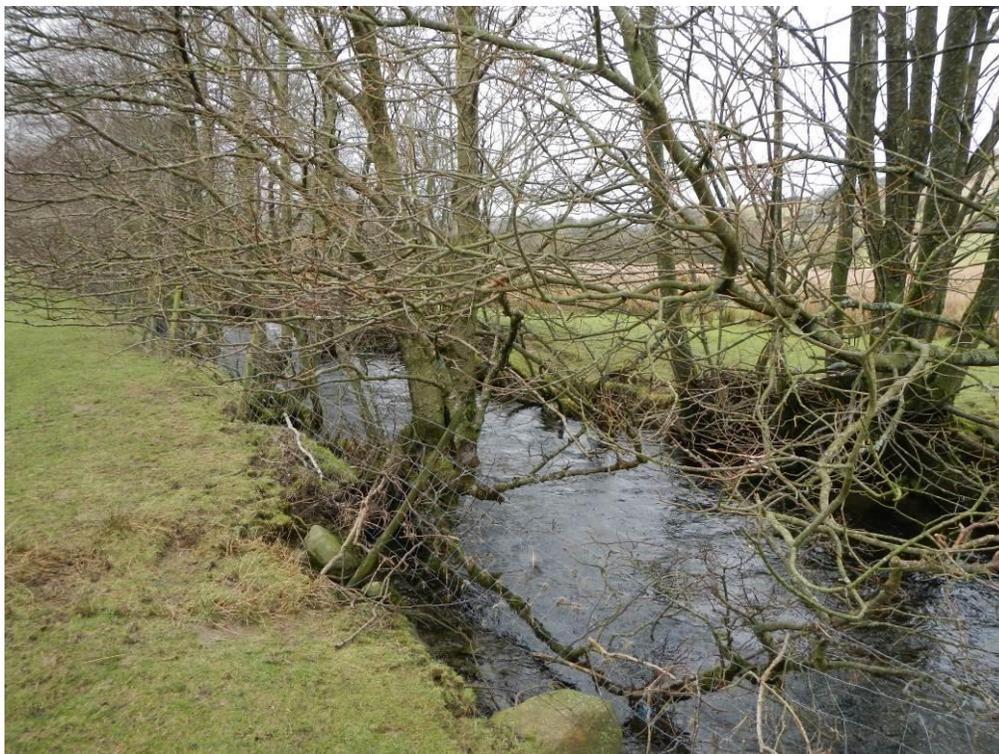
Torver Beck has been the subject of significant realignment and historic channel modification, which has left an unnaturally straight channel throughout much of the length inspected. In addition, the Beck is now incised within its banks, likely due to the amount of material removed when the channel was excavated, and exacerbated by the increased scour within an overly steep, confined channel. This is an issue throughout, but particularly notable in the section immediately downstream of the A5084 road bridge, where the channel is uniform and significantly narrower than would naturally occur for the size of the beck. As a result, the beck cannot escape the confines of the banks and dissipate its energy at medium and high flows. This creates excessive bed scouring, with little subsequent opportunity for substrate deposition, leading to loss of bed material from the reach and undercutting of the banks and riparian trees (Figure 2).

Figure 2. Overly narrow and straight channel for the size of beck where flows are uniform and high velocity, leading to increased scouring and erosion, especially where banks are heavily grazed.

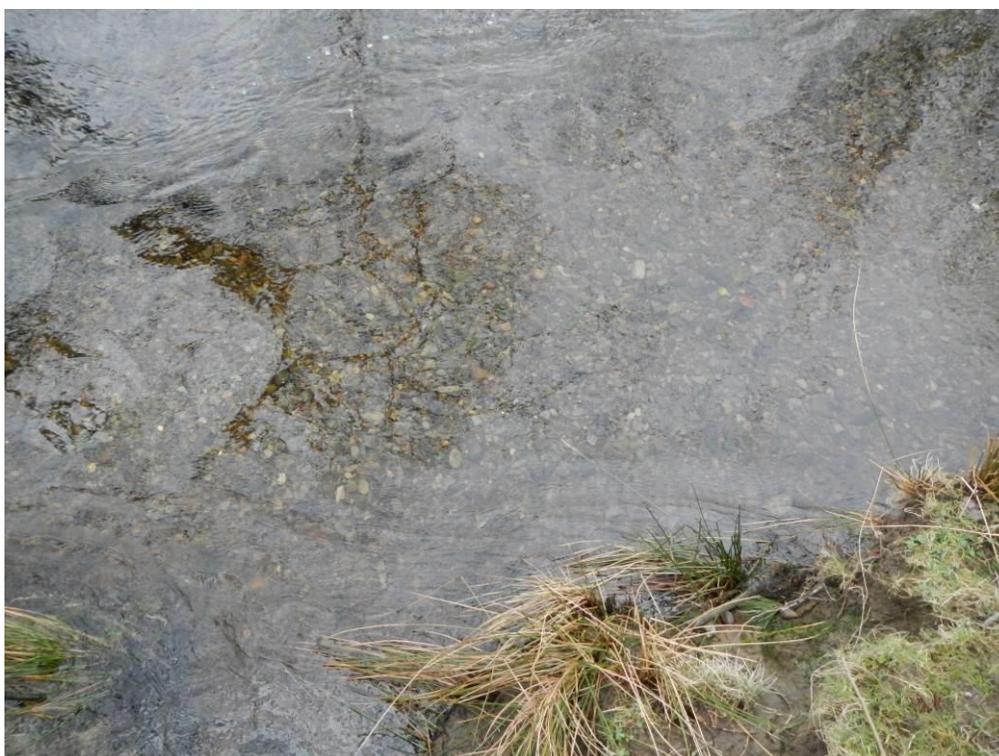
The narrow confined nature of the channel significantly modifies habitat, greatly accelerating flow velocities and creating an unnaturally high energy environment. Substrate is maintained clean and well sorted, but is in many areas of a higher than natural size for this order of beck. As a consequence, habitat is generally better suited to salmon than trout; however, diadromous fish access is restricted to the beck by the waterfall at the downstream end. The lack of slower deeper areas means that habitat for larger, resident adult trout is limited. In wider areas, where flow energy is dissipated, some good quality trout spawning substrate is present (Figure 3).

Figure 3. Suitable sized gravel for trout spawning.

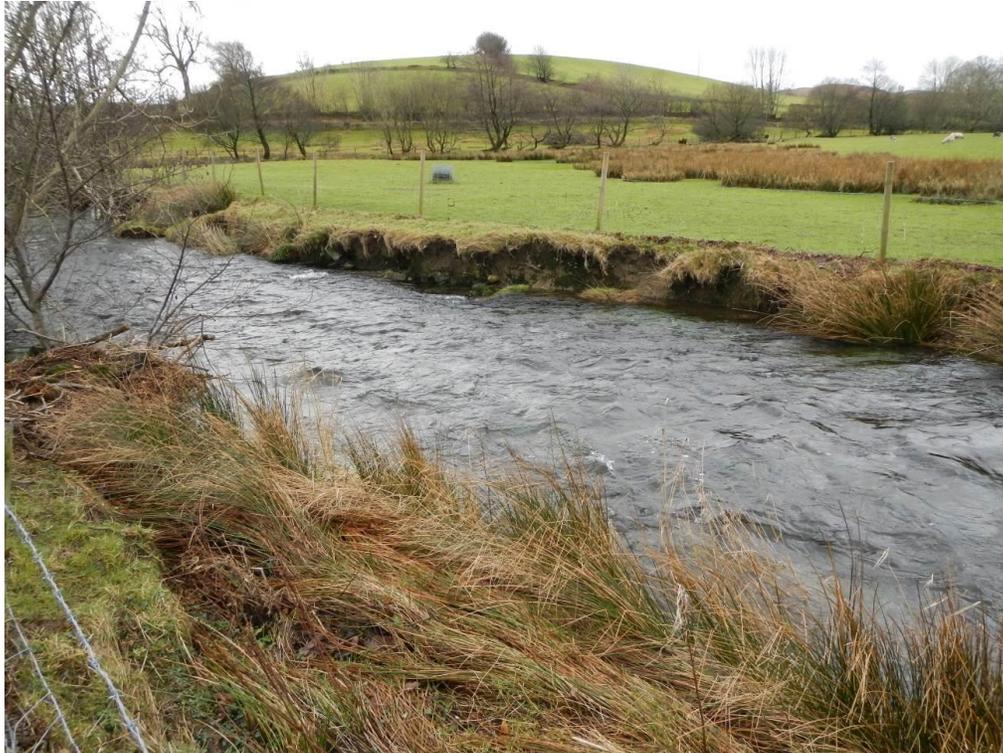
In many areas, erosion has resulted in bank being lost, generally where there is no tree-lining to provide bank stabilisation, or in-between trees where the absence of marginal vegetation has left the bank susceptible (Figures 4 & 5). This is something that needs to be controlled to manage the land loss currently being experienced; however, it is important to preserve areas of wider channel, as they provide valuable energy dissipation that will reduce erosive river forces acting upon the banks (locally and downstream) and provide vital refuge habitat for fish. This should not simply be seen as unnecessary erosion and land loss in every instance, but instead, as the beck attempting to reinstate a more natural channel width.

Figure 4. Straight, high-energy section where a lack of tree and vegetation cover allows bank erosion.

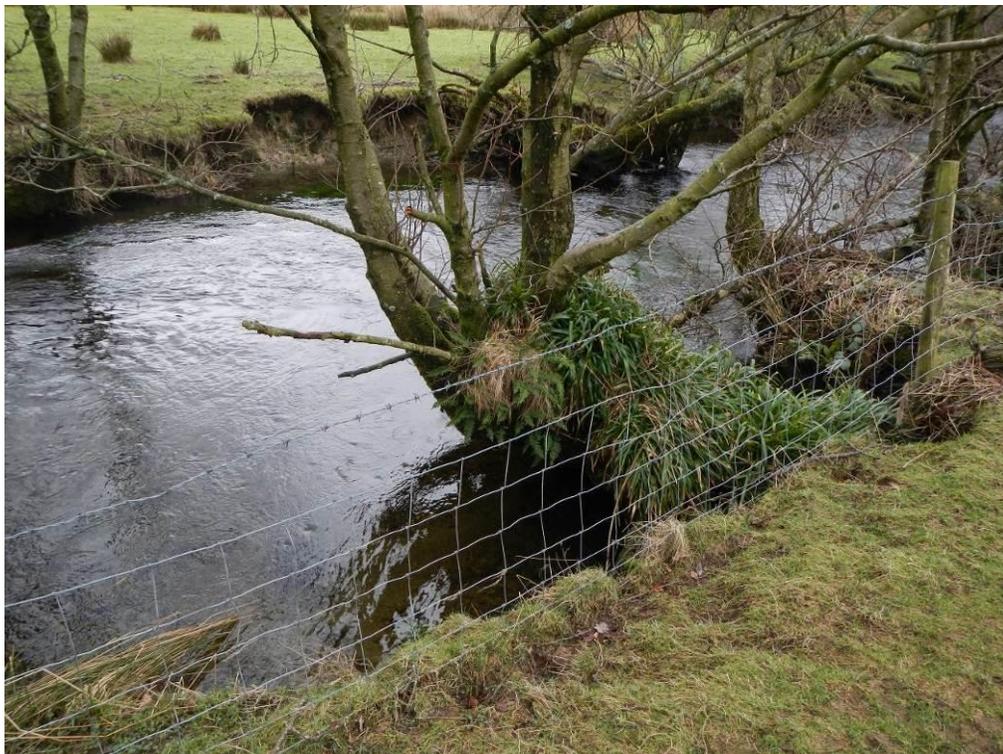
Figure 5. Erosion around bankside Alder Trees. While this represents a loss of land, the wider channel allows some flow dissipation so is beneficial in reducing river energy and providing habitat.

There are also, however, notable areas where it will be essential not to fill in the erosion bites in the bank. In instances such as those depicted in Figures 5, 20 and 23, retention of the slack, back-water habitat that is so scarce along the waterbody will be vital in maintaining habitat diversity. Here, coppicing the trees should reduce flow deflection into the bank short-term until the buffer strip vegetates. The choice of which areas to leave will have to be made through careful inspection of each individual location to ascertain where the trees are well enough anchored to survive simply through the protection provided as the well-vegetated buffer strip develops.

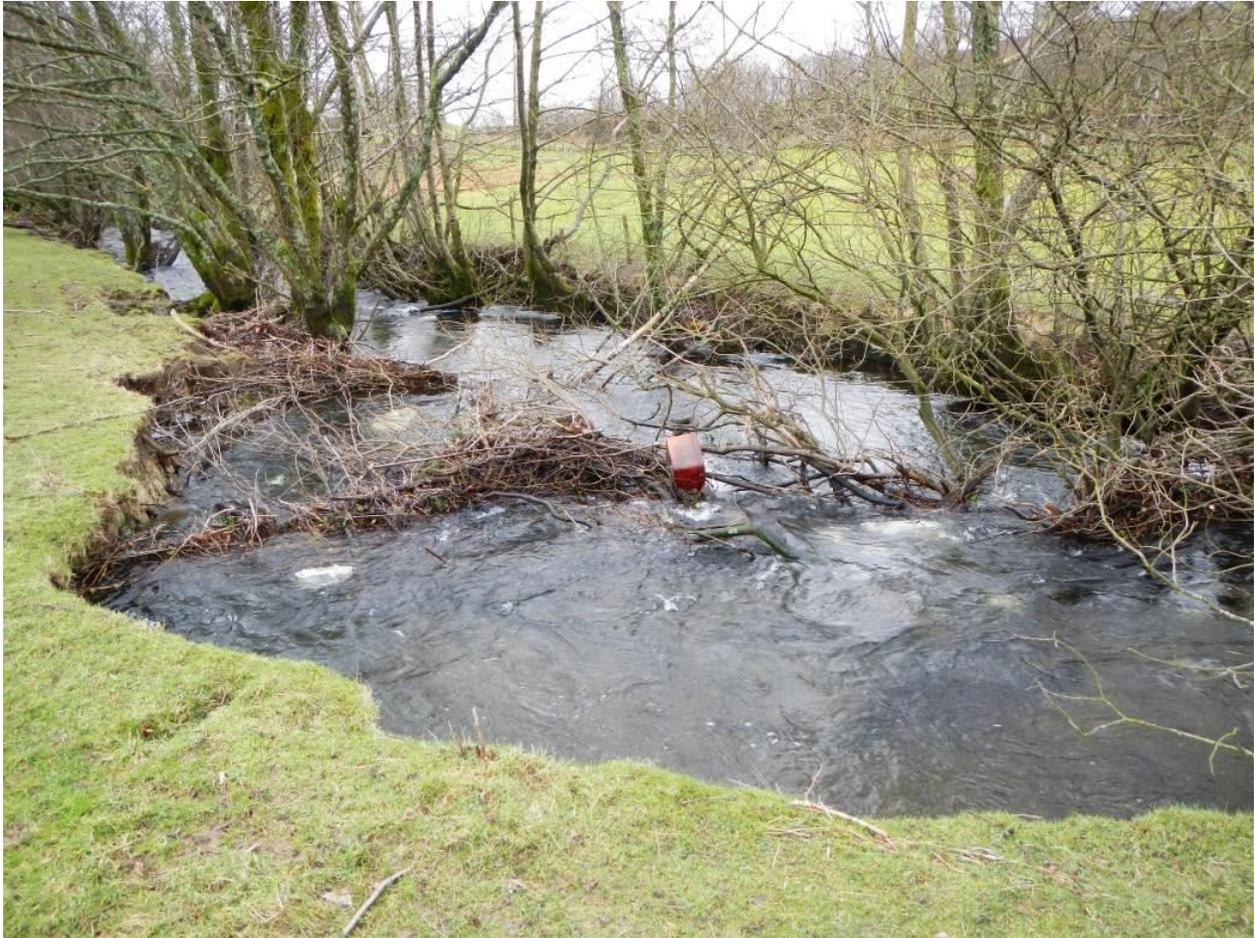
It is also important to ensure that erosion does not continue to a point where the beck becomes overly-wide, which can be an equally significant issue for its function. This is the case where an area of large woody debris (LWD) has led to erosion where grazing has left the bank susceptible (Figure 6) and some management of the material is now required.

Figure 6. Area that would benefit from a central channel being cleared to reduce pressure currently acting upon a susceptible grazed bank. On a well-buffered, vegetated bank, this issue is unlikely to have occurred.

The overlapping brash technique is demonstrated on a larger scale with a mixture of willow and other species in Figure 17. This method diffuses flows along the bank, increasing deposition in areas that were subject to excess erosion. The benefit of using living willow being that, if at least some of the branch is in contact with the water and bank, it should start to root. This technique would be particularly beneficial in areas such as that depicted in Figure 4, and along the erosion in Figure 6 where clearance of the central channel would also be beneficial to relieve pressure from the bank.

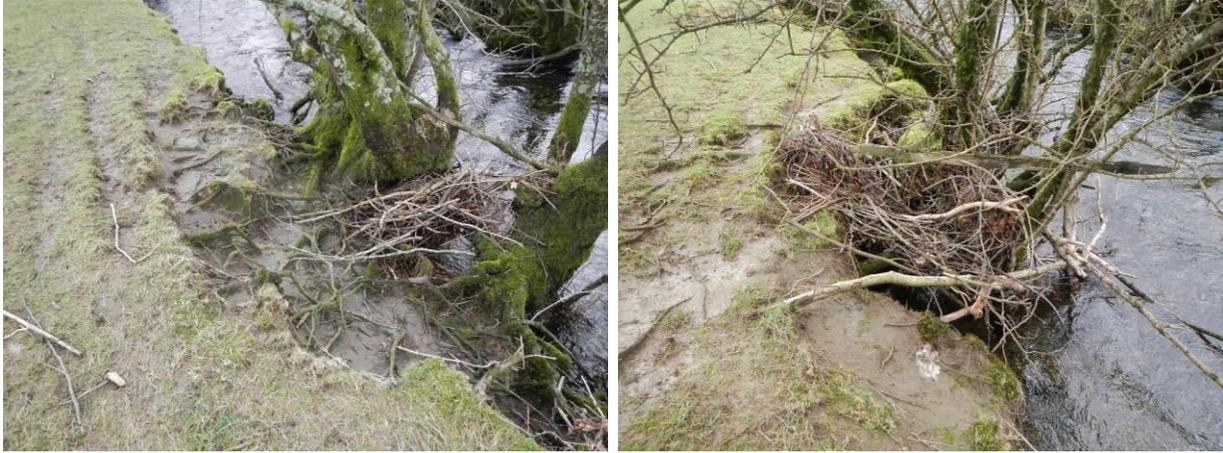
A consequence of the bank erosion that has to be managed carefully is the potential for tree loss along the bank-line. Loss of trees in most instances will have a negative impact upon bank stability and lead to a loss of valuable habitat. Fencing livestock well back from the river bank helps to mitigate this by allowing a natural herbaceous margin to develop that will provide bank protection above and below the ground, and complement the root structure already present from the trees. Failure to exclude livestock from the bank will create a high probability of tree loss as the earth around the tree is eroded. This issue is occurring at several points along the reach which are at different stages. The issue begins with erosion around the back of the tree (Figures 7 & 8), with the erosion eventually cutting right behind the tree and the tree ending up within the new width channel (Figures 9 & 10). Ultimately, this process is likely to lead to loss of the tree, if left unchecked. Sheep can thus lead to the loss of mature trees!

Figures 7 & 8. The first stages of erosion behind a tree.

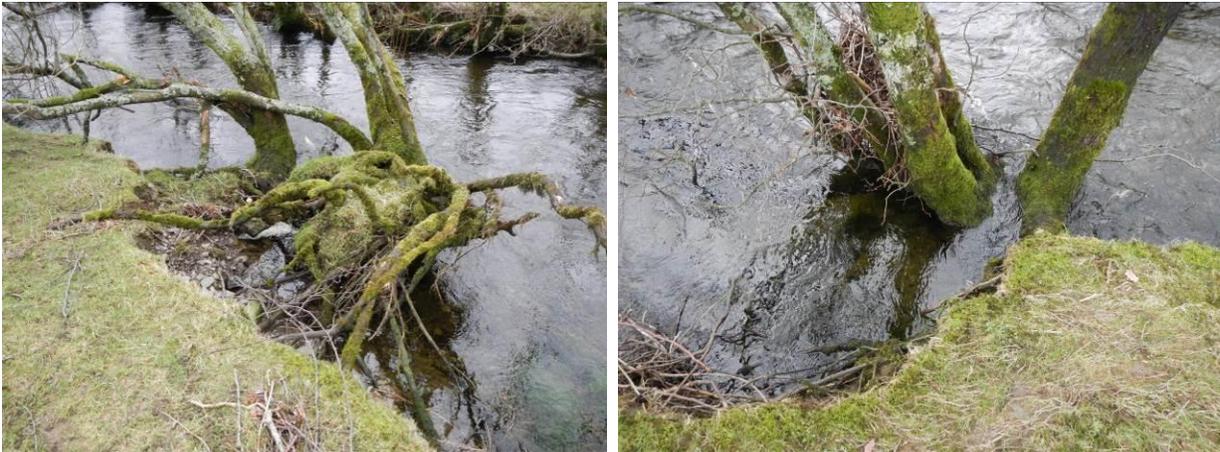
Figures 9 & 10. Erosion that left unmanaged will likely lead to loss of trees.

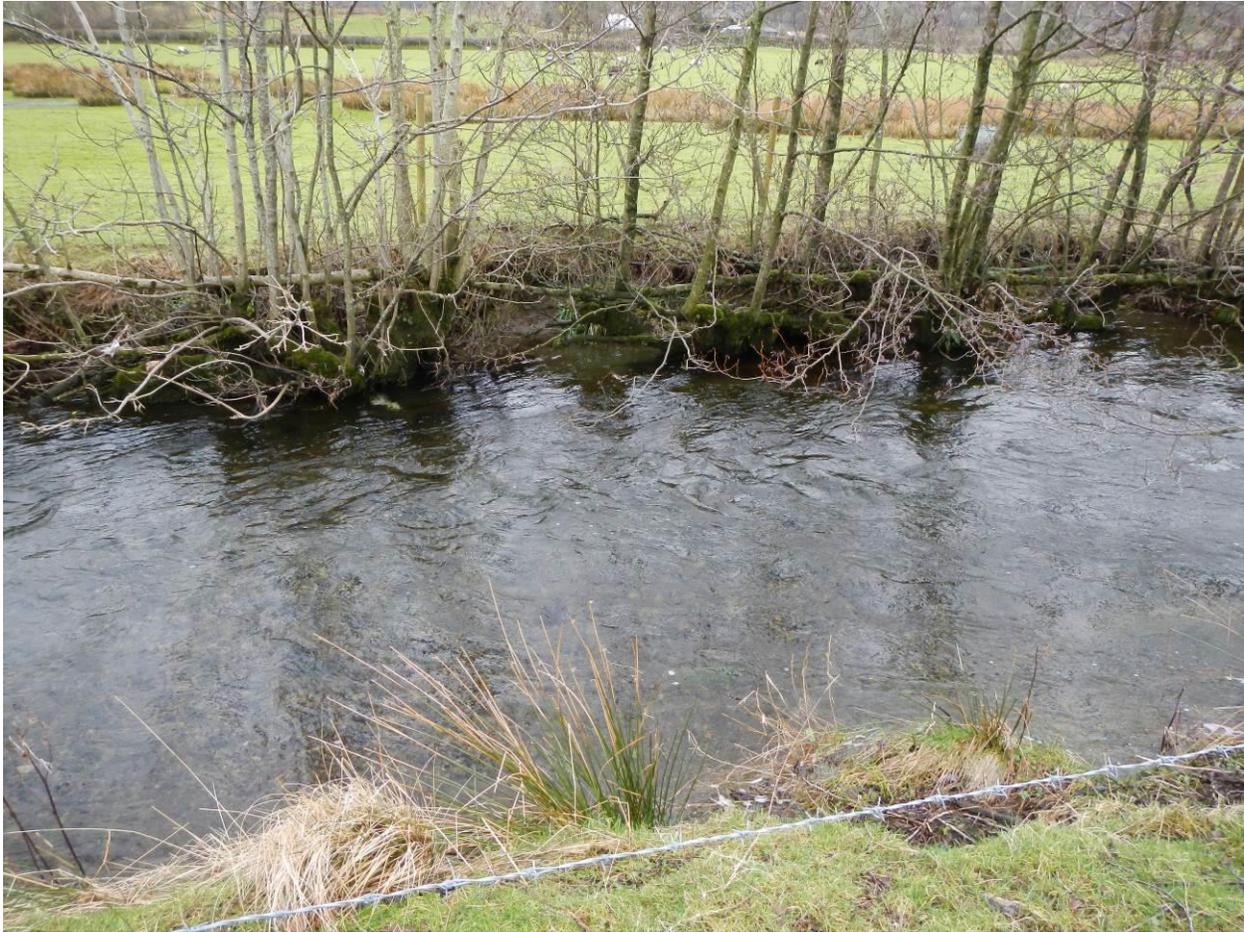
There are obviously signs of historic tree management along the beck (laying and coppicing), and the confined nature of the current channel in many areas is a product of the tree lining (Figure 11). As with most tree maintenance, the job is an ongoing one and in many areas along the channel previously managed trees are now at a stage where they are somewhat over-shading the channel and banks. This is inhibiting the growth of both aquatic and bankside vegetation.

Figure 11. Obvious signs of historic coppicing and laying bankside trees, which are now in need of maintenance.

The almost continuous tree line in places along the bank would greatly benefit from rotational coppicing, as would several other areas, where every third or fourth tree should be coppiced to allow light penetration to the river bank and bed. This will ensure beneficial balance of light and shade along the watercourse and promote growth of both aquatic and marginal vegetation. Coppicing would be particularly beneficial on trees that are subject to large areas of erosion behind or at either side of them, to reduce the leverage currently acting against the root-ball and allow the bank time to stabilise through the beneficial effects of the buffer strip (e.g. Figures 9 & 10 and any similarly susceptible exposed trees). In such examples it would also be beneficial to install wired brash around the base of the tree to encourage sediment deposition, or to fix brash bundles around the tree base to trap sediment and provide a medium for vegetation to colonise.

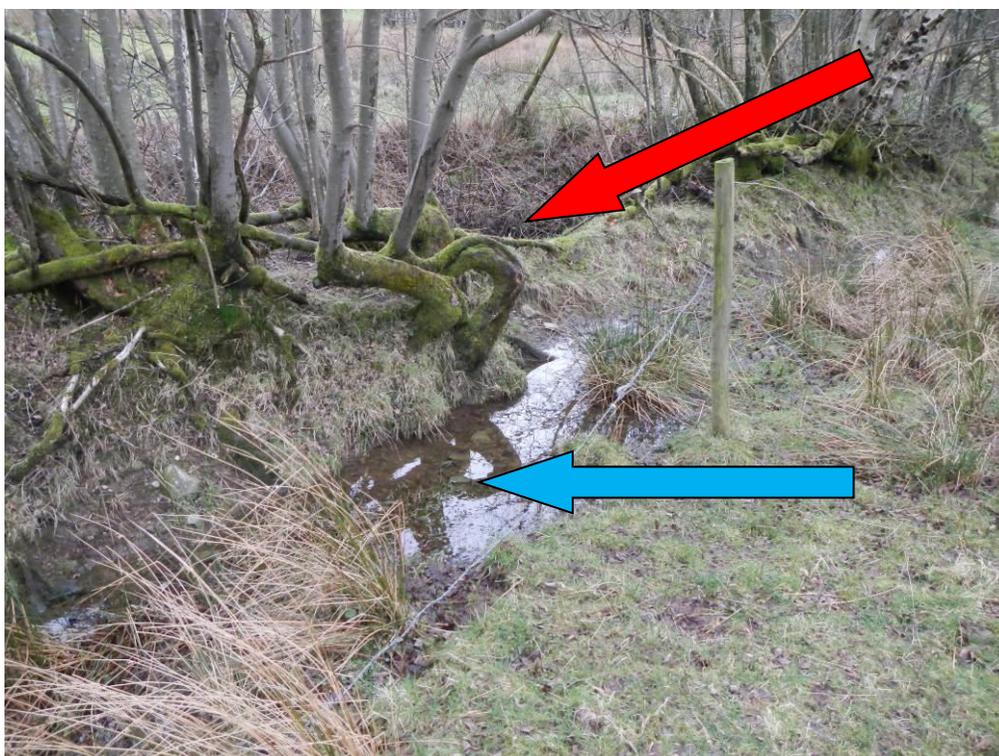
Figure 13. Watercourse in the background (blue arrow), water trapped behind the bund unable to get back to the watercourse following high water centre of shot (red arrow).

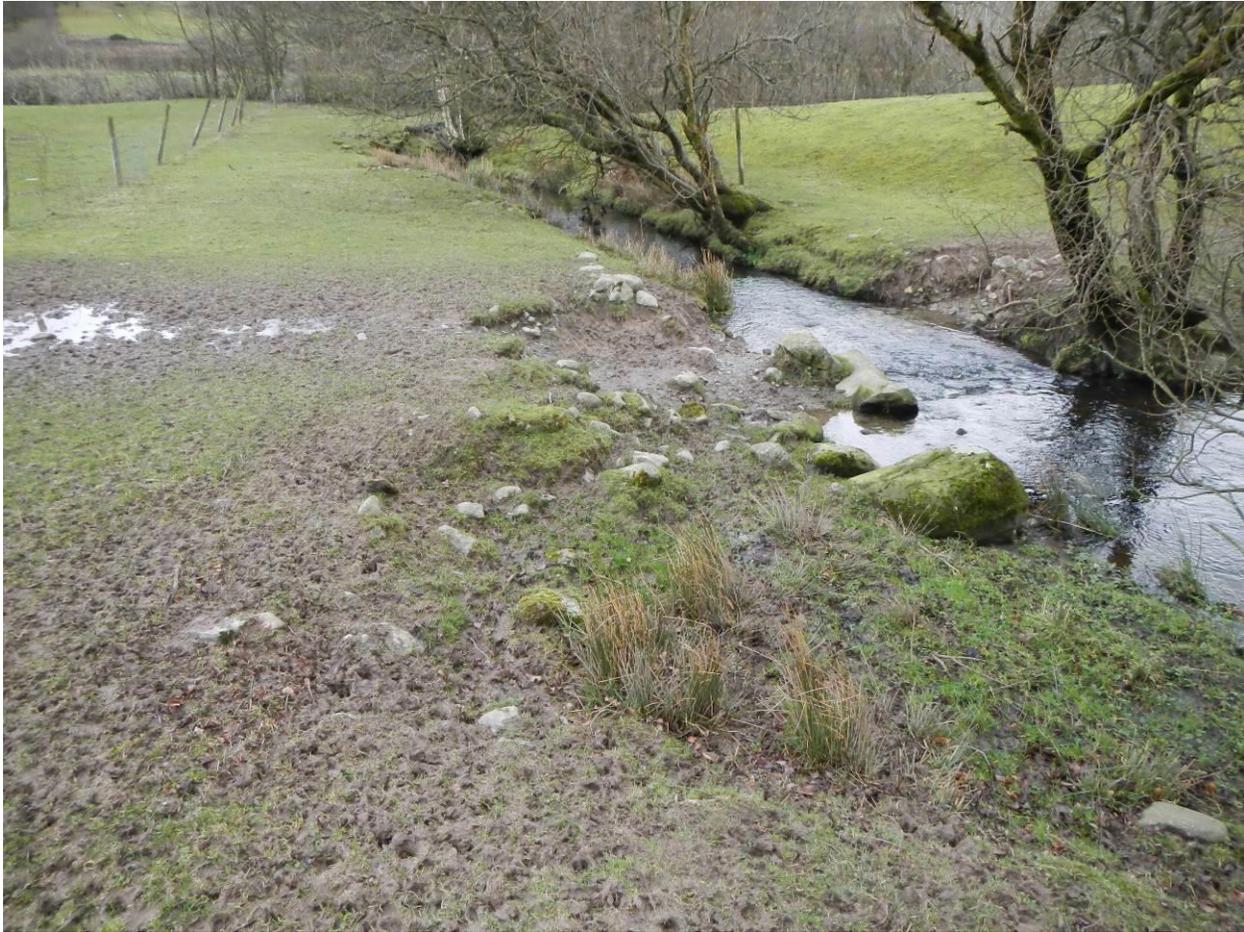
Two potential issues were noted on tributary crossings points where benefits can potentially be realised for both the function of the watercourse and for the land management. There appears to be a capacity issue with a culvert that crosses a tributary on the LB (NGR: SD 28574 93733: Figure 12). There, high flows appear to be backing up and spilling over the bunded banks, with water then becoming trapped behind the bunds (Figure 13). The other issue is one of stock fording a tributary, where poaching of the banks is leading to sediment being liberated to the watercourse (Figure 14).

Figure 14. Issue of stock poaching at a crossing point that is leading to sedimentation of the watercourse.

On the main RB tributary the issue with poaching at the fording point (Figure 14) could be rectified by buffer fencing; however, if this is not possible, installation of a clear span bridge to cross the watercourse may be a solution. This will incur additional cost, but the high banks, relatively equal height banks in several locations could easily facilitate such a bridge. Either option is likely to require some kind of additional water source for livestock.

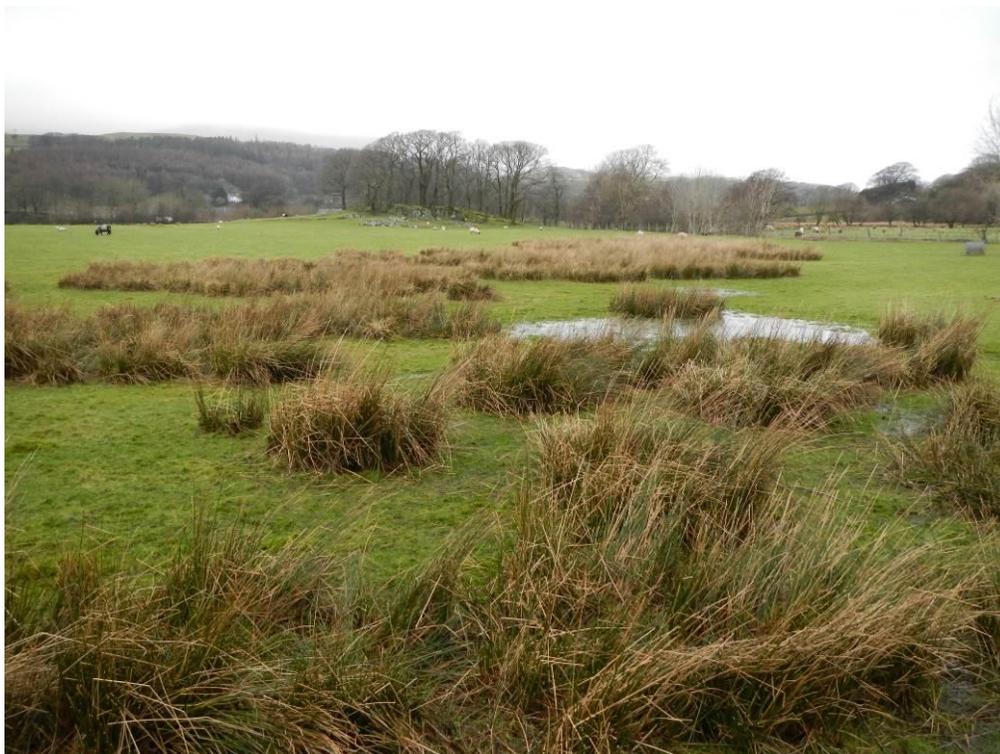
Figure 15. Low-lying wet areas along the paleo-channel, where the beck would have originally flowed.

The ultimate solution to the channel morphology, function and habitat issues is to create a more sinuous plan-form to the beck, creating natural channel dimensions suited to the flows it receives. Ideally, this should be achieved through reinstating the original course of the beck; however, this is likely to be a long-term goal, owing to the considerable cost, planning and negotiation that would be required. There is scope for this to be achieved, if agreement could be made, as demonstrated by obvious signs of the paleo-channel within the adjacent land (Figures 15). This is something that is particularly evident within the wood at the downstream section of the reach (Figure 16). Funding for this work may be difficult to obtain, as the land is not within a SSSI, so outside the scope of the River Restoration Strategy.

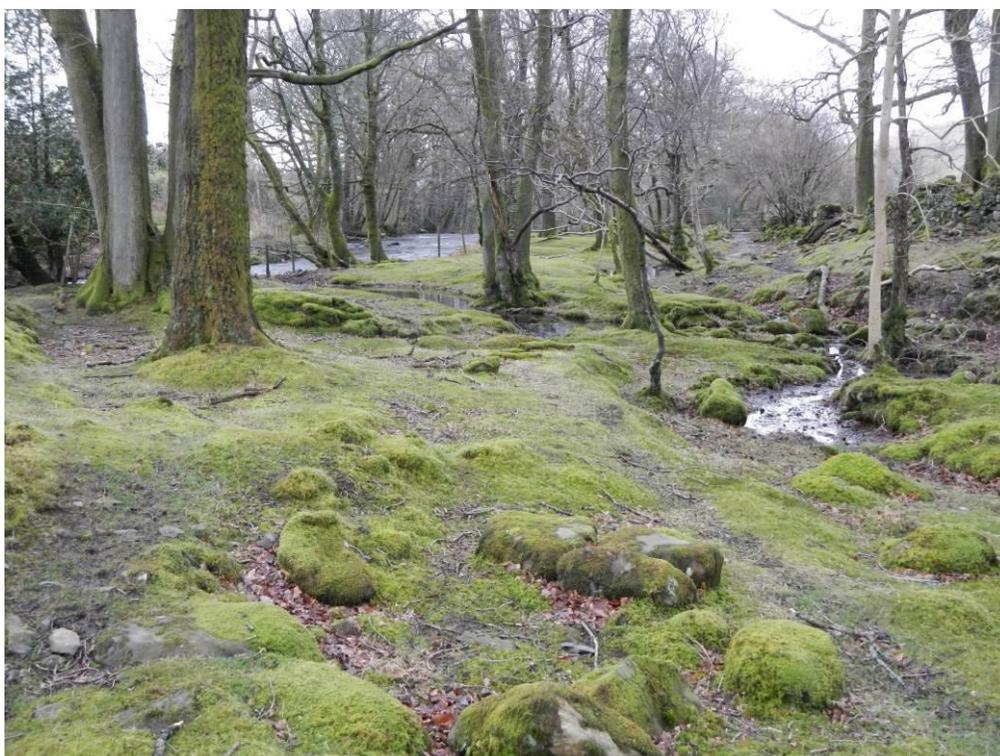
Figure 16. Obvious signs of the paleo-channel within the wood at the downstream end of the reach.

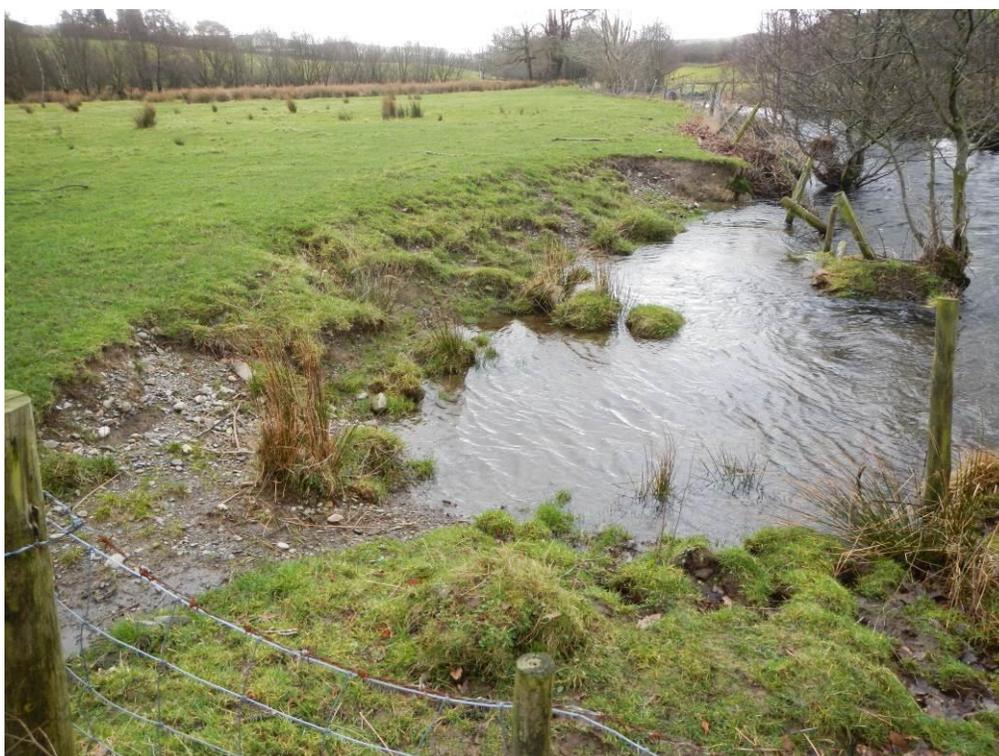
Figure 20. A perfect example of an area where erosion is likely to stop as soon as the vegetation grows up within the buffer strip.

Some of the bank erosion being experienced will ultimately be beneficial, through the increased channel width it is creating; however, in general erosion is something that should be managed. Installation of the buffer strips to exclude livestock from the watercourse will address the issue in some cases (Figure 20), but in others the use of overlapping brash revetment or installation of brash bundles will assist in management of the issue.

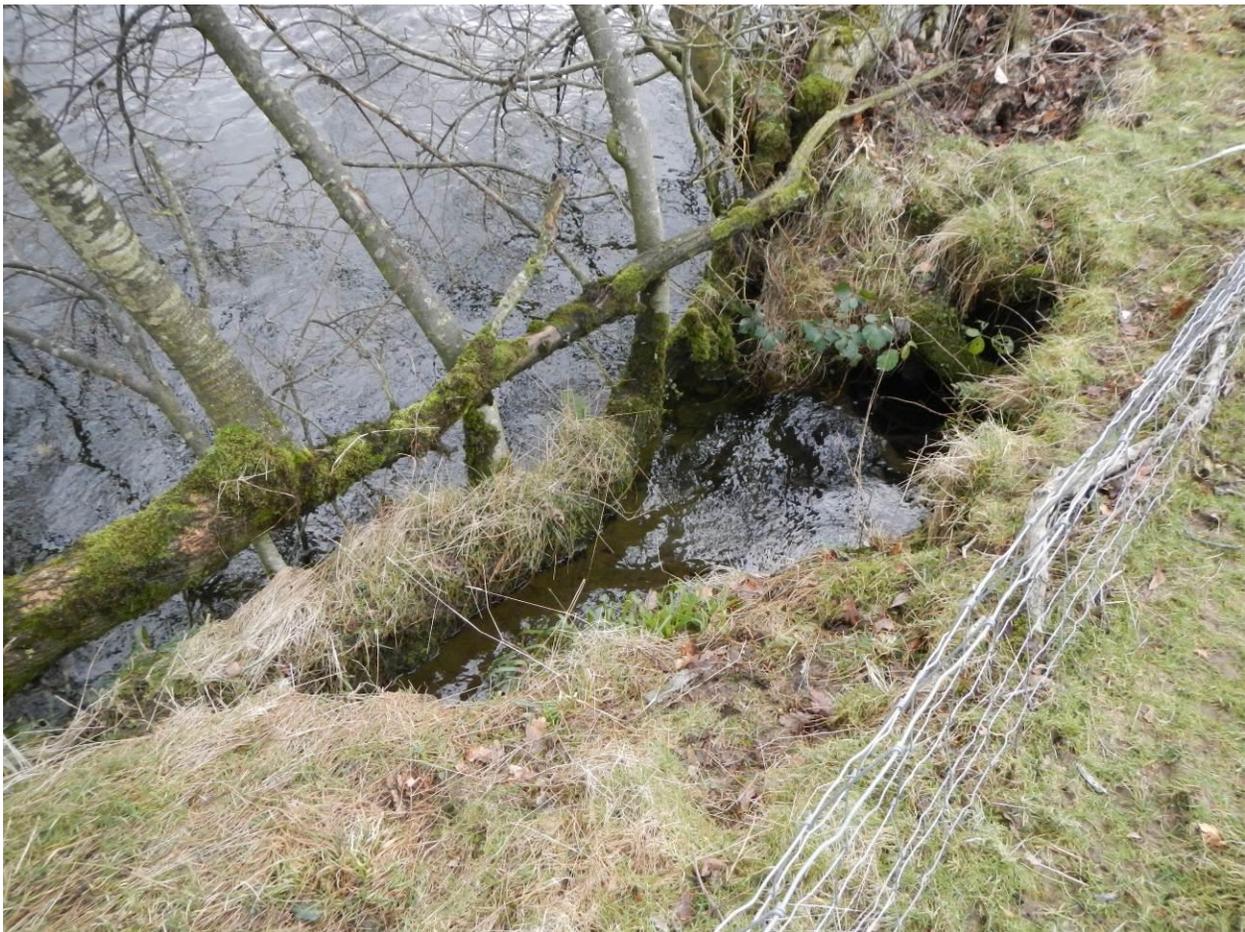
Figure 23. Not every area of eroded bank should be filled with brush, so that the valuable and scarce adult trout holding water can be retained.
