Advisory Visit
River Trent, Stoke-on-Trent
October 2014

Introduction

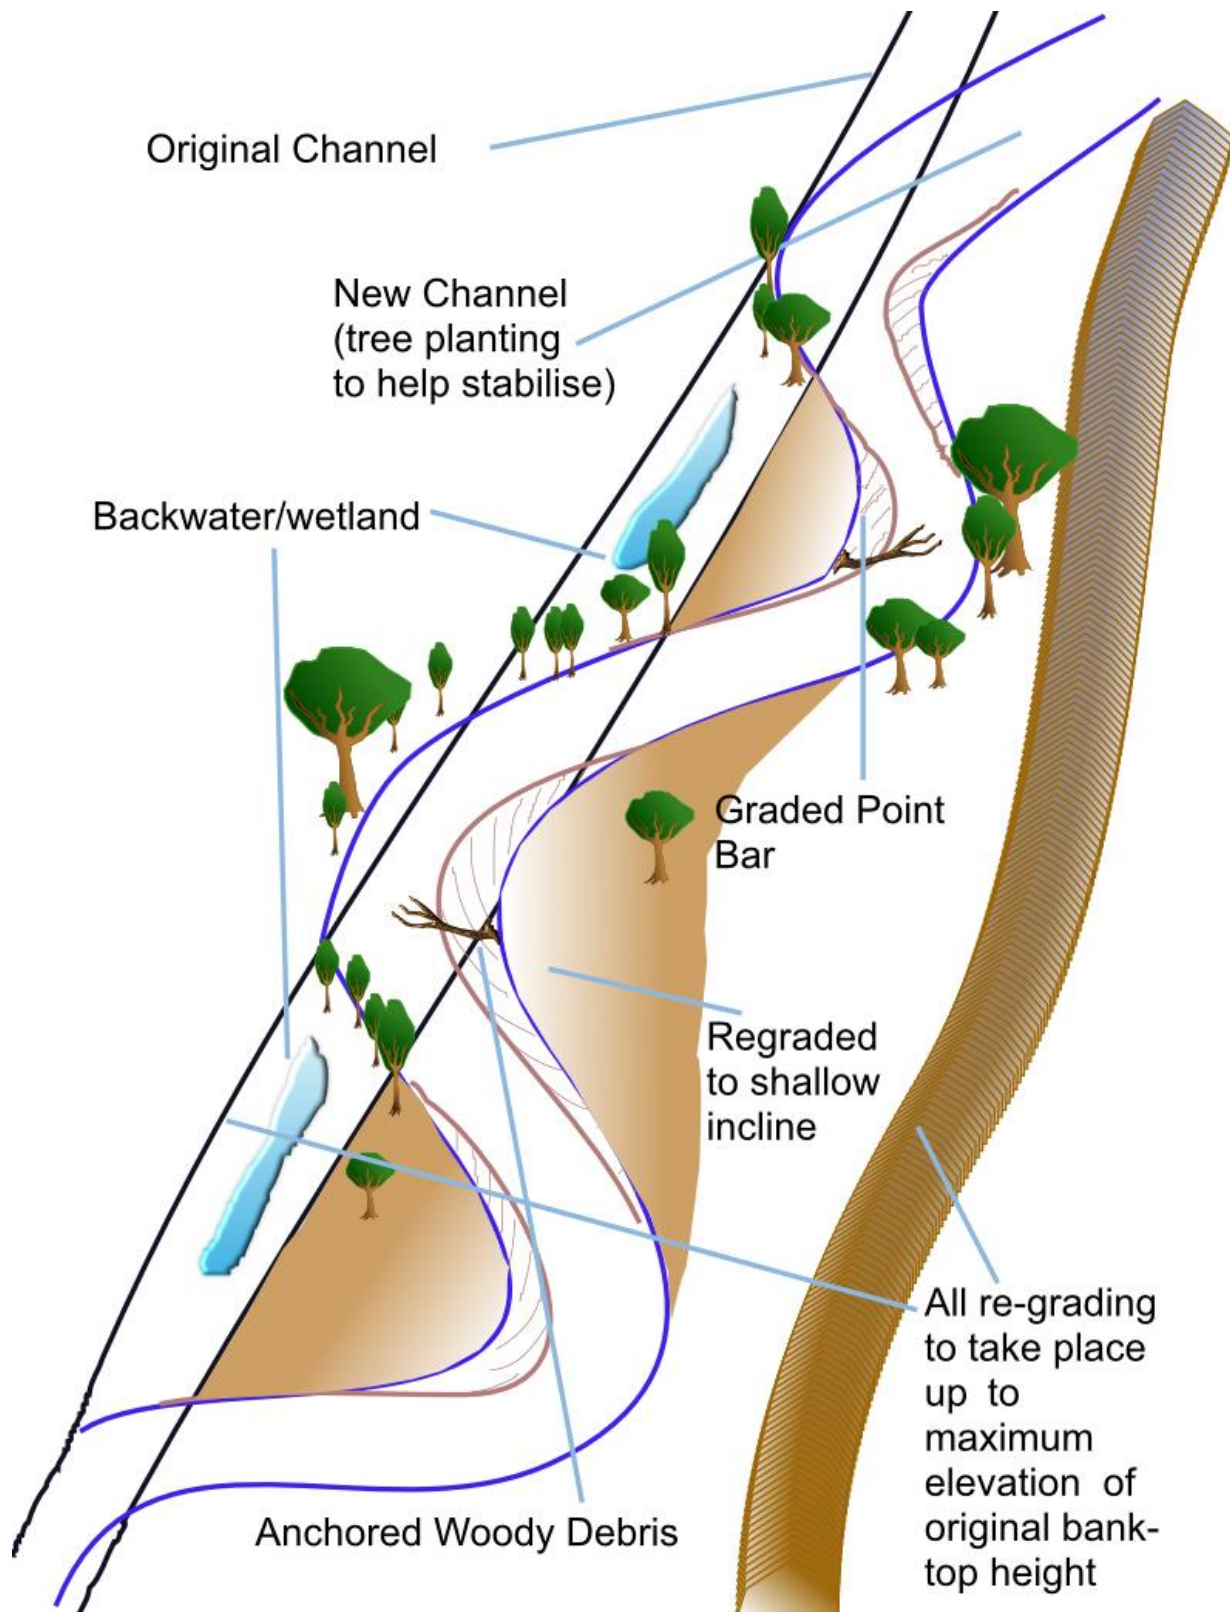
Figure 1: Indicative sketch impression of the measures involved in a designed re-meandering of the channel planform - with attendant reinstatement of significant ecological and geomorphological functions (including improved floodwater storage and control). Sketch is not to scale and does not represent a formal design.

- Option 1: Re-meander the river channel to create a sinuous planform with a pool-and-riffle structure. This would involve digging out new sections of channel and backfilling some existing sections (Figure 1), plus excavating a floodplain alongside the channel (within the bounds of current bank heights at the outer edges). The latter would be designed to inundate more frequently, but would provide improved flood storage capacity reducing flood risk to property in the area. Some back-filled channel areas could be left as backwaters, adding to the improved habitat value provided by the new river plan-form and floodplain.

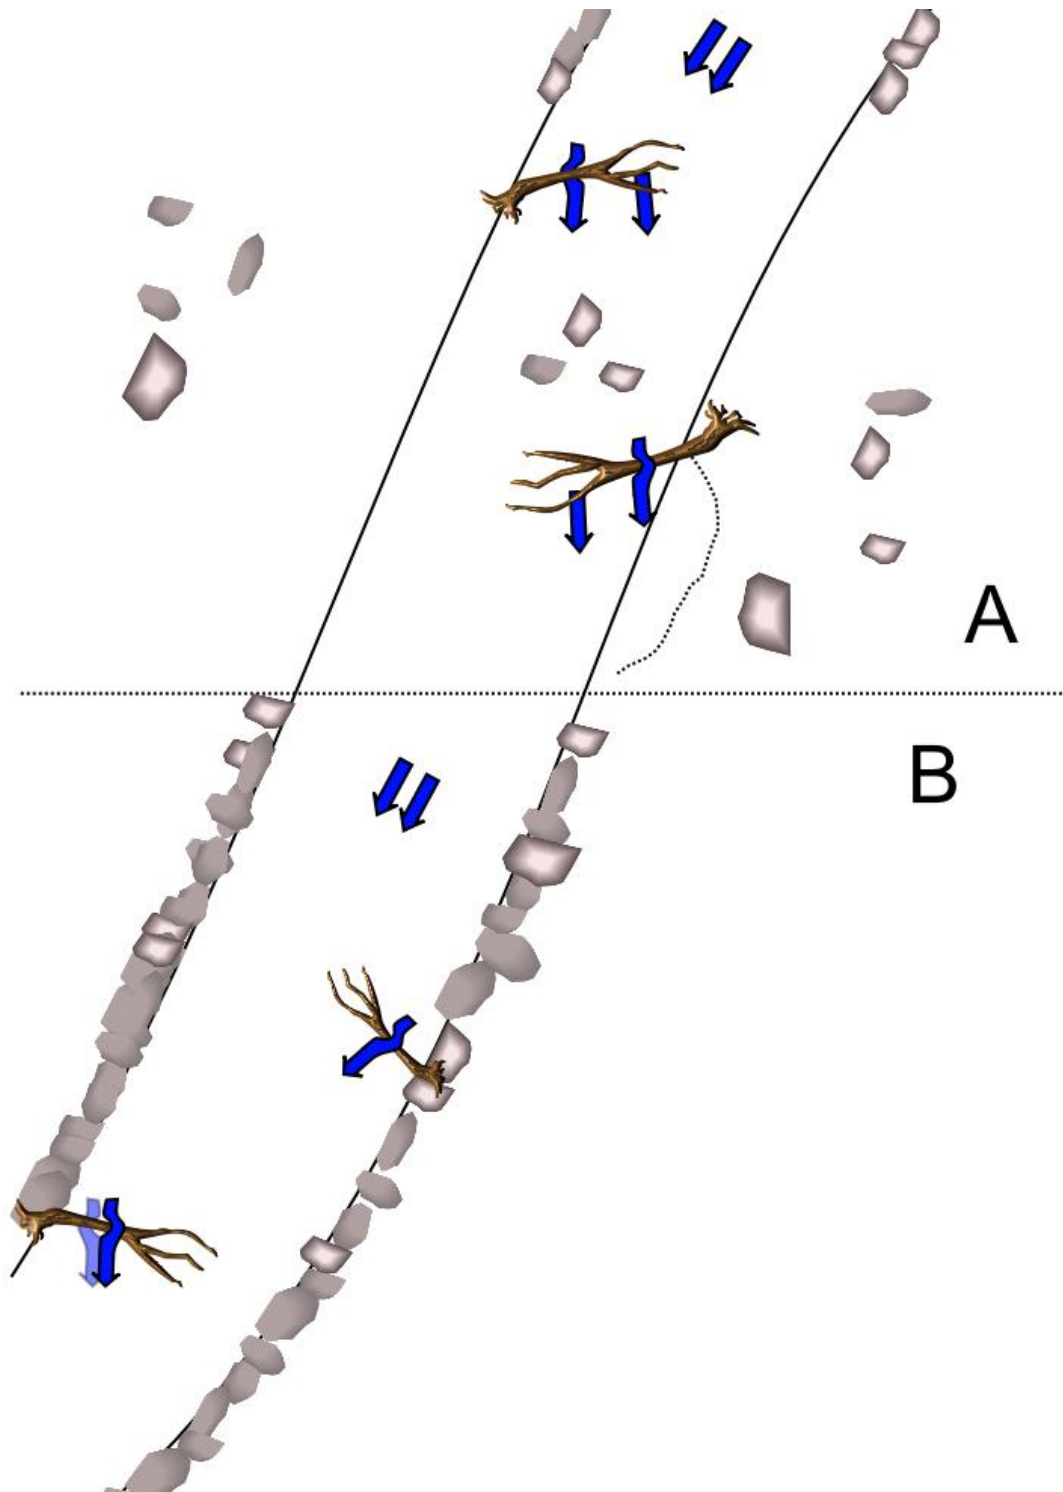
Figure 2: Indicative sketch showing removal of bank armouring and allowing channel to achieve a limited amount of autonomic re-meandering (A) and example of installation of structure within an armoured channel with no realignment of the channel planform (B). Note that in option A, there will be scope to modify the inclusion/design of specific woody debris installations according to desired effects. Blue arrows indicate the impact of structures on current flow (including “downstream” orientation used to deliberately promote bank-erosion, indicated by curved dotted line, in option A).

- Option 2: Remove the stone toe from the river channel and allow the resulting increased rates of erosion and deposition to create more natural channel features (Figure 2a).

- Option 3: Install in-stream structures (flow deflectors) to create bed scour and sorting of substrate in localised areas (Figure 2b).

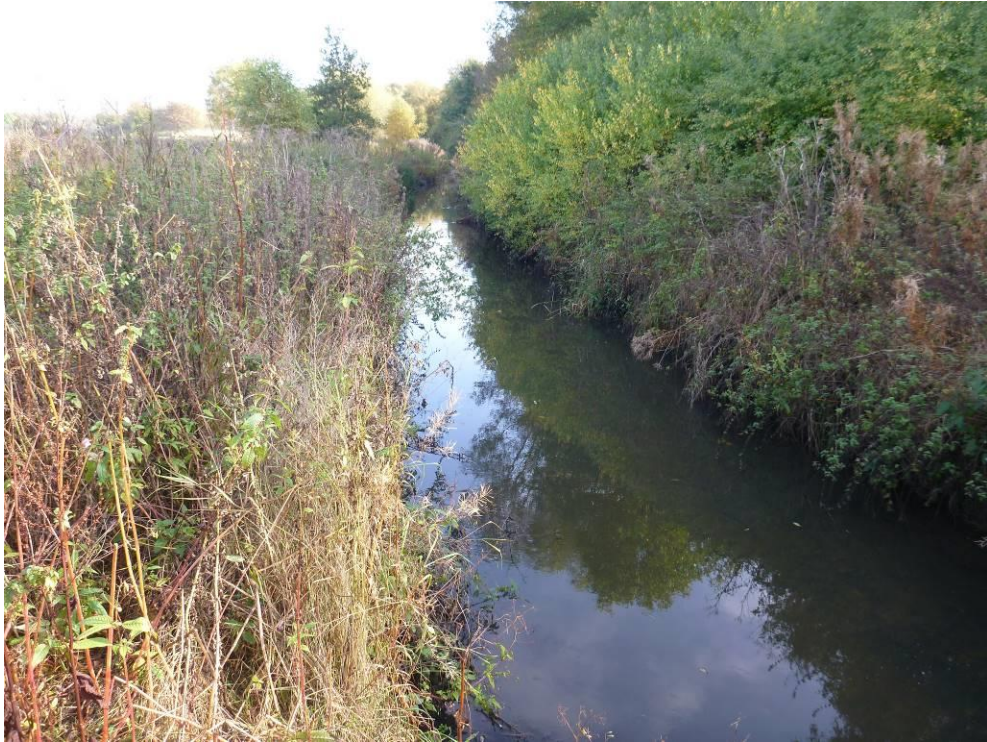
The in-stream habitat within the river along this reach is generally poor. The channel is artificially straight and uniform in width and depth. It lacks meanders and a natural pool-riffle sequence, meaning the river-bed substrate is poorly sorted and dominated by fine sediment (sand and silt). Some gravel is present at the downstream end of this reach (adjacent to the pools), where the channel gradient appears to be steeper.

Photo 1 Artificially straight channel with uniform width and depth, typical of the University reach.

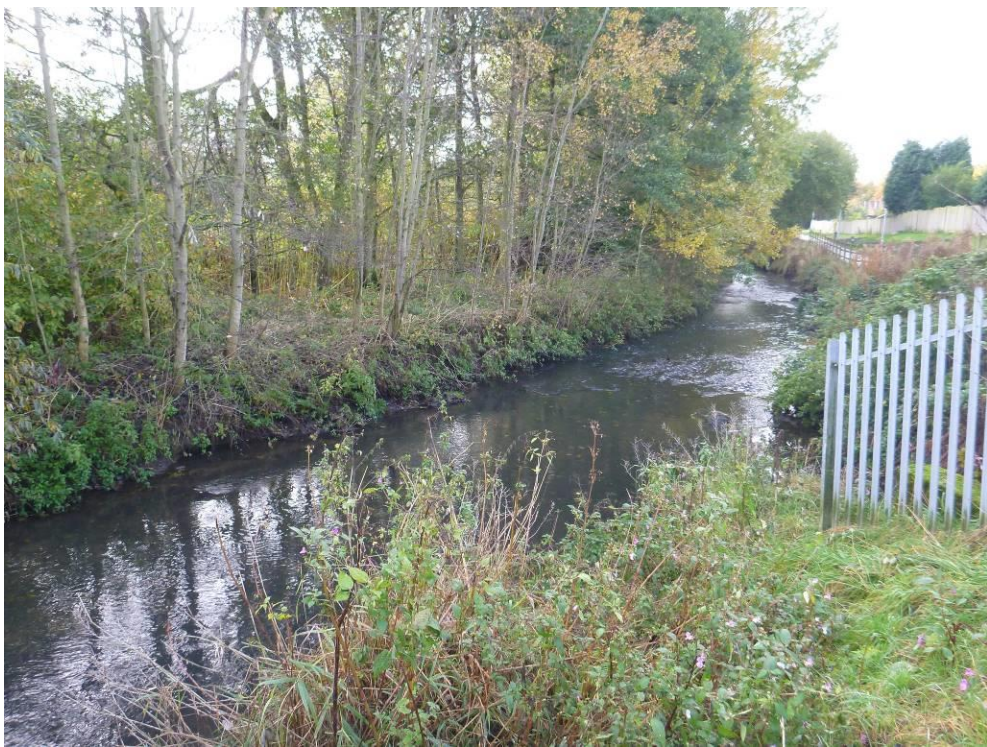
Photo 2 View at the downstream end of the University reach (parallel to Seven Arches Way). The channel appears steeper here and has some riffle habitat and gravel substrate.

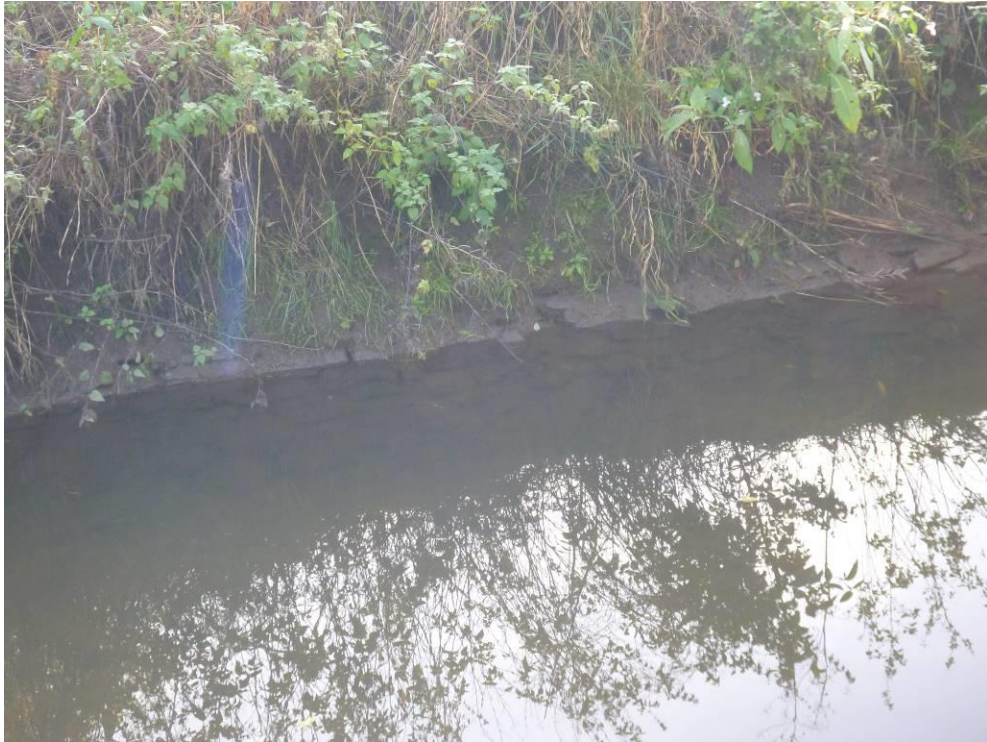
The toe of the river bank is armoured with stone which confines the river to its present course by preventing bank erosion and the re-establishment of channel sinuosity.

Photo 3 Stone reinforced toe of the bank

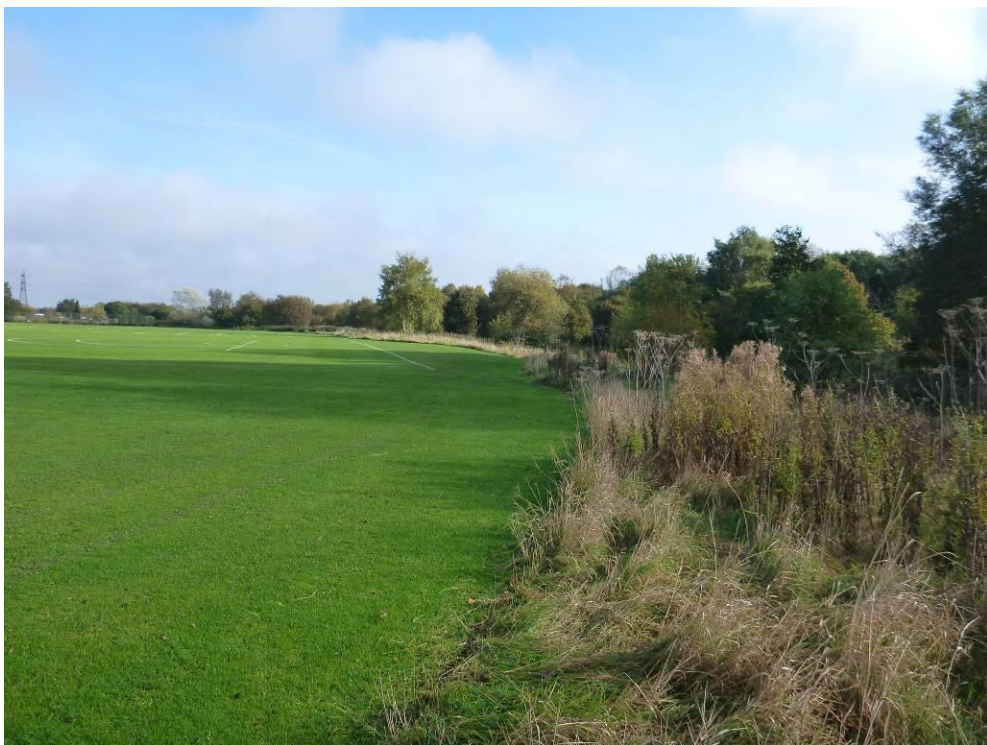
Photo 4 Upstream view of the true right bank of the river with the good riparian habitat (nature reserve) and adjacent sports fields.

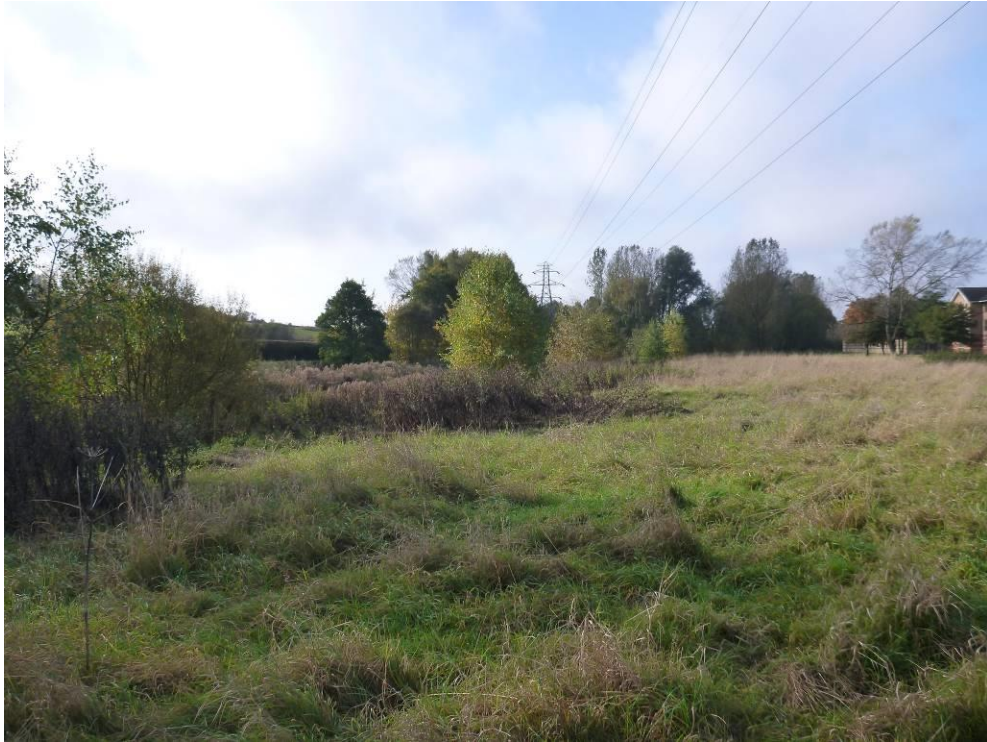
Photo 5 Downstream view of the true right bank – enough space to re-meander the river

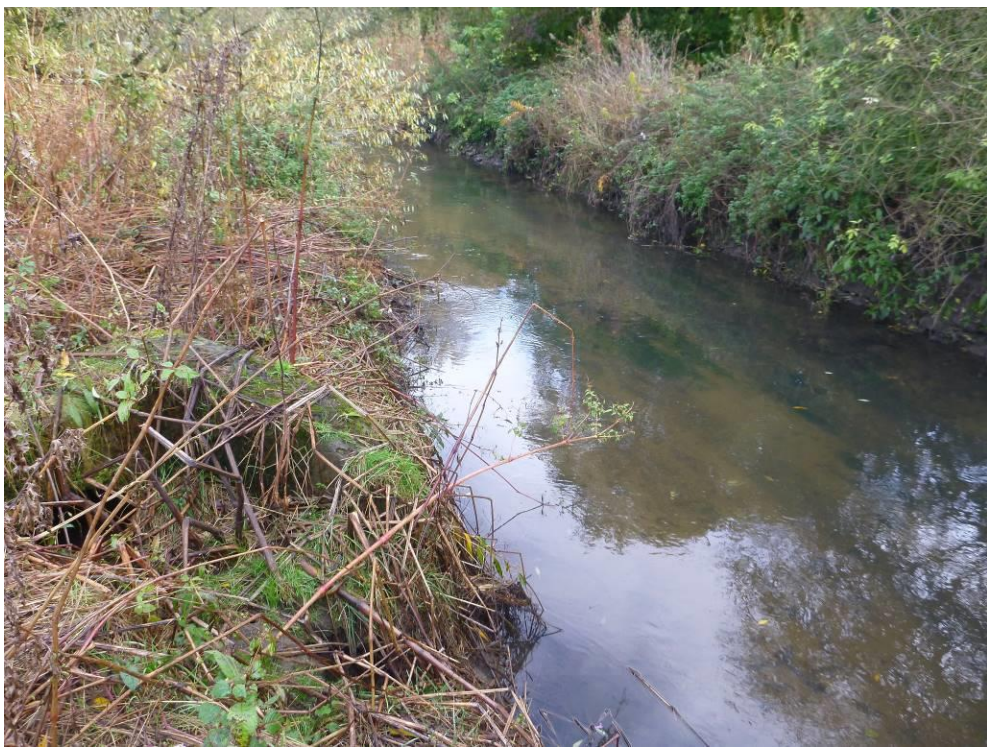
**Photo 6 Illustrating the straight channel, stone toe of the bank, unsorted bed substrate and an outfall structure (left foreground).
The latter if probably a surface water drain – such connections need to be considered during any project.**

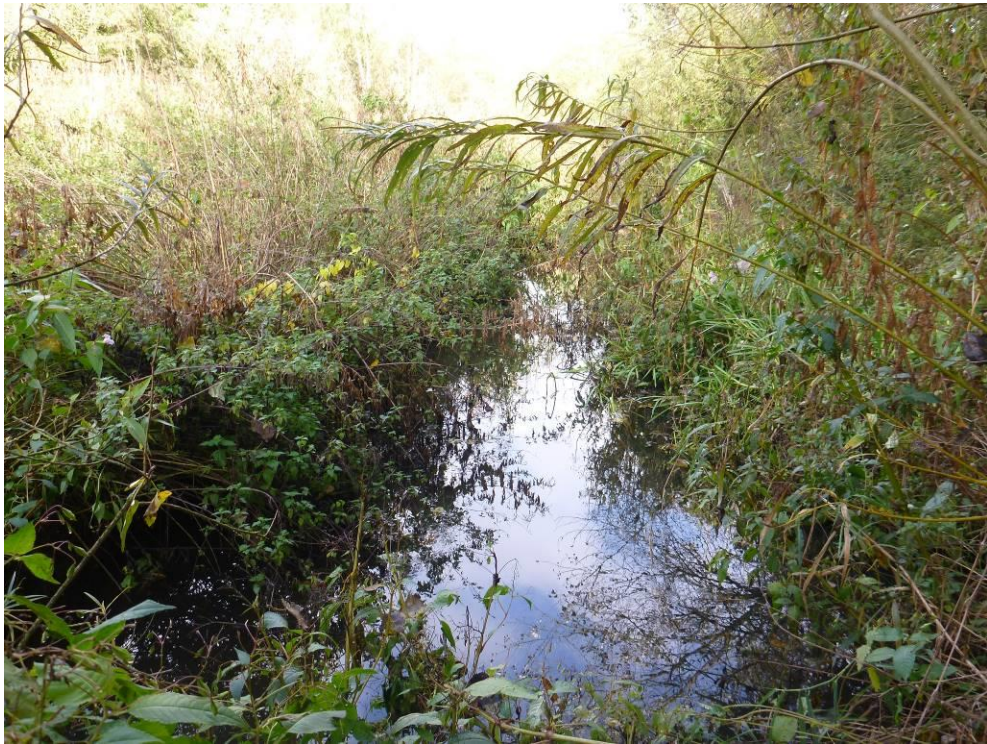
Riparian habitat varies depending upon the amount of shading from trees; in open sections the bankside vegetation is dominated by tall herbage which provides reasonable cover in the margins of the river (Photo 7). In shaded sections the marginal cover is lacking, meaning these areas are likely to support fewer fish (Photo 9). At the upstream end of the reach inspected, there is a steeper, gravel-bedded section (below A53 bridge) and a trout was observed here (Photos 10, 11).

Photo 7 River Trent upstream of Millrise Road

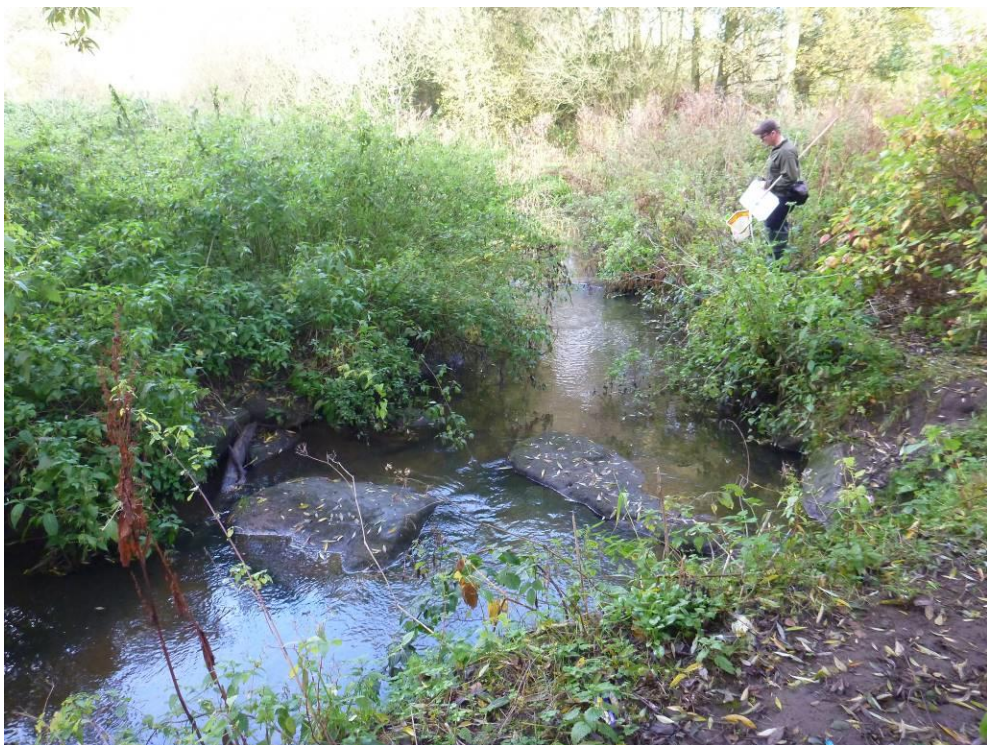
Alternatively, in-stream structures could be installed within the existing channel to create localised scour. Photo 8 shows some large stone blocks in the channel which are creating some habitat variety compared with the rest of this reach; whilst these are not deliberately introduced, nor desirable in terms of materials and "design", they do illustrate that structures on this scale are not a great cause for concern, for example in terms of increasing flood risk. Similarly sized flow deflectors and woody debris could be introduced.

Photo 8 “Stepping stones” in the river – a former weir?

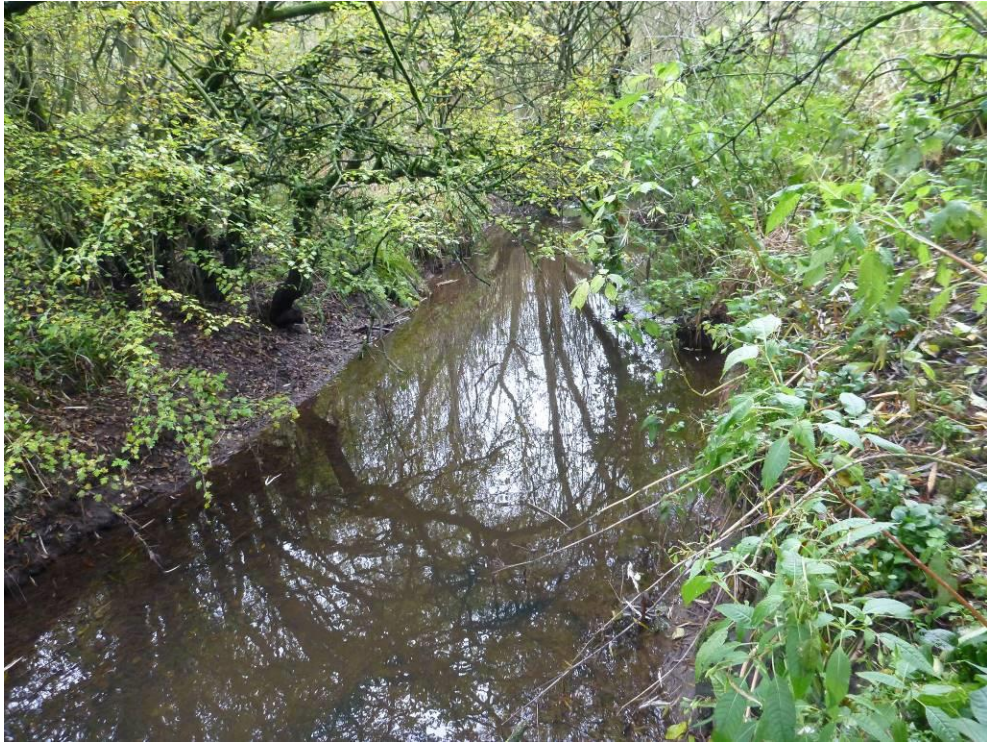
Photo 9 Trent alongside the Caldon Canal (approx. SJ9022450449)

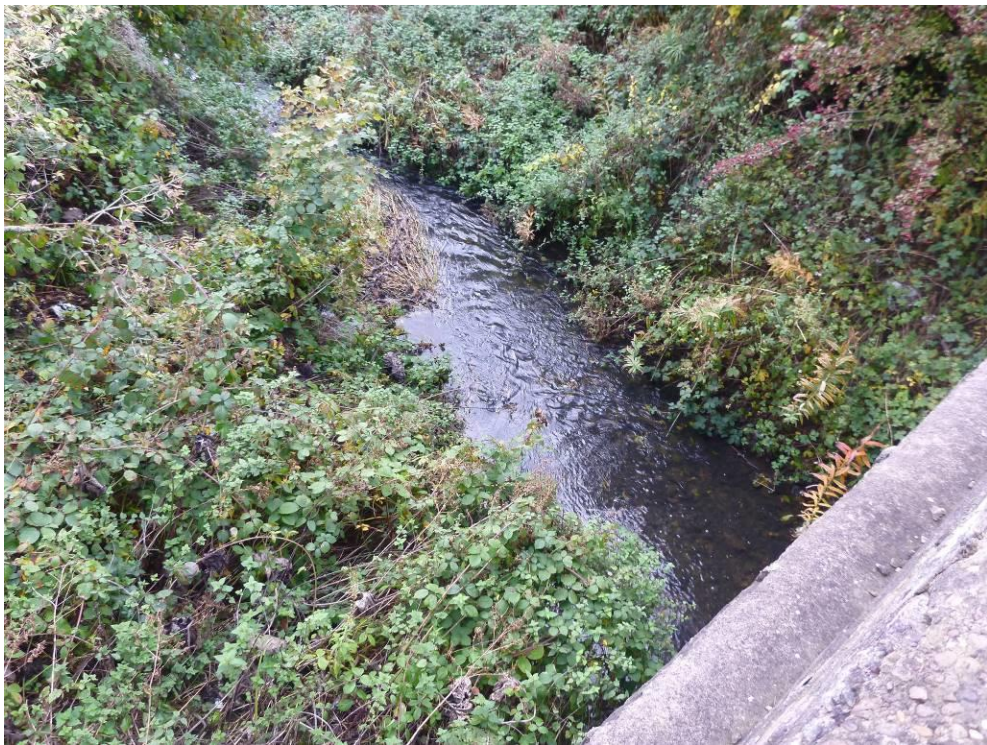
Photo 10 Trent at A53 Leek Road bridge – faster flowing with a gravel substrate in a localised area. A trout was observed here (see below).

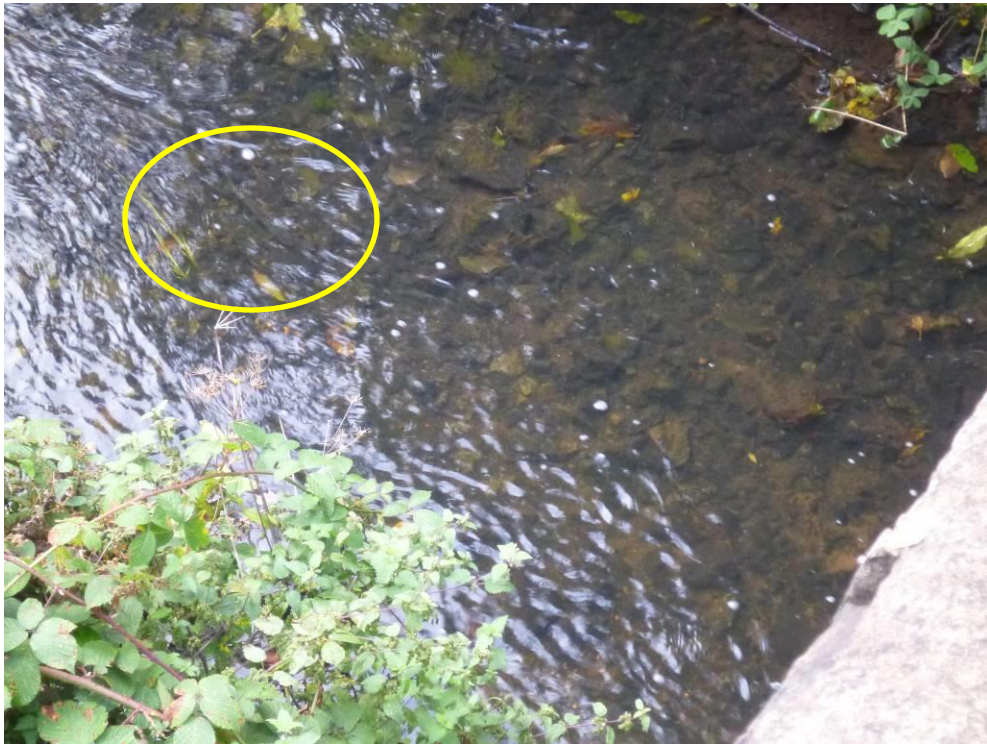
Photo 11 Trout observed at A53 bridge

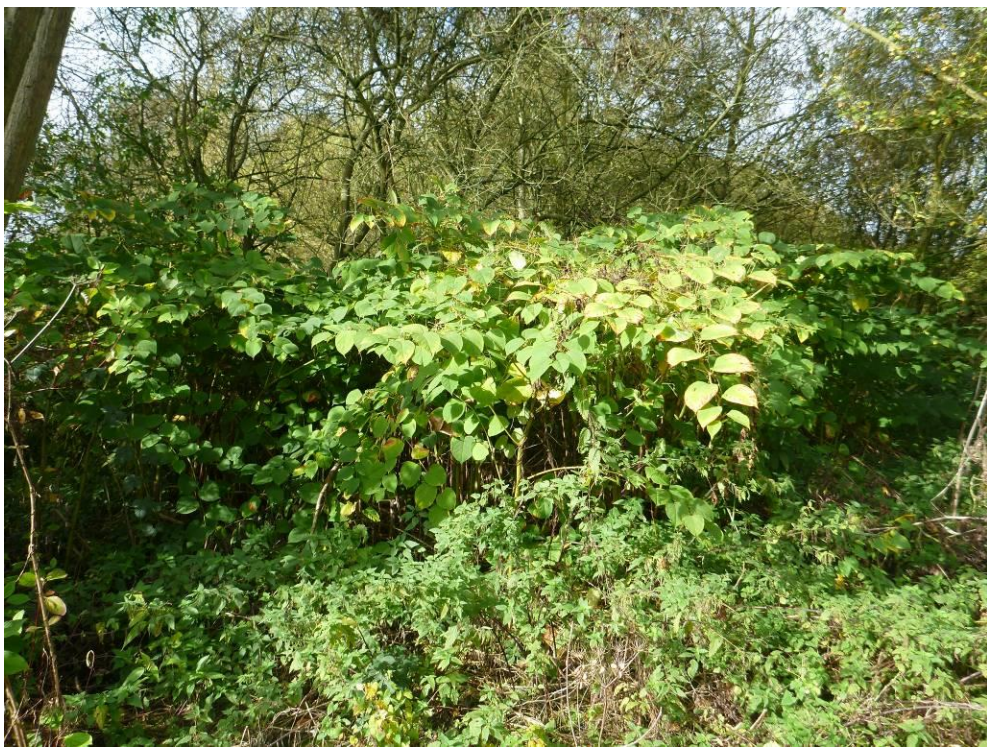
Photo 12 Japanese knotweed present between the Trent at the small left bank tributary

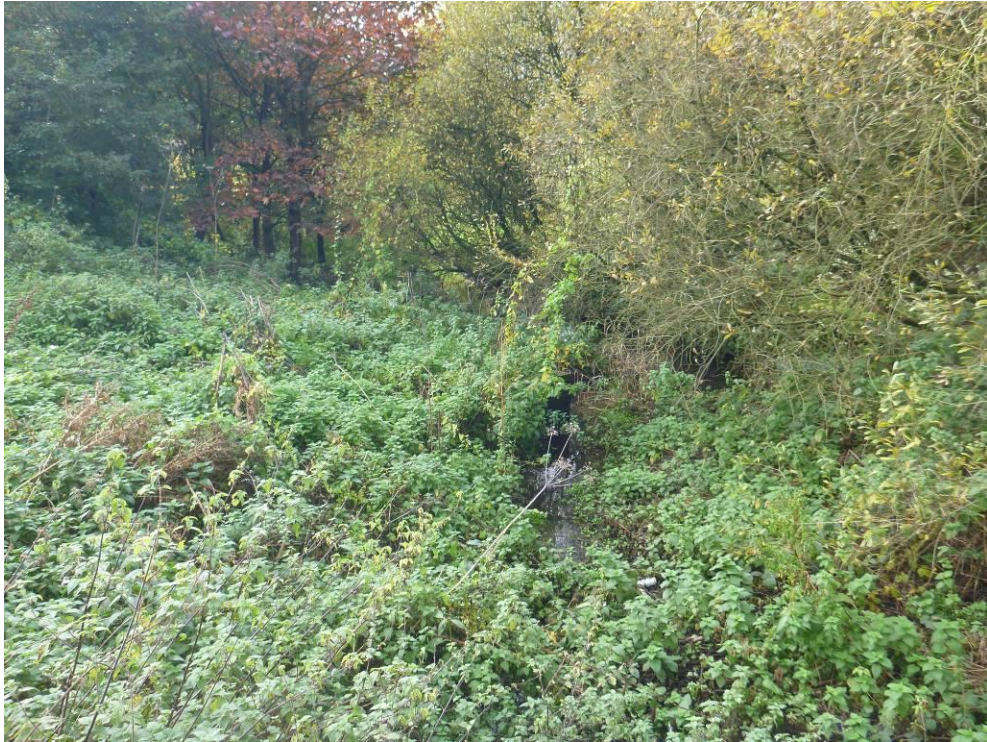
Photo 13 Small left bank tributary – open section

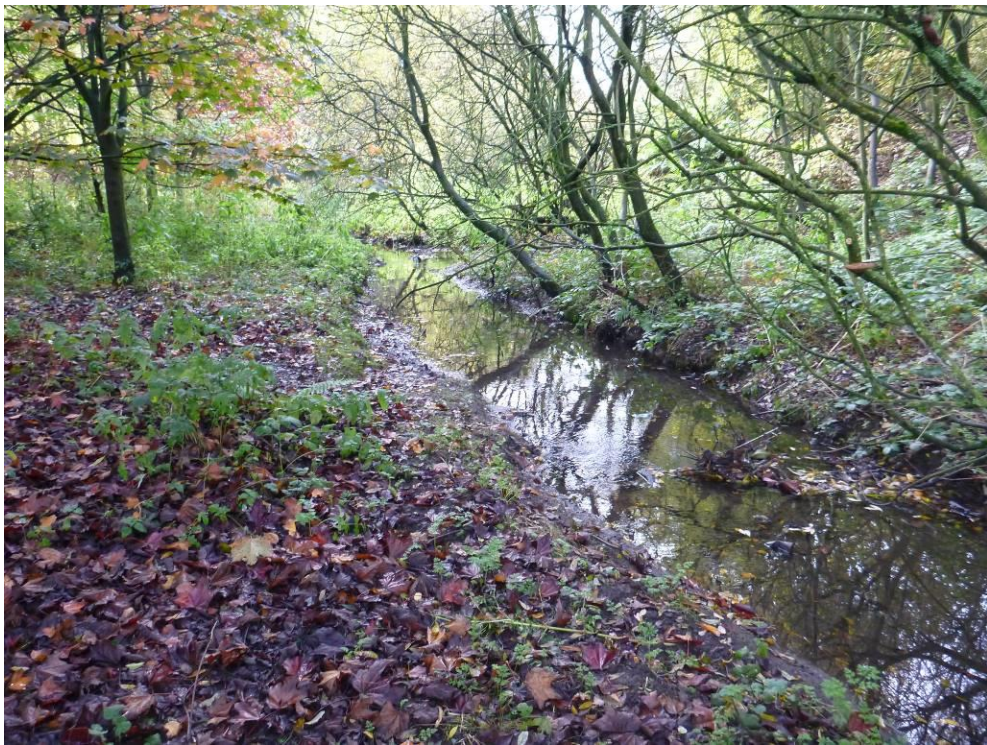
Photo 14 Small left bank tributary – shaded section

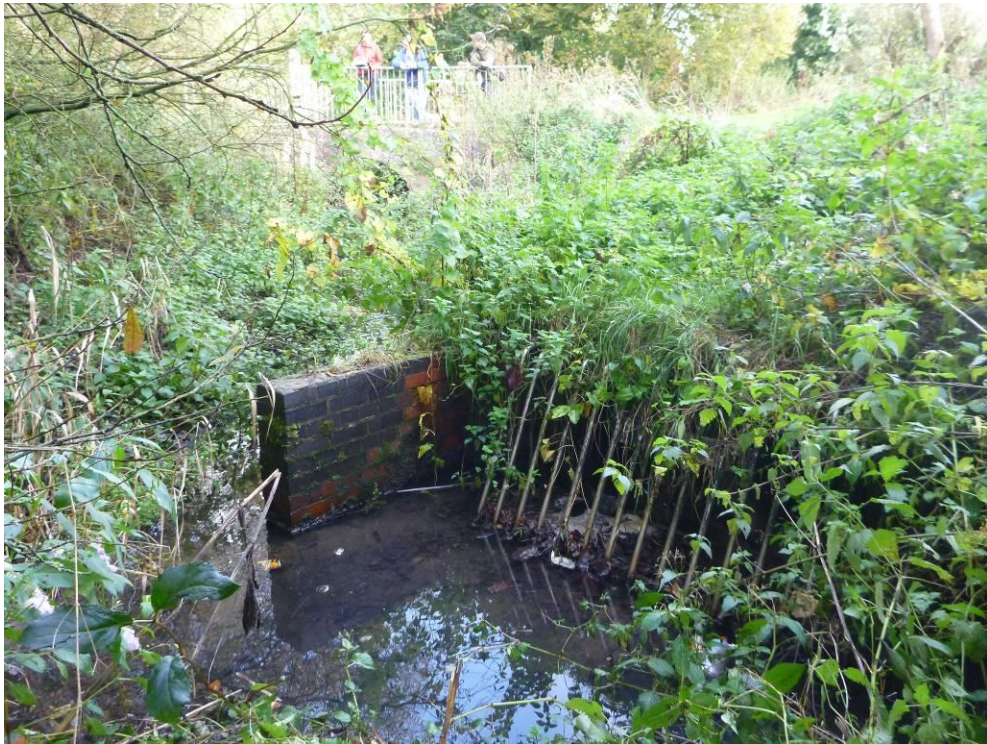
A small tributary stream enters the Trent on the left bank in this reach. The habitat is similar to the main river, with riparian habitat varying depending upon the extent of tree-shading (Photos 13, 14). A combined sewer overflow enters the tributary (Photo 15) which may impact water quality on such a small watercourse. Non-native plants species were observed including Himalayan balsam and stands of Japanese knotweed.

Photo 15 Combined surface water-sewer overflow entering the small left bank tributary

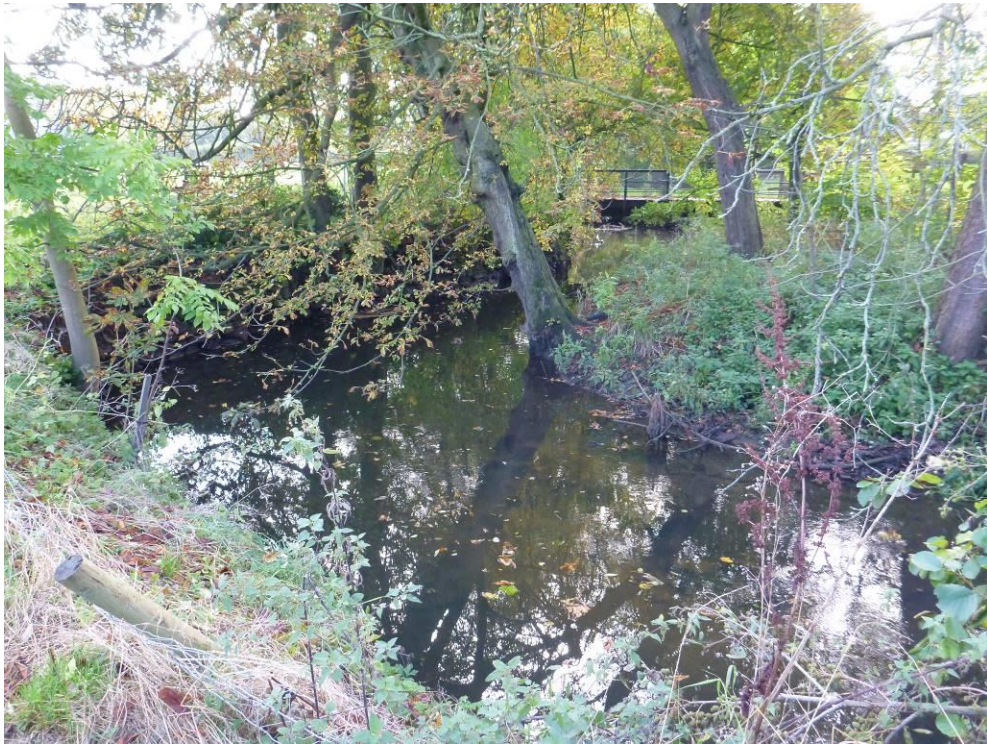
Photo 16 View downstream to the footbridge at former city farm

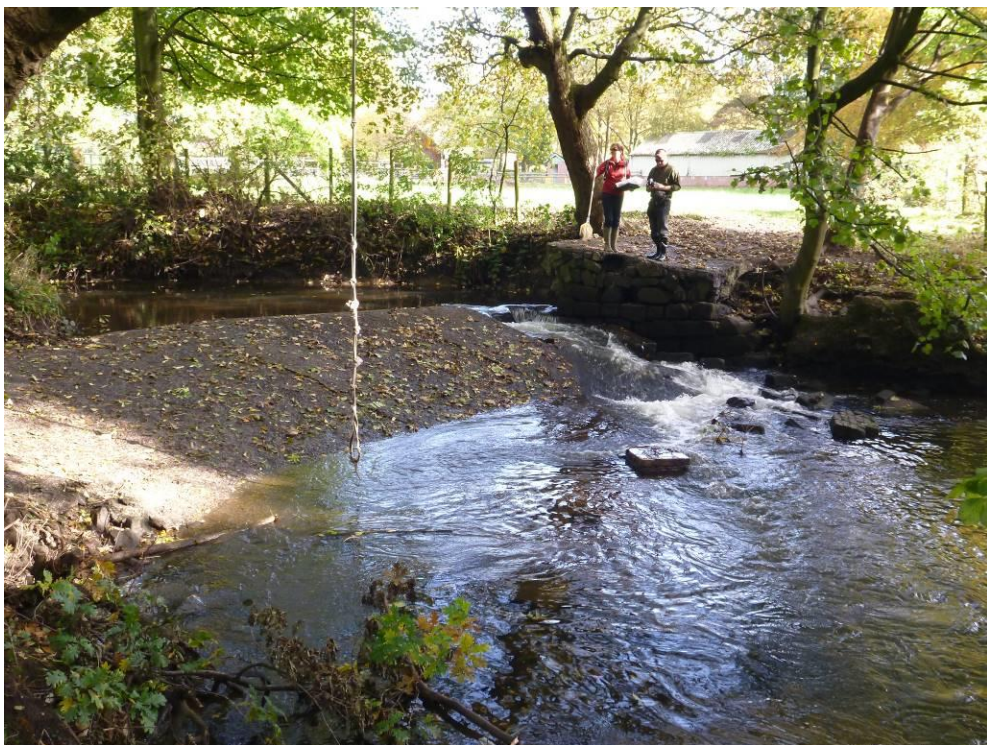
This site was inspected from the bridge into the former city farm at SJ8992247475 (Photo 16) upstream to A5009 Leek Road (SJ8980747632) (Map 4). Several trout were observed in this reach indicating good water quality; a non-native signal crayfish was also observed. There is a weir about halfway along this reach which forms a barrier to fish passage and has a detrimental effect on in-stream habitat by impounding the river (Photos 17, 18). The weir is redundant and an obvious candidate for removal to provide a “quick win” for habitat improvement.

Photo 17 Weir in Finney Gardens

The EA commissioned ARUP to investigate a preferred option at this site in 2012/13 and complete removal (or a rock ramp as a backup option) was recommended. The work included a topographical survey. The project has been put forward internally within the EA for funding WFD funding in 2015/16 to progress this project (ideally staggered removal) but the bulk of the consultation remains outstanding (Dan Johnson, pers. comm.).

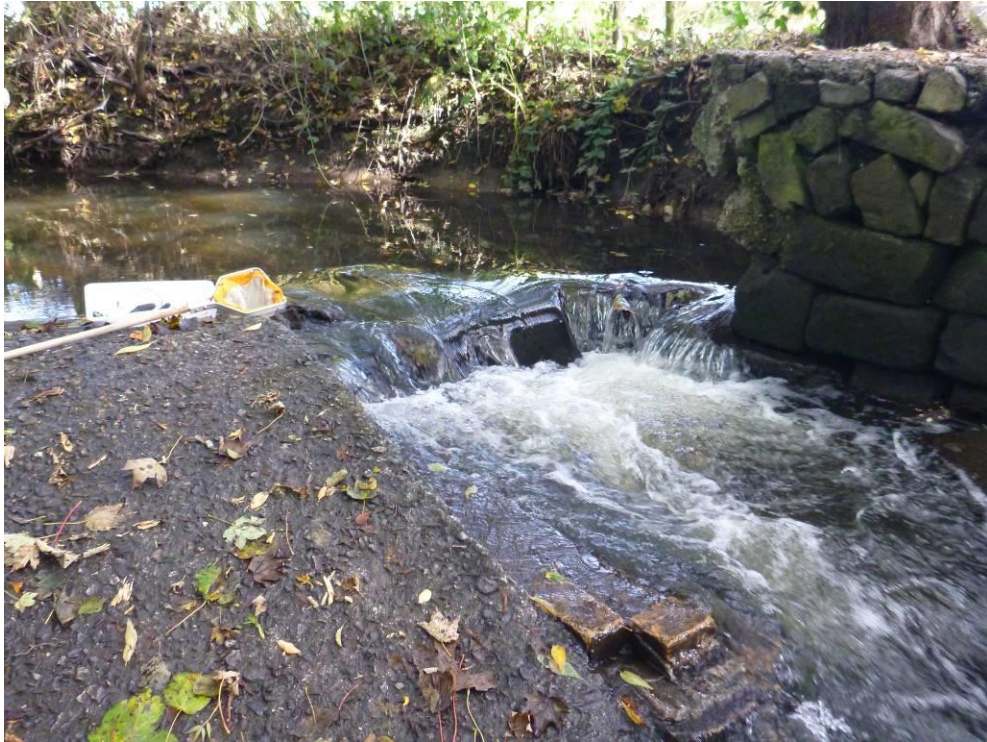
Photo 18 Close up of channel at left side of weir

Staggered weir removal should be very straightforward. Photo 18 shows that low flows pass through a channel on the left side of the weir crest. The channel appears to have been in-filled with blocks of stone; these could easily be removed to lower upstream water levels and assess the extent of river bed re-grading which occurs.

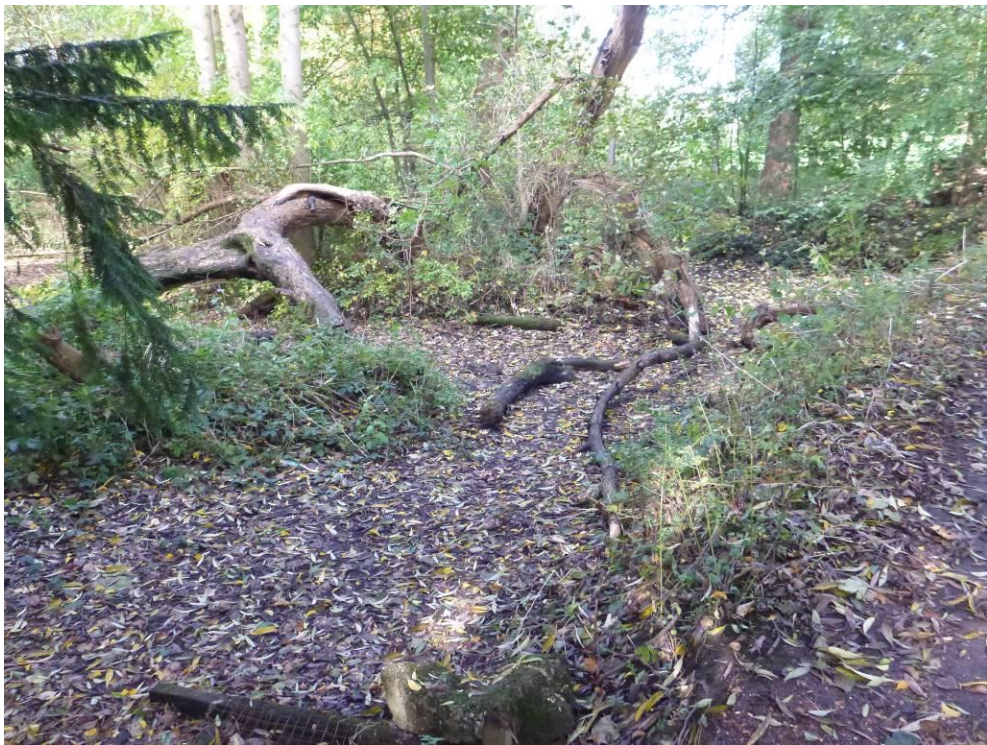
Photo 19 Low-lying ground on the right bank of the river adjacent to the weir – possibly a former pond or leat fed from the impoundment?

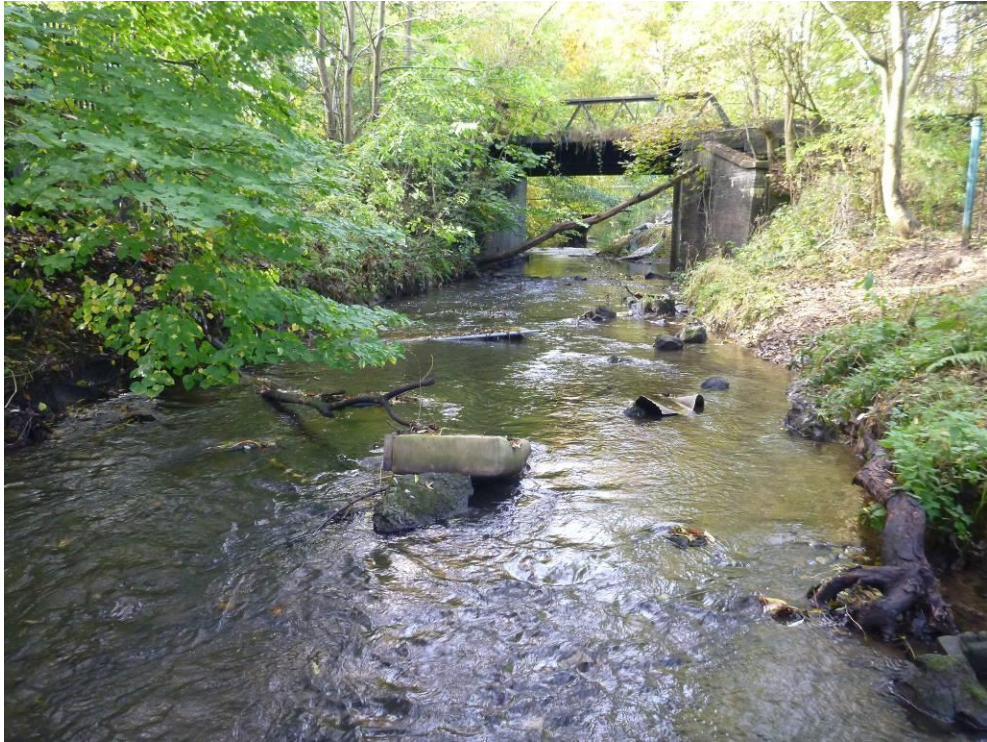
Upstream of the weir, the river impoundment extends to within approximately 40m of a disused railway bridge, now a footpath (Photo 20). A short distance upstream is the A5009 road bridge. Removal of the weir will cause re-grading of the river-bed upstream of the weir, with the potential to damage the footings of these bridges; both have been subject to previous maintenance (Photos 21, 22). This risk is likely to be low, but should be quantified as far as reasonably possible (this may have been considered in the above ARUP report). Often in these circumstances it is not possible to accurately assess the risk and it may therefore be better to proceed with a staggered weir removal alongside with a financial provision for bridge work should it be required.

Photo 20 Former railway bridge, photographed from the approximate upstream limit of the impounding effect of the weir.

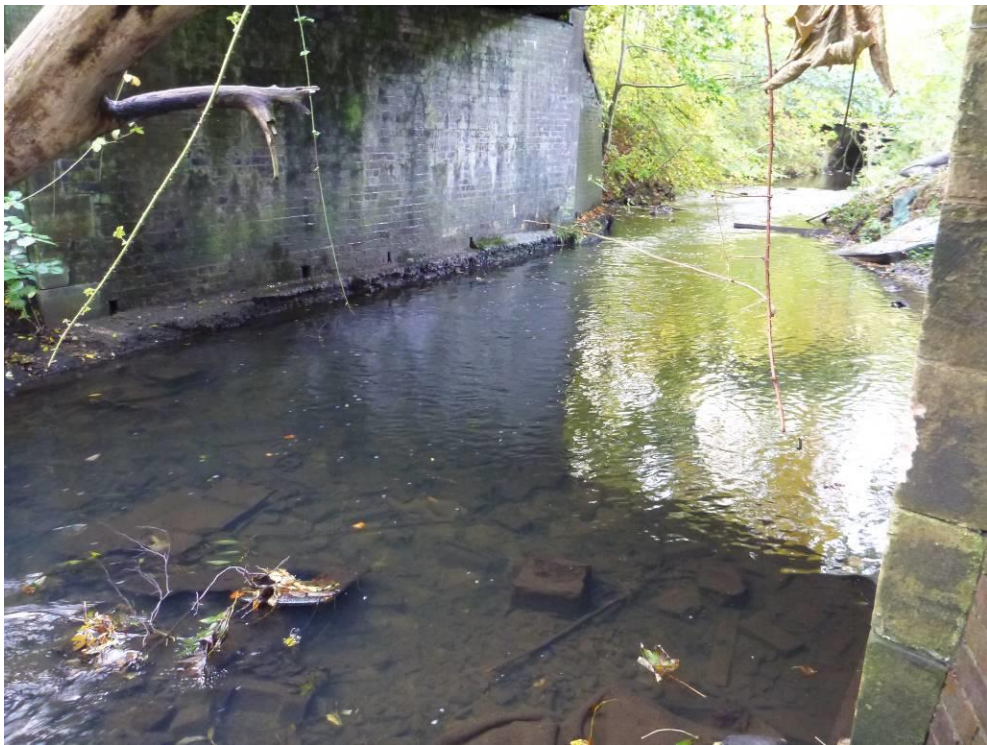
Photo 21 Under the former railway bridge. Concrete has been cast at the toe of the brickwork on the far bank at some time in the past.

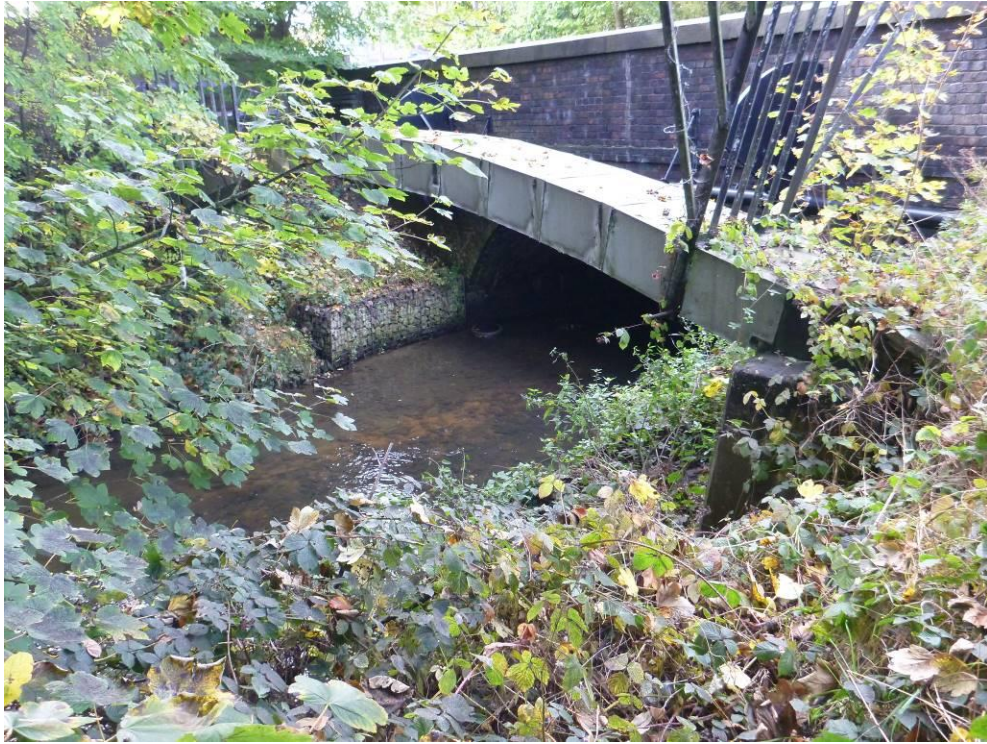
Photo 22 The A5009 road bridge at the upstream extent of this reach. The far bank has been protected with gabion baskets.

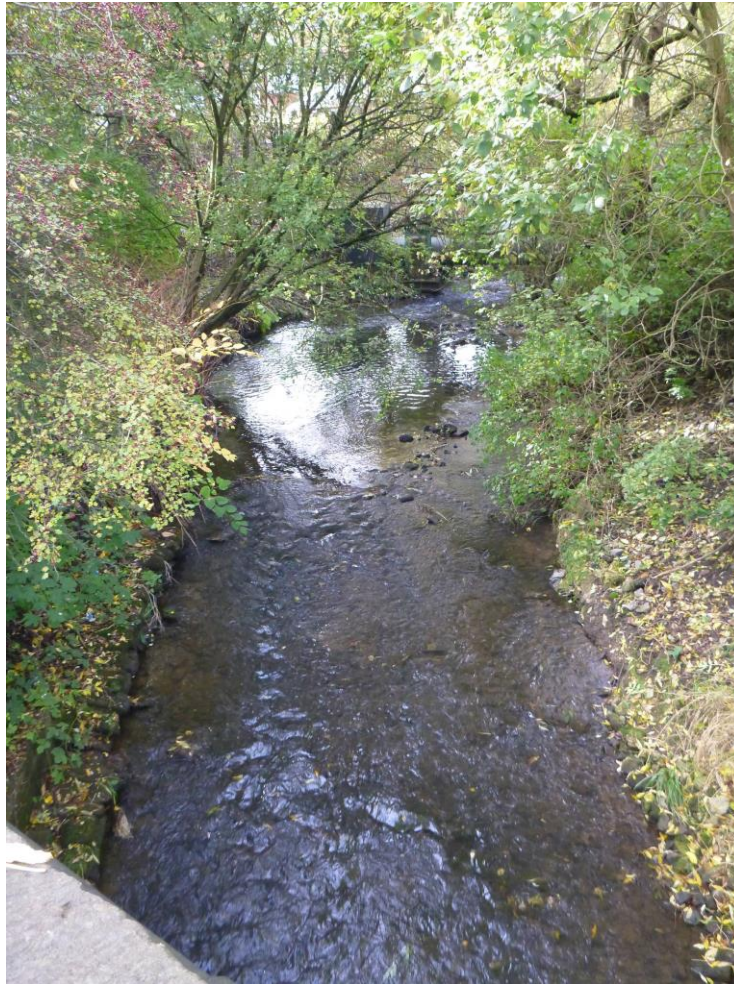
Alongside Cromer Road the river was at the foot of a steep bank and relatively inaccessible. In-stream habitat appeared to be relatively good, with a gravel substrate and variation in flow patterns and depths. The channel has a good degree of shading by trees (Photo 23).

Photo 23 Section alongside Cromer Road, upstream of A5009
