Advisory Visit
River Trent, Stoke-on-Trent
October 2014

Introduction

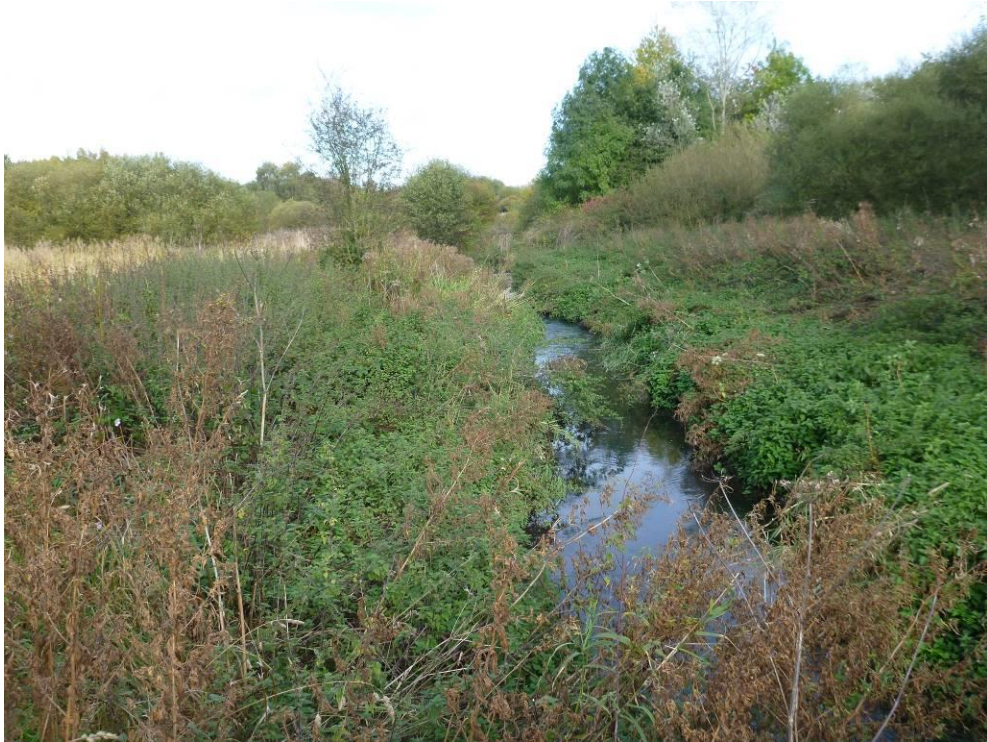
Photo 25 Typical habitat within the upstream end of this reach

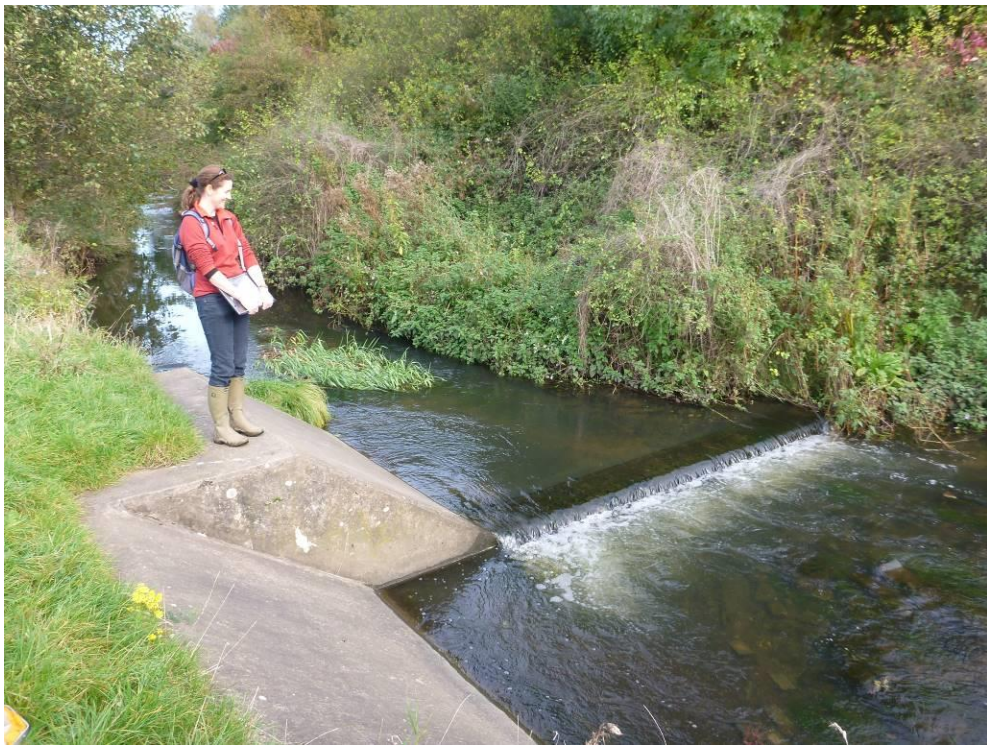
A small weir is present (Photo 26) which appears as though it may have been used previously for flow gauging. The extent of encroaching vegetation across its crest from the left bank (about a third of the crest) indicates it is not currently in use. The weir may be a barrier to minor fish species and it appears it could be easily and cheaply removed.

Photo 26 Small weir

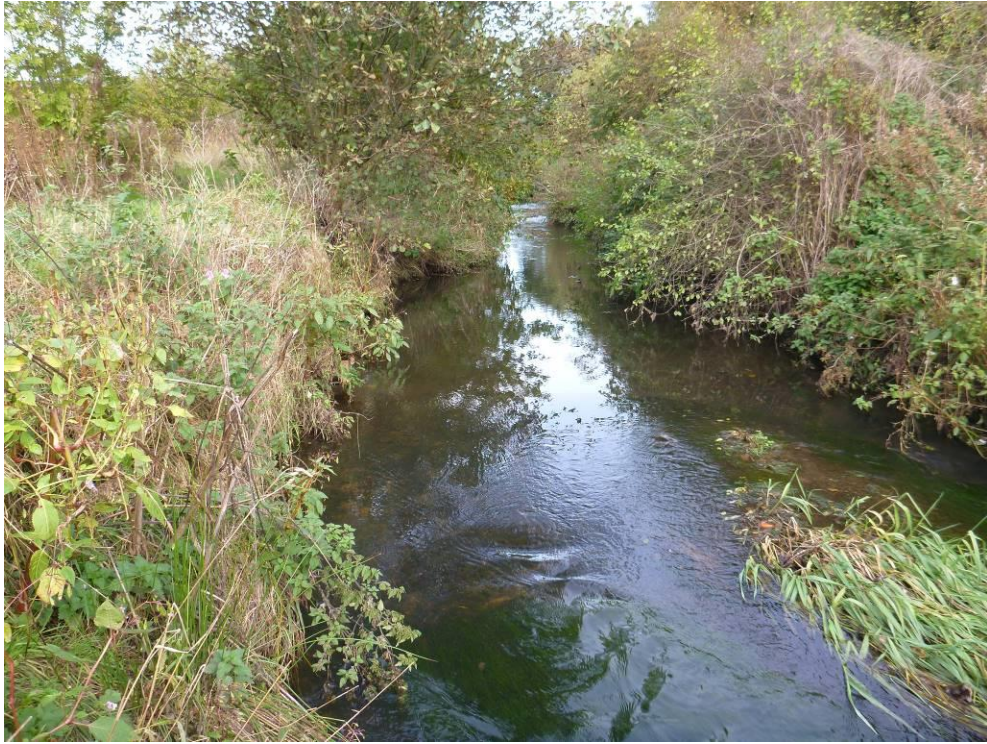
Photo 27 View upstream from the small weir
