Upper Avon, France Farm

An Advisory Visit carried out by The Wild Trout Trust August 2012

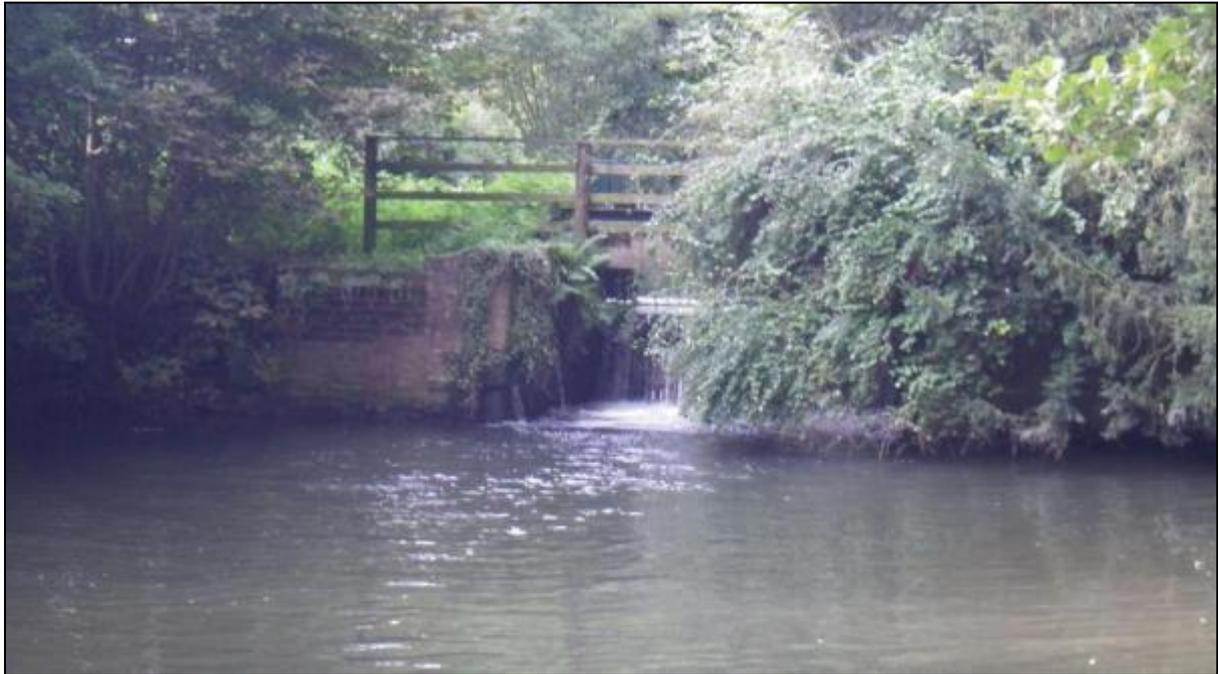
The Avon West through France Farm is heavily impounded by a set of large undershot hatches currently fully closed and acting as a weir. This structure is not only a complete barrier to fish migration but is also critically degrading the

Figure 2: The hatch at France Farm is a complete barrier to fish movement

- It is recommended that the hatch currently backing up water on the Avon West through France Farm is opened and a natural flow regime is reinstated. This action will result in a drop in water level and dramatic change in the physical conditions of the river upstream. The river will require a short period of adjustment, possibly followed by narrowing works to accommodate the new flow conditions.

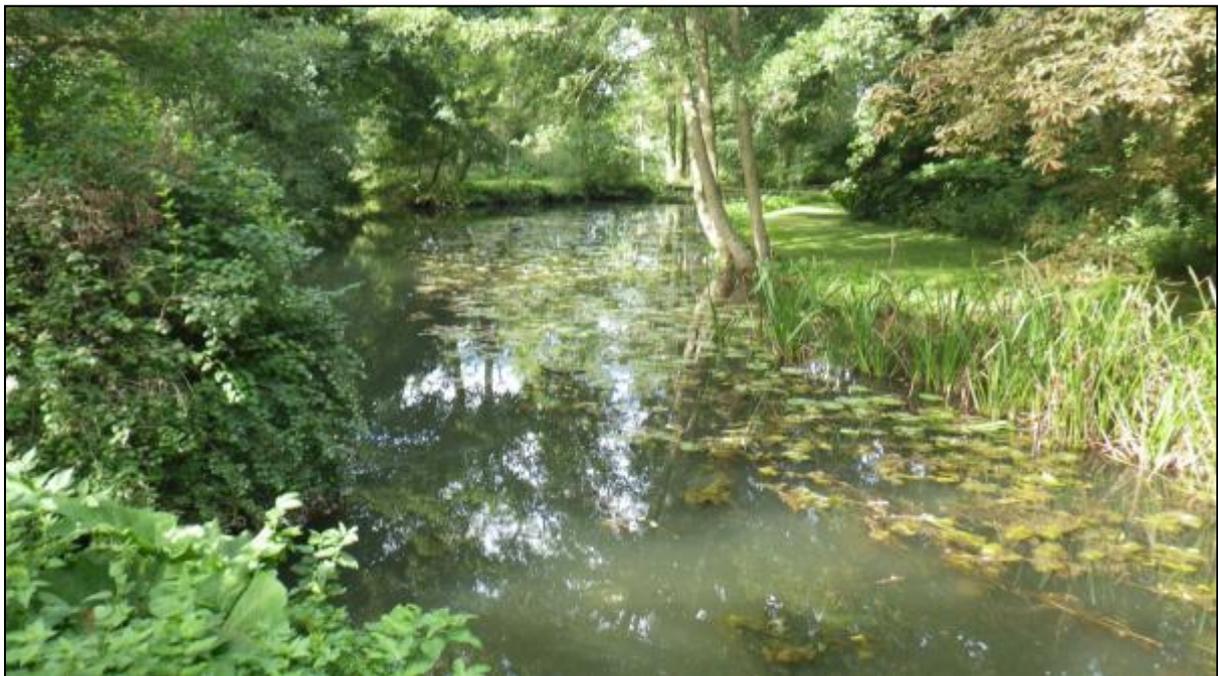
habitat upstream. The river above the hatch is colonised by water lily (probably *Nuphar lutea*) and more closely resembles a pond habitat than that of a southern chalkstream. The river is very slow flowing and this has allowed the bed to become smothered by a thick deposit of sediment.

Figure 3: The poor-quality river habitat upstream of the hatches

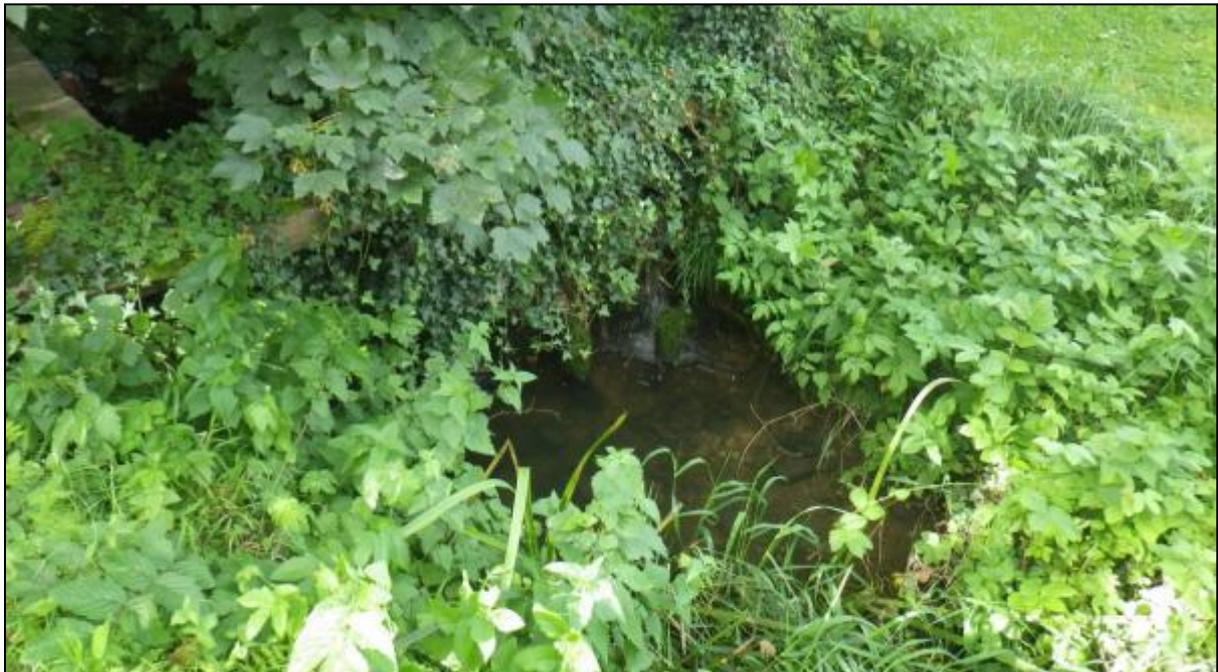
Approximately 80m upstream of the hatch, an off-take on the left bank is dependent on the water level maintained by the hatches and feeds a sweetening flow of water into a large pond stocked with rainbow trout. The off-take is in a dilapidated condition and may require works in the near future to remain functional.

Figure 4: The off-take for the pond is in poor condition and may need replacing in the near future

The off-take for the adjacent pond will most-likely be left dry as water levels drop. In order to retain the pond, it is recommended that any restoration works include an alternative water supply to the pond. This could be in the form of a pipe or culvert from further upstream where the natural gradient of the river is higher than the pond, or a pumping system to take water from the new river water-level to the pond.

Another option may be to install a small borehole and pump to supply the pond with water. This option however, may prove controversial as abstraction is a heavily debated topic of contention throughout the Avon catchment.

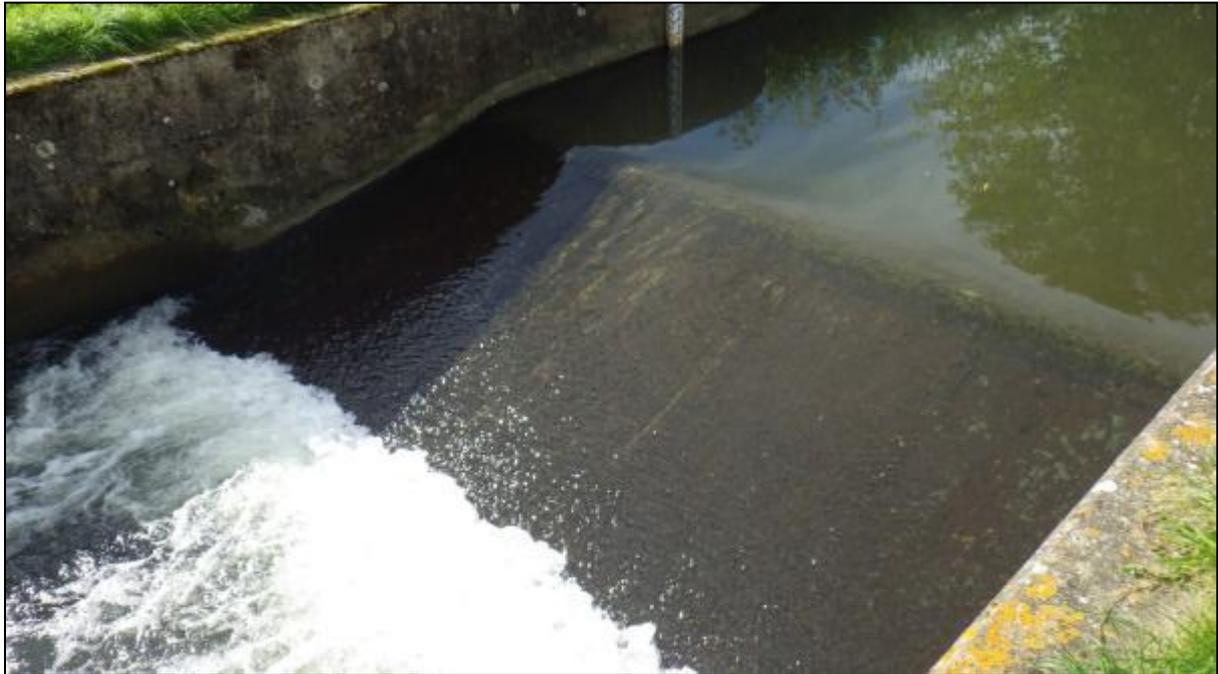
The river passes under the A345 and becomes impounded again by an EA flow-gauging weir where the Avon West meets the Avon East. The flow-gauging weir is also a significant obstacle for fish passage and is likely to be a complete barrier under most flow conditions.

Figure 5: The EA flow-gauging weir is a significant obstacle to fish passage

- Downstream of the hatch, options should be explored with the EA to remove the flow-gauging weir or replace it with a gauging system that does not act as a barrier to fish passage.

If the gauging weir cannot be replaced in the short-term, options should be explored to improve fish passage over the weir. The EA has some experience in easing fish passage over similar 'crump' style weirs by baffling flows with timber baulks fixed to the downstream face of the structure.

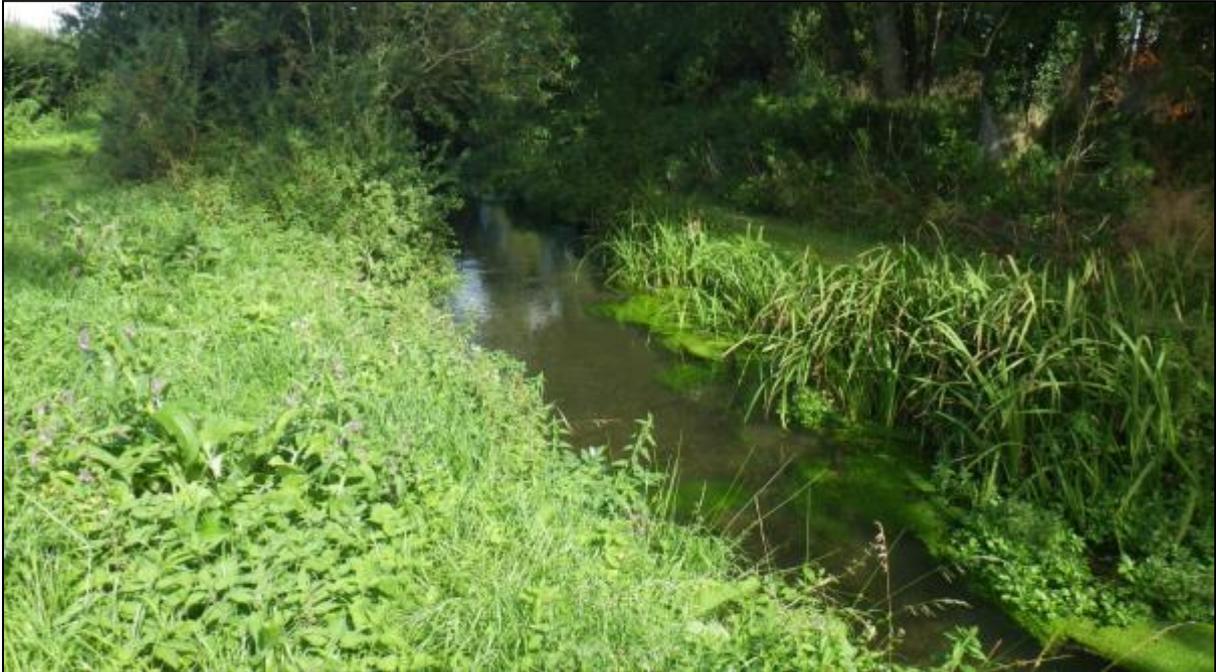
Figure 6: The upper reaches of the fishery on the Avon East

There is some potentially very good spawning habitat along this reach where flint gravels are scoured clean of sediment. This could be further enhanced by the introduction of some large woody debris (LWD) to deflect flows and increase localised scour of the gravel. This method of habitat enhancement will be discussed further in the *Recommendations* section.

LWD flow deflectors secured to the river bed to promote localised scour and accentuate flows over existing riffles will help loosen gravels and to 'sort' bed material into various sizes. This will make it easier for trout to create productive redds (spawning nests) and will ensure that eggs are kept free of silt and provided with a fast flow of well-oxygenated water.

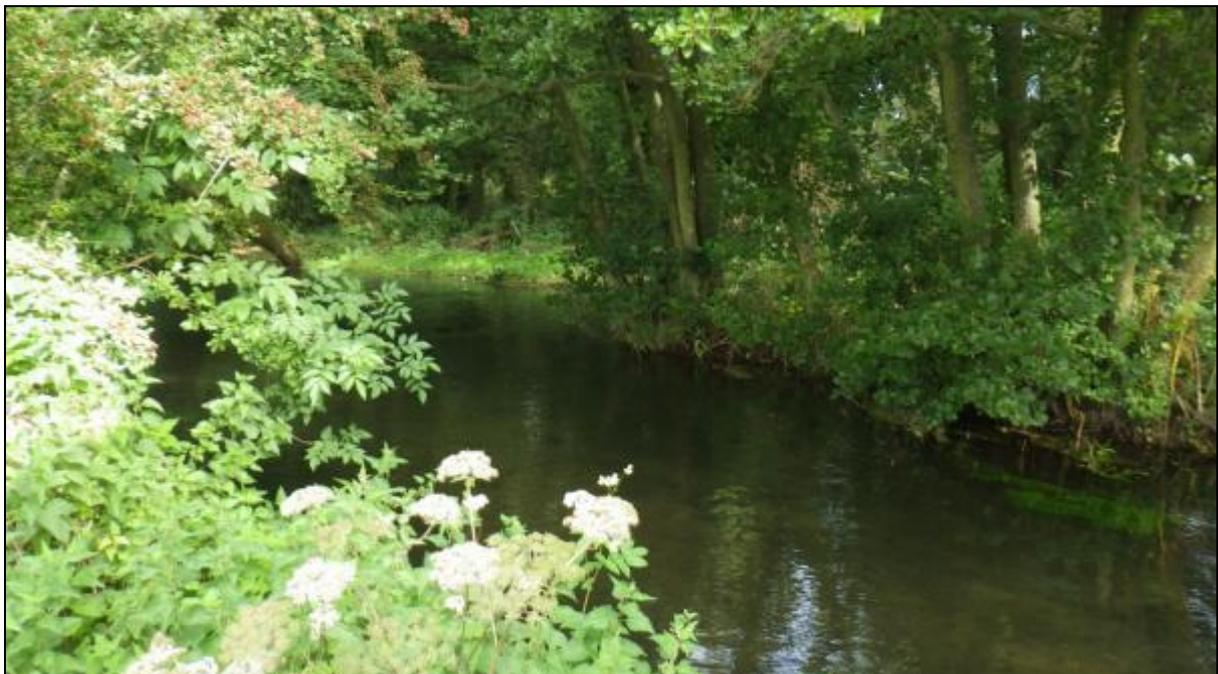
Within the more shaded reach, the LB is not fished and has been left more-or-less unmanaged. This allows some low-lying branches to hang close to the water and provide valuable cover for trout. This constitutes the optimal scenario for a wild trout fishery, providing excellent sport for an adept wild fishing enthusiast. Bankside access is made difficult by the unmanaged margin and the steep bank. The river here would be best fished from in-stream and any works to improve access should focus on creating small access points to wade the river.

Figure 7: Overhanging branches provide shade and cover for trout

Some light tree works could be undertaken to create a few select 'skylights' in the canopy over shallow riffles where increased light levels may result in increased weed growth. Additionally, a few overhanging branches could be removed to make casting a little easier. Any such works should be as conservative as possible and be undertaken with a 'less is more' approach, concentrating in the central third of the channel to retain low and trailing branches in the margins.

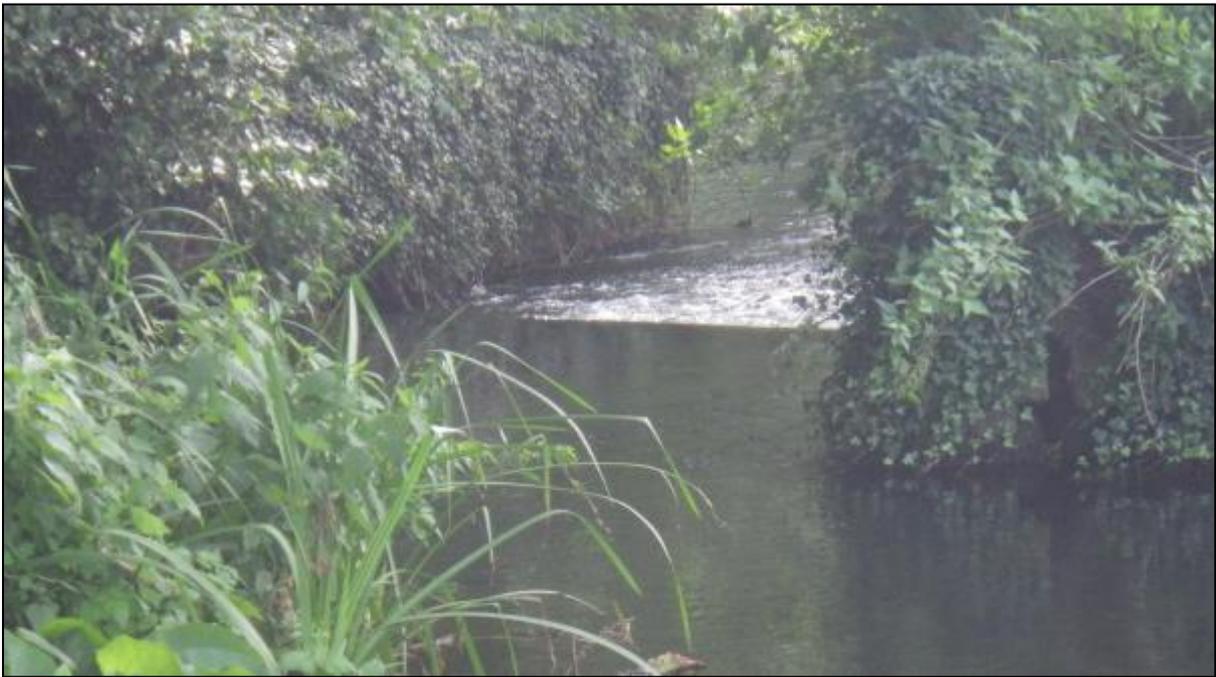
At the top of the next field downstream, a small impoundment slightly backs-up the flow. This appears to be the remains of an old hatch structure dating back into the 1800s (www.old-maps.co.uk) that once diverted flows through a small, now disused carrier. The remains of this structure form a small weir which slightly impounds the river upstream but does not act as a barrier to fish passage.

Figure 8: The remains of a disused structure slightly impounds the river upstream

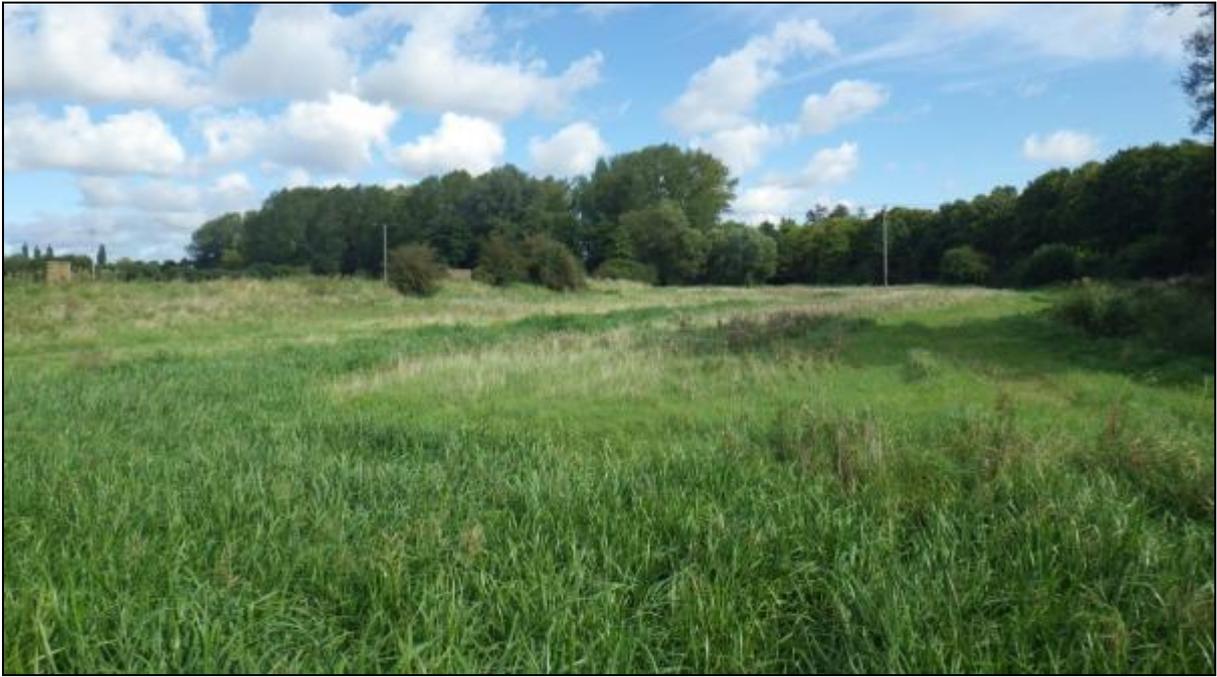
A wide semi-inundated ditch also runs alongside the main carrier and appears to drain the floodplain during flood conditions. This semi-inundated channel is populated by a community of reed sweet grass (*Glyceria maxima*) and provides an excellent wetland habitat important for amphibians and invertebrates that benefit the overall ecology of the river. The abundance of reed sweet grass is a potential source of marginal plants that could be translocated (simply dug-up and re-planted) to the river margin to help kick-start habitat improvement works.

Figure 9: A semi-inundated channel adjacent to the river is a good habitat for amphibians and invertebrates

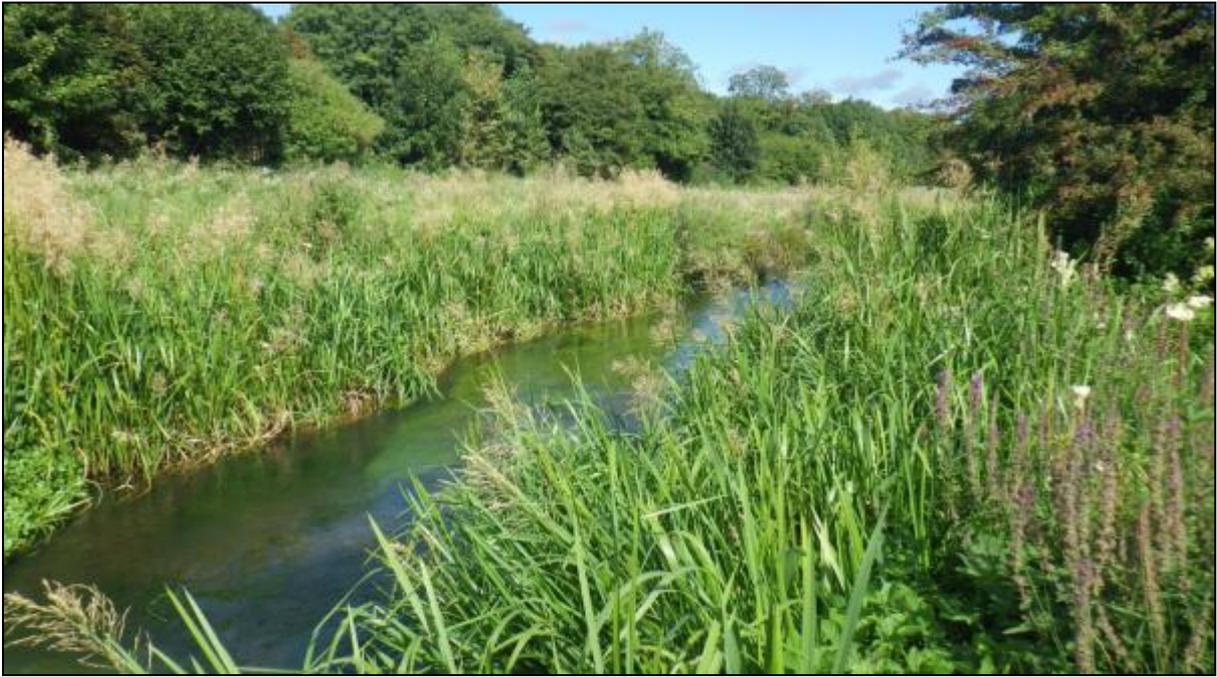
As the river flows from the east side of the field towards the A345 on the west side, it flows through grazed grassland and tree cover is reduced to only the occasional alder or hawthorn. Throughout this reach the river margin has been fenced-off from grazing livestock allowing a diverse range of emergent and marginal plants to establish along both banks. A buffer of rough un-mown grassland on both banks is also present and provides excellent peripheral habitat for fly life. The dense marginal vegetation helps to mitigate the lack of trees by providing alternative shade and cover for fish. However, the reach would certainly benefit from having a few more trees.

Figure 10: Fencing the river margins from grazing livestock has allowed a diverse range of emergent and marginal plants to flourish

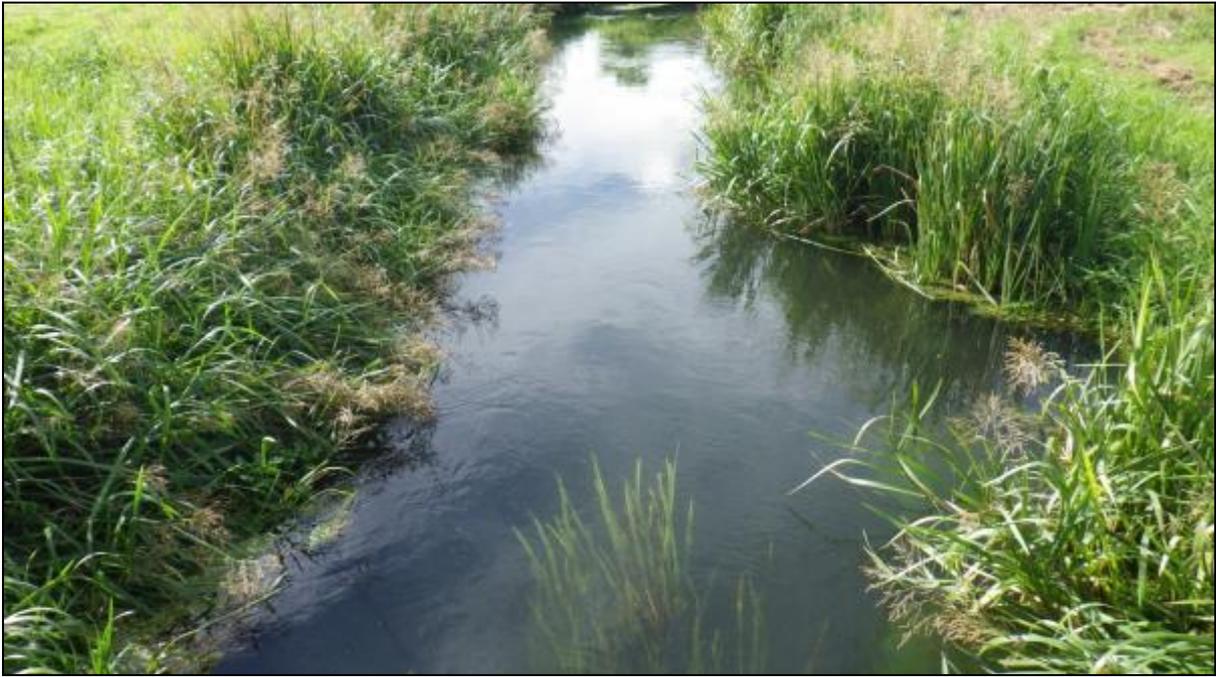
A great deal of the river through this reach has been dredged and is very deep. This has slowed flow velocity and allowed sediment to drop out of suspension causing the bed to become heavily silted. Flow-loving aquatic plants such as water crowfoot struggle to flourish and spawning opportunities for gravel-spawning fish are virtually non-existent. Where the river is shallower, water crowfoot and starwort are growing well but the classic fast-flowing riffle habitat is absent. Riffle habitat is not only important for spawning but is also a refuge for juvenile fish from some predators that can only hunt effectively in deeper water.

Figure 11: Dredged sections of the Avon East result in slow flows and a heavily-silted bed

Options to raise bed levels through previously dredged rivers are available and are discussed in the *Recommendations* section.

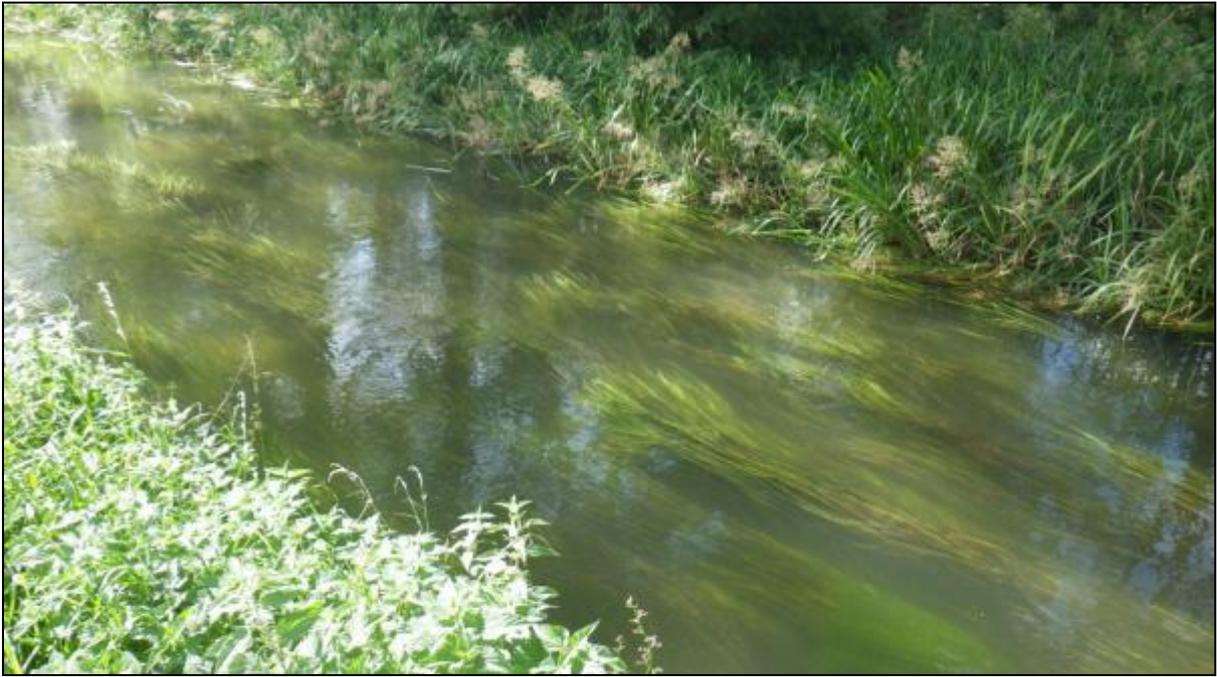
Downstream of the confluence, the Avon flows through mostly agricultural land and alongside Riverside Mobile Home Park and some private residences. The river appears to have been dredged in several locations where it is very deep and relatively slow flowing. These sections are characterised by the presence of slower-flow loving plant species such as unbranched bur-reed (*Sparganium* sp.) and a dark-looking sandy silt riverbed.

Figure 12: Unbranched bur-reed is an indicator of slow flows and a bed substrate of sandy sediment

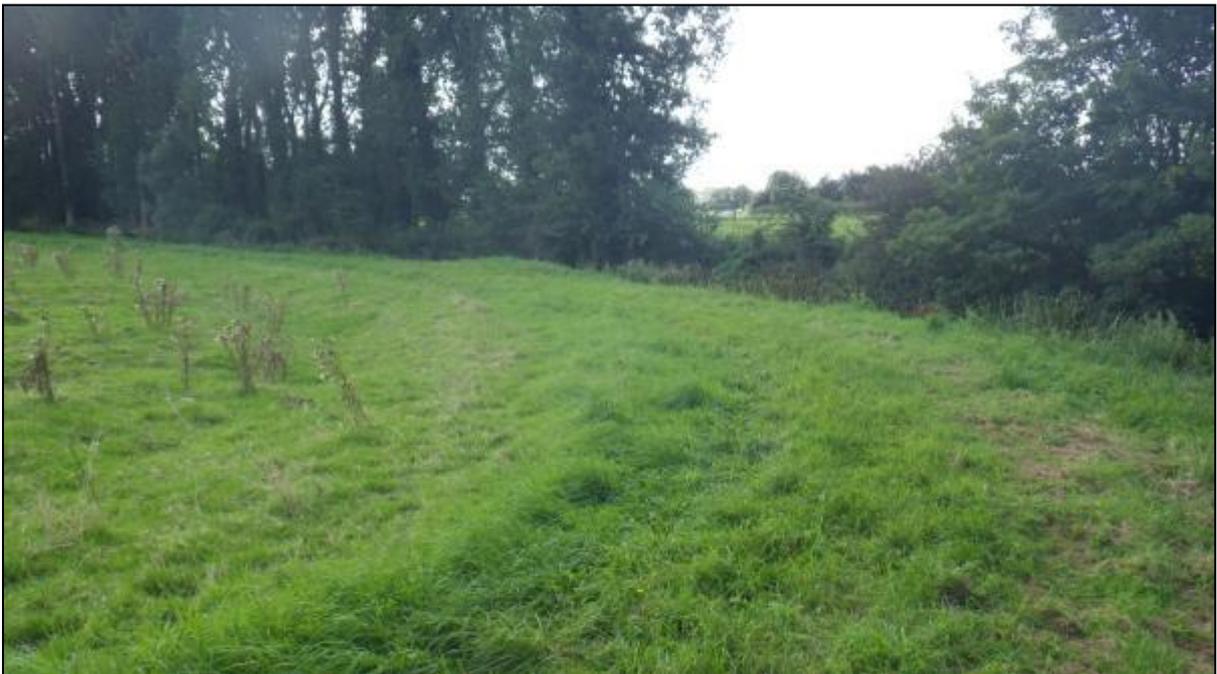
The dredging spoil appears to have been positioned on the upper LB to form a wide bund.

Figure 13: A bankside bund most-likely built from dredging arisings

Providing that the percentage of fine material within the bund is not prohibitively high, this may be a potential source of gravel that could be utilised for habitat

enhancement. Excavating a small trial pit would help determine the consistency of the bund material. Removing the bund would also help to reconnect the river habitat to the surrounding floodplain and reduce the steepness of the banks.

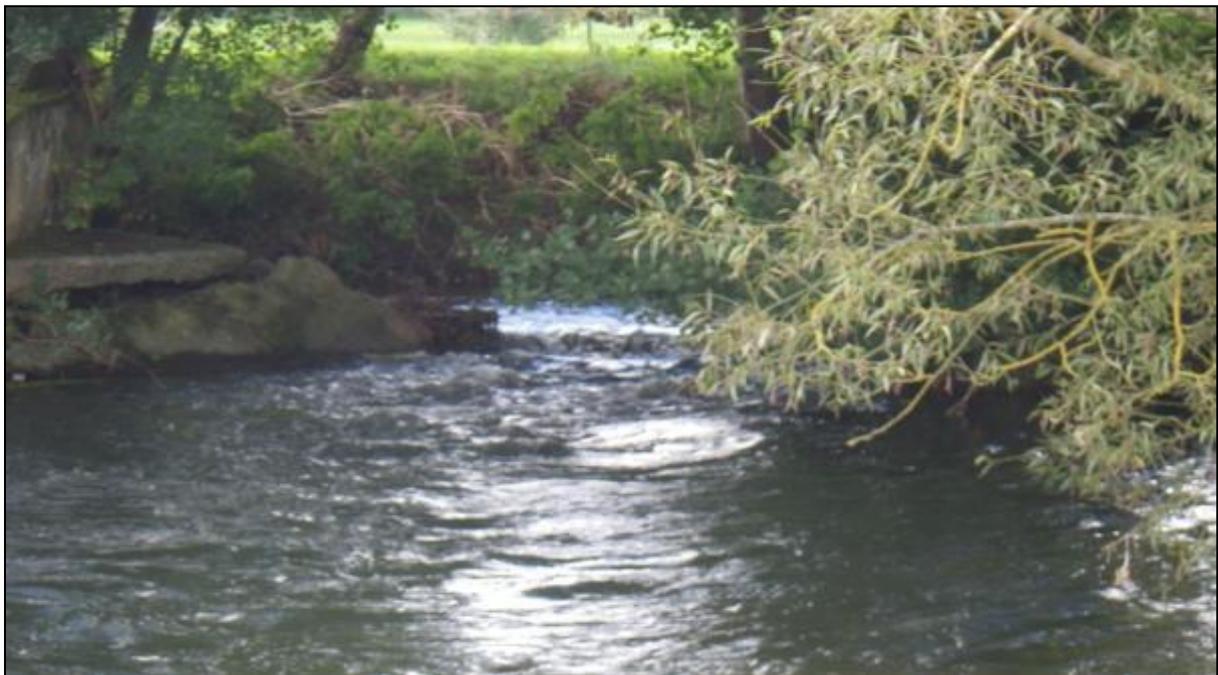
Near to Riverside Mobile Home Park, the remains of a mill weir structure are having an impounding effect and may be an obstacle for fish movement during low-flow conditions. The river becomes suddenly wide through the remnant of the mill pool.

Figure 14: The remnants of an old mill weir and pool

- The remnants of the mill sluice on the Avon near the mobile home park should be dismantled to allow the river to flow naturally. This will improve the habitat quality upstream and ensure that it connects fully with the habitat downstream.
- A programme of bed-raising through sections of the Avon East would help to speed-up flow velocity through some of the deeper sections. Unfortunately, the Avon East is not currently included within the scope of the Avon restoration strategy. Regardless, the river should still qualify for Water

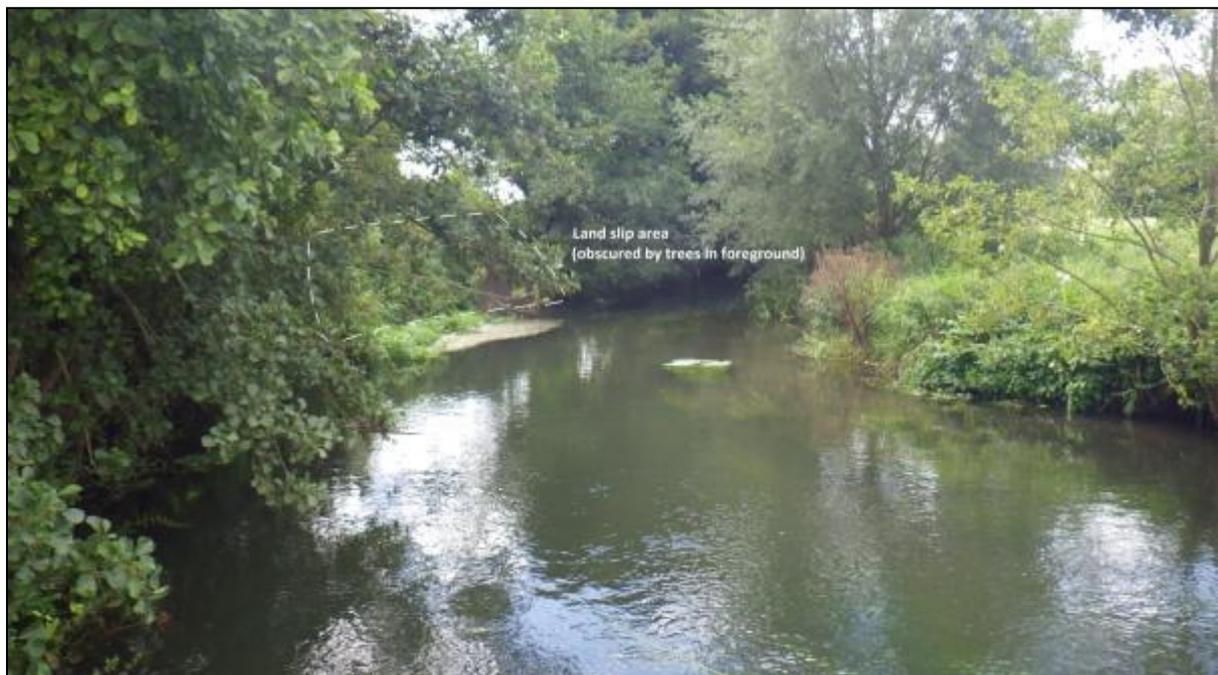
Towards the downstream boundary of the fishery, the left bank is perched very high above the river. As a result, the bank has become particularly unstable on the LB of a right-hand bend. Erosion naturally occurs on the outside bend of a meander and is usually deposited on the inside of the next bend downstream. When a riverbank is particularly high above the water, the process can become accelerated as the exposed face becomes undercut and slumps into the river.

Figure 15: A high, vertical bank is rapidly eroding. Deep water makes access difficult

- Where the bank is perched high above the river, the rate of erosion should be monitored and an assessment made as to whether or not the bank should be stabilised. The potential habitat value of the bank for kingfishers and sand martins should be taken into consideration even if no nesting burrows are observed.

Ideally, natural processes should be allowed to continue but if action is required, the bank could be re-profiled back and planted with live willow stakes to help stabilise the soil. This is a cost-effective and environmentally friendly alternative to hard engineering and will become stronger with time as willow roots spread through the bank.
