Advisory Visit

R. Ure, Middleham

Leeds & District Amalgamated Society of Anglers

June 2019

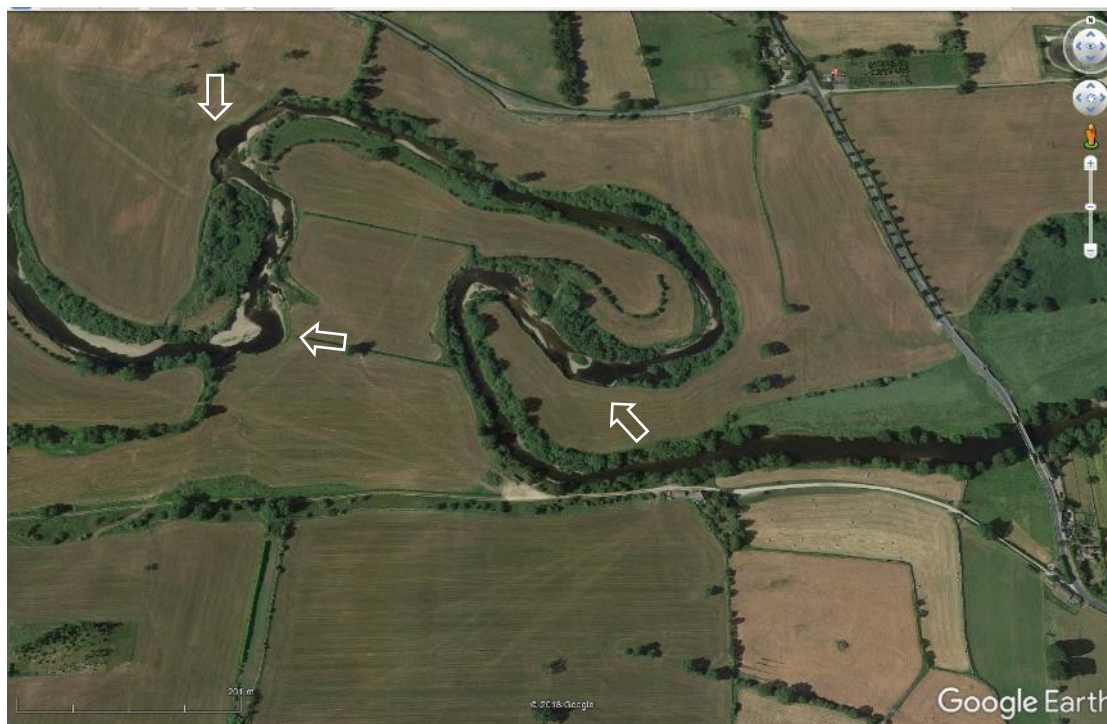
Fig 3. The upper reaches of the Middleham waters. White arrows depict new meanders beginning to form and it is very clear that such erosion is only occurring where there is a lack of buffer strip between the improved pasture and the bank edge.

The meanders comprising the upper component of the Leeds DASA waters might at first appearance seem quite natural but bank revetment and trees along the flood banks have essentially pinned the river into that position. On closer inspection from aerial imagery (eg Fig 3), the dynamism of the system is revealed with numerous nascent meanders forming where former bank protection has been breached or farming practice has weakened the bank. The white arrows in Fig 3 all depict areas where cropping has occurred to the very bank top (eg Fig 6). Such dynamism should be a natural characteristic of the river within its low gradient flood plain, and should not be regarded as an issue for the fishery *per se*, except where erosion rates might be unnaturally high.

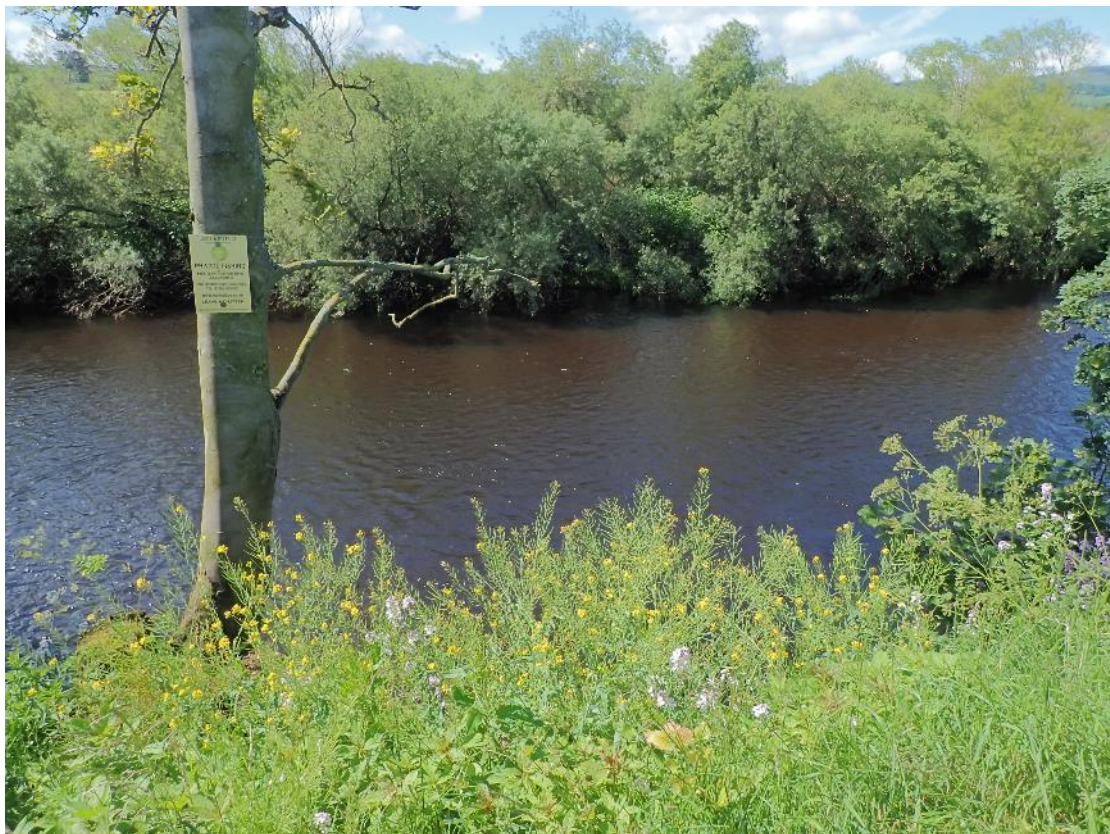
Fig 4. Upper limit of Leeds DASA waters on a relatively straight section with few channel features of note. The buffer zone on both banks was between 5-30m wide and of diverse herbage on the LB while dominated by scrubby goat willow on the RB.

The toe of the bank for long sections was lined with scrubby species of willow, mostly goat willow, but with occasional crack willow (Fig 4). Behind those were mature sycamore and the occasional ash. Hence, there was little diversity in the tree species, and as already mentioned, regeneration appeared slowly probably due to livestock browsing. With the threat of ash die-back in the catchment and the loss of those trees over the next few decades, the species diversity in the fringe should be diversified, particularly with species like alder with nutritious leaf litter that can provide food for invertebrates in the river. Alder have root nodules harbouring nitrogen-fixing bacteria that create nutrients from atmospheric nitrogen that are used by the plant and passed on to the leaves.

While the goat willows were clearly doing a good job of protecting the bank from erosion, and providing a modicum of shade and refugia in terms of root masses and overhanging / trailing branches, the homogeneity of cover on both banks in places essentially kept the flow path of the river down the centre of the channel and meant the instream habitat was also rather uniform. It is a difficult balance to strike: trees are generally good and required for a healthy water-bank interface, but too many trees of the same species of the same

In the longer reaches of willow lining along the straighter channel sections, one or two trunks could be laid over into the channel to force flow around the living structure and diversify flow paths. In conjunction, some light coppicing on the opposite bank and slightly d/s could create a back water which would benefit weaker swimming species and life-stages (both fish and invertebrates).

On any sections of the fishery where the age of the tree canopy is more uniform, eg the goat willow fringe, some judicious rotational coppicing of one or two trees would be beneficial to create a mosaic of cover and increased 'edge' which is where most ecology happens! Coppicing retains the living root, thereby retaining the bank stability function, but also encourages fresh, dense, low growth.

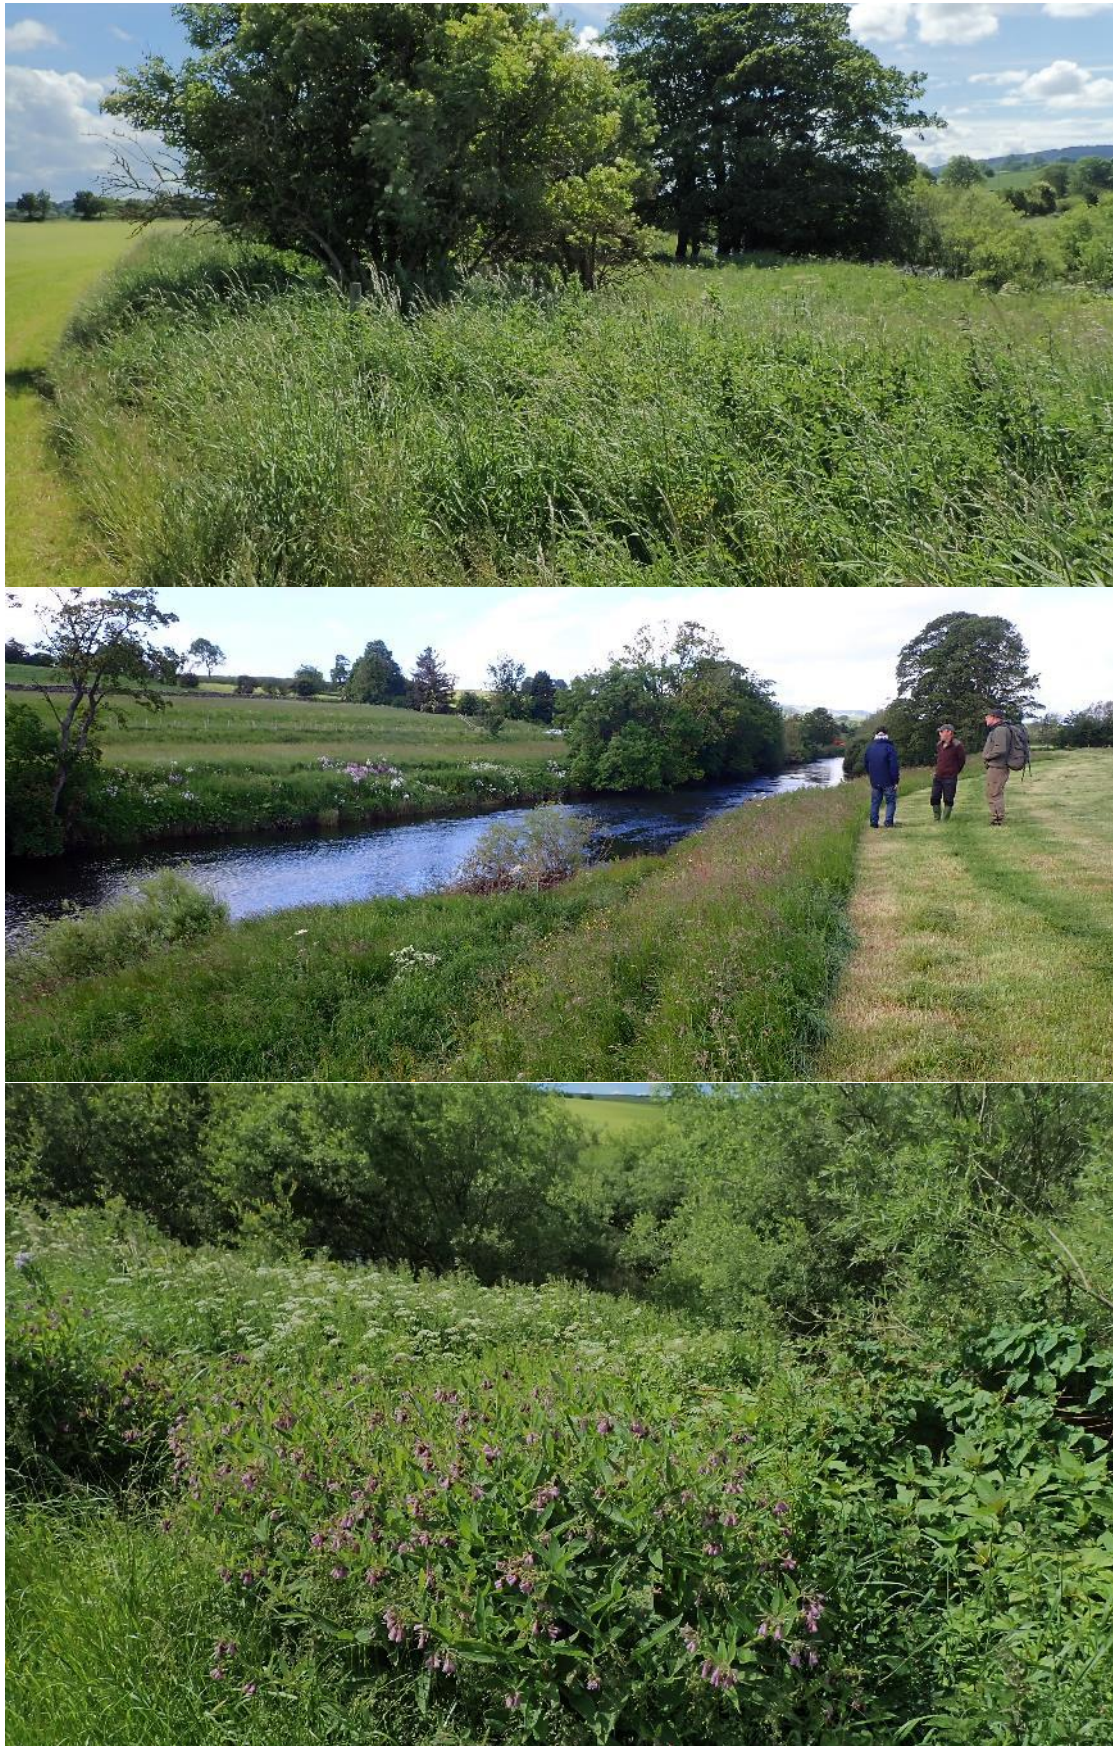
Where a buffer strip has been allowed to develop, the vegetation was diverse and comprised a good mix of native species such as comfrey, cranesbill, and various umbellifers (Figs 4-5). This was despite the close proximity of the improved pasture, recently cut for silage. The lack of nettles and thistles suggested that slurry or manure application was likely to be precise, perhaps by direct injection; there was little evidence of nutrient enrichment of the bank flora, often exemplified by a dominance of nettles. However, there was also a lack of self-set trees and the bank profile in certain locations

underneath the lush summer growth hinted at livestock access at times during the year.

Fig 5. Where present, the buffer strip was rich in native species such as comfrey and umbellifers, and with little evidence of nutrient enrichment from the improved grass adjacent. However, it was not fenced and livestock are probably grazed after silage cropping.

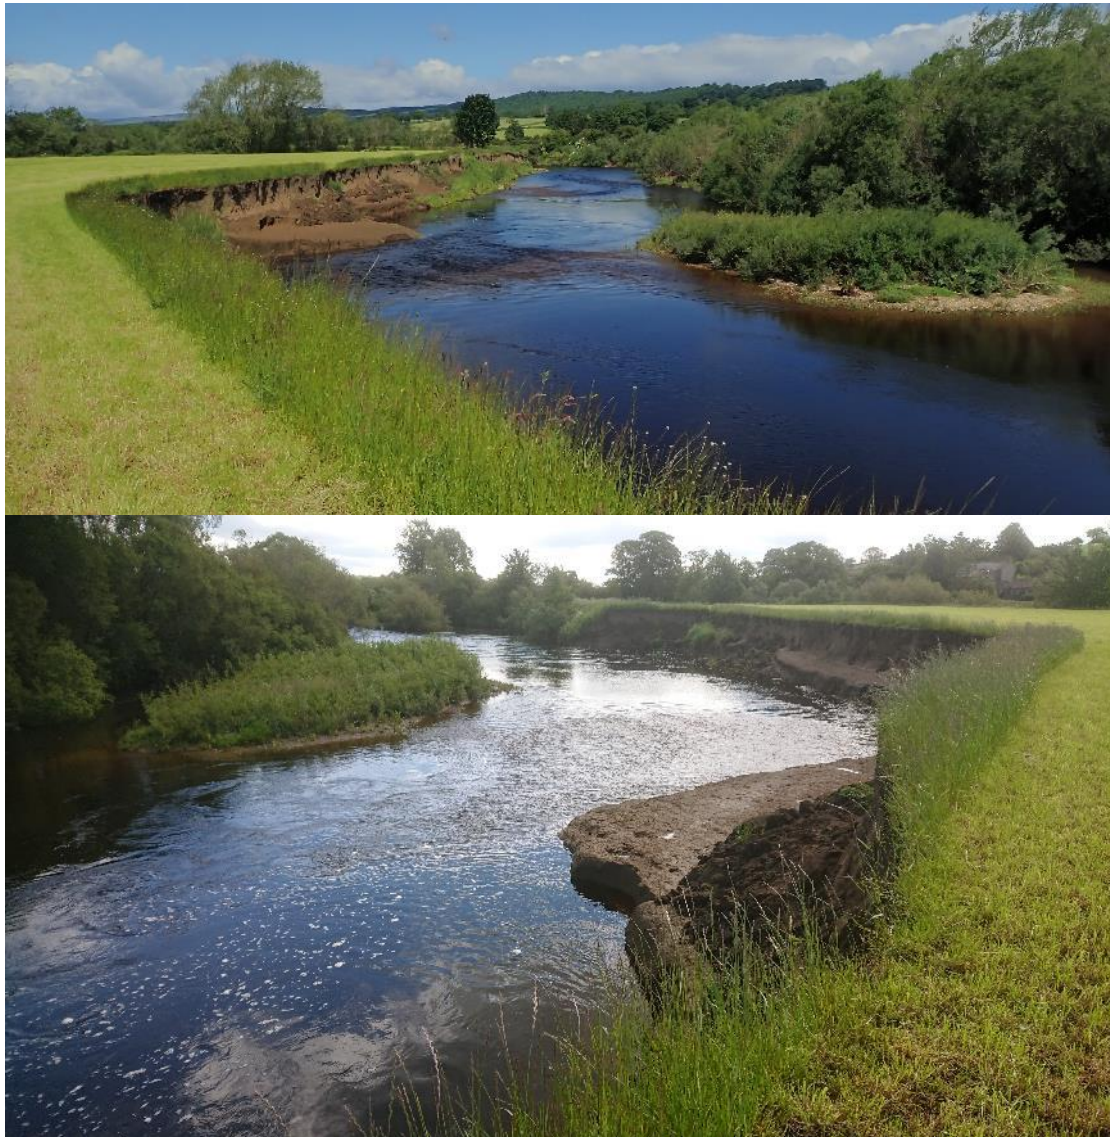
Fig 6. No buffer zone, evidence of heavy plant onto the bank top to cut the silage crop, and consequent bank collapse.

The Ure will have been back and forth across the valley bottom over millennia, cutting through previous deposits of gravel and cobble and relaying new deposits as it meanders. The new addition of gravel and other substrate to the river is a natural process. What is unnatural is the rate at which erosion is occurring downwards and causing further incision of the channel (cutting through the clay 'bed') because of former dredging and flood banking not letting the energy dissipate 'out of bank', or cutting laterally into the bank by helicoidal flow where it has been weakened by livestock trampling, grazing or cutting of crops; both can be seen at the location in Fig 6. However, what

should also be noted is that deposition bars were readily forming on the opposite bank and some of these were already colonised by pioneering vegetation which, over time, will stabilise the structure until it is eventually a contiguous part of the bank (Figs 6-7). Hence, the proportions of the wetted channel on the bending sections of the river were relatively natural, with diversity in depth and substrate profile all contributing to habitat heterogeneity, the mosaic of differing habitats required to sustain multiple life-stages of fish (and their food). Unfortunately, the accelerated contribution of fine material (soil / silt) is likely to be contributing to the degradation of gravel substrate by smothering and blocking the interstices, especially in the marginal transition zones from faster to slacker water where some of the coarse species might lay their eggs. Combined with warmer and drier late spring / summer periods with subsequent low flows, it provides the perfect conditions for biofilm to further smother those surfaces and reduce the suitability of substrate or indeed viability of eggs / larvae.

Those sections of bank with insufficient buffer zone and where cropping of silage has removed any effective root matrix within the soil (eg Fig 6) require substantial protection otherwise the river will continue to erode laterally at those points. To re-establish the benefits of natural vegetation will require fencing set-back at least 10m from the current bank edge and 3-5 years without disturbance. Seeding with an appropriate mix of tall herbs and shrubs will speed up the process. Once established, it may be possible to allow some light, periodic grazing (as above).

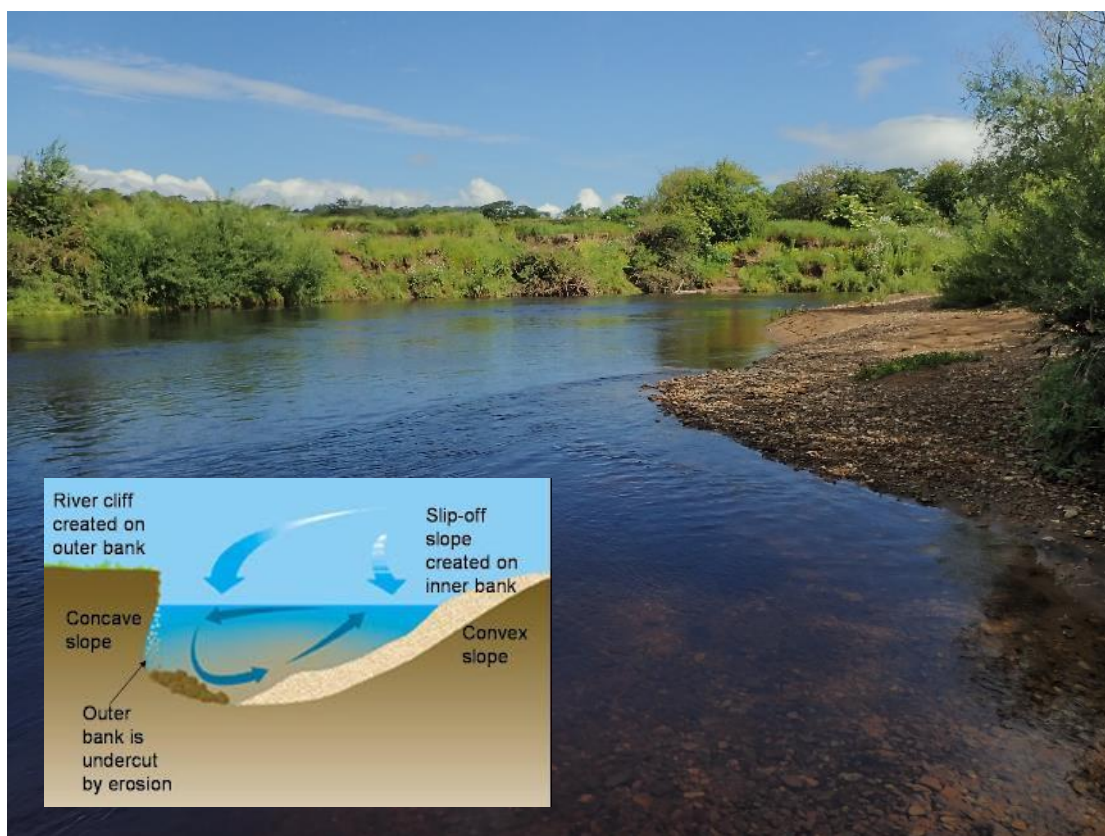
Fig 7. Very steep bars of gravel deposition, especially on inside of bends indicate the constraint of spate energy within the channel and strong helicoidal flow (see insert).

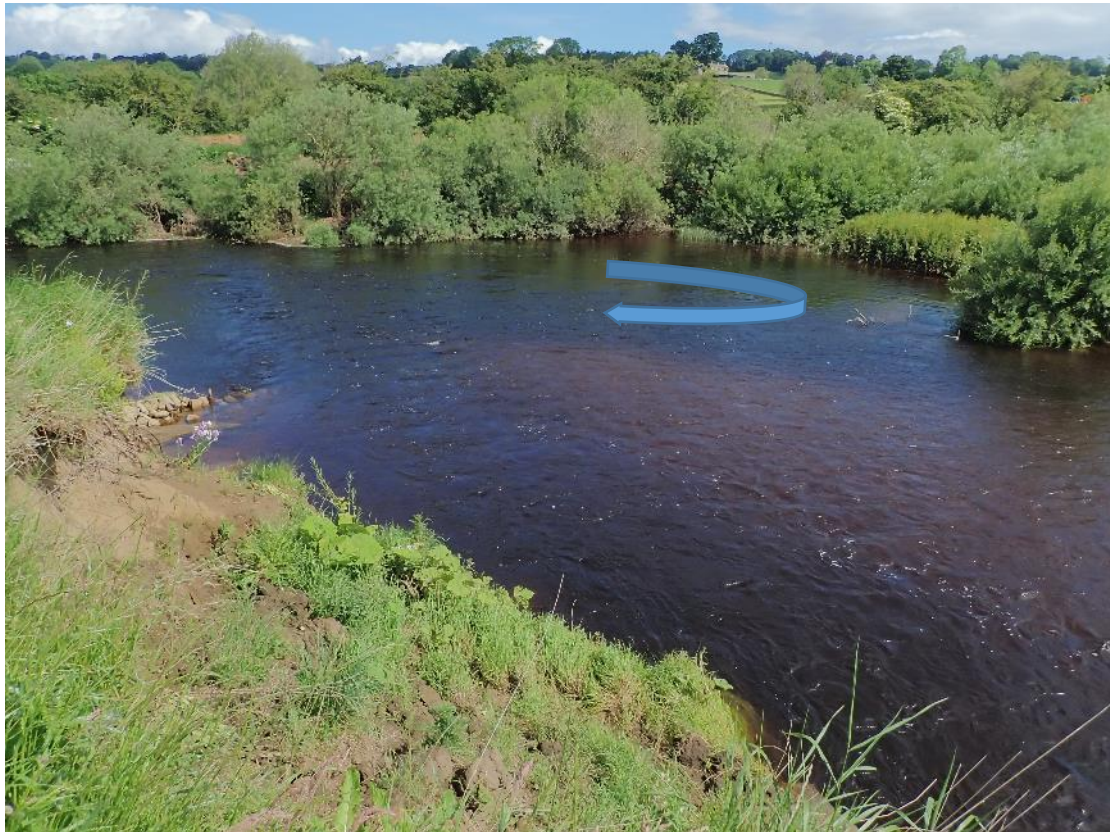
A further example of the dynamic nature of the sediment within the Ure at this location was the extension of a 'tongue' of clean (ie freshly turned) gravel and cobble d/s from a helicoidal scour pool. This had created a considerable riffle and eventually will probably lead to the isolation of the pool to the RB (Fig 8). Sustained dumping of manure

on the RB at this location is in breach of the Farming Rules for Water and is probably contributing low-level nutrient pollution to the river, as well as weakening the bank by preventing growth of plants.

Fig 8. An abrupt left hand bend which probably has bank revetment behind the scrubby willow on the RB. There was evidence of long-term, sustained dumping of manure on the RB at this point. An eddy to the RB (blue arrow) had scoured a deeper hole which might eventually become isolated via the development of a gravel tongue, currently mid-channel.

There were no obvious point sources of sewage pollution seen and little evidence of any further excess nutrient influxes, although the position of the manure dump should be reviewed with respect to the 2018 Framing Rules for Water. Any suspicious discharge of discoloured or malodorous water should immediately be reported via the EA hotline (0800 807060). If not undertaken already, it would be useful for a local member / regular angler to partake in the Riverfly Partnership's Anglers Riverfly Monitoring Initiative to provide some site-specific information on water quality, or possibly consider extending this to SMART rivers organised by Salmon & Trout Conservation UK.

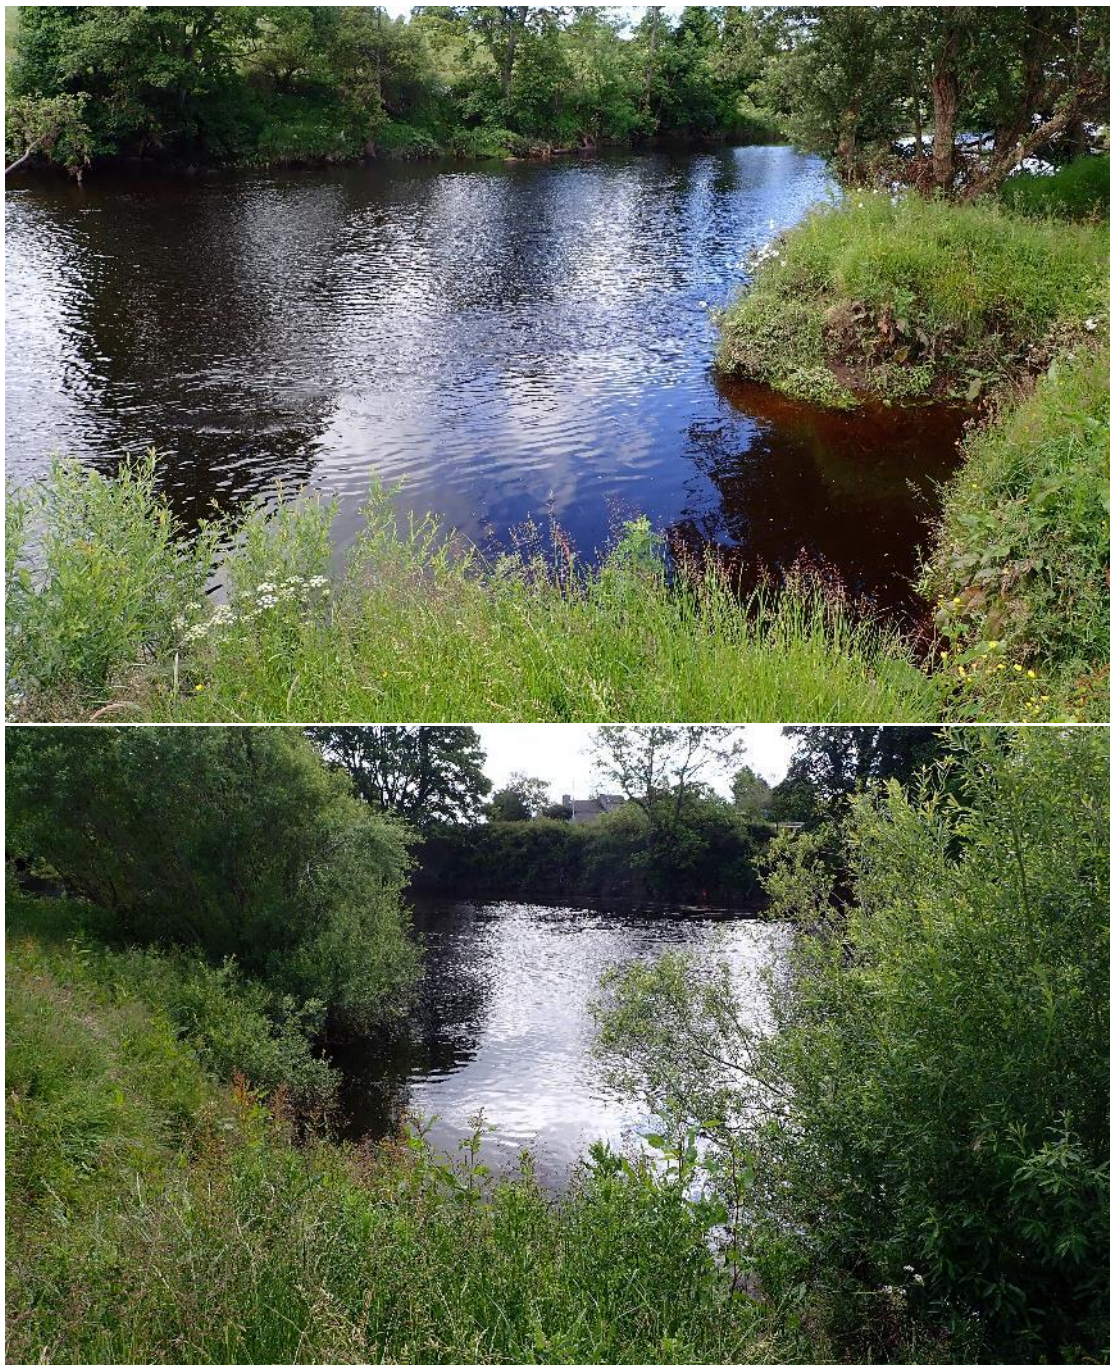
Occasional nicks in the bank (Fig 9) formed valuable slack water refugia but apart from a few scrubby goat willow at the toe of the bank and hence beyond the reach of browsing livestock, the majority of the trees were mature and likely of a similar age forming an avenue high above the water-line. This of course provided good shade but few low or trailing branches to diversify flow and provide cover (Fig 10) and those reaches are crying out for interventions like 'tree-kickers' – see Recommendations.

Fig 9. Scallops of erosion on relatively straight sections of bank u/s of Middleham Bridge which may have been caused by loss of a mature tree and / or by livestock accessing the water. These now form important fry refugia.

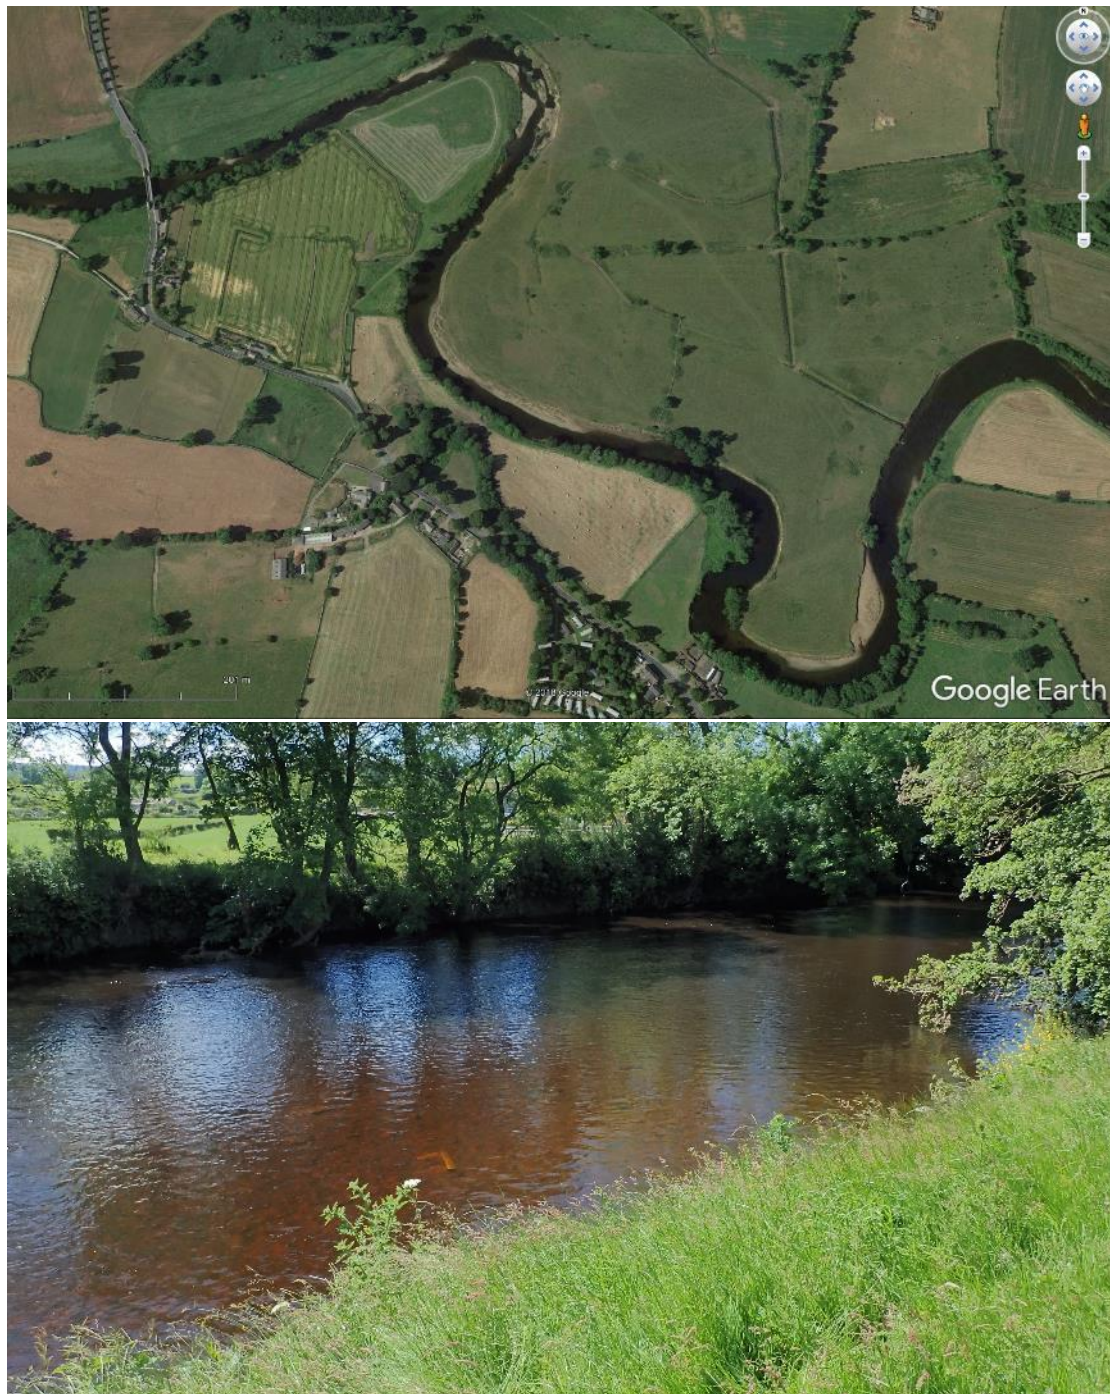
In contrast, the straightened sections (upper limit of the waters, Fig 4; above and below Middleham Bridge, Figs 9-10) were relatively featureless, trapezoidal channels with uniform depth and distribution of sediment leading to sluggish glide conditions under normal flows. With a lack of instream features, it is therefore important to maximise the potential of bankside vegetation.

Fig 10. Upper: Google Earth image of the waters below Middleham Bridge depicting the straightened nature of the channel through the bridge and the abrupt turn forced upon the river via rock and rubble revetment and bunding. Lower image shows typical homogenised bed form and lack of distinct flow path within the straighter sections.

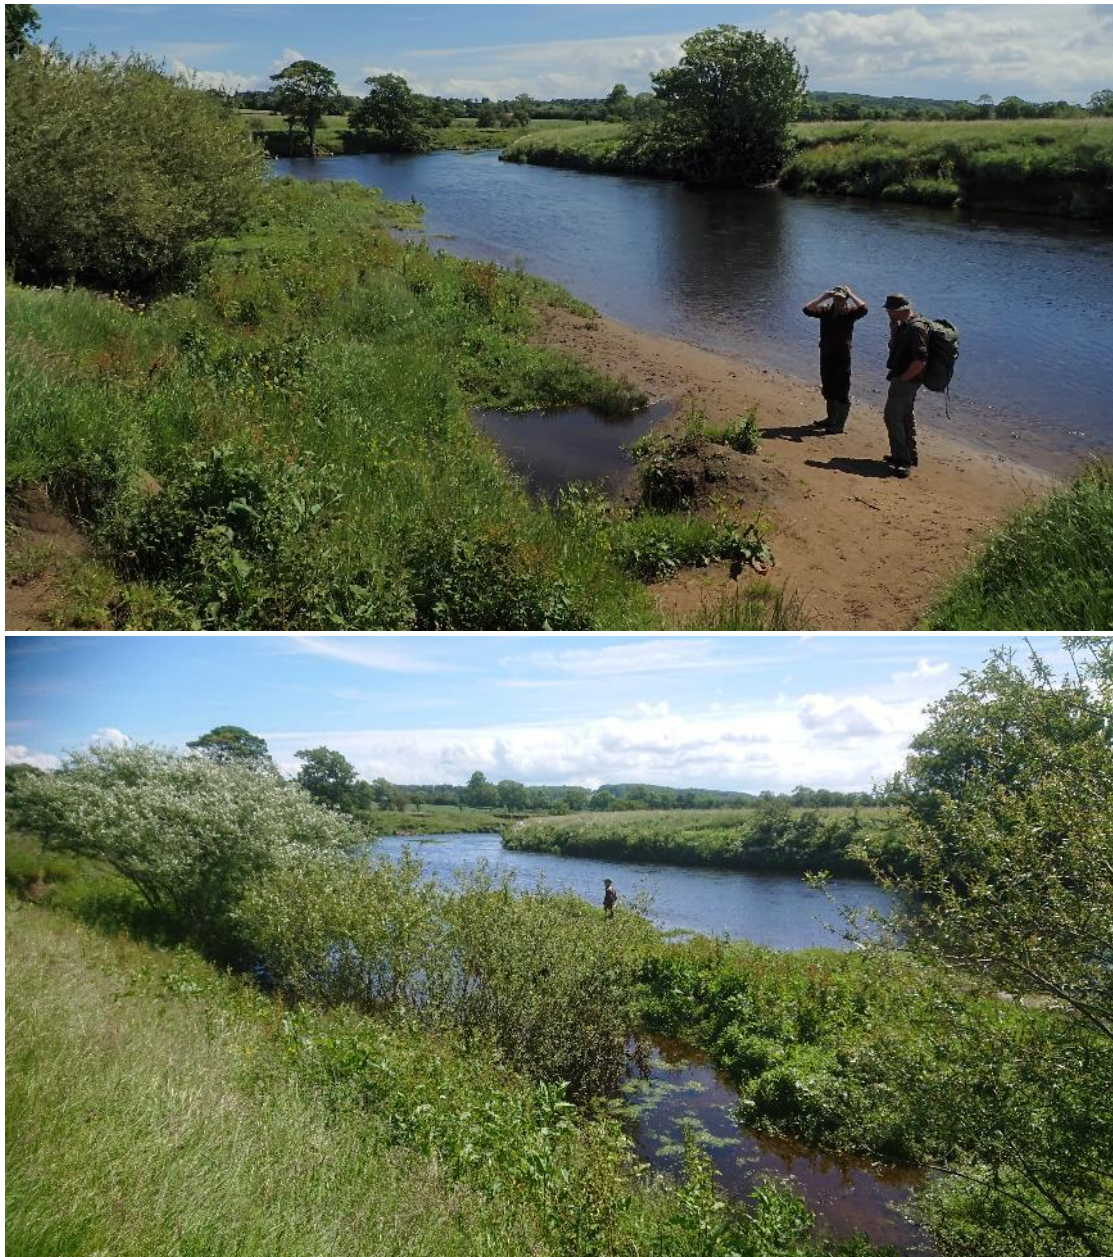
The long, straightened section to retain the course under Middleham Bridge has further consequences d/s for the channel morphology. Due to the increased gradient and lack of pools and bends to slow the flow, accelerated velocities and excess sediment transported through the straight section arrive at an abrupt and unnatural bend to the right, enforced by boulder revetment. This has resulted in a deep pool and deposits of gravel and cobble both u/s (LB; Fig 11) and d/s (RB; Fig 12-13) of the pool.

Fig 11. Deposition bars forming at the tail end of the straight section below Middleham Bridge. Colonisation and hence stabilisation of the structure has preserved some backwater habitat; again, important for fry, and larger fish during spate flow.

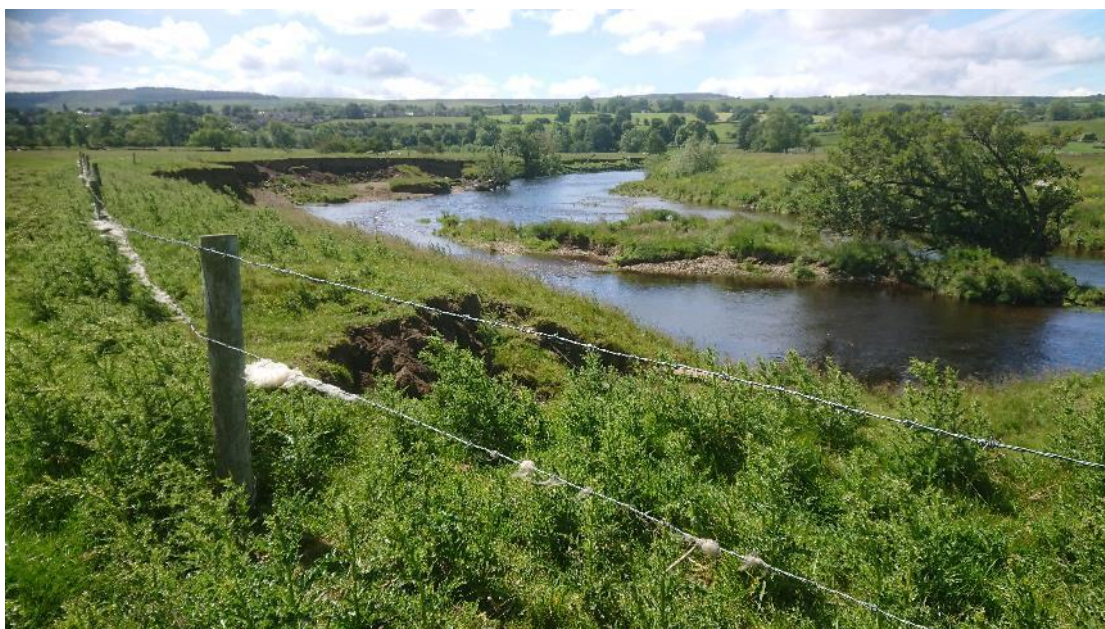
Downstream of the bend, the pasture on the LB was given over to grazing of cattle and sheep. At some point in the past, perhaps associated with revetment 'protection' of the bend, a double strand fence had presumably excluded cattle from the bank, but did little to prevent sheep from accessing it and grazing (Fig 12). Sheep are just as damaging to bank stability as cattle; although considerably lighter

in terms of trampling and poaching, they have a tendency to try and access lush vegetation at the toe of the bank, and can maintain areas of bare soil by rubbing, scratching and laying up. Flood specification fencing (7 or 9 strand with sacrificial points at double strainers) can be just as effective as excluding sheep as netting without the associated risk of loss due to clogging with debris under spate flow. The outside of this unnatural bend will be subject to accelerated flows at the end of 'bridge straight' as outlined above and hence needs all the help it can get from vegetation to increase resilience to erosion. Fencing would be an ideal start although might require placement of some intercepting posts to stop larger debris ploughing straight into the fence-line, at least until some shrubs and trees establish.

Fig 12. Defunct fencing which, while currently doing nothing to protect the bank, may indicate that the landowner / tenant farmer may have some interest in preventing further erosion of the land.

The buffer strips *in situ* demonstrate that a natural seedbank is present and recovery of the herbaceous plants should be rapid if given relief from grazing. Fencing would be beneficial where livestock has regular and sustained access (eg Fig 14). While there is always a potential risk of washout by spates, the protection to the bank and associated vegetation, and the habitat enhancement that it facilitates make it worth the risk of having to reinstate a flood-damaged fence. The small loss of, usually, poor grazing to the tenant/landowner is also mitigated in the longer term by greatly reduced erosion rates and a more stable boundary. Flood-spec fencing generally comprises 'Gripple' type tensioners on the wires, and sacrificial breaks in the fence-line every 50m (or more frequently depending upon location) – these are double-strainer posts joined by wooden rails, a good

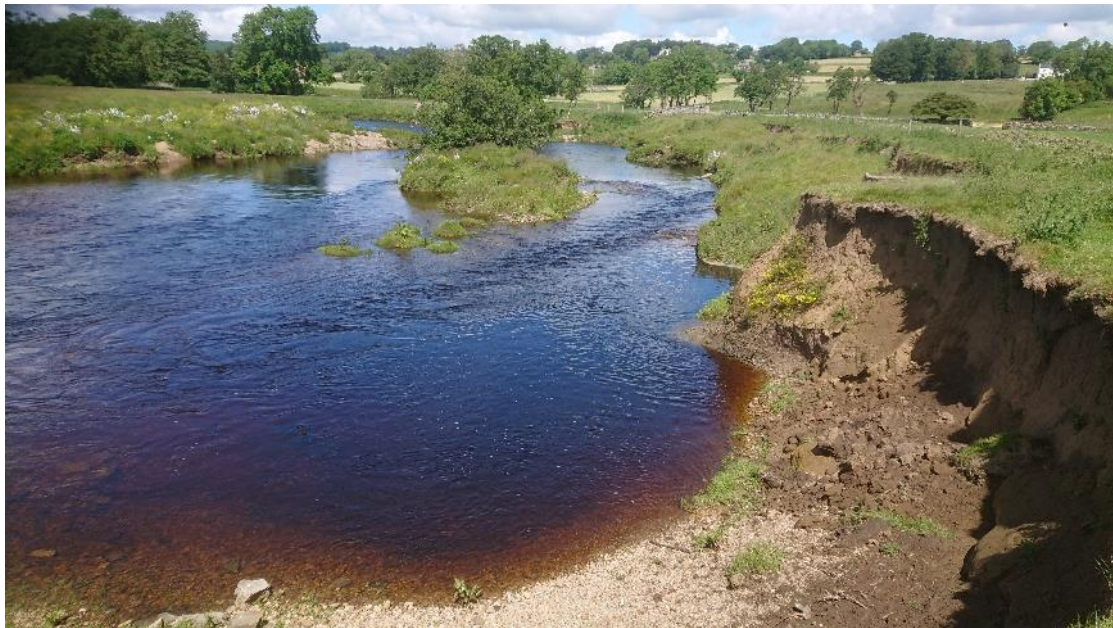
Isolation of a short section of the 'fixed' LB by the river eroding behind it, a function of the unnatural bend u/s, has created an island which still retains some shrubby vegetation and one or two larger trees (Fig 13). Coupled with erosional and depositional features nearby, this was the most diverse instream reach providing fast, slack, deep and shallow water and considerable sorting of the sediment as flow velocity changed. A cursory inspection of the invertebrate life associated with some hand sized cobbles in the faster water revealed cased caddis, 'stoneclinger' heptageniid and 'olive' baetid mayflies, and stoneflies indicating reasonable water quality and supply of food for fish.

Fig 13. Looking u/s at the 'island' in Fig 12, probably formed as part of the LB was circumvented by the river being forced too sharply to the right at the end of the 'bridge straight'. The diversity of flows around it introduced some much-needed habitat diversity. Note the lack of root matrix under the grazed sward and hence block failure of the soil.

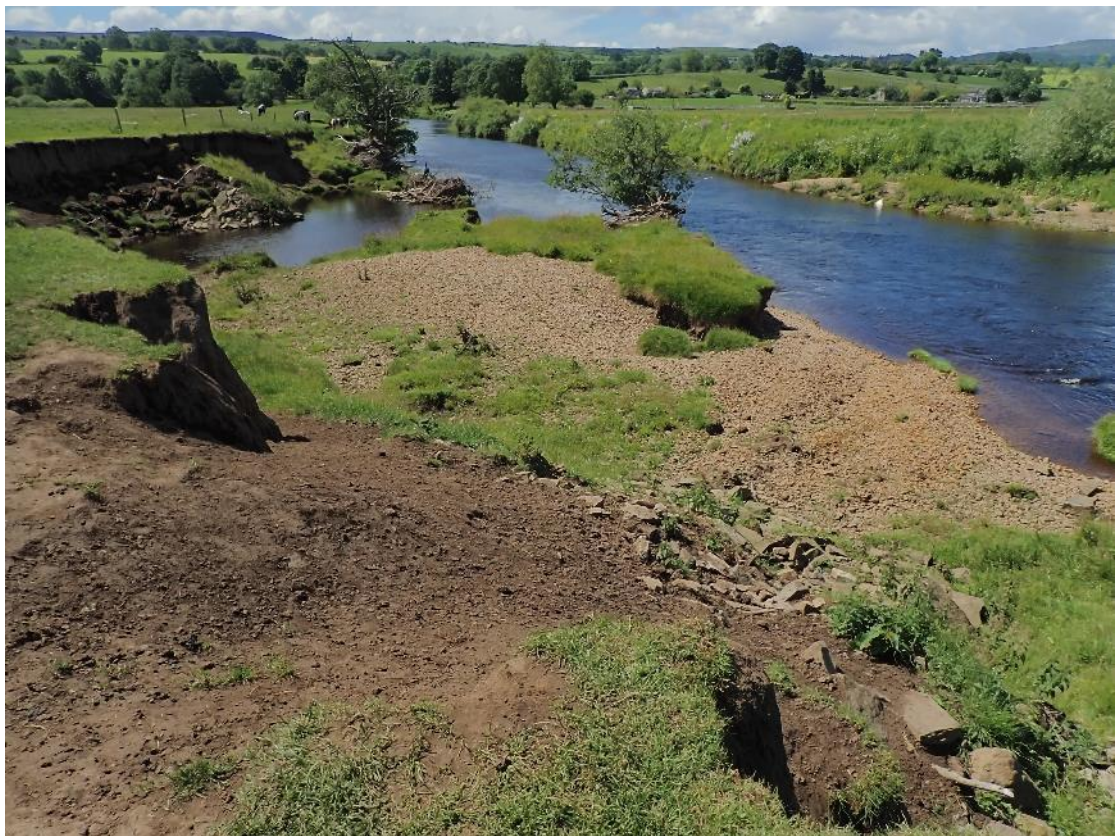
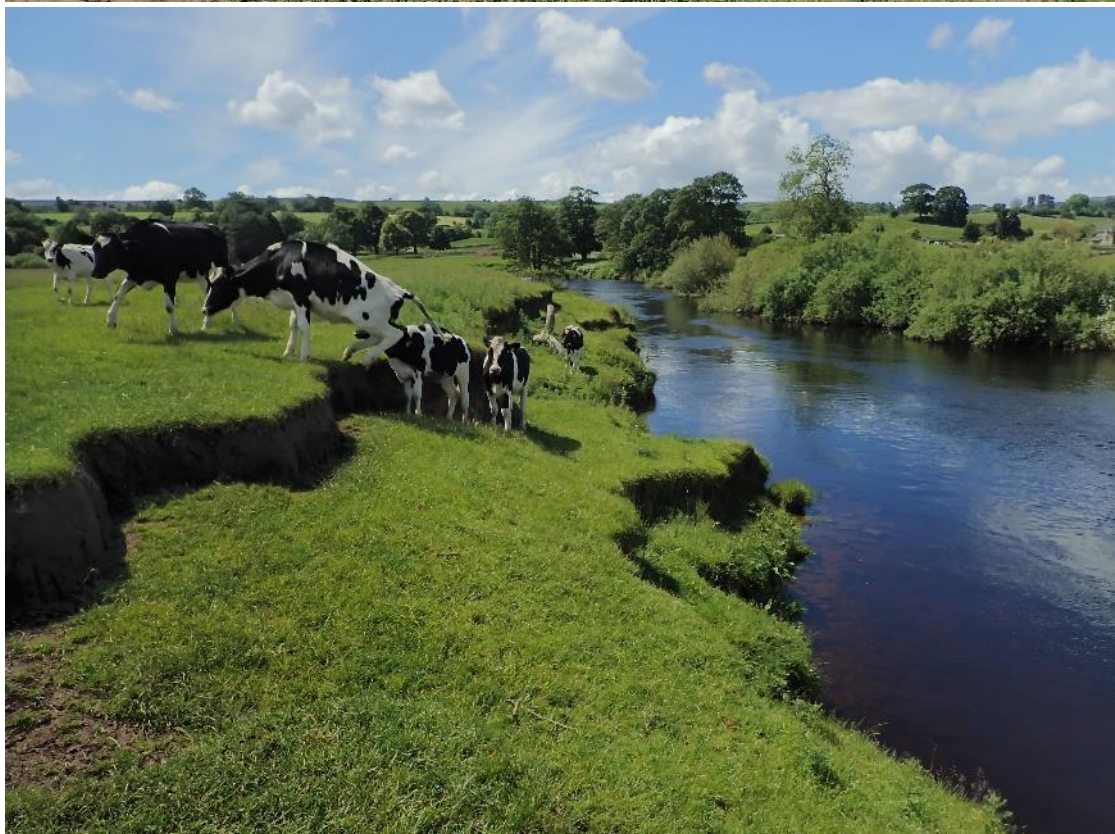
Only a short gently-curving reach was examined further d/s below the 'island'. The LB was devoid of any vegetative cover, being heavily grazed by livestock, whereas the RB was afforded a buffer strip of native vegetation but again lacking in self-set trees aside from goat willow at the bank toe (Fig 14). The contrast in resistance to erosion was clearly evident: cattle were exacerbating the slumping scars and maintaining pathways of bare soil, a source of diffuse agricultural pollution, down to the river.

Fig 14. Typical erosion scars and slumps caused by livestock weakening the bank integrity. Note, scant diversity in vegetation where livestock had unfettered access.

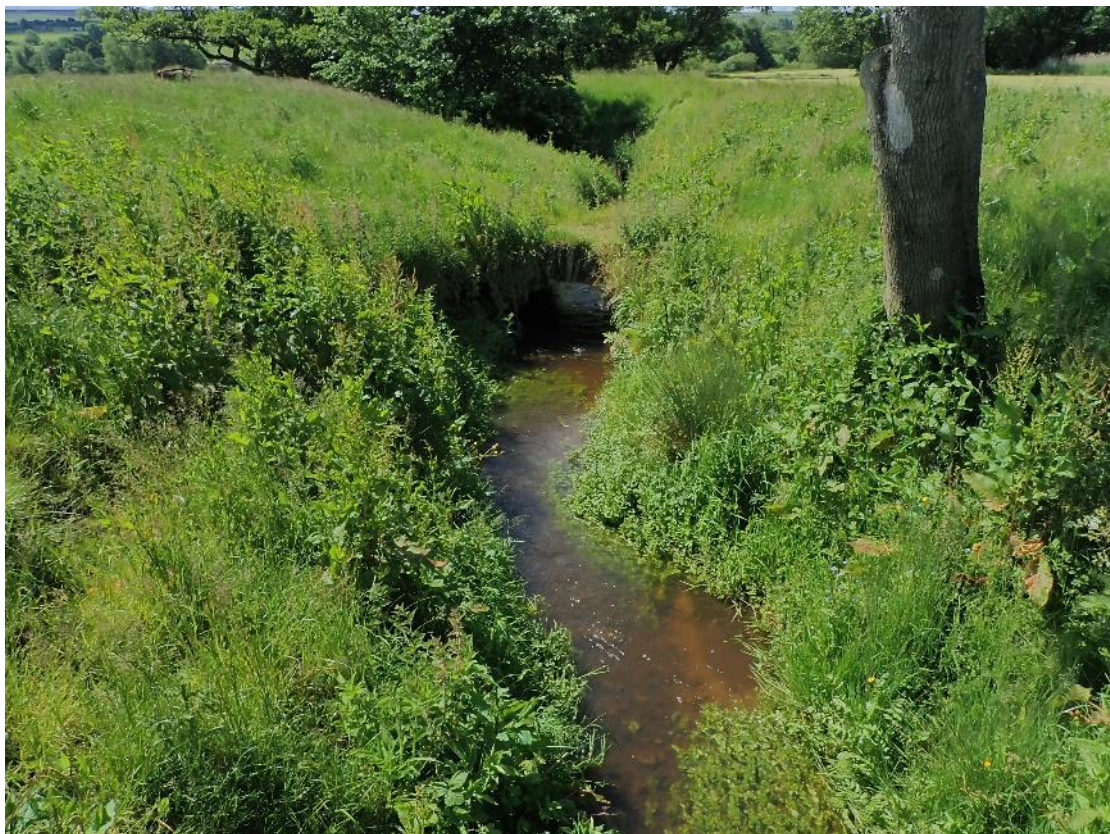
Mill Beck, a small tributary, was examined ~50m u/s from its confluence at a clear span farm track bridge. Given the time of year and relative lack of rainfall in advance of the visit, the flow of the beck was substantial indicating some influence of spring input. The buffer strips within inspection distance were of a similar quality to those on the main river with little evidence of nutrient enrichment in the flora, and the gravels appeared to be reasonably clean. Hence, Mill Beck might be an important nursery stream for spawning and fry development for species such as trout willing to move out of the main river.

Fig 15. A small tributary, Mill Beck, appears to be spring-fed (OS map: to west of Harmby) and, anecdotally, flows consistently. As for the main river, the buffer zone seen near the confluence was ample and did not exhibit any signs of nutrient enrichment. The bed comprised cobble and gravel of appropriate size for salmonid spawning.
