**Advisory Visit**

**R. Burn, R. Ure tributary**

**Northern Fishing School**

**July 2019**

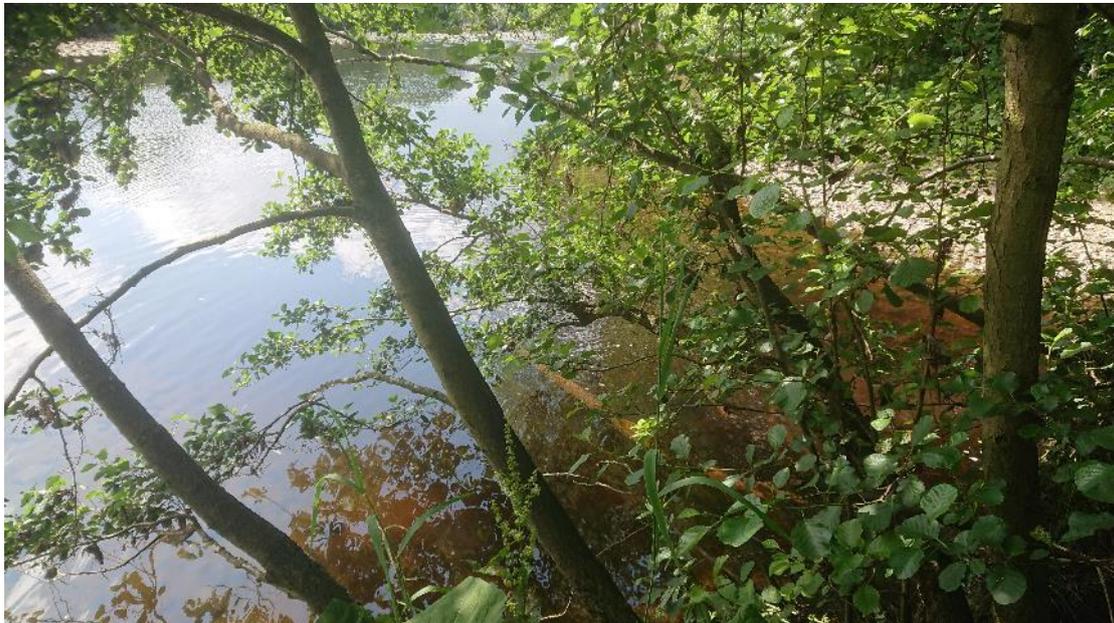
The confluence of the Burn with the mainstem Ure (RB) was well protected by alder trees and maintained sufficient depth of water for uninterrupted fish passage to and from the tributary (Fig 1). The presence of trees on either side is beneficial for two main reasons. They provide low cover for fish as they transition from the relative safety of the larger, deeper Ure into the shallower Burn for larger fish, and vice versa for smaller fish emigrating the Burn. Tree roots also stabilise the banks and maintain the width of the Burn channel in a sufficient pinch to ensure that substrate transported down the Burn during spate flow is 'blown' straight through into the Ure, rather than backing-up and depositing at the mouth, and hence, reducing the depth and opportunities for fish passage.

**Fig 2. The confluence of the R Burn (from the RHS of image) with the mainstem Ure at SE 23085 79751 was accessible / passable to fish at low flow and had good low cover from native riparian trees, mostly alder.**

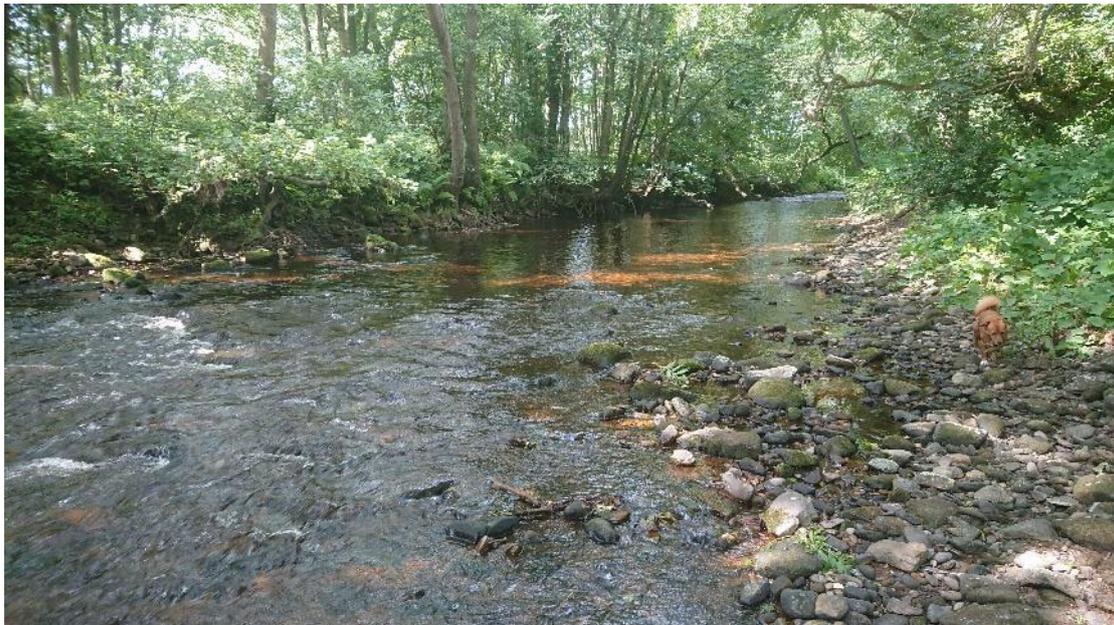
The lower reach from Thorpe Rd bridge to the confluence exhibited the hallmarks of historic straightening: rock revetment along the banks, an over-capacity channel with dry substrate to the banks, and almost continual fast glide or riffle characteristics (Fig 3). A straightened channel is steeper and, consequently, water flows faster causing greater erosion, scouring away smaller components of the substrate like gravel and leaving behind a predominance of boulder and cobble. A saving grace for the reach was the decent buffer (>30m in places) of (mostly) native riparian (bankside) vegetation, protecting the channel from any undesirable chemicals and nutrients applied to the improved agricultural land on either side. Further benefits include much needed shade, introduction of leaf litter directly

to the Burn for invertebrates to feed upon, and food and shelter for terrestrial invertebrates which will also fall onto the water and contribute to the diet of fish. However, because the channel was over-capacity for the majority of flows, the wetted channel was separated from the bank by dry substrate and hence the vegetation provided scant low cover via trailing / submerged stems or branches, essential refugia for fish from predators and spates. Only the occasional alder root matrix extending from the toe of the bank created such habitat.

**Fig 3. The lower reach of the Burn from Thorpe Rd to the Ure has been straightened and exhibited almost continuous riffle or shallow glide. Note no low cover over the water's edge. The riparian fringe was broad – a good buffer from the improved pasture on either side, but some extensive stands of the invasive Japanese knotweed were evident.**

Some stands of Japanese knotweed were quite extensive. There were few obvious signs of this pernicious invasive species further u/s on the Burn, hence, they probably originated from the Ure and propagules deposited during spate flow; see Recommendations.

The banks were remarkably free of invasive species, aside from the Japanese knotweed noted below. This must be treated via herbicide stem-injection (best during autumn as energy is withdrawn to the roots) as mechanical removal increases the risk of propagules spreading. The knotweed was mapped and data submitted via Yorkshire Wildlife Trust's INNS-mapper tool online.

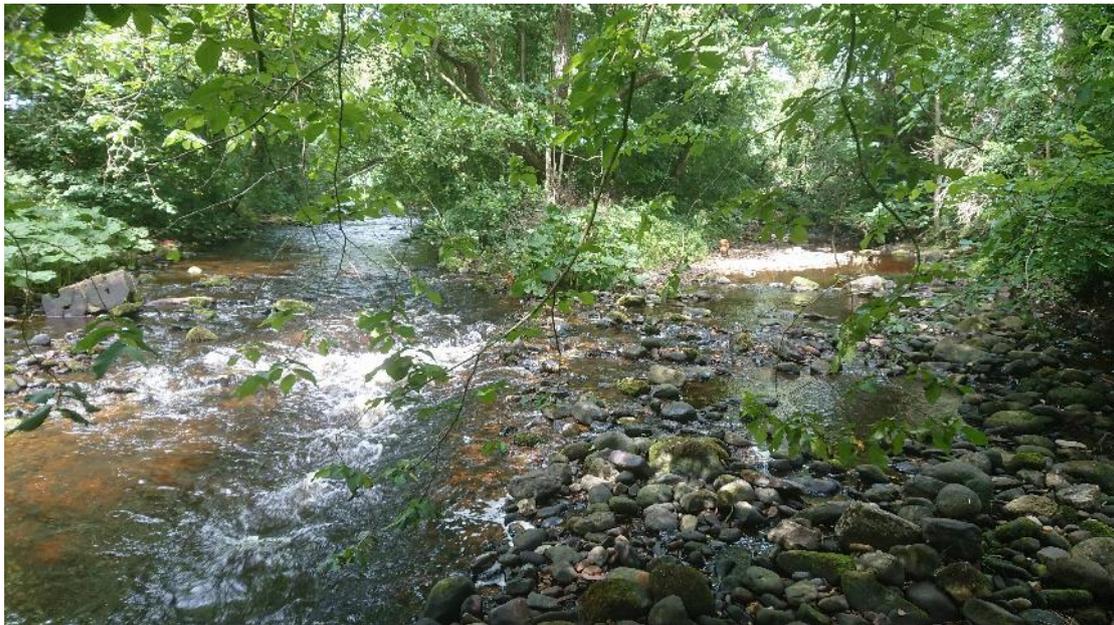
Just below Thorpe Rd Bridge, there was a defined split in the channel around a well-established and vegetated island which was probably caused by sediment deposition d/s of the 'pinch' of the bridge (Fig 4). The two channels exhibited very different characteristics, and both are important for different reasons. The minor channel, while probably not 'fishable', provides slower flow characteristics and more shelter for juvenile life-stages, especially the vulnerable fry, whereas the main channel will be favoured by parr and adult fish.

**Fig 4. Potentially resulting from sediment deposition d/s of Thorpe Rd bridge (SE 22661 79835), an island had formed with the main channel hugging the RB and a smaller but nevertheless important side-channel to the LB.**

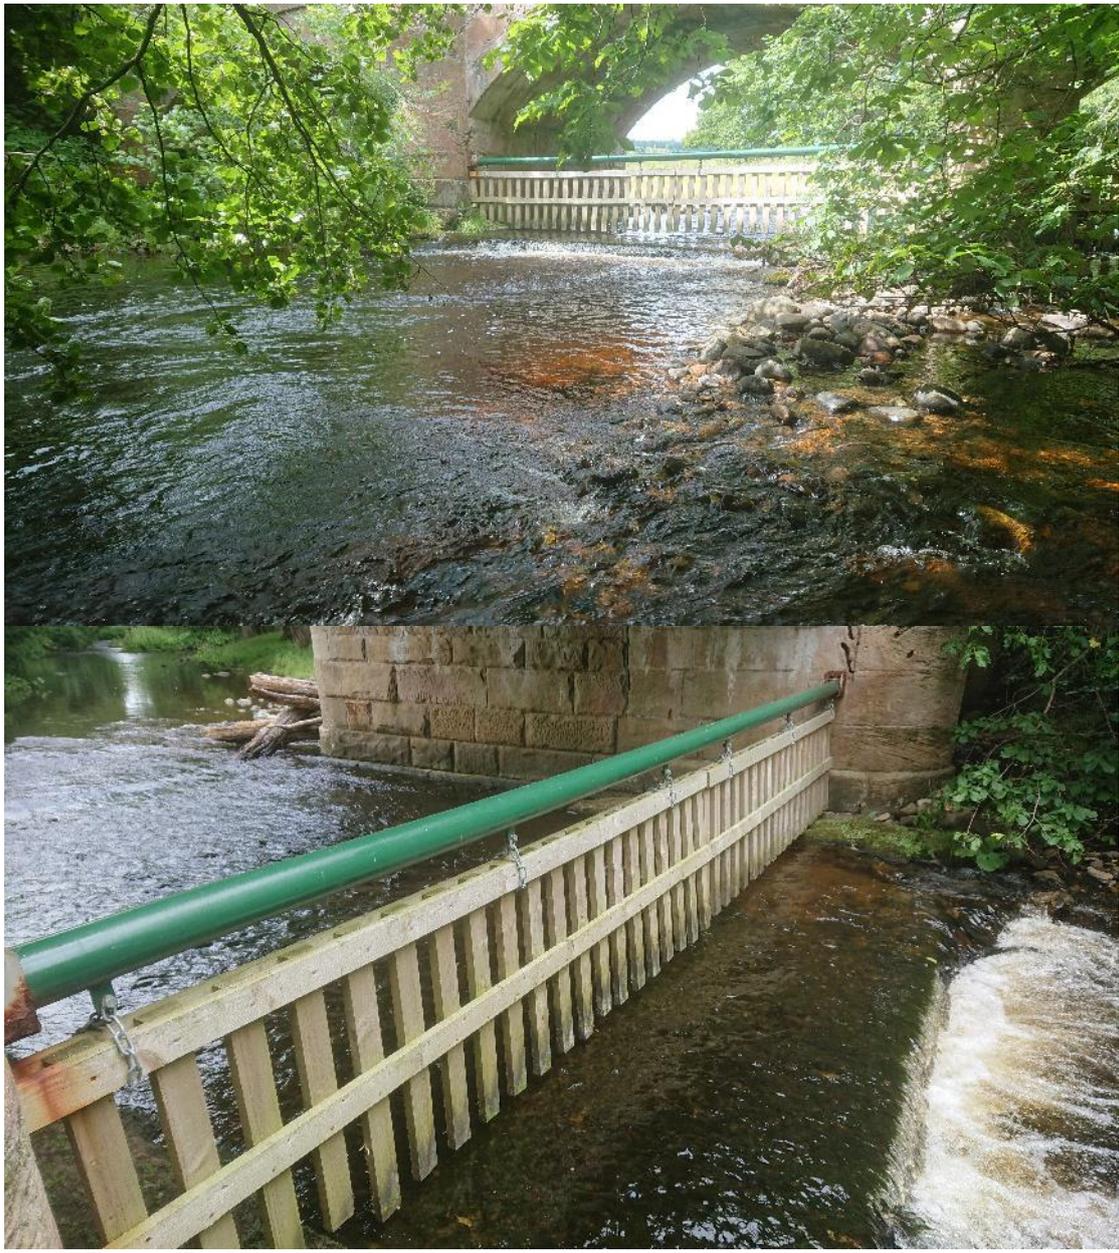
Thorpe Rd Bridge presented the first obstacle to free fish passage on the Burn, the extensive footings creating shallow fluming flow beneath the bridge and culminating in being 'perched'; i.e. the substrate d/s of the formal structure having eroded away over time (Fig 5). That erosion has been exacerbated by the impounding effect of the footings on the u/s side, effectively interrupting re-supply of gravel and small cobble.

**Fig 5. Thorpe Rd Bridge was multi-arched with the majority of flow passing through one aperture. Footings of dressed stone were perched on the d/s side presenting ~15cm headloss into a deep weir-pool. The step combined with a shallow flume of water over the footings for ~10m present an obstruction to fish passage. Note the impounded section u/s. Water-gates prevented stock movement d/s – these always present ongoing maintenance issues, and it is usually more effective (with wider benefits) to simply exclude livestock from the watercourse.**

The footings of the various bridges can be made more passable with relatively low-cost techniques. Bolting wooden or stone baffles to the structure to provide an attraction flow (a focal point for fish where the majority of water is concentrated) and simultaneously creating a greater water depth over the footings which will improve passability. Options such as these have been bespoke-designed for numerous waterbodies around Yorkshire.

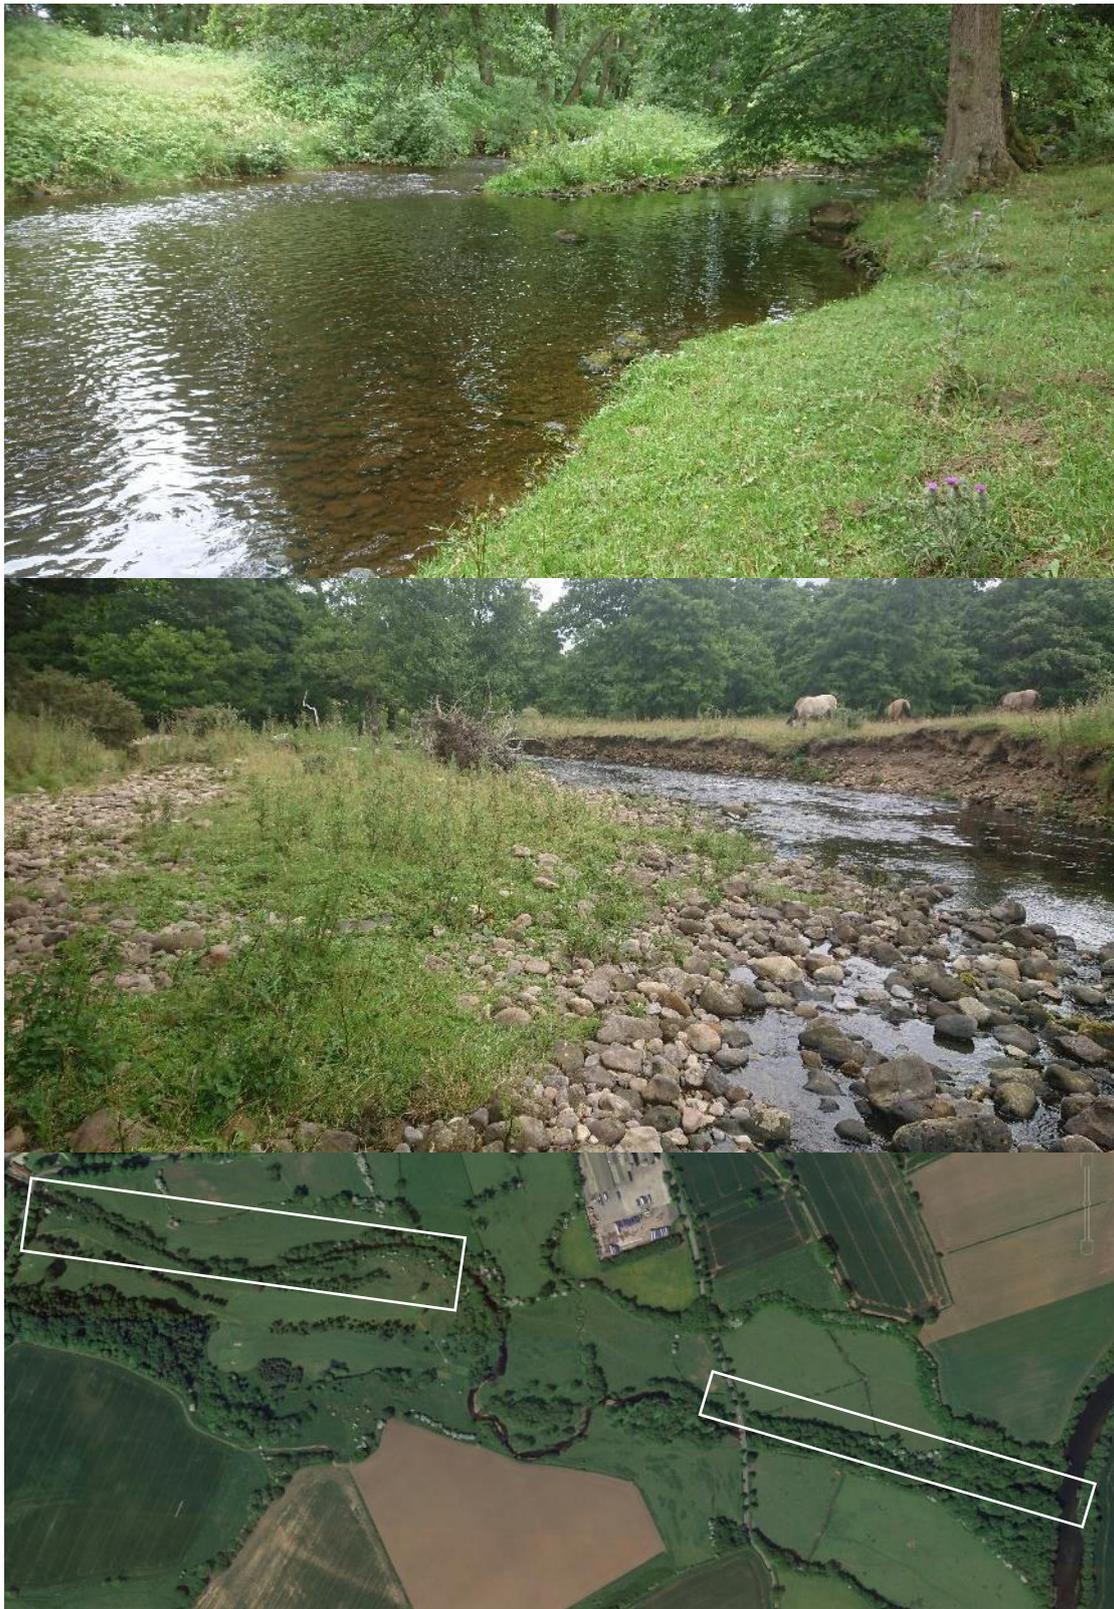
Immediately u/s of the bridge, the impounded section was shallow and wide with no focal flow path and little cover for fish. Without defined flow, sediment had deposited uniformly across the channel. These undesirable channel characteristics were further exacerbated by both banks being heavily grazed by livestock (horses present during the walkover; Fig 6). The understory vegetation was reduced to a predominance of short-sward grasses, which, when continually cropped by grazing, invest energy in replacement of shoots rather than generation of roots. Hence, cropped banks only have a very shallow root matrix present in the soil which offers little resistance and resilience to spate damage or livestock trampling. There were no self-set trees evident either; these are typically browsed

**Fig 6. U/s from Thorpe Rd Bridge, livestock had free access to the bank edge for ~750m. Consequently, erosion was rife and cover limited to mature trees. Note lack of root matrix in the soil on the RB (mid panel). Google Earth image (lower panel) demonstrates the meandering Burn where the banks have been weakened by livestock, between the heavily straightened /realigned sections u/s & d/s (in white boxes).**

preferentially because they are relatively nutritious compared to grasses. Thus, despite some mature tree coverage near to the waterline, there were no saplings in line for the future. Rather perversely, the reduction in bank stability facilitated by livestock

access in this reach appears to have rekindled geomorphic process and the river has begun to meander again (Fig 6: lower panel). The nascent meanders and active deposition bars in the Google Earth image hint at how dynamic the river should be between Leighton and the Ure, rather than the straightened reaches or long-sweeping bends constrained by revetment. It should be remembered that erosion (and subsequent deposition) is a natural process, providing the river with essential substrate, but unfettered livestock causes excessive erosion rates. Removing the influence of the livestock would allow the banks to revegetate, improving the root matrix, increasing resilience and slowing the erosion to a natural rate, while still allowing for dynamism.

The simplest and most effective means of restoring the native vegetation along the banks is to exclude livestock, which will for the most part improve the health & welfare of stock as well. The native seedbank will quickly restore degraded sections if given half a chance. If watering of stock is a concern, then there are various techniques available (mains supply where available, pasture or ram pumps, solar-powered pumps). Any troughs should be sited sufficiently distant from the waterbody so that faeces and poaching of soils do not affect water quality. That is why drinking bays are a poor option as dense lines of compacted / poached soil develop from repeated access to a focal area, ultimately guttering water and soil plus faeces into the river in wet conditions. Cows are five times more likely to defecate when they are stood in water (useful pub quiz knowledge!), again causing nutrient issues at a point source.

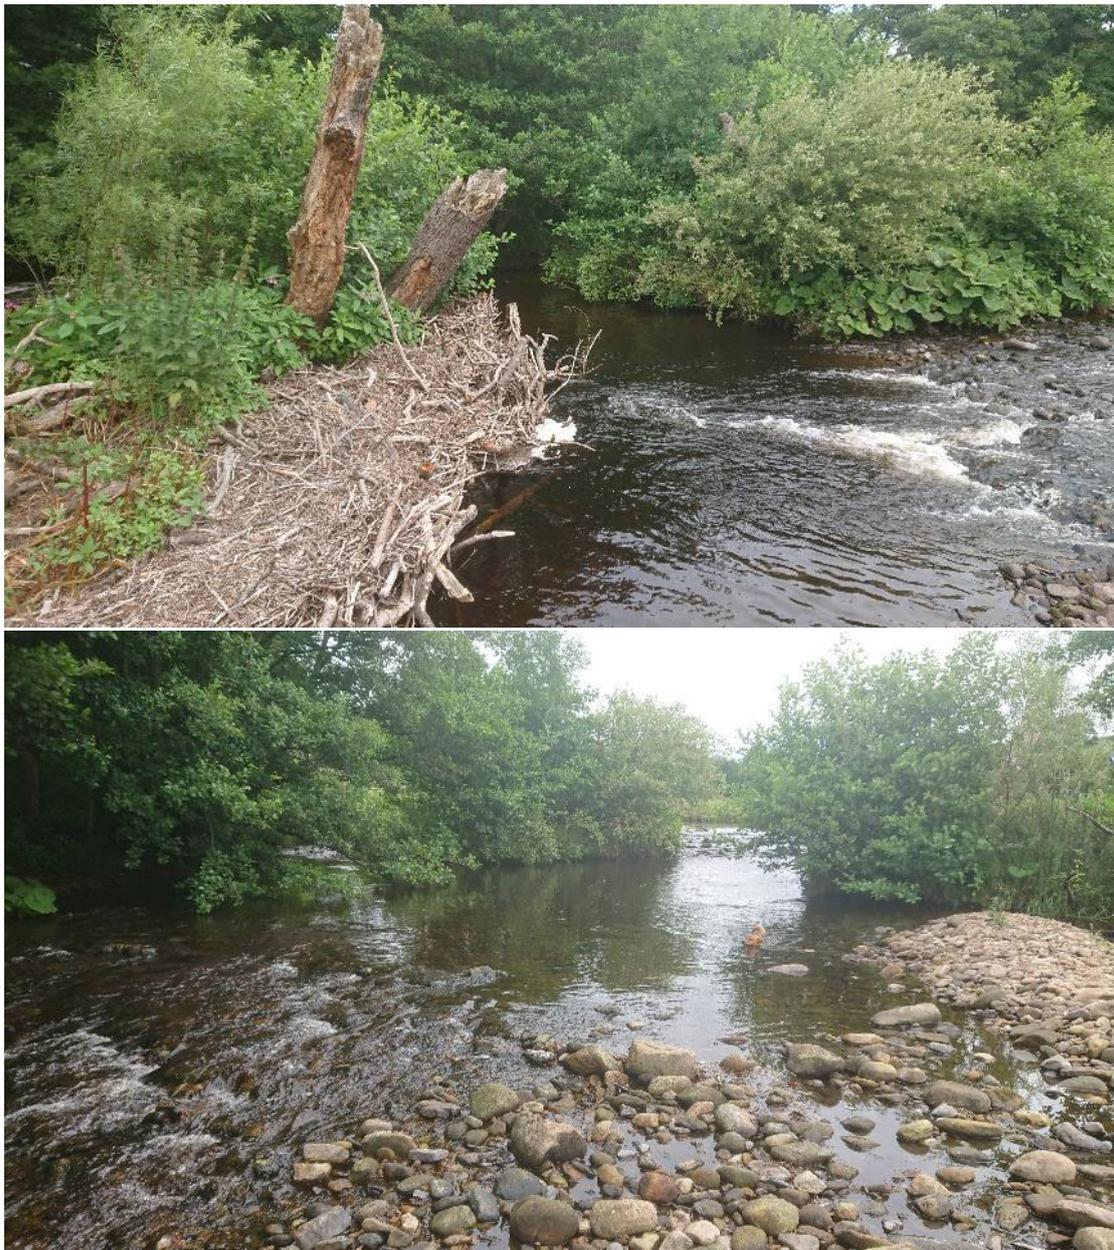
**Fig 7. Upper panel: a natural pinch in the channel provided by the stump of an old alder tree which had also trapped spate debris. The focus of flow has caused down scour to create a deep holding pool around the stump. Lower panel: looking u/s at the pinch from the fan of sorted cobble and gravel deposited at the tail-end of the pool, creating potential salmonid spawning habitat.**

Within the grazed reach, there was one dead alder and a few saplings beyond the reach of browsing (Fig 7) that were creating some wonderful habitat features. A large mat of debris had pushed up against the trees, probably helping to protect them from livestock, and forcing the flow down and around the obstruction, scouring a deeper pool and depositing a fan or ramp of sorted substrate on the d/s side. The sorting element is crucial for creating suitable spawning habitat: heavier sediment deposited first and finer sediments last.

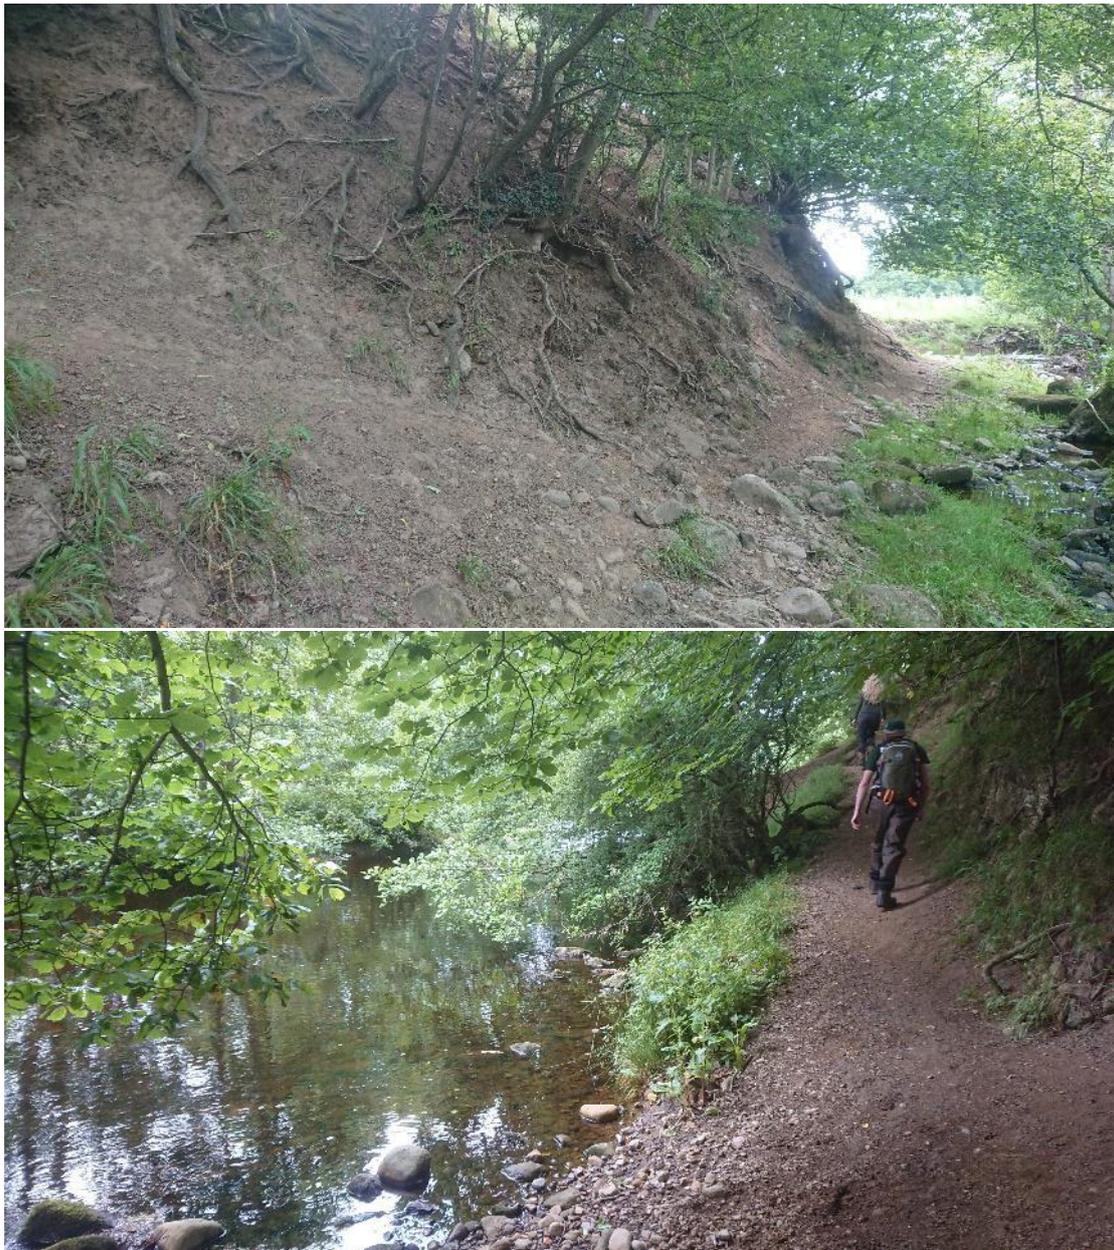
**Fig 8. Tracking & grazing by livestock (primarily sheep) and the proximity of the footpath to the river probably contributes considerable fine sediment to the channel – diffuse pollution.**

Where the Burn had been pinned against one side of the valley, the proximity of the footpath and concentration of sheep tracks and grazing across the steeper ground had caused issues of fine sediment ingress to the channel. There were several focal points where this diffuse pollution was evident (Fig 8). Prevention of stock access with

a short fence (plus stile or gate) to an area with very poor grazing potential would rectify the situation quickly and easily.

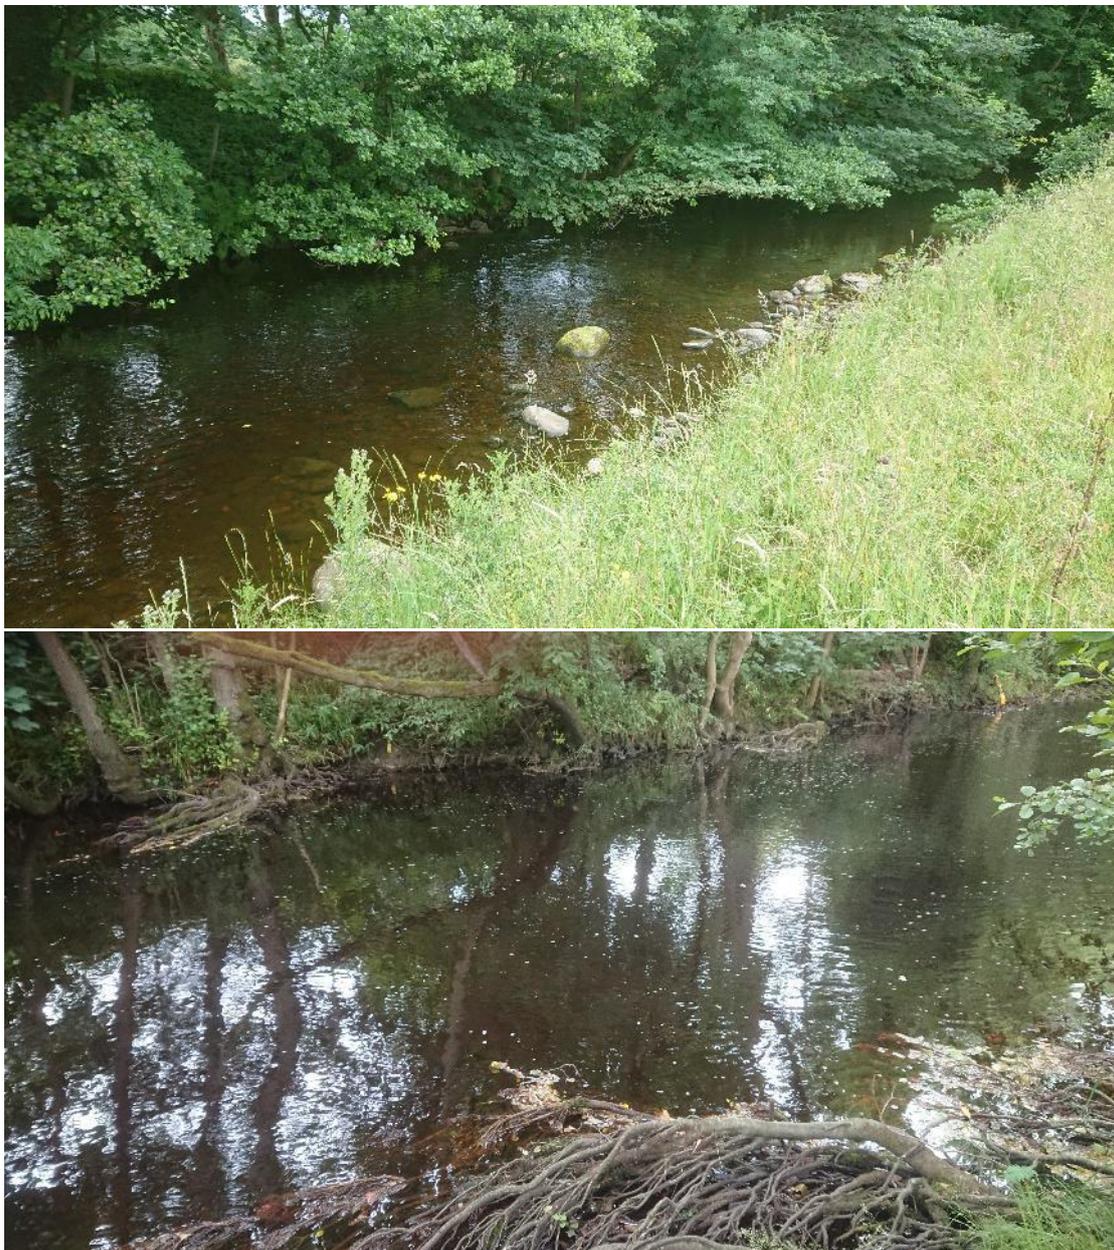
The presence of trees, even when restricted to one bank, provided vital habitat along the straightened lower reaches bordering the golf club. Low branches and complex submerged roots provided good cover, especially where the branches shaded deeper water (Fig 9). Such habitat will provide micro-niches for a greater density of trout and should be protected; any attempts to 'tidy' them will reduce the holding capacity of the river. There was still a notable lack of large woody material in the river *per se*, which could easily be rectified given the raw materials to work with along the banks – see Recommendations.

**Fig 9. Examples of low and submerged cover provided by native tree branches and roots, essential for most of the life-stages of salmonids, and especially where one bank is open to livestock grazing and hence devoid of cover.**

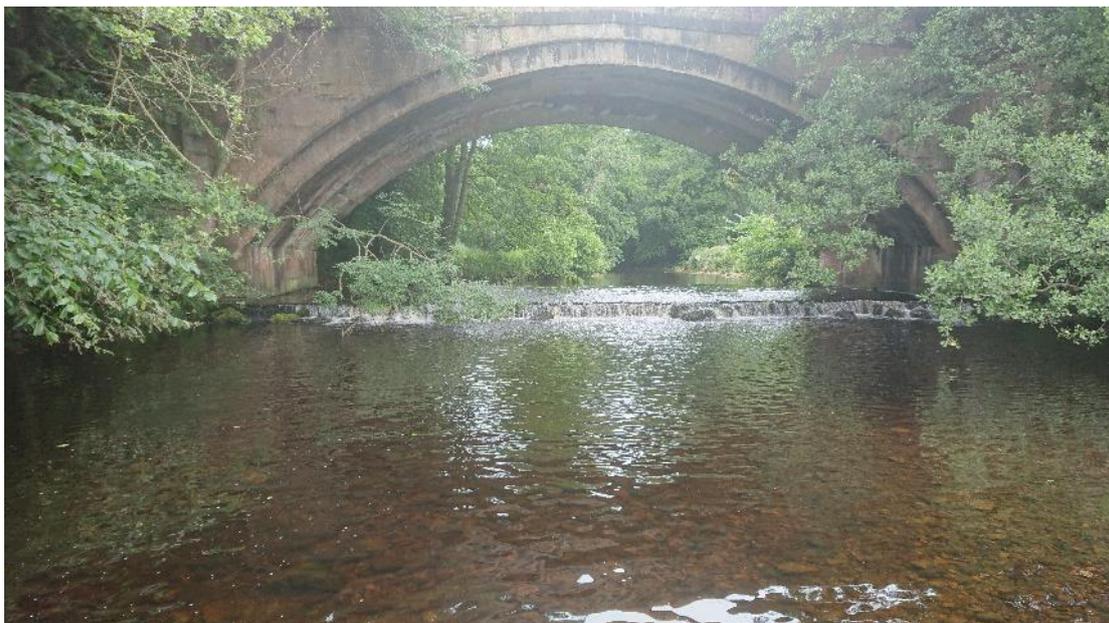
**Fig 10. Swinton Rd Bridge at SE 21643 80172 has created a weir pool beneath the perched bridge footing (similar to that in Fig 5) and thus reduces passability for fish.**

The bridge carrying Swinton Rd over the Burn (Fig 10) had similar footings to those on Thorpe Rd (Fig 5) and causes similar issues in terms of perching and impoundment. The latter was evident for ~100m u/s, creating a deep, sluggish glide of little habitat value, with heavy boulder revetment along the LB.

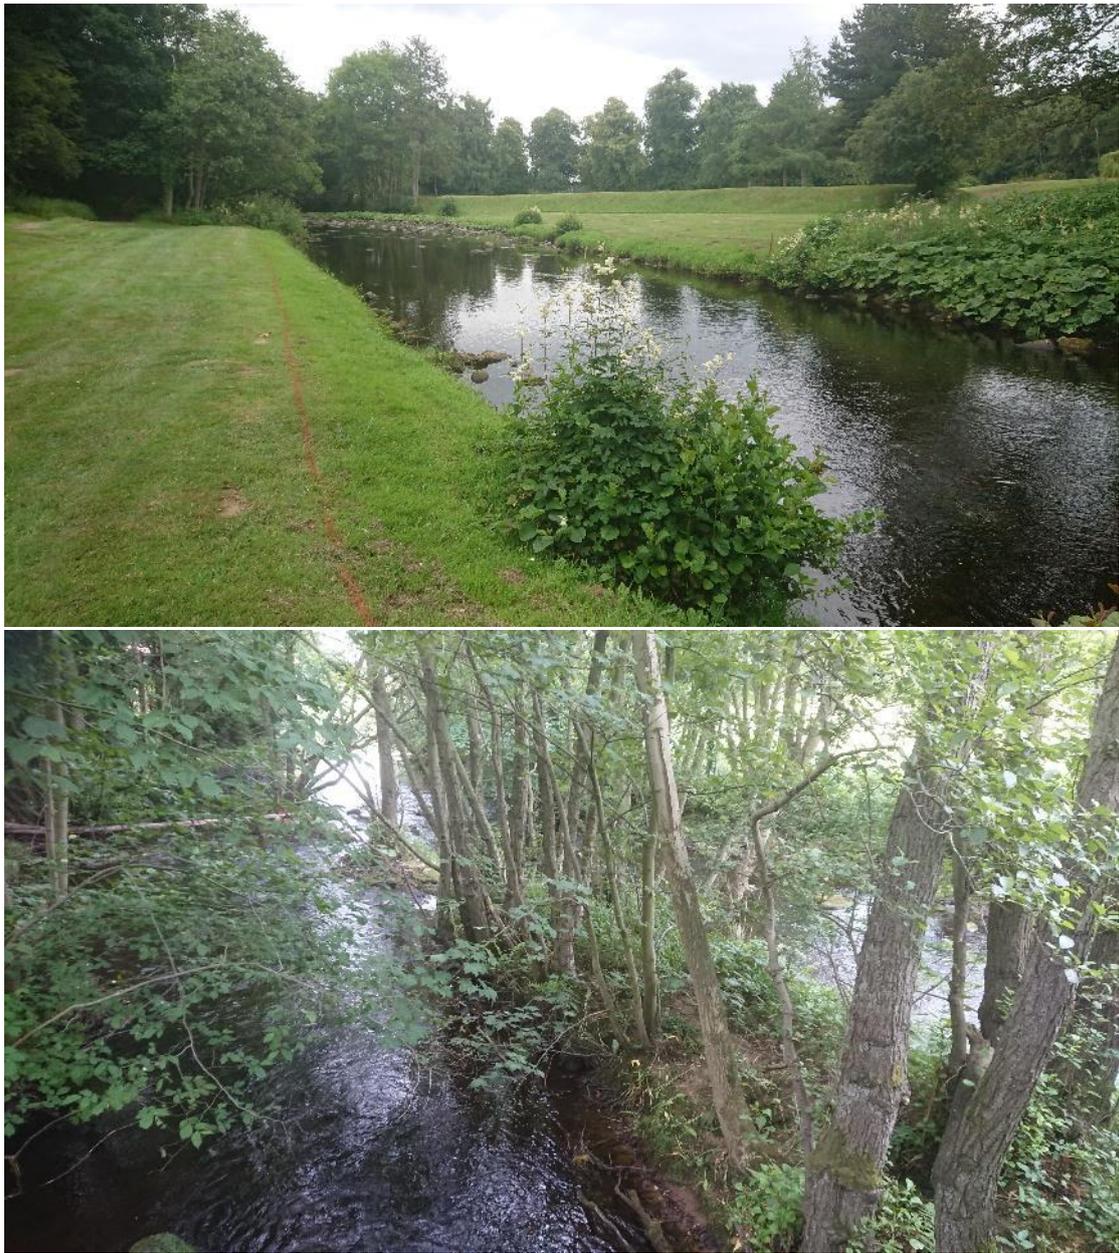
Indeed, habitat throughout the golf club's influence was a real curate's egg. There was a (thankfully) short stretch where natural vegetation had been pared right back and it resembled a barren canal. In direct contrast, the channel both d/s and u/s of the manicured stretch was extremely diverse in terms of riparian cover (Fig 11). Another split in the channel around a small island, and the appearance of bedrock in one or two places also diversified the channel morphology, despite it still being straightened and hence unnaturally steep in gradient. Again, as in the straight reaches d/s, fast riffle / glide dominated and the channel would benefit markedly from flow being interrupted by introduction of large woody material, especially as there was copious amounts to be found on both banks (Fig 12). Where wood has fallen and been allowed to remain, for example along Havernook Lane (Fig 13), the resultant excellent quality habitat mosaic comprises: deeper holding pools for adults scoured beneath or alongside trunks and root boles; ramps of well-oxygenated gravel, ideal for redd creation and better quality habitat for clean water specialist macroinvertebrates; slackwater for fry; and shallow riffles and pocket water for juveniles / parr.

**Fig 11. Compare & contrast: Upper panel depicts a manicured straightened stretch managed by the golf club, unnaturally wide and devoid of flow or cover, which is immediately u/s of a naturally split channel (lower panel) fringed with alder and heaving with habitat diversity!**

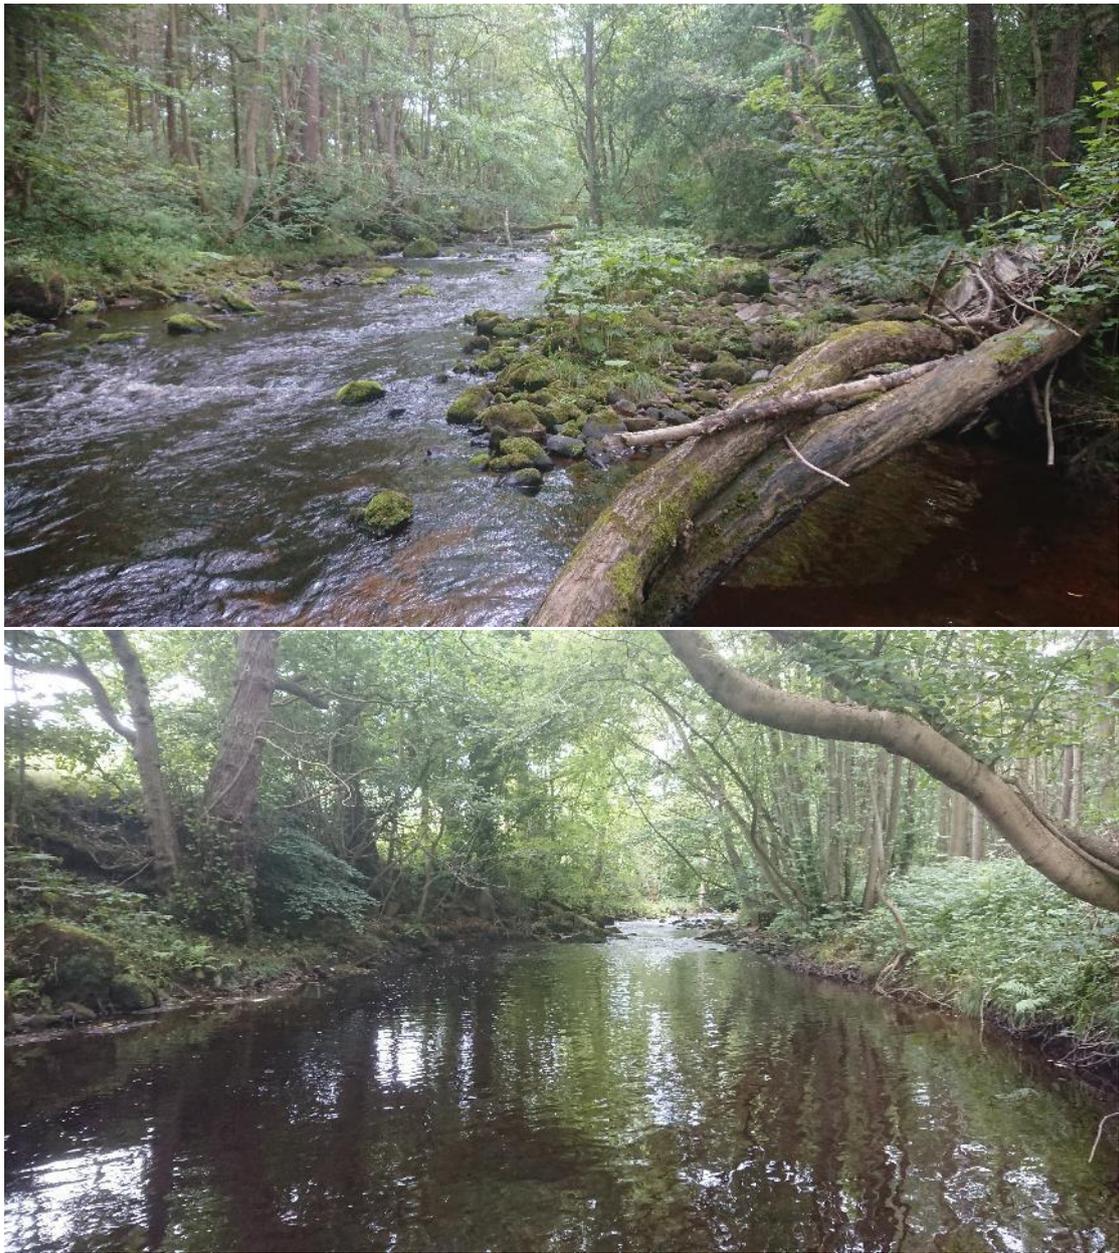
**Fig 12. Bordering the golf club for  $\sim 300\text{m}$ , and u/s for another  $\sim 350\text{m}$ , the Burn has been historically straightened and pinned to one side of the valley by boulder revetment. Despite substantial fringing of native deciduous trees on both banks (and some plantation), there was relatively little evidence of woody material in the channel. Habitat was dominated by continuous fast riffle and glide, and larger boulders interrupting the flow created pocket water ideal for parr.**

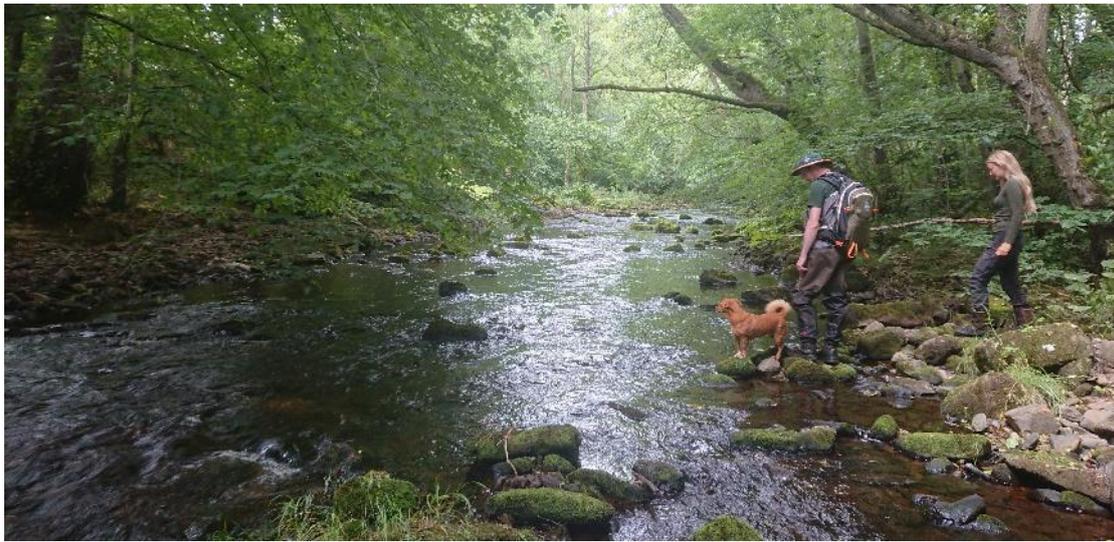
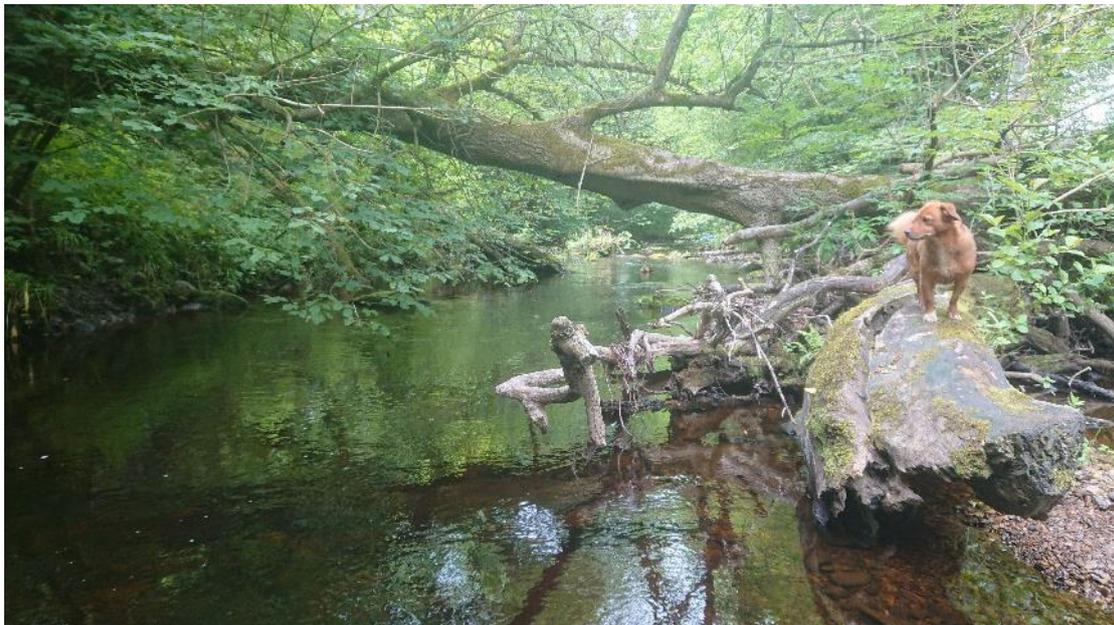
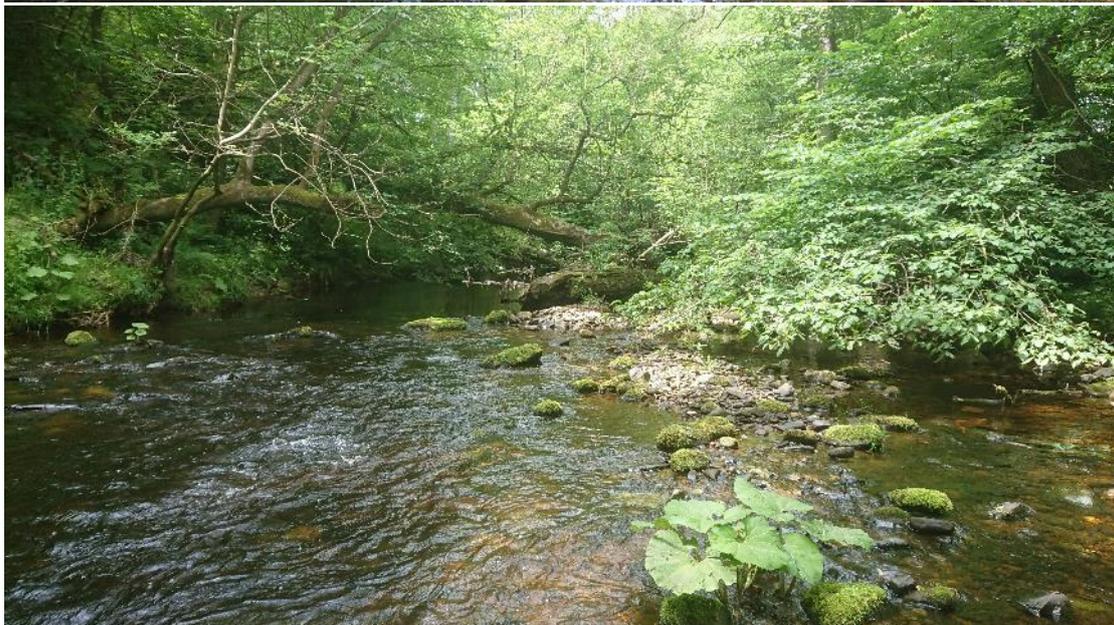
**Fig 13. While still straightened by proximity to Havernook Lane, along this reach there was a greater influence from natural falls of large woody material which divert flow and instigate scour & deposition to create a habitat mosaic providing for all life-stages of salmonids.**

In conjunction with riparian management above, existing trees can be used to diversify instream habitat. Good examples of this were along the Havernook Lane reach (Fig 13) where large woody material had been retained within the channel but were rare elsewhere. This not only increases hydraulic roughness (as the riparian plants do) but encourages localised scour and deposition to diversify channel morphology and provides refugia. Laying or hinging of appropriate pliant species such as willow or elm at a downstream angle  $<30^\circ$  to the bank retains a living attachment point and reduces undue stress on the hinge during spate flows.

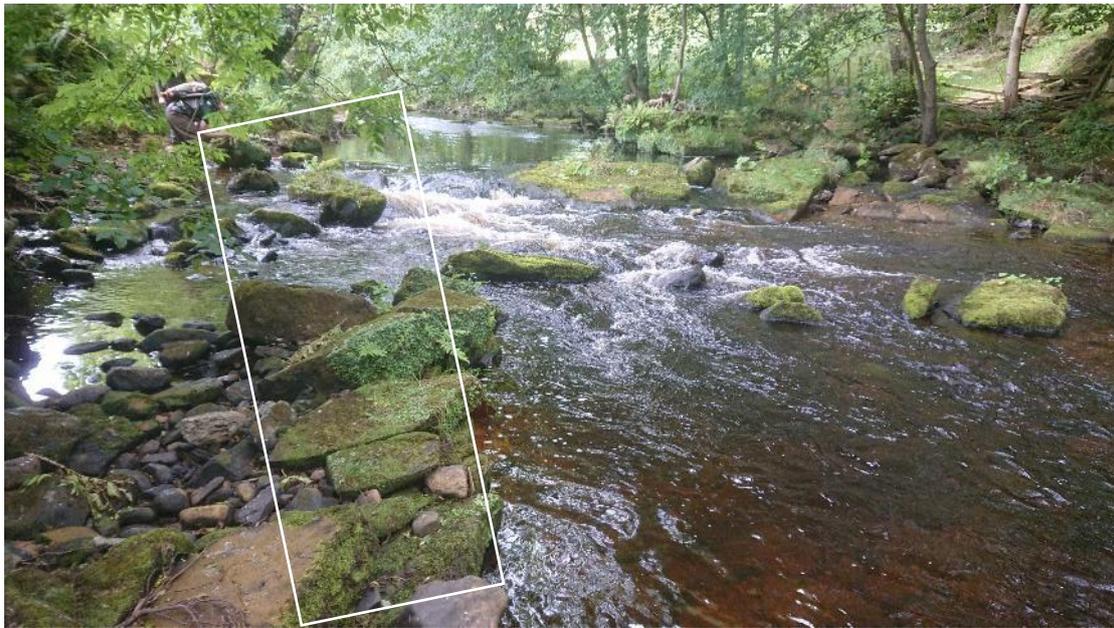
Around Swinton Moor, the river has occasionally circumvented the historic boulder revetment and the introduction of that material back into the channel (from it where it might have originated anyway) has created further habitat diversity, pinching the channel and creating pocket water (Fig 14). Active removal of revetment to reinstate a more natural channel and invigorate other river processes is being explored in a project by Yorkshire Dales Rivers Trust in the Upper Wharfe.

**Fig 14. Pinned to one side of the valley at Swinton Moor (around SE 19971 80307), the boulder revetment of the formalised bank-line (highlighted in the white box) has failed over time and that material is now providing some benefit – here, pinching the flow into a natural chute and discharging into a pool below.**

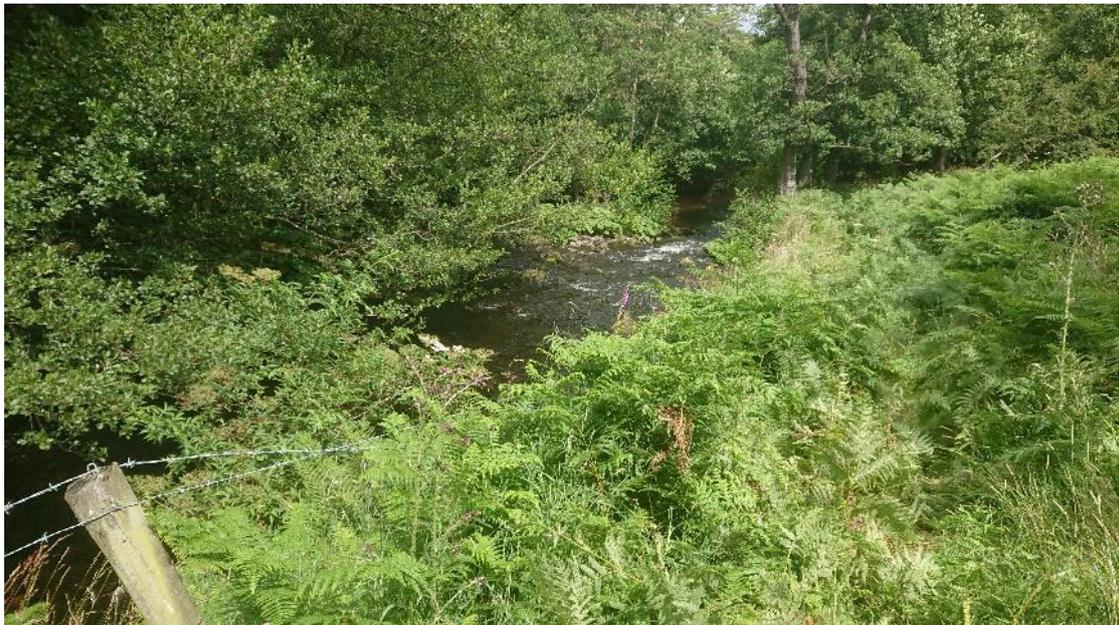
There was clear evidence of livestock along the RB of Swinton Moor. A dilapidated fence at the u/s end of the field clearly still offered some protection as the riparian fringe was dominated by bracken and native shrubs (Fig 15) but the majority of the bank throughout the field was reduced to grass and mature tree cover. This reach exemplifies a livestock paradox in river restoration. The trampling of the RB by cattle has reduced the unnaturally incised nature of the channel and created a gentler bank profile which will allow spate energy to dissipate more readily. However, continued access has led to poaching and associated fine sediment ingress (diffuse agricultural pollution), and the vegetation remains depauperate as noted before, especially in the lack of self-set trees. The disbenefits outweigh the benefits to the river in most instances.

**Fig 15. At the boundary between Fearby Low Moor Plantation and Swinton Moor (SE 19787 80175), the Burn was split again around a sizeable island, creating channels of very different morphology. Native woodland dominated the LB while the RB was at first dominated by bracken and hawthorn scrub before giving way across Swinton Moor to bare understory due to livestock (cattle) access.**

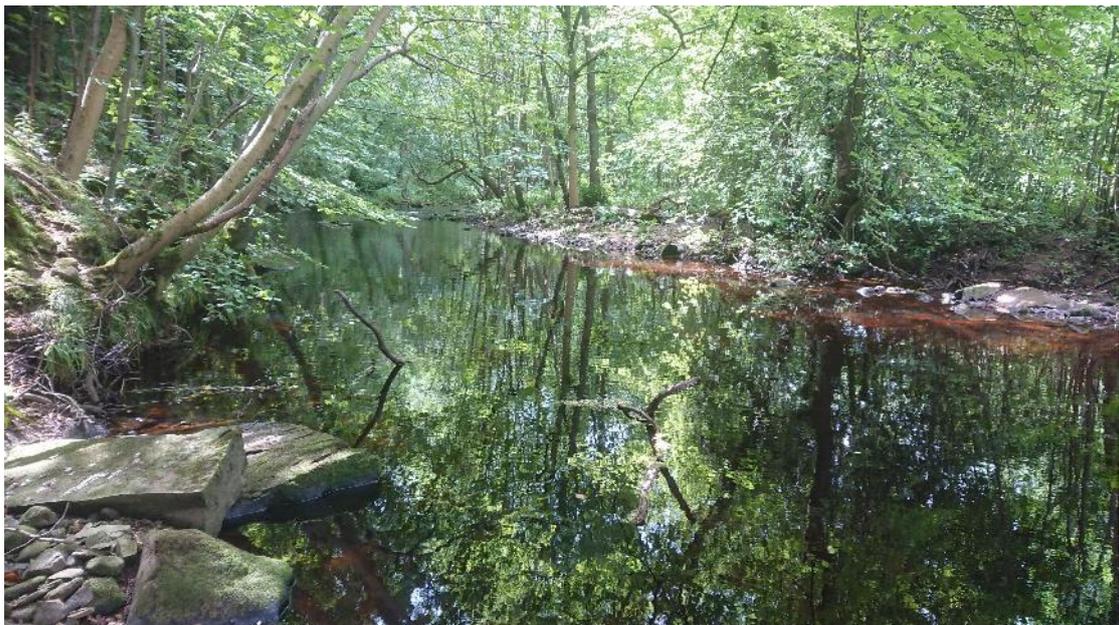
Throughout the plantations, there was a distinct lack of woody material in the channel, hinting at active management to remove it which is a pity in an area of such low flood risk (Fig 16).

**Fig 16. The Burn within Fearby Low Moor Plantation appeared to be slightly impounded, assumed due to deposition and creation of the island (Fig 15), or perhaps realignment along a contour line.**

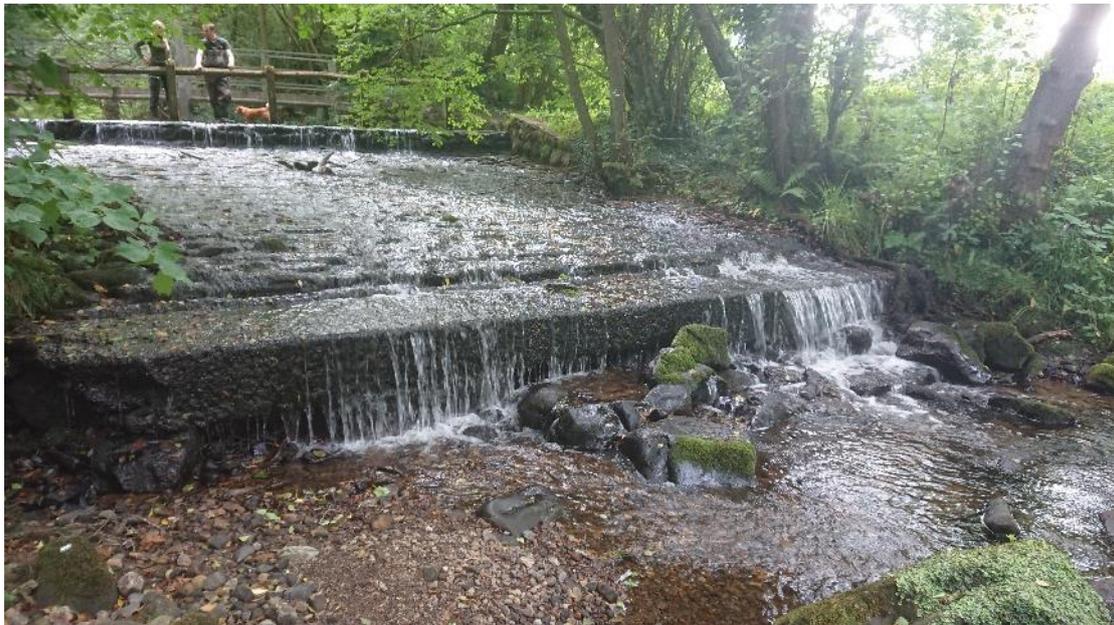
There were few tributaries to the Burn of any significant size until Sole Beck. Numerous springs and seeps, some obviously emanating from relatively nutrient rich limestone bedrock, were noted throughout. These small systems, the majority certainly fishless, are probably far more important as rich sources of macroinvertebrates for the Burn. While Sole Beck was of a size and character that could hold and produce salmonids, it was unfortunately disconnected from the Burn by a substantial ford at its confluence (Fig 17).

**Fig 17. At SE 19143 79948, Sole Beck and another un-named watercourse entered the Burn from the RB but both had been made impassable by the construction of a ford.**
