**Advisory Visit**

**R. Burn, R. Ure tributary**

**Northern Fishing School**

**July 2019**

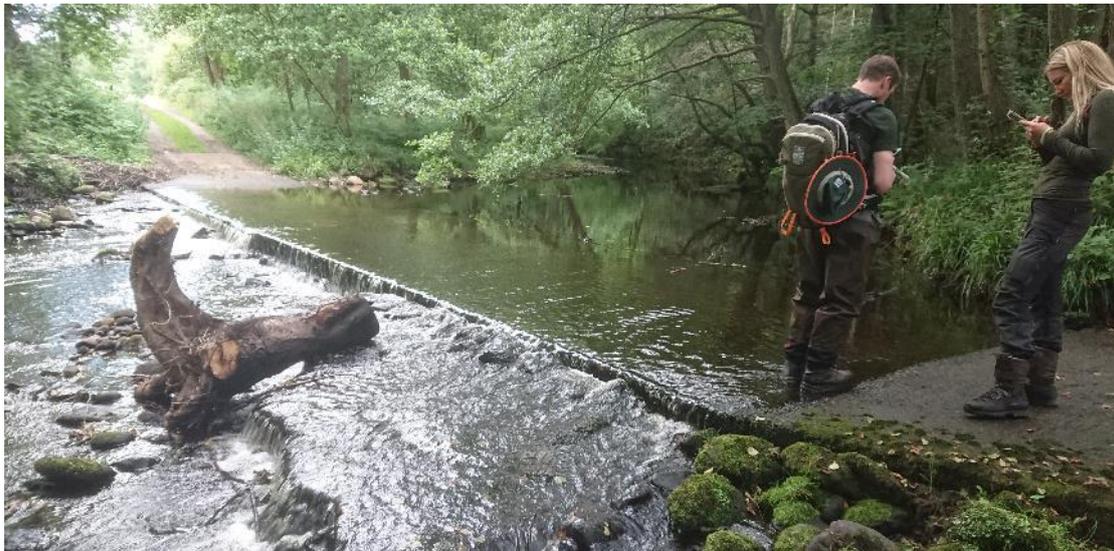
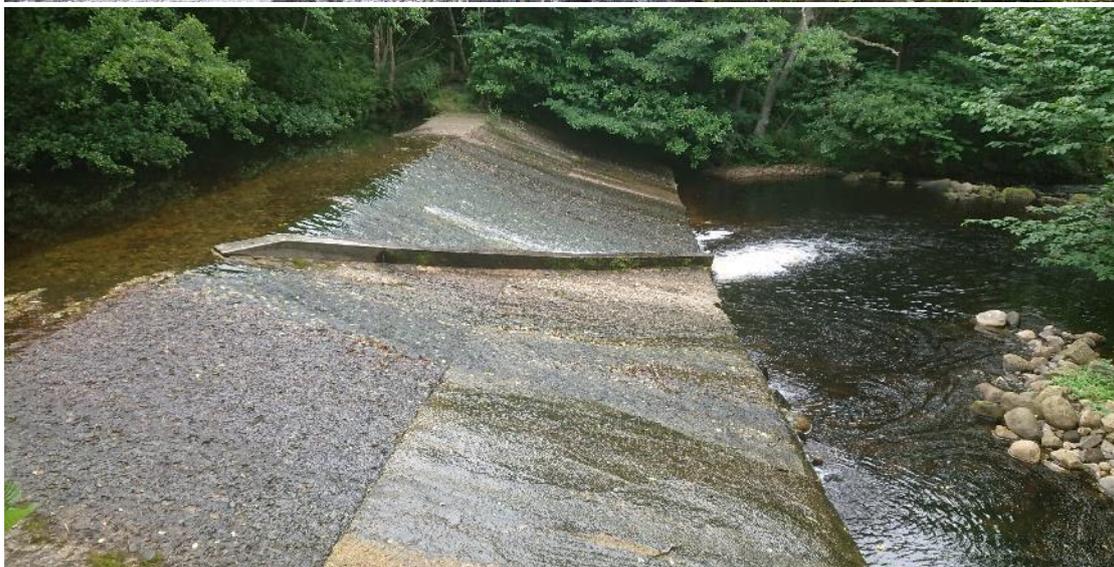
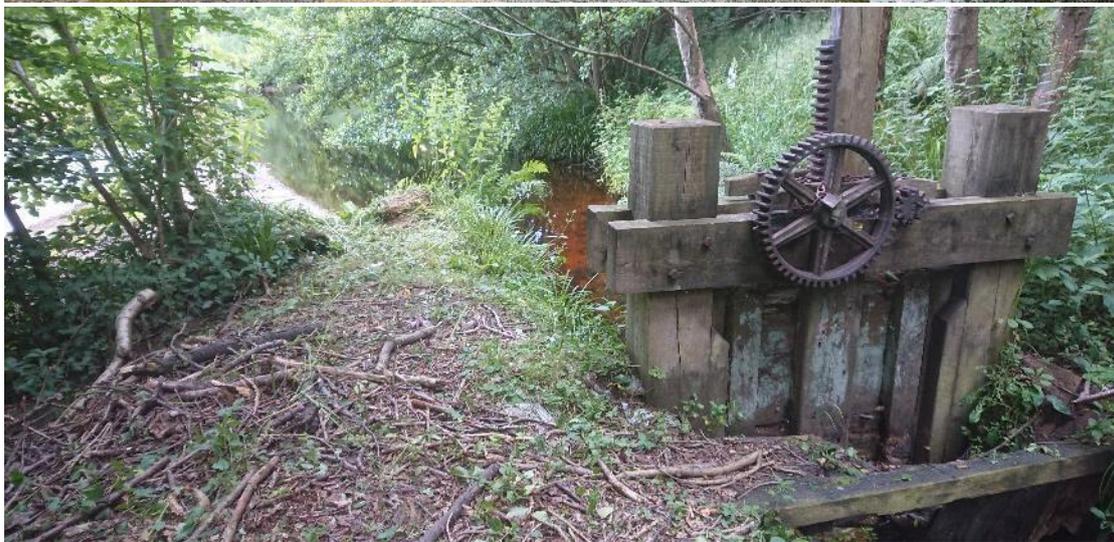
The construction of a mill (prior to 1853: Healey Cotton Mill) at the Swinton Saw Mill (sic) site resulted in major changes to the Burn, the legacy of which continues to this day. For ~600m, the channel was noted to be robbed of a considerable proportion of its flow, diverted by a large weir along the mill leat to what is now a fish farm. As this is a flow-through system, the farm will be introducing a plethora of undesirable nutrients and chemicals in its effluent, as well as escapee fish, their parasites and diseases. Further impacts include the formalisation of a ford, a low-head obstruction caused more by the shallow depth across it, and the issues to geomorphology and fish-passage at the weir itself (Fig 18).

The weir was fitted with a baulk pass which relies on the burst swimming speed of a fish sufficiently powerful to overcome the force of water flowing down the angled chute. Such a design is highly selective in which species or individuals may pass, and very inefficient overall. For example, with the lower end perched above the river, it was impassable at the water level observed which probably equates to ~80% of the time. Removal would be the ideal as it would restore all the flow to the Burn as well as reinstate connectivity for both sediment and fish. Any 'improvement' to the fish pass is effectively a last resort, not a good solution.

**Fig 18. Assorted infrastructure formerly associated with Swinton Saw Mill which has since been converted into a fish farm, all of which degrade the environment for wild fish and the wider ecology. Upper panel: a concrete ford which, being d/s of the weir used to offtake water for the fish farm, had very little water going over it. Mid panel: the sizeable weir, completely impassable at the flow height observed, with baulk pass of questionable design and efficacy. Lower panel: the sluice-gate at the offtake with no apparent screen in place to prevent escapees from the fish farm entering the river. NB – there could have been (unseen) ample preventative measures in place elsewhere.**

The major obstacle was the weir supplying the offtake to the fish farm and this business currently negates its removal (the gold standard approach). The baulk pass *in situ* appears deficient to improve fish passage in any meaningful way. A headloss of this size on a spate river requires a more substantial, better engineered solution such as rock ramp or by-pass channel, or even a technical fish-pass to overcome the various issues. With that comes associated cost and

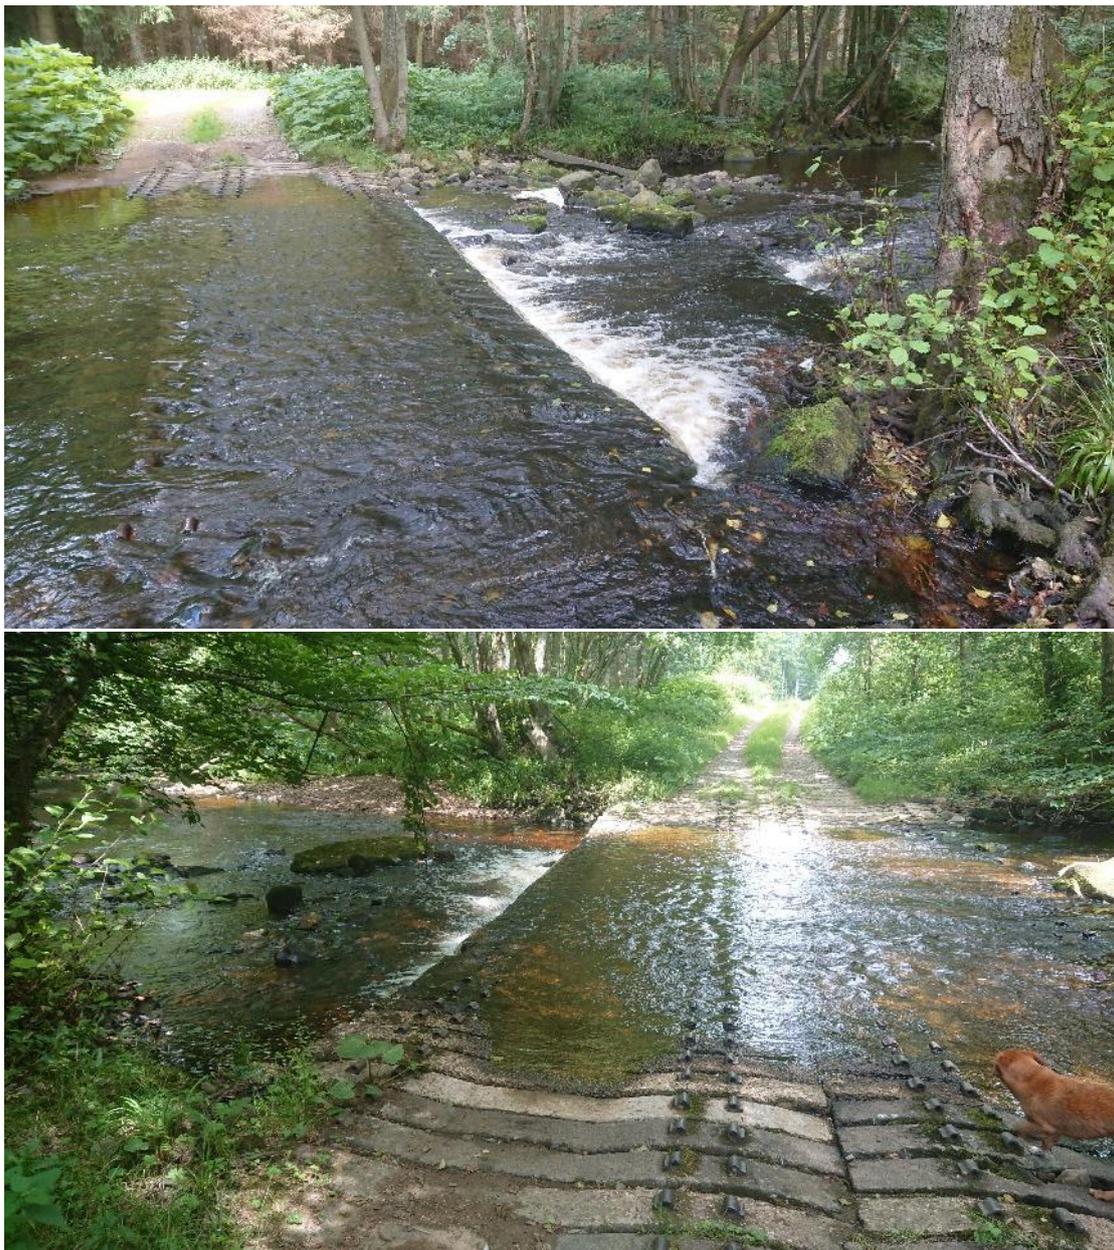
Above the weir and beyond its long impoundment reach, the Burn flowed through a mixture of plantation and native deciduous woodland managed for game rearing. There were several track-crossings, semi-formalised using concrete railway sleepers which, while less than ideal, created less of a barrier to fish passage than the previously observed bridge footings because they were irregular in form and thereby offered focal flow paths and retained sufficient depth (Fig 19). Each track crossing was still preventing free movement of fish and substrate, and impounding the river upstream, albeit for a short distance because of the gradient.

**Fig 19. Examples of track-crossings made from concrete railway sleepers which have interrupted sediment transport, impounded albeit short reaches of the Burn, and created obstructions to fish passage.**

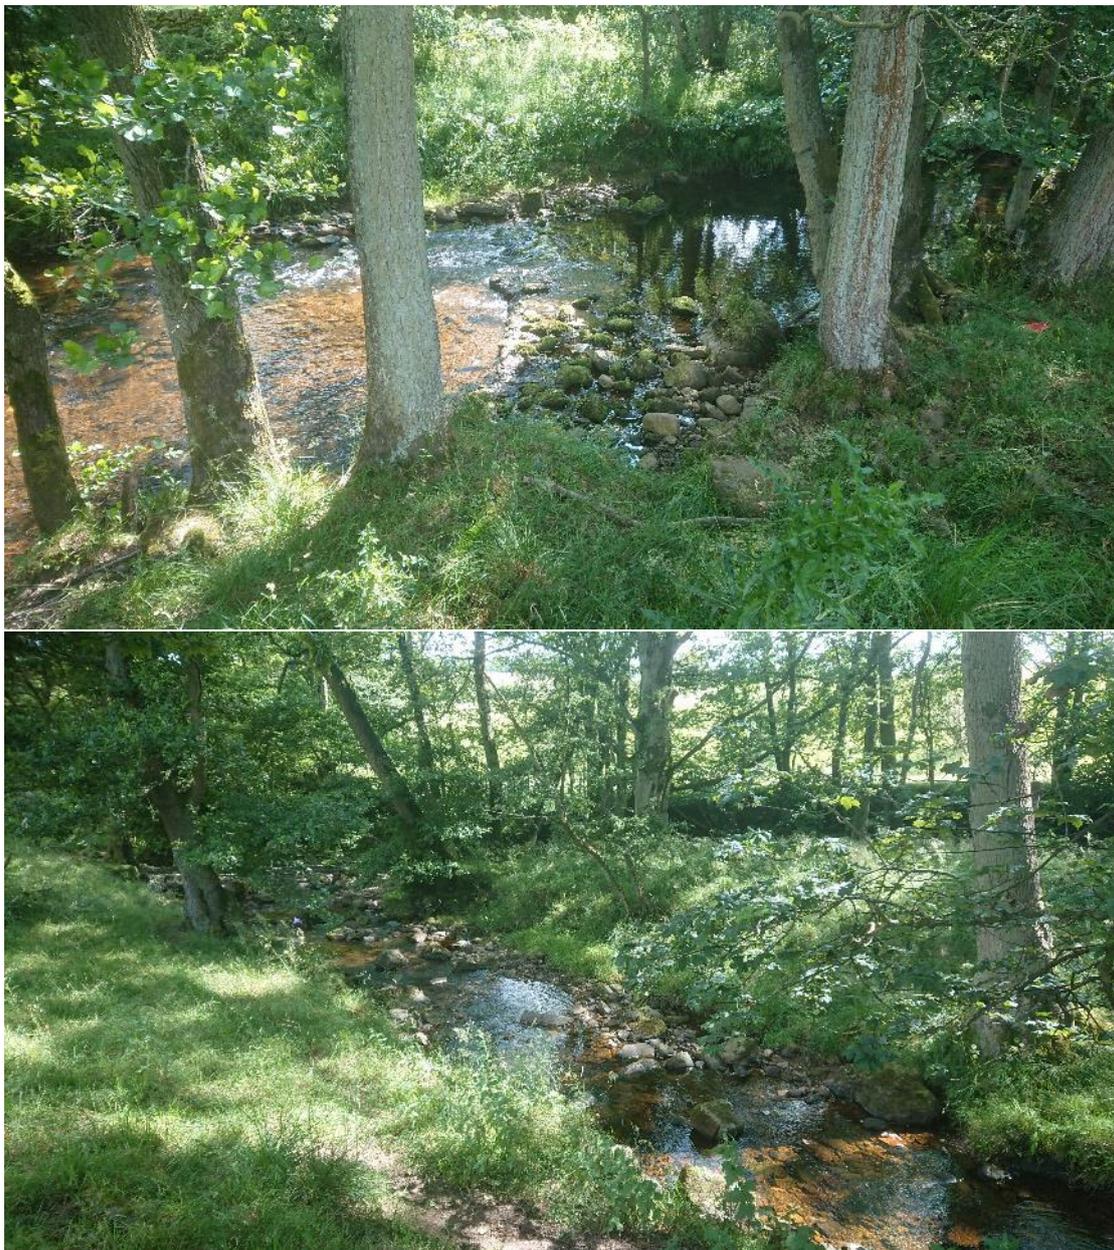
On the approach to Leighton (Pott) Beck, the RB retained mixed larch and deciduous cover while the LB opened to improved pasture (Fig

20). Unfortunately, various lengths of walling and/or fencing had not been maintained and sheep had gained access to the LB – there was a notable decrease in plant diversity and sward height, and more obvious signs of associated fine sediment accumulation on the bed.

**Fig 20. From SE 17453 80062, the LB understory was degraded and there was a corresponding paucity of self-set trees. Breaches in the walling and fencing had allowed livestock (sheep) unfettered access and the bed of the Burn was noticeably impacted by fine sediment as a result.**

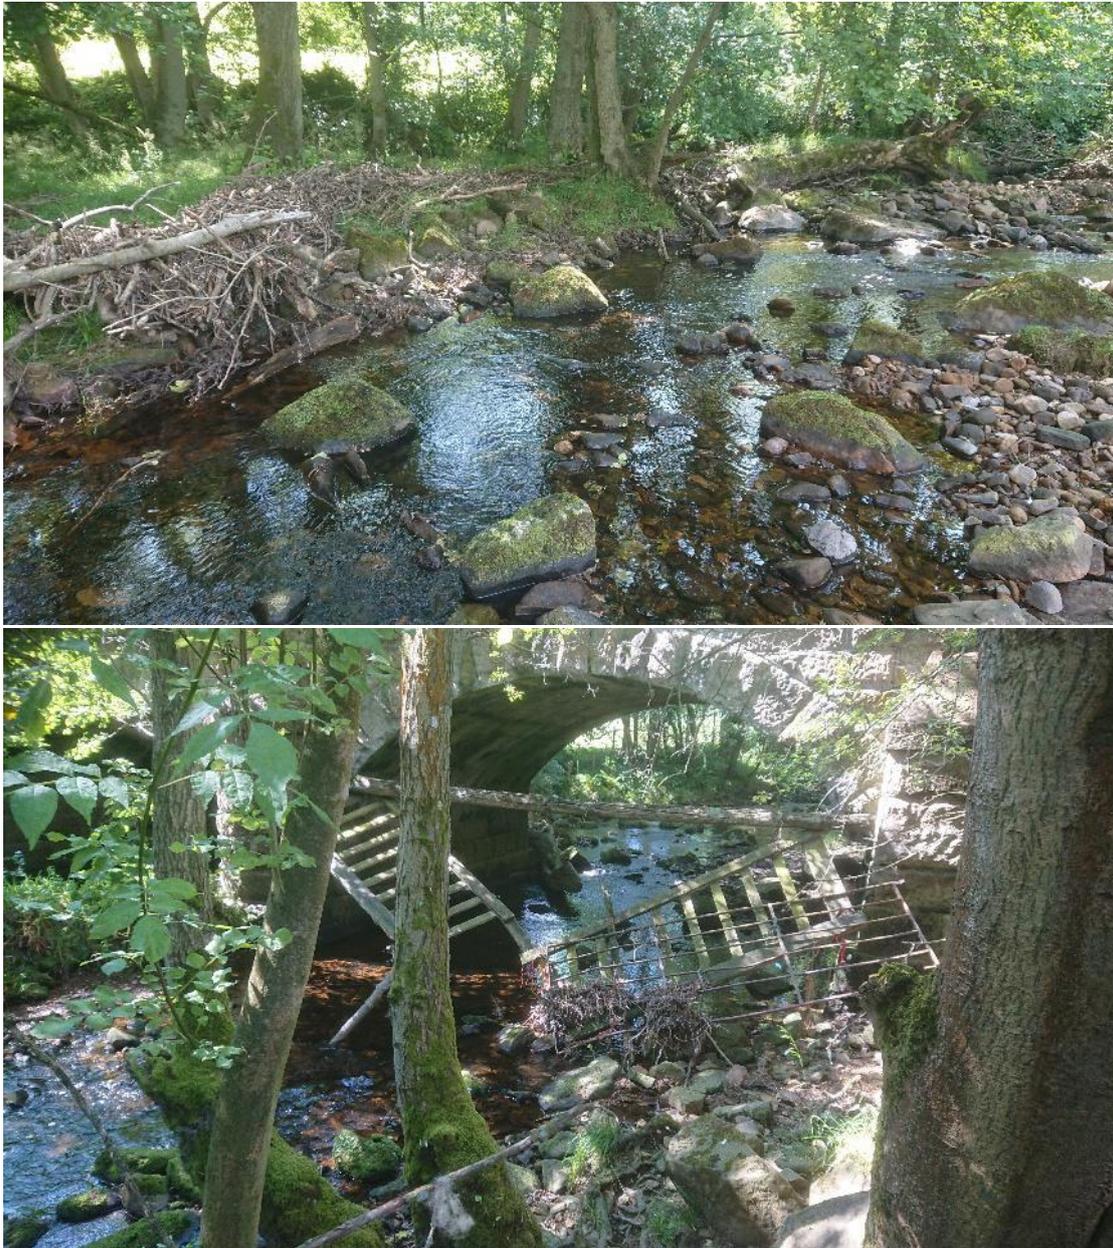
The short reach examined u/s of Leighton Beck to Leighton Bridge was classic pocket water dominated by large boulders within the channel, ideal for parr (Fig 21). The water-gated bridge created a pinch-point and hence a deeper pool but from thereon u/s it was assumed that the Burn, tightly constrained in a naturally narrow and steep-sided valley, would maintain a pocket water character for several kilometres.

**Fig 21. Another island immediately below Leighton Bridge (SE 16656 80037) split the channel into two branches, and while not viewed directly, it was assumed due to the channel proportions and later consultation online that there would be little other than parr habitat further u/s.**
