River Culm, Culm Fly Fishing Club

An advisory visit by the Wild Trout Trust September 2012

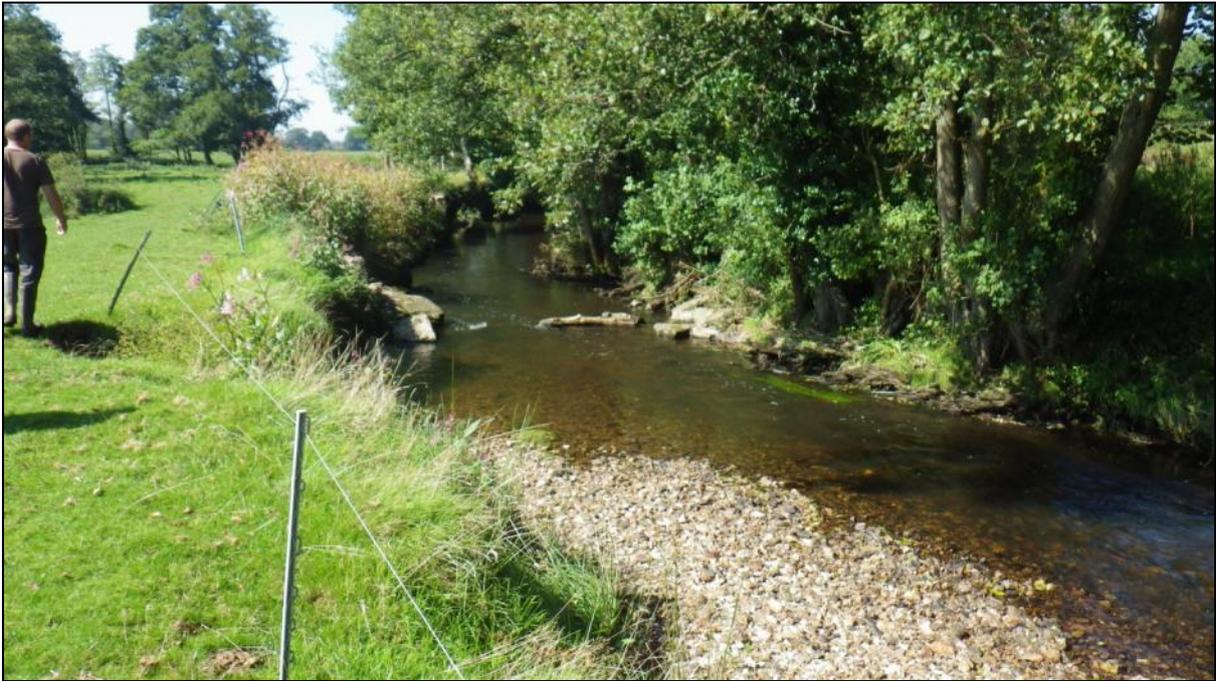
From the upstream boundary of the club waters, the river flows west from Hemyock through grazed fields. The left bank is open grassland whilst the right bank is densely wooded with alder trees and scrubby bushes. Some sections of the right bank run alongside a dismantled railway line. Where this occurs the bank has been reinforced with sleeper and/or stone revetments. The combination of established root systems, vegetated banks and occasional man-made revetments has resulted in the right bank being relatively robust against erosion forces. The left bank by comparison is exposed and vulnerable. The grass monoculture and vertical bank profile mean that soil is stripped out of the bank during fast flows leaving undercut banks that eventually slump into the river and are washed away.

Figure 2: The grazed left bank is a stark contrast to the heavily wooded right bank

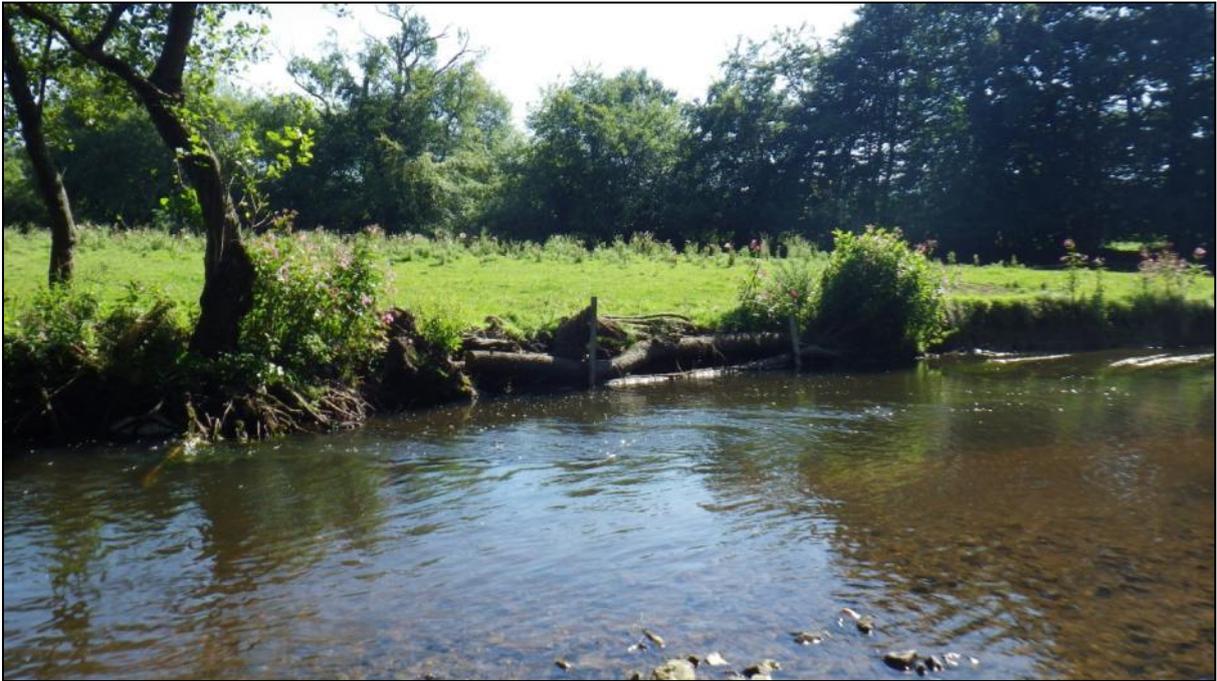
The club has attempted the construction of some large woody debris (LWD) revetments to protect the left bank. In one particular location, spate flows have ripped much of the wood out of a structure despite sturdy angle-iron bars being driven into the bed to retain the material. The river often breaches its banks around this location during high flows to flood the adjacent fields. Specially engineered road and foot bridges have been installed nearby to allow flood waters to pass under the road.

The wide-ranging flow conditions of the river mean that channel geomorphology is particularly active. This means that the river profile is constantly shifting and changing and bed material is probably transported some distance during higher flows. This should be taken into consideration when planning any habitat enhancement works as any installed structures will have to be able to withstand not only the force of the fast-flowing water, but also the abrasion of gravel and large stones carried by the flow.

Figure 3: LWD revetment secured with angle-iron bars

- The club has already done a sterling job of utilising LWD to create anti-erosion revetments. This type of work is warmly encouraged as a means of introducing more woody habitat into the river and repairing erosion problems

without resorting to environmentally unfriendly 'hard engineering' techniques. The design previously used by the club could be improved by incorporating a sloping cross section. This will make the structure more resistant to flood flows by presenting a smoother face to the flood flows and limiting the hydraulic pressure within the structure that could otherwise lead to revetments being dismantled under turbulent conditions.

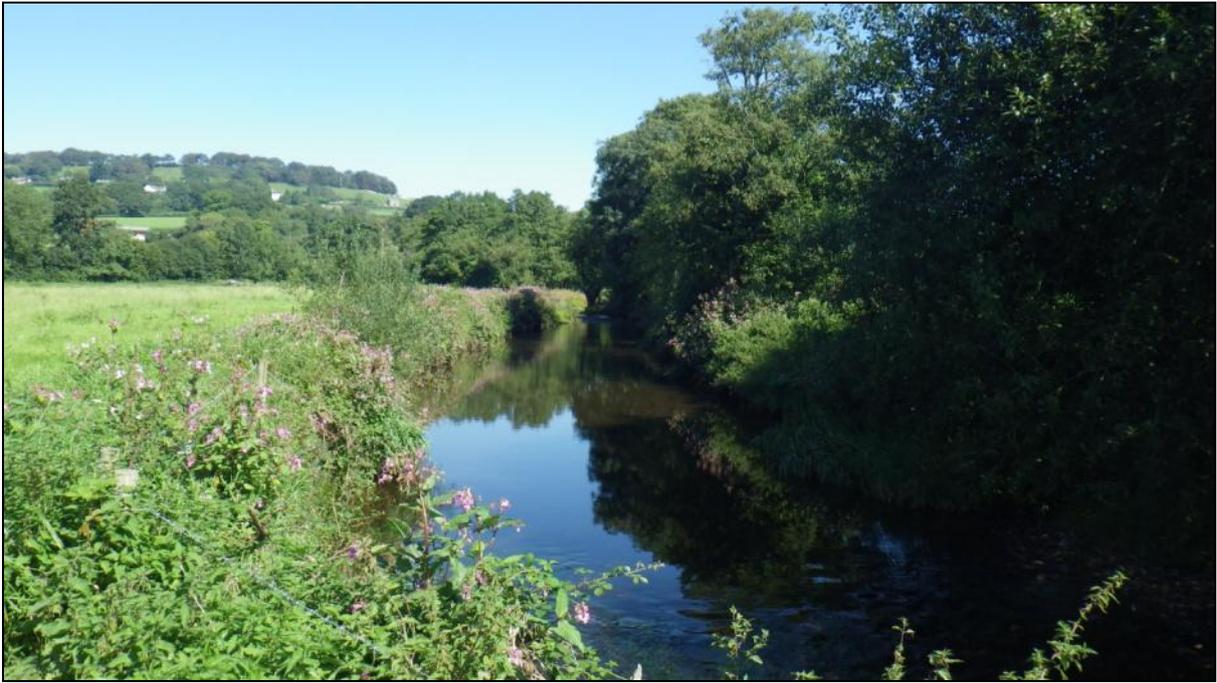
Between the fence and the top-of-bank, a dense bed of nettles, brambles and Himalayan balsam (*Impatiens glandulifera*) has established. In many places this bed has formed an impenetrable hedge that prevents the club's anglers from easily accessing the river.

In many situations, fencing off a riverbank from grazing land is an important method of protecting the margin from poaching and allowing a diverse range of marginal species to establish. However, the Culm through this reach has exceptionally high and steep banks making the margin an almost entirely terrestrial habitat unsuitable for typical moisture-loving marginal species such as meadowsweet (*Filipendula ulmaria*) or sedge (*Carex* spp.).

Figure 4: The river margin is dominated by nettle, bramble and Himalayan balsam

Areas of bank protected by fences will usually require some annual maintenance (strimming, brushcutting etc.) to prevent monocultures of nettle or Himalyan balsam. Fences will also require maintenance from time to time. These are factors that will need to be considered when planning any fencing-off of the riverbank.

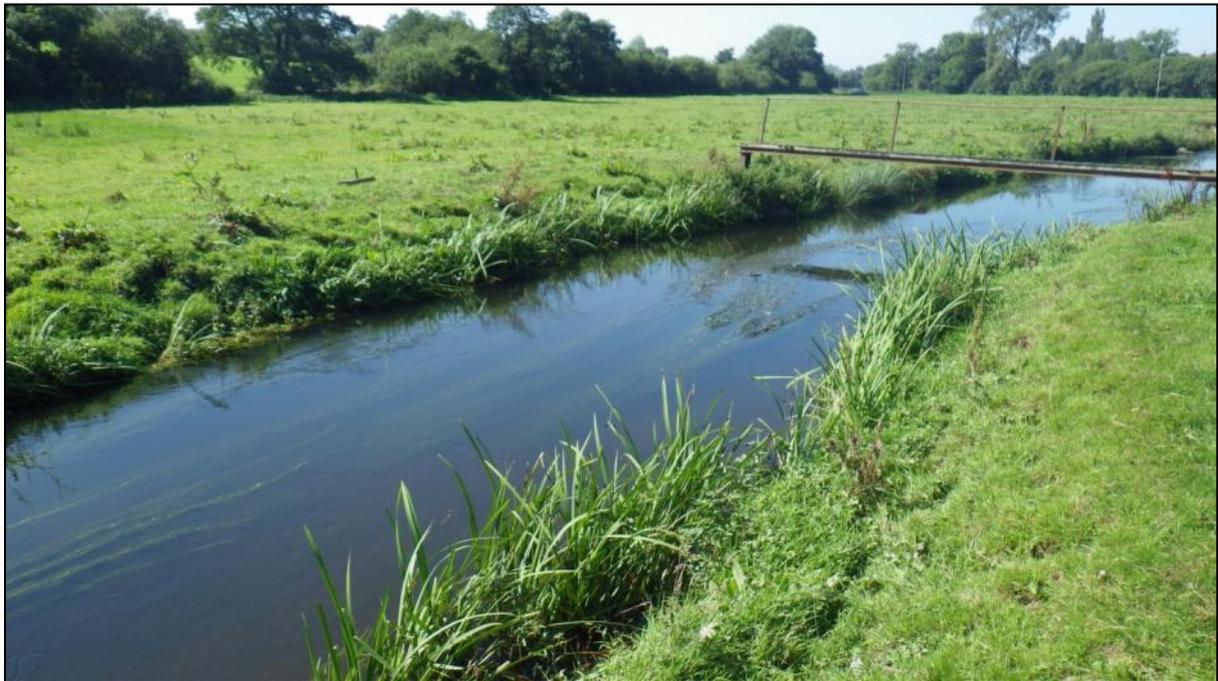
The bank characteristics change again through the next field downstream. The banks are much less steep and show some signs of light poaching from cattle. It appears that the banks on both sides have slumped forward but not been washed away. Beds of emergent reed sweetgrass (*Glyceria maxima*) and reed canary grass (*Phalaris arundinacea*) have established in the margins and swathes of water crowfoot (*Ranunculus* spp.) have established in-channel.

Figure 6: Marginal plants established on the slumping banks

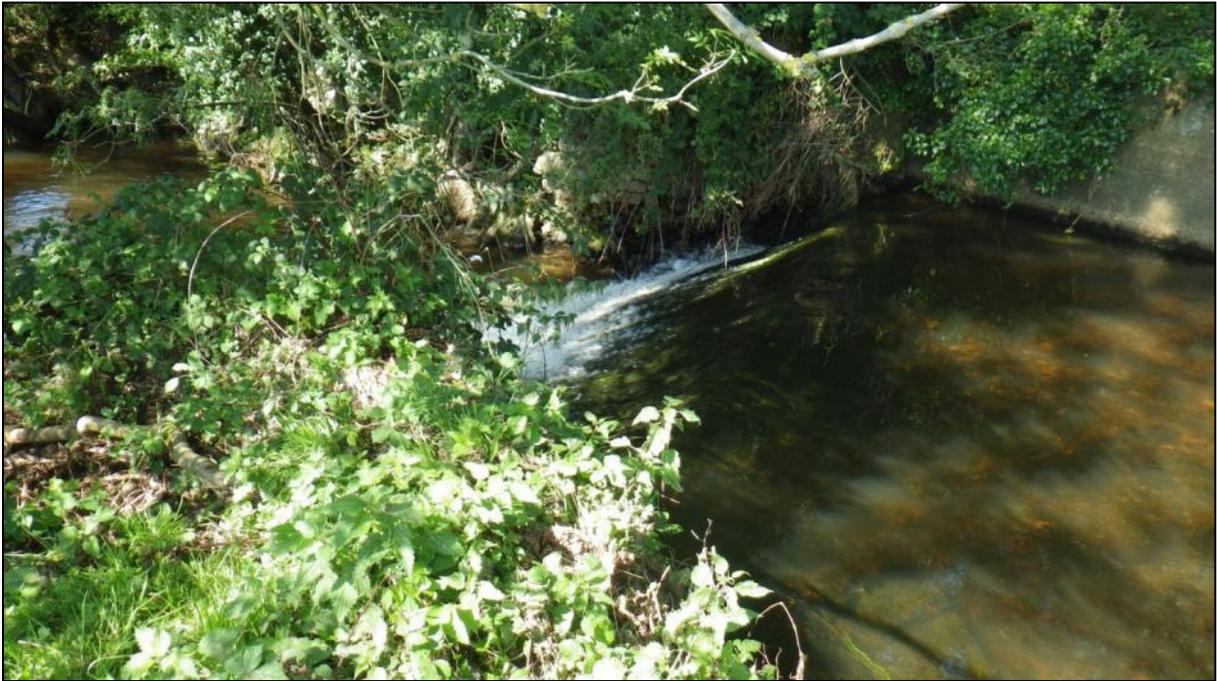
About halfway through the field, the reason why the slumped-in banks have not been washed away becomes apparent. The river is impounded by a tall crump weir that is backing up water and slowing flows upstream. The weir appears to have been installed to divert water through nearby Whitehall Mill. The weir is a complete barrier to fish passage and it is not known if fish can pass through other smaller carriers to bypass the weir.

Figure 7: A tall crump weir diverts flows through Whitehall Mill

- The weir near Whitehall Mill is a barrier to fish passage. If fish cannot bypass the weir via the mill or the other small carrier to the south then this structure will be fragmenting fish populations within the club's waters.
- The Culm catchment appears to suffer water quality issues resulting from diffuse pollution sources. This may be affecting invertebrate populations and limiting food availability for fish. This is a complex issue that requires a catchment scale approach to resolve.

- The weir near Whitehall Mill is a barrier to fish passage. It is recommended that the potential for fish to bypass the structure via the mill stream or a small stream located to the south be fully investigated. If a suitable alternative route is not available, options to improve fish passage should be explored. The weir could be removed or lowered to ease fish passage through the system. This may however, have the consequence of depriving flow through the mill. Alternatively, the weir could be modified to ease fish passage by means of timber baulks fixed to the downstream face to raise water depth over the structure.

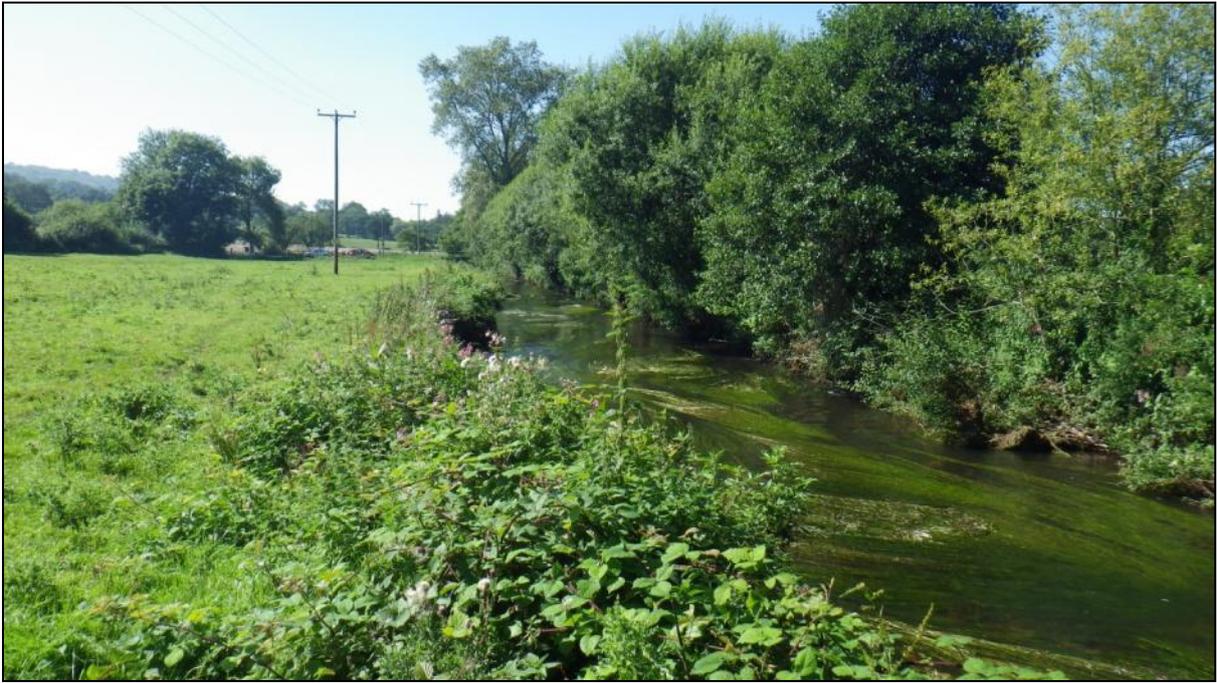
Downstream of the weir (through the lower half of the field) the river flows along an artificially straightened channel and passes under a small bridge. The straightened section consists almost entirely of a long glide and is lacking in habitat diversity. The right bank is densely wooded and these trees have been managed in such fashion that they are of an almost entirely uniform height and width. This has resulted in a channel that is either uniformly shaded or exposed to direct sunlight. A change in management to the trees on the right bank would not only diversify the ratio of light to shade over the stream but would also provide the raw materials to diversify the flows through the straightened channel. Options to improve this reach are discussed in the *Recommendations* section.

Figure 8: Artificially straightened channel with uniform height trees

- Small-scale and selective tree works should be undertaken with a goal of creating a diverse range of canopy heights (and therefore a diverse range of light conditions). A 5-year rotational programme will be of greater benefit than a large-scale programme in terms of both management and habitat quality. Through some of the less accessible reaches, some sympathetic tree works could be undertaken to create access points for anglers and allow enough space to cast. This could also include some 'skylighting' to allow some patches of sunlight into the river where required.

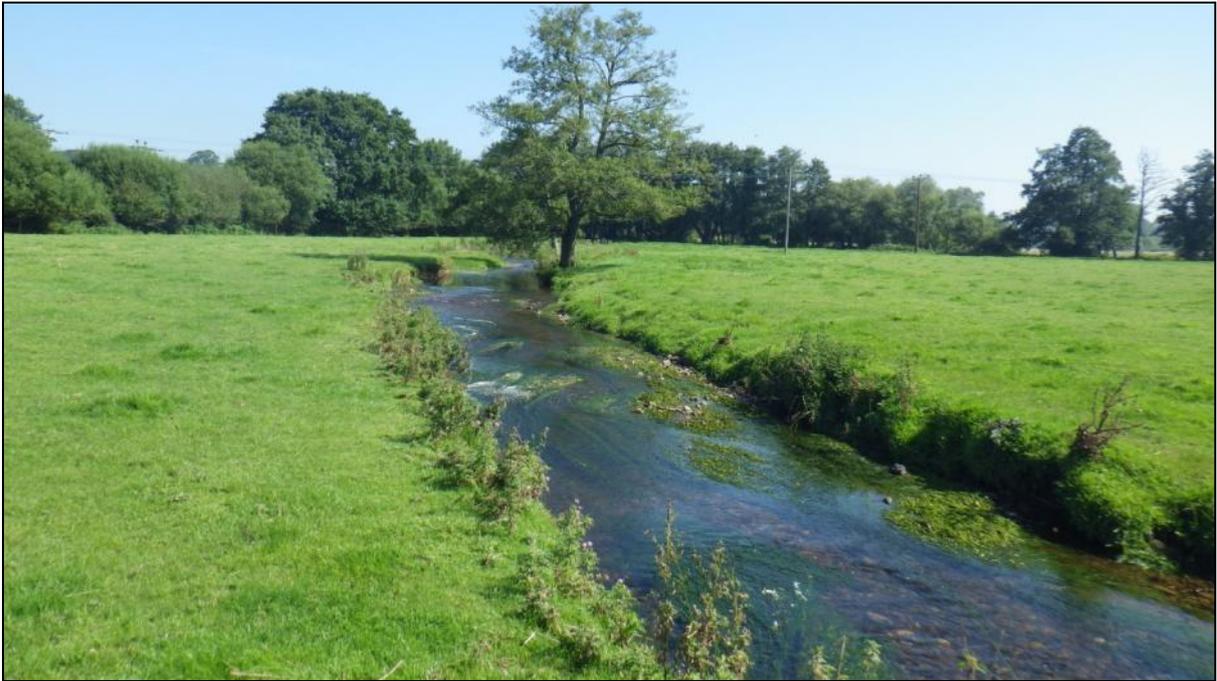
Downstream of Whitehall Mill, the club's waters resemble those of a famed Dorset chalkstream such as the Piddle or Frome. Swift moving waters flow over clean gravels and swathes of water crowfoot along a naturally meandering stream. On the day of the visit the water was gin-clear and displayed a wide range of flow patterns. In the backwaters of eroded bays a variety of marginal plants have been able to establish but the majority of the banks were dominated by grass. For around 500m downstream, tree cover is again extremely sparse leaving the river potentially vulnerable to over-heating.

Figure 9: The Culm resembling a chalkstream channel

This section would benefit from additional tree cover and protection from grazing livestock.

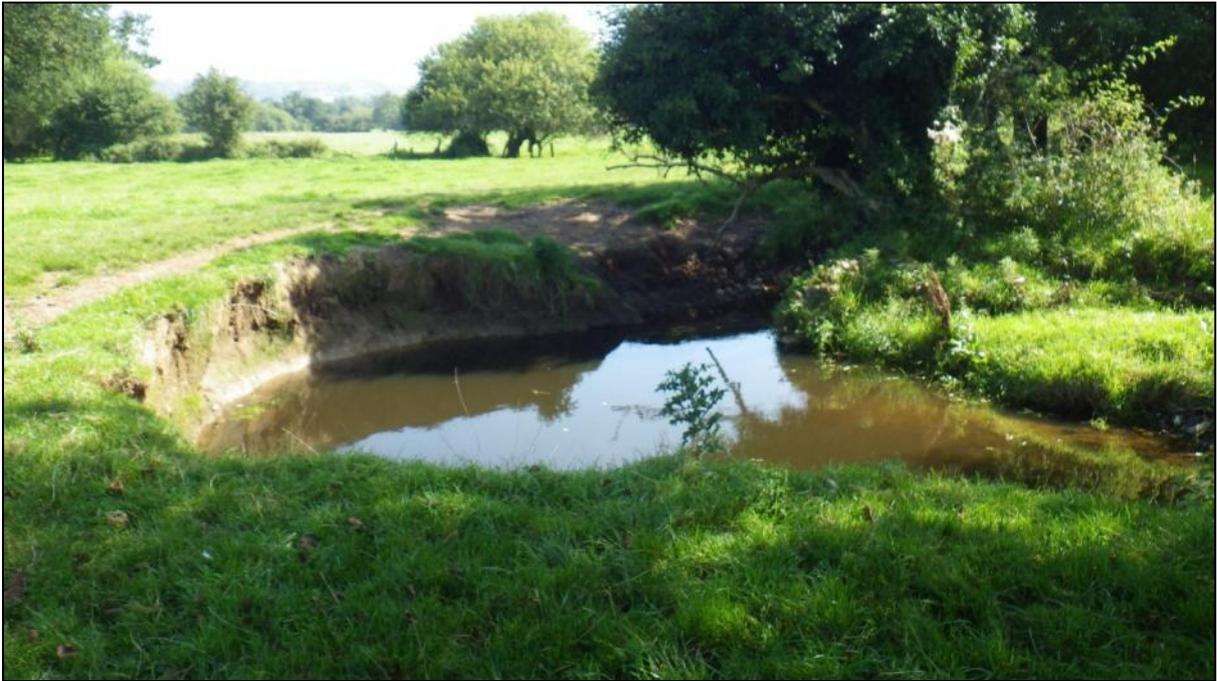
Near Lower Westown, the footings of a footbridge (possibly the remains of a control structure) pinch the river and accelerate flows. Immediately downstream the river suddenly opens out into wide bays on either bank. This has most-likely been formed by back-eddies during high flows. The river is deep and probably provides a good holding habitat for adult trout. On the right bank, a backwater pool has eroded to form an off-line pond that becomes an online backwater in higher flows. This interesting feature has the potential to be used as an alternative cattle drink and could help to protect the wide bay from further erosion if it were to be properly fenced from cattle.

Figure 10: An online backwater could be modified to form an alternative cattle drink

- At present many of the tall and steep banks are fenced from livestock whilst the lower banks are left exposed to grazing animals. If possible, land owners along the club's waters should be engaged and encouraged to consider fencing-off areas of bank with more shallow gradients. This could allow marginal species to establish at the water's edge and an area of rough grassland to establish on the upper bank. Alternative cattle drinking arrangements should be considered including making use of backwaters such as shown in Figure 10 or the use of pasture pumps.

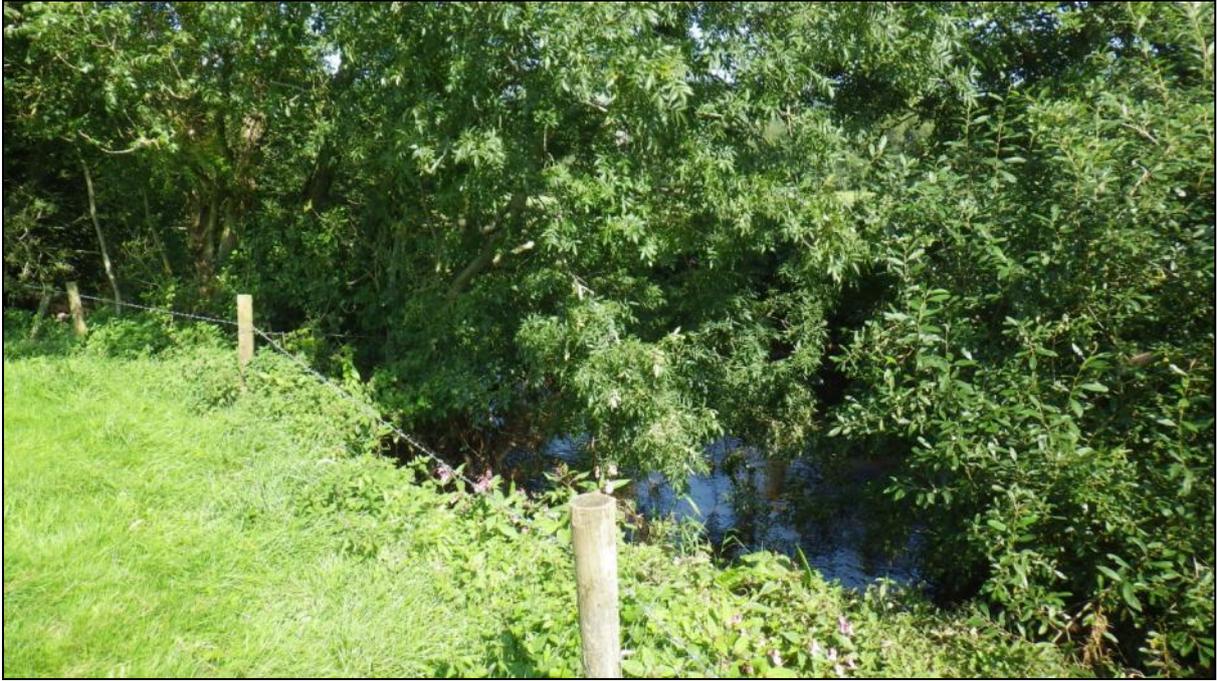
Angler access is limited by the dense tree cover and low-lying sallow and scrub. Woody material protruding into the channel is an important habitat feature and any plans to improve access should be sensitive to the shade and cover currently provided. Options for improving access whilst protecting the habitat are discussed in the *Recommendations* section.

Figure 11: Low lying tree cover providing shade and woody habitat

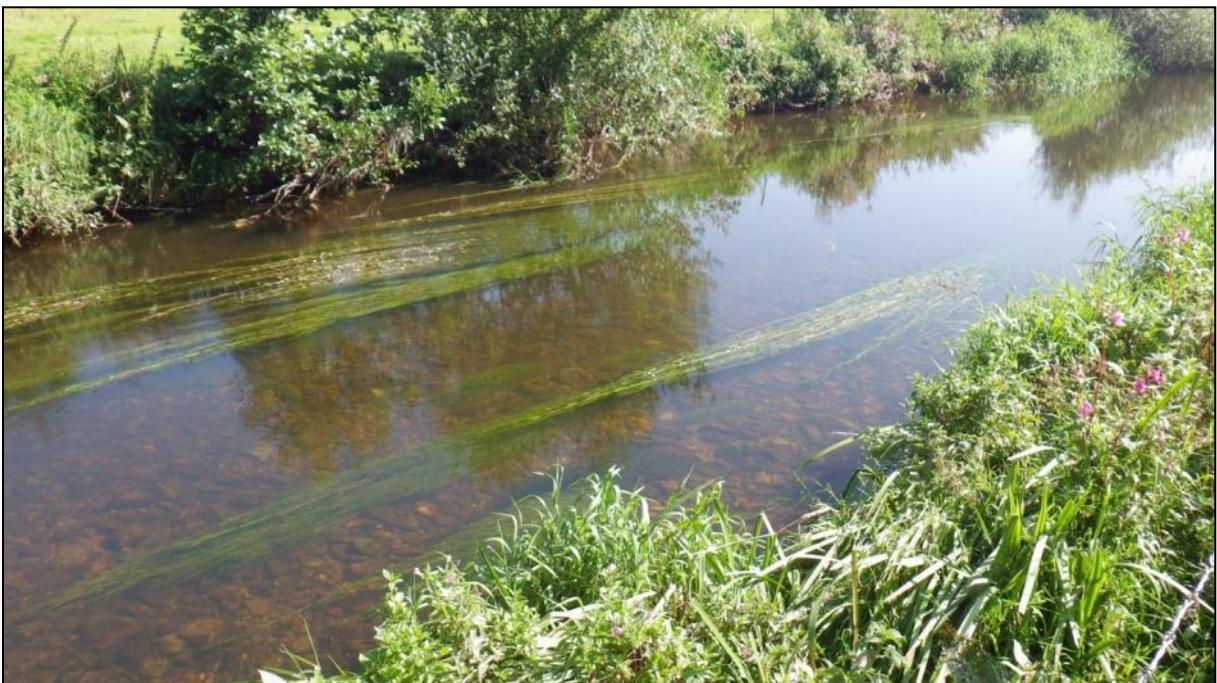
Some short stretches along this reach are without tree cover but still retain the low-lying willow and hawthorn scrub. Here the banks have a shallow gradient and are fenced from livestock grazing. A community of marginal plant species have colonised the bank. Some Himalayan balsam has established and this should be controlled to prevent it out-competing native species.

Figure 12: Low lying scrub and marginal native plants

- The Culm has an obvious Himalayan balsam problem that will need to be addressed in order to preserve the biodiversity and stability of the riverbanks. Himalayan balsam is an aggressively invasive species that can out-compete many native marginal species. This can result in a monoculture along the riverbank and reduce habitat diversity. Balsam is also an annual plant with shallow roots. When it dies-back in winter months, banks are left bare and vulnerable to erosion.

Many clubs have significantly reduced the impact of balsam by organising work parties to pull the plants from the soil in the late spring before they go to seed. Some success has also been reported from programmes of repeated strimming above the first node on the stem.

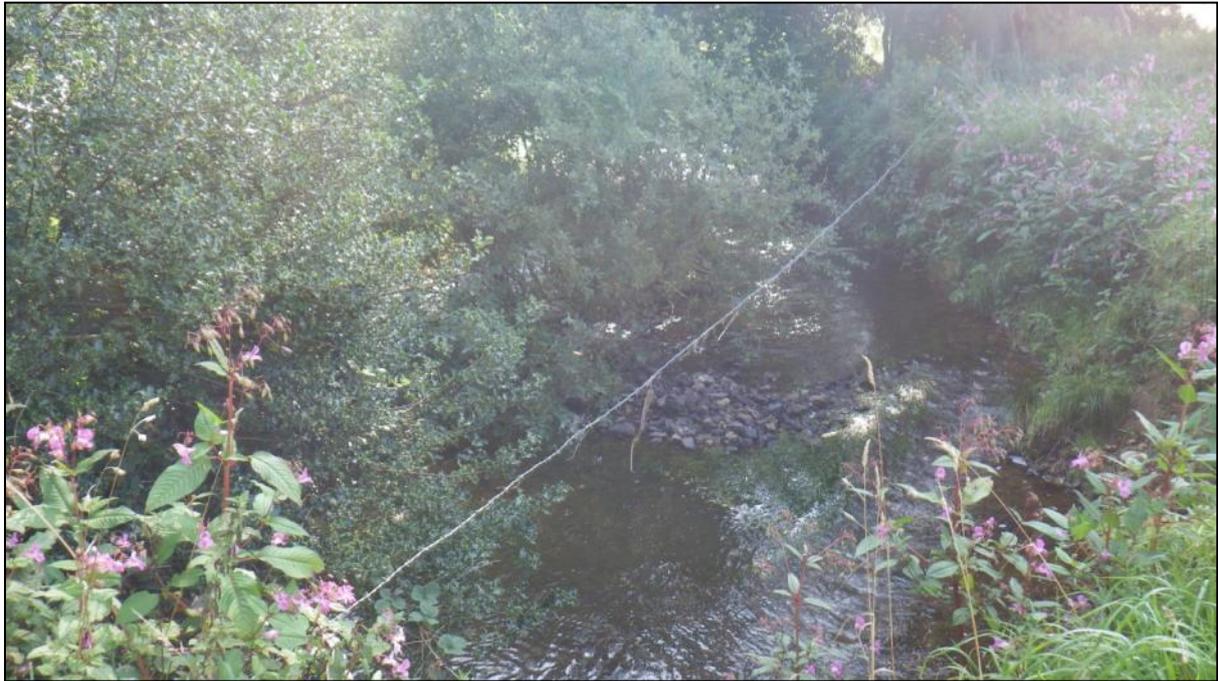
The next reach downstream is also tricky for angler access. The banks are very steep and the adjacent land is elevated considerably high above the river. Erosion on the left bank is particularly aggressive as can be observed by the remains of a barbed wire fence that now hangs over a steep drop.

Figure 13: The rate of bank erosion illustrated by a barbed wire fence now suspended over the river

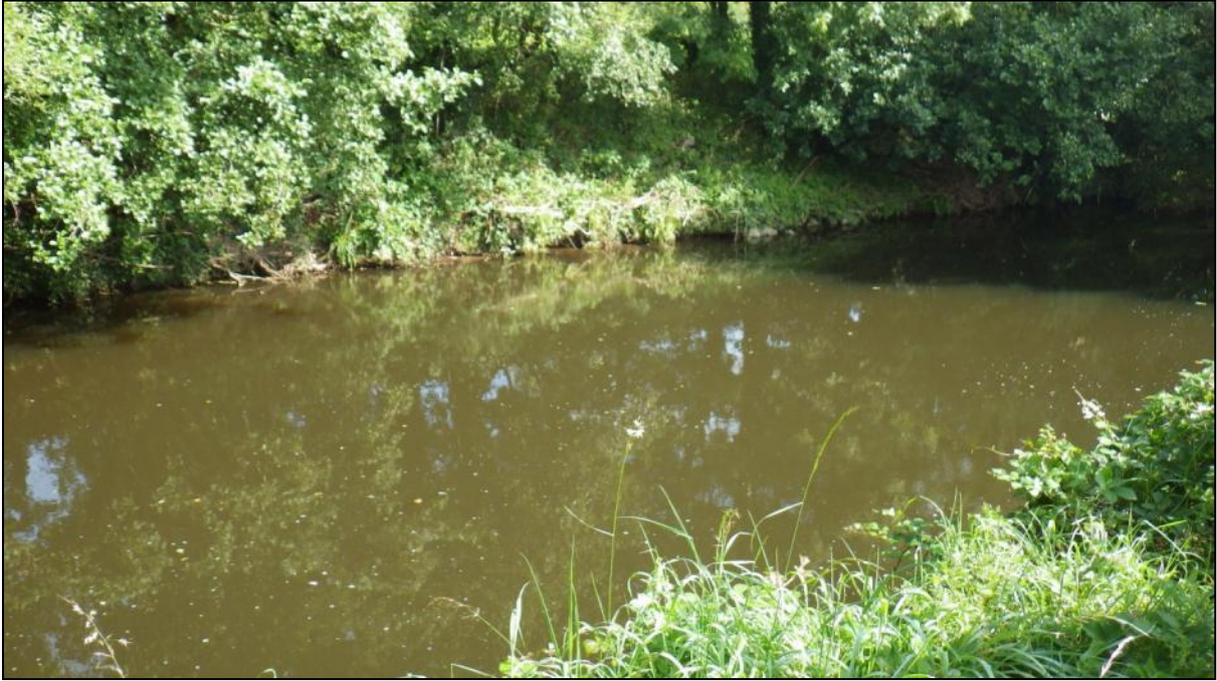
From an outstanding example of natural geomorphology and wild habitat, the character of the river shifts dramatically just a couple of hundred metres downstream. The river becomes suddenly straightened, very deep and slow flowing. The channel is over-wide and the left bank is near vertical and was at least 1 metre above water level on the day of the visit. This deep pool is a homogenous stretch of river that may provide good holding water for occasional adult fish but is an otherwise poor quality habitat. The steep banks and deep water limit opportunities for macrophyte plants to establish.

Figure 15: A deep, wide and straightened section of river hints at previous land use

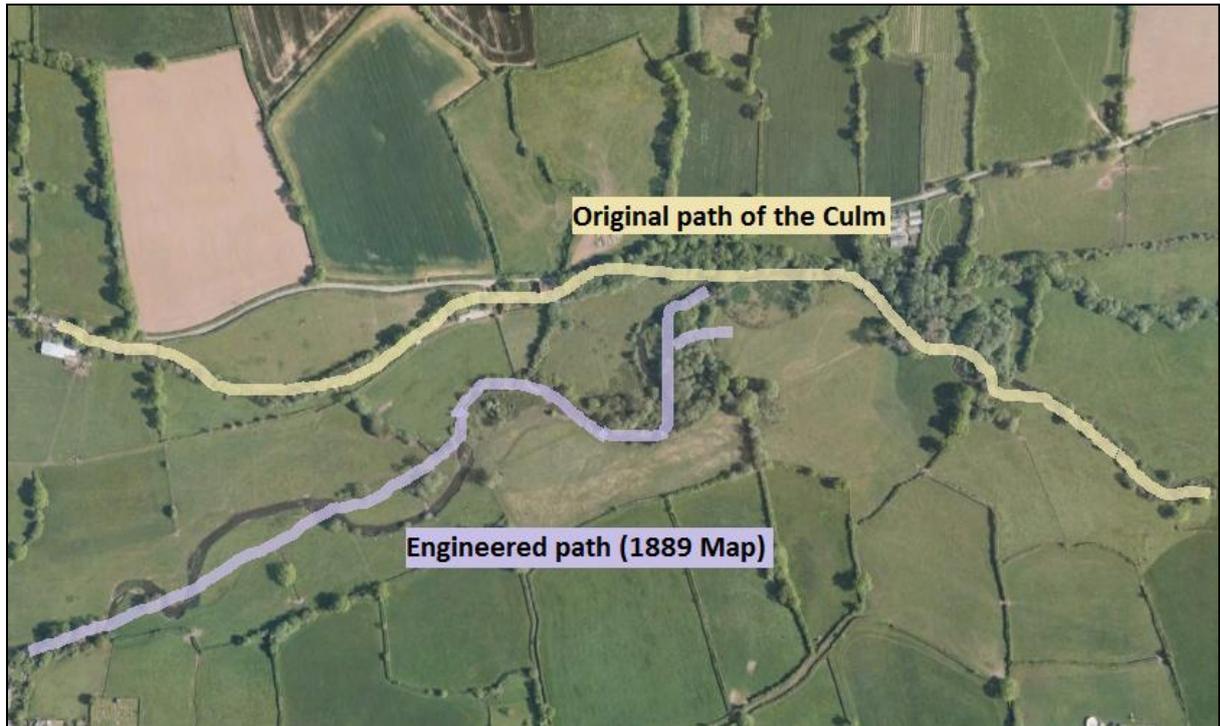
At the downstream extent of the deep and wide section, the crumbling remains of a large weir structure are situated on the left bank. The channel is man-made and runs parallel to a now dismantled railway line. At some point, a channel appears to have flowed across the field on the left bank. A shallow divot runs in a meandering line and is populated by moisture-loving plants such as soft rush (*Juncus effusus*).

The unnaturally straight, wide and deep channel, the remains of the weir and the proximity of the railway line suggest that perhaps this part of the river may have once been used to hold water for steam trains. An old map of the site (1889) shows the natural path of the river passing under the railway line and flowing west. Water was taken off at the weir to flow southwest towards Culmstock (the same direction the river presently follows). However, in 1889 the river was a straight line and did not meander in the fashion it does today (www.old-maps.co.uk).

Figure 16: The historic man-made changes to the Culm displayed over modern satellite photography (Google Earth)

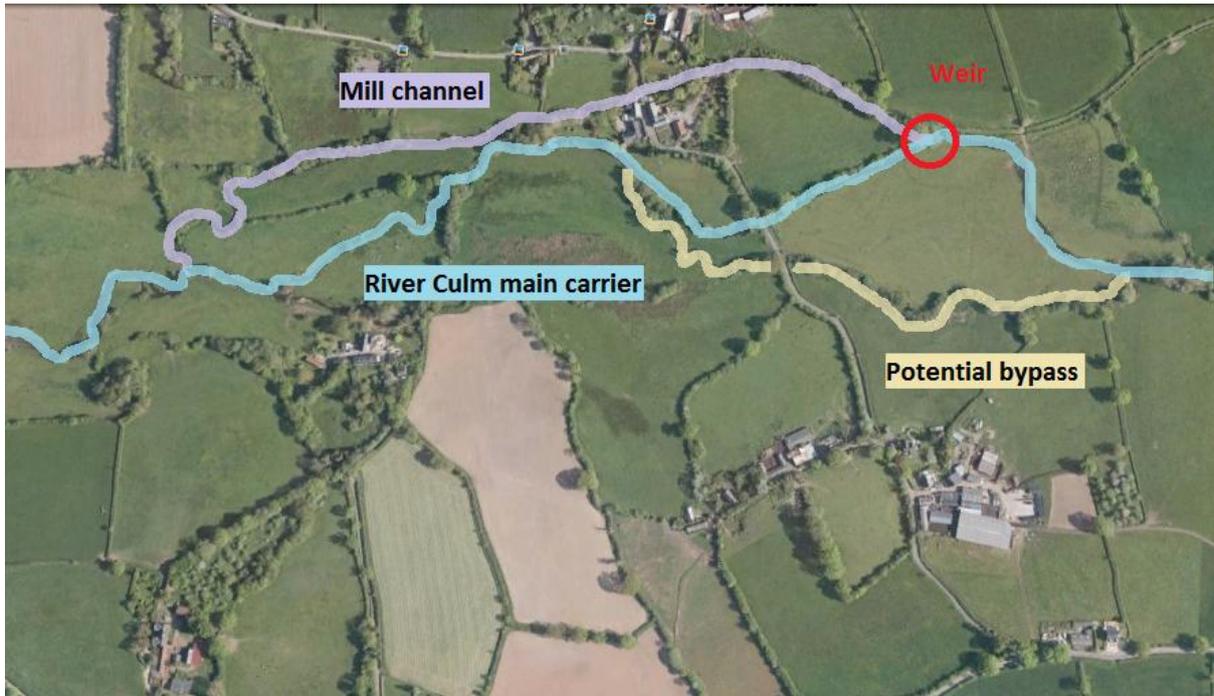
Figure 23: The location of the weir near Whitehall Mill and possible bypass channels
