**Advisory Visit**  
**River Mimram, Hertfordshire**  
**April 2019**

## **1.0 Introduction**

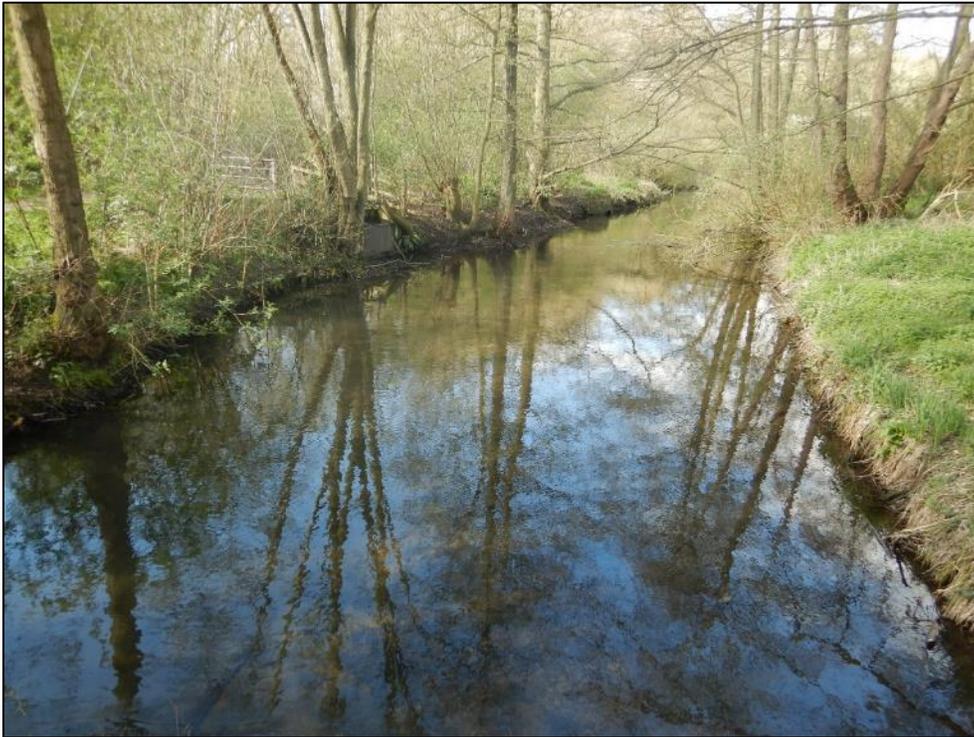
The visit started upstream of A414, where the river was partially shaded with little marginal vegetation and no aquatic weed growth (pic 1). The channel width was ~8m with little flow diversity. The water depth was relatively uniform at ~0.75m. One brown trout of ~20cm was seen. Two outfalls, presumably road drainage from the A414, were noted and appeared to deliver run-off direct to the river, with an accumulation of tell-tale grey silt noted in the vicinity of the outfalls.

Pic 1 – Above the A414 the river was over-shaded, had little marginal cover and lacked flow diversity.

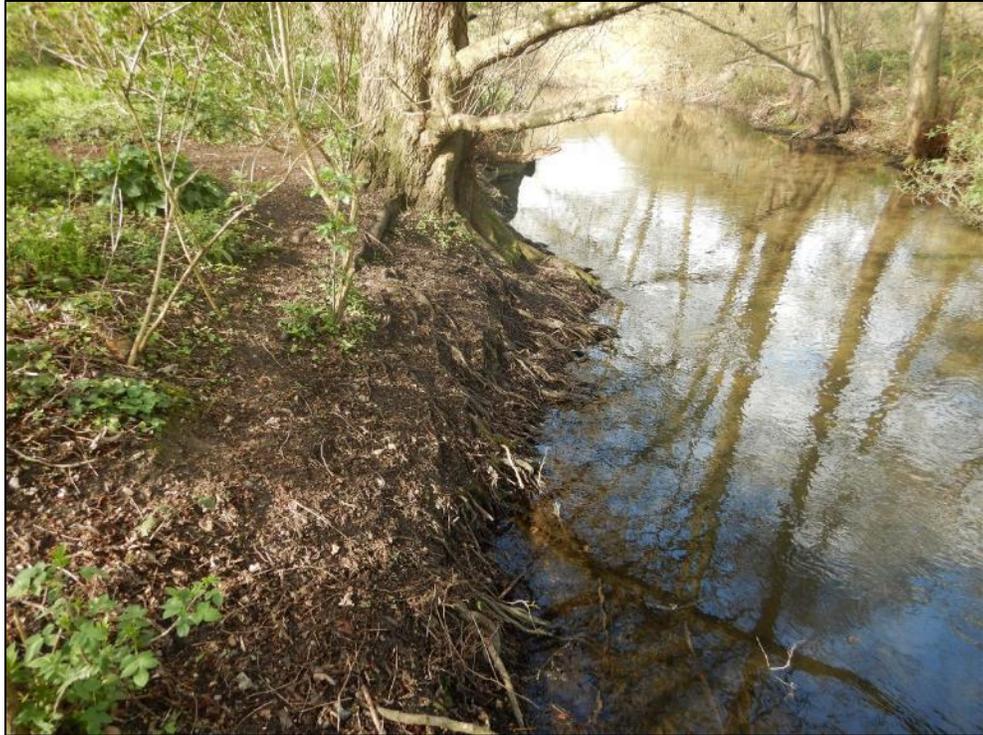
Pic 2 – Dogs were causing bank erosion.

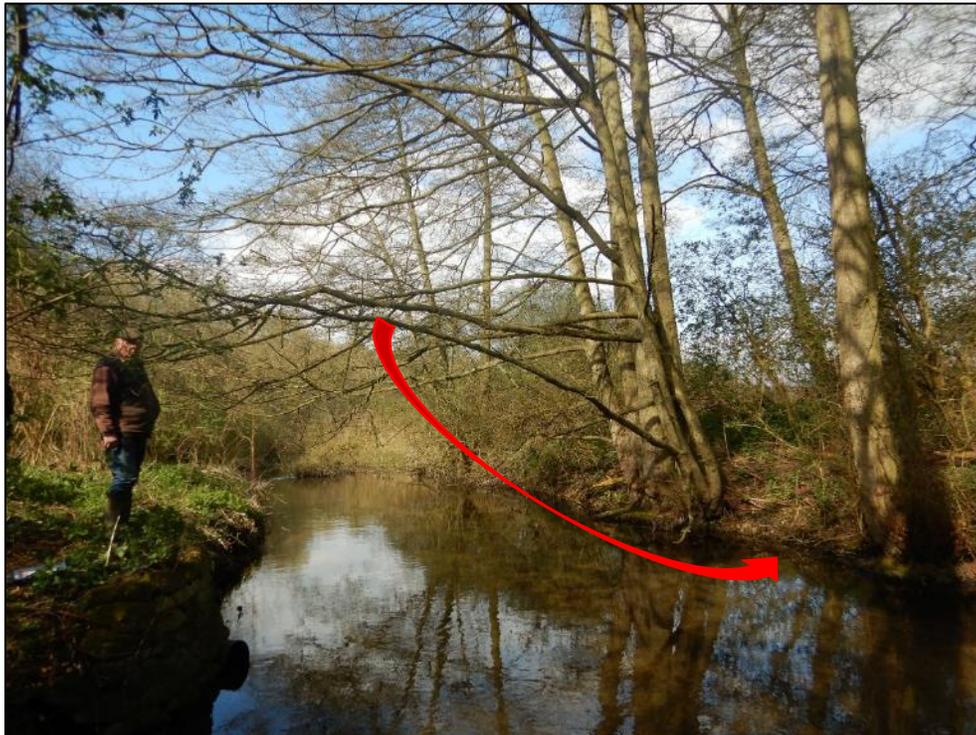
Picture 3 shows many low branches reaching out across the river, the club were minded to cut them to enable easier casting, with some high branches retained. However, a win-win situation could be achieved through the partial cutting of the low branches to allow them to trail into the water at the margins. This would provide some instant marginal cover, create flow diversity and allow light to the margins. The effect was already being achieved to a lesser extent by a partially collapsed elder. The slight flow deflection that it created was apparent by the differing deposits of silt.

Pic 3 – The lower branches could be partially cut, pulled back to the margins and fixed in place at water level to increase marginal cover.

A technique favoured by the Wild Trout Trust for delivering instant woody cover at water level is tree-hinging. Trees (large or small) are cut to produce an effect similar to hedge laying. Species such as willow and hazel respond particularly well. Laying retains a living hinge that secures the cut stem to the tree stump so structural strength is retained. With the tree-top laid at water level, it provides excellent over-head cover, flow deflection and, if beneath the surface, increased habitat for aquatic invertebrates and cover for fish against predators. The tall trees adjacent to the river present many opportunities for tree-hinging.

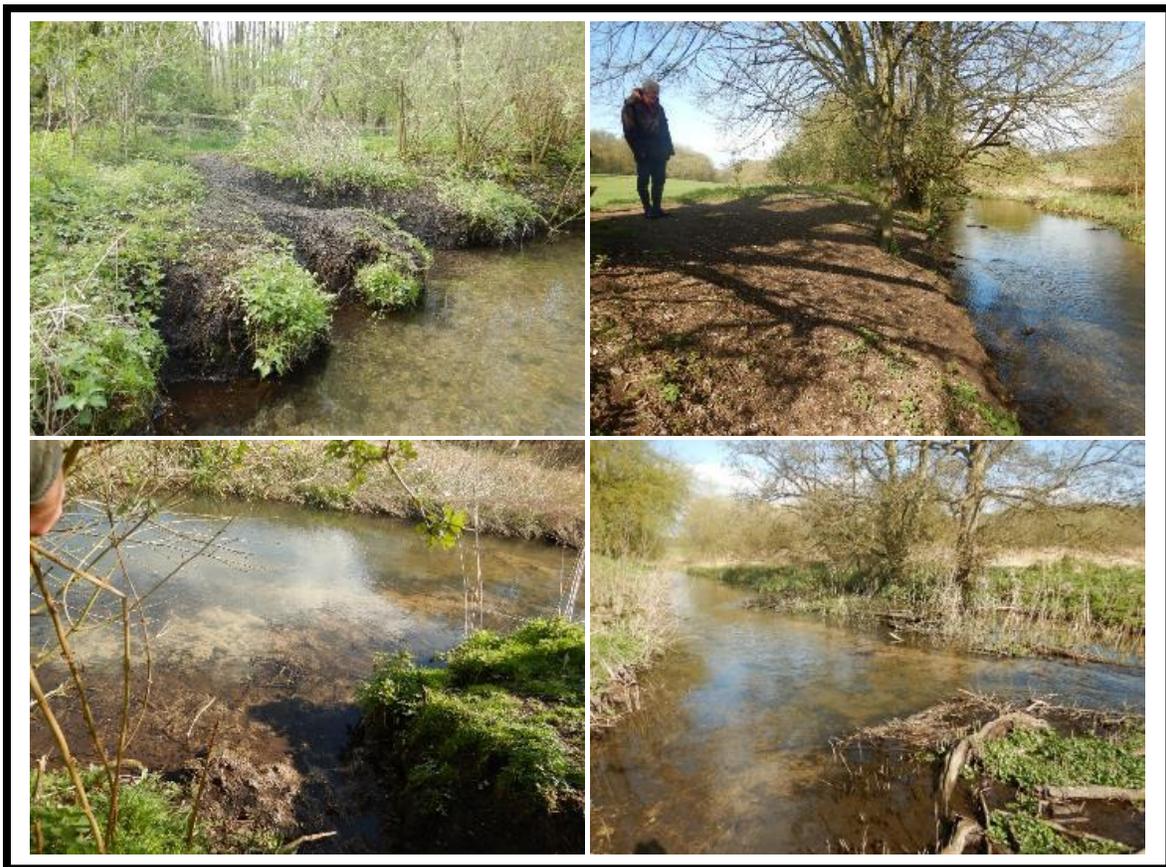
Pic 4 – A montage of the numerous dog slides negatively impacting the river.

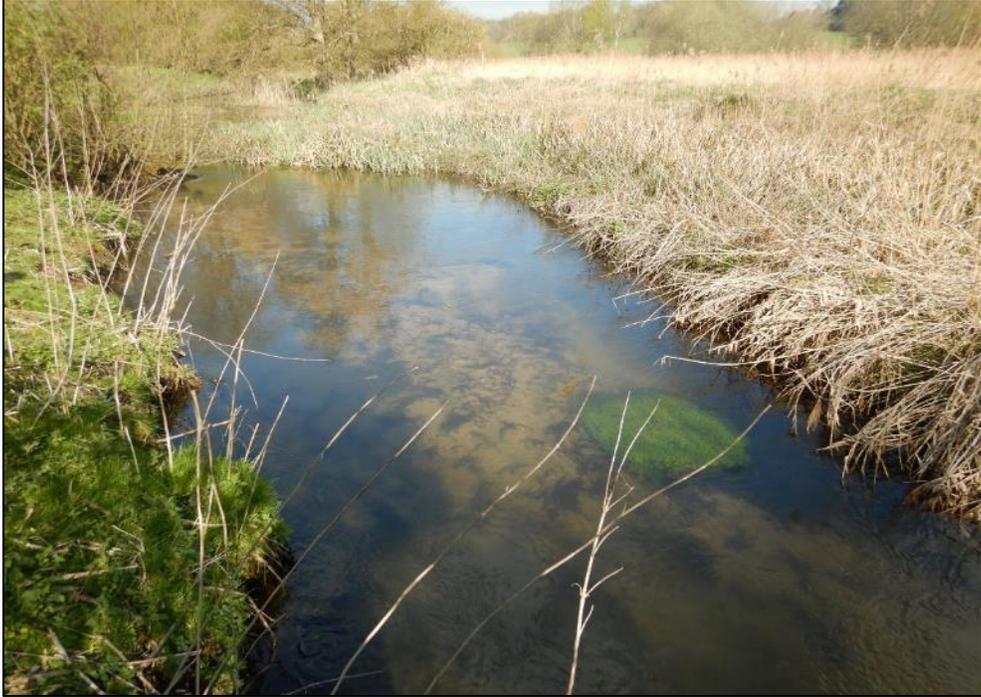
lack of aquatic plants will be due to dogs constantly moving through the water and dislodging them. At one location only a single plant of starwort was observed, normally the river would be expected to have a dense growth of the plant (pic 6). Dogs have also affected the growth of marginal plants, such as lesser pond sedge. Dog activity is negatively impacting upon the river's fish population, aquatic invertebrates, plants and water vole population.

Pic 5 – Constant disturbance of the riverbed by dogs has resulted in a reduced number of aquatic plants, damage to marginal vegetation and mobilisation of fine sediment.

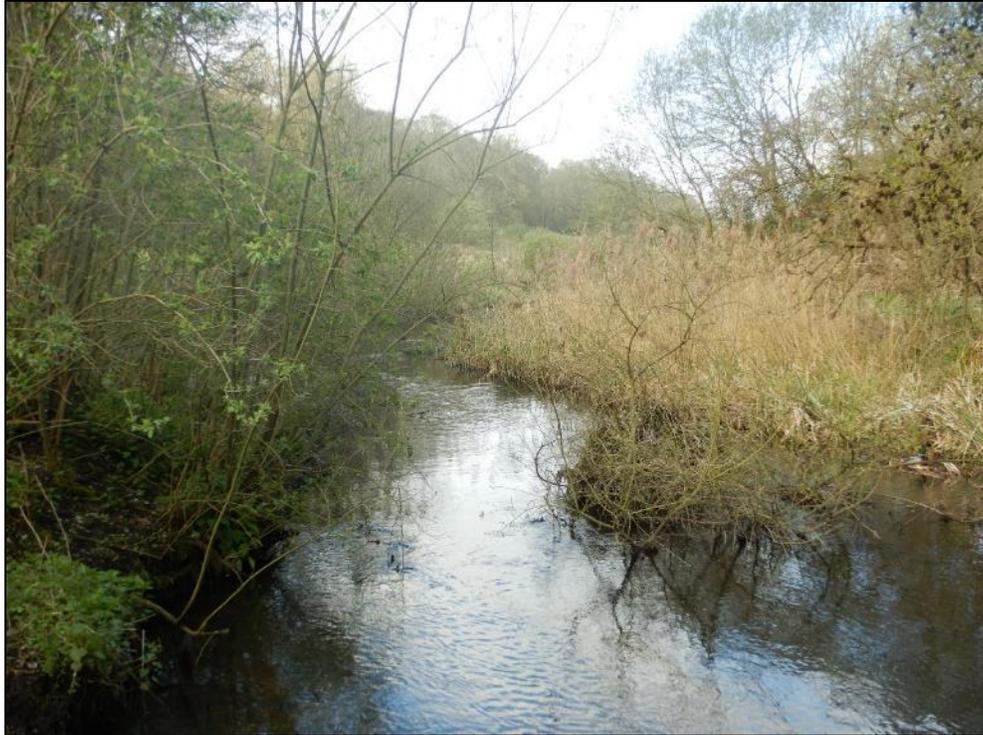
Pic 6 – Unshaded reaches had dense fringes of marginal vegetation which allowed the channel to become naturally narrowed, leading to an increased water velocity and sediment transfer.

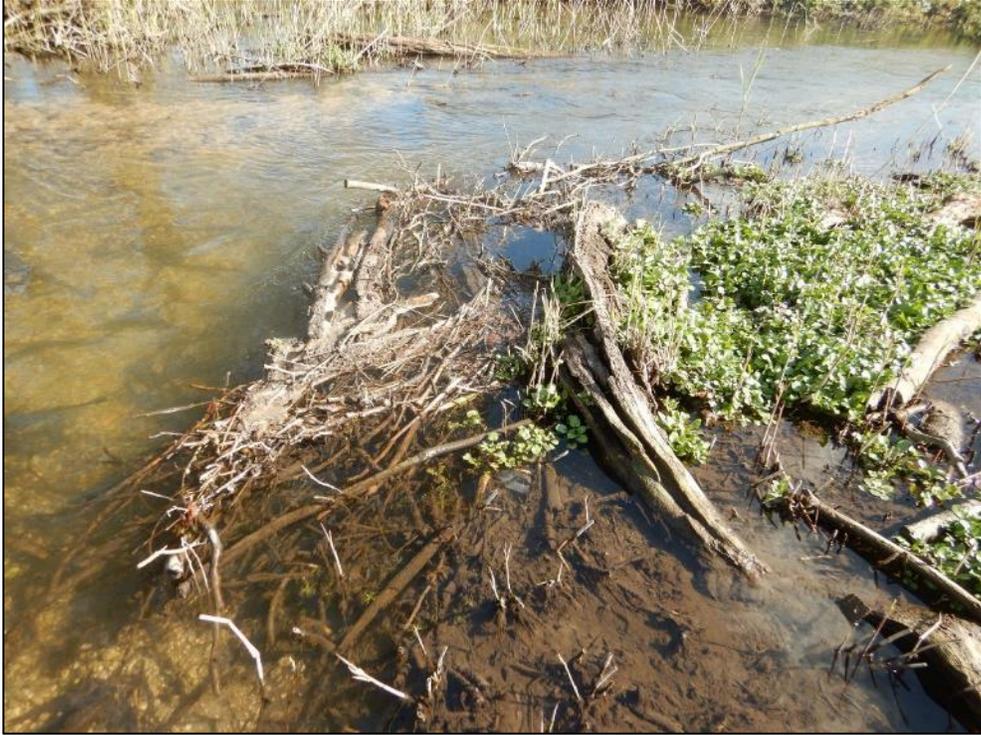
Pic 7 – Accumulations of fine woody material at the margins should be valued as fry habitat. This type of material should not be removed. If necessary, it can be stabilised using posts, wire and battens.

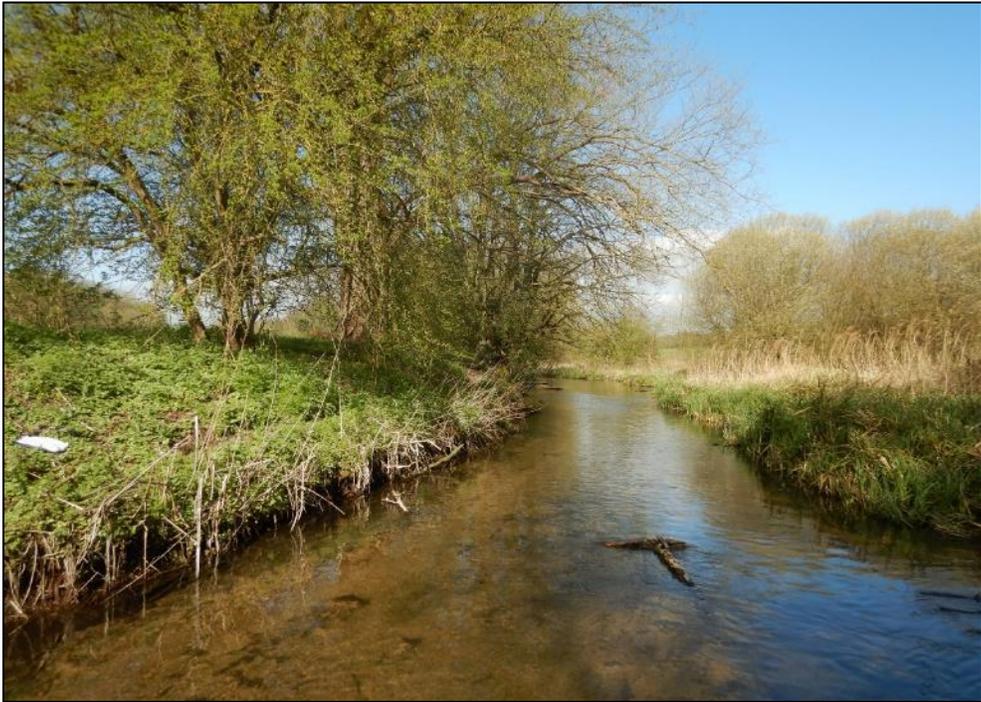
Pic 8 – The river was surprisingly clear of brushwood material given the large number of riparian trees. Many banks lack vegetation (as can be seen to the left of the picture).

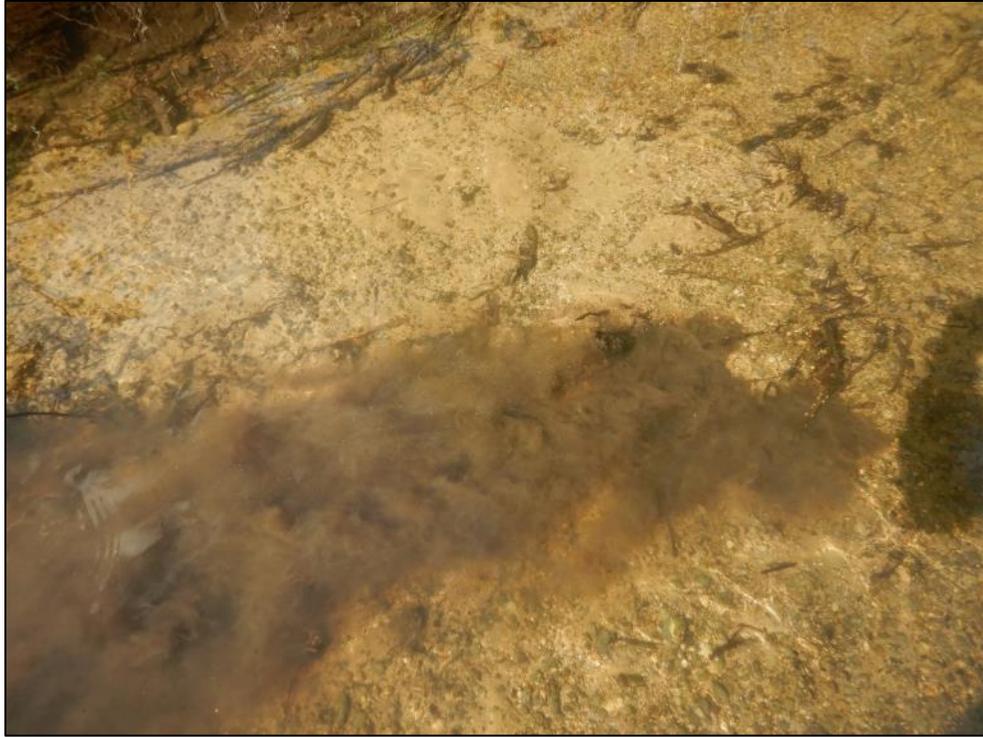
The riverbed was disturbed by foot to assess the quality of the gravel. The disturbance revealed a very high component of fine sand and black sediment. The bed in the lower reaches of the Park was poorly sorted, degraded by fine sediment and unsuitable for brown trout to spawn upon (pic 9). Trout will spawn on well-sorted gravels (particularly in the range 15-40mm) with a swift flow moving over them.

Pic 9 – Disturbance of the riverbed revealed gravel unsuitable for brown trout to spawn upon.

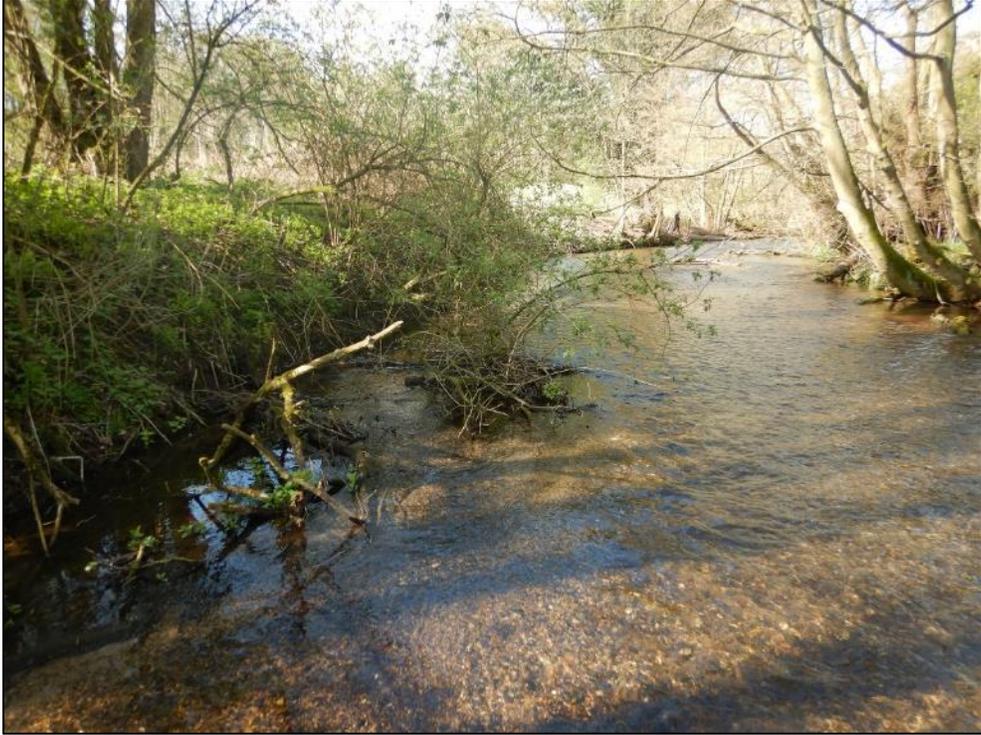
Pic 10 – Small pieces of loose brushwood provided some marginal cover and flow diversity, but they are prone to wash-out.

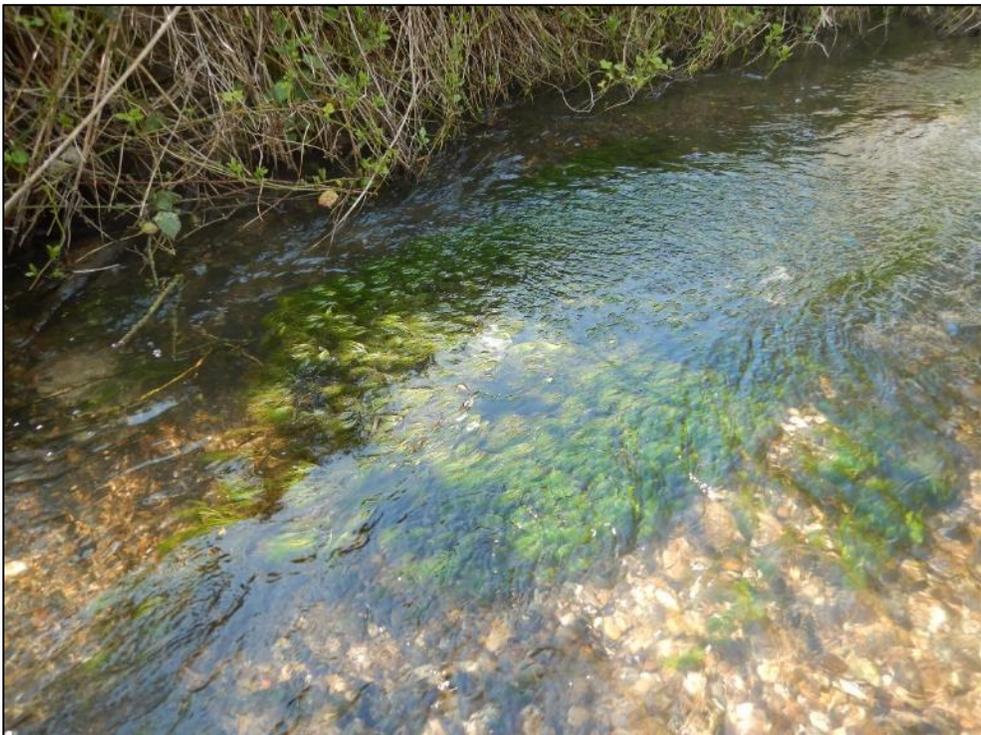
Pic 11 – Where flow conditions were suitable, and the bed undisturbed, water crowfoot was present.

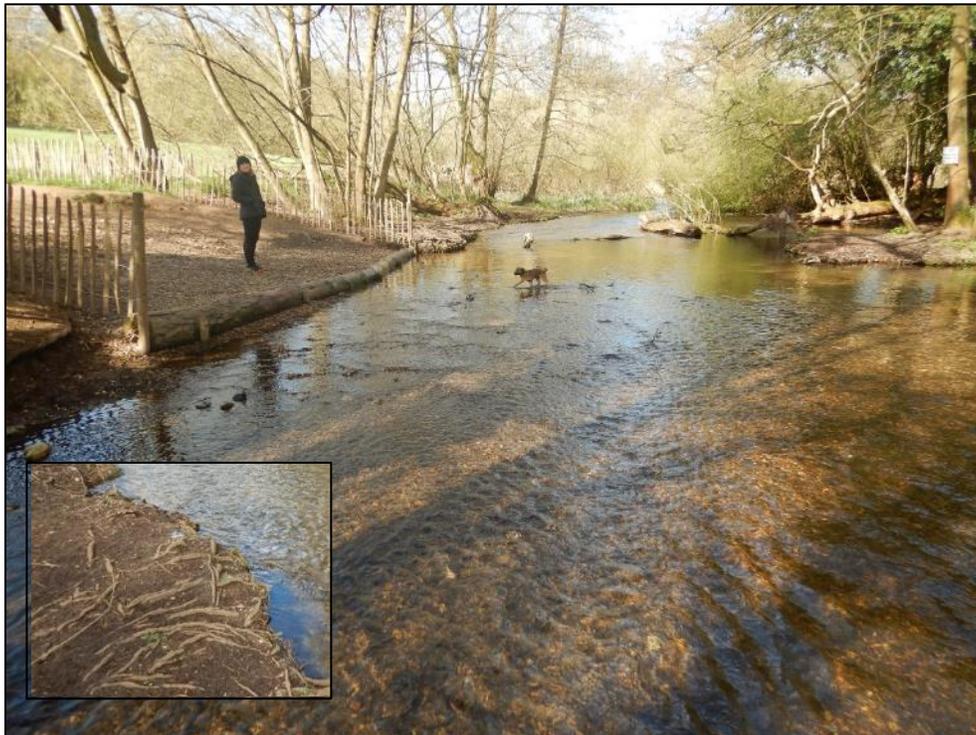
The formal dog slide clearly provides a valued feature for visitors to the Park, but it appears to have created some problems too. The stones put down to reinforce the slope have been kicked (or thrown) into the river resulting in a localised shallowing of the bed and an aggregation of uniform particles sizes (~20mm) (pic 12). In the low-flow the shallow conditions potentially presented a minor obstruction to the movement of fish. Whilst the slide is fenced, it is no barrier to dogs using the banks either side of it. Erosion of the banks both upstream and downstream was significant and represented further significant sources of fine sediment input (see inset pic 12).

Pic 12 – The formal dog slide has not taken pressure off other parts of the river as 6 further slides were observed over a relatively short distance. Dogs are accessing the banks either side of the slide causing bank erosion.

The formal dog slide has resulted in stones being added to the river, this has shallowed the bed of that area. The shallow bed could hinder the movement of fish in certain flows. A slightly deeper “trench” could be raked through the area to aid fish movement. Ideally the stones should be put back on to the dog slide to provide bank protection again.

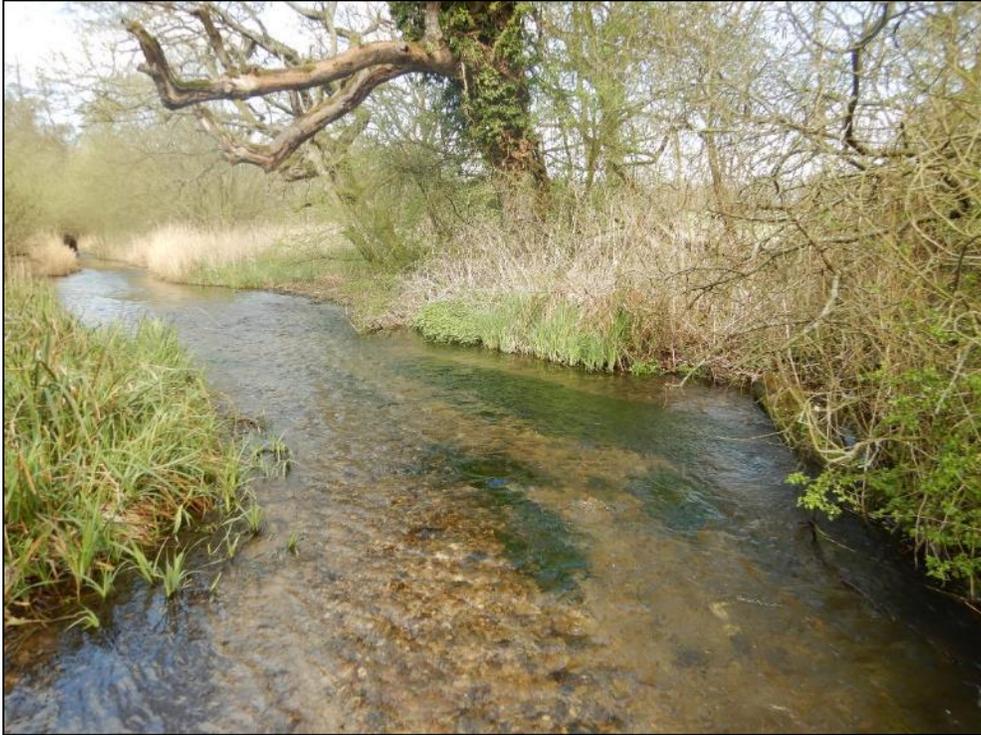
Pic 13 – Good trout habitat was found above the formal dog slide.

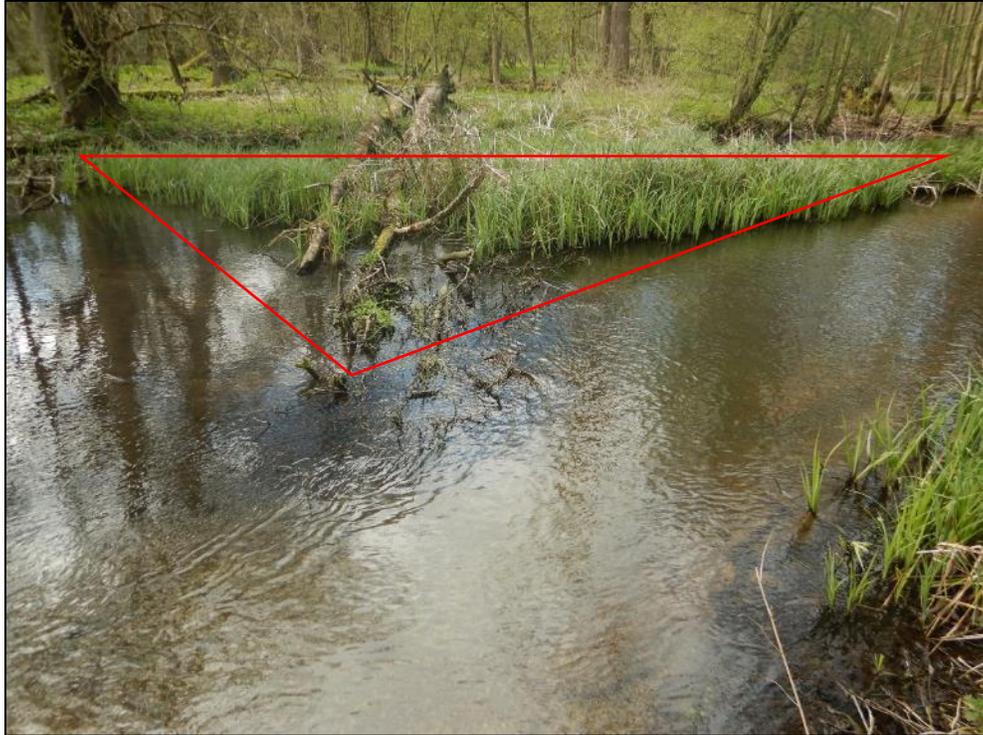
Pic 14 - Note how the sedge has grown out into the river to colonise sediment that had accumulated around the fallen tree. This feature is effectively a natural A-wing flow deflector.

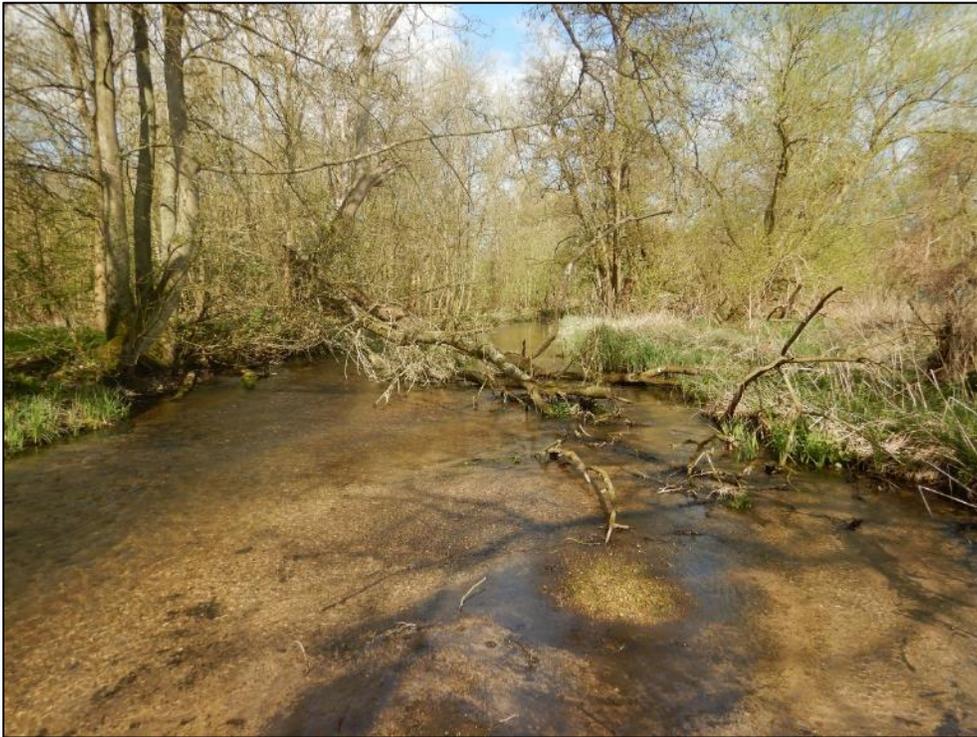
Pic 15 – Fallen trees provided excellent natural habitat enhancement and should not be cleared unless they pose a significant flood risk to property.

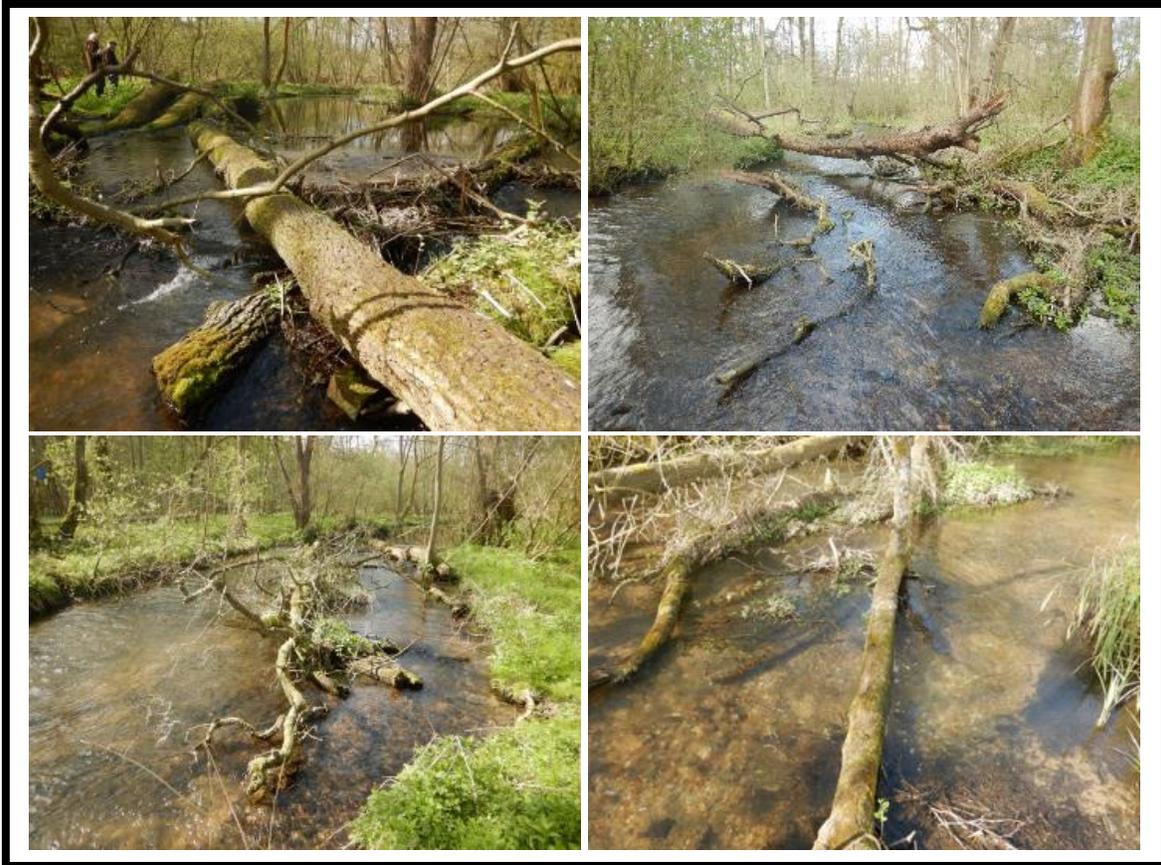
Pic 16 – The range of micro-habitat presented by large fallen timber is extremely important.

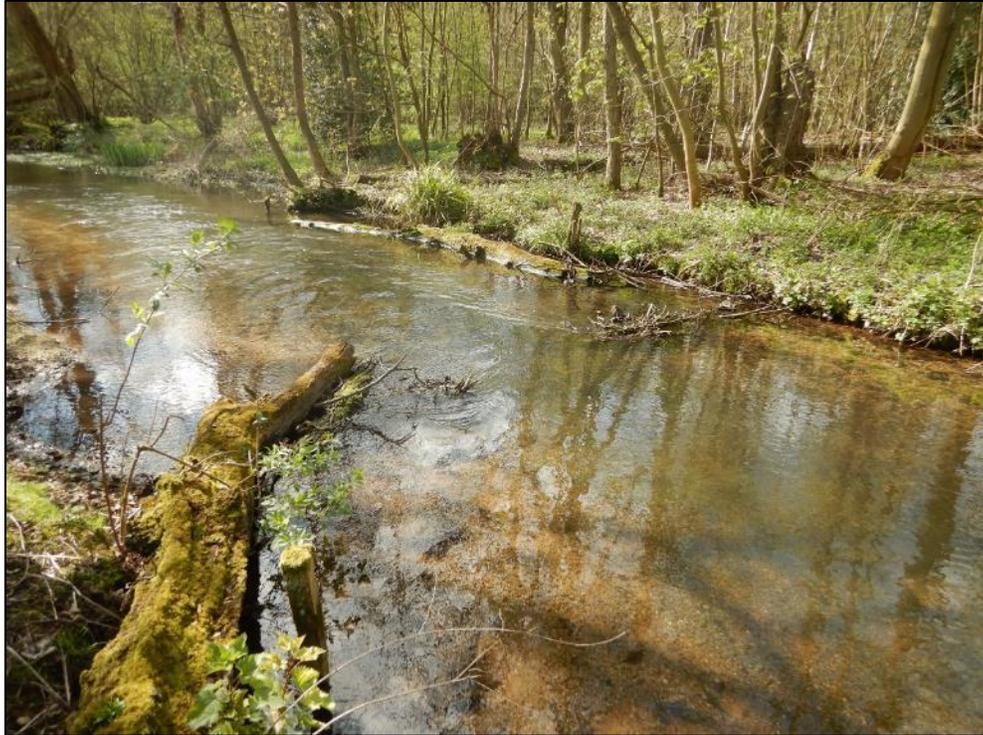
Pic 17 – A long-established scour pool as a result of habitat enhancement work several years earlier.

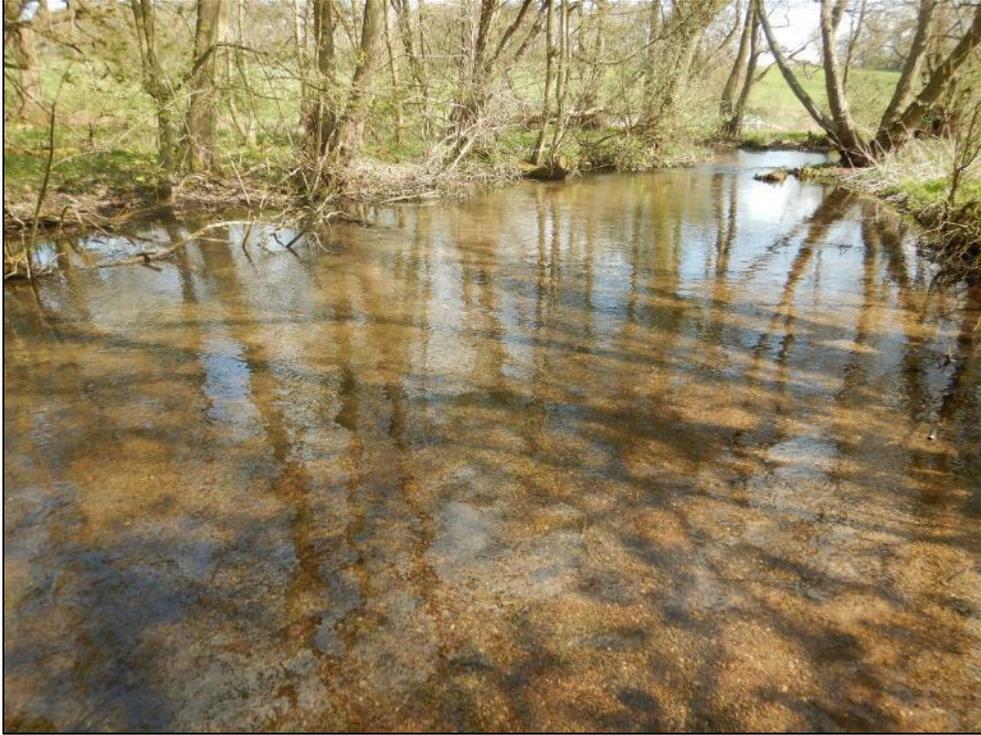
Pic 18 – Without the flow and depth variation created by fallen LWM much of the wooded reach would be wide and shallow, and unsuitable for trout (as shown).

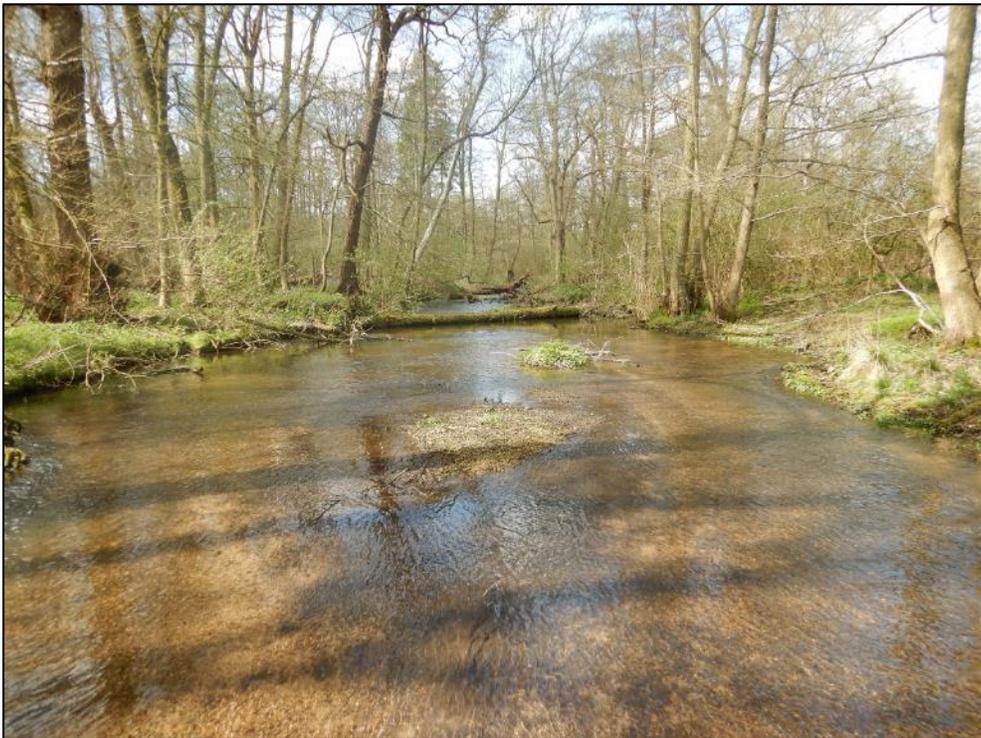
Pic 19 – The low-flow conditions had revealed mid-channel gravel bars. This location would benefit from tree thinning to allow light to reach the exposed gravel bars.

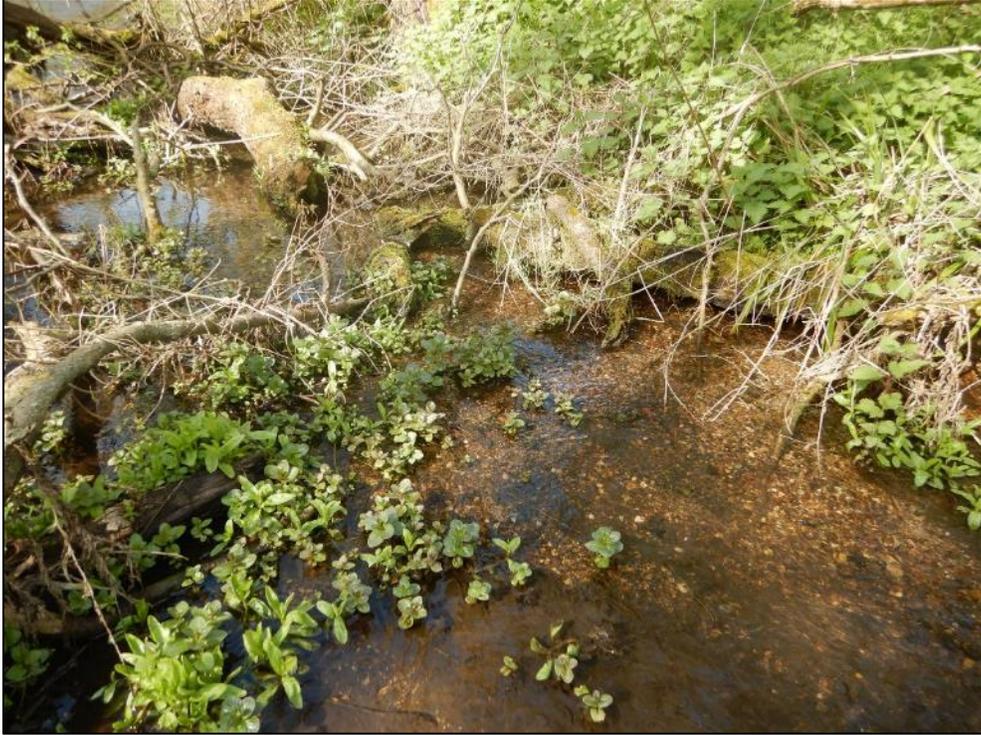
Pic 20 – Slower pockets of water created by fallen LWM provided habitat for trout fry in the margins, and act as anchor point for plants to take root.

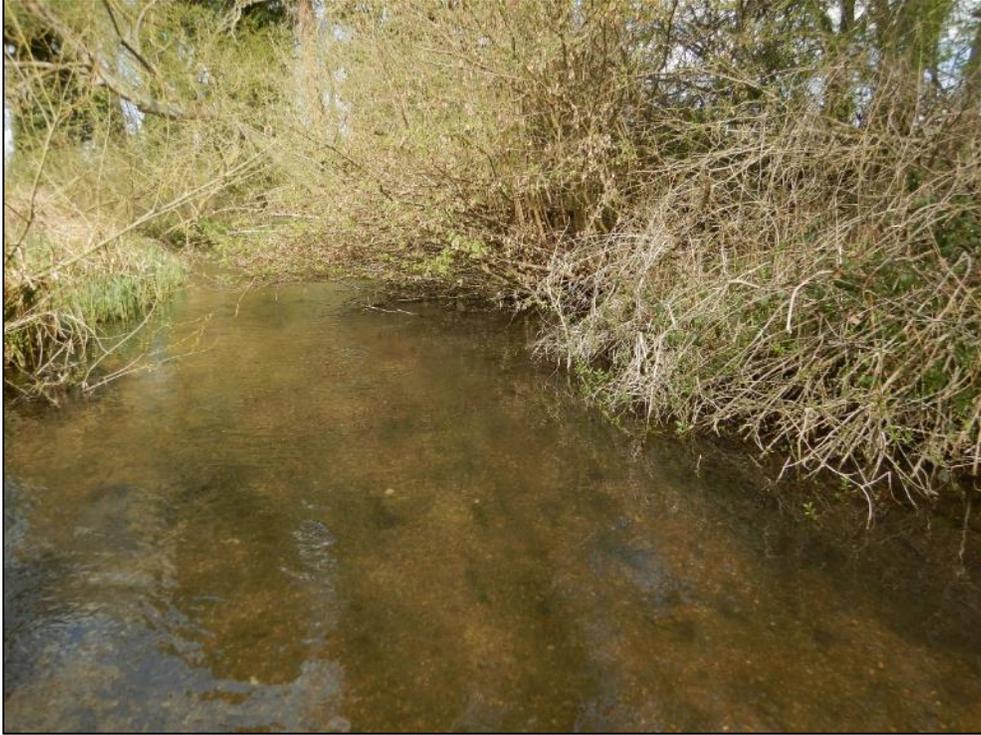
Pic 21 – Trailing shrubs provided important cover above shallow water.

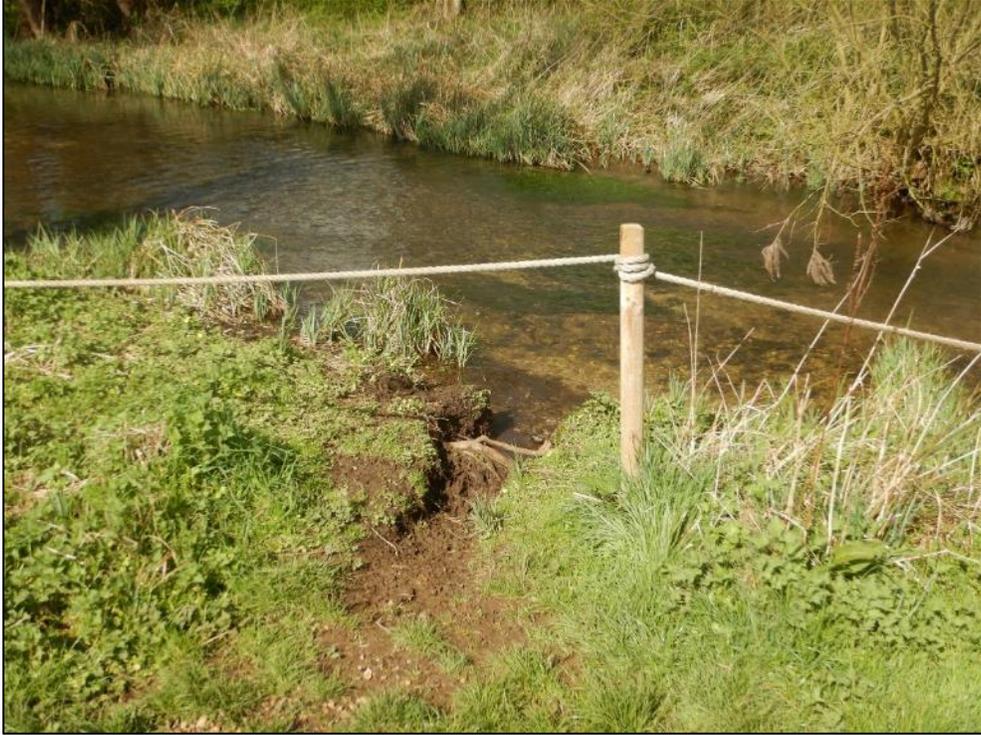
Pic 22 – A simple rope barrier is ineffective at deterring dogs from entering the river.

Above the brick-arch bridge the Herts and Middlesex Wildlife Trust had erected a number of signs drawing visitors' attention to the presence of water vole and the importance of chalk rivers as a globally threatened habitat. Sadly, the simple rope barrier is not an effective barrier to dogs which continue to damage the river bank with a negative impact upon the water vole habitat (pic 22). A simple means of controlling people and dogs is the use of dead-hedging (simple stacks of cut material held by posts and wire), or through tree layering, where the limbs of willow or hazel are pinned down to the ground to encourage them to take root. These measures create physical barriers but still look natural.

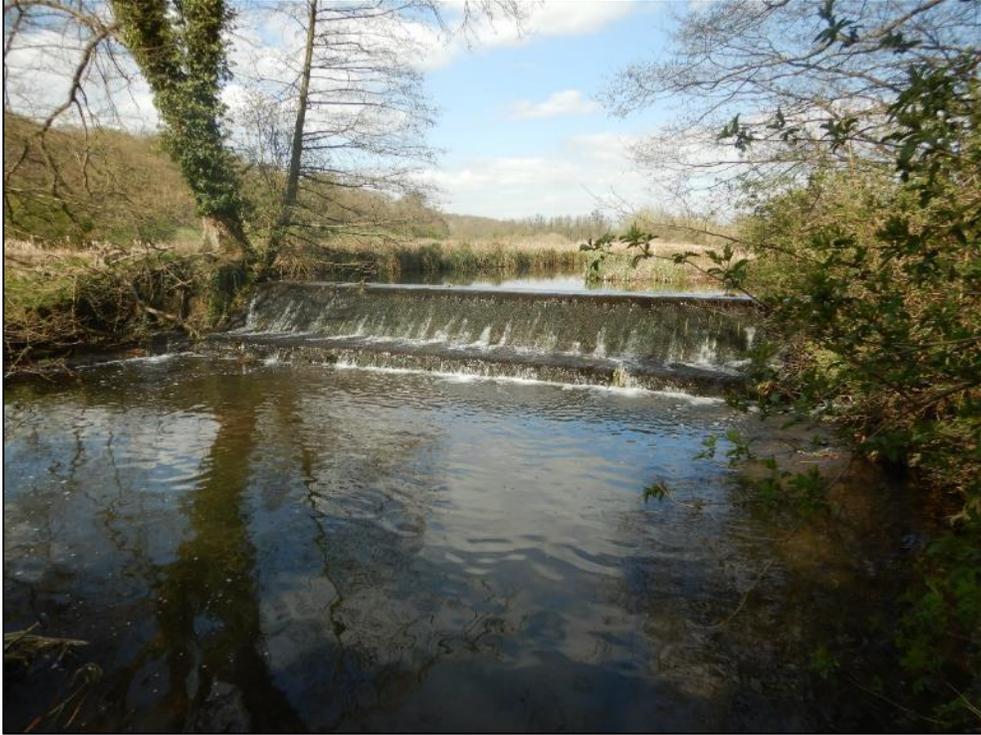
Pic 23 – The main course of the River Mimram was dammed by a weir to form one of the Park's Broadwater lakes. However, the by-pass channel provides a route around the lake.

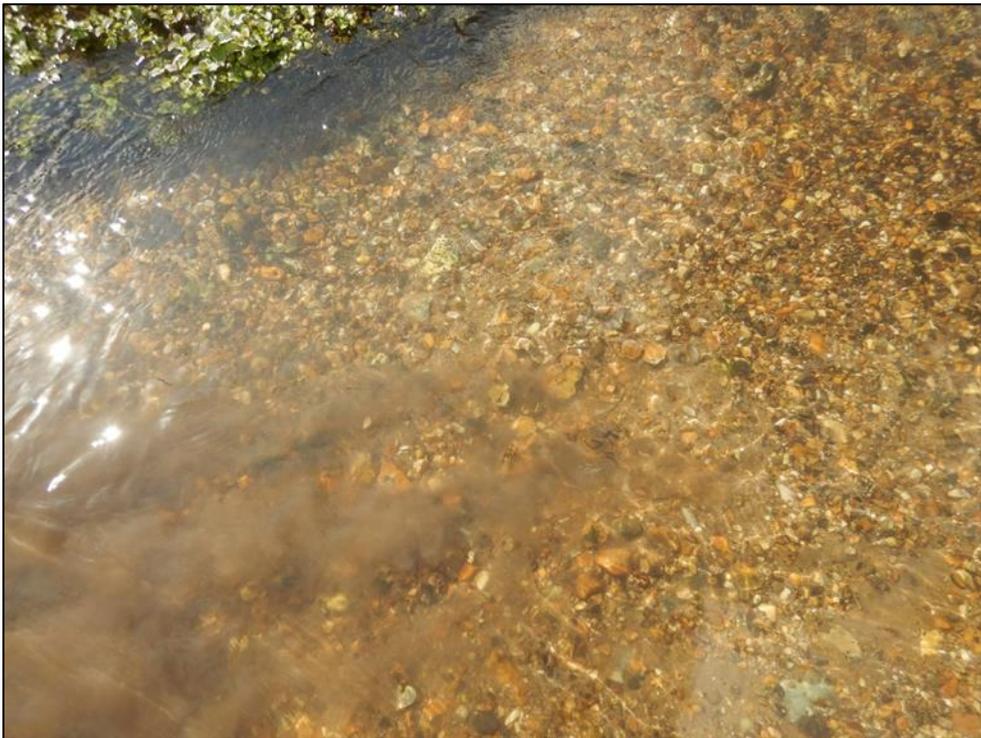
The by-pass channel had much potential for wild brown trout. The gravels were well-sorted and generally clean of excessive sand and silt (pic 24). Not all of the channel could be walked, but it was apparent that water voles were very numerous in the well-vegetated banks. Some recent coppicing of willows had taken place to prevent water vole habitat from being shaded. Fortunately, some trailing branches had been retained and provided good overhead cover for any fish moving through the reach (pic 25). There were occasional plants of starwort and lesser water parsnip but the by-pass channel (surprisingly) lacked significant in-channel vegetation. Much of the channel lacked depth cover and sinuosity. In the current low-flow conditions, the by-pass channel was unsuitable for adult trout but did provide habitat for trout fry and parr. It was surprising not to find any trout redds in the by-pass channel.

Pic 24 – The gravel bed of the by-pass channel was suitable for brown trout to spawn upon.

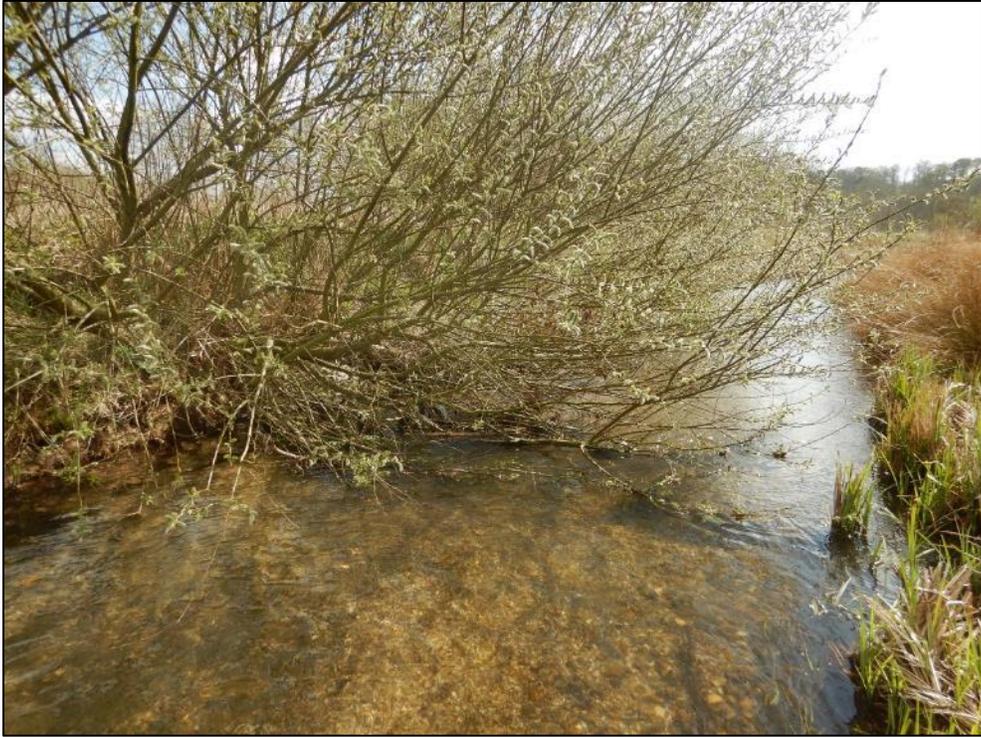
Pic 25 – Trailing willow branches provided important cover at water level.

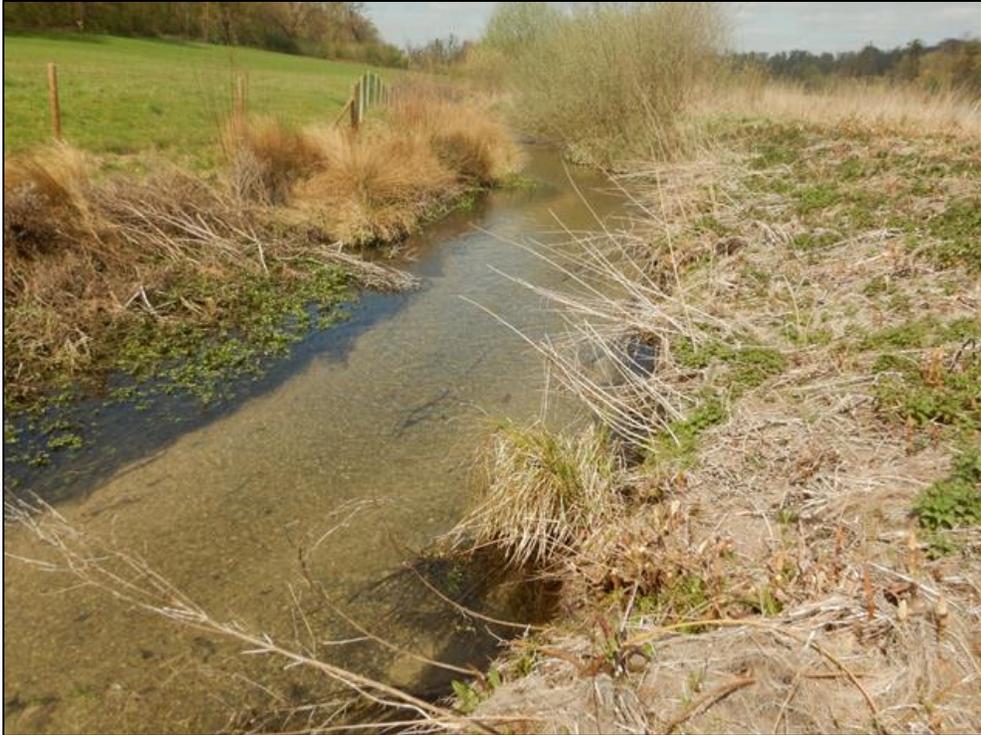
Pic 26 – The coppicing of willows has retained a number of shrubs that provide important overhead cover. A balance is being struck between cover for fish and open habitat for water voles.
