River Wey – Bishops Meadow Trust

An Advisory visit by the Wild Trout Trust – August 2012

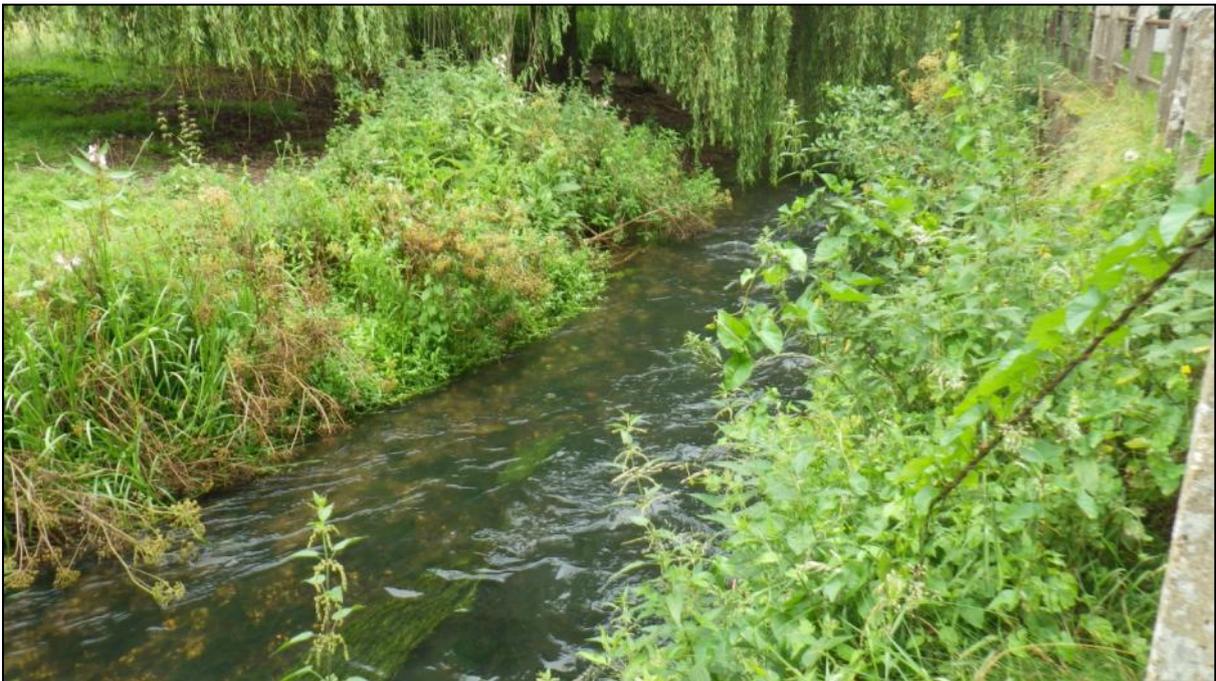
Figure 2: Marginal vegetation and overhanging tree cover on the top end of the milling channel

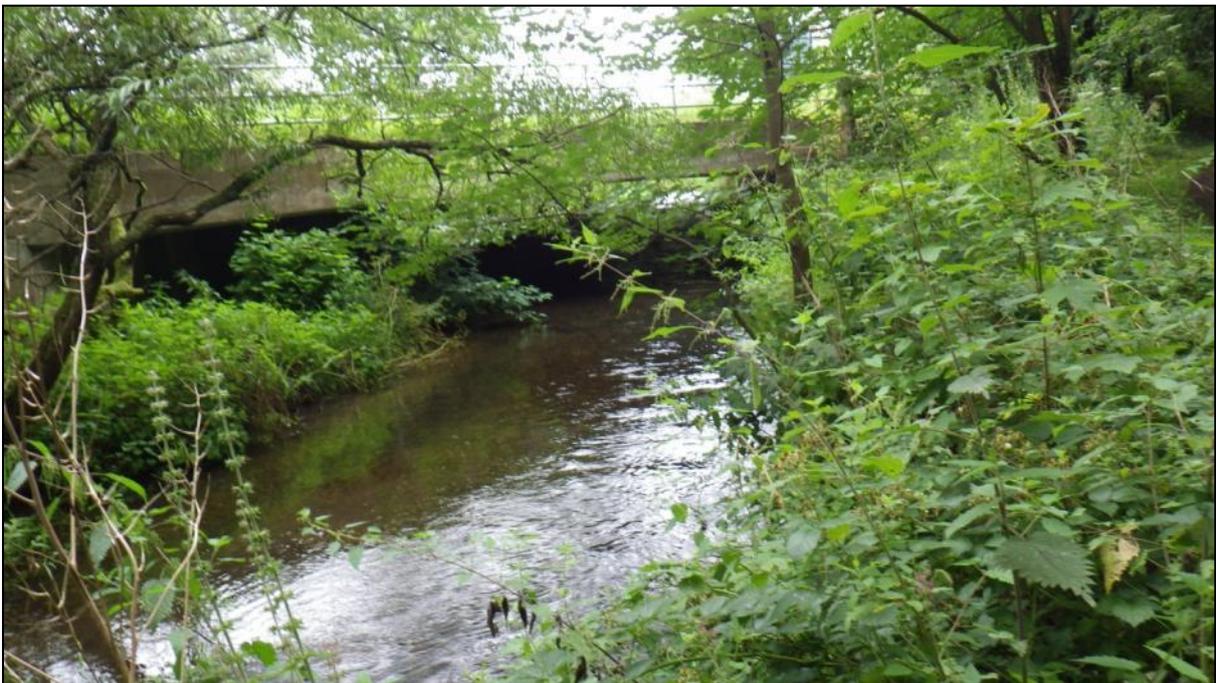
In this case the wide dimensions of the culvert (in relation to its length) allow a good quantity of daylight into the channel. The culvert also supports enough depth of water to accommodate effective fish passage. It is very unlikely that the culvert would pose a problem for any fish moving up and down the stream.

Figure 3: The wide box culvert under the A31

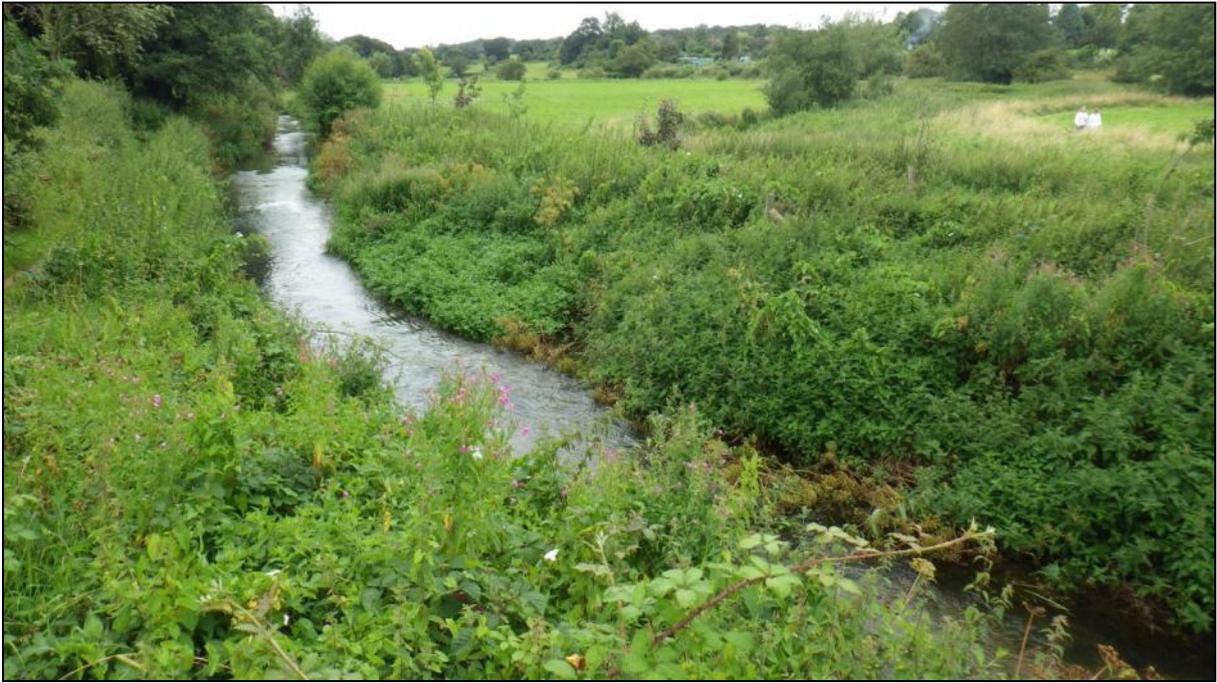
Figure 4: Marginal vegetation helping to add some sinuosity to the straight channel

Along this straightened reach, the pool-glide-riffle sequences observed upstream are no longer obvious and the channel appears to be more-or-less uniform in terms of depth and width. Despite the relatively homogenous habitat, marginal vegetation growth has helped to introduce some sinuosity into the reach and overhanging plants provide some good cover for fish. As the stream approaches Weydon Mill, water is backed-up and slowed by the mill weir impoundment. This structure is likely to be impassible to fish under most flow conditions and effectively fragments fish populations and river habitat.

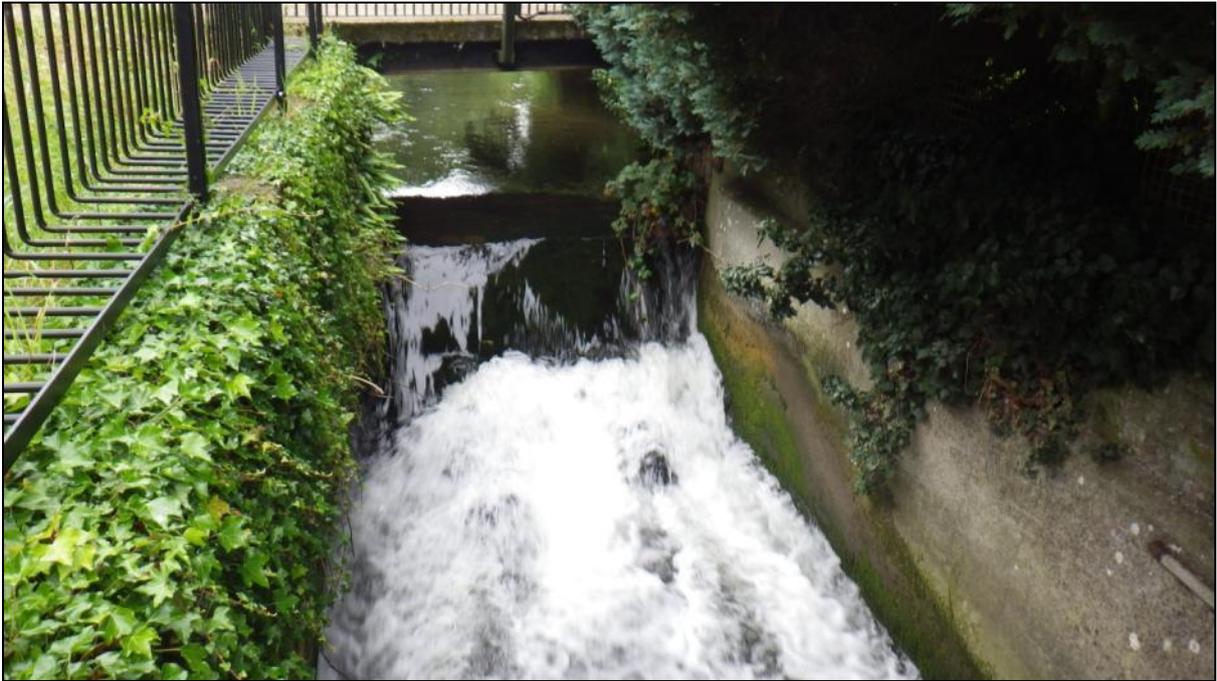
It is worth noting that despite the milling channel being impounded by Weydon Mill, the river supports some good quality habitat for flow loving fish species. This is mainly due to the bed slowly re-grading over time.

Figure 5: The weir at Weydon Mill. This is a significant obstacle to fish passage

The offtake weir currently depriving the natural channel of flow should be re-engineered so that the majority of water flows down via this route. Increasing flow rate through the river's natural channel would open up a long stretch of good quality habitat for flow-loving plants and animals whilst also functioning as a bypass around the Wey Mill weir obstruction.

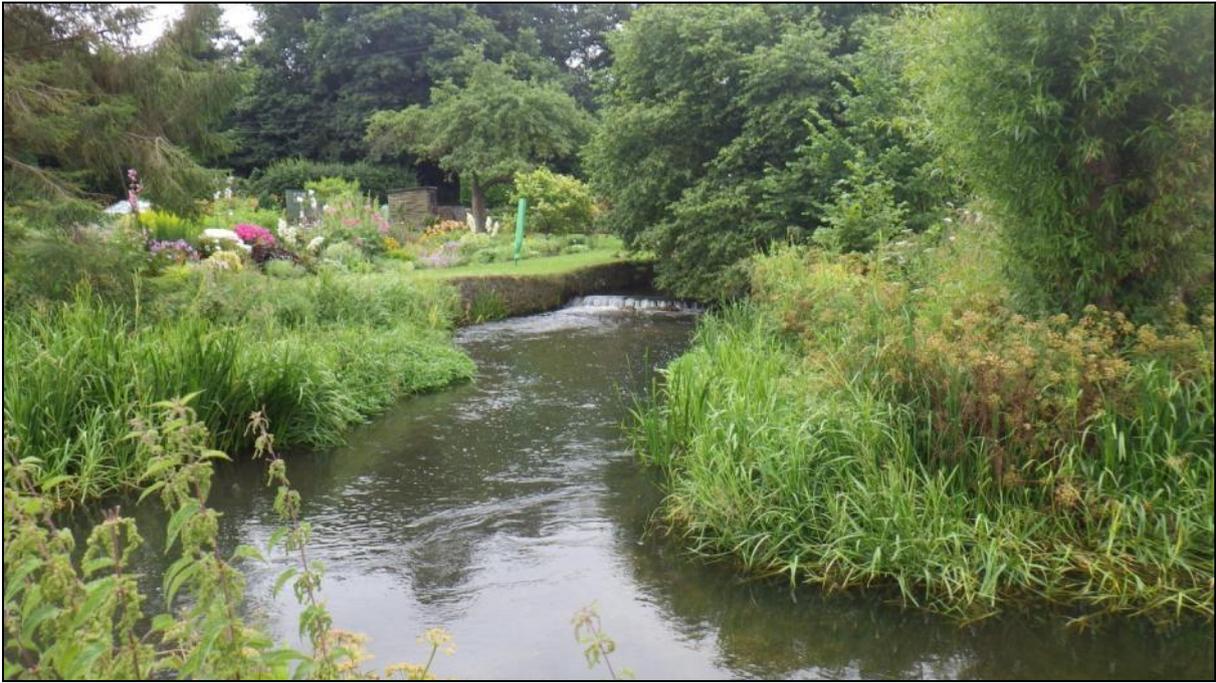
Figure 6: The confluence of the milling and original streams. Marginal growth helping to naturally narrow the river promoting gravel cleansing water velocities.

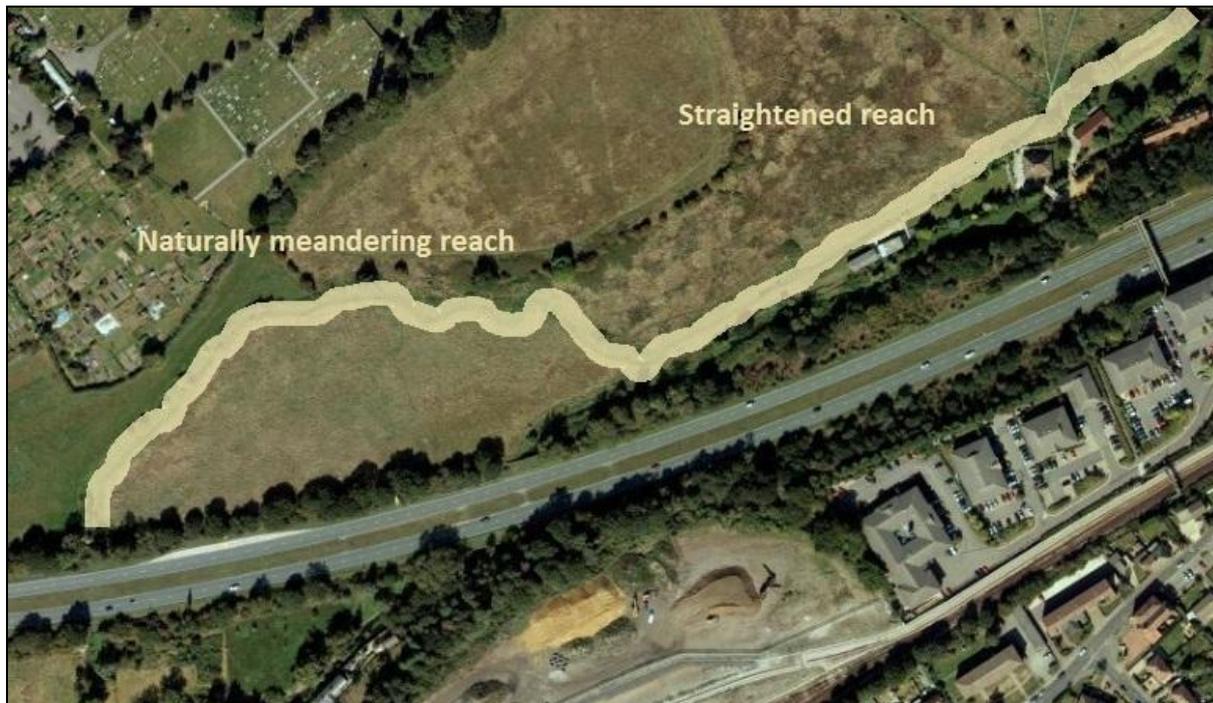
This stream flows under the A31 via a culvert similar to that on the milling channel. Downstream of the culvert the naturally meandering path of the river is clearly visible from aerial photography (Google Earth etc.). The stream follows sweeping meanders that give it greater overall length and therefore a greater total area in terms of potential habitat compared to the straight milling channel. The banks are also populated by a greater volume and diversity of marginal plant species compared to the milling channel.

Figure 7: Aerial photograph showing the natural path and straightening of the original channel

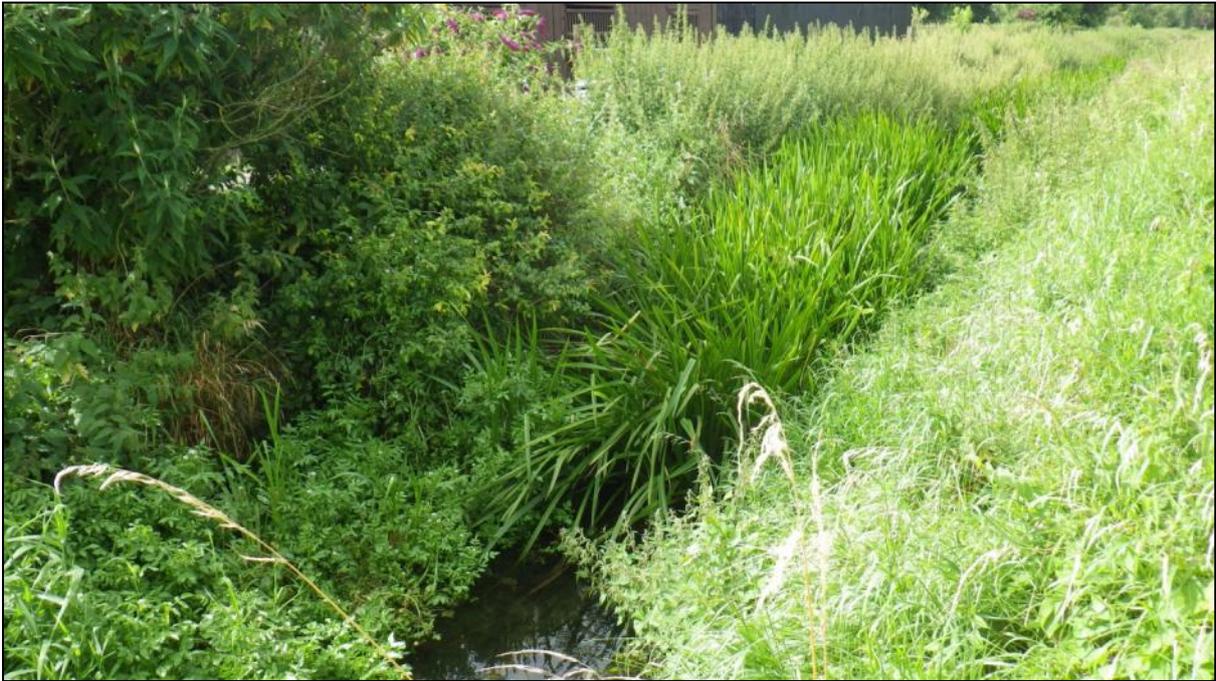
Further downstream the original channel has also been straightened. Here the flood conveyance performance is significantly reduced by overgrown emergent vegetation including reed sweetgrass (*Glyceria maxima*) and watercress (*Nasturtium officinale*).

Apart from the take-off weir at NGR SU830458, the original channel is free from artificial impoundments and obstacles to fish passage. However, the dense emergent vegetation probably restricts fish movements. Small species such as minnows and some coarse fish fry are likely to take refuge in the channel and the stream is likely to be a good habitat for amphibians. However, adult larger fish and flow-loving species are unlikely to inhabit the stream.

Figure 8: Overgrown emergent vegetation in the straightened reach of the original (now modified) channel

The slow flow rate is causing sediment to drop out of suspension and smother the bed. No suitable spawning habitat is available for trout or other gravel spawning fish species.

The overgrown emergent vegetation in the original channel needs to be managed in order for the stream to function properly. The channel needs to be opened-up to allow water to flow unimpeded. This can be achieved either by hand using a turk scythe etc or with a glyphosate-based contact herbicide.

This would be best done sympathetically – opening up a flow path through the vegetation as opposed to completely clearing the channel.

symptom of low flows combined with an overabundance of direct sunlight. It is strongly recommended that additional native trees are planted along the reach to help regulate both the overgrowing vegetation and the temperature of the river during summer months.

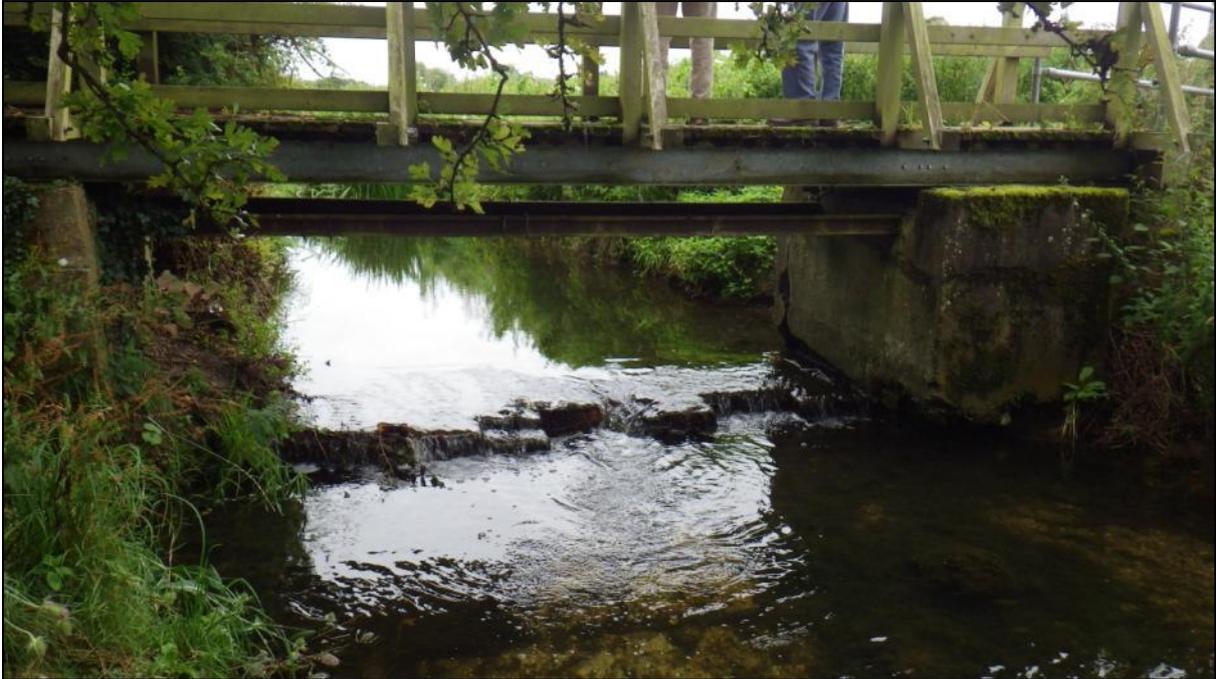
At the downstream extent of the straightened reach, flow is slightly impounded by a sill between the footings of a footbridge. The sill is a brick structure in a

state of deterioration. Head loss over the sill is minimal but the low-flow conditions through the channel make even the smallest of obstacles potential barriers for small and juvenile fish.

Figure 9: The crumbling brick sill under the footbridge from Wey Mill onto the meadow

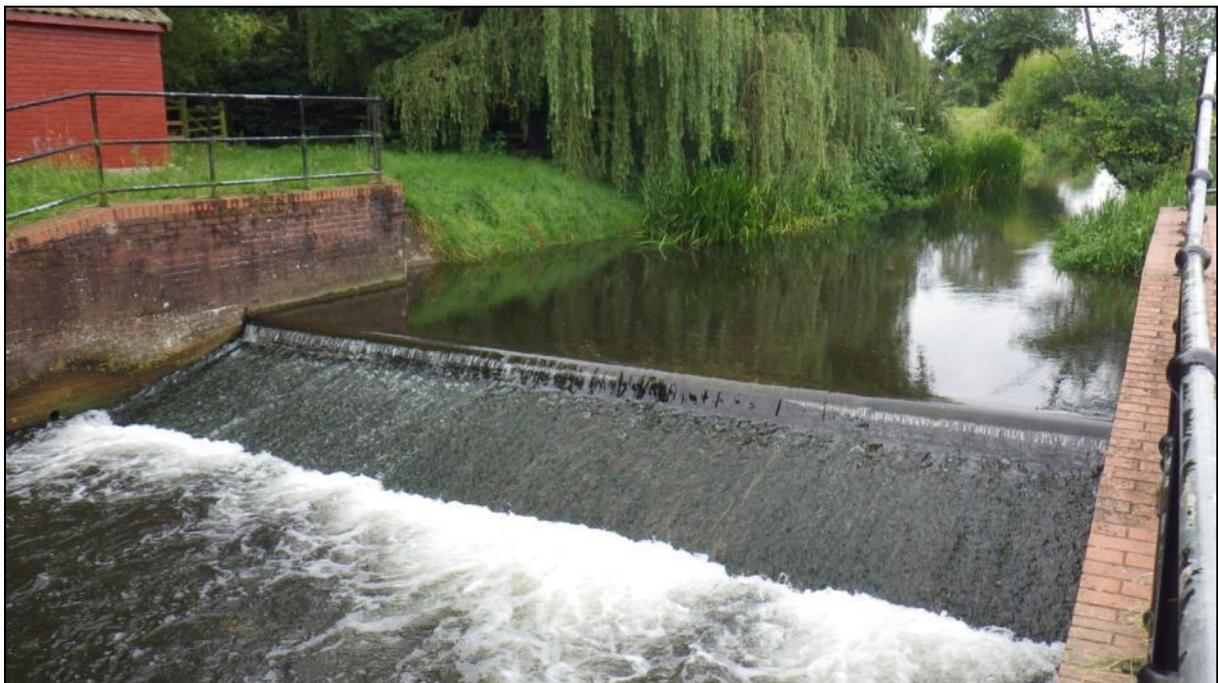
Downstream of the confluence of the two streams, the river is impounded by an Environment Agency flow gauging station. This is in the form of a crump weir with a high crest. The structure is a complete block for fish passage and is impounding flows and trapping bed material upstream. This structure is adversely affecting the overall habitat performance of the river through Bishops Meadows by slowing flows upstream and as well as acting as a barrier to fish migration.

Figure 10: The gauging weir is a block for upstream fish migration and impounds the water upstream causing slow, deep flows and heavy sediment

Removing the weir would markedly improve the habitat value of the reach. This would however be an expensive undertaking and a replacement system for monitoring river flows would have to be installed.

A less effective alternative to complete removal could be to install an 'easement' structure onto the weir that would allow fish passage over the obstacle. This kind

The gauging weir is potentially a complete barrier to upstream migration. It is recommended that a dialogue is opened with the Environment Agency with regards to easing fish passage over the structure. Ideally, the structure could be completely removed in favour of a more modern gauging station that does not require a crump weir. Alternatively, a project could be designed to ease fish passage without removing the weir or affecting the performance of the gauging station. An example easement project using timber baulks to baffle flow and raise water levels over the downstream face of a crump weir is shown in **Figure 18** below:

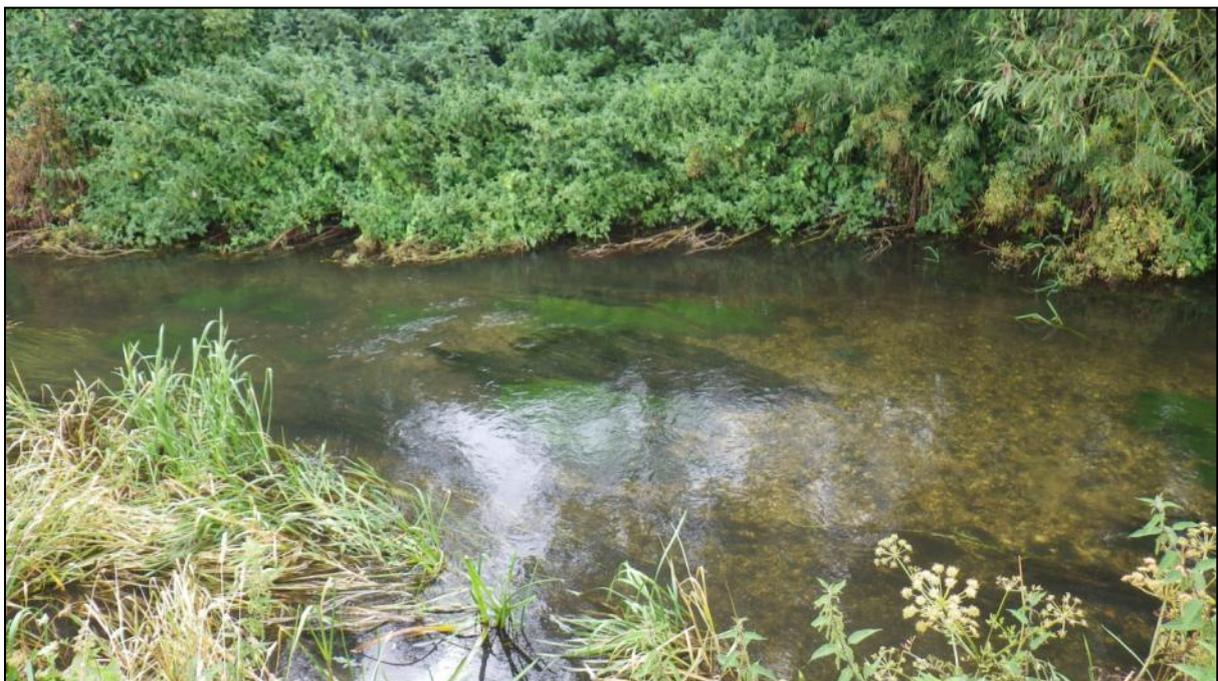
Figure 11: Good quality habitat with a clear gravel bed, swathes of water crowfoot, and a variety of emergent and marginal plants

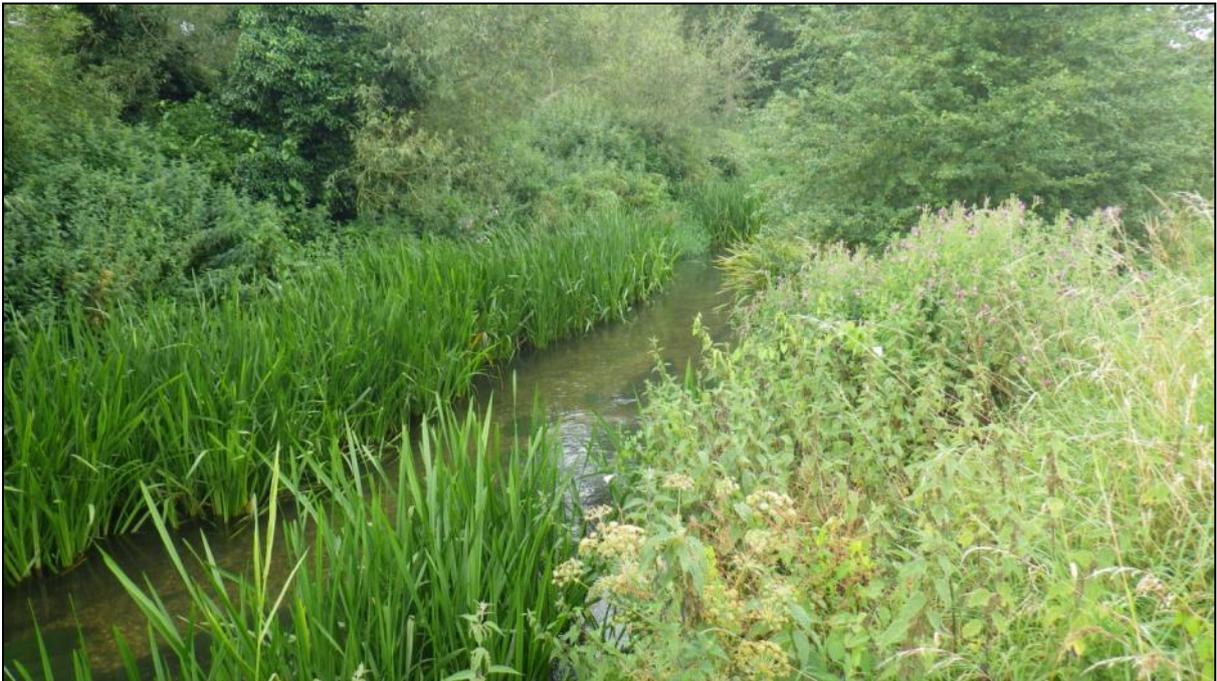
Figure 12: Emergent reeds pinching the channel, maintaining faster flow velocity and helping scour silt from the gravel bed.

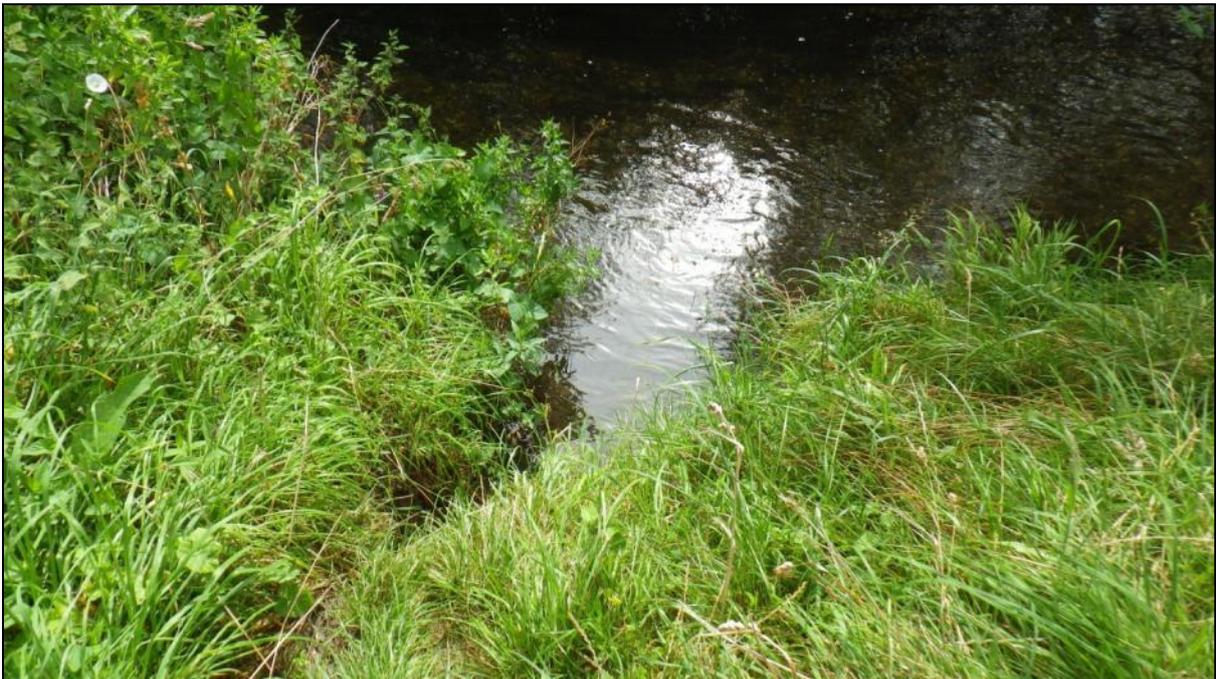
Towards the downstream boundary of Bishops Meadow, tell-tale tracks of bank erosion confirm that the river is being accessed by dogs. Dogs scrambling up and down river banks can lead to serious erosion problems if unchecked. Often the solution is to establish specific dog access points that can be reinforced with gravel etc. At present the problem is not a serious one but should be carefully monitored.

Figure 13: Erosion tracks from dogs scrambling in and out of the river. Unchecked this can become a serious problem.
