**Advisory Visit**

**R. Wharfe, Myddleton Angling Club**

**16/06/2017**

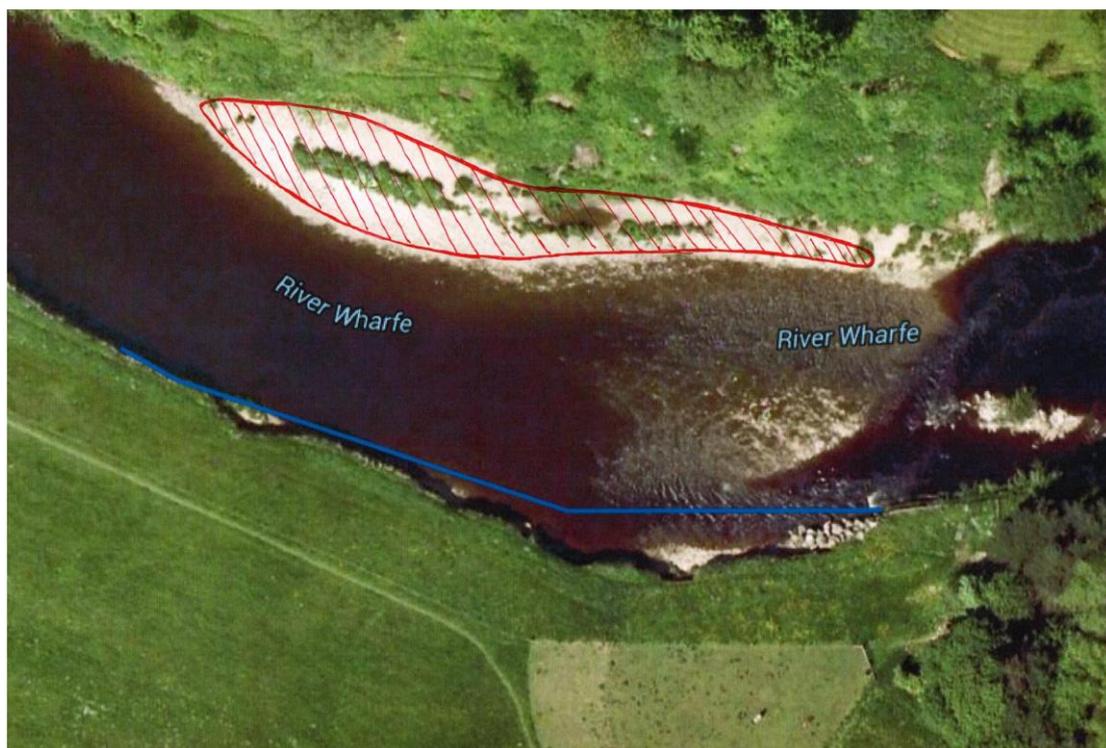
This image was taken in May 2009, prior to a line of willow trees being planted along the RB (bottom of photo), and the scour and erosion along the full length of the RB has extended considerably in an u/s *and* southerly direction.

According to the documentation supplied, Coxon Bros. proposed to reinstate a bank line (in blue, above), face it with 1-2 tonne rock armour for ~90m and backfill with gravel extracted from the opposite bank (red-hatched, above). Weetwood propose several options revolving around sheet piling along the former revetment bank line.

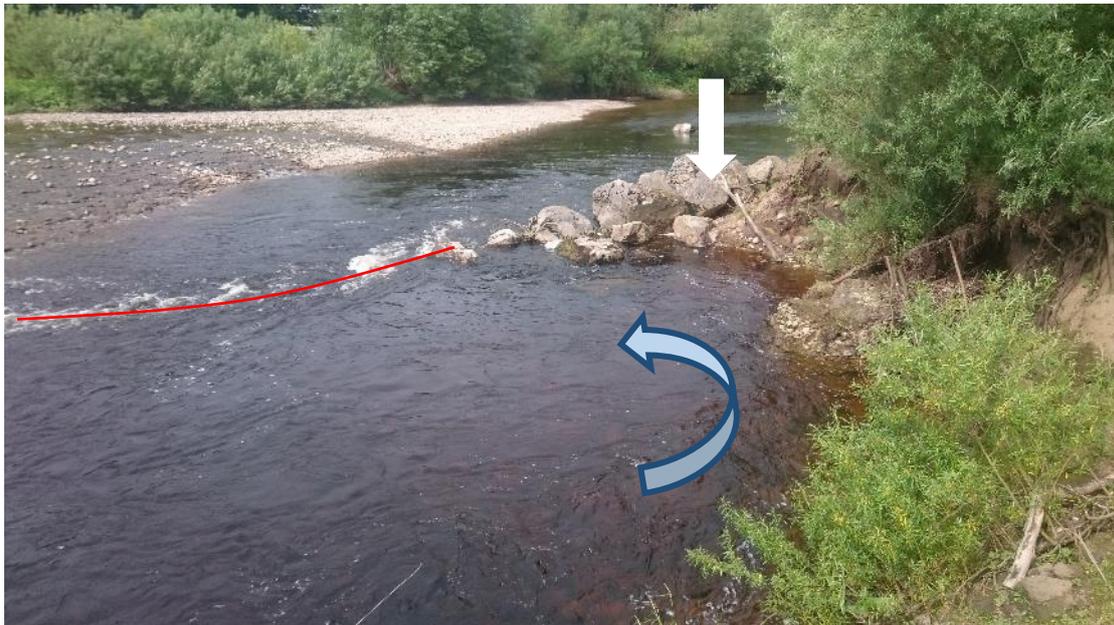
The focal erosion area affecting the RB immediately u/s of the ILTSC is a result of the Wharfe beginning to return to a more natural sinuous course across the floodplain. As such, the geomorphological processes of erosion and scour have produced great variability in depth profiles which provide some excellent habitat for brown trout and grayling. The depositional zone toward the inside of the bend (LB) provides shallow, well oxygenated water with many stones proud of the surface: this is good habitat for fry and juvenile parr stages (Fig 2). The scour pool created behind the failed bank revetments has created greater depth of water and varied flow for adult trout holding lies, as do each of the erosion cells further u/s on the RB (Fig 3). Recirculating flow, which is in part exacerbating the erosion of the RB, is indicative of a slower flow regime around the remainder of the RB d/s and this has led to localised deposition and sorting of gravels around larger boulders (Fig 4). If these short gravel beds are relatively stable under winter flow regimes, they could be a potential spawning site for smaller individual trout; they certainly provide high quality habitat for stoneflies, mayflies, and other flow-loving invertebrate species – i.e. good feeding for resident fish.

**Fig 2. The main scour pool eating into the RB adjacent to the Tennis Club. The original bank revetment position is depicted by the red line. Willow has been planted along the bank top rather than bank toe – too little, too late to prevent any further erosion. Gabion baskets topped by large boulders (white arrow) from the original revetment have now entrapped the river, essentially exacerbating erosional scour (blue arrow) but creating excellent habitat features for wild trout (diverse flow / depth profile / boulder lies).**

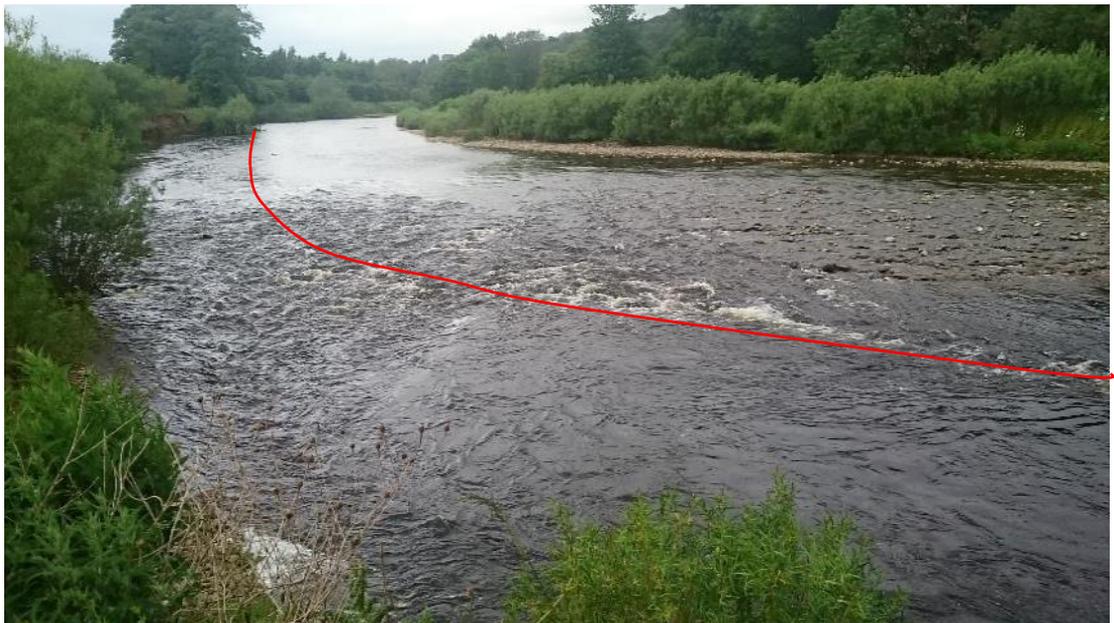
**Fig 3. Looking u/s from immediately above the scour pool in Fig 2, demonstrating the extent of erosion along the RB. The original revetment position is roughly indicated by the red line and most bank protection options supplied propose that the bank be reinstated to this line; ~100m of relatively smooth faced rock armouring introducing a featureless sweeping curve.**

The willows (visible to the left of Fig 3) planted along the RB top are a relatively recent addition (<8y). Their position on the bank top does little to alleviate erosion pressure as that is occurring at the toe of the bank and the soils above are cantilevering into the channel (block-failure). In their present state, some saplings overhanging and some slipping into the channel, they are providing some much needed

low cover to the water which is otherwise poor along this section of bank.

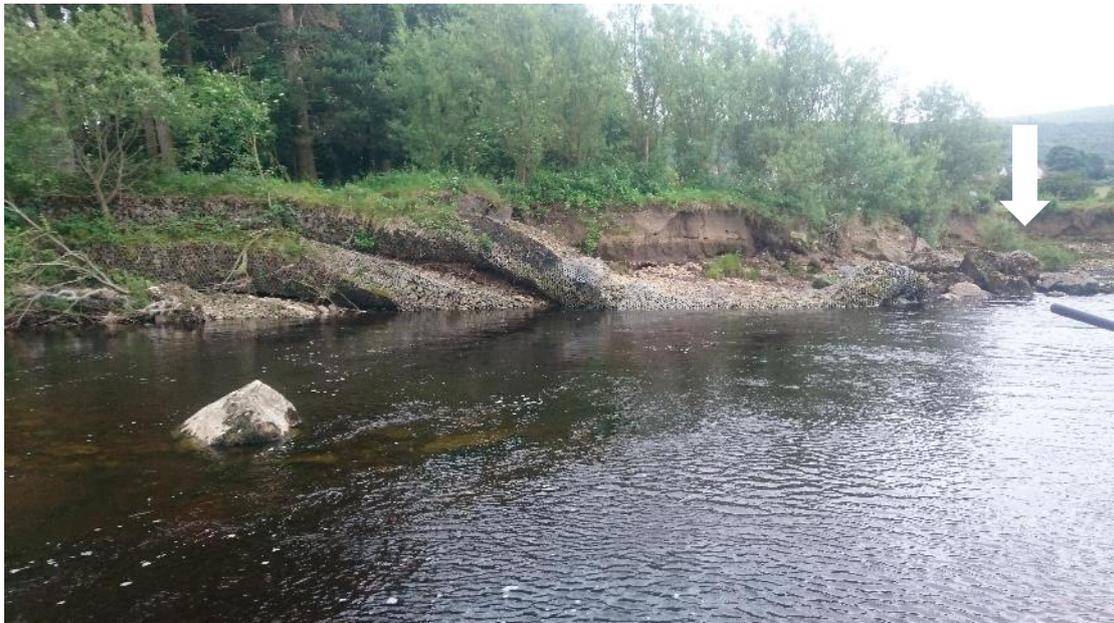
**Fig 4. Gabion basket revetment that has failed immediately d/s of the scour hole from Fig 2 (position marked by white arrow) which will require repair and further disruption to the bank and bed characteristics. Note large boulder (to the left of image) and localised scour introducing depth variability, some gravel deposition and sorting.**

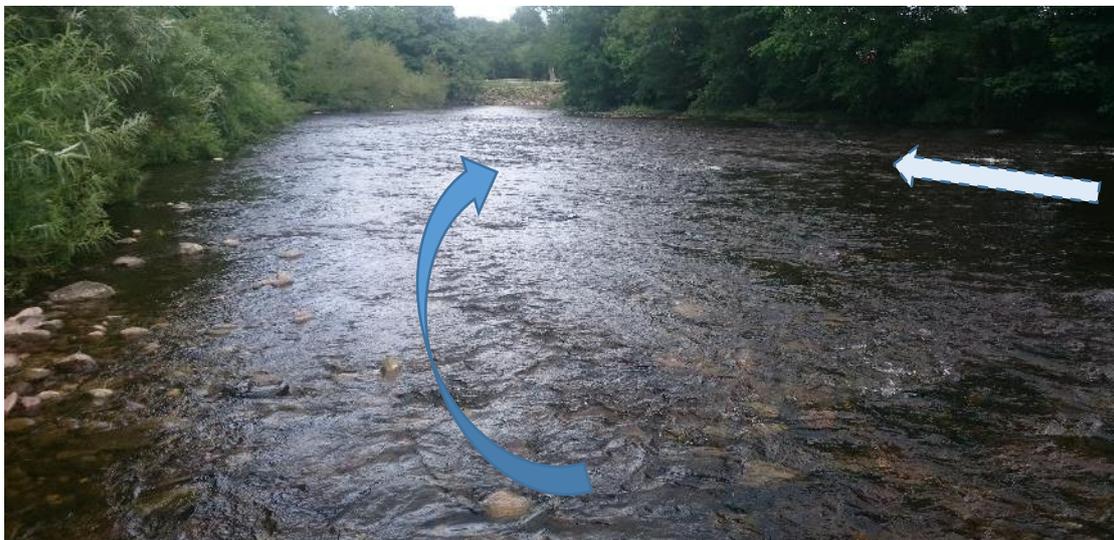
The deflection of the main current out of the scour hole and across towards the LB has diversified the flow pattern to a more meandering course d/s as opposed to simply sweeping around the outside of the bend – see Fig 5. Such flow diversion is very valuable in what would otherwise be almost continuous glide habitat in a straightened section of river below the bend.

**Fig 5. Looking d/s from Fig 4 at the riffles and shallow glides that currently provide good juvenile parr habitat for ~250m. The disturbance on the river surface gives some indication of the main flow patterns now meandering from the RB to the LB and back to the RB (blue arrow), as opposed to the main flow line (pale, dashed arrow) continuing around the outside of the bend along the RB which will likely occur following bank protection.**

The LB is lined with low-growing, relatively young willow, providing excellent low cover via trailing and submerged branches, but only over water which is relatively shallow (so, good for juveniles but little worth for larger fish). The RB is lined with mature trees toward the

bank top; shade from these appears to have inhibited sapling growth at the waterline (Fig 5). Some judicious coppicing of one or two mature trees to diversify the canopy age / height structure, and allow more light in, plus providing opportunities for introduction of willow with its lower growing properties would be beneficial.

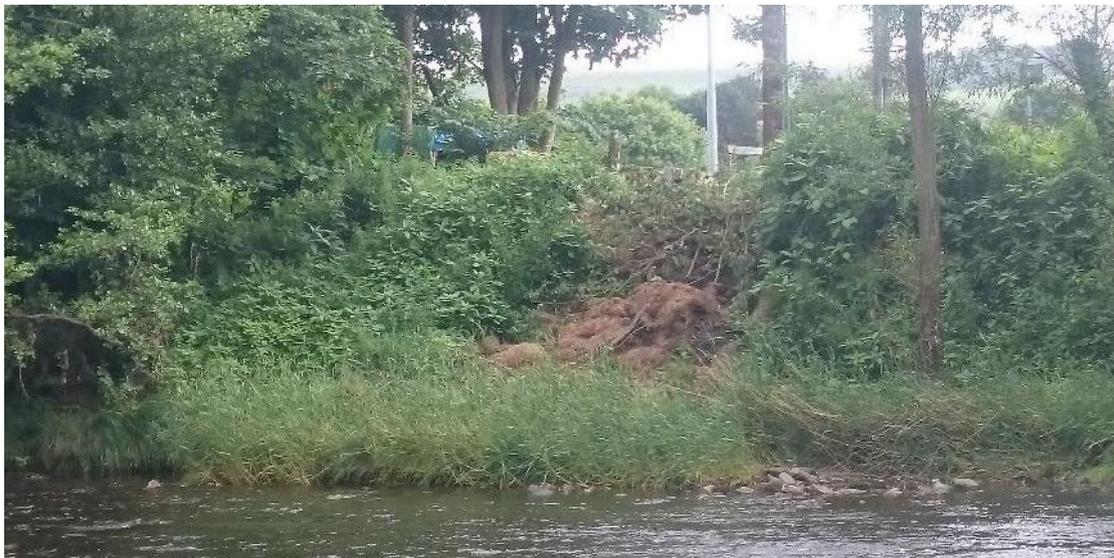
Approximately halfway along the RB (passing the ILTSC; Fig 6), there was evidence of grass cuttings and other cut plant material being dumped into the channel. Not only is this using the river as a waste disposal system, but potentially introduces viable non-native plants to the wider river ecosystem. The grass cuttings in particular begin to breakdown quite rapidly, leaching nutrient-rich liquor into the soil (which slows the colonisation of the bank by other plants, hence making it more susceptible to erosion when the cuttings are washed away in spates), and ultimately into the watercourse.

**Fig 6. Grass cuttings and other plant materials from pruning at the Tennis Club that have been deposited directly onto the riverbank. This should be disposed of responsibly.**

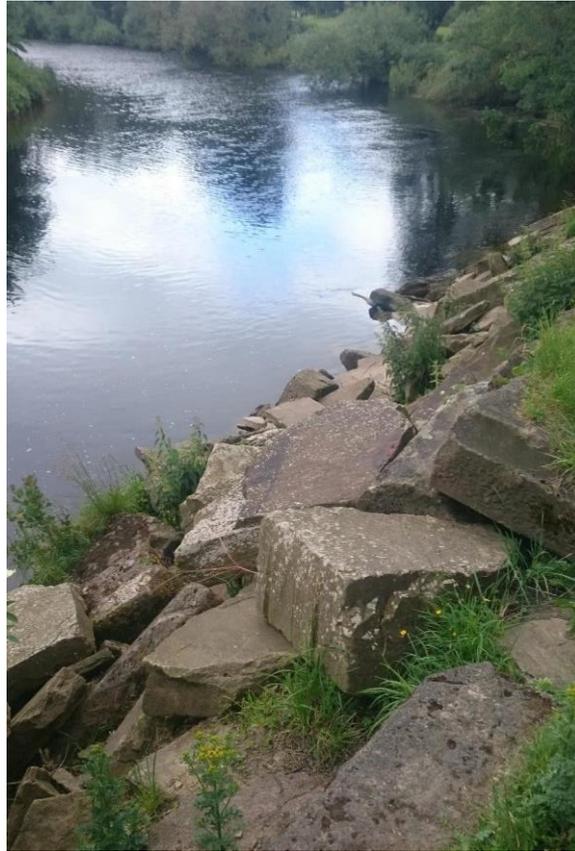
Downstream from the main buildings of the ILTSC, the Wharfe is forced to turn right and then left in relatively quick succession (Figs 7 & 8). The RB is still within the grounds of the ILTSC until the left hand bend and the bank riparian structure remains similar to that along the straight in Fig 5; generally mature trees with a dense canopy. A weir below the Old Town Bridge is responsible for impounding the river almost to the right bend in Fig 7, some ~460m.

**Fig 7. At the d/s end of the section depicted in Fig 5, the river is forced to turn right abruptly, and the scale of the armouring required to coerce it to do so is evident in the foreground. Note that the river is beginning to suffer from the impounding effect of the weir at Old Bridge, ~460m d/s.**

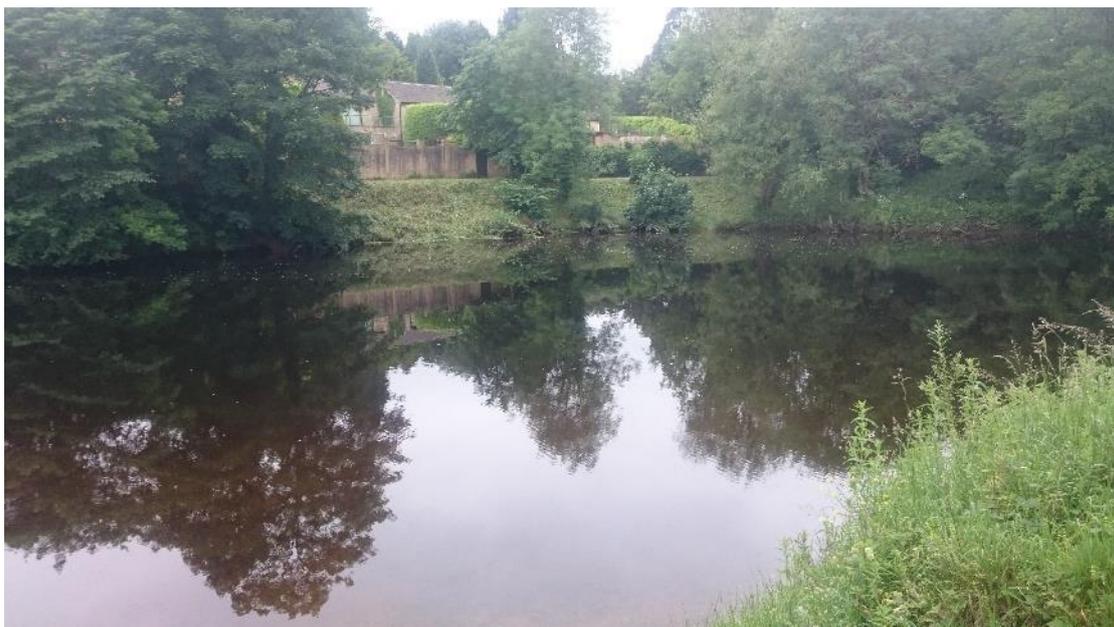
The deeper glides and pools in this lowest section are less favourable habitat for wild trout and grayling, which will be better adapted to the faster water u/s. These pools may retain stocked trout for longer than they would otherwise persist in the reach.

**Fig 8. A deep pool on another 90° bend to the left, with barely discernible flow caused by the weir impoundment ~200m d/s at Old Bridge.**

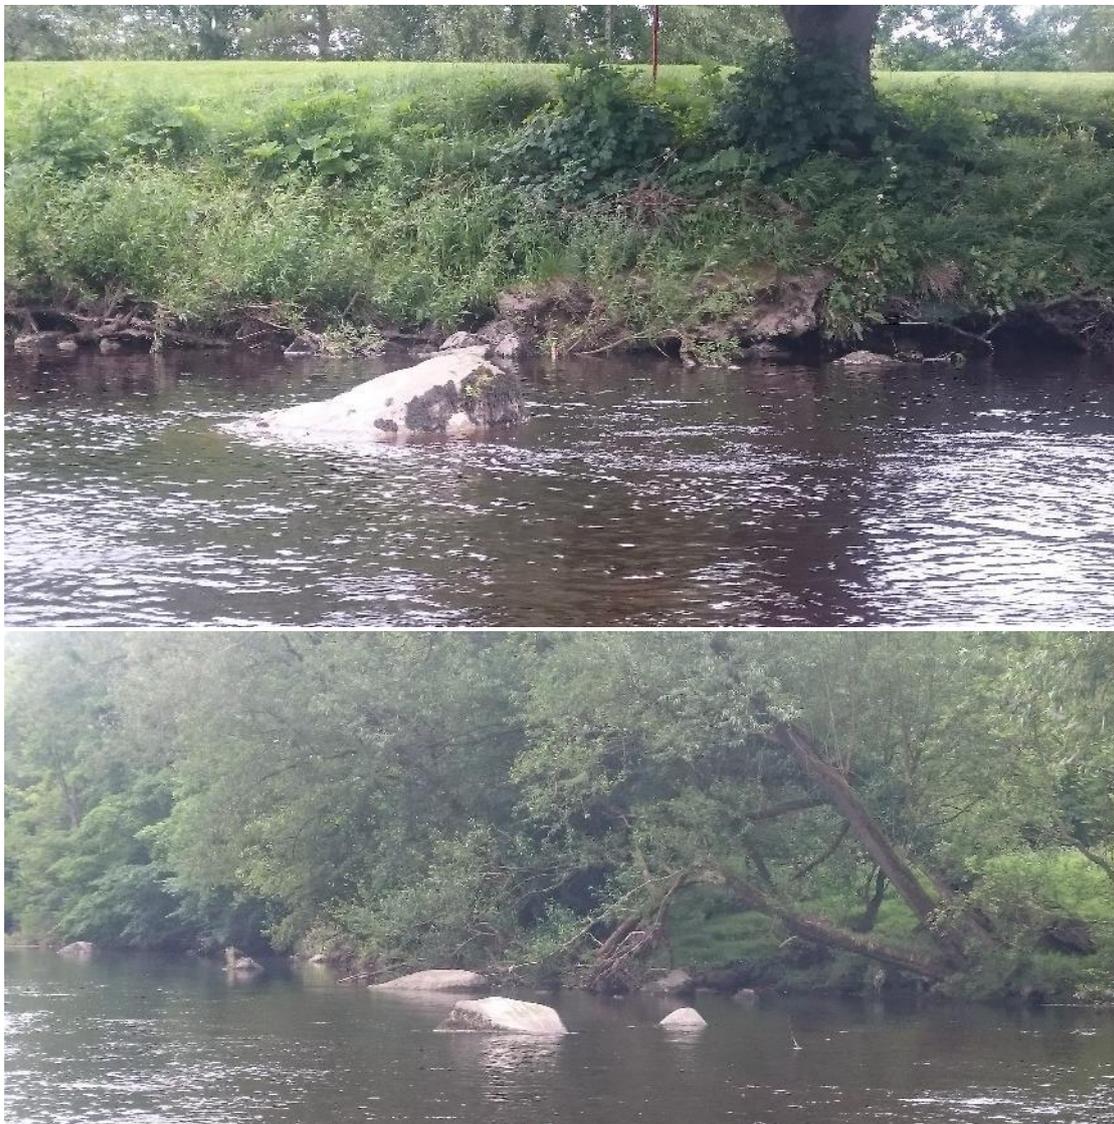
The habitat was also assessed toward the top of Myddleton AC waters on a slightly more natural bend in the river (Fig 9). While the inside of the bend (LB) is still influenced heavily by revetment to protect greens and fairways on the golf course, the outside (RB) is butted up to a bedrock outcrop at The Hollins. Unmanaged native deciduous trees fringe the RB, with a diverse species composition and canopy structure caused by natural tree fall creating 'gaps' which have been exploited by self-set saplings. Many branches and some trunks were jutting over the channel, and low branches provided cover over deeper water, suitable for holding larger fish. There were also quite a few large boulders occurring naturally within the channel, again creating localised flow, scour and deposition around each to increase the channel habitat diversity. This is a useful exemplar stretch for more natural conditions along the Wharfe.

**Fig 9. In the upper reaches between Riddings Lathe and The Hollins, the Wharfe retains slightly more natural characteristics, more so on the RB (lower panel) where the river is naturally tight to the side of the valley butting up to bedrock. Here, a combination of natural, low tree branches and large boulders in the river create habitat diversity and cover for fish.**

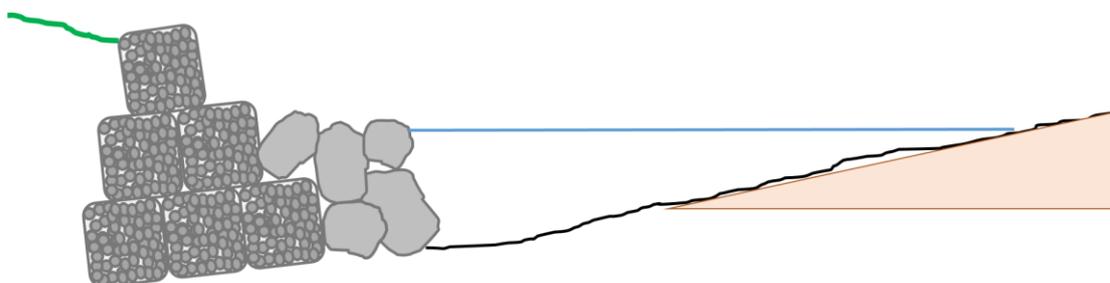
Thus, below the waterline there will essentially be a simplified triangular channel created by constraining the flow around a long sweeping bend (Fig 10). Above the waterline, vegetation will be so far removed as to have little direct benefit to aquatic organisms.

**Fig 10. Schematic of potential bank protection solution, here gabion basket and rock armour modified from the Weetwood report, and the likely simplified channel cross-section resulting from helical flow continuously applied to a long sweeping bend of low curvature. The red triangle depicts the gravel deposition bar that is potentially to be removed for infill behind the gabion baskets**

At least one proposal implies removal of the gravel deposition bar from the LB to provide infill behind the defences – see Fig 10. Obviously, this would be highly disruptive to the bed of the river, disturbing all links in the food chain to trout and grayling. It would further simplify the trapezoidal channel cross-section by making the depth more uniform. It will also inevitably increase local conveyance and accelerate erosion and transport of new material from upstream to resupply the void left behind; i.e. to reinstate equilibrium. Depending upon where this material comes from, there may be noticeable changes to habitat structure u/s in Myddleton AC reaches. The uniformity of channel and lack of any natural cover above the water will leave the whole reach vulnerable to increased rates of predation, especially from avian predators such as goosander and cormorant.
