Water Framework Directive Investigation

Barlow Brook

Waterbody - GB104027057700

May 2012

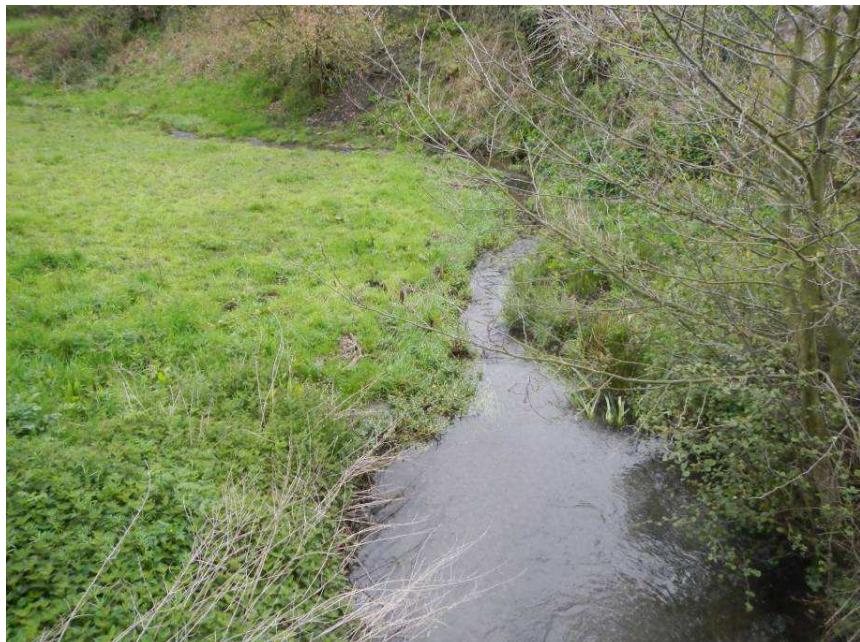
Before commencing the walkover, spot checks were undertaken along Highlightley Lane to provide a brief assessment of the watercourses contributing to the Barlow Brook. This assessment revealed an unnamed tributary, too small to provide significant habitat for trout populations and that the Black Carr Brook although small, had potential as a spawning and nursery area for salmonids, with suitable sized, relatively clean substrate (Picture 1).

Picture 1. Salmonid spawning and juvenile habitat available on the Black Carr Burn.

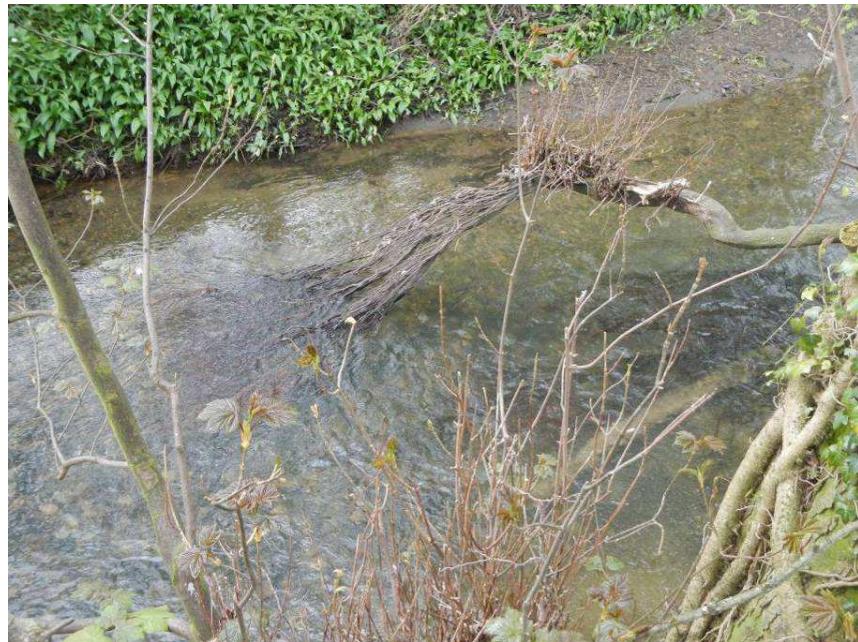
Picture 2. Excellent trout habitat provided by low-level cover from roots and branches.

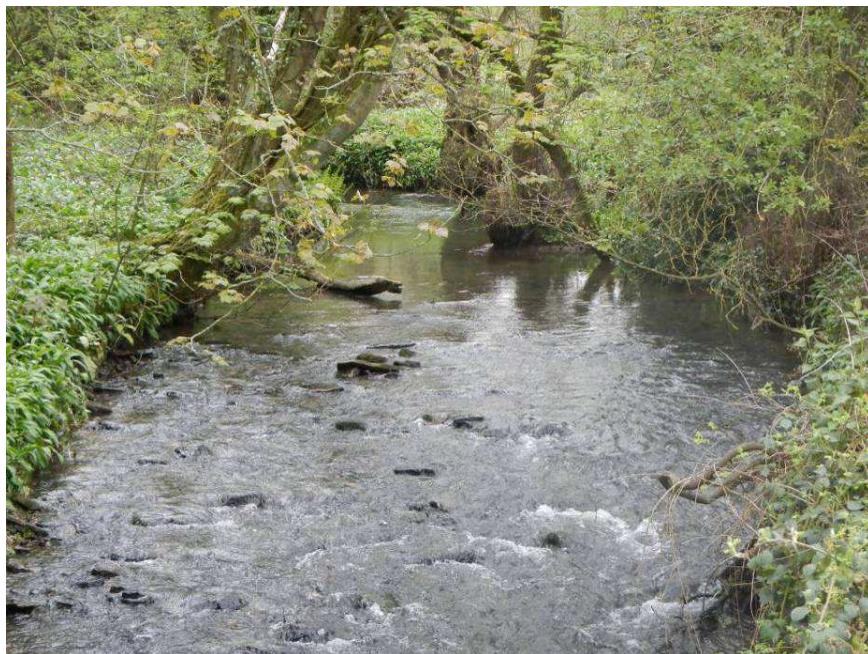
Picture 3. Healthy river channel with natural pool and riffle sequence and an abundance of marginal and aerial cover.

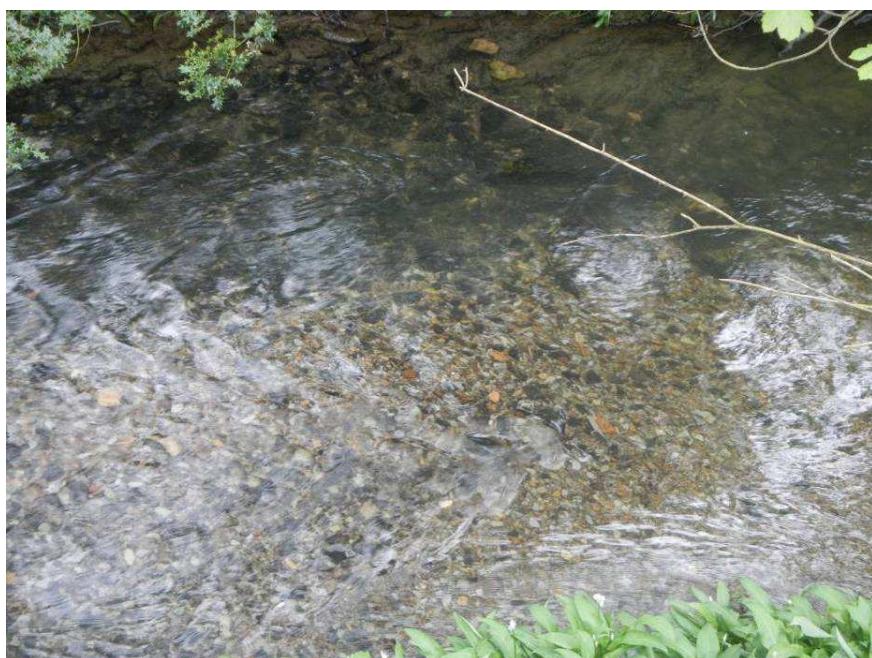
Picture 4. Clean naturally sorted bed material, ideal for salmonid spawning.

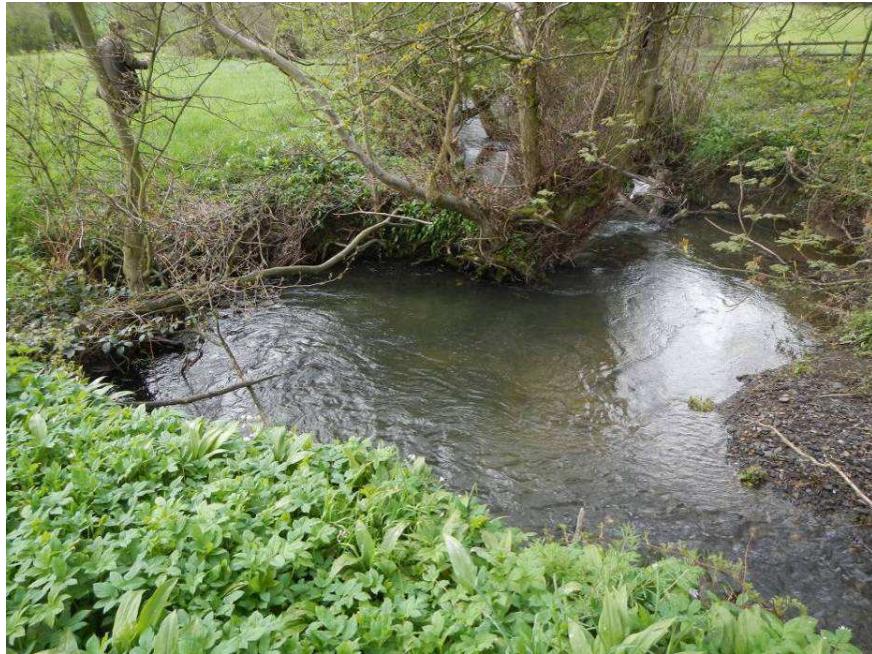
Picture 5. Another example of the high quality habitat throughout the upper section of this reach.

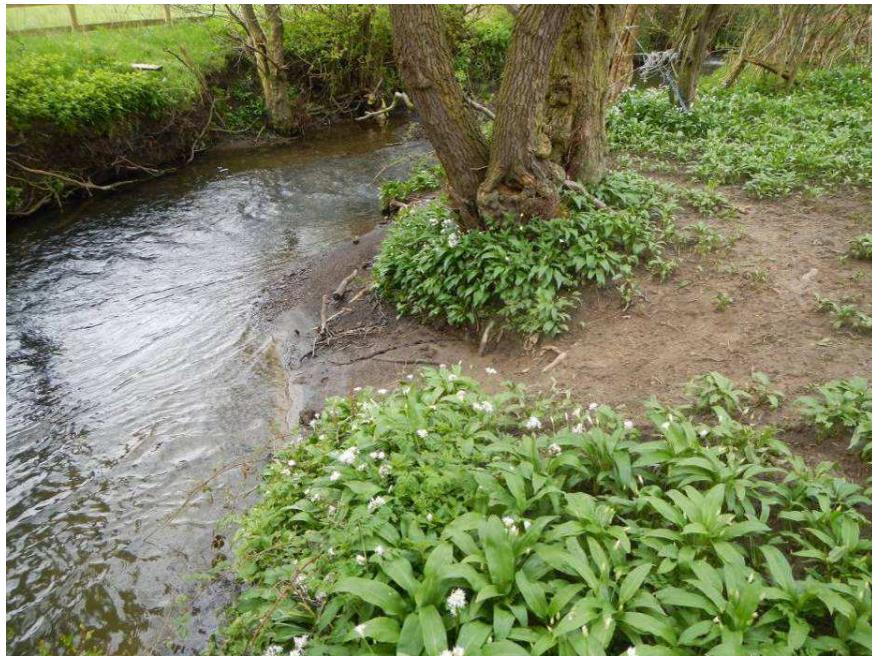
There were in fact few issues observed within the upper section, although a small amount of poaching was evident where livestock had access to the watercourse, but even this was usually limited to discrete watering points (Picture 6). The impact of this is likely to be low due to the small extent, but will contribute some sediment input to the system and could be prevented by installing hard standing around restricted watering points, or installing an alternative water source (e.g. trough fed from the river or pasture pump).

Picture 6. Small area of erosion resulting from stock access.

Impact	Description	Picture	NGR	Action
Low	Small area of erosion associated with livestock watering point	6	SK3311275840	Install Buffer Fencing on grazed fields restricting access to one point/install alternative water supply
High	Ford and access track	As 13	SK3374175758	Formalise access track and reduce usage if possible
High	Ford and access track	As 13	SK3383475678	Formalise access track and reduce usage if possible

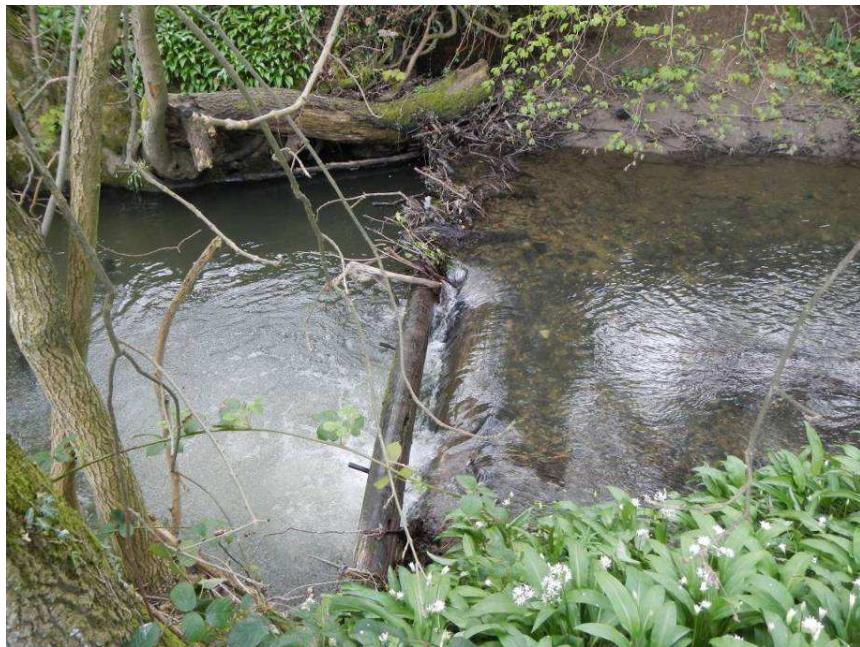
The issues considered to be a significant impact on the upper section are the barriers. These range in size, but five consisted of telegraph pole gravel check weirs (SK3290875913, SK3302175842, SK3303475835, SK3307775830, SK3352575731), all similar to the one shown in picture 7. Although only likely to be an issue to 0+ fish, they could be turning the Brook into a one-way, downstream conveyor for those individuals. In addition they are also restricting the natural transportation of bed materials.

Picture 7. One of five gravel check weirs, which pose an obstacle to 0+ trout and smaller species (bullhead and lamprey etc). Without these, spawning substrate would be better distributed throughout the reach, potentially in more beneficial locations, without the impact of impounded water.

- Undertake removal of the small weirs in the upper section. This is likely to low cost as, due to their wooden construction. This may be a task that the local angling clubs or a Rivers Trust could undertake.

Description	Picture	NGR
Log Weir	Similar to 7	SK3290875913
Telegraph Pole Weir	7	SK3302175842
Telegraph Pole Weir	Similar to 7	SK3303475835
Log Weir	Similar to 7	SK3307775830
Stone Weir	Similar to 7	SK3352575731

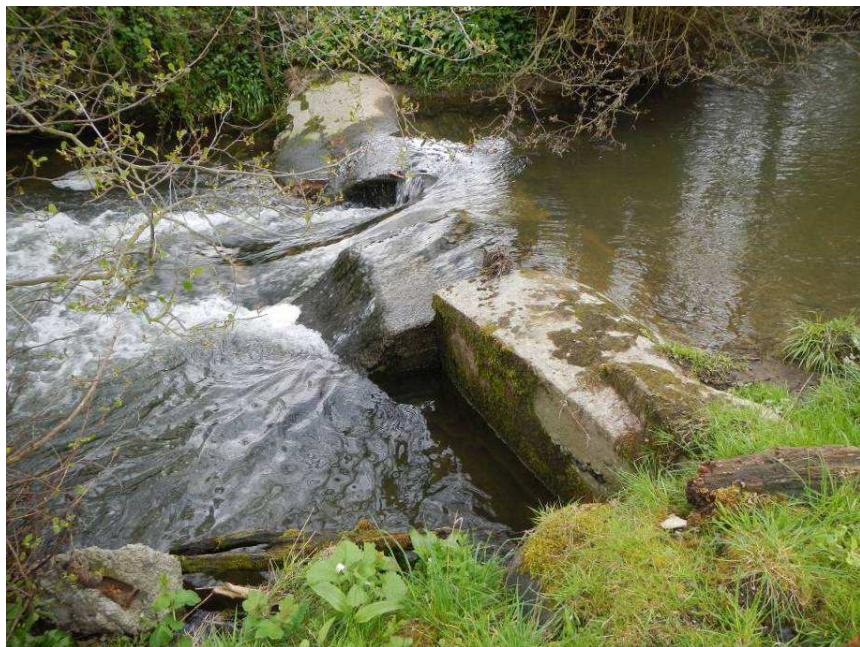
There were also three larger barriers on the Barlow Brook. One, a c.0.45m slotted concrete weir, which poses a significant barrier to smaller trout and smaller species (particularly lamprey) at most flows (Picture 8, SK3351675733), and two very large barriers, 2-3m high, which are impassable to most fish at most flows; one at (Picture 9, SK3341275705) and the other at the upstream limit of the fish farm (Picture 10, SK3364075748).

Picture 8. Concrete weir with notch. This structure was relatively low, but flow velocities within the notch greatly limit its passability.

Description	Picture	NGR
Concrete Notch Weir	8	SK3351675733
Impassable Stone-sett Weir	9	SK3341275705
Concrete Faced Weir	10	SK3364075748
Concrete V Weir	21	SK3538375433
Cobnar Concrete Weir	22	SK3556375522

The exception being that some could possibly be tackled by an angling club with EA support (Pictures 8, 9, 21 & 22); these type of structures have been tackled by angling clubs before, with a good example on the Cong Burn, Co Durham (Appendix 1). On the Cong Burn, a weir was removed, along with installation of 120m of culvert baffles for c. £20k (from recollection c.8k was for the weir removal). By this standard it is anticipated that the smaller weirs in question of the Barlow Brook could be tackled for £<10-20k each, with a local contractor possibly taking on the work as a job lot for a reduced price.

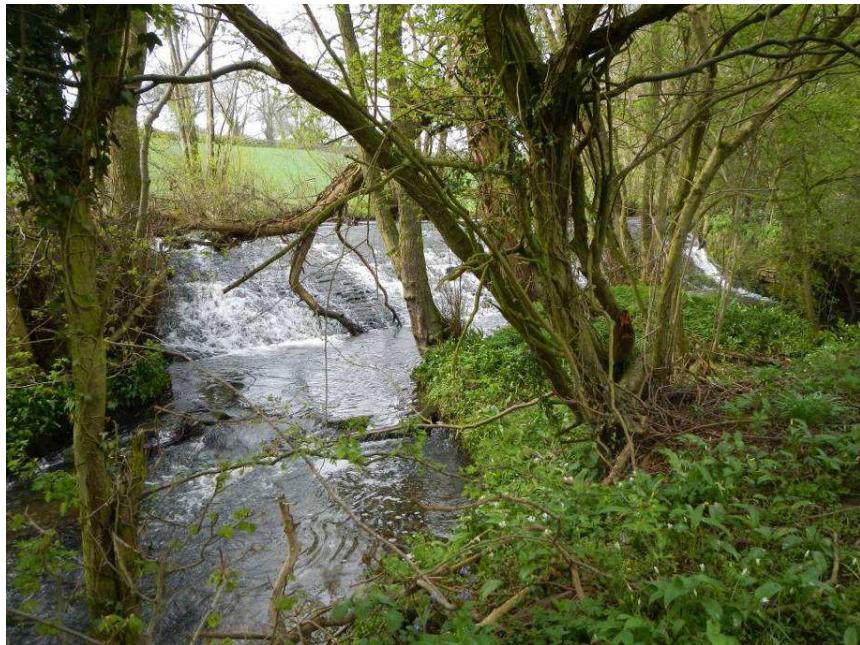
Picture 9. The first major weir encountered, posing an impassable barrier for all species at most flows. This weir, in conjunction with the one downstream (Picture 10) is likely to completely isolate the Upper Section of this waterbody from the downstream sections.

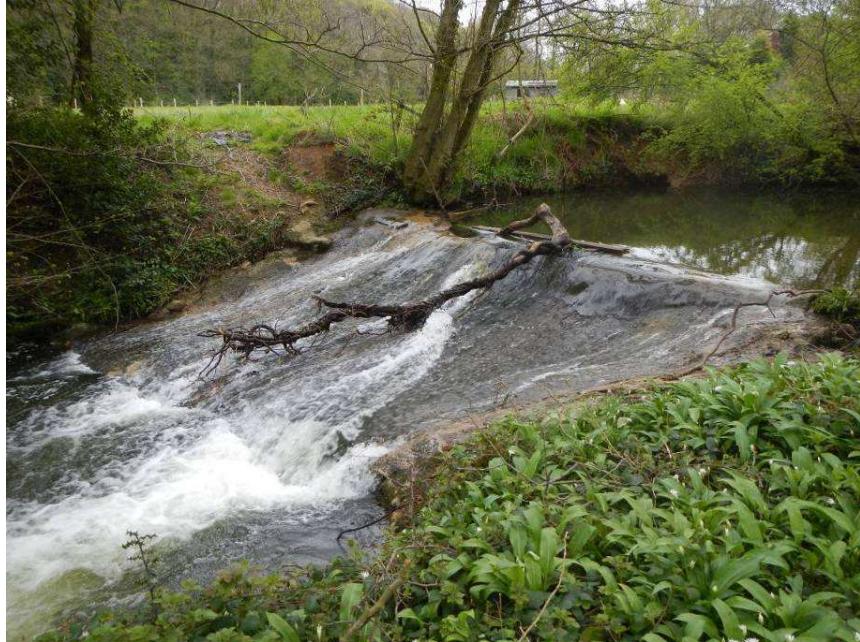
Picture 10. Large weir that is impassable at most flows, only likely to be passable by some larger salmonids at higher flows. This structure isolates the majority of the fish populations within the Lower and Middle Sections from the good quality habitat of the Upper Section.

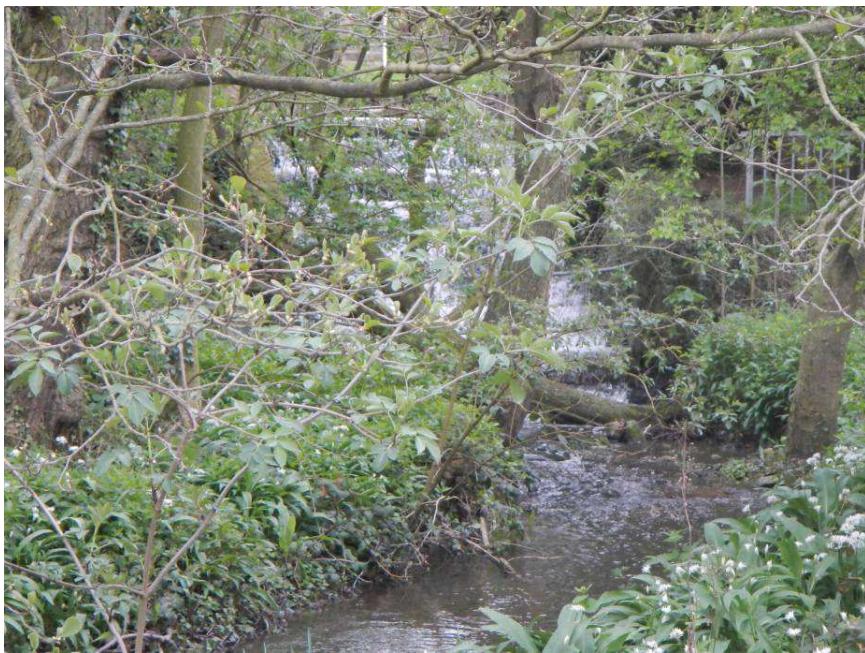
In addition, there was another impassable barrier on Crow Hole Brook, the tributary that joins Barlow Brook near the western end of Highlightley Lane (Picture 11, SK3361675713). The substrate of this watercourse appeared to be of a suitable size for trout spawning and it could be a significant loss as a spawning tributary.

Picture 11. Barrier just upstream of Barlow Brook on Crow Hole Beck.

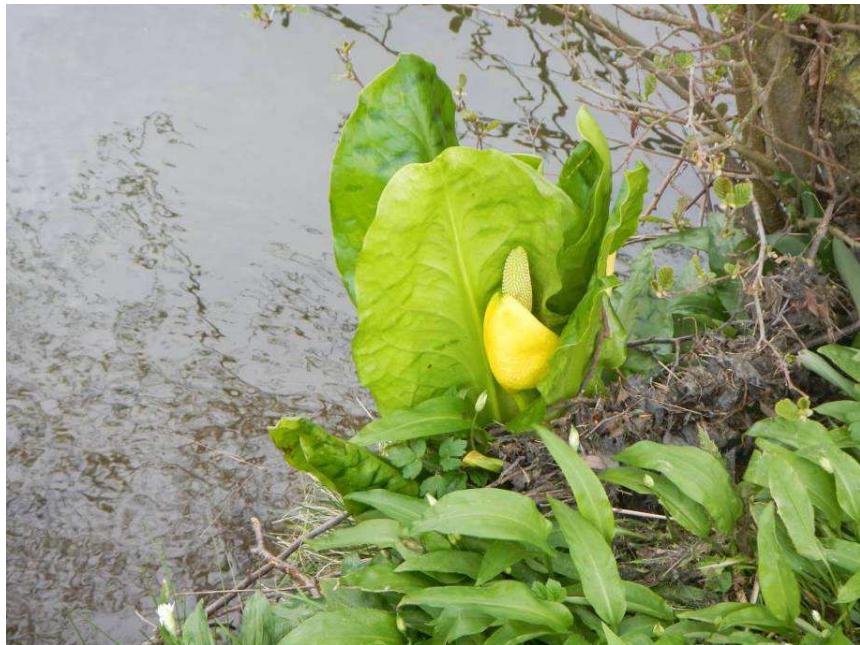
One other issue of note was the presence of a serious non-native invasive plant species, the North American skunk cabbage (*Lysichiton americanus*), recorded at SK3355875724 (Picture 12).

Picture 12. North American skunk cabbage.

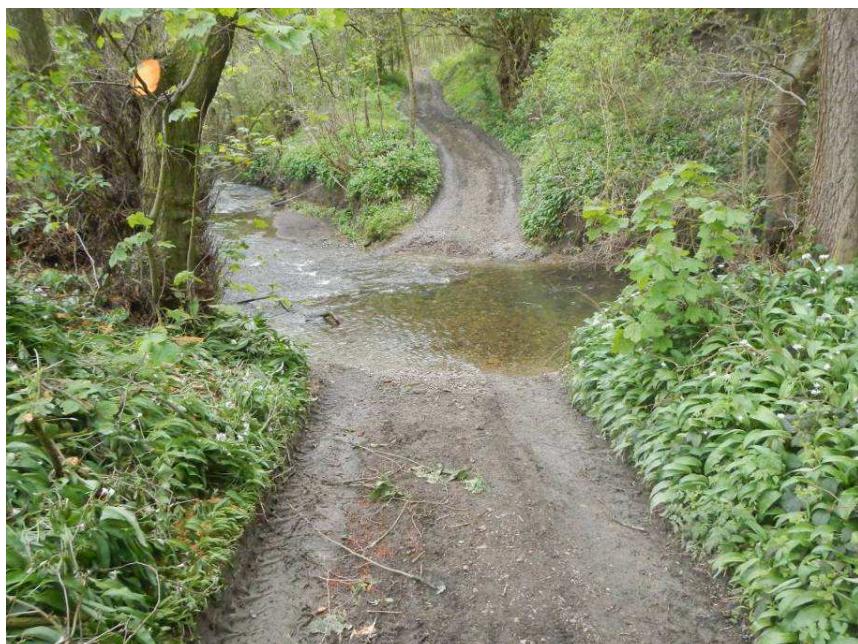
Three further significant sources of sediment input were observed in the location of the fish farm and fishery (SK3374175758, SK3383475678 and SK3398475618), where access tracks ford the brook. The issue is not limited to the fording points as the approach tracks also appear to be acting as a conduit for runoff and sediment entering the Brook (Picture 13). From around this area there was a

Picture 13. Fording point leading to bank erosion and supplying sediment from the access tracks.

High	Ford and access track	13	SK3398475618	Formalise access track and reduce usage if possible
Medium	Runoff from track/path	17	SK3446875503	Disconnect surface runoff from Brook
High	Erosion through livestock access Holmesfield Brook	19	SK3451075510	Install Buffer Fencing on grazed fields restricting access to one point/install alternative water supply
Medium	Livestock access to the watercourse leading to erosion and cumulative sediment	20	SK3458775416 - SK3478075371	Install Buffer Fencing on grazed fields restricting access to one point/install alternative water supply
Medium	Livestock access to the watercourse leading to erosion and cumulative sediment	As 20	SK3505175424 - SK3542575533	Install Buffer Fencing on grazed fields restricting access to one point/install alternative water supply

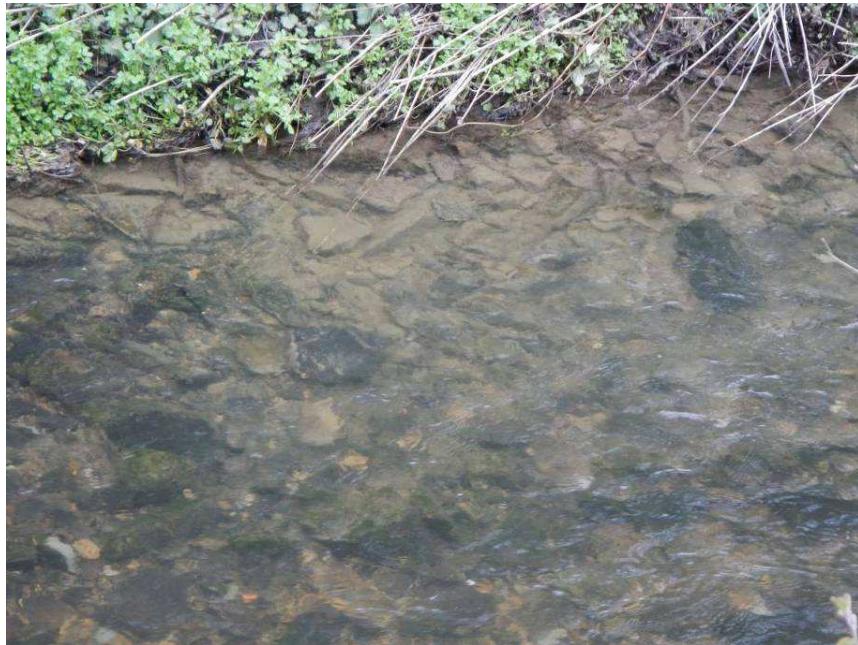
notable increase in the fine sediment levels observed on, and within the substrate (Picture 14). It is also known that during development of Crow Hole Reservoir, prosecutions were brought due to sediment pollution, and the Crow Hole Brook discharges to the Barlow Brook in this area. Residual sediment from this issue may still be having an impact both here, and throughout the waterbody downstream.

Sediment impacts have greatly degraded spawning habitat in this area, leaving it silty and less mobile. There was also a general reduction in the level of 10-40mm substrate observed throughout this section, likely due to the lack of supply past the weirs upstream.

Picture 14. Notable increase in the level of sediment accumulating in the river margins and within the bed material.

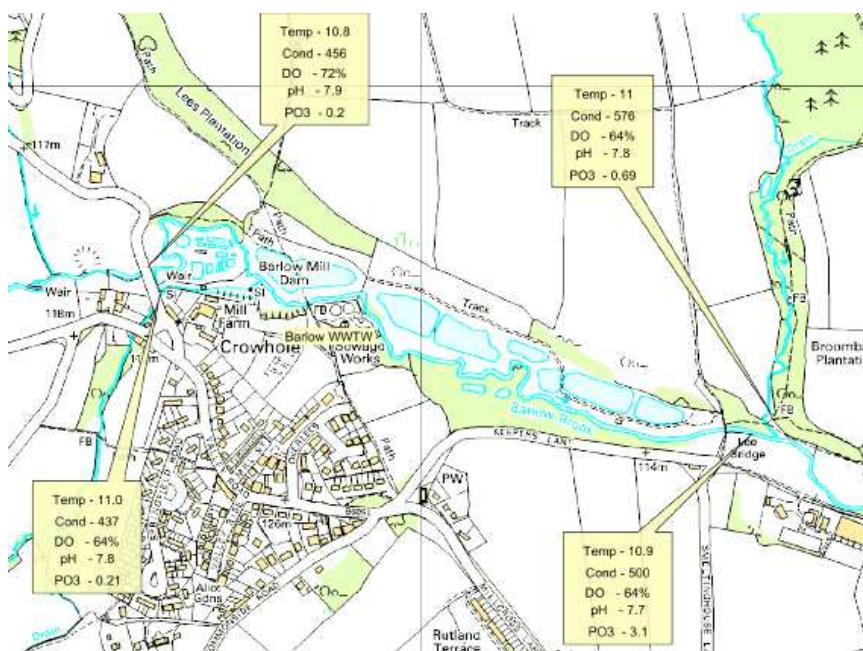
The waste water treatment works (WWTW) in this section (along with Holmesfiled WWTW downstream) is suspected to be the source of elevated phosphate within the Brook, as indicated by levels which increase from 0.2 and 0.21mg/l upstream of the works, to 3.1mg/l downstream (Picture 15). This does not, however, take into account that the fishery and fish farm effluent could also be contributing to elevated phosphate levels, as both the WWTWs and fish farm discharge between the same two sample points (Picture 15). While the WWTWs are likely to be the primary issue it is also worth considering that the fishery complex could also be contributing.

Picture 15. Both the WWTW and fish farm/fishery complex discharge within the section of the Barlow Brook in which the elevation of phosphate occurs.

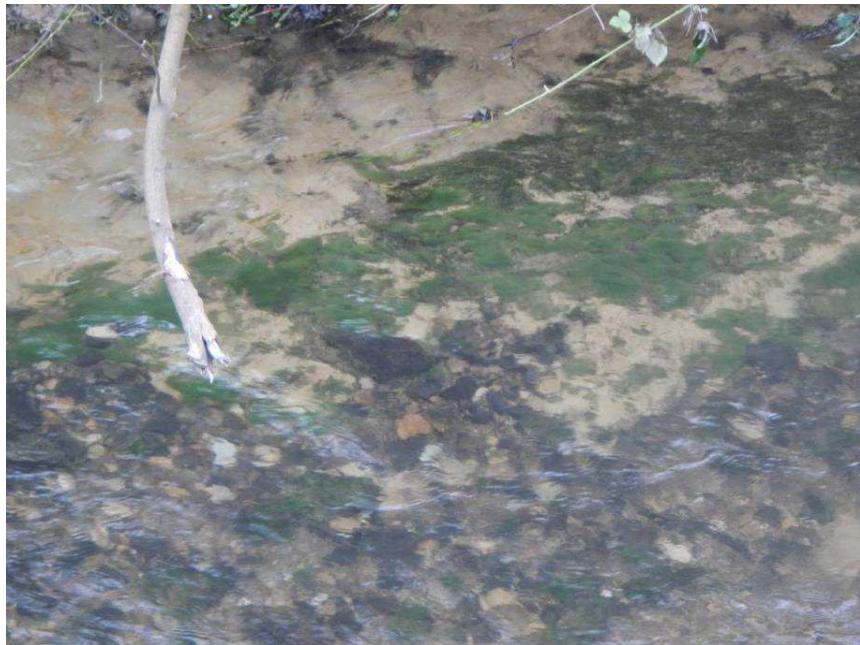
In addition, significant, plainly visible algal growth on the riverbed was first noted at SK3405275597 (Picture 16), which is upstream of the fishery outlet, but downstream of the WWTW and fish farm (and possibly the fish farm outlet). This could also be associated with increased nutrient levels.

Picture 16. The first area of algal growth observed on the Bed of the brook in either of the upper two sections, observed downstream of the WWTW and fish farm.

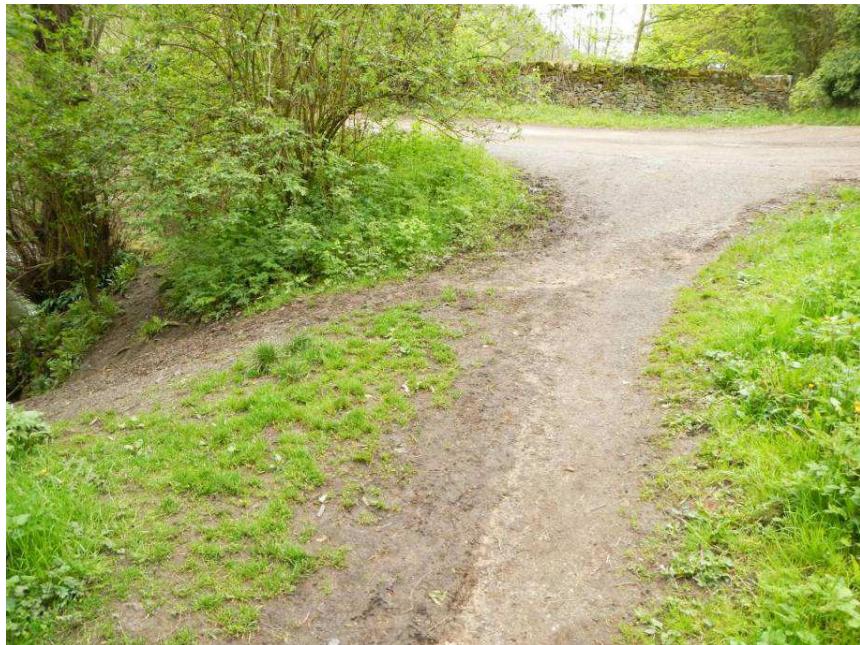
Downstream of the fishery further sediment input issues were identified from the track over Lees Bridge, which was supplying surface runoff directly to the Brook (Picture 17, SK3446875503). This could be addressed by diverting the runoff to a better vegetated area of ground, or a purpose-dug soak away.

Picture 17. Sediment pathway to the Brook from Lees Bridge. Obvious signs of direct runoff to the Brook were observed at this point, compounding sediment issues from upstream.

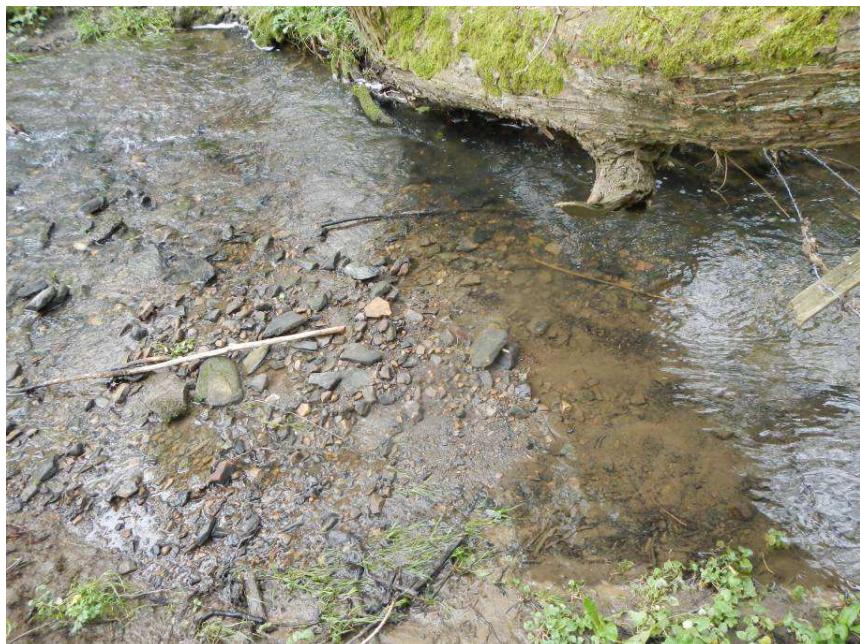
Continuing downstream, Holmesfield Brook is a potential spawning tributary with substrate suitable for salmonids. Unfortunately, the Brook is also compromised by sedimentation issues, likely to inhibit its contribution to recruitment (Picture 18). A quick glance on the Brook, upstream of the Barlow Brook confluence, revealed issues that could be reduced by livestock exclusion, thereby improving its potential (Picture 19).

Picture 18. Obvious signs of sedimentation on the Holmesfield Brook, which could otherwise serve as a valuable spawning tributary for the Barlow Brook.

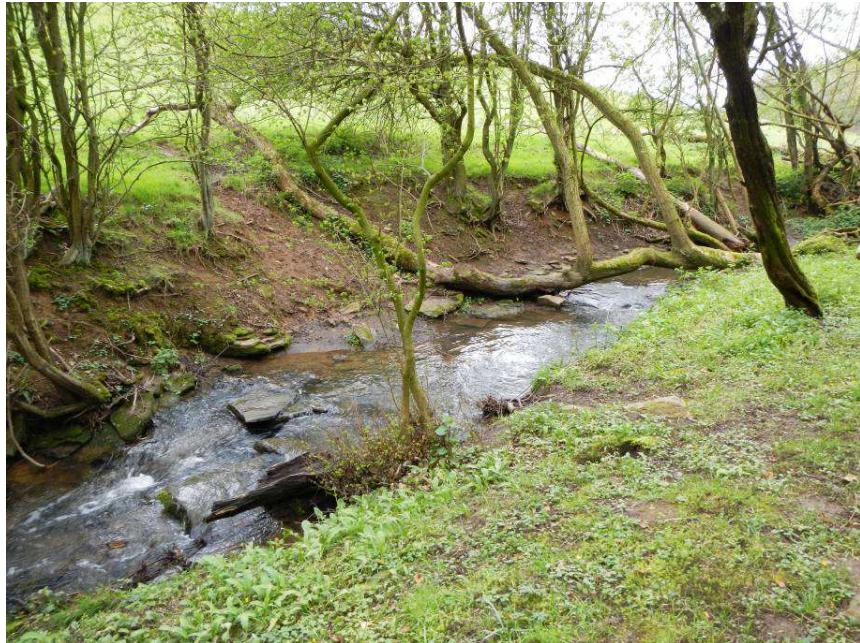
Picture 19. Sediment sources through livestock pressure on the banks of the Holmesfield brook.

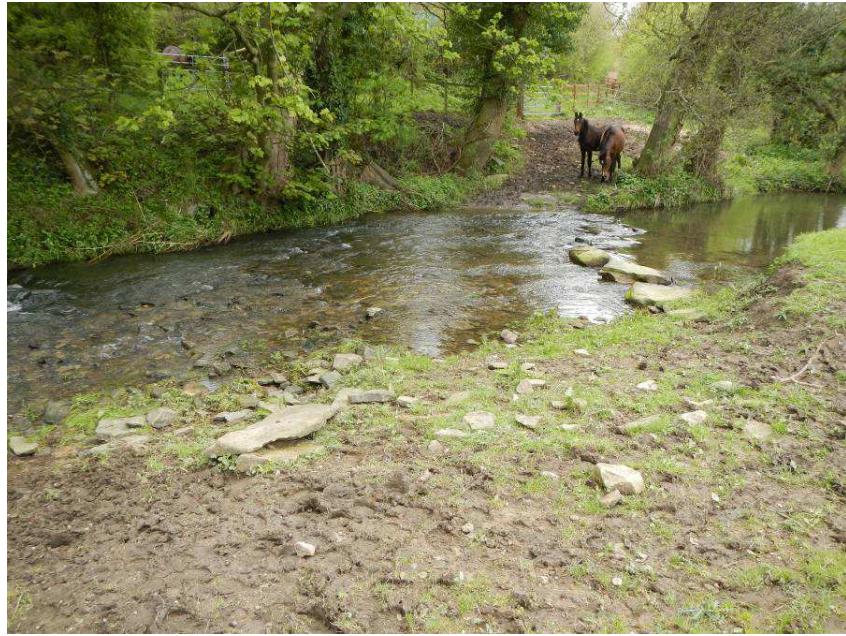
Further issues with livestock poaching and trampling were encountered downstream, wherever livestock had access, but specifically between SK3458775416 and SK3478075371, and between SK3505175424 and SK3542575533. This is another fine sediment source to the Brook and adds to the problems already impacting the watercourse upstream. The issue is particularly bad in areas where stock have access to both banks (Picture 20, SK3470475348). It is likely that the fording point is being used as sole access to the opposite bank and it may be hard to prevent this. It may however be possible to install hard standing, or encourage fencing of the watercourse, with access gates to allow more restricted access for fording.

Picture 20. Unrestricted livestock access to both banks, where the river is being forded, leading to increased siltation.

If access in these sections could even be restricted to one watering point per field the problem could be reduced. Alternatively, creating areas of hard standing at the watering points, or arrangement of alternate water supply to troughs or pasture pumps, depending upon the location, would be greatly beneficial.

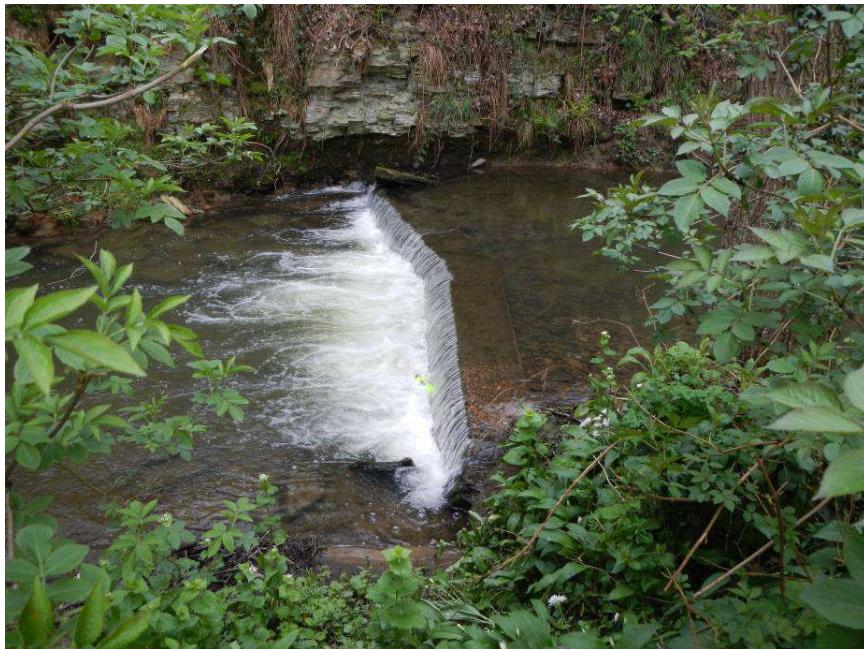
Picture 21. Small concrete V weir greatly reducing passability for juvenile trout and smaller species.

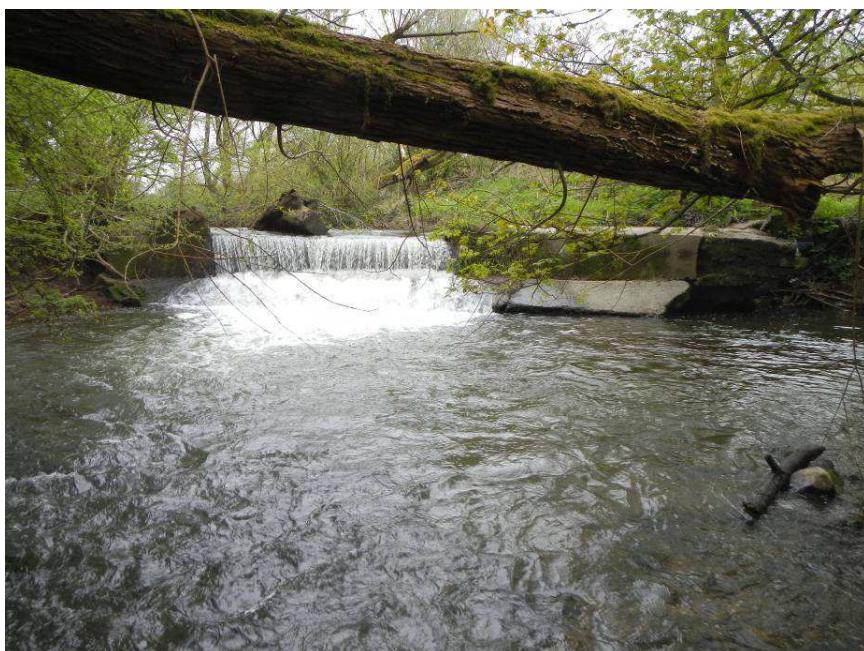
Areas of good quality trout habitat were available in this section. However, the issues of barriers upstream and within this section are likely to severely limit the full utilisation of all habitats available within the Barlow Brook. This is particularly pertinent when considered that this reach is fragmented by reduced passability at small weirs (Picture 21, SK3538375433), and isolated from the Upper Section (Picture 10) and Lower Section (Picture 22, SK3556375522) by large impassable weirs.

Picture 22. Major impassable barrier isolating the Lower Section from the Middle and Upper sections.

Other options that could be undertaken at the Cobnar Wood Weir is the reinstatement of some of the original Barlow Brook course, which appeared to originally take a large meander loop in the area of the current ponds. Reinstatement of this channel may be infeasible, due to later developments, but if a possible course remains, or new course

could be created, this could avoid the requirement for weir removal and reinstate a longer section of natural watercourse.

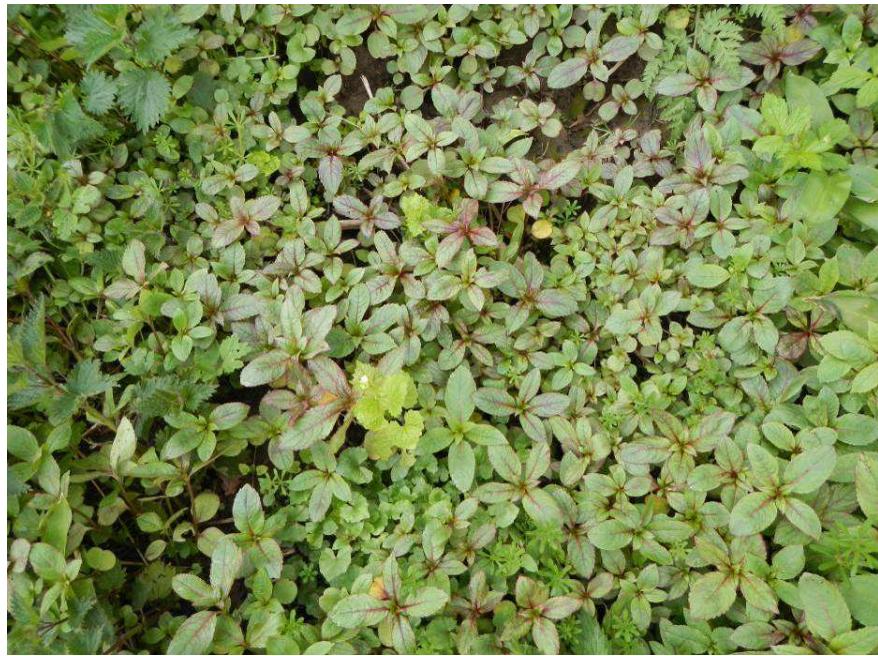
This reach was also the first place that Himalayan balsam was observed, at SK3545475492 (picture 23), although at the current stage of growth it is possible that other areas upstream were missed.

Picture 23. The first stand of Himalayan balsam observed on the watercourse.

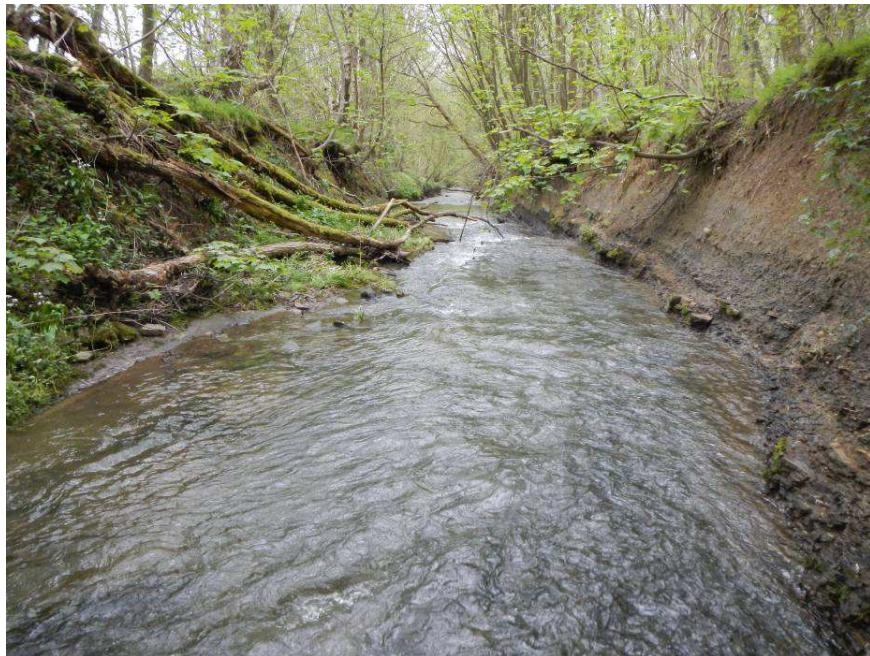
Downstream of Cobnar Wood Weir the character of the Brook changes significantly, entering c.200m of straightened channel. This is further exacerbated by the prevention of substrate transport past the weir. This result is a deeply incised channel, with an absence of deeper pools and a predominantly cobble substrate, lacking in smaller, salmonid spawning size gravel (Picture 24). The incision of the channel has also exposed large areas of bank to erosion, increasing siltation of the watercourse.

Picture 24. Deeply incised channel lacking in cover through an absence of pools and low-level cover. Due to the lack of supply and fluming effect within the incised channel most of the smaller salmonid spawning sized substrate has washed out.

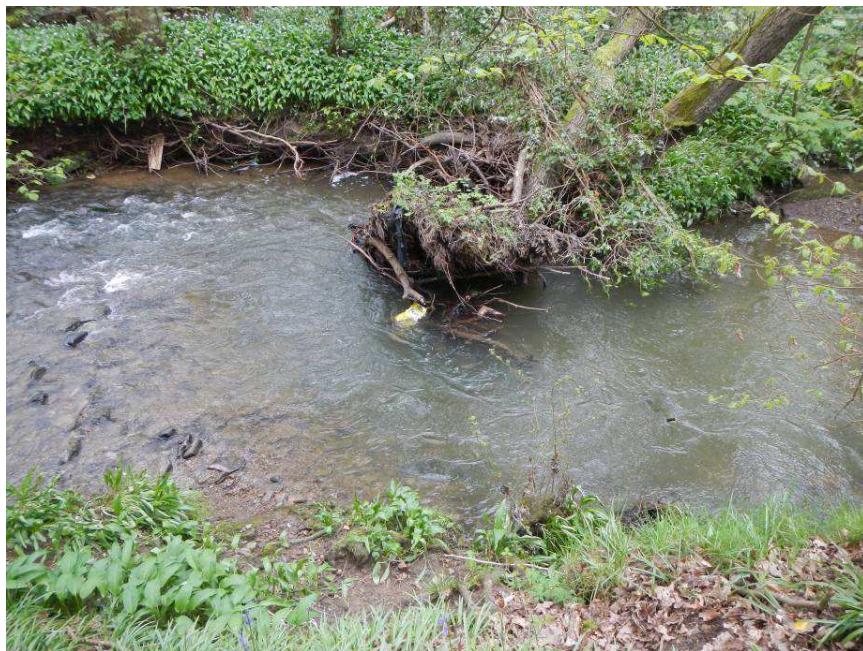
Where small bends occurred (Picture 25) and bank-side trees create flow deflection (Picture 26), the in-channel habitat improved through scour and pool creation, but a general lack of spawning sized substrate remains. This is likely due to the reduced supply from upstream and the constrained channel flushing out much of the smaller gravels won via erosion. Where sheltered areas occurred, some areas of spawning sized substrate were retained, but suffered from sedimentation issues (Picture 27).

Picture 25. Localised scour and cover provided by WD/bank-side trees.

If the level of WD and bank-side trees could be increased to improve flow diversity the habitat could be improved and trout habitat increased. This would however be enhancement of a heavily modified system and by no means returning it to an un-impacted state.

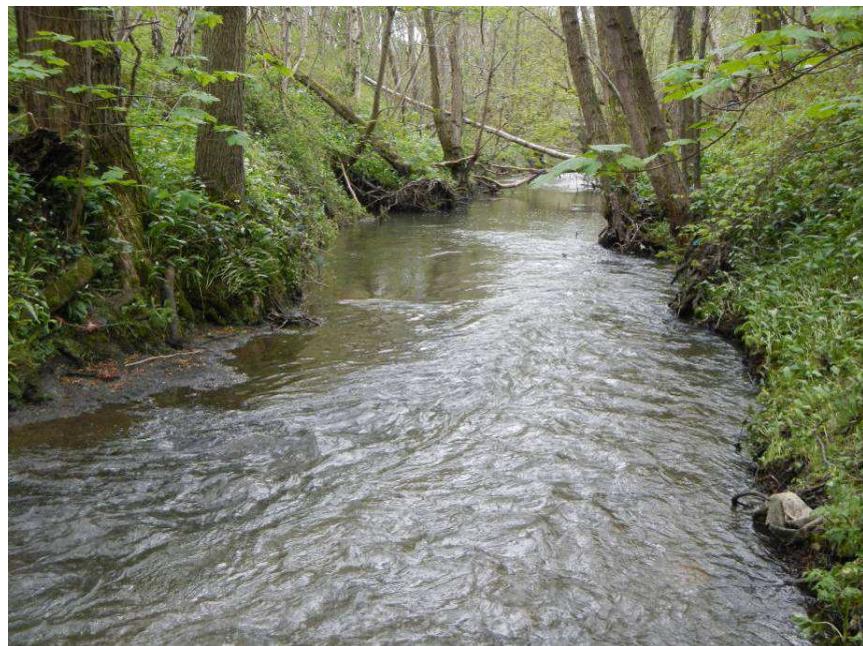
Picture 26. Increased sinuosity provided by trees, creating flow deflection on a heavily straightened section of the Brook.

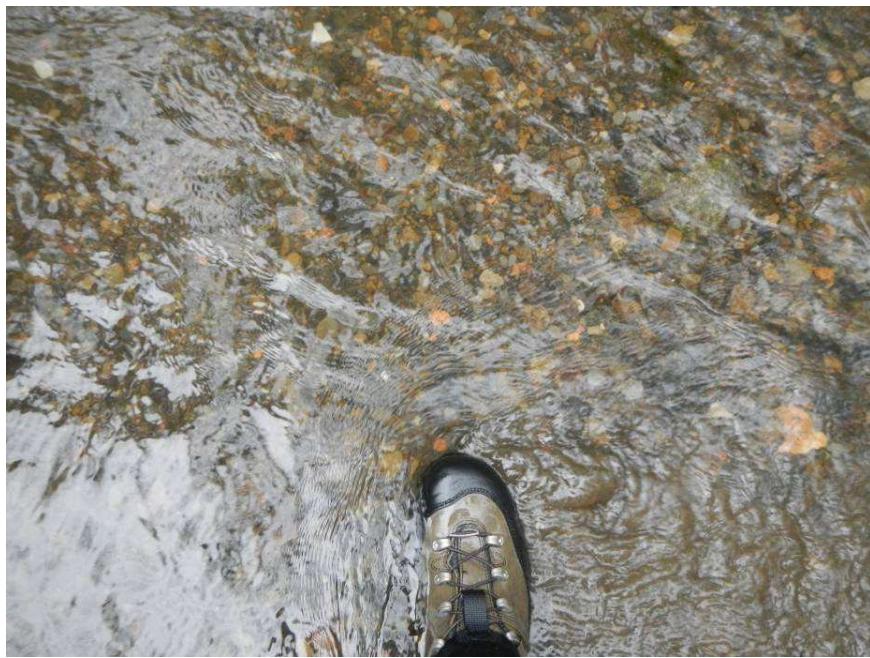
Picture 27. Sediment liberated from potential spawning substrate.

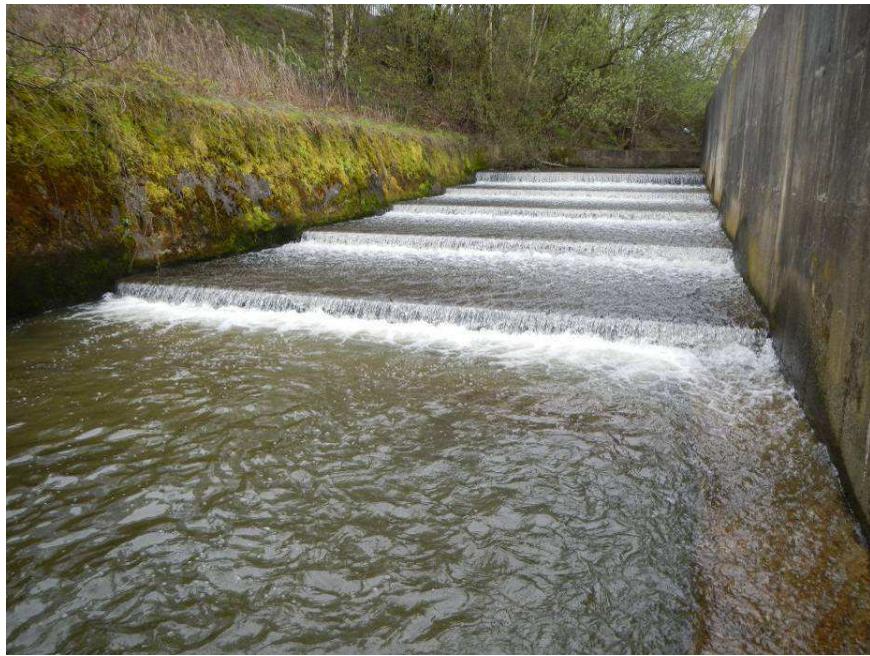
Within this section Carr Wood Road crosses the Brook twice. The upper Culvert poses no major problems, but the Lower crossing creates an area of shallow water above a long stepped weir (Picture 28). This is another very significant barrier to fish passage, impassable by most species in most flows (probably a complete barrier to eels).

Picture 28. Stepped weir with very poor passability due to a lack of water depth. Conversion to a rock ramp would greatly improve passability.

As removal of this structure is infeasible, due to the impacts on the road bridge and bank stability, the ideal solution would be to convert the stepped weir face into a rock ramp/rock chute type fish pass, thereby making it passable by most species. This is unlikely to compromise the integrity of the structure and should actually increase flow dissipation through the baffling effects of the rocks.

Description	Picture	NGR
Impassable Stepped Weir and Culvert with shallow water	28	SK3628175284

Design of a large scale rock ramp or rock easement type pass will require consultation with, and approval from the EA's Fish Pass Panel, but a cursory assessment of the area available and gradient suggests that it could certainly be used to create a pass/easement <10%. This is outside the Fish Pass Manual guidelines of 1-5%, but a rock ramp of c. 10% has been effective for sea trout in Wales.

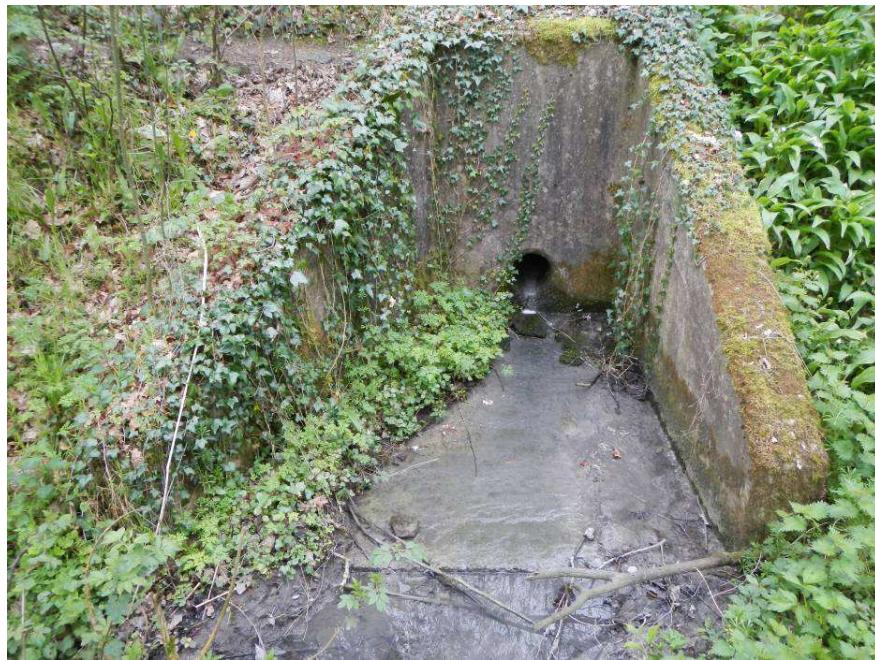
Numerous outfalls were also present throughout this section, as would be expected from an industrial area. On the day of the walkover most of these were relatively clean (possibly surface drainage), although one appeared to be a potential source of further enrichment/pollution (Picture 29, SK3577675507).

Picture 29. Possible pollution source.

- Investigation of a possible additional pollution source at SK3577675507 should be undertaken (Picture 29).

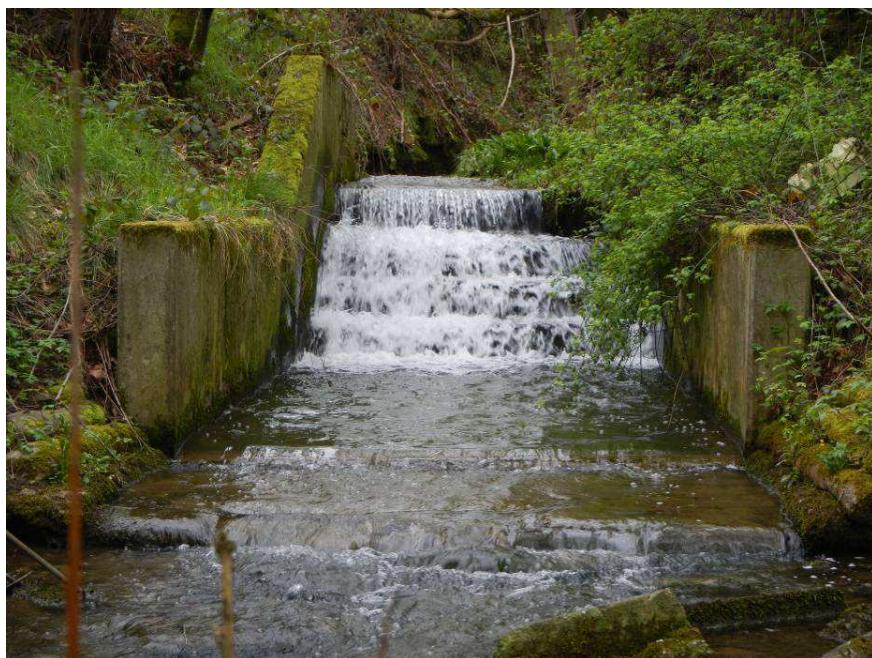
Two tributaries were present along this section; however, only the Sud Brook was considered to have potential for spawning, and even so, had a large impassable weir a short distance up from its confluence with the Barlow Brook that would need to be addressed (Picture 30). The substrate in Sud Brook appeared to be of a suitable size for spawning, if a bit silty, but later assessment of local maps suggests that it may also be culverted for a long section above the weir. The water quality is also unknown and it is suggested that this is investigated before any other potential improvements are considered.

Picture 30. Impassable weir on the Sud Brook. This tributary may have potential as a spawning tributary, but has several potentially large issues.
