Water Framework Directive Investigation

King Water

Waterbody - GB102076074080

May 2012

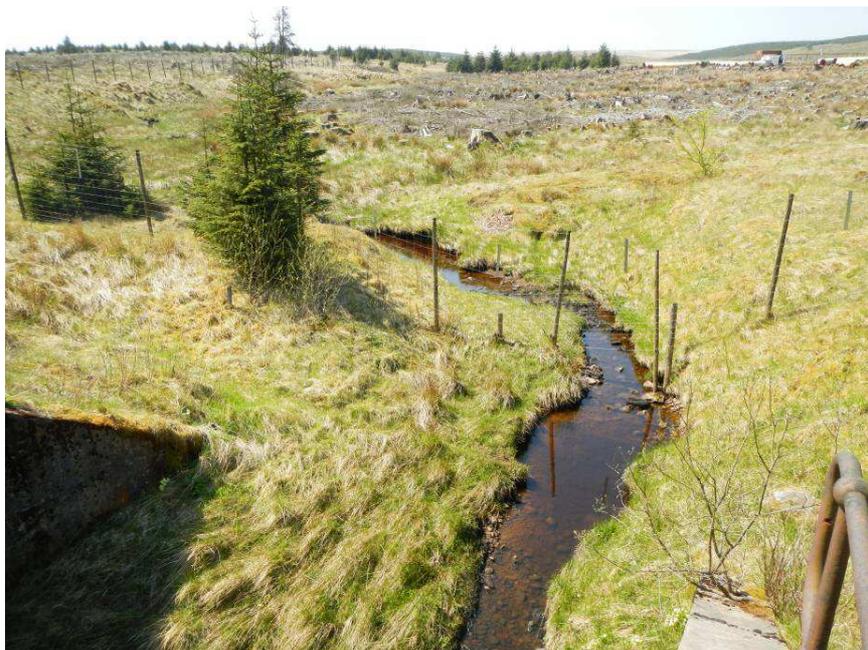
The headwaters of this waterbody (primarily King Water and Caud Beck) lie on the edge of Spadeadam Forest, where large areas adjacent to the watercourse have recently been harvested, leaving the watercourse open, lacking in-channel structure and with little shade (Picture 1). Downstream of the main forestry area the upper sections of this waterbody are subject to unrestricted sheep grazing which has also denuded the banks of trees, shrubs and herbaceous vegetation (Picture 2). This reduces habitat quality, by reducing the availability of suitable refuge and leaves the watercourses susceptible to high temperatures on warm, sunny days.

The substrate in the upper King Water and tributaries was generally coarse, comprising predominantly cobble and boulders (Picture 1 & 2). There were sufficient areas of finer, 10-40mm gravels suitable for successful trout spawning, but generally less than in comparable catchments. The juvenile habitat would be greatly improved, however, by the presence of more riparian cover.

Picture 1. The result of recent felling operations can be seen in the background.

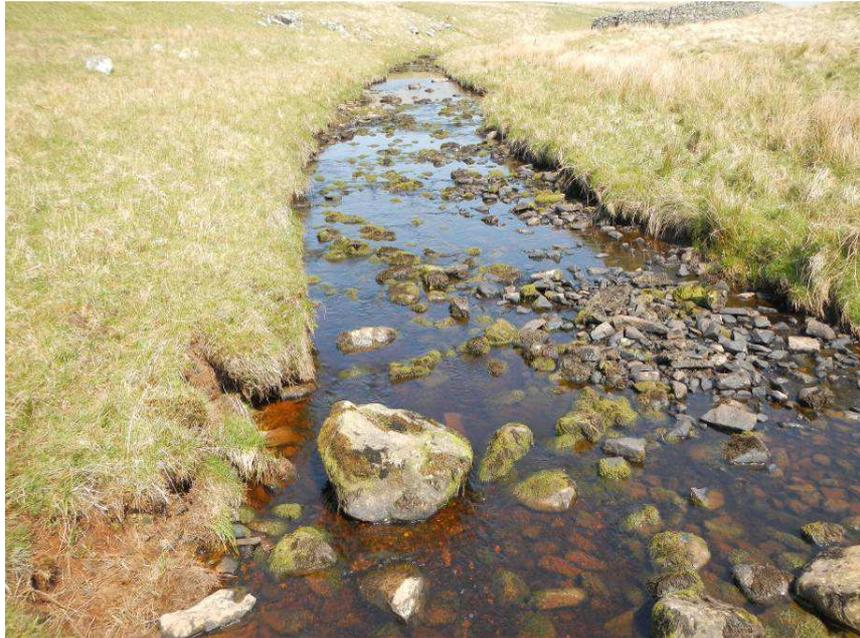
Enrichment was impacting on the watercourse, even in the upper reaches, as shown by algal growth on the river bed (Picture 2). This may be attributable to the forestry operations adjacent to the watercourse. Some areas are now being replanted with deciduous species which should help to act as a buffer strip for nutrients, but also provide beneficial shade and in time, a source of woody material to the watercourse.

Picture 2. Open Channel, with little riparian vegetation, typical of the upper King Water and tributaries. Higher than expected algal growth was observed on the bed.

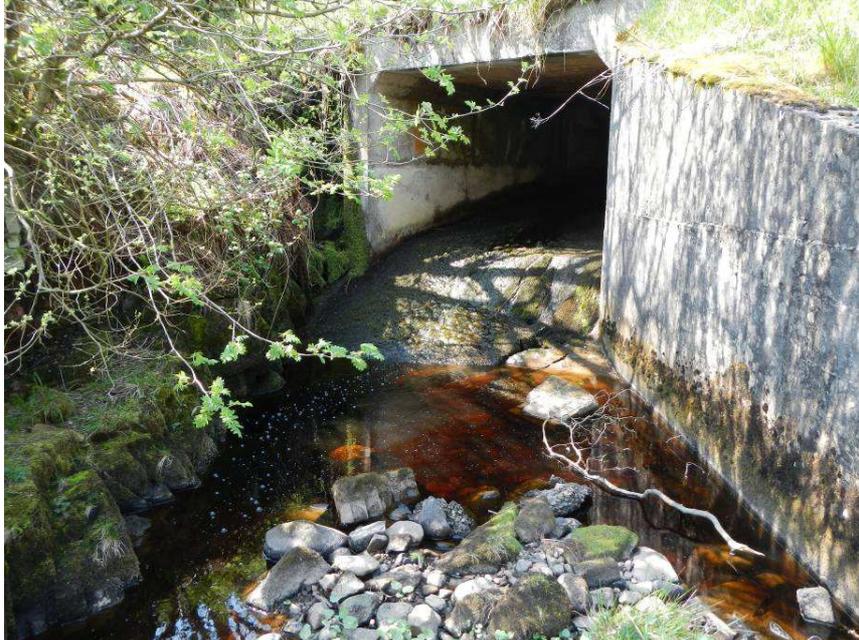
The other major impact on the fish populations of the upper King Water is the presence of a two significant structures, on the Middle Shield Beck (Picture 3) and King Water (Pictures 4). Both of these are associated with the access road to the RAF Spadeadam base and form significant barriers to fish movement, particularly trout. Their size means that by the time flows are sufficient to reduce the head difference and make them passable, water velocities are likely to be towards the upper limit of trout swimming capability.

Picture 3. Culvert providing access to Spadeadam base that exacerbates fish passage issues over a significant natural obstruction (NY6170170343). No fish were observed above this point on the Middle Shield Beck.

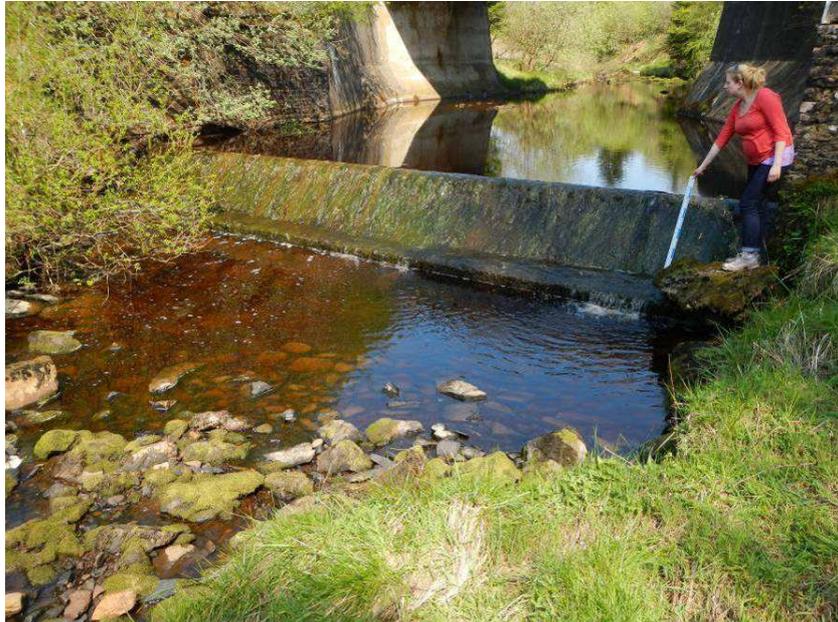
Immediately downstream of the barrier on the King Water (Picture 4) was the confluence of the Middle Shield Beck. A natural obstruction on the latter Beck prevents its utilisation as a spawning tributary by fish that cannot ascend the weir on the King Water, as may ordinarily occur.

Picture 4. Weir on the King Water, presumably to protect the upstream Spadeadam access bridge/culvert (NY6180470173). This is a significant barrier to all species, but particularly so for trout and smaller species. While at site a minnow was seen unsuccessfully trying to ascend the structure demonstrating the issue posed for juvenile fish and smaller species.

- Undertake removal of all major weirs and man-made obstructions or installation of species appropriate easements. These are larger scale projects, potentially requiring large scale rock ramp-type, or more technical fish passes, but could potentially be tackled through partnership working with Eden Rivers Trust (ERT).

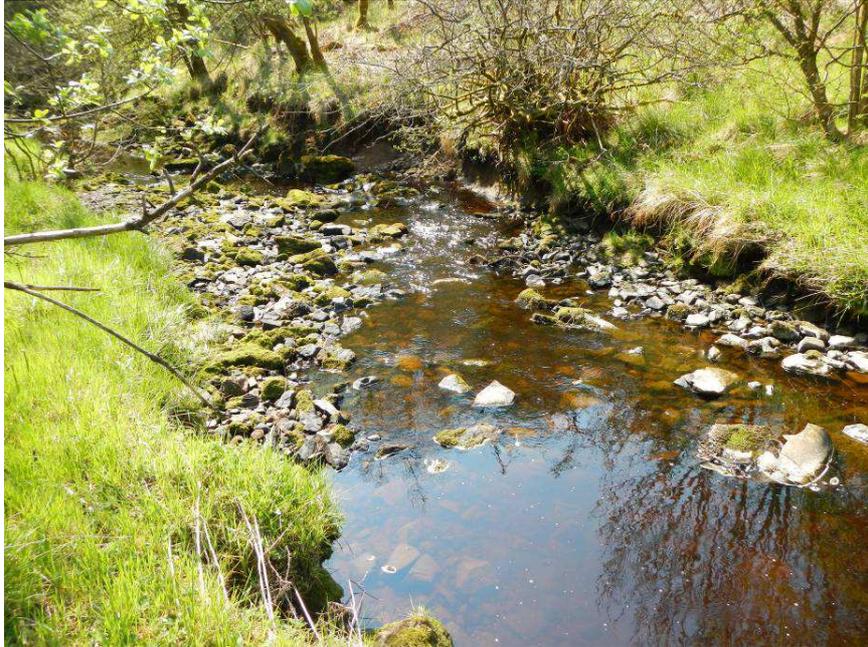
Immediately downstream of the weir, the King Water descends into a relatively steep narrow section, where the substrate is again cobble and boulder, providing little spawning substrate for trout, or other species that fail to pass the weir.

Picture 5. Coarse cobble and boulder substrate, with little opportunity for trout spawning, immediately downstream of Spadeadam access road.

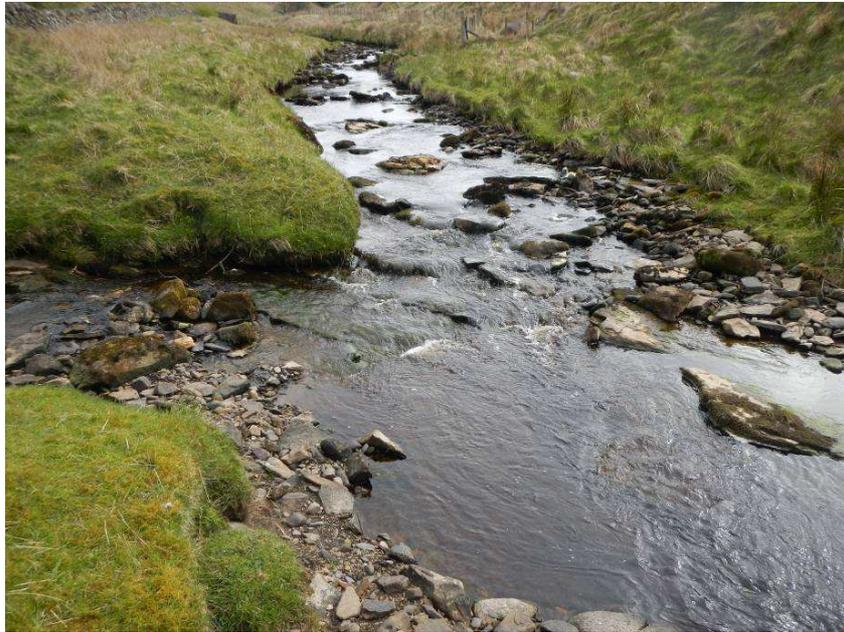
Picture 6. Confluence of the King Water and Trout Beck. Around this point the bed is dominated by bed rock and boulders. This section was walked on 03 May and high algal growth was already apparent.

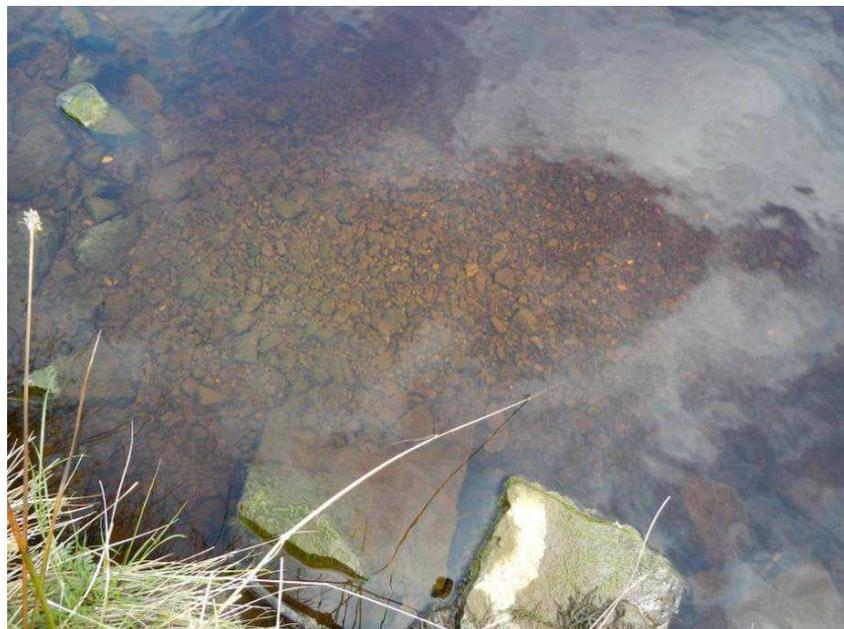
Further downstream the valley opens slightly and the land use reverts to sheep grazing. Here, beneficial riparian shrubs and vegetation are again absent due to grazing and habitat quality is reduced for trout. From this point downstream, bedrock becomes a significant component of the bed material, with boulders making up the other significant portion (Picture 6). This appears to be a natural consequence of the steep gradient and relatively narrow river valley producing flows that transport finer material further down the system; although, there may be a sediment trapping influence from the weir structure upstream. This area provides lower than optimal spawning opportunities for trout, although small pockets of suitable gravel were present in sheltered areas behind boulders (Picture 7).

Picture 7. One of the few pockets of gravel available to provide trout spawning substrate. By the nature of these aggregations, being in the lee of boulders and out of the flow they are likely to be sub optimal for egg incubation.

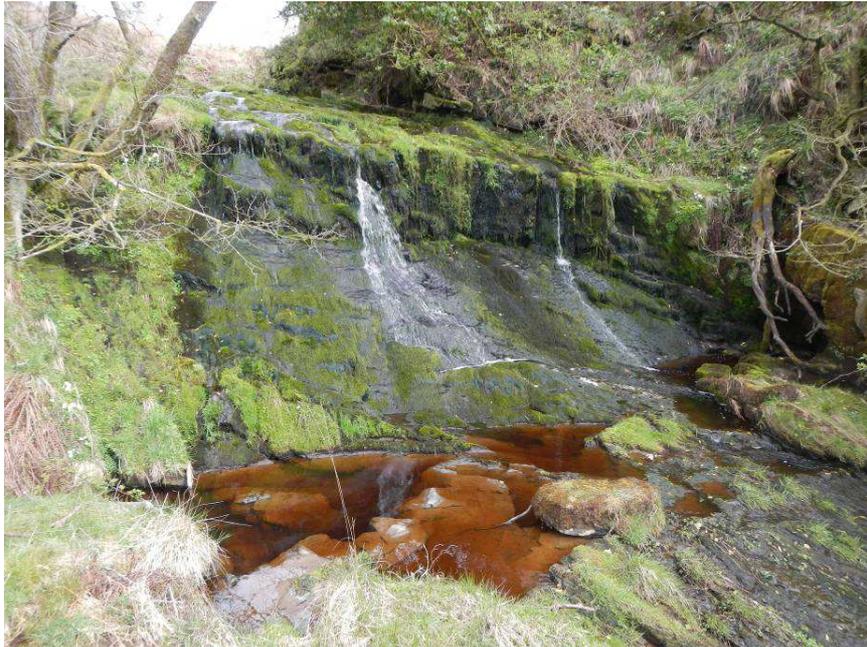
In this area, another significant tributary (Trout Beck) enters the King Water, which would potentially provide good spawning and juvenile habitat but an impassable natural waterfall prevents access a short distance upstream from the confluence (Picture 8). Inaccessible tributaries that would

Picture 8. Impassable waterfall on the Middle Shield Beck, which prevents its use as a spawning tributary (NY6062570285).

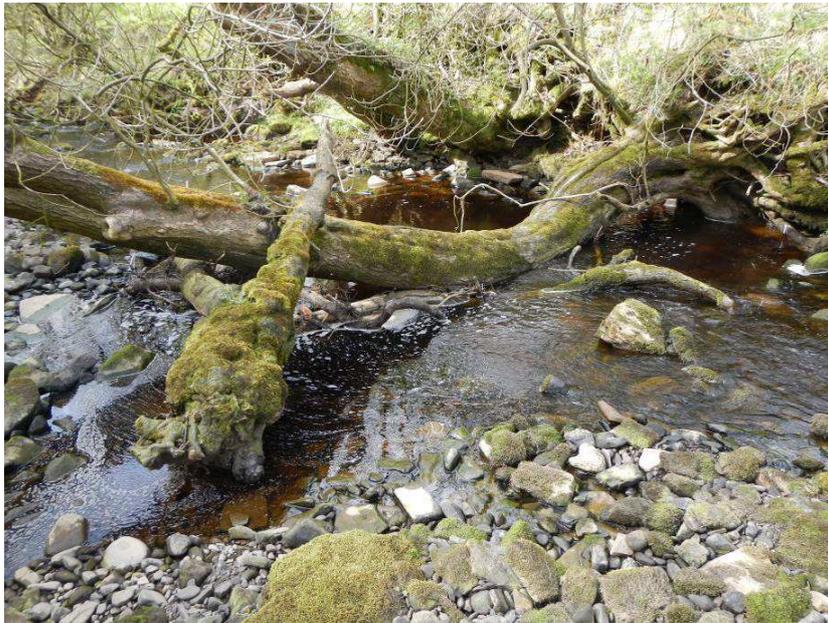
Further downstream trout habitat quality increases significantly as riparian trees become more prevalent, increasing the level of shading. Shading and in-channel structure increases to a beneficial level. Alder (*Alnus glutinosa*) and ash (*Fraxinus excelsior*) trees provide high quality canopy cover above, and root structure below the water surface. There is also a more readily available supply of woody debris (WD), which becomes a regular feature (Picture 9).

Picture 9. Good quality in-channel habitat provided by root structure, WD and canopy shading.

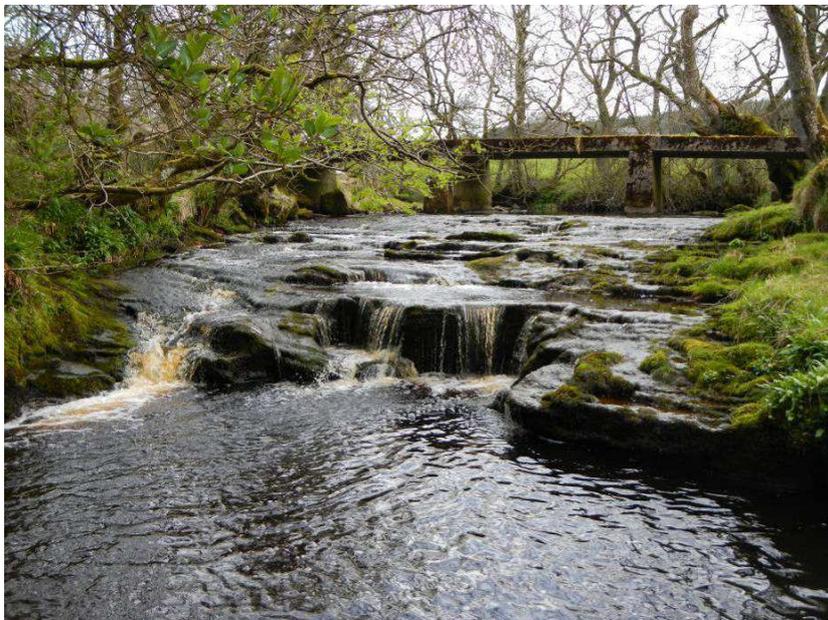
The channel remains heavily influenced by bedrock, with many small chutes and natural falls, most of which are a minimal issue to fish passage. However, the large outcrop over which the High Stead Ash access track crosses forms a significant natural obstruction and behavioural barrier (Picture 10). Another, further downstream, also poses an obstruction to fish movement (Picture 11).

Picture 10. Bedrock outcrop preventing optimal utilisation of available habitat u/s (NY5986168610).

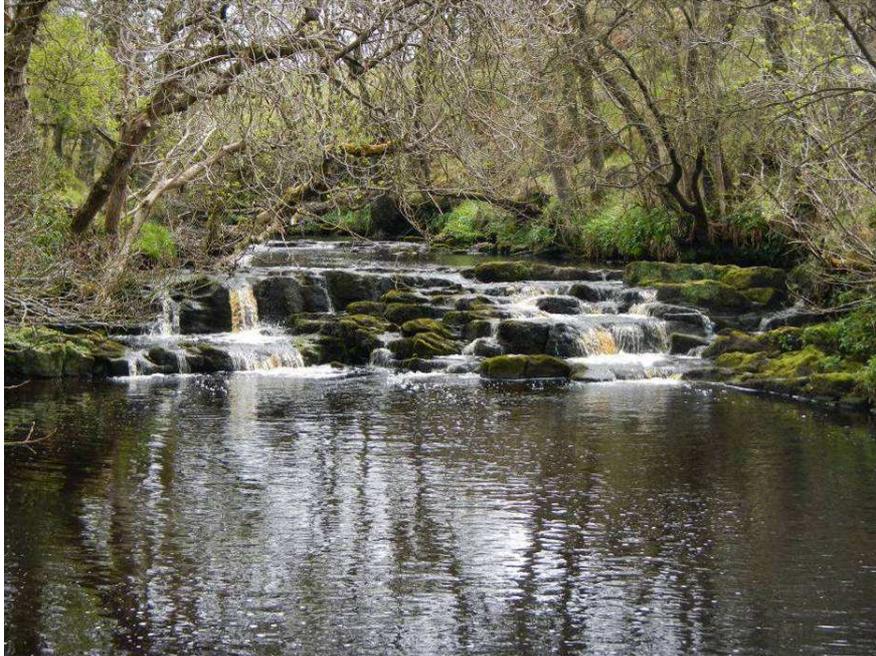
Picture 11. Medium sized natural rock outcrop (>1.25m) that will inhibit upstream migration of trout and smaller species (NY5869368056).

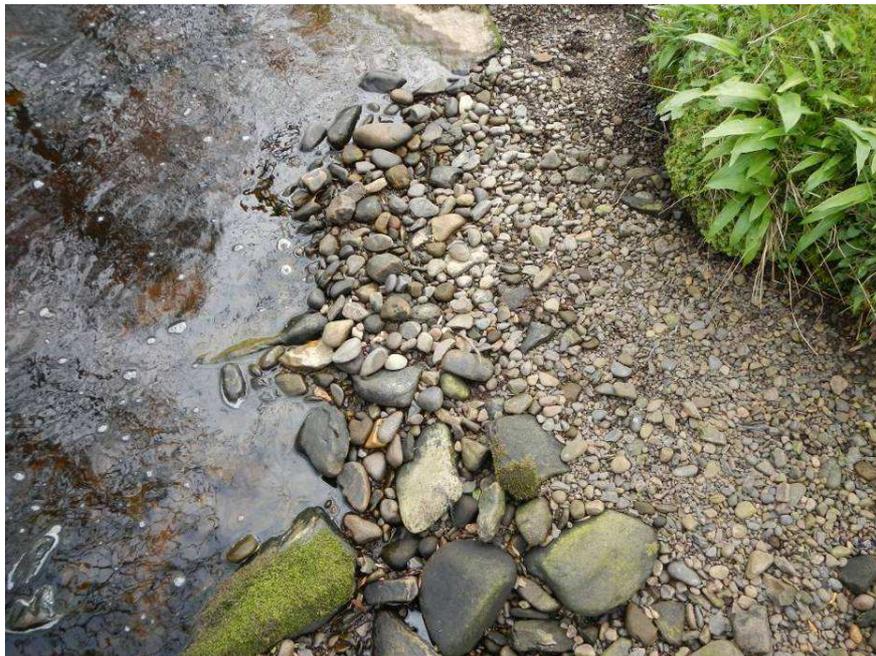
a result of the naturally constrained channel and relatively steep gradient. The potential impact of forestry drainage increasing the flashiness of spates and low summer flows may also play a part. Where gravel does deposit, it is generally away from the required cleaning flows and in some cases exposed by low flows, so provides little benefit for spawning (Picture 12).

Picture 12. Grading of bed material, typical of the King Water, with boulders in the main flow, cobbles towards the river margin and gravel only retained in the very edges; in this case becoming exposed by lower flows. This may be a naturally occurring issue due to gradient and geology, but may also be exacerbated by upland land management and drainage around the headwaters. This lack of suitable sized and located spawning substrate creates a significant limiting factor for trout spawning.

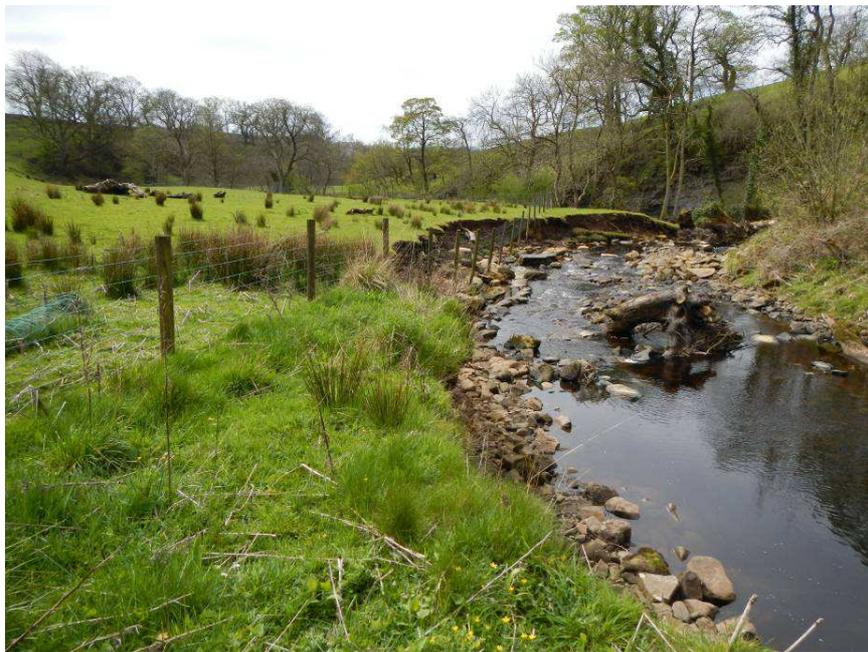
Approximately 0.5 km upstream of Kingbridge Ford, the river valley character starts to change, becoming wider and reducing in gradient. The land use in this area also changes, with the level of grazing increasing, and riparian and in-channel cover decreasing. It is from around this point that the first major issues with erosion were encountered (Picture 13). This appeared to have been a result of a land slip on the RB pushing the flow over into the LB, but the grazing of the banks within the buffer fencing in the background will be exacerbating the issue.

Picture 13. The first significant area of bank erosion observed.

Impact	Description	Picture	NGR	Action
Low	Erosion through stock access on RB	30 (Appendix 3)	NY5992268654	Buffer fencing
Medium	Erosion LB	13	NY5803467779	Increase size of buffer strip and prevent future grazing within strip
Medium	High grazing pressure resulting in a lack of riparian vegetation RB	31 (Appendix 3)	NY5747467247	Install buffer fence
High	Serious siltation of Mill Beck which is a valuable spawning tributary (LB & RB)	15	NY5726667160	Install buffer fencing
High	Serious siltation of Stone Beck which is a valuable spawning tributary (LB & RB)	16	NY5694767393	Install buffer fencing
Medium	Damage to banks through livestock leading to increased erosion (LB and RB)	32 (Appendix 4)	NY5671467363	Install buffer fencing
Medium	Suspected grazing issues, although the	33	NY5535266774	Install buffer fencing and

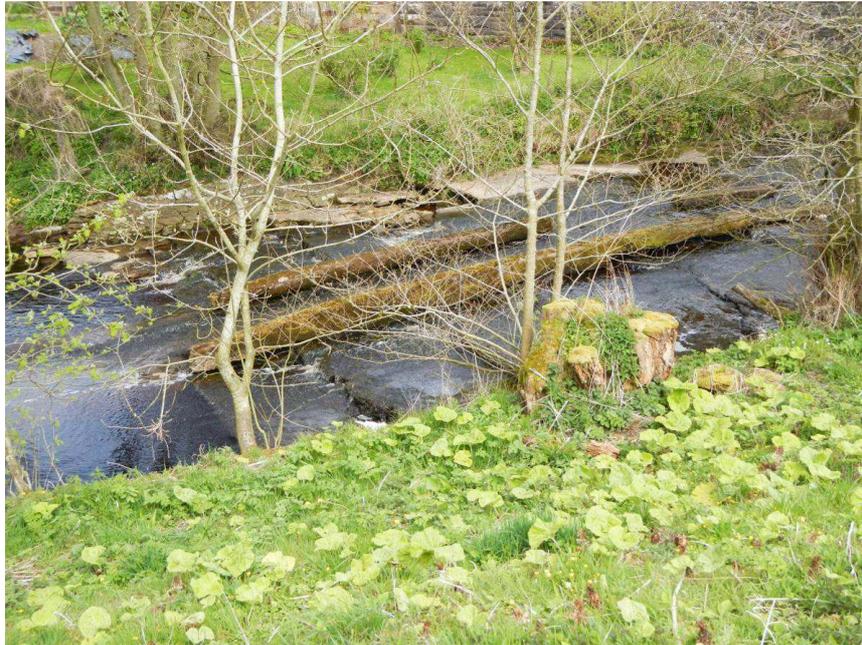
Kingbridge Ford bridge footings pose another issue to upstream fish passage, particularly for trout and smaller species. It may be that there is some form of natural barrier underneath, as is often the case with bridge locations, but the situation is certainly exacerbated by the concrete work and bridge footings. Improvements to fish passage have been attempted here, as seen by the dilapidated fish passage structure (Picture 14). This was never of a suitable standard and certainly no longer provides a significant improvement. A replacement fish pass/easement structure is required at this location.

Picture 14. Dilapidated fish pass at Kingbridge Ford (NY5775267462).

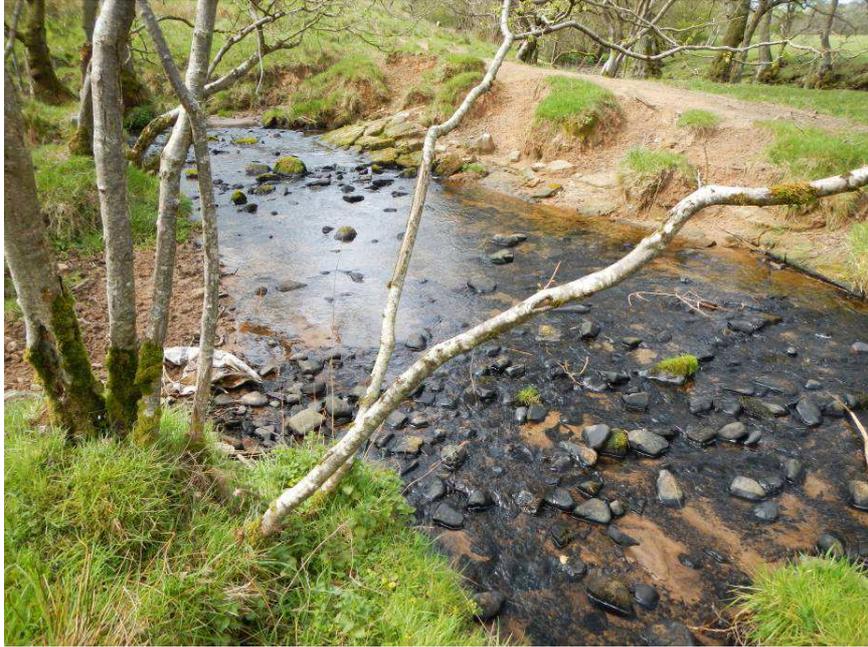
Picture 15. The Mill Beck, which provides significant potential as a trout spawning tributary if the stock access and sedimentation issues can be addressed (NY5726667160).

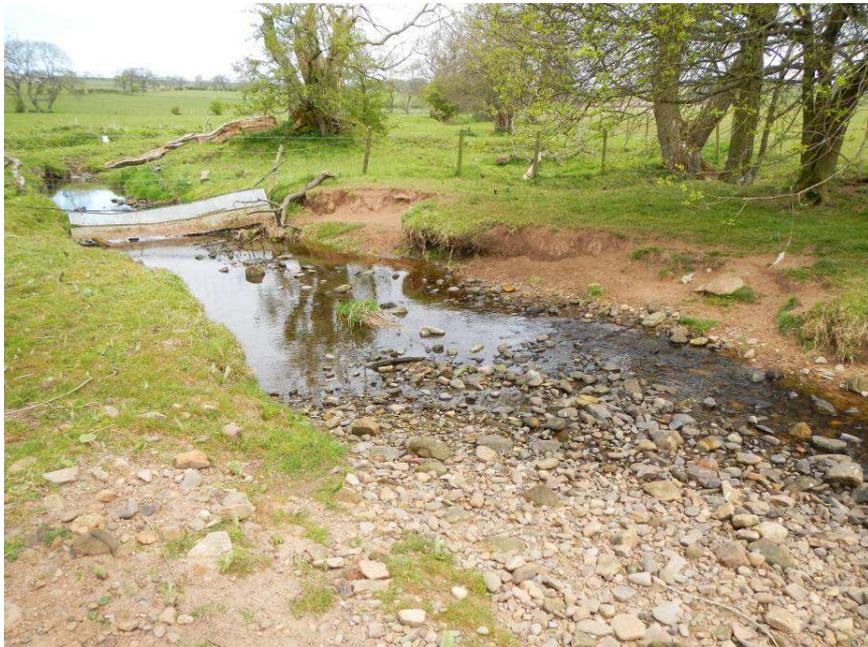
Picture 16. The Stone Beck also has potential as a spawning tributary but suffering from livestock access, dredging and a barrier to fish passage created by the B6318 road crossing (Picture 17).

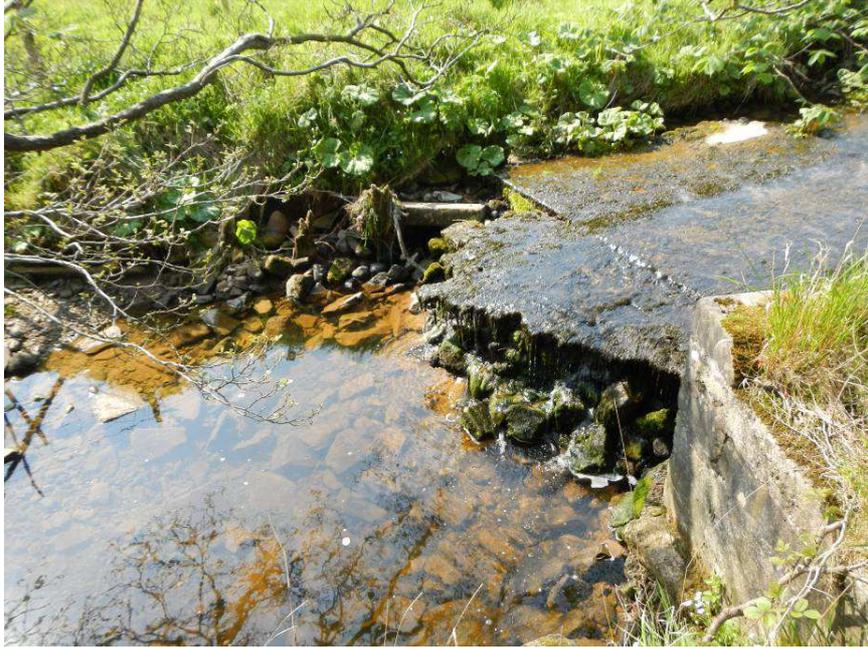
Picture 17. Obstruction on Stone Beck, created by the B6318 road crossing (NY5694767393).

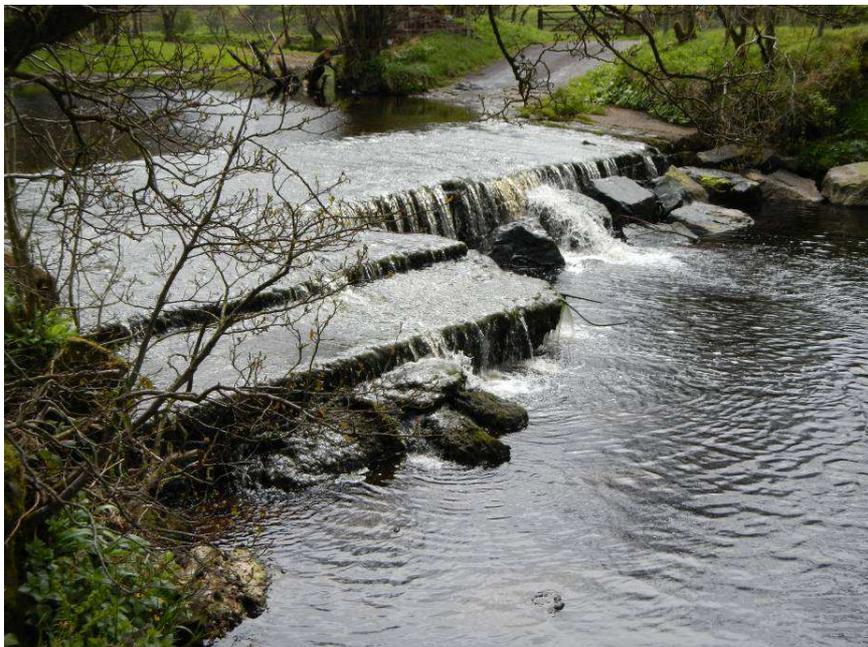
A short distance downstream on the King Water was another significant barrier restricting fish access up the river. The issue is a road ford crossing that is now significantly perched above the river bed, impassable to most species in most flows (Picture 18).

Picture 18. Perched road ford to West Hall, posing a serious obstacle for all species (NY5667667438).

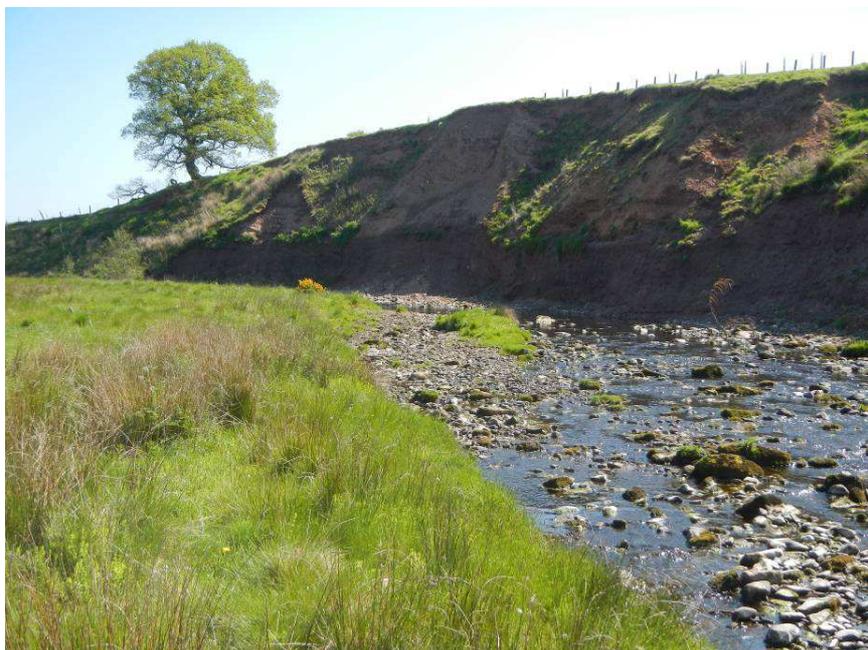
The fields downstream of the West Hall Ford on both the RB and LB suffer erosion issues associated with cattle access and grazing, particularly around NY5653867462. This forms another significant nutrient and sediment input to the river. Major erosion issues are also occurring a short distance further downstream (Pictures 19 & 20), which greatly exacerbate sedimentation of the King Water.

These land slips are in part natural, due to the steep banks and light friable soils, but have potentially been exacerbated by past land drainage activity, leading to saturated areas towards the top of the banks that are susceptible to slumping. Past grazing and gravel extraction may have also played a part, and although the gravel extraction is greatly reduced and stock is now excluded, the legacy of this management remains and the banks will be difficult to stabilise.

Tree planting at the top of the bank may provide a little benefit, but the main issue currently is the fact that the river is now undercutting the bank toe, which greatly reduces the opportunity for slumped materials to stabilise through vegetation.

Picture 19. Serious erosion and land slippage that is leading to high sediment loading of the watercourse downstream. In this example the issue is likely to be exacerbated by the historic ridge and furrow land management of the field above concentrating drainage to certain areas.

In addition, there are several locations, particularly around NY5612167147 and NY5576667104 (Pictures 19 and 20) where a detailed geomorphological survey would be beneficial to fully understand the pressures and measures to address them.

While undertaking the walkover discussion with the landowner Richard Ritson, of Swaites Farm, which encompasses much of the land around the affected area, indicated that he may be willing to try brush toe protection on some of the lower banks. This treatment may retain enough of the slumped material and protect the bank long enough for it to consolidate and naturally re-grade and form the basis of an experimental project.

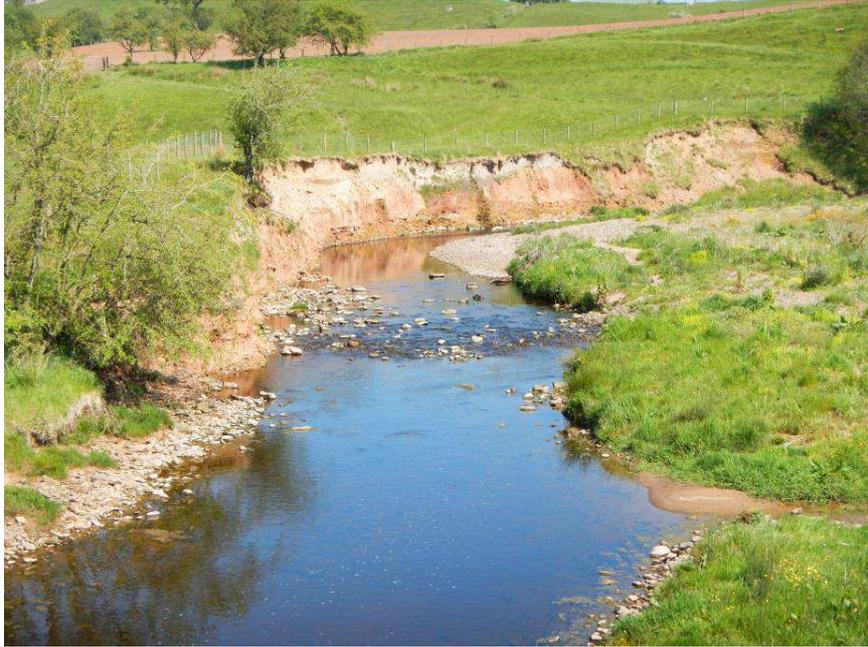
Picture 20. More typical erosion on smaller banks. still hard to stabilise due to the soil type.

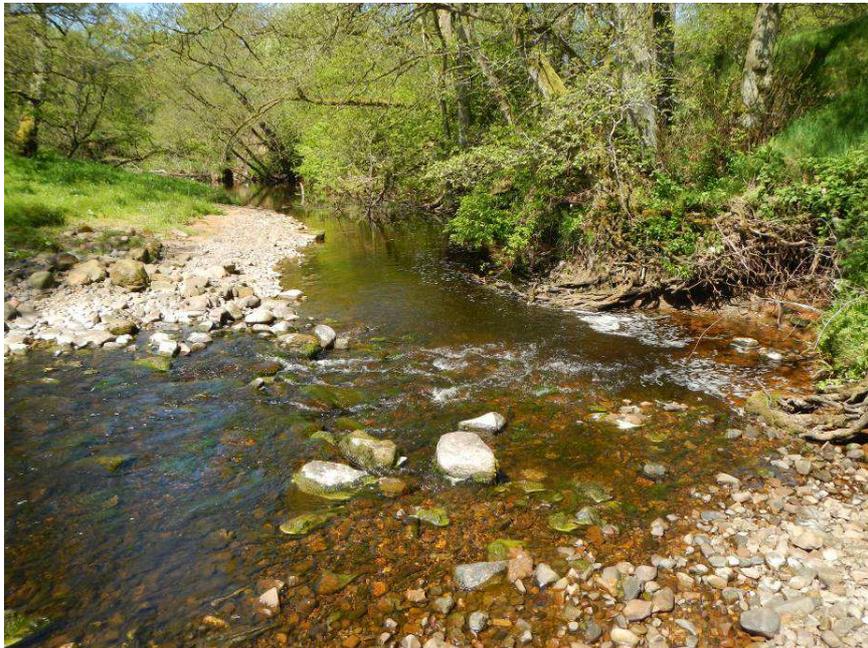
Despite serious erosion issues, high quality trout habitat (particularly for adults) was available, most notably in the areas where livestock are excluded. Due to the sediment and nutrient issues, algae were still very notable and gravels contained high levels of fine sediment (Picture 21).

Picture 21. Algae in the foreground, but high quality adult trout habitat in background.

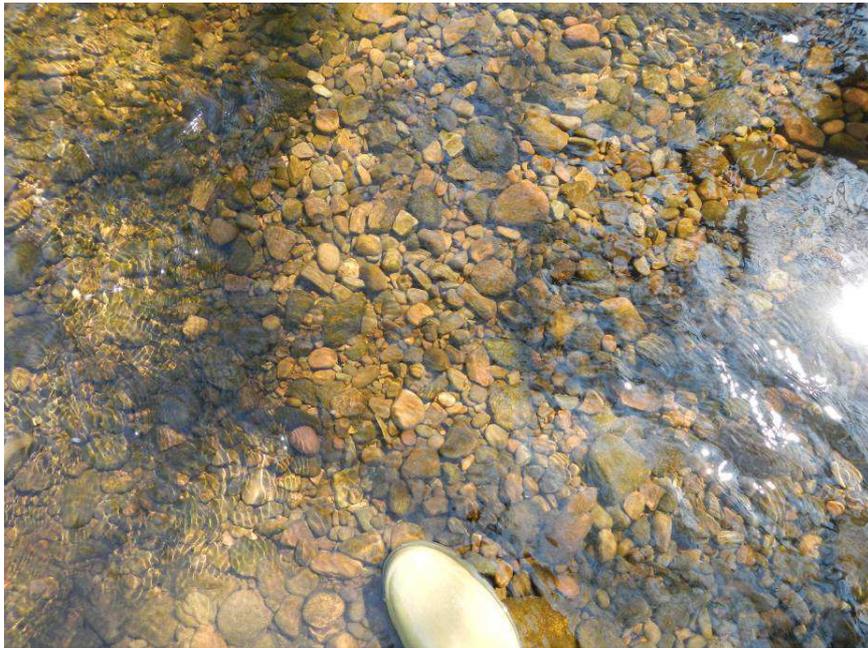
In the more heavily shaded sections, particularly where flows facilitated a healthy level of gravel sorting, the issues with algae and siltation were greatly reduced. This, coupled with the generally lower gradient of the bottom third of this waterbody and less constrained channel, allows the deposition of suitable trout spawning substrate (Picture 22).

Picture 22. The bottom third of the waterbody was the only section to have regular aggregations of suitable trout spawning substrate.

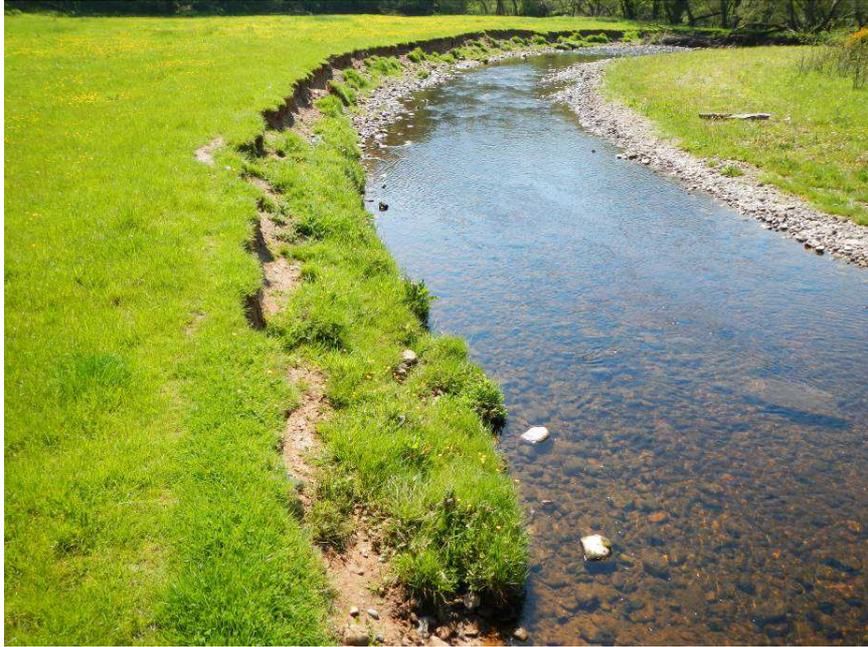
Livestock access to the river bank is a continuing issue at locations throughout the bottom third of the waterbody, where poaching and overgrazing of the banks is leading to increased erosion. If livestock access is restricted it is very probable that the banks will naturally re-grade and re-vegetate. This process has already started in pictures 23 and 24, but is likely to be reversed when stock are given access to the bank.

Picture 23. Naturally re-grading bank that is likely to consolidate, providing stock access is prevented (NY5396165712).

field appears to be in silage during the walkover	(Appendix 4)		allow buffer between mowing and banks
Medium	Erosion on LB that could easily be prevented by stock exclusion	23	NY5396165712	Install buffer fencing
Medium	Erosion to LB that is likely to be reduced through reduced grazing pressure	34 (Appendix 5)	NY5385665548	Install buffer fencing
Medium	Unrestricted stock access to both LB and RB leading to serious siltation	24	NY5299464686	Install buffer fencing

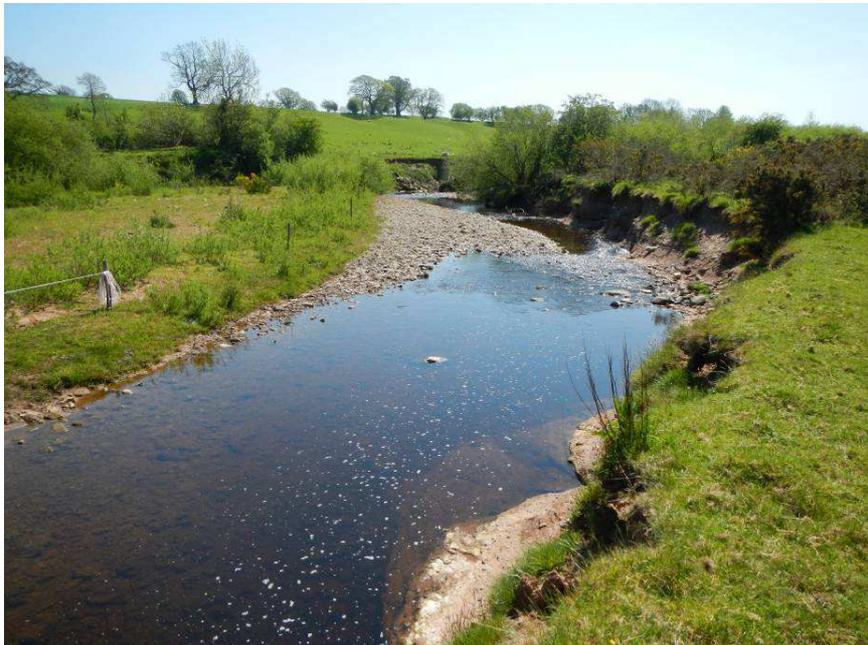
Picture 24. Unmaintained fence allowing livestock to the riverbank. Poaching damage on the RB is likely to prevent natural bank stabilisation (NY5299464686).

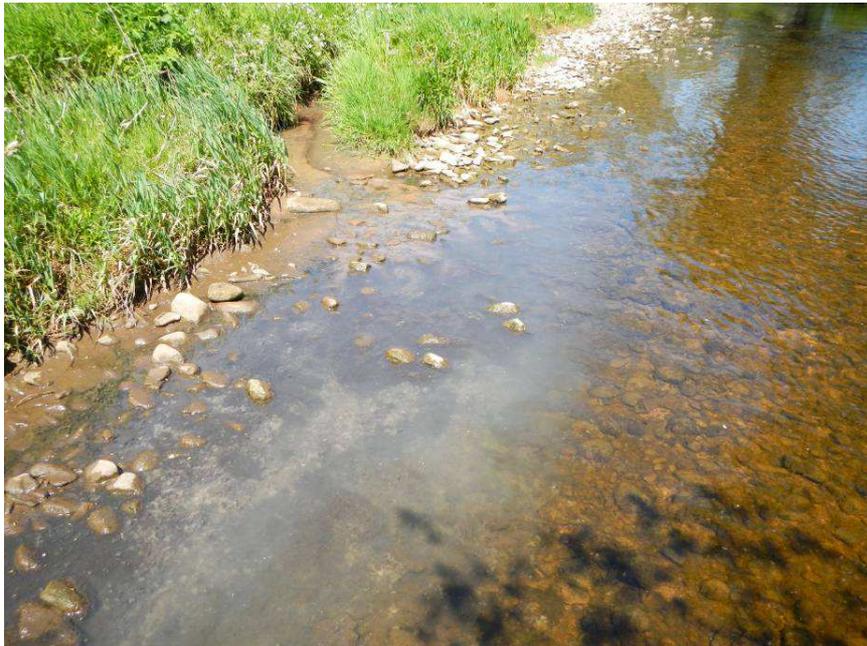
Only one point-source pollution was identified during the walkover and this was towards the bottom of the waterbody. This discharge was considered to be a serious impact on the lower end of the waterbody and water bodies downstream, as shown in picture 25. The discharge appeared to contain high organic content.

Picture 25. Pollution occurring at a flap valve on the lower King Water (NY5256663976).

- Investigation of pollution source at should be undertaken at NY5256663976.

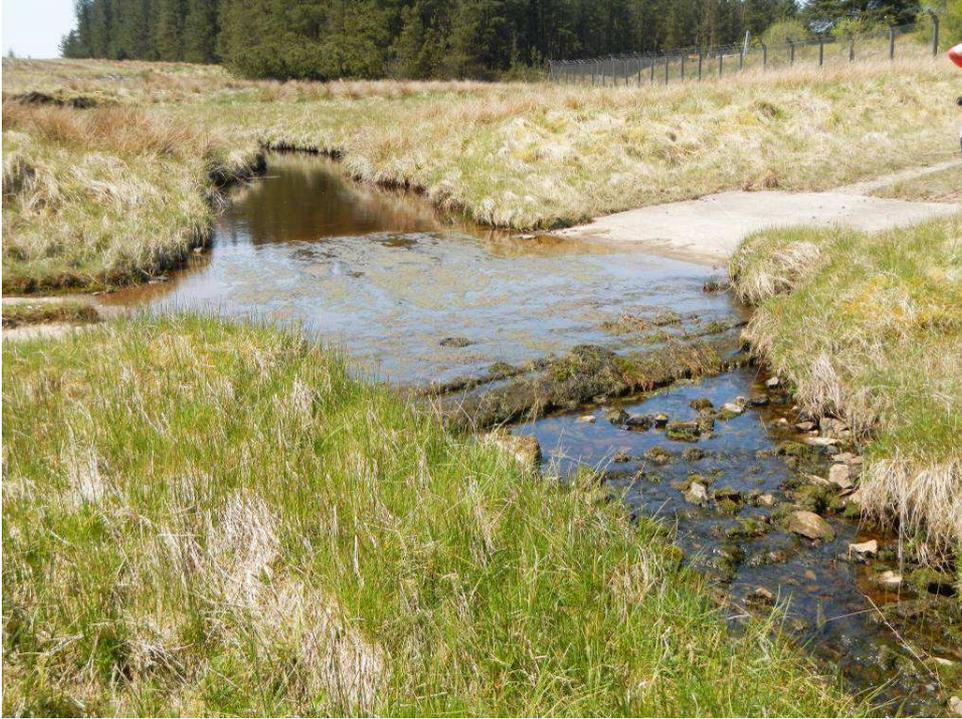
Picture 26 (NY6266172211)

Description	Picture	NGR
Ford at edge of Spadeadam	26 (Appendix 1)	NY6266172211
Concrete pipe culvert on Spadeadam	27 (Appendix 1)	NY6200670948
Corrugated pipe culvert on land leased by GL Noble Denton	28 (Appendix 2)	NY6093572517
Concrete pipe culvert on Spadeadam	29 (Appendix 2)	NY6042672819

- Install easements at the minor barriers around RAF Spadeadam and adjacent forestry area. These barriers are all small scale but easements would improve fry and juvenile utilisation of the available habitat. The work could easily be tackled with a partnership project between the EA and ERT.
