Advisory Visit

River Witham, Easton Estate, Lincolnshire

20th October 2009

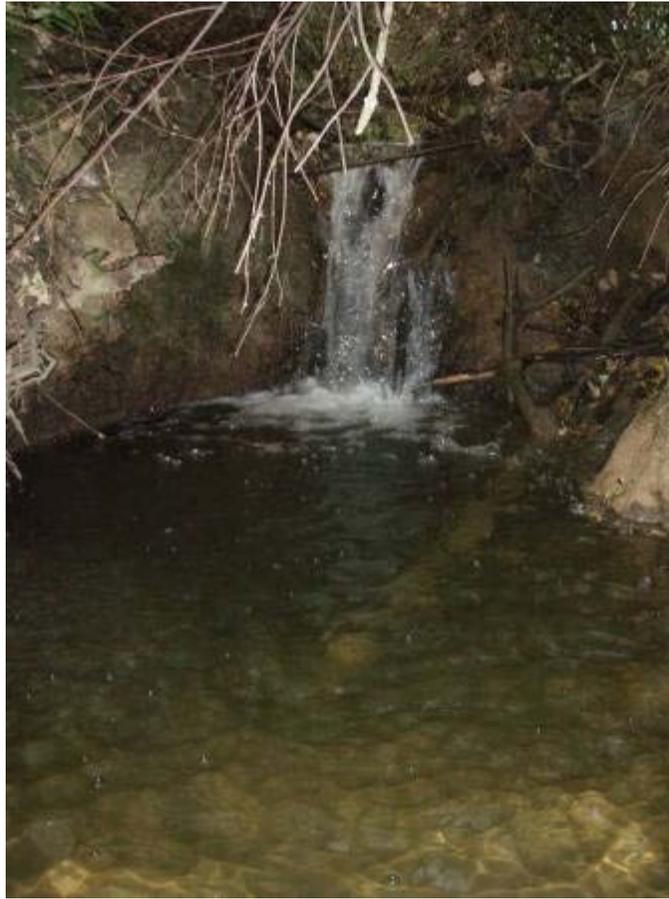
A tributary stream enters on the LHB in Broadlands Plantation, but it flows over a drop of approximately 1 metre just above the confluence, making it impossible for trout to access this tributary for spawning (Photo 1). This may indicate that the main river channel has previously had its bed lowered for land drainage purposes, and the tributary level represents the former river bed level. In the river at the confluence the channel has been encroached by snowberry bushes (*Symphocarpus albus*), and there is an accumulation of debris and aquatic vegetation; this has impounded water upstream to the new footbridge and created a very slow-flowing section where fine sediment is settling out and duckweed (*Lemna* sp.) has colonised (Photo 2).

Photo 1 Outfall of tributary stream into the river – impassable for fish

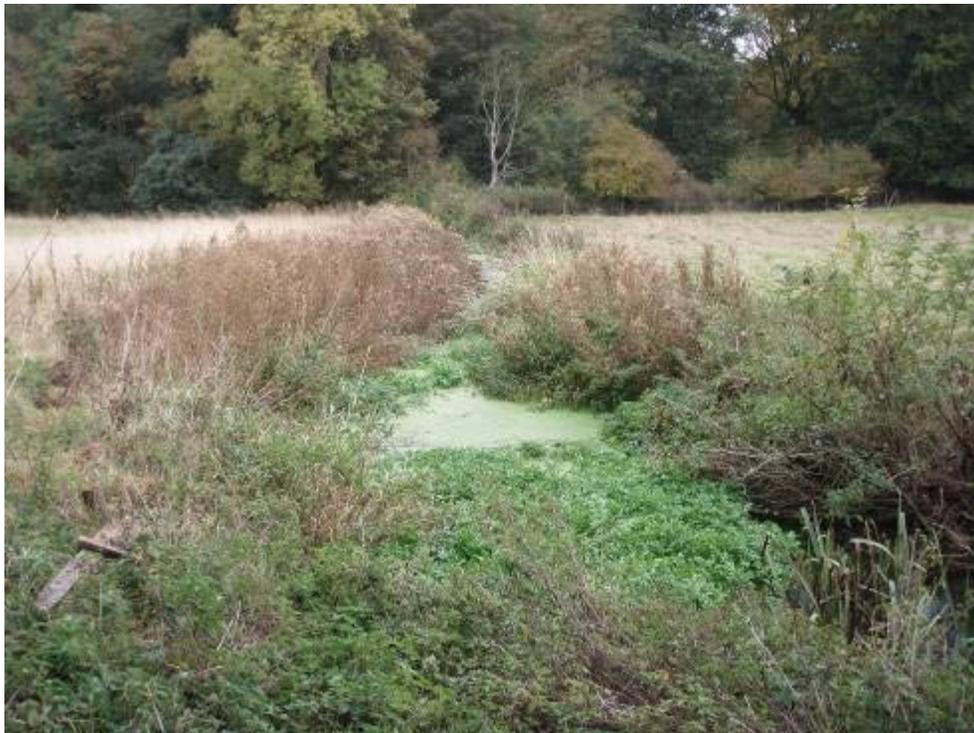
Photo 2 Impounded section upstream of Broadlands plantation

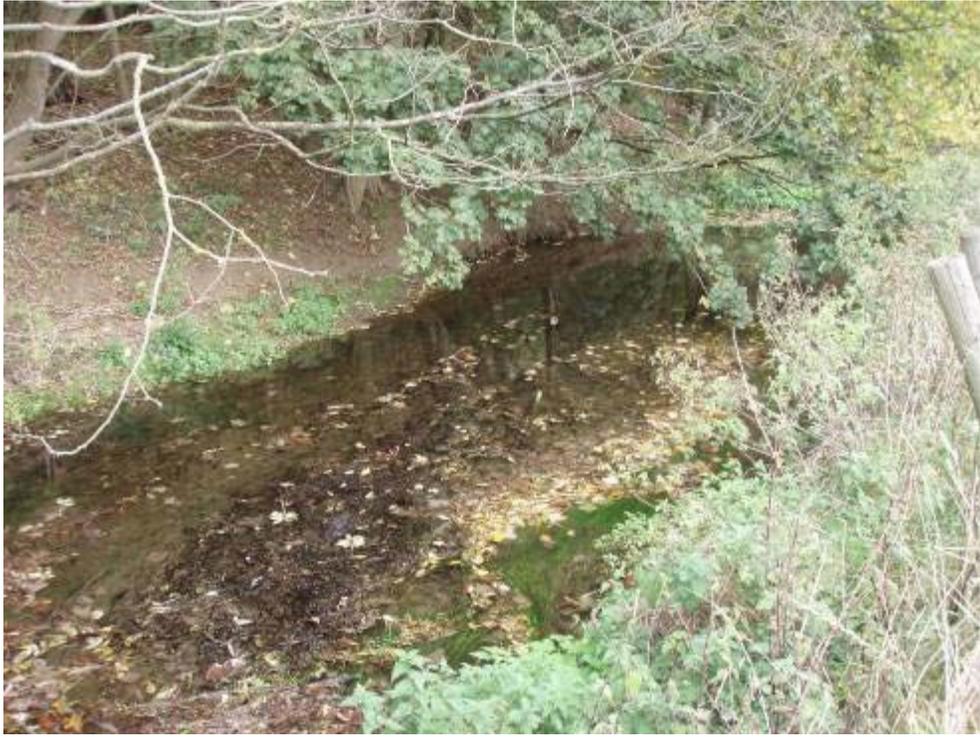
Alongside Post Office plantation the river is heavily shaded and the channel is wide, shallow and has a bed dominated by fine sediment (Photo 3). Submerged aquatic weed present is dominated by slow-flowing species including *Myriophyllum* sp. and pondweed *Elodea* sp.

Photo 3 Wide, shallow channel alongside Post Office plantation

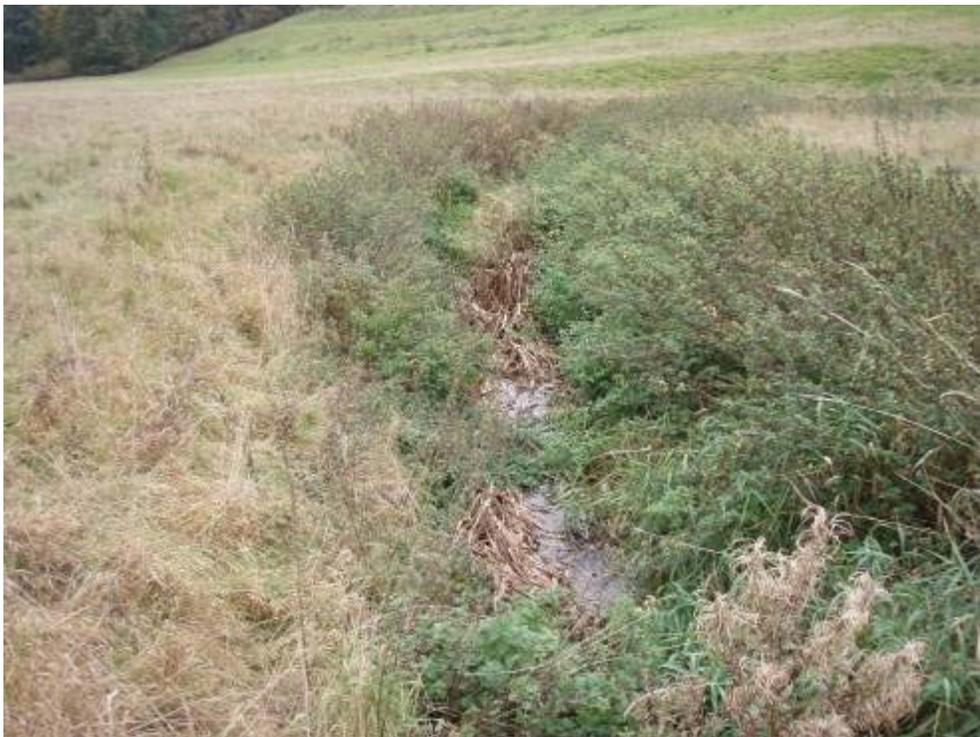
In contrast, upstream of the plantation channel has an open aspect and is dominated by emergent vegetation such as burr-reed (*Sparganium erectum*); this has grown across the channel in some areas pooling up the water and creating pond-like conditions. The channel here is quite incised, possibly as a result of previous land drainage works (Photo 4).

Photo 4 Incised and weed-choked channel upstream of Post Office plantation

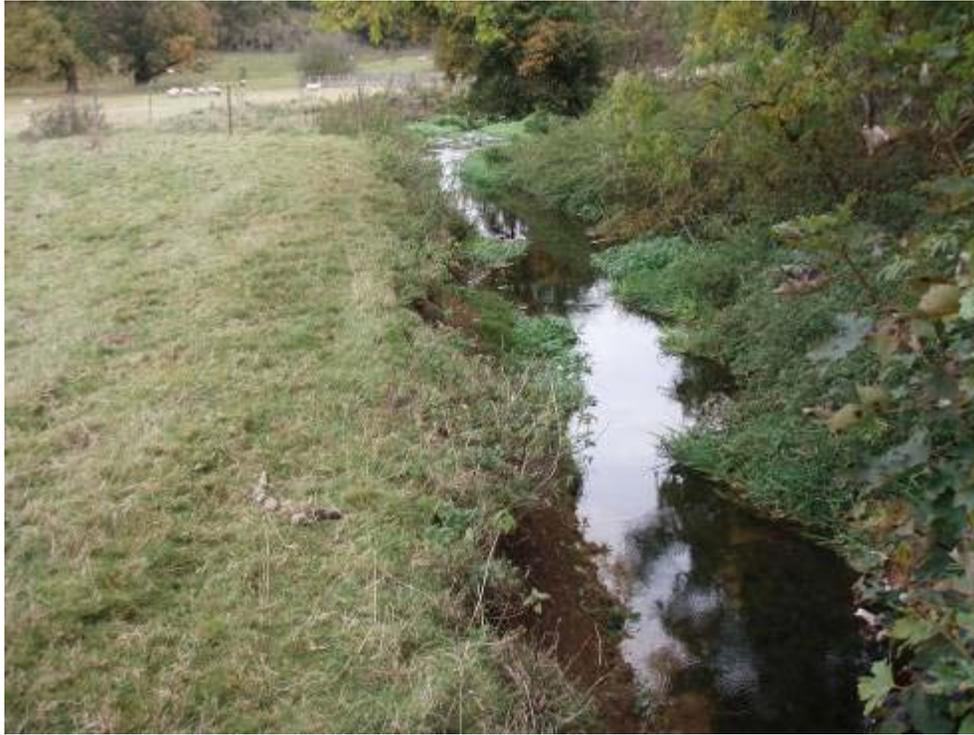
Upstream of the old footbridge, the LHB is steep and wooded (Mill Hill plantation), and the RHB is sheep-grazed grassland. The balance of light and shade is better on this part of the river, and there is a balance of open water and aquatic vegetation (Photo 5). There is however little variation in depth (predominantly shallow – ankle depth), and the bed substrate is poorly sorted fine gravel and sand. The LHB is unfenced and livestock have access to the river; this has resulted in some light poaching of the banks in some areas.

Photo 5 A more open channel alongside Mill Hill plantation, resulting from a combination of shading on the RHB and stock access on the LHB

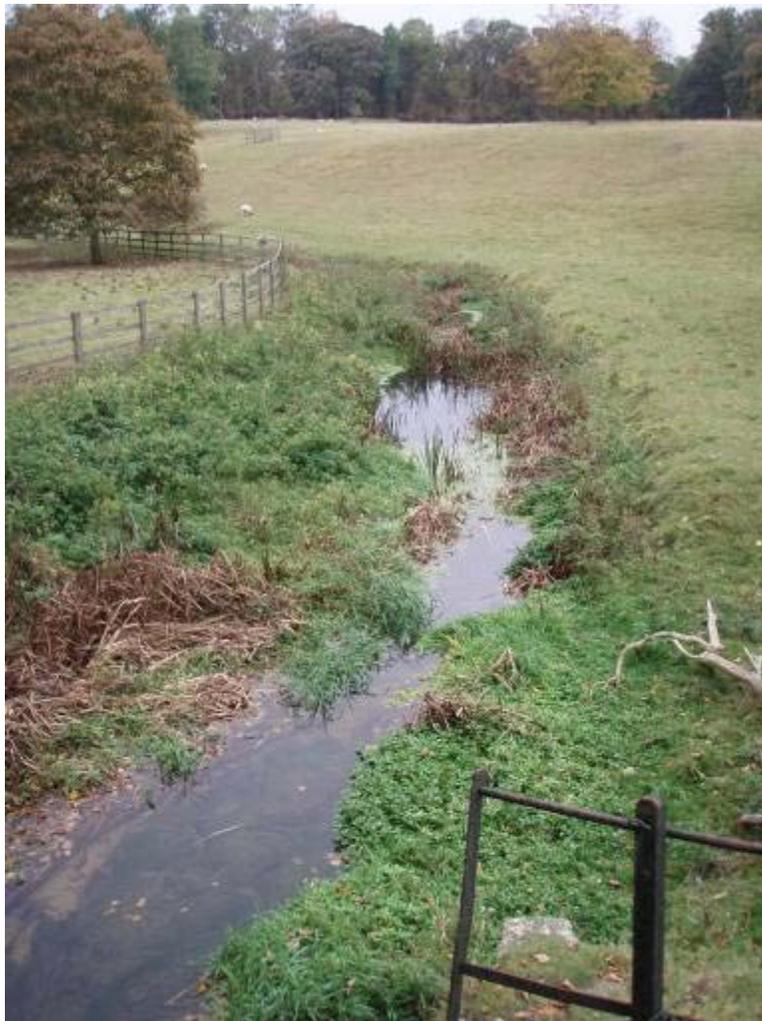
Upstream of the twin-arch bridge the river is fenced on the RHB and grazed by sheep on the LHB. The channel is dominated by emergent vegetation (*Sparganium erectum*, *Phalaris* sp. and reedmace *Typha latifolia*), and is generally shallow, although there is some deep water suitable for adult trout on the outside of a bend.

Photo 6 Upstream of the twin-arch bridge

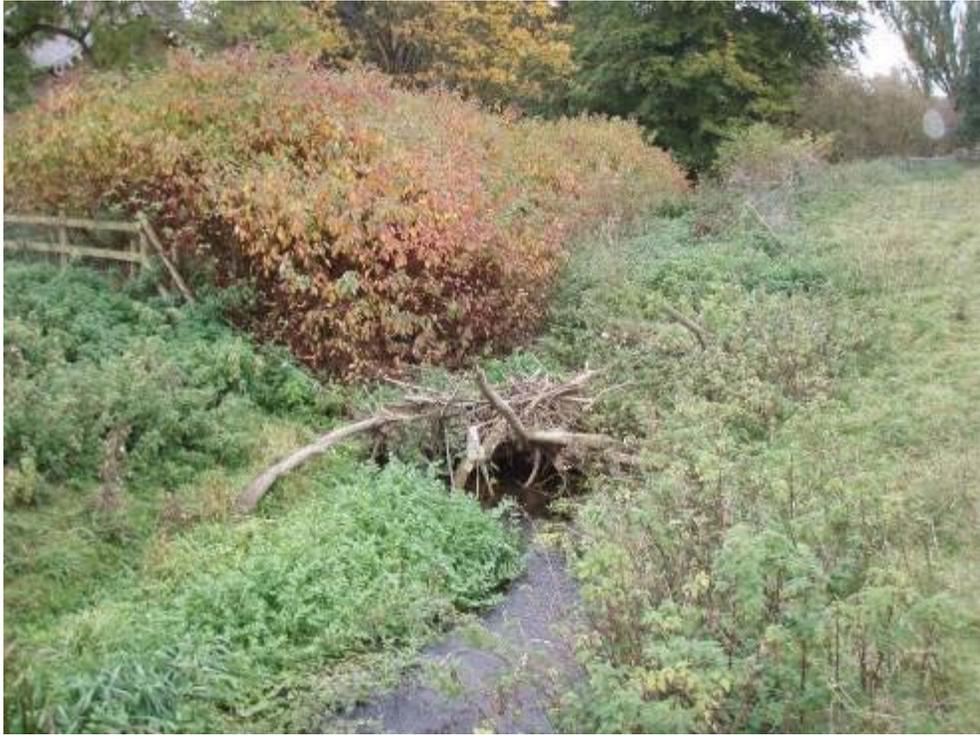
The RHB alongside the garden of Forge Cottage is dominated by a dense stand of dogwood, and stock fencing begins here on the LHB. The fencing crosses the river here and has accumulated debris against it which is likely to damage the fencing in future high water events. Further upstream towards the walled garden the LHB is heavily grazed despite the fencing – possibly by rabbits?

Photo 7 Forge Cottage – encroaching dogwood and debris accumulated on fence

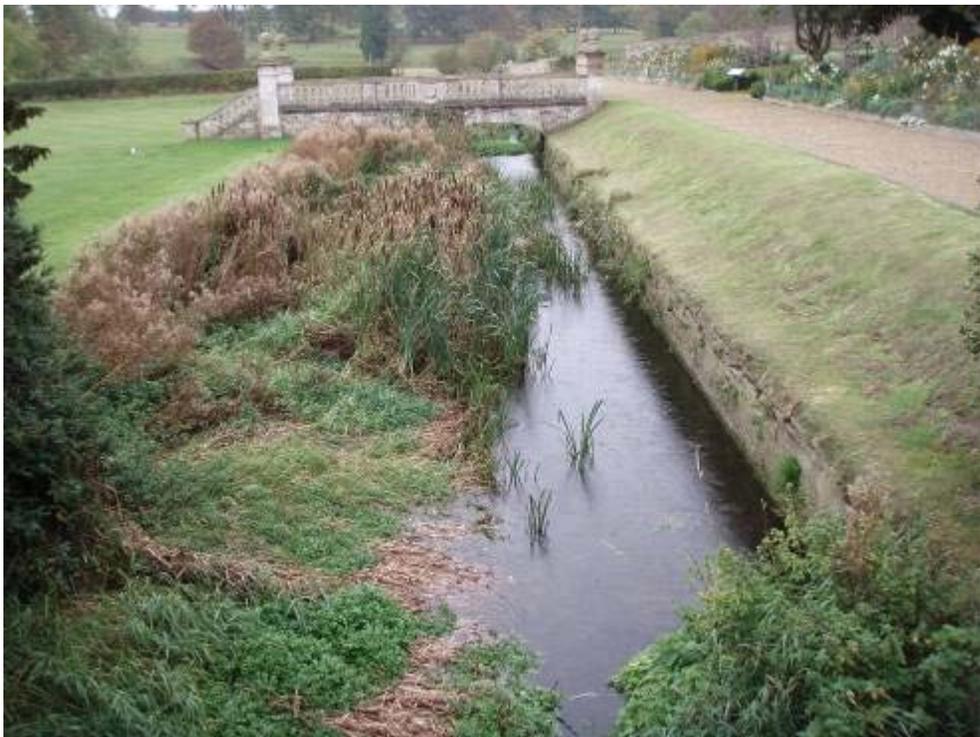
The river has been straightened for a 400-m section above, below and through the formal walled gardens. Within the gardens, the banks are walled with a ha-ha on the RHB to conceal the river from the hall. The channel width between the walls is very wide and emergent vegetation (reedmace) has colonised it extensively. There is a deeper pool at the upstream end of the garden below a constriction in the channel, and an adult trout was observed here.

Photo 8 Within the walled gardens

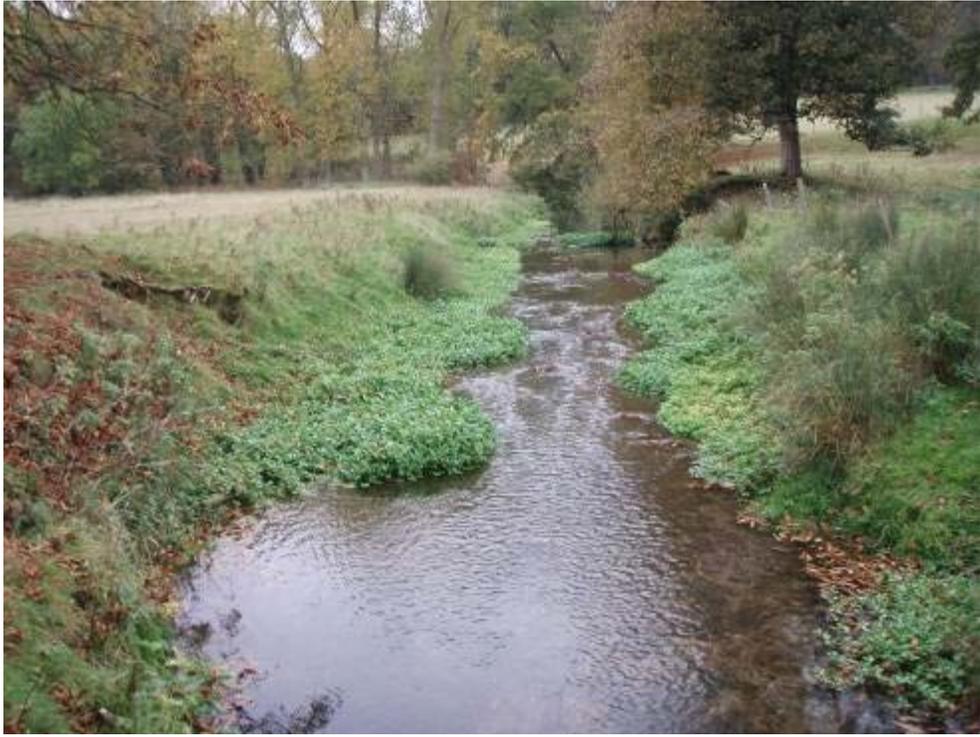
Upstream of the gardens, the channel remains artificially straight. There is some reasonably good gravel substrate, and three or four high spots in the channel comprising blocks of stone (livestock fords, or possibly the remains of old weirs). With progress upstream, the channel is less straight but remains largely shallow and wide.

Photo 9 Wide, shallow channel typical of the section upstream of the gardens

Witham include “cut and fill” (Figure 1) to create a two-stage channel in areas such as that shown in Photo 9, the placement of flow deflectors to create scour, and the use of Large Woody Debris (LWD) (Photo 14; Figure 2). Raising the river bed level with introduced gravel is also possible, and would benefit trout by providing a good spawning substrate, and contribute to re-wetting adjoining land – something that is beneficial for conservation and may be desirable under the Higher Level Stewardship scheme.

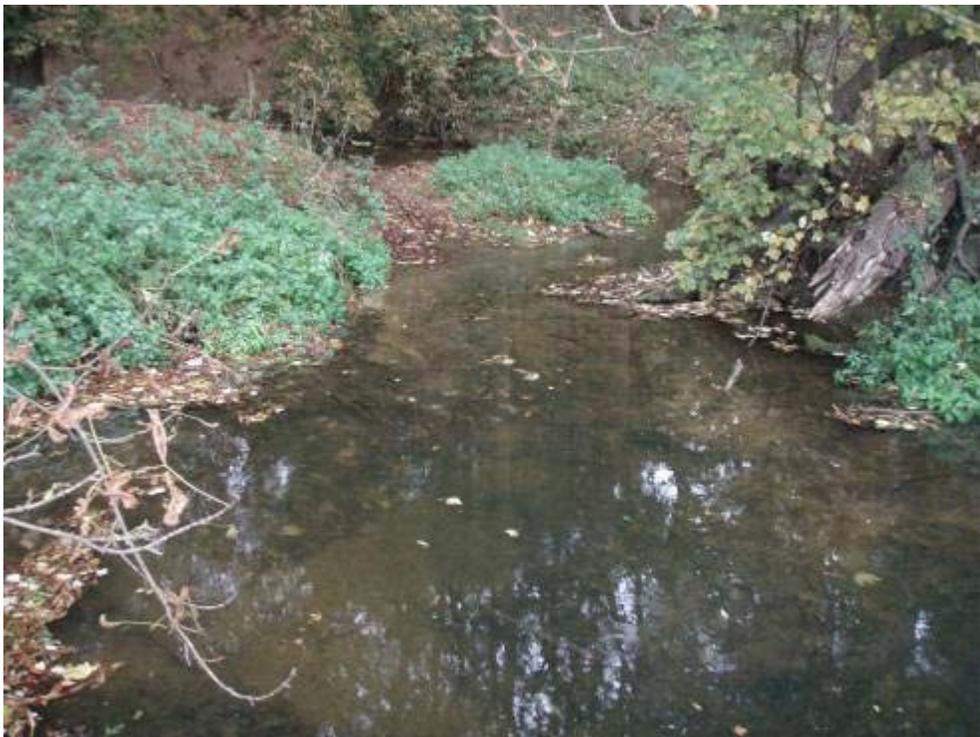
The channel returns to a meandering planform alongside North Road plantation. There are some excellent natural channel features in this area which provide some good trout habitat. There is a variable depth profile with some deep (1 metre) pools, shallow areas with well-sorted gravel substrate, gravel shoals and side bars, and good cover from submerged tree roots. Not surprisingly, the majority of trout observed during the visit were seen in this area.

Photo 10 Good habitat alongside North Road plantation – lateral scour pools, gravel shoals and side bars.

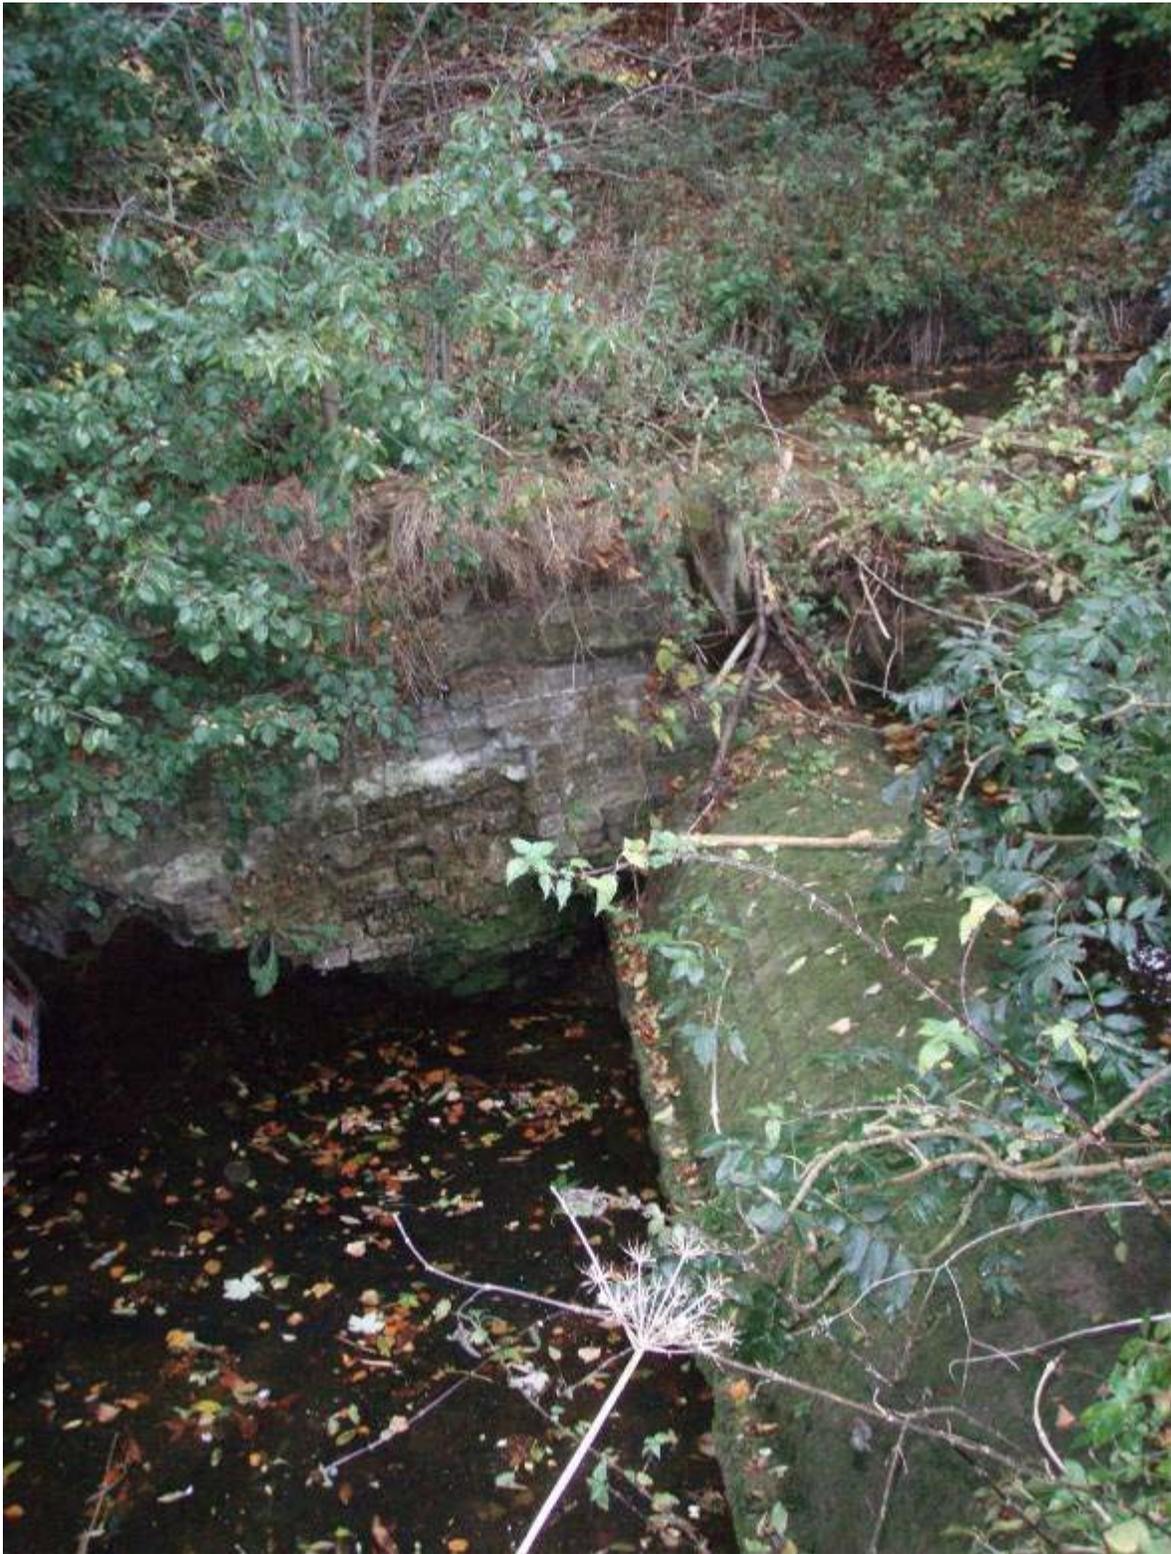
Just upstream of the pump house tributary there are the remains of a brick weir or sluice structure within the river channel (Photo 11). Despite the dilapidated state of the structure, there is still a head difference of around 1 metre across it. This presents an impassable barrier to fish wishing to move upstream, and is a bottleneck in terms of fish reaching good spawning habitat and post-pollution re-colonisation. No fish were observed in the reach upstream of this structure, despite adult fish being observed a short distance downstream near the track bridge.

Photo 11 Brick weir / sluice structure – a significant barrier to fish movement and an obstacle to re-colonisation of the river following the 2008 pollution.

- Connectivity – the brick structure (photo 11) is a major obstacle preventing fish reaching good spawning habitat upstream, and hindering the re-colonisation following the 2008 pollution. It is recommended that the structure is removed, and the river bed upstream is allowed to regrade (i.e. erode to produce a more pronounced longitudinal slope).

Because of the accumulated bed materials upstream of the weir, its removal will create a 'nick point' which will migrate upstream as the bed regrades to a new level. During this process the increased energy of the river may cause banks to slump, and the loss of some bankside trees. This rate of change could be managed by the strategic placement and fixing of tree trunks within the channel to check the rate of sediment movement. A bed level survey and modelling of the predicted extent of the regrading is recommended prior to removal works.

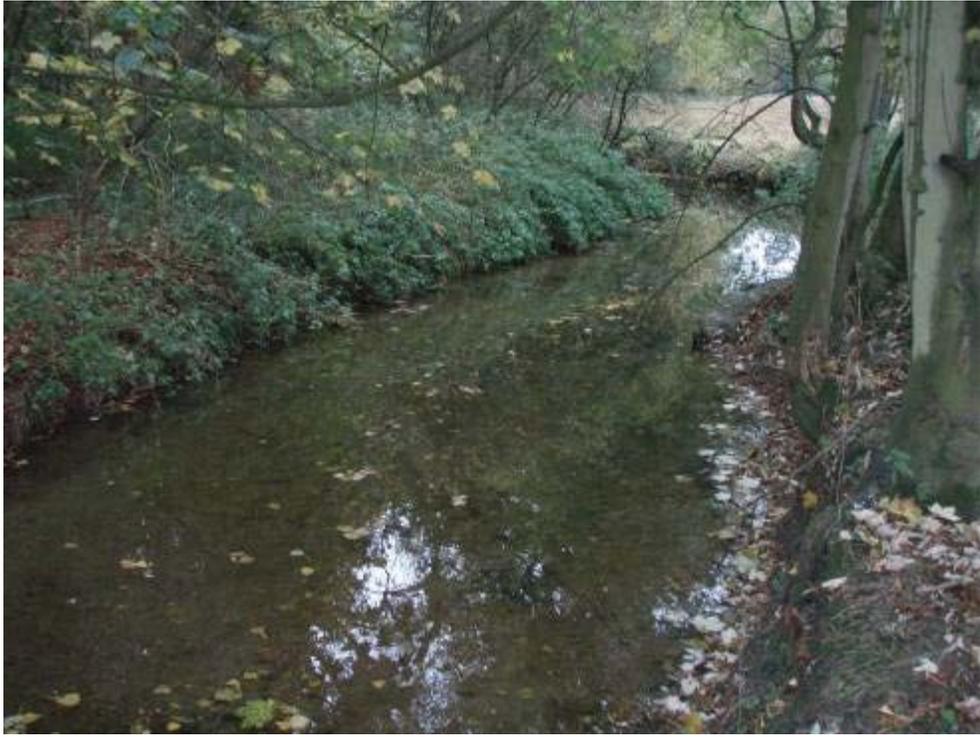
Upstream of the brick structure, the river is impounded and sediment has accumulated creating a wide, shallow channel (Photo 12). Upstream, beyond the impounding effect the habitat is good for spawning and the juvenile stages of trout; there is a good gravel substrate although the river does not meander to the same extent as below the plantation hence there it tends to be shallow, with fewer of the deeper pools that tend to occur on the outside of bends (Photo 13).

Photo 12 Accumulated sediment upstream of the structure creates a wide, shallow channel

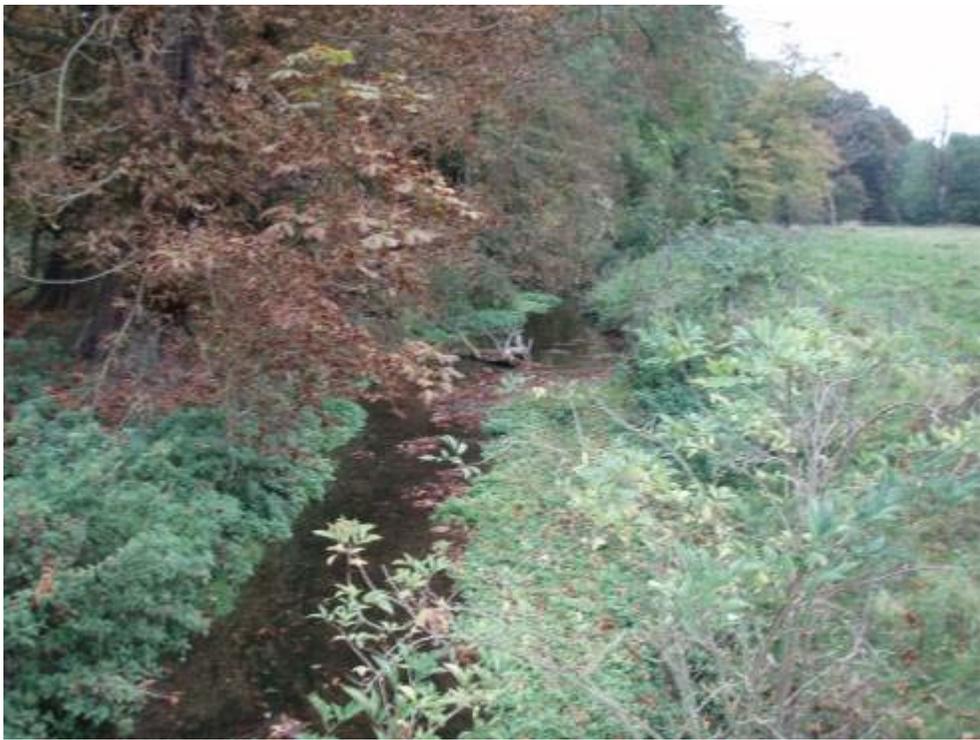
Photo 13 Relatively good spawning and juvenile habitat in the section below the A1

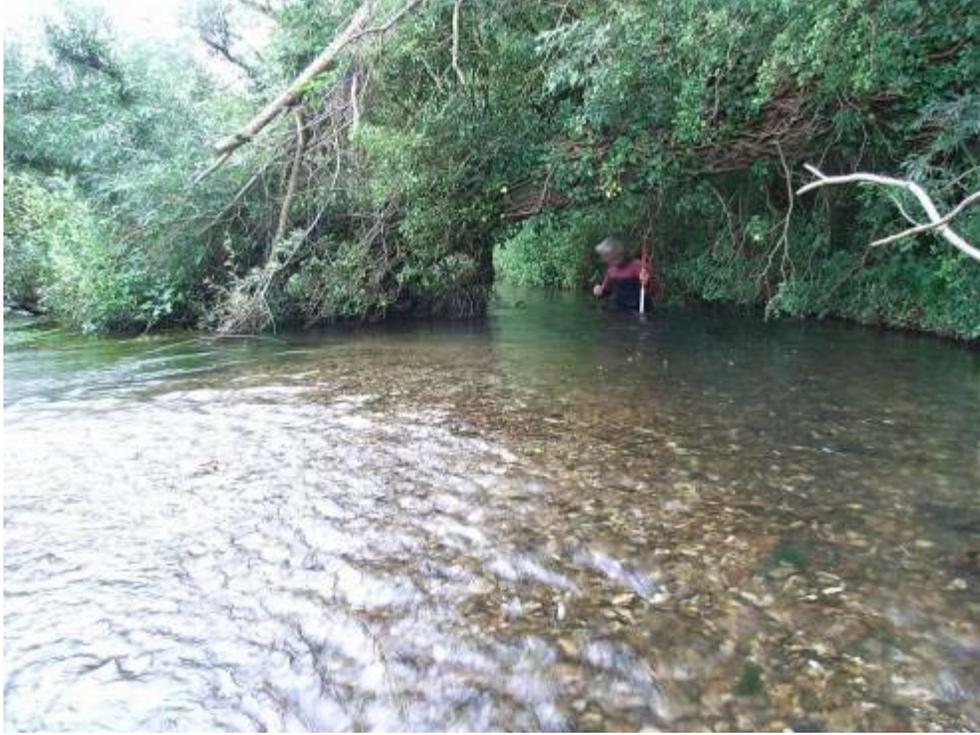
Photo 14 Beneficial effects of LWD – note the depth heterogeneity and the clean, well-sorted gravel.
