Advisory Visit

River Witham, Marston, Lincolnshire

April 2015

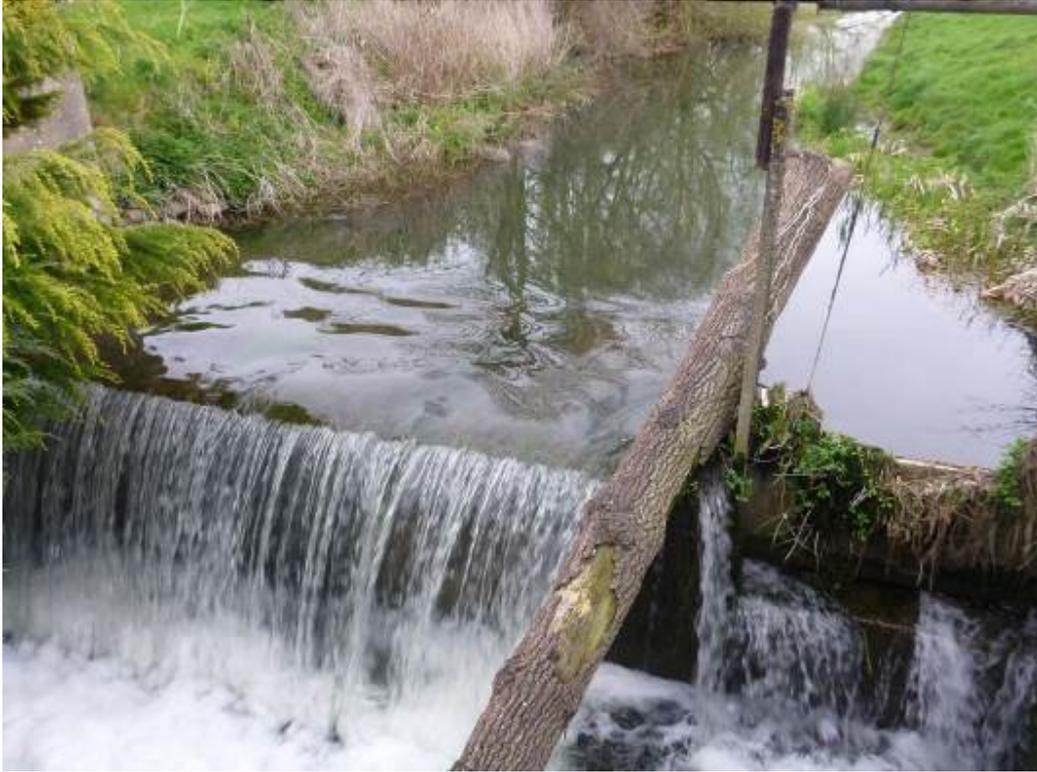
Mill Farm Weir (Photo 1), an Environment Agency owned structure, has a crest about 1.5m high, the water falling vertically onto a concrete sill under the farm track bridge and into the weirpool downstream (Photo 2). The weir crest has a penstock on one side (closed at the time of the visit); if opened, the invert level of the penstock is approximately two-thirds that of the main weir, so would lower upstream water levels but not completely remove the impounding effect.

Photo 1 Mill Farm weir, with penstock sluice on right of picture.

The Environment Agency have indicated that they would be willing to see Mill Farm weir decommissioned, as it would reduce their maintenance burden and provide flood risk reduction benefits. This opens the way to developing a project similar to those described above, re-routing the river from somewhere around the upstream boundary, through the field to the south (in the vicinity of the old channels in Figure 1), under the Mill Farm access track and re-joining the river in the vicinity of the weir pool.

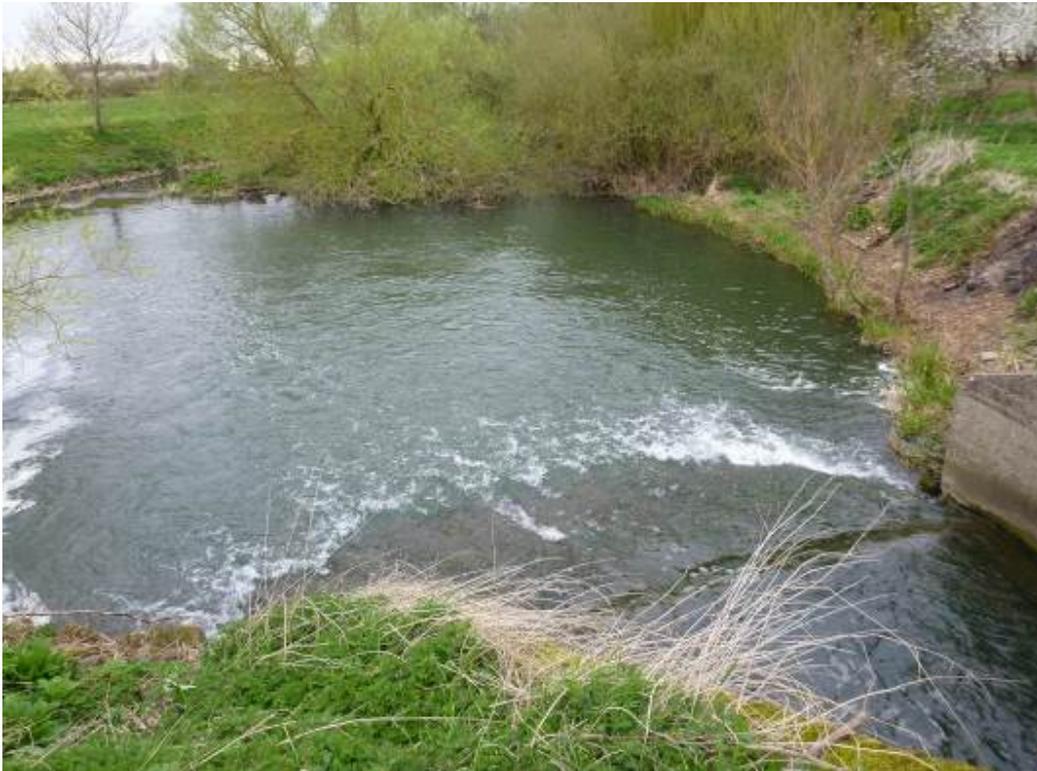
Photo 2 Run out from the weir into the pool downstream.

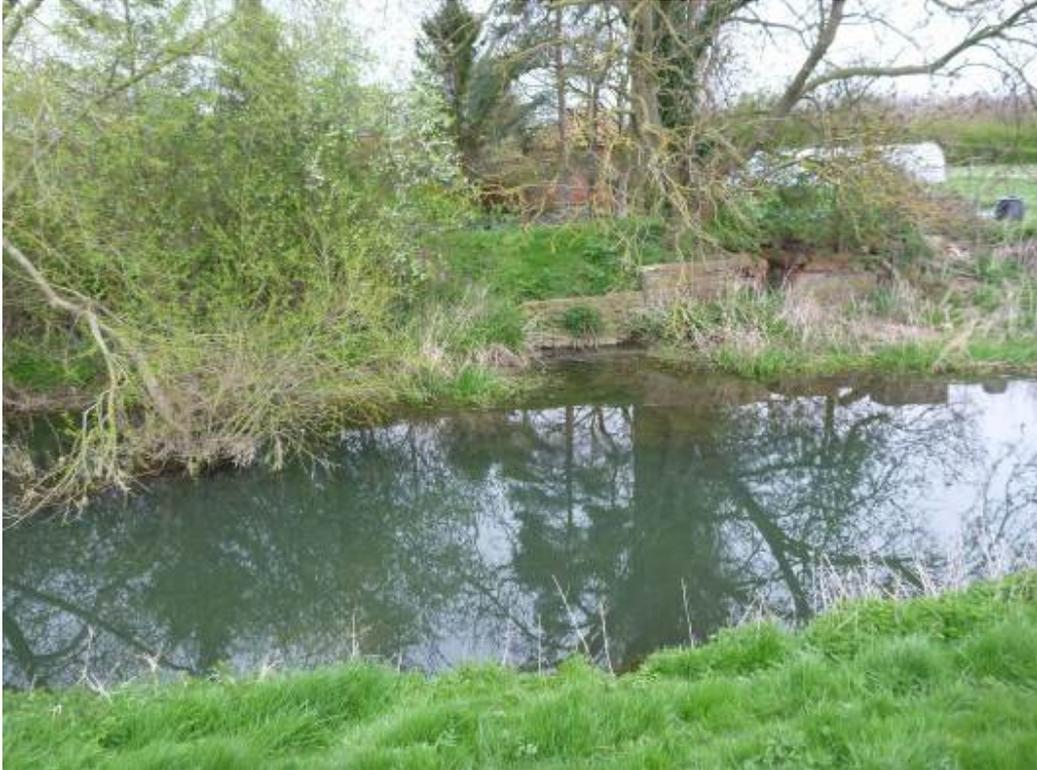
A short distance upstream of the weir on the right bank there is an offtake via a pipe into a small stream running through the garden behind the converted mill house (Photos 3, 4), re-joining the river at the weirpool downstream of the mill. The stream is known to contain native crayfish.

Photo 3 Offtake point on the right bank feeding the stream below.

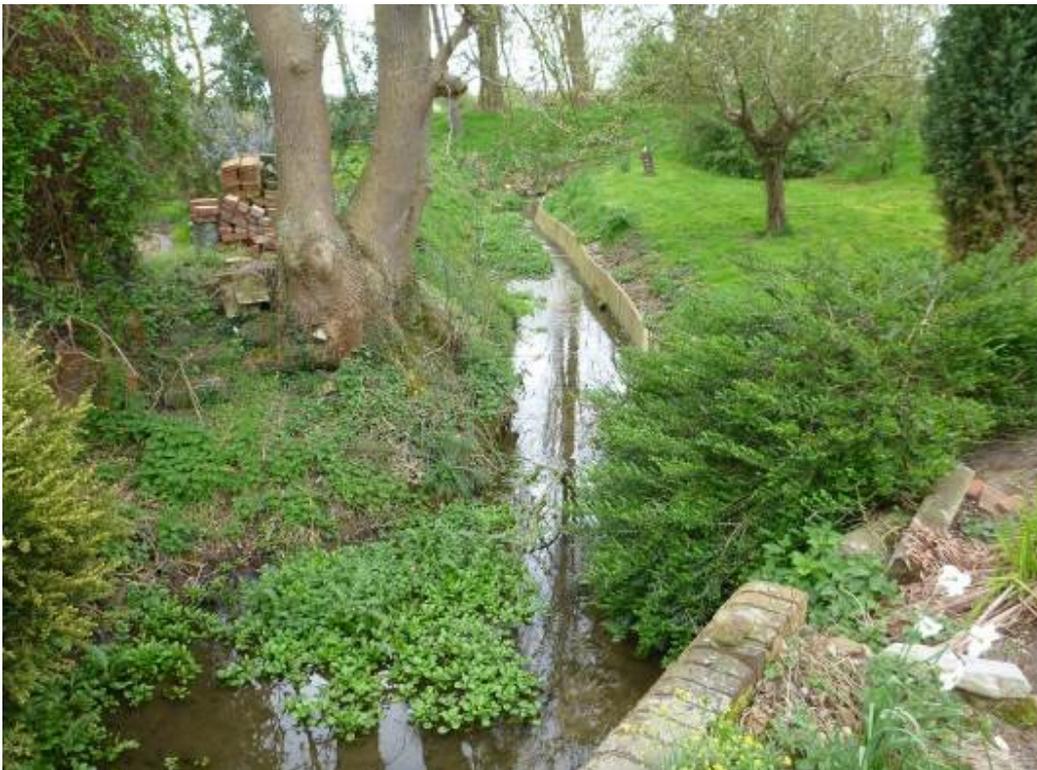
This stream relies on the impounded water levels provided by the weir to maintain its flow.

Photo 4 Stream running through the garden behind the mill house.

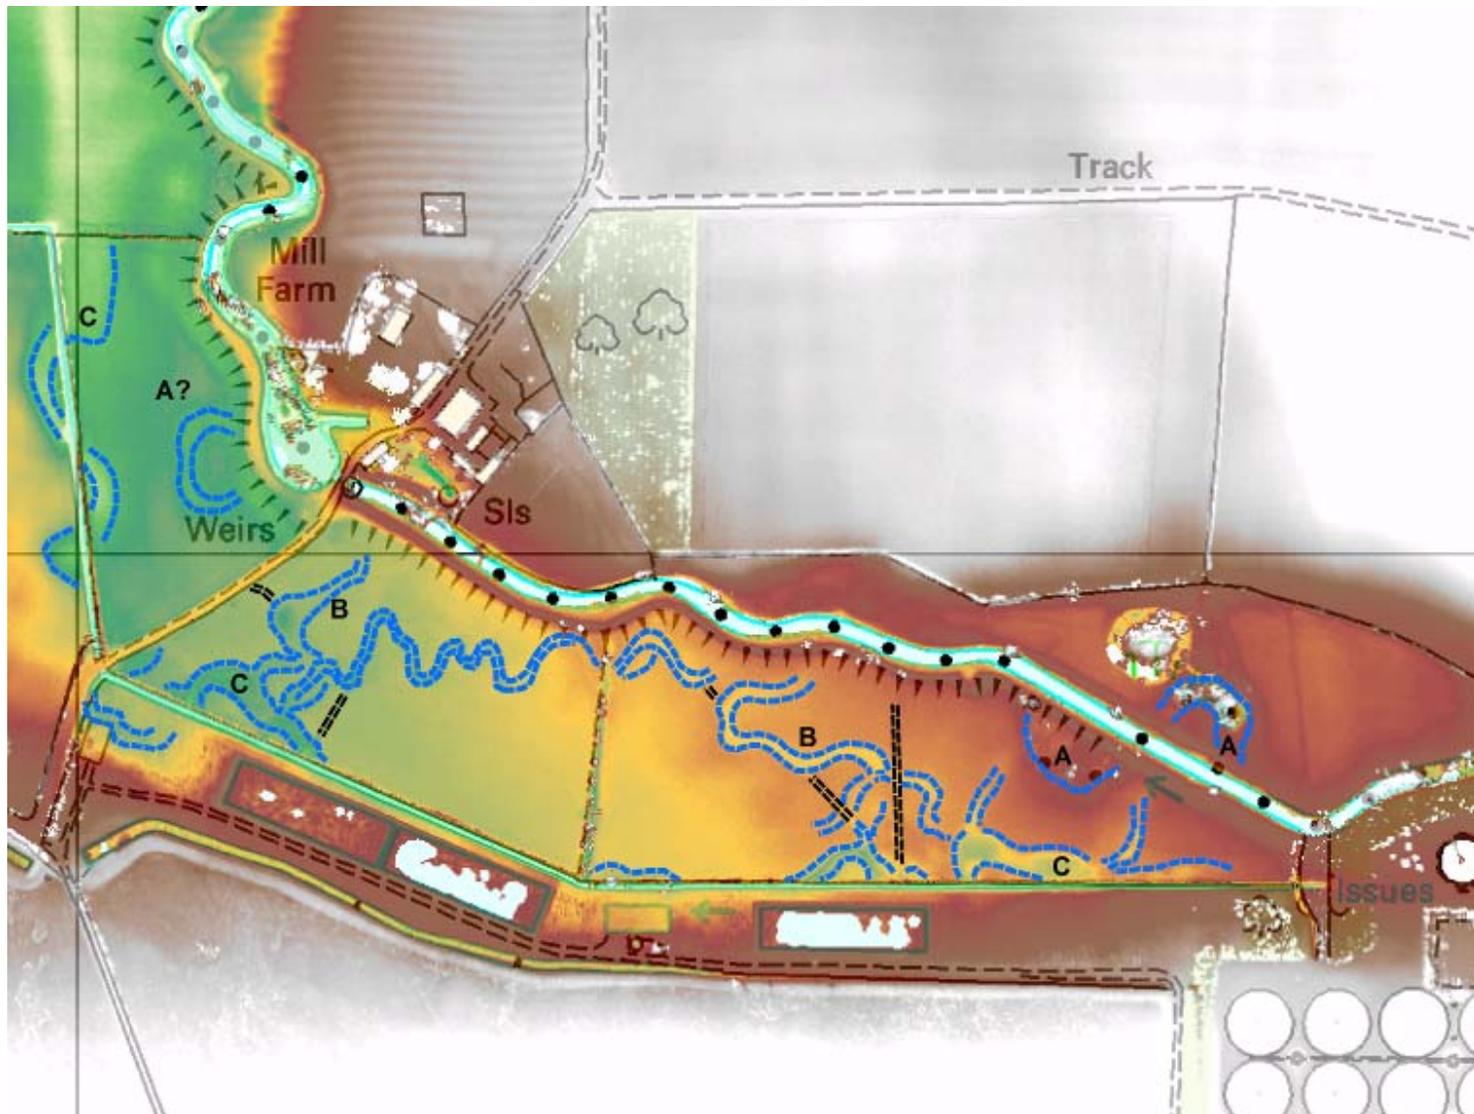
The river habitat quality upstream of the weir is very poor, being profoundly affected by the impoundment for the entire length to the upstream boundary. When the mill was constructed, the course of the river would have been moved to the valley side to provide the height of water (held back by the weir) to drive the mill wheel. The channel would also likely have been greatly enlarged and embanked to store water for milling (embankments are evident on the left bank, Photo 7). This means the river does not currently occupy its natural position at the lowest point on its valley floor. Figure 1 is a LiDAR map (a technique of measuring land levels with lasers) which shows the differences in levels at this site and clearly illustrates the old channels occupied by the river before it was altered for milling; these lie largely to the south of the existing channel (Photo 5).

Figure 1 LIDAR image showing the old channels formerly occupied by the Witham prior to modification for milling. Green indicates low lying ground and red/brown is higher ground. Image courtesy of Environment Agency.

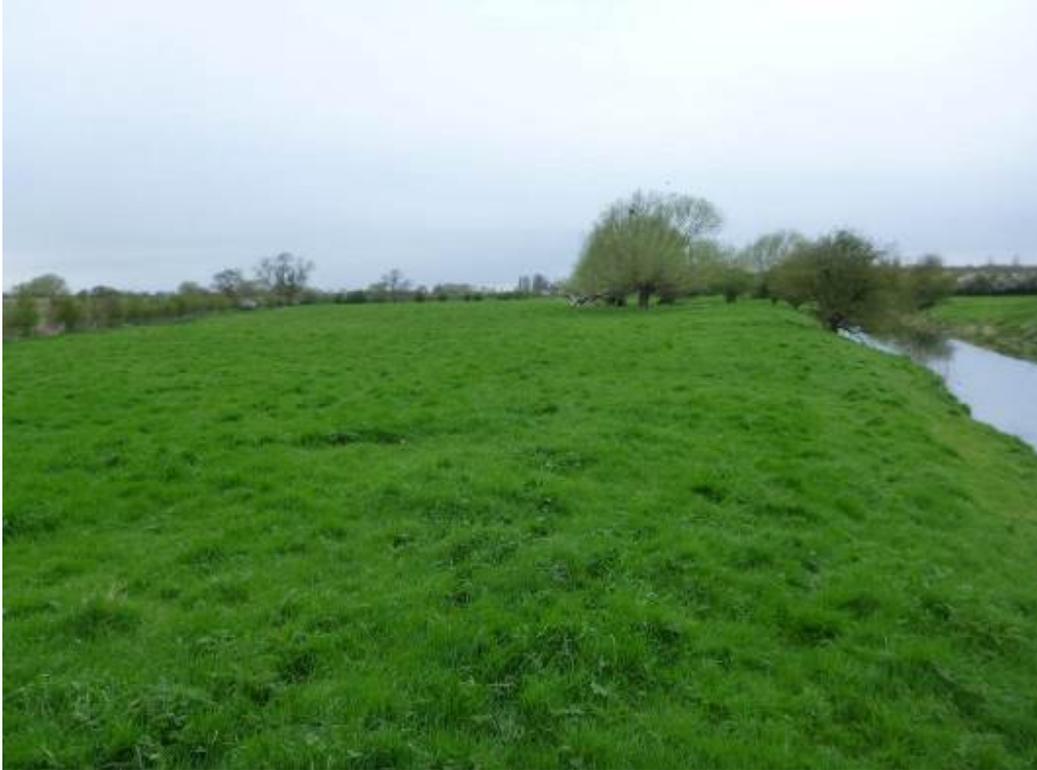
Photo 5 The true valley floor, where the original, natural river channel would have been, lies to the south of the existing river in the field pictured.

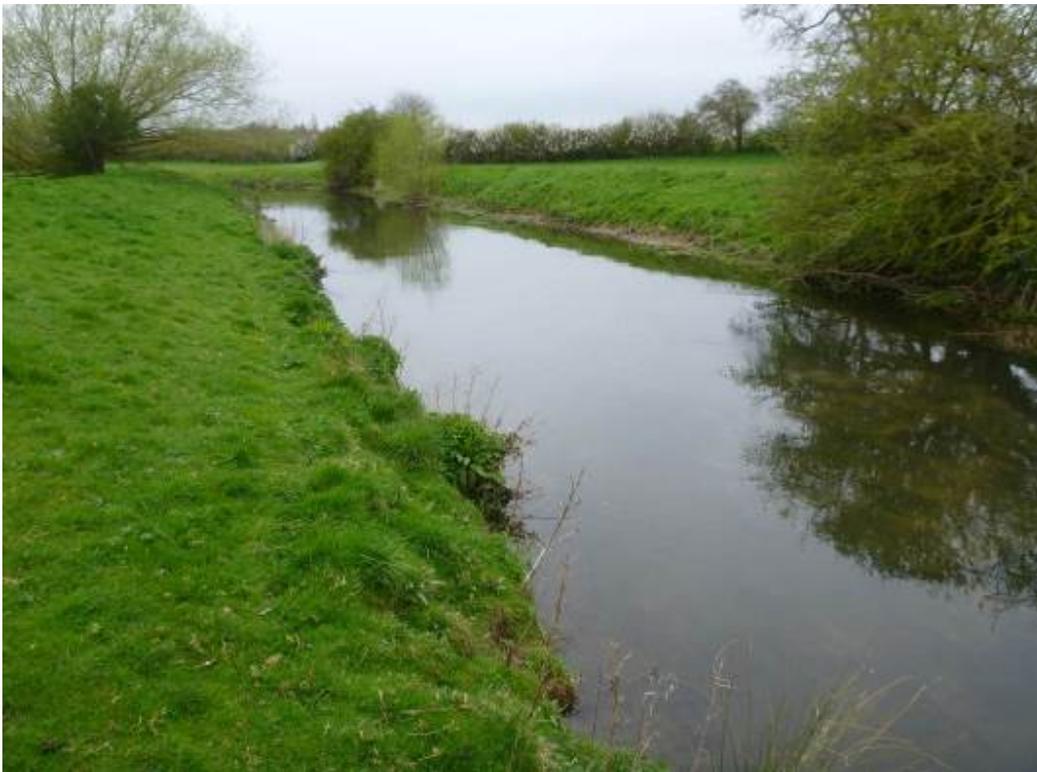
The river upstream of the weir is wide and shallow, the bed substrate dominated by fine sediment accumulated because of the impounding effect (Photo 6). There is little variation in depth, flow velocity or bed substrate composition which makes this reach unsuitable habitat for the earlier life stages of trout (spawning and juveniles) and very poor for adult trout. Only a small number of fish were observed in this section, including pike and possibly adult trout. There is little in the way of overhead cover (which would provide more adult fish holding areas), apart from a small number of willow pollards, the branches of which have leaned over into the channel (Photo 8).

Photo 6 Upstream of the weir, river habitat quality is poor – wide, shallow, silty and lacking cover.

- Provide some additional low cover over the water by hinging suitable trees into the margins (Photo 14). This would be a beneficial treatment to undertake on some of the trees in Photos 6, 8 and 12.

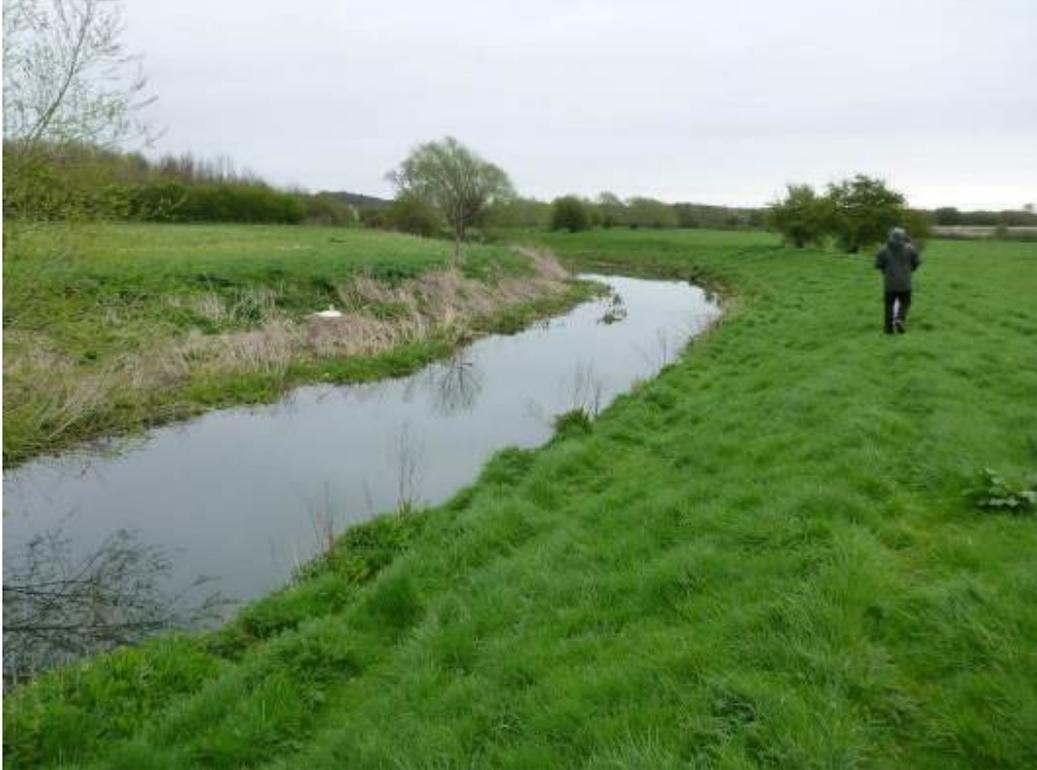
Photo 7 Embankments which would have provided water storage capacity for milling.

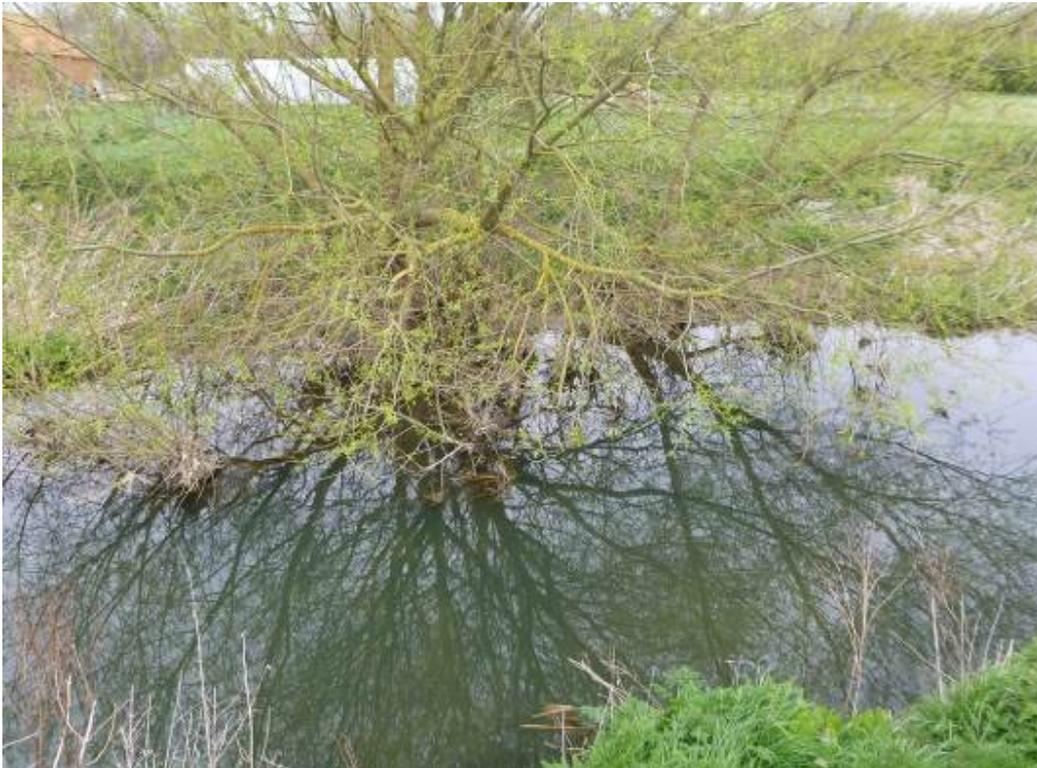
Photo 8 Overhanging willows provide some cover for fish in the impounded section. Any maintenance of these trees should retain the low branches over and in the water at their current extent.

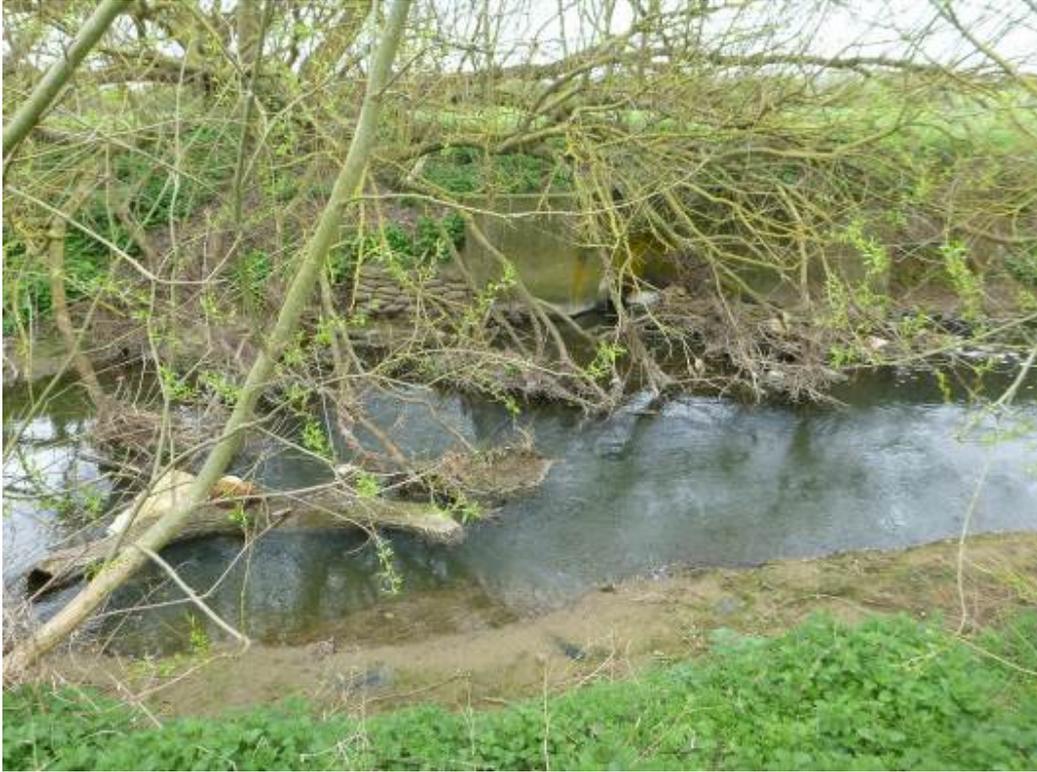
Below the weir is a large weirpool. The energy from the weir has scoured a deep pool, displacing bed sediment downstream to form an island which has vegetated with willow trees and stabilised. The river bifurcates around the island and a short distance downstream, the effluent from the Anglian Water sewage works on the left bank discharges to the river. There are no reported water quality problems here. Water quality could be simply monitored here by taking kick samples of invertebrates downstream of the discharge; the Riverfly Partnership provide excellent guidance and training (www.riverflies.org). There are some fallen willows in the channel here which are providing excellent cover. Although the river is inaccessible for fishing here, having a few such spots on a fishery is no bad thing, providing fish with some refuge areas (Photo 9).

Photo 9 Sewage works discharge point.

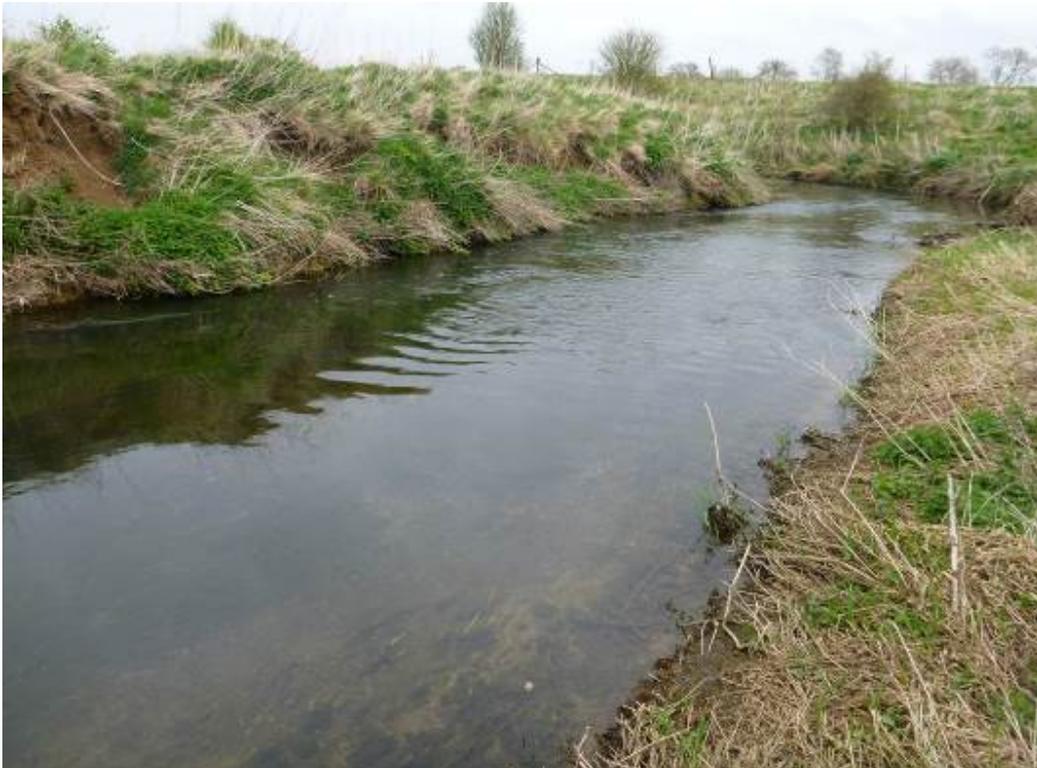
In contrast to the section upstream of the weir, this reach is not impounded and the in-stream habitat is much better. Although the river has obviously been engineered in the past (steep banks, bed much lower than surrounding land), the channel remains relatively sinuous. These meanders, combined with the free flow of the river, have allowed deep lateral scour pools to develop on the outside of bends and shallow, gravelly riffle areas (Photo 10) to form in between. This pool-riffle sequence is the basis of good in-stream habitat, providing spawning habitat (gravel riffles), juvenile habitat (shallower glides) and adult habitat (deeper pools). A number of trout were observed in this section of the river.

Photo 10 Shallow riffle areas provide spawning habitat for trout. These could be enhanced by providing more overhanging bankside cover.

- Stake some woody material alongside the riffles to provide cover for adult fish in the winter at spawning time (Photo 15). Plant some trees/bushes in these areas to provide cover in the longer term; sallows such as grey willow and goat willow (*Salix cinerea* and *S. caprea*) are ideal because of their low-growing, bushy habit. Whips could probably be sourced from existing local trees. Hawthorn and alder could also be used in this context.

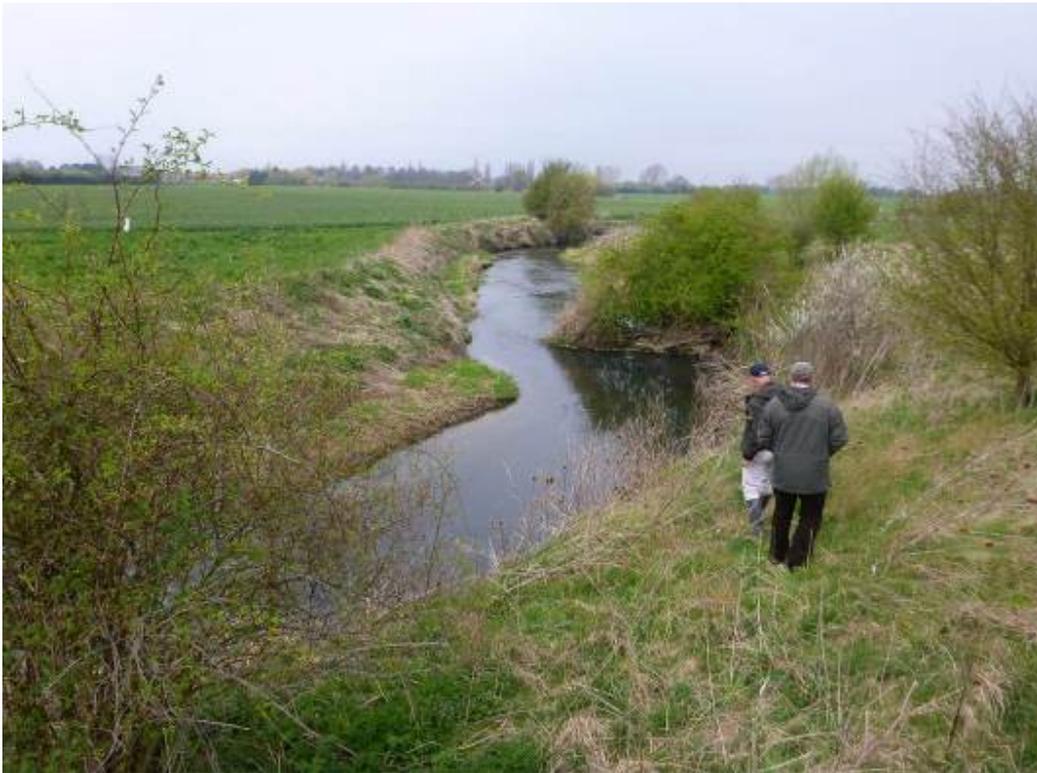
In addition to the good in-stream habitat, the riparian habitat is also much improved compared to the upstream section (Photo 11). The banks are fenced here and no grazing takes place. This reportedly makes access difficult in summer because of high vegetation, but strimming access points and retaining the good bankside habitat is preferable to bare banks. There are some good examples of low cover over the water provided by bushes and trees (Photos 11, 12). These are excellent habitat for adult trout and should be retained and more examples created by tree planting and "hinging" existing trees (see recommendations).

Photo 11 Good in-stream and riparian habitat.

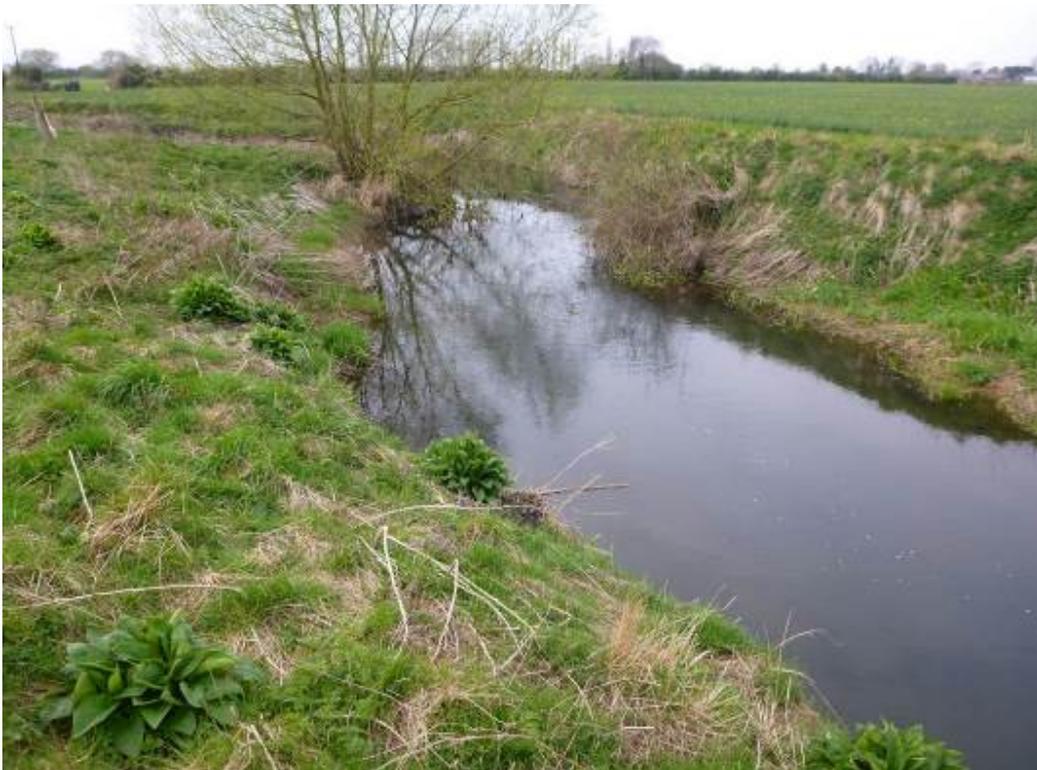
Photo 12 Excellent example of low cover over the water provided by the trees and bushes on each bank. This could be enhanced by hinging and laying the tree branches.

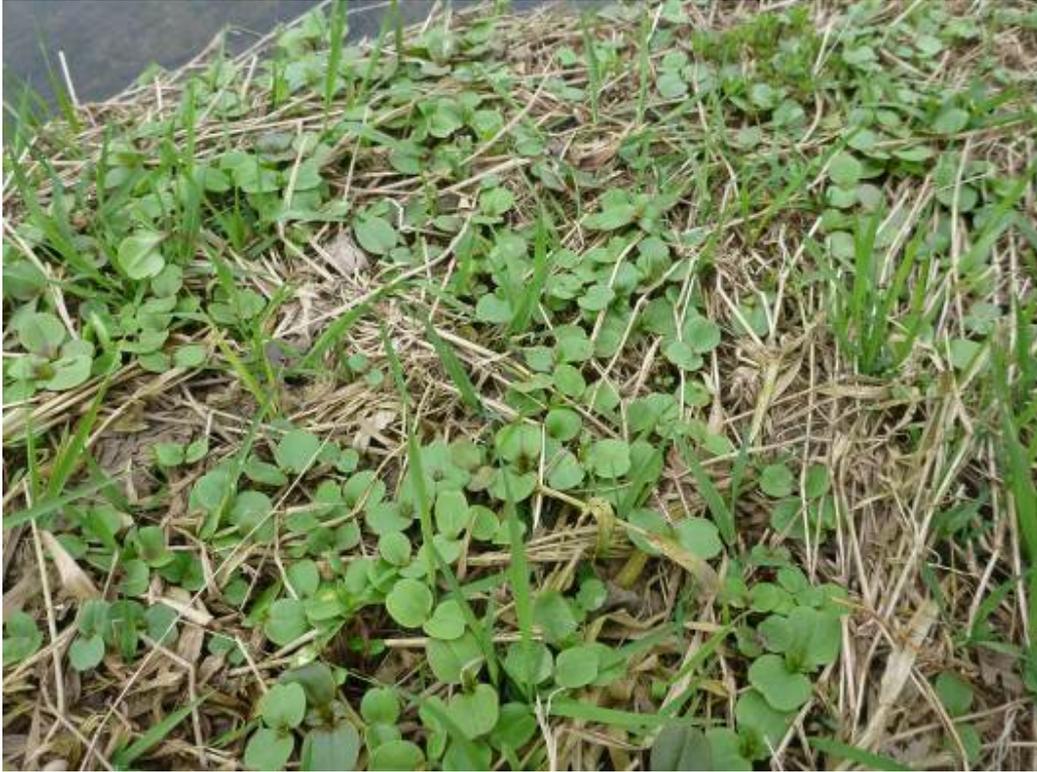
A small area of the invasive, non-native plant, Himalayan balsam (*Impatiens glandulifera*) was observed (Photo 13). The main issue with this species is its rapid rate of spread and the physical damage that results to river systems by blanketing river banks; being an annual it shades out other

species during the growing season, but provides no soil retention over winter leading to erosion problems and sediment inputs. The main method of control, and usually the most appropriate, is hand-pulling plants before they flower and set seed (usually end of June/early July). The arisings from this work should be left off the ground until they have dried out to prevent continued growth. The seed bank from this plant is relatively short-lived (about three years), so regular pulling is an effective control. Further information can be found at

Photo 13 Himalayan balsam, an invasive non-native plant species that should be controlled before it gets out of hand.

- Retain the woody debris from fallen/overhanging trees. Be judicial when managing trees and leave plenty of cover and refuge areas for fish.
- Control the Himalayan balsam by hand-pulling
