River Wylfe, Wylfe, Wiltshire

An Advisory Visit by the Wild Trout Trust July 2014

Introduction

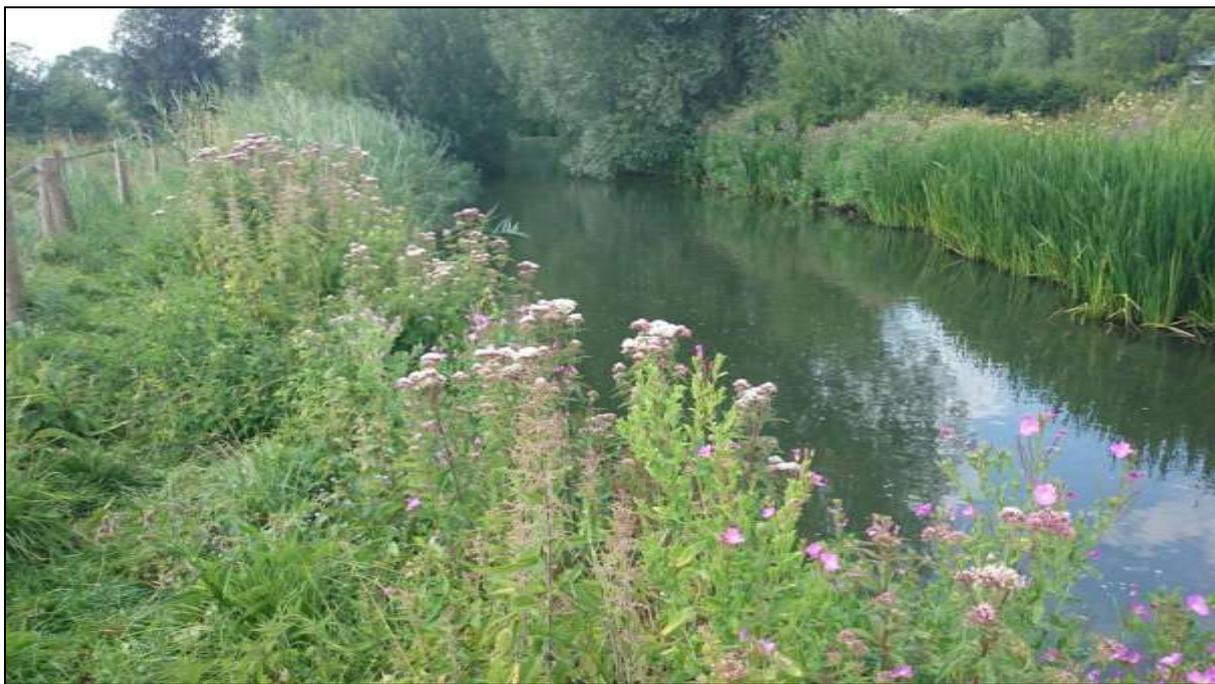
Near the upstream extent of the reach, the bank has eroded over recent years and the top of the bank is now relatively close to the fence (Figure 2).

Figure 2: Towards the upstream boundary of the reach, the margin between the fence and the top of bank is narrower than downstream

Erosion is a natural part of river morphology and there are a number of factors that contribute to the rate of bank erosion. The most pertinent factor in this situation is probably the shape of the channel cross-section. Much of the course of the Wylfe has been historically modified and the channel dredged and straightened for land drainage or modified to flood water meadows or to power mills. These modifications often result in parts of the river being incised with steep, almost vertical banks. Steep banks are more vulnerable to erosion as they are less-easily colonised by plants and can become undercut by fast flows.

The fact that the bank is on the outside of a slight bend in the river will also contribute to the rate of erosion. Secondary flows (turbulent flows and corkscrew-like eddies within the main flow) transport material from the outside of a bend to deposit it on the inside of the next bend downstream (Figure 3). This is what causes meanders to form and increase in amplitude over time.

2. Consider moving the fence back from the top of the bank to create so that a path can be mown further back from the top of the bank. This is essentially a 'managed retreat' option and may be worth doing in combination with other options to reinforce the bank and reduce the rate of further erosion.

- Install a log flow-deflector upstream of the eroding bank to deflect high-energy flows away from the bank as much as possible. This option will however involve keying a log into the bank and so will require finding a suitable location near the eroding bank that does not have signs of water vole occupancy.

- Reinforce the toe of the bank with brushwood revetment. This will slow flow along the bank toe, absorbing energy and reducing the rate of erosion. Translocating some emergent/marginal plants into the structure will further help to strengthen the bank and prolong the lifespan of the revetment. Driving whips of live willow into the structure may also significantly increase its lifespan. However, it should be noted that live willow will require a certain amount of annual maintenance.

- Create a sloping toe of large flint gravel rejects along the toe of the bank. This could be achieved by bringing gravel across the adjacent field with a tractor and trailer and placing gravel against the toe of the bank with an excavator bucket. This option may be more expensive than a brushwood revetment but is much less labour intensive and will involve less disturbance of vole habitat.

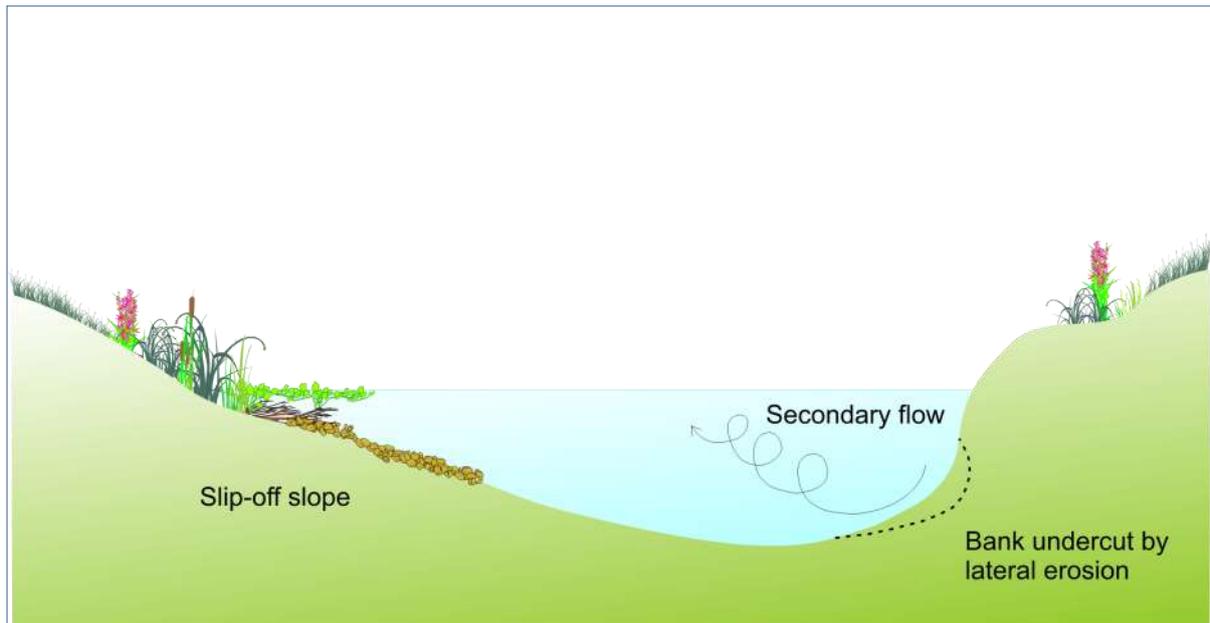
Figure 3: An illustration of a river cross section. The river is bending to the left causing erosion on the Right Bank and deposition on the Left.

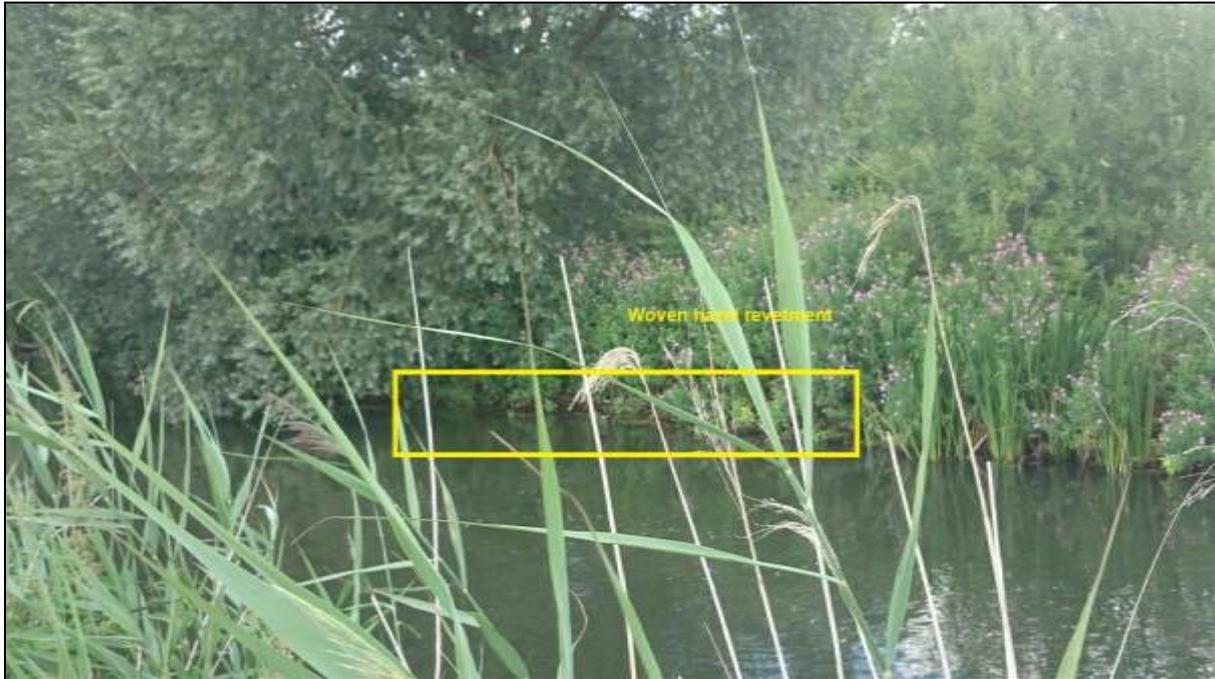
The rate of erosion may also have been accelerated by an increase in deposition on the opposite bank. A soft-engineered channel-narrowing and habitat creation project installed in 2007, involving the installation of a woven hazel spiling revetment on the LB has led to an increase in deposition and the development of a bed of branched bur-reed (*Sparganium erectum*) (Figure 4).

Figure 4: A woven hazel revetment on the LB is facilitating deposition which may be contributing to erosion on the RB as the meander amplitude increases.

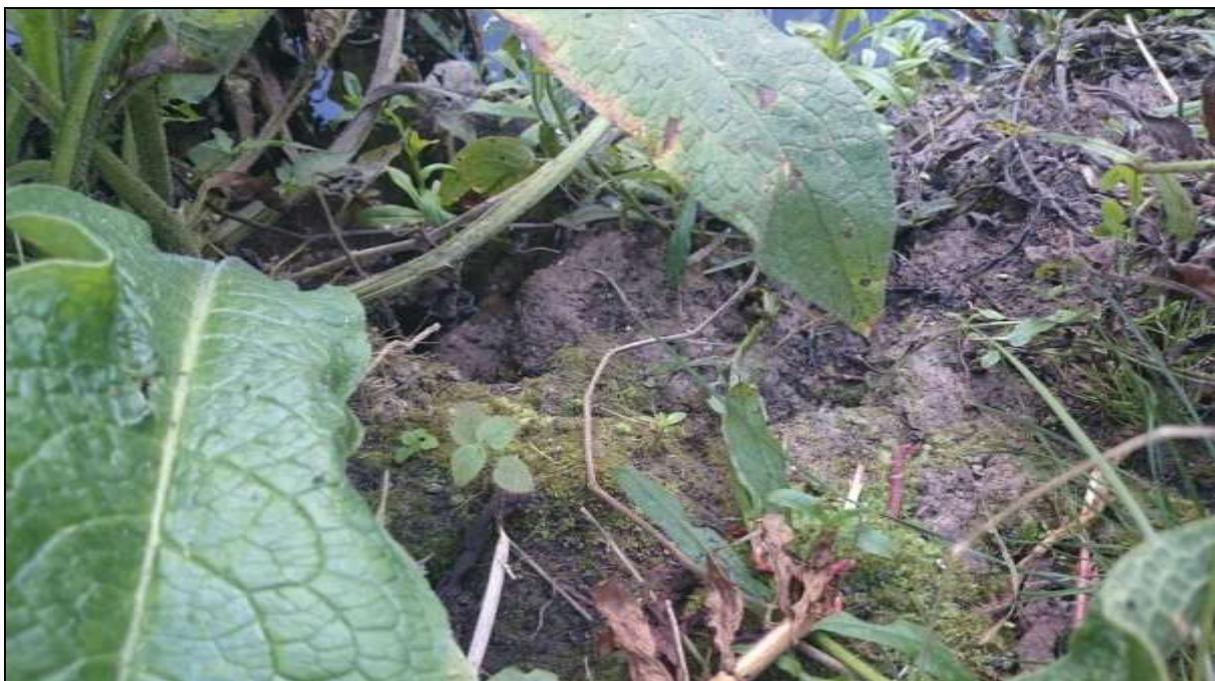
The final factor that was observed contributing to the rate of erosion was the presence of water vole (*Arvicola amphibious*) activity in the bank. A close inspection from the water was not possible on the day of the visit but a cursory examination of the lower bank revealed water vole latrines and a series of well-used tracks along the bank and through the vegetation, known as 'runs'. Holes in the bank amongst the runs were probably burrows (Figure 5).

Figure 5: Scratched mud around a hole amongst a water vole run suggests that water voles are burrowing in the bank.

3. The presence of water voles, a nationally protected species, limits the available options to reclaim and reinforce the bank. Under the Wildlife and Countryside Act 1981 (as amended in 2000) It is illegal to intentionally or recklessly damage, destroy or obstruct access to any structure or place which water voles use for shelter or protection or disturb water voles while they are using such a place.
(<http://publications.naturalengland.org.uk/file/86043>)
It is recommended to contact Fergus Mitchell at Natural England (Fergus.Mitchell@naturalengland.org.uk) to discuss options to protect the bank from erosion without causing too much disturbance to water vole habitat.
