**Water Framework Directive Habitat Survey
Upper River Yare and Blackwater, Norfolk
February 2012**

1.0 Introduction

This report is the output of a site visit undertaken by Tim Jacklin of the Wild Trout Trust to the upper River Yare and Blackwater, near Reymerston, Norfolk on 1st and 2nd February, 2012. Comments in this report are based on observations on the day of the site visit and discussions with Jez Wood, Biodiversity Officer with the Environment Agency, Anglian Region.

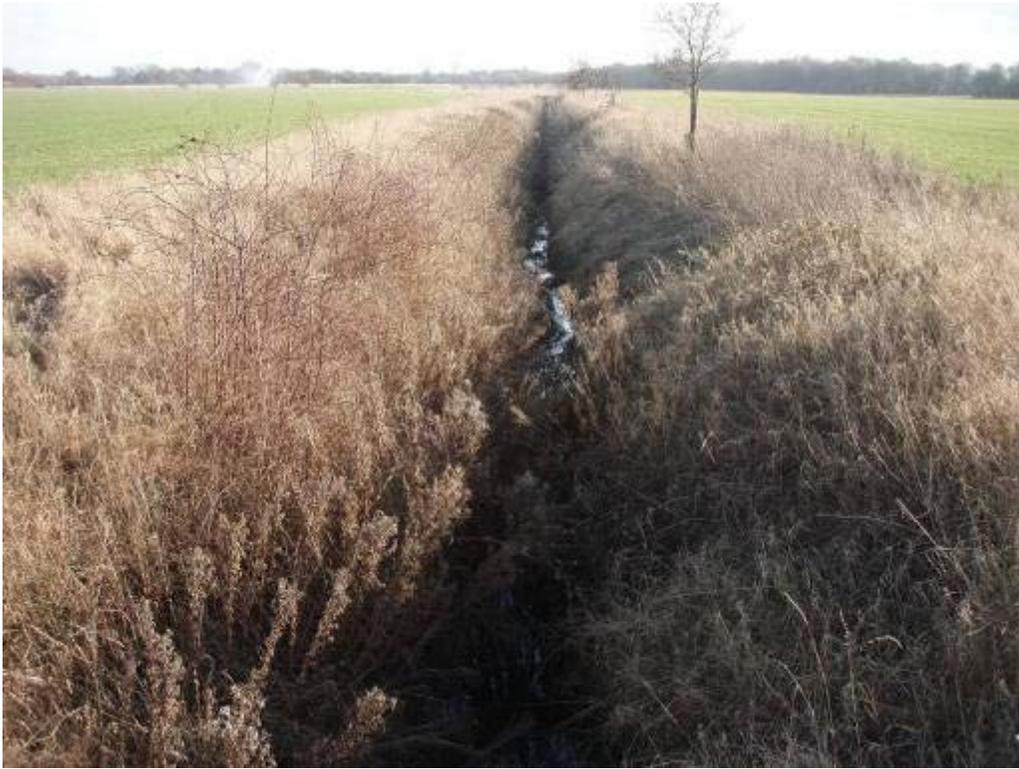
The source of the Blackwater is close to Saham Grove (TF933065), west of Shipdham; the river here is very small (Photo 1) and flows east under a minor road (Photo 2) then the A1075 towards Shipdham before turning south-east. The river is essentially a field drain here, being straightened and lowered. It is unlikely that trout would be found in these very upper reaches because of the small channel size and low volume of water present.

Photo 1 Blackwater near the source at Saham Grove (TF933065)

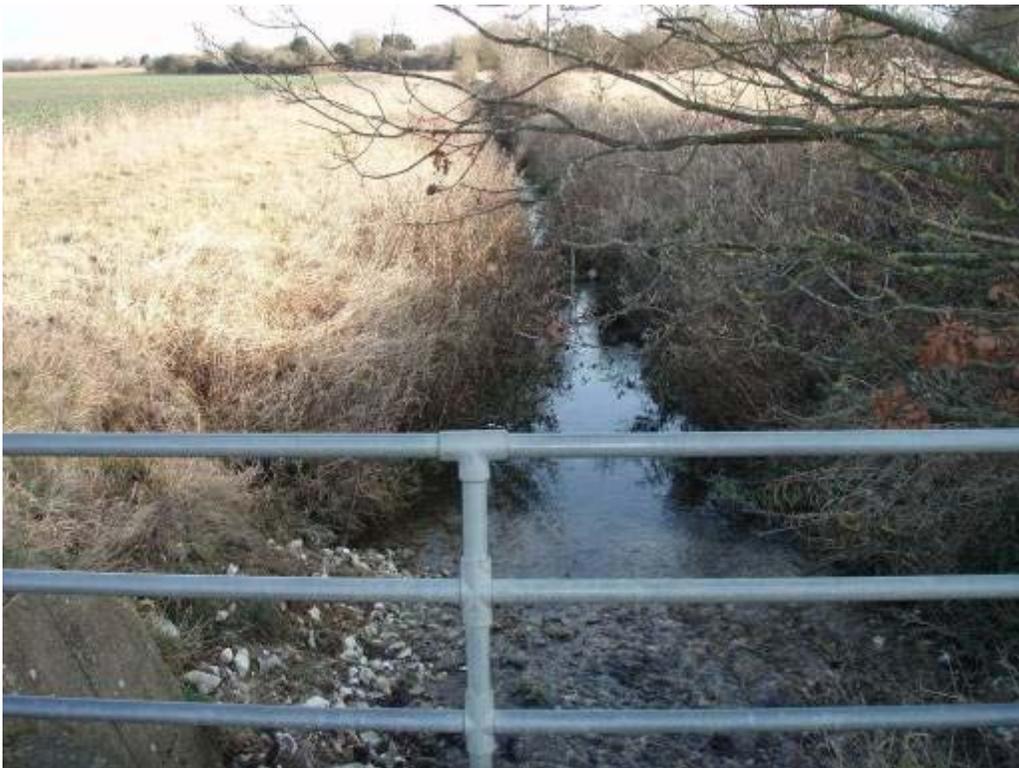
Photo 2 Blackwater at road bridge at TF946066

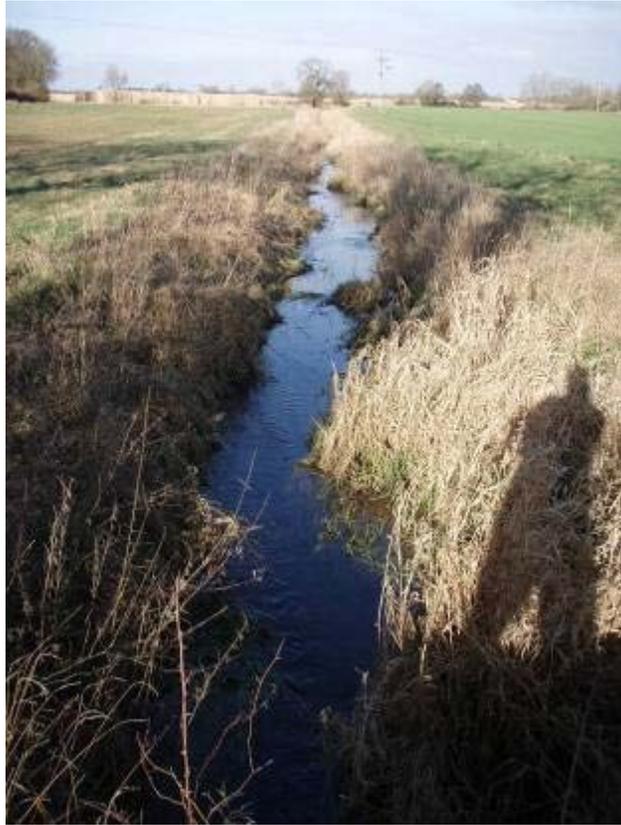
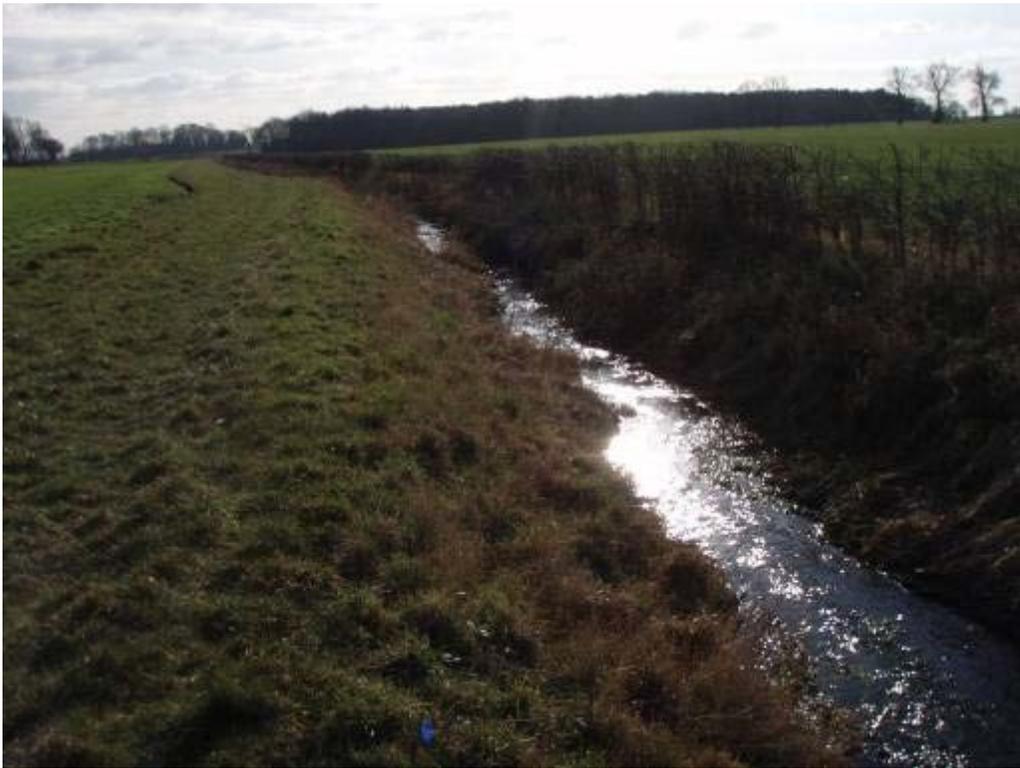
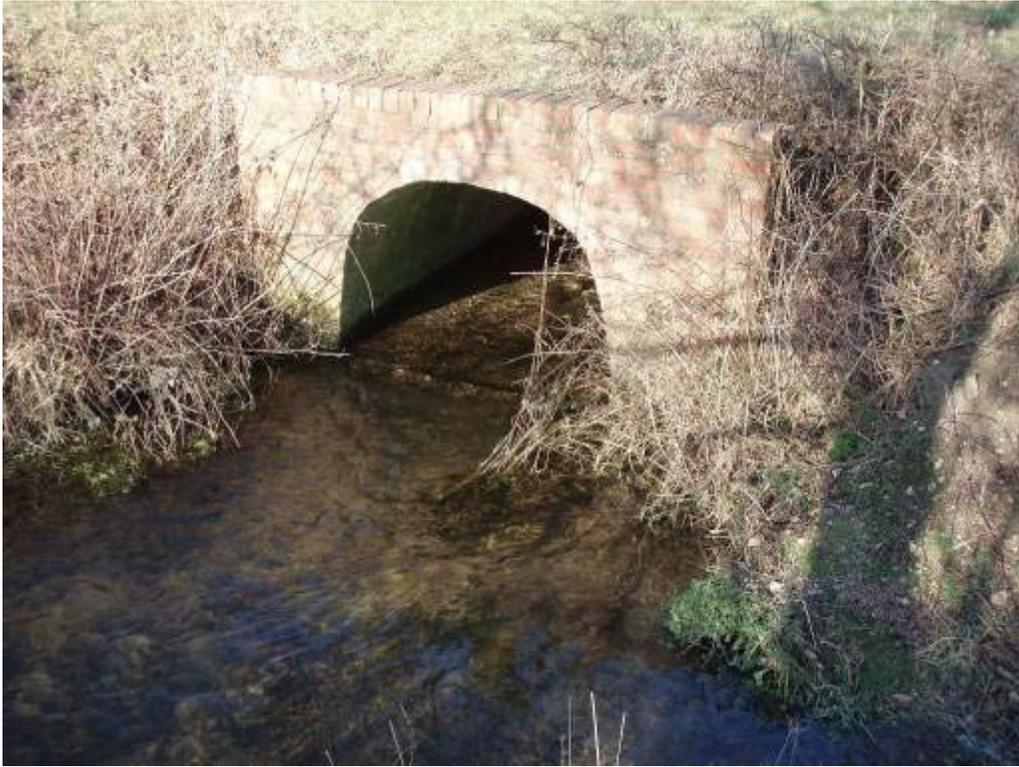
A track crosses the river at TF 962056; the river here is larger and of a size where trout would be expected to be present. The channel is straightened and lacks a natural pool-riffle sequence, but channel vegetation management appears to be relatively light providing some cover within the channel and a gravel bed is present. A wide field margin is present on the left bank downstream of the track. The bridge culvert does not form an obstacle to fish movement (Photos 3-5).

Photo 3 Upstream view, track crossing at TF962056

Photo 4 Downstream view, track crossing at TF962056

Photo 5 Bridge culvert, track crossing at TF962056

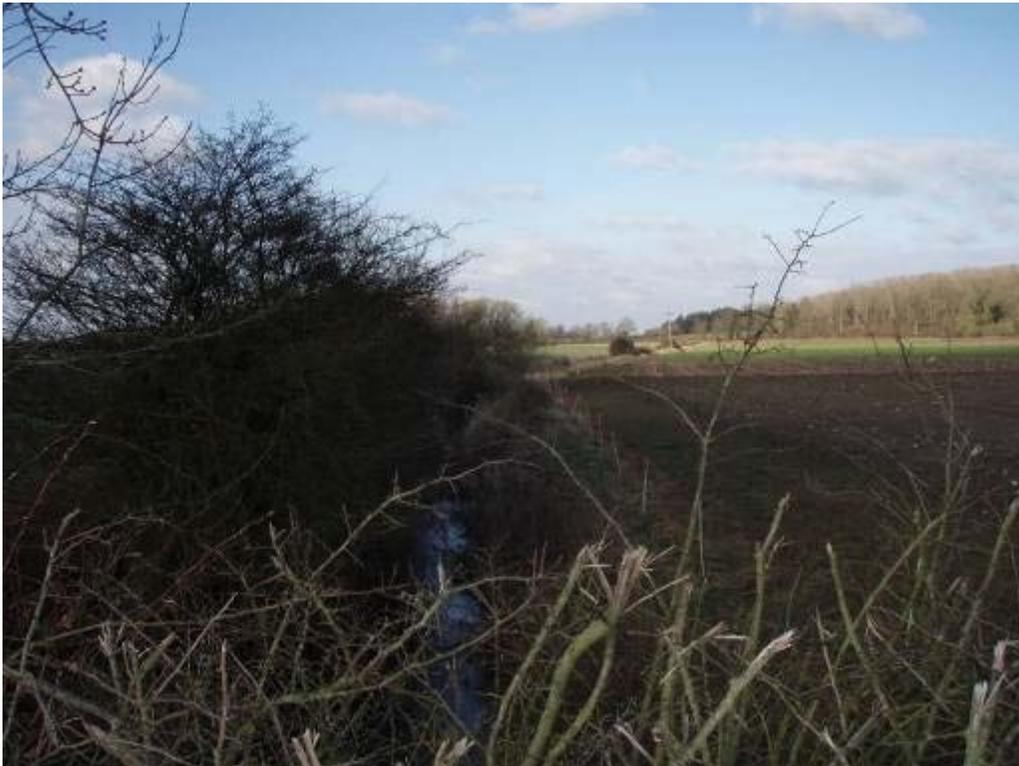
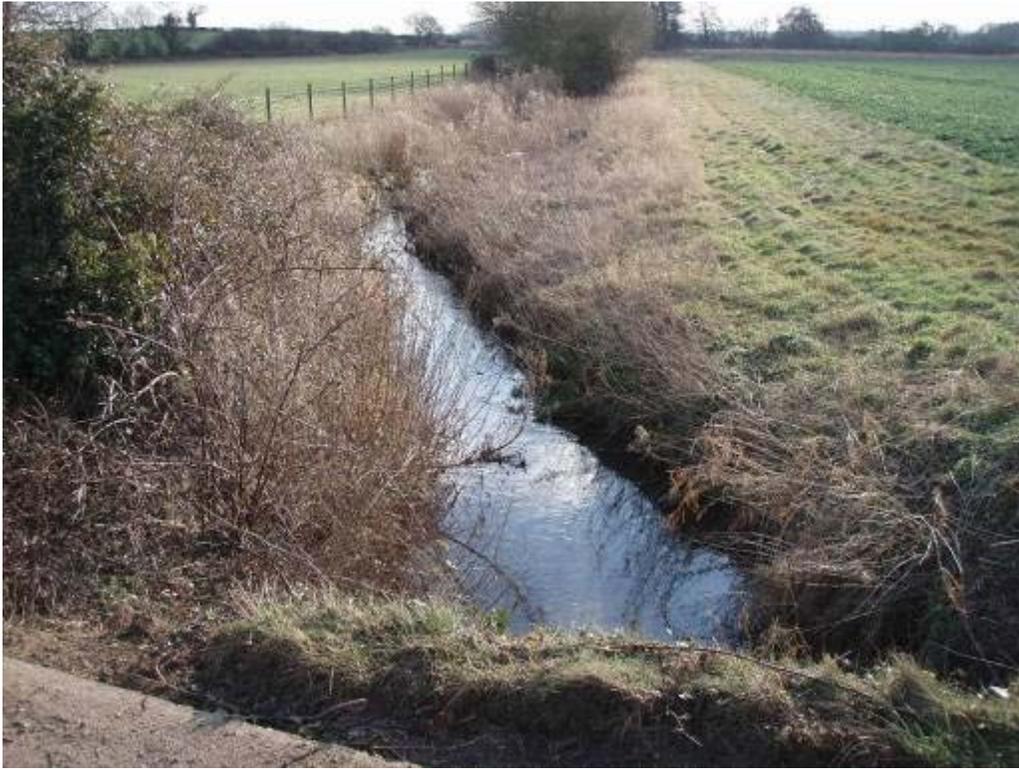
The river is of similar character near Cranworth at TF976045. More bankside trees are present here (hawthorn) and wide field margins are present downstream of the track on the RHB. The bridge culvert does not form an obstacle to fish passage (Photos 6, 7).

Photo 6 Near Cranworth, TF976045, upstream view

Photo 7 Near Cranworth, TF976045 downstream view

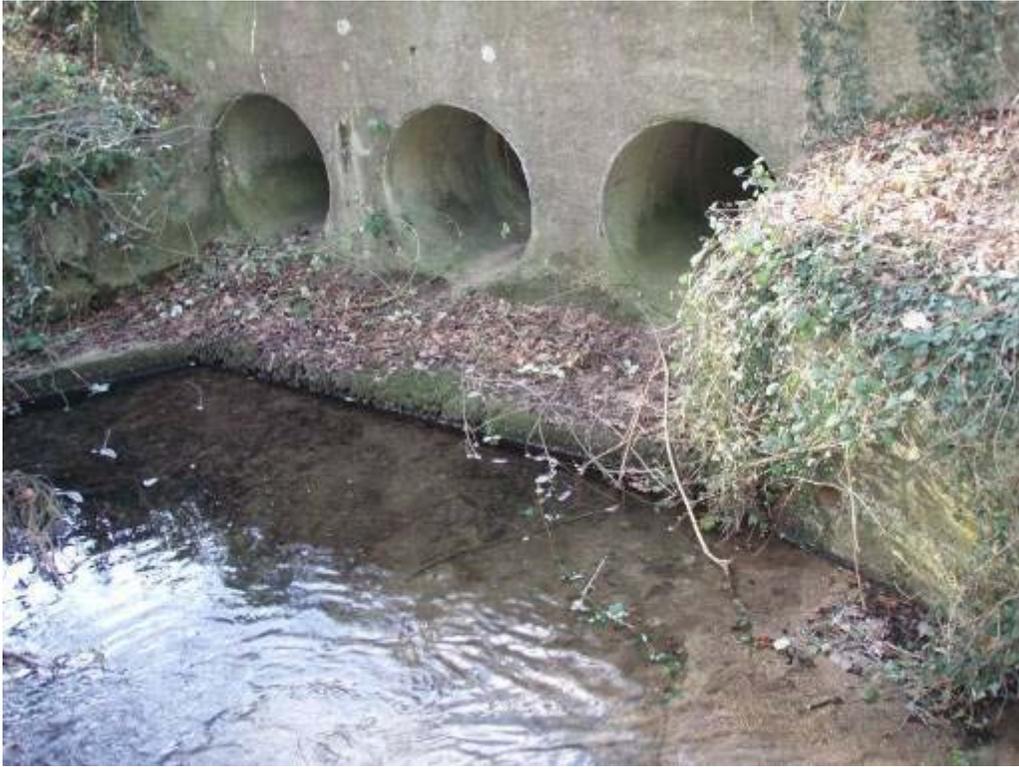
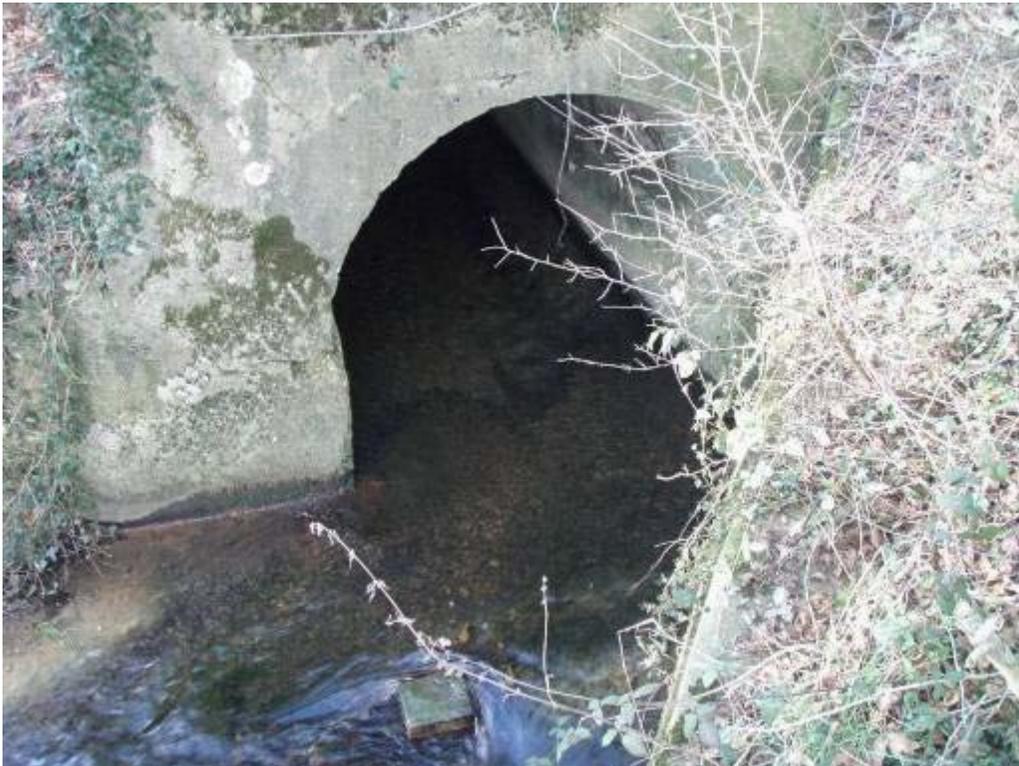
The road bridge south of Cranworth (TF987039) comprises an arched brick culvert which takes all the river flow at normal levels, plus three higher level pipes for higher flows (Photos 8, 9). Fish passage is possible through the existing arrangement (via the brick arch), but low, rounded baffles on the base of this culvert would improve the situation. In-stream habitat is better in the vicinity of the bridge, with a less straight planform and the presence of more varied riparian vegetation including trees (Photo 10).

Photo 8 Road bridge culvert, Blackwater TF987039

Photo 9 Road bridge culvert, Blackwater TF987039

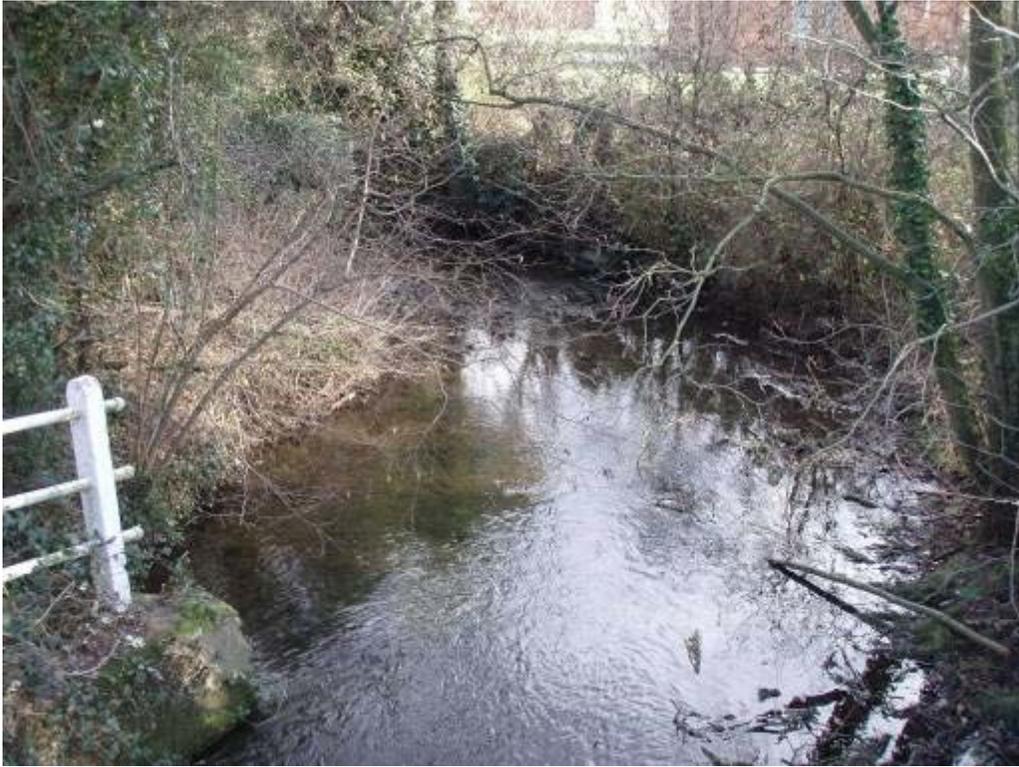
Photo 10 Downstream view from road bridge, Blackwater TF987039

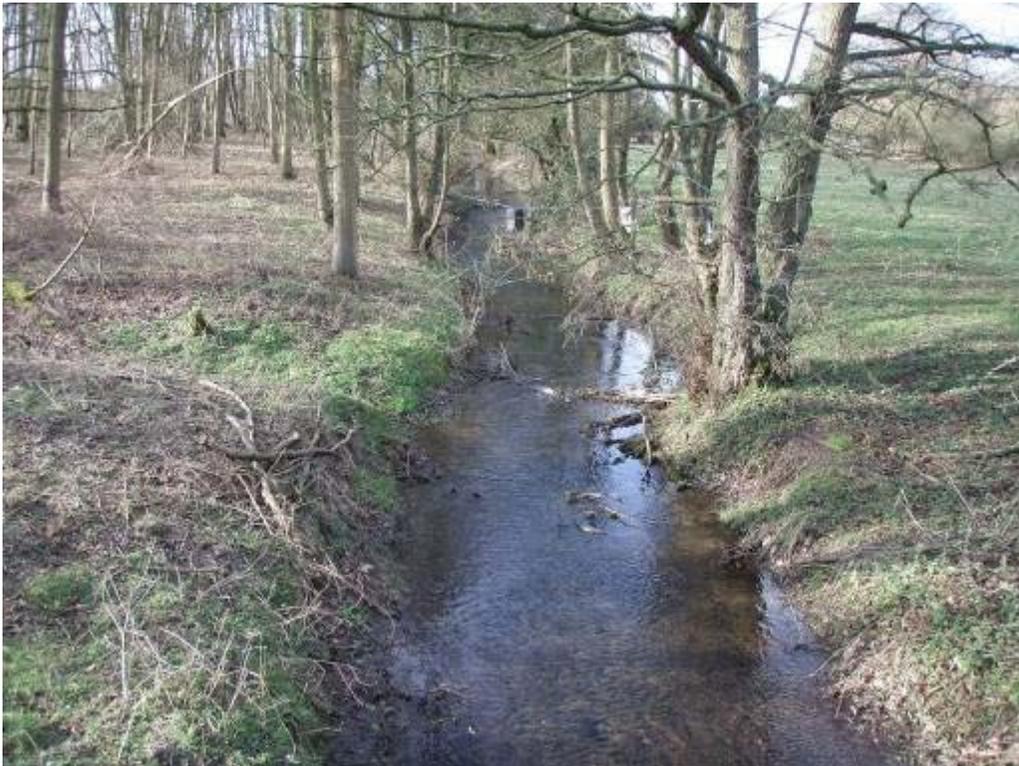
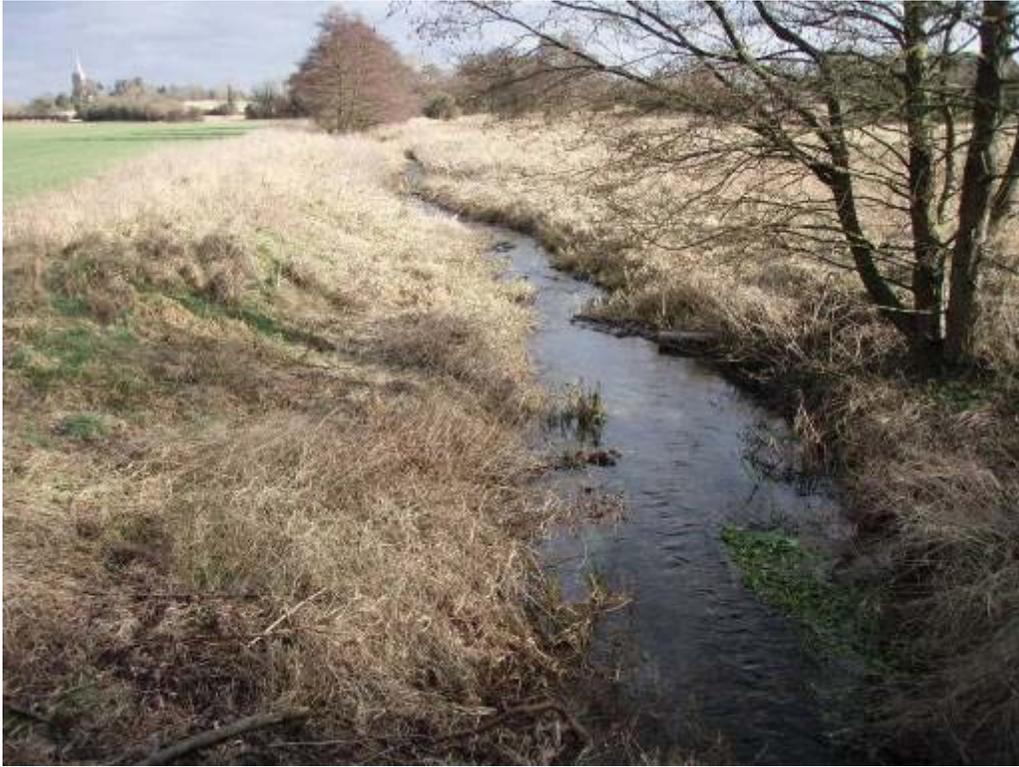
At White Bridge near Southburgh the riparian habitat is better than upstream sections, with mature trees present and relatively low, scrubby banks (Photos 11, 12). The in-stream habitat however lacks variety; there is an absence of a pool-riffle sequence and the depth is uniform and shallow. Further downstream towards Calveley Hall the river is split into two channels around a series of disused, concrete trout rearing tanks (Photo 14). Just downstream of this point there is a short section of river with excellent in-stream habitat; large woody debris is present and the river has scoured deeper pools and cleaned and sorted gravel (Photo 15).

Photo 11 Upstream view from White Bridge near Southburgh, Blackwater TF997044

Photo 12 Downstream view from White Bridge near Southburgh, Blackwater TF997044

improvement identified during the current visit include the White Bridge (TF997044) to Dereham Road bridge (TG028057) section of the Blackwater; the aims of a project here should include in-stream habitat restoration, restoring connectivity around the lake complex and improving fish passage over the barrier at Dereham Road.

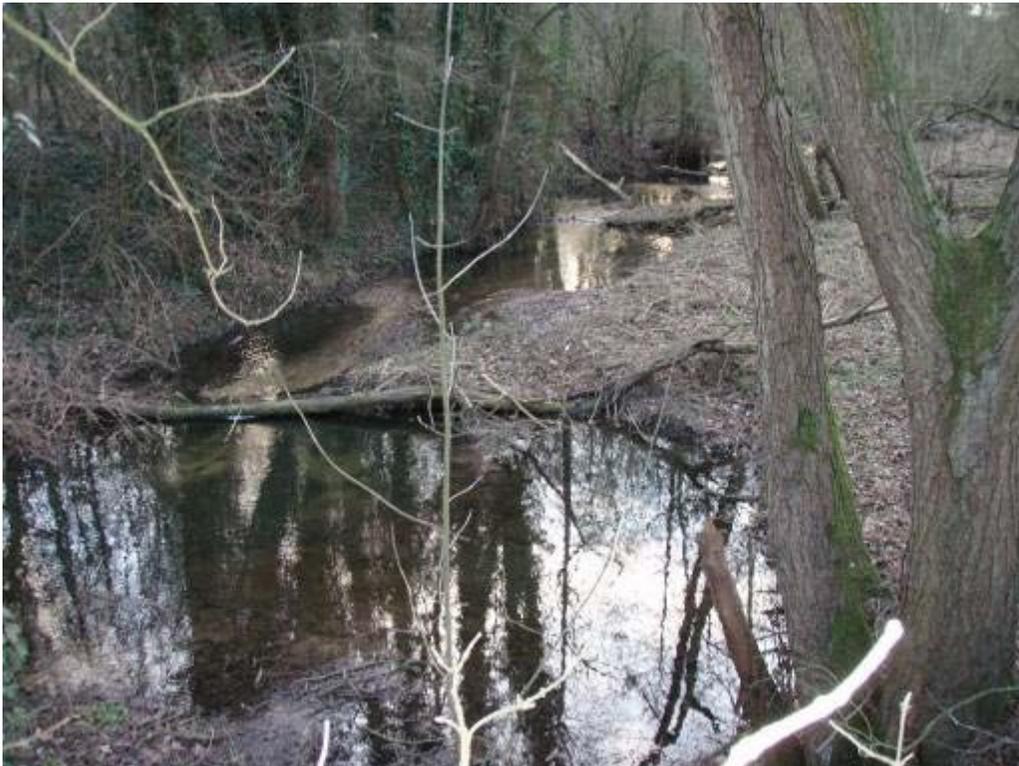
Photo 15 Blackwater immediately downstream of Photo 14 – some excellent in-stream habitat with large woody debris, scour pools, a good depth variety and well-sorted gravel substrate

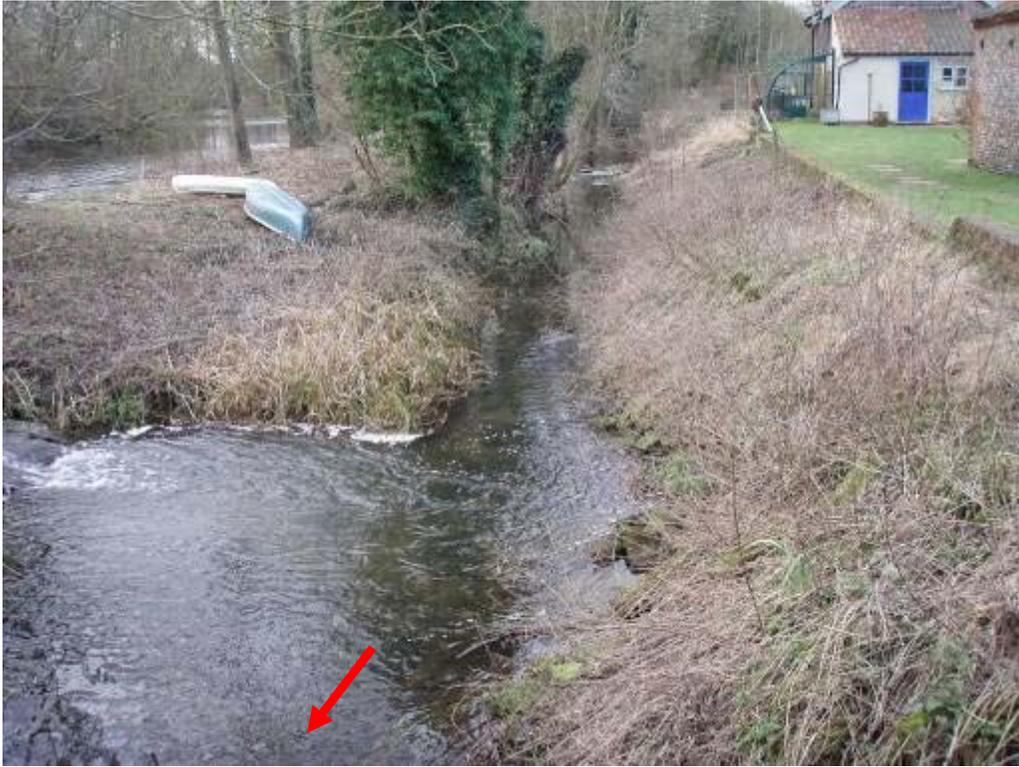
Immediately downstream, the river enters a series of on-line lakes. Although Ordnance Survey maps show the river bypassing the lakes to the north, no evidence of a river bypass channel was found on site at the upstream end of the lakes. However, further downstream at Bridge Farm (Photo 16), the outflow from the most downstream lake does join a channel on the north side; this may emanate from other lake overflows or springs. It was not possible to gain access along the whole length of the lakes to verify the existing situation, but it does appear that there is no direct route for fish passage around the lake complex. Further investigation is required with a view to creating a bypass channel around the lakes and providing continuous river habitat.

Photo 16 Outflow from the lake (background and left) and upstream view of river channel (centre), Bridge Farm, Blackwater, TG021049. Arrow indicates flow direction.

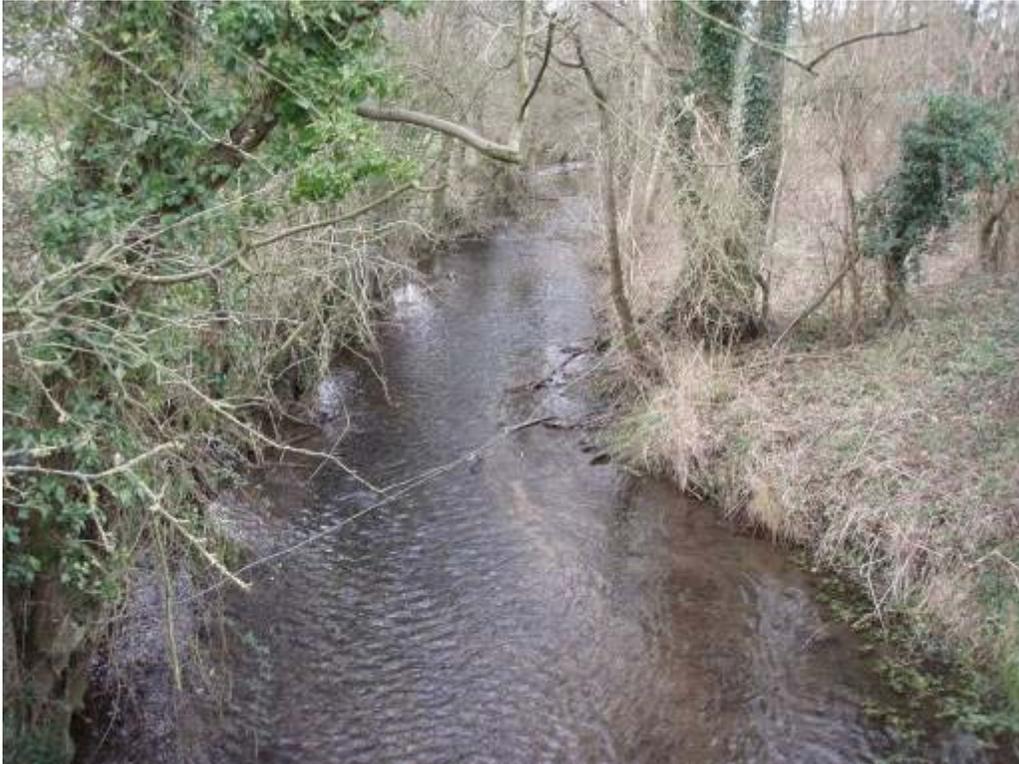
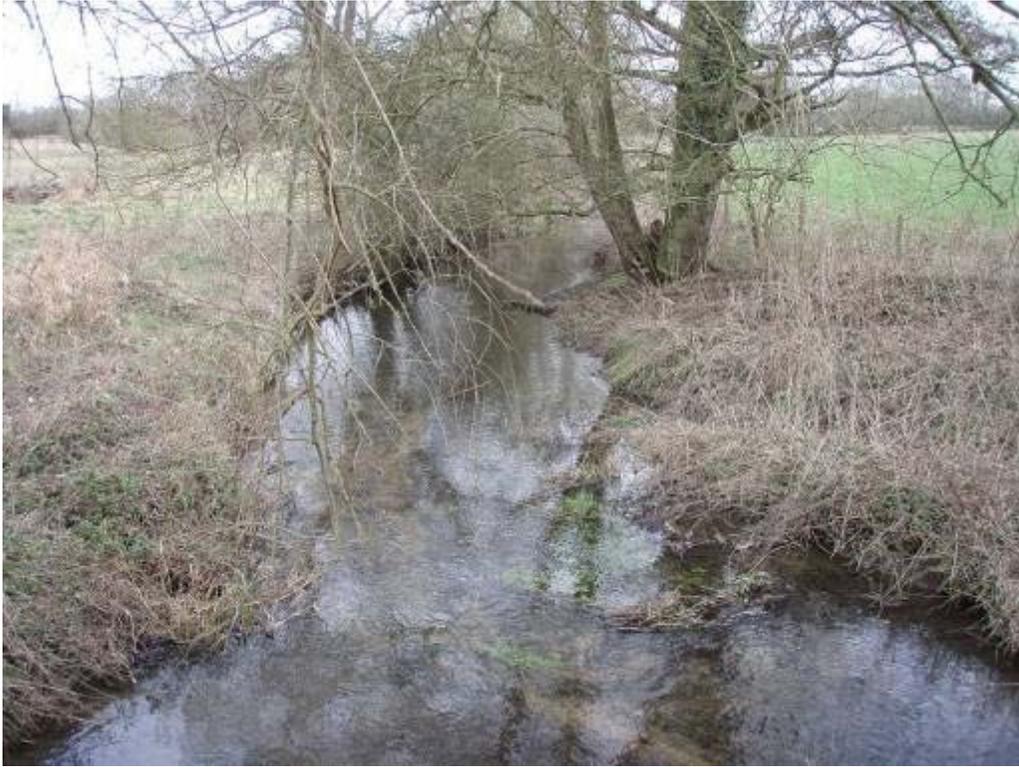
At Blackwater Bridge (TG022049) riparian habitat was good, but in-stream again lacked variation in depth, being mostly shallow glide (Photos 17, 18). Conversation with a local farmer revealed that his son did fish in this area and had observed trout.

Photo 17 Upstream view from Blackwater Bridge, TG022049

Photo 18 Downstream view from Blackwater Bridge, TG022049

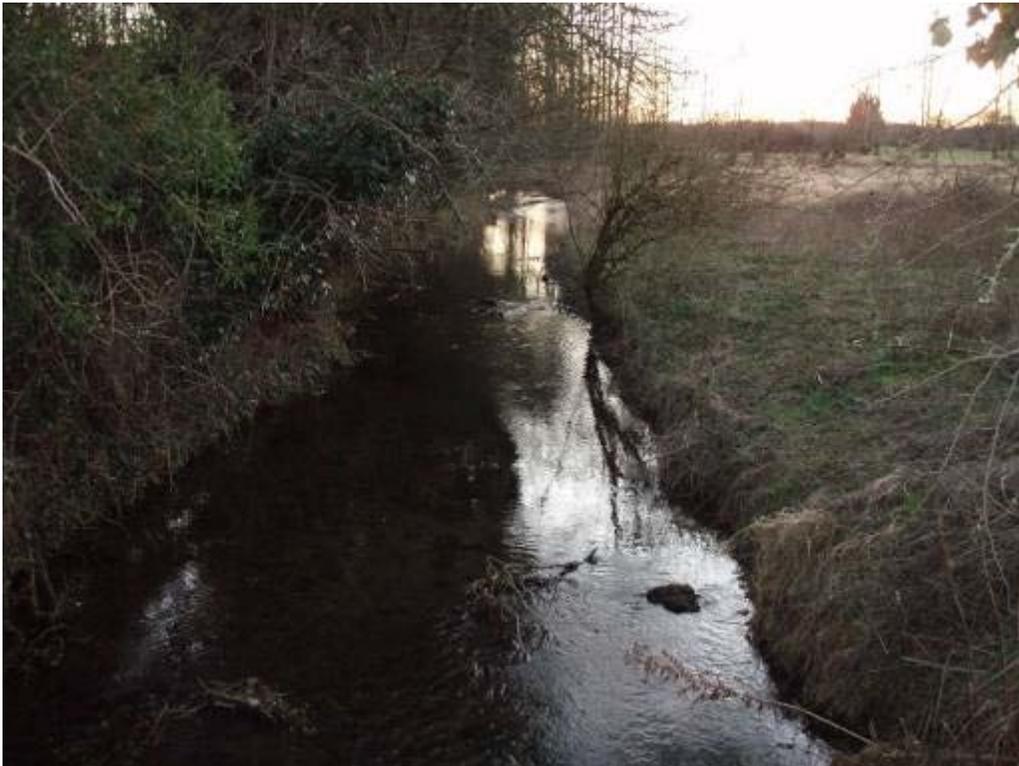
Photo 19 Upstream view from Dereham Road bridge (TG028055). River impounded above structure shown in Photo 20.

Improving fish passage here would be most cost-effectively achieved by the construction of a rock ramp, or series of pre-barages downstream of the weir. Upstream of the bridge the river is impounded, straight and shallow, with a bed dominated by fine sediment; there is space on the LHB here for river channel re-routing (adjacent to the golf course, Photo 19). A short distance downstream are two much smaller structures that are likely to be passable by fish (Photo 21) and could easily be improved by notching. Downstream of this point for approximately 500m, the river habitat is excellent. A pool-riffle sequence is present with many natural features including gravel shoals and point bars, woody debris and deep pools bordered by tree roots. The left bank here is a land-filled gravel pit which appears to have been over-filled creating very steep banks down to the river; the right bank is much lower and is signed as a wildlife area. Both banks are wooded, mainly with young alder trees of a similar size/age (about 20-cm trunk diameter).

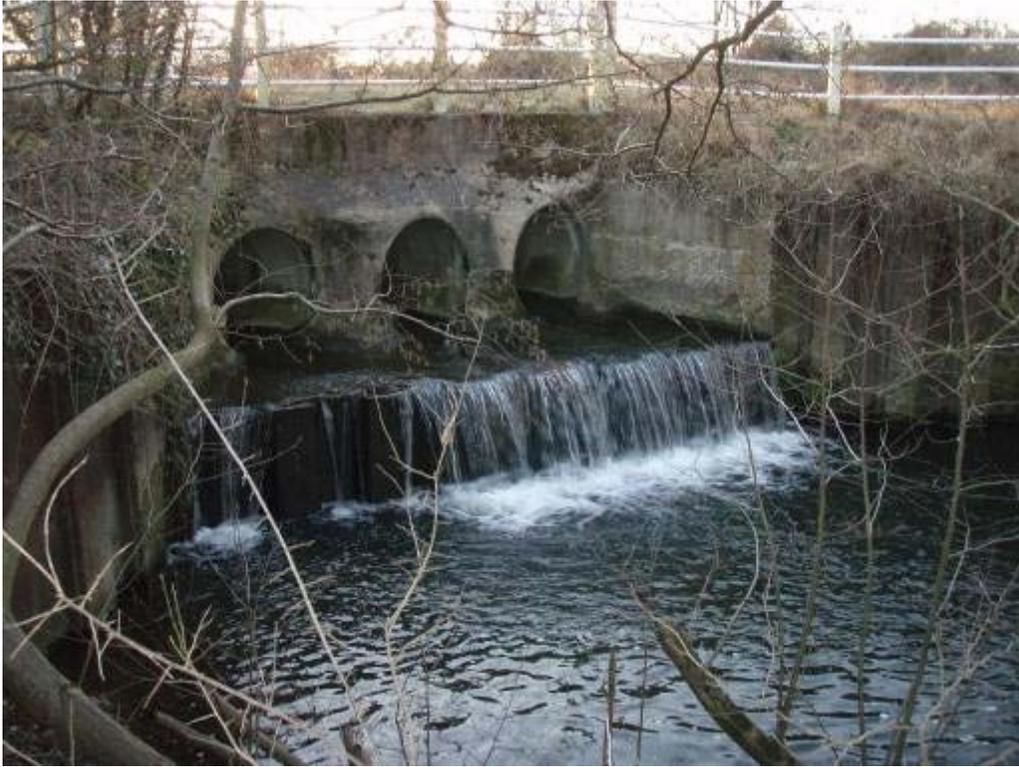
Photo 20 Dereham Road bridge culvert, near Reyermerston. A major obstacle to free passage of fish. Blackwater TG028055

At Dereham Road bridge near Reymerston, the bridge culvert poses a significant obstruction to upstream fish passage, having an approximately 1-metre head difference across a vertical sheet-pile weir (Photo 20).

1. Extensive channel modification for drainage (straightening, bed lowering), for the majority of the river length inspected resulting in impoverished habitat for fish.
2. Two significant obstructions to the free movement of fish, one at Dereham Road bridge (TG028055) and another at the on-line lakes near Calveley Hall (TG015048).

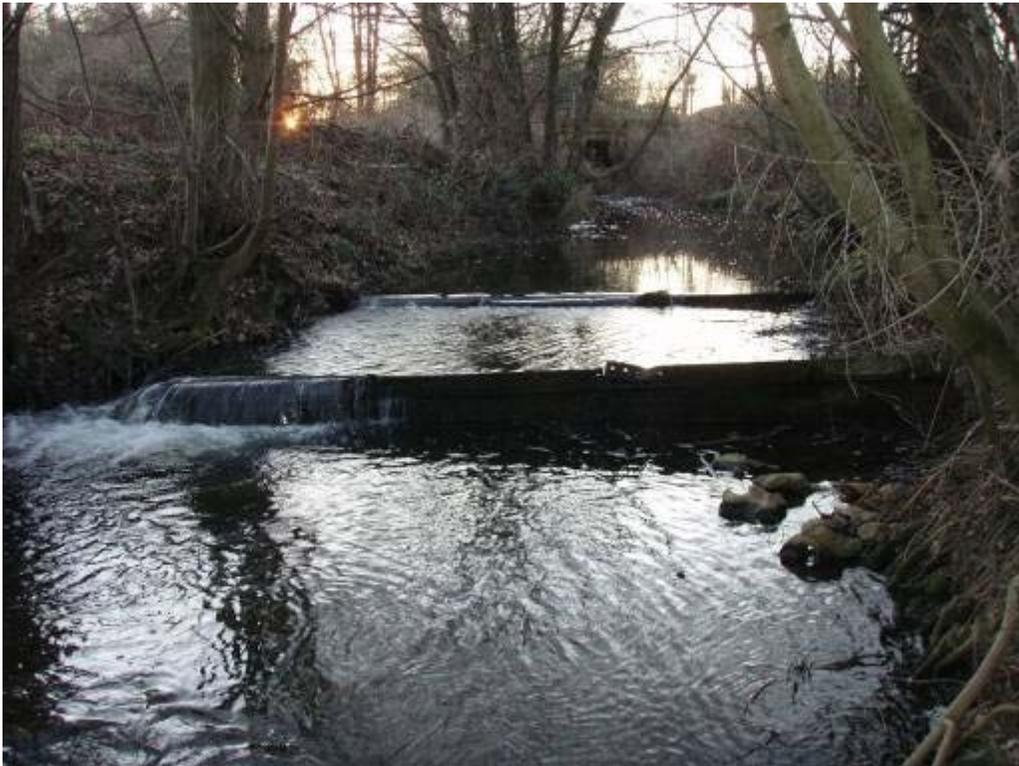
Photo 21 A smaller obstacle to fish passage a short distance downstream of Photo 20

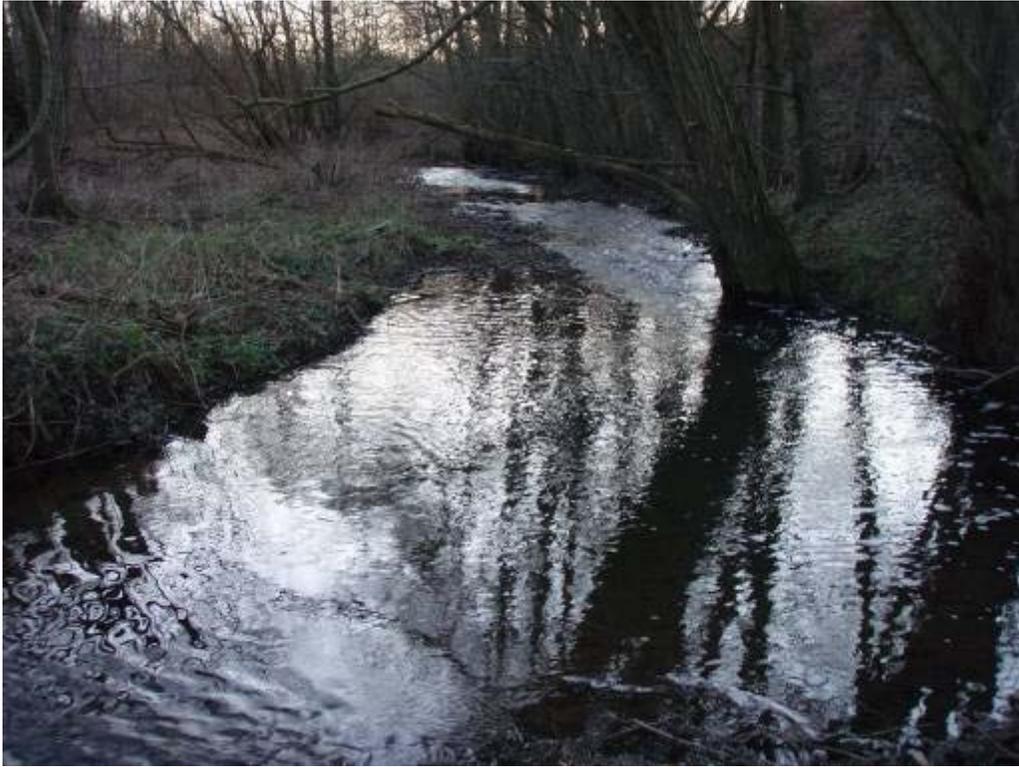
Photo 22 Very good in-stream habitat downstream of the road bridge at TG028055 for about 500 metres, alongside a nature reserve on the RHB.

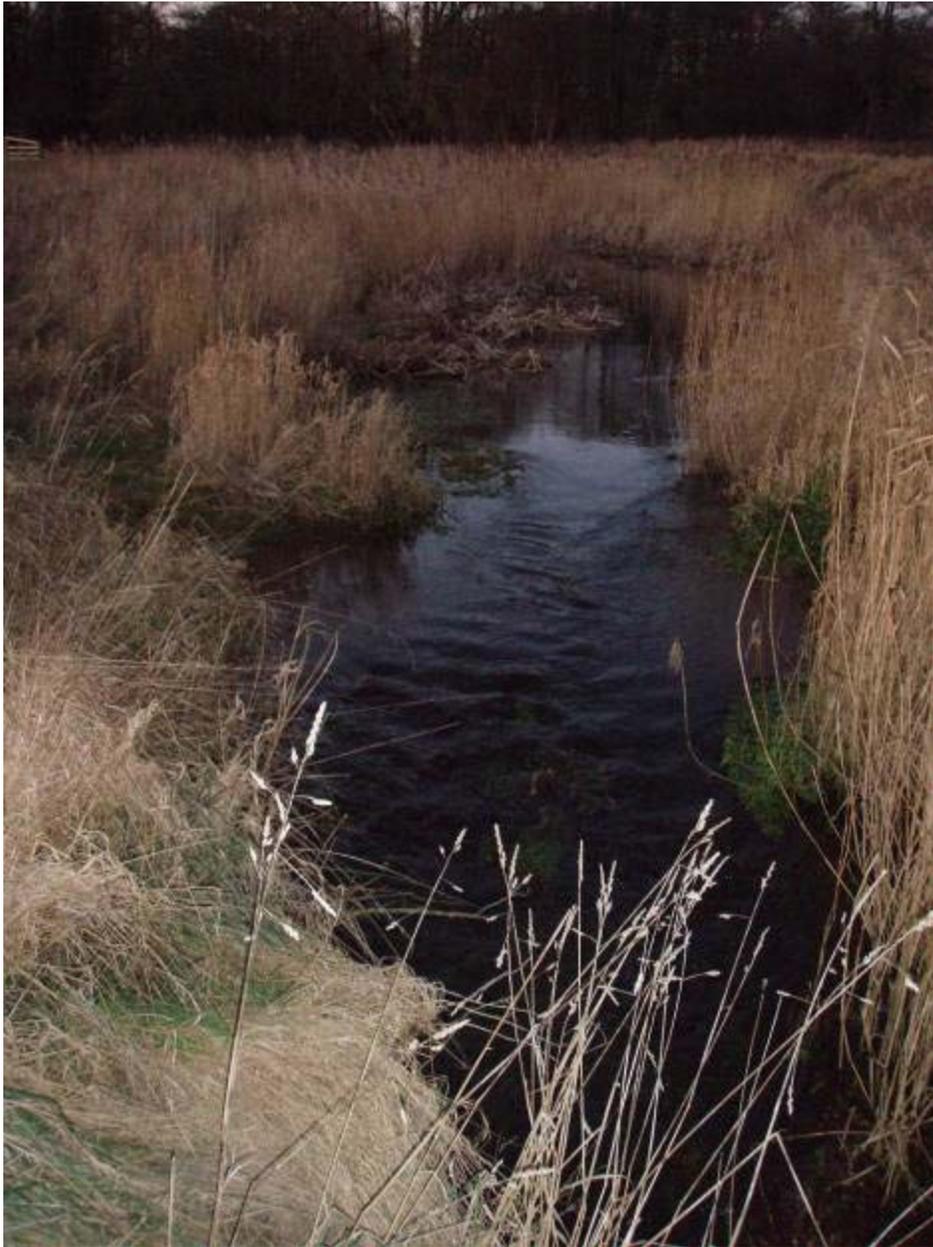
Photo 23 Part of the section of the Blackwater that was the subject of a river restoration carried out approximately 10 years ago
By Prof. Richard Hey following gravel quarrying, Blackwater TG035057

With progress downstream the channel becomes wider and shallower with fewer in-stream features. The next point inspected was adjacent to Hardingham Church alongside the lakes (former gravel pits). A section of river here was the subject of a river restoration project (following gravel extraction) supervised by Professor Richard Hey (pers. comm.). The project involved the re-creation of a river channel with a meandering planform, pool-riffle sequence and functioning floodplain, between the approximate grid references TG036058 and TG039057 (Photo 23).

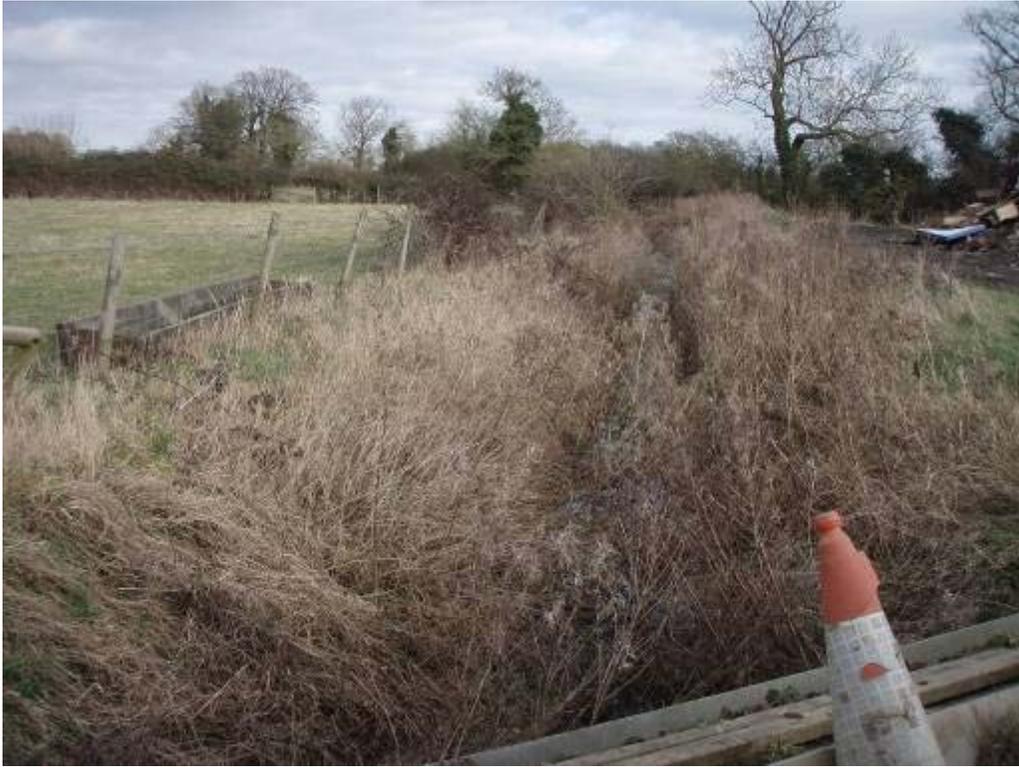
Photo 24

The source of the Upper Yare is north-east of Shipdham at TF972083. The river is culverted for approximately 1 km under Shipdham airfield and inspection at Park Farm (south of Whinburgh, TG003084) showed the river is very small at this point (Photo 24).

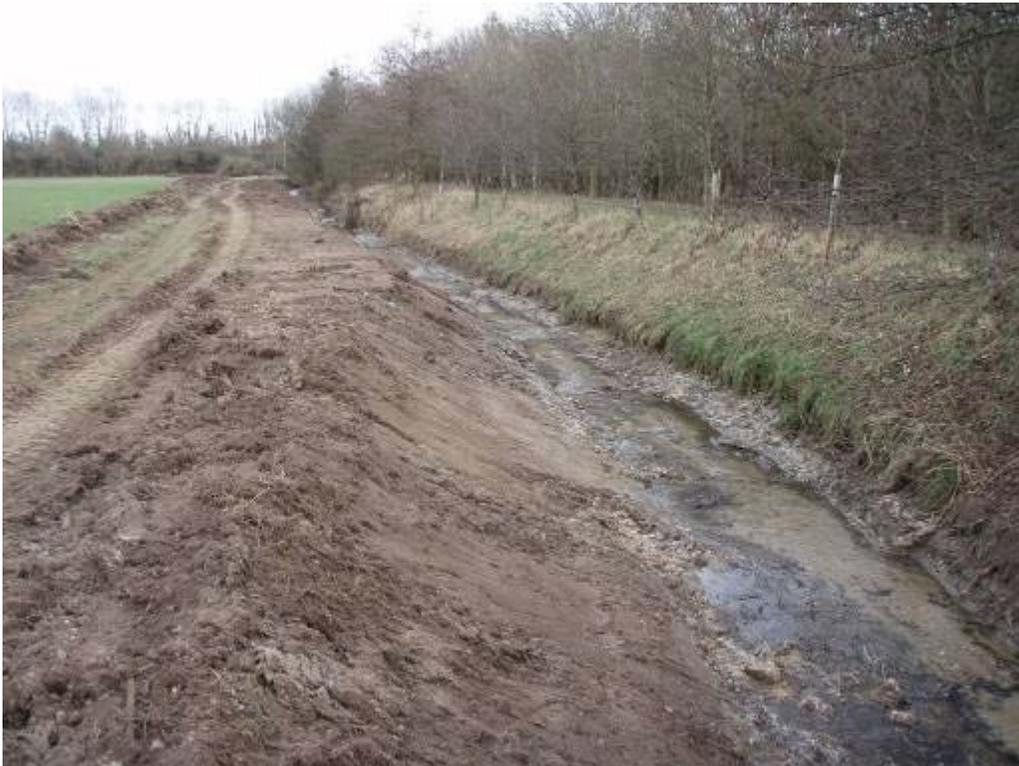
Photo 25

Downstream of the B1135 road bridge north of Garvestone (TG013085), the river has been recently dredged (Photo 25) for a length of approximately 400 m. The left bank has been battered back to a 30-degree angle and the river bed lowered by about 20 cm. The bed lowering has left only fine bed substrate and appears to have effectively increased the height of the weir immediately below the road bridge, and hence the obstacle to fish movement (Photo 26). It is thought that the works are not consented by the Environment Agency and it is obvious that no consideration has been given to habitat for fish or other wildlife. No meaningful in-stream habitat remains along this length. Ironically, this length of river appears to border land on the LHB in a Countryside Stewardship agreement.

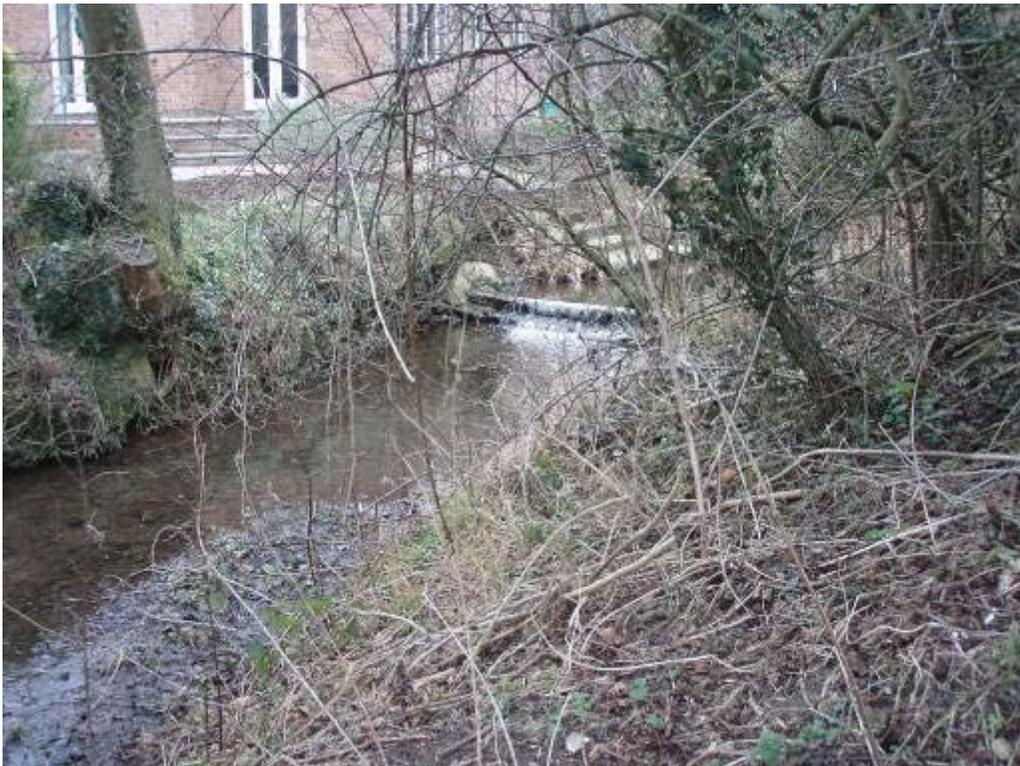
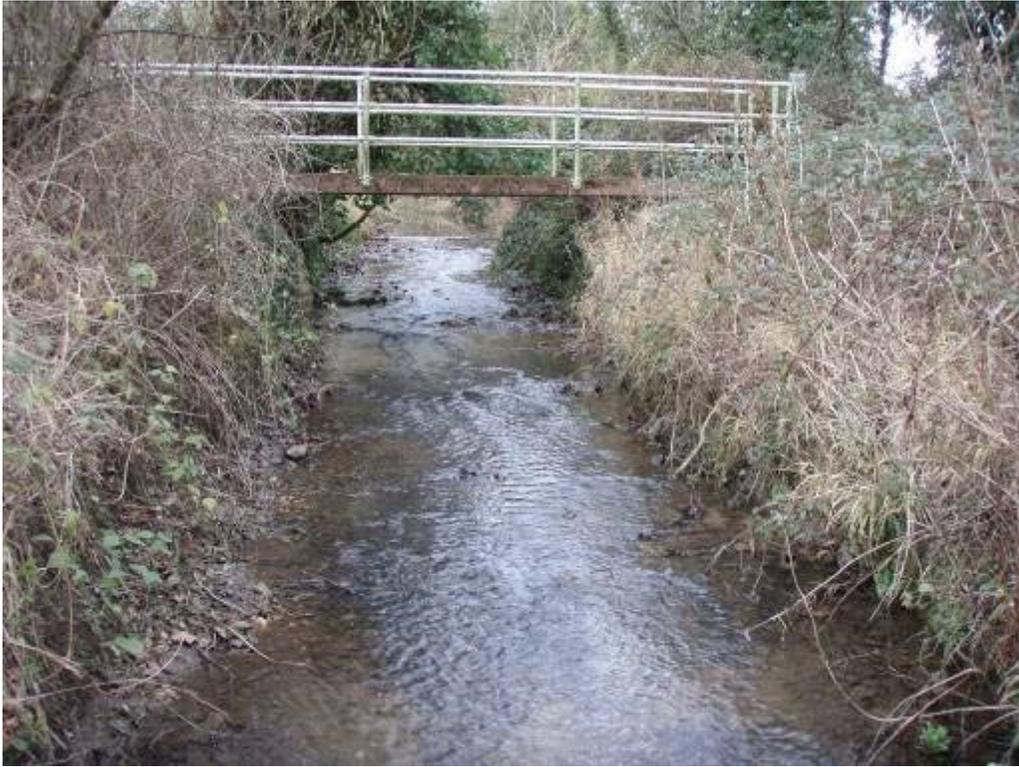
Upstream of Garvestone village the river is straight, wide and shallow; it flows alongside residential properties coming into the village and some low, presumably ornamental, weirs are present (Photos 27, 28). There is a ford in the village consisting of pipes under the road for low flows and a lowered road surface for higher flows; this is potentially an obstacle to fish movement, especially if the pipes block (Photo 29).
