**Water Framework Directive Habitat Survey
Upper River Yare and Blackwater, Norfolk
February 2012**

1.0 Introduction

This report is the output of a site visit undertaken by Tim Jacklin of the Wild Trout Trust to the upper River Yare and Blackwater, near Reymerston, Norfolk on 1st and 2nd February, 2012. Comments in this report are based on observations on the day of the site visit and discussions with Jez Wood, Biodiversity Officer with the Environment Agency, Anglian Region.

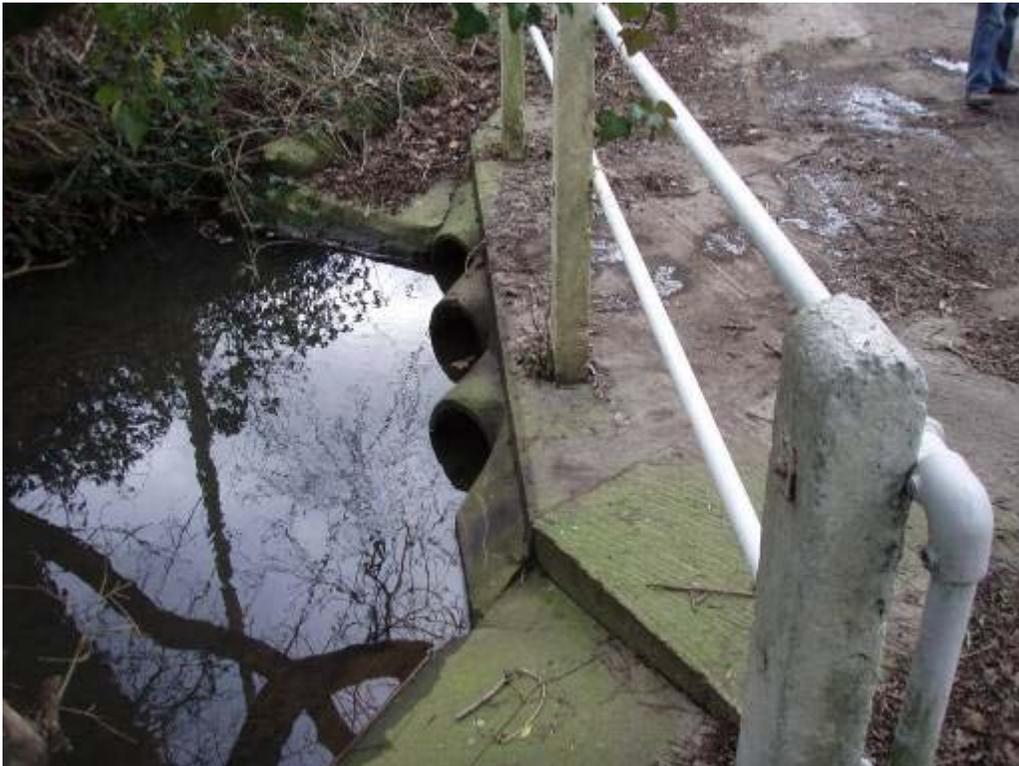
Photo 29

Upstream of Garvestone village the river is straight, wide and shallow; it flows alongside residential properties coming into the village and some low, presumably ornamental, weirs are present (Photos 27, 28). There is a ford in the village consisting of pipes under the road for low flows and a lowered road surface for higher flows; this is potentially an obstacle to fish movement, especially if the pipes block (Photo 29).

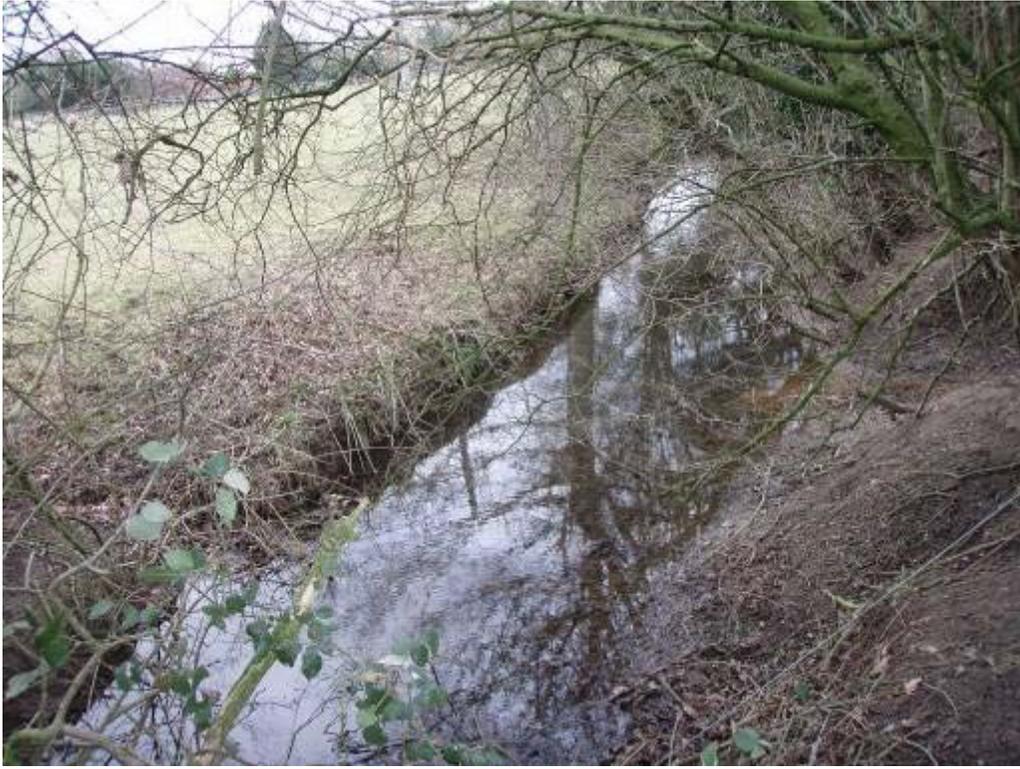
Photo 30

Between Garvestone and Thuxton, the river has more natural features although at the time of the visit flows appeared to be very low. Rainfall has been exceptionally low in recent months, but it would be worth investigating abstractions in this catchment to assess their potential impact. Some parts of this section were heavily shaded by marginal hedges (hawthorn) and would benefit from sensitive riparian tree management (Photo 30).

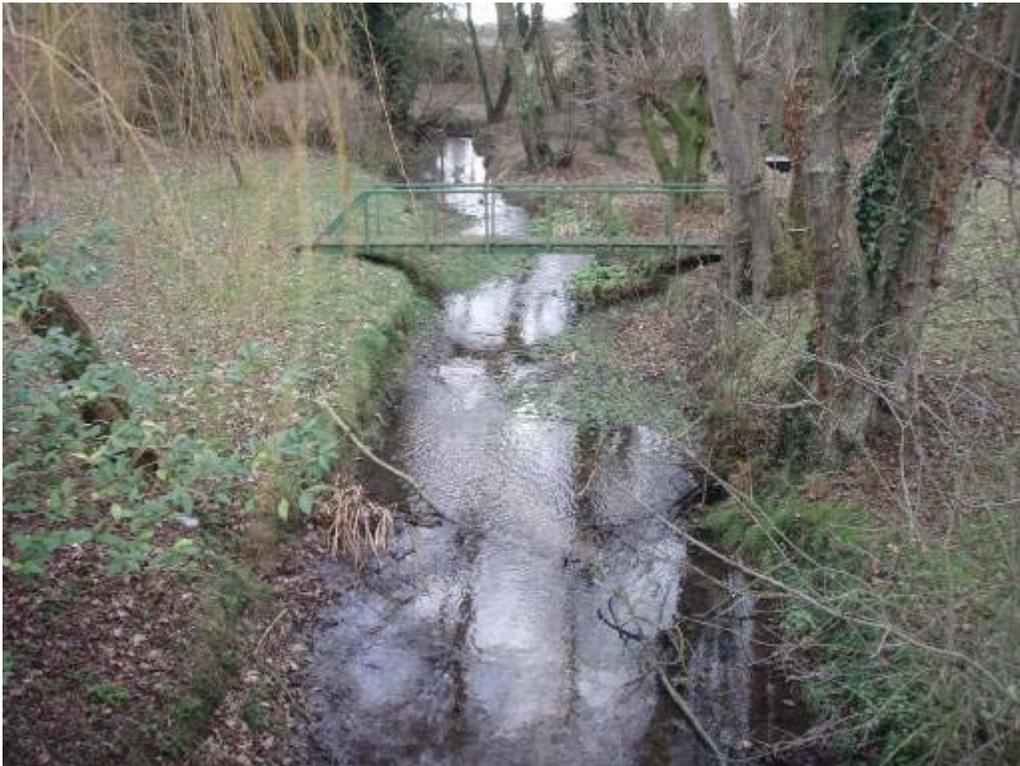
Photo 31

In Thuxton, a brook joins the river from the west, via a bridge culvert under the railway line (Photo 32); fish access could be improved here by installing baffles on the culvert base. The brook itself was overwide and shallow within the village (Photo 31).

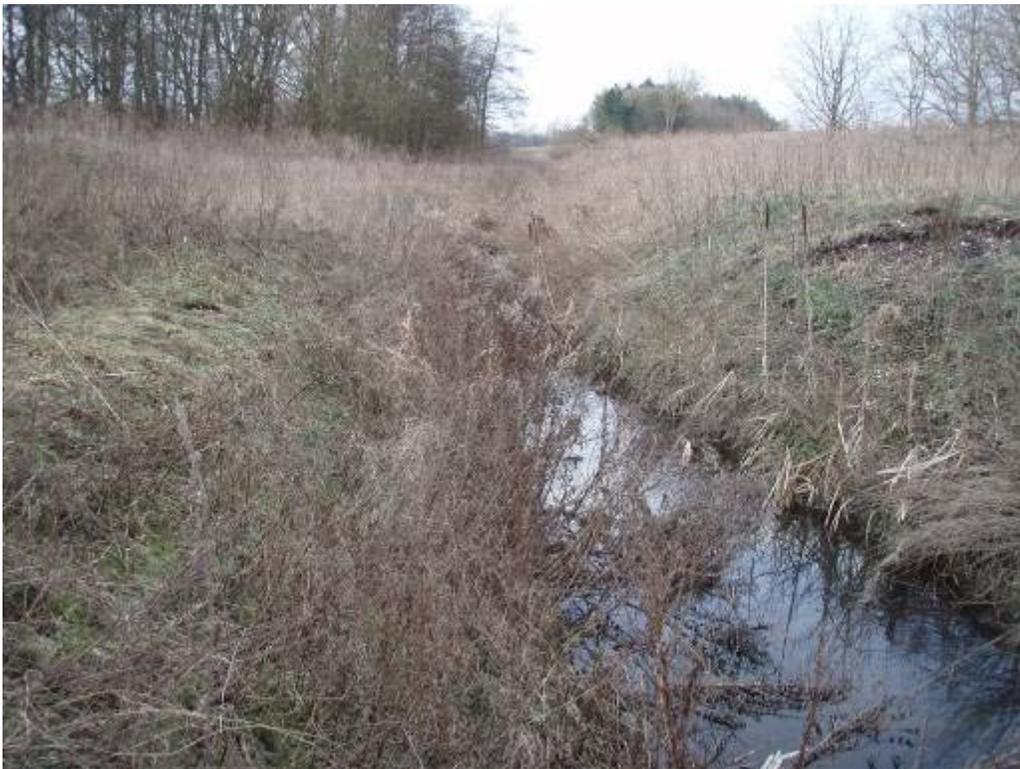
Photo 33

Downstream of Thuxton, the river has a meandering planform but becomes straightened alongside the railway line before circumventing a stillwater trout fishery. The river channel here is incised, straight and slow-flowing (Photo 33). A short distance downstream is the confluence of the Yare and Blackwater.
