Advisory Visit

Dick Brook, Worcestershire

January 2012

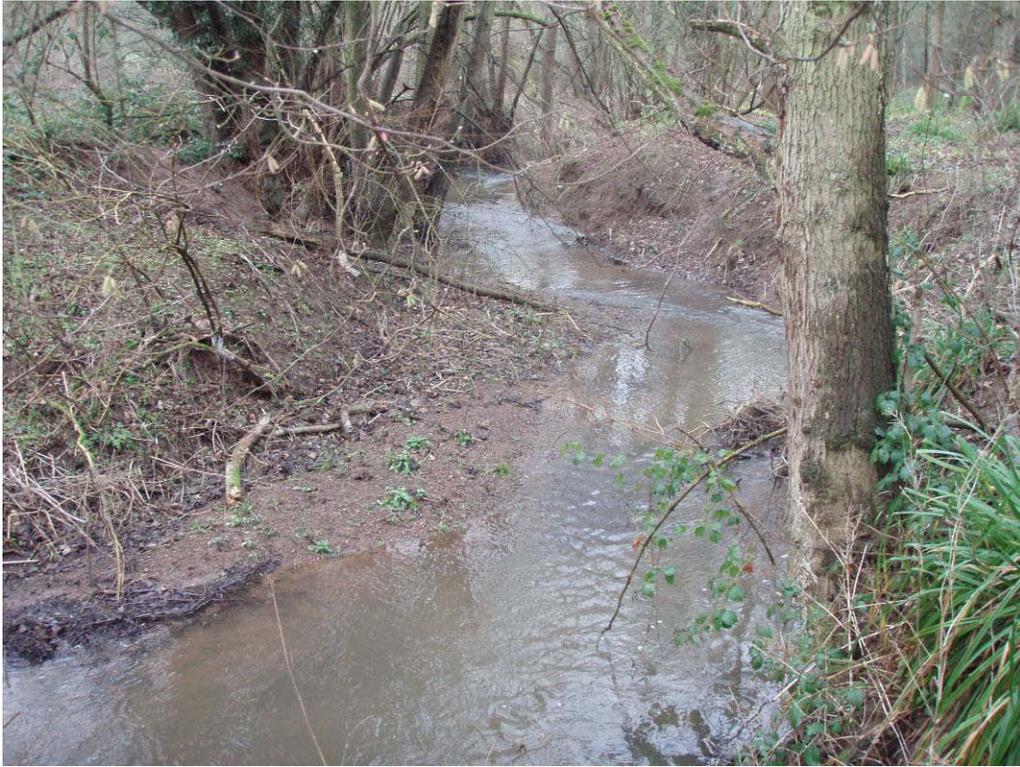
Upstream of the A451 the brook has generally good habitat, with a natural pool-riffle sequence and plentiful woody debris structures which provide cover for fish and river crossing points for terrestrial wildlife (Photos 1-3). The brook runs over sandstone geology in a naturally steep-sided, incised channel. Part of this section runs through a sandstone gorge alongside a pond perched on the valley side (left bank).

Photo 1 Typical section upstream of A451

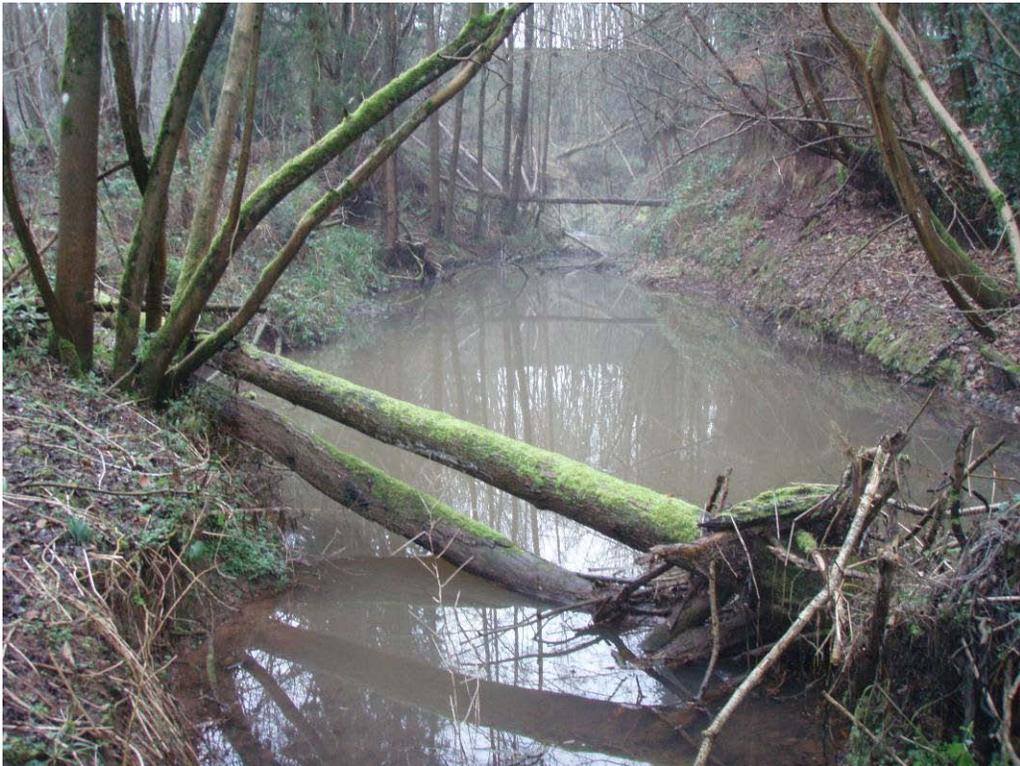
Photo 2 Slower, deeper pools are also present and woody debris structures providing excellent habitat

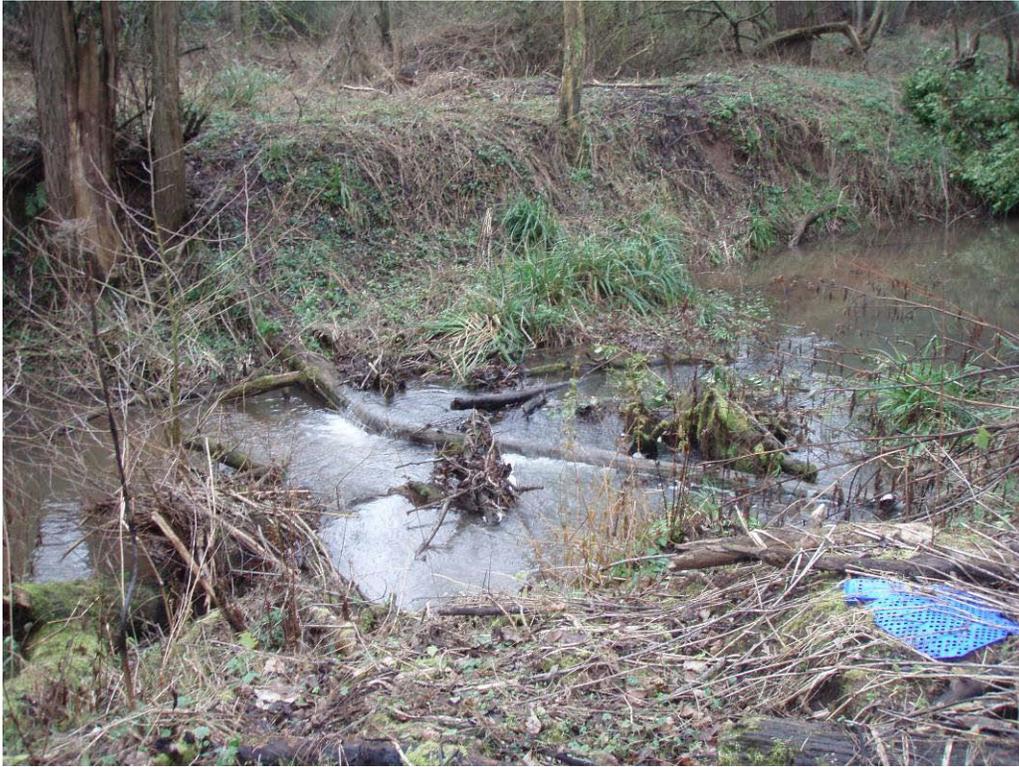
Photo 3 Retention of woody debris provides superb in-stream habitat for fish and invertebrates

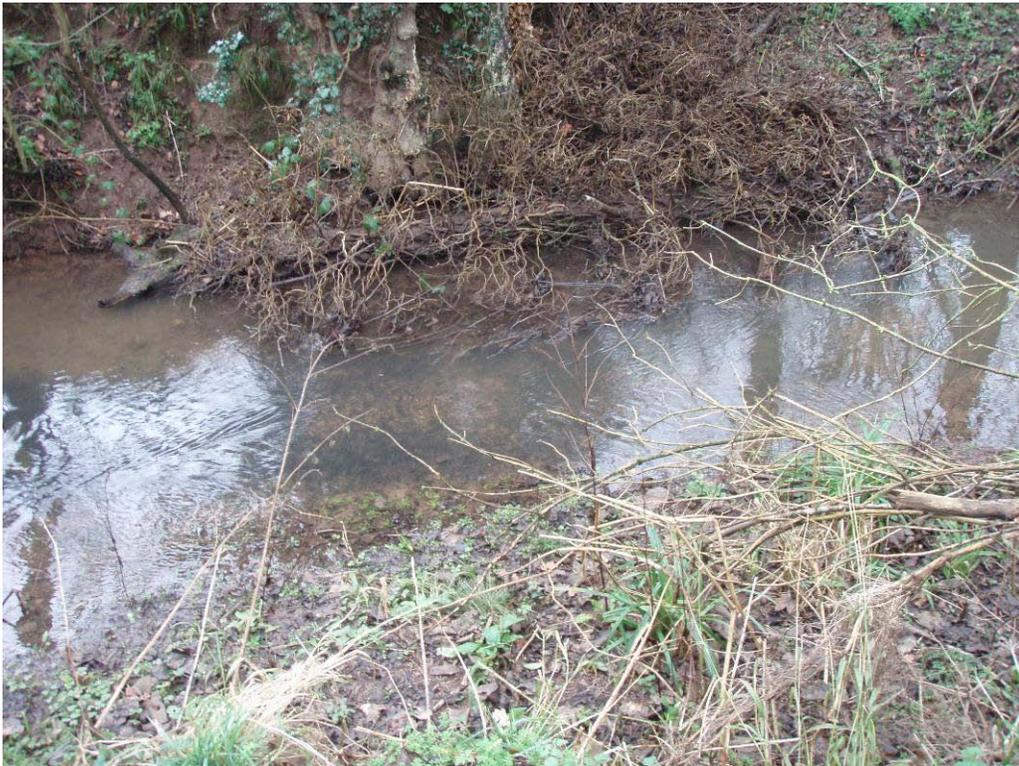
Land use immediately adjacent to the brook is deciduous woodland meaning the channel is shaded (an advantage in keeping water temperatures down in hot weather, but also preventing understory vegetation development which binds fine sediments). A combination of the shading and the sandstone geology means there is a relatively high proportion of fine sediment present in the river bed substrate; this is not ideal for trout spawning success but the good geomorphology and woody debris features offset this disadvantage. A number of trout redds were observed at the tails of pools within this section (Photo 4).

Photo 4 A superb combination of habitats for wild trout: gravel at the tail of a pool (where trout have already spawned, indicated by the light patches) and the close proximity of woody debris providing cover for both spawning adult and juvenile trout

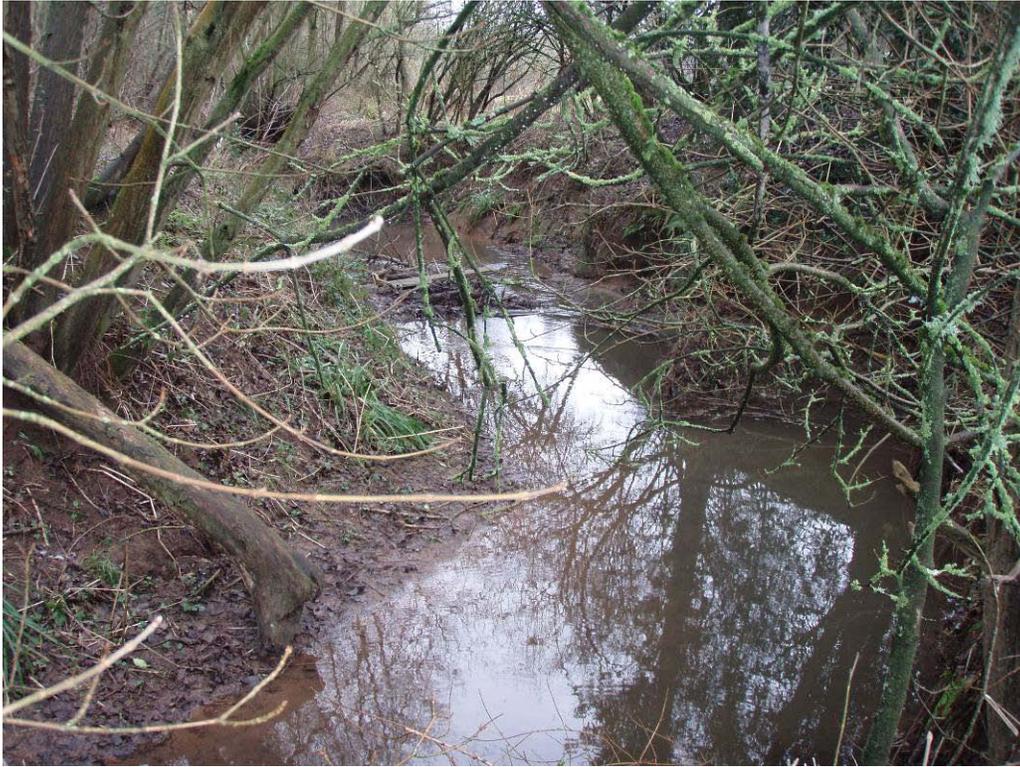
Downstream of the A451 the good habitat continues, with pool-riffle sequence and deep holes bordered by tree roots (Photo 5). Adjacent land use is woodland and pasture, with the former comprising a poplar plantation, giving way to coniferous forestry on the left bank. On the right bank there is pasture but with a generous fenced margin alongside the river; Himalayan balsam is present here (Photo 6). There is one point at a field gateway where the concentration of animal footfall is causing excessive poaching of the ground and run-off of fine sediment to the brook (Photo 7).

Photo 5 Deep pools and tree roots – great adult trout habitat

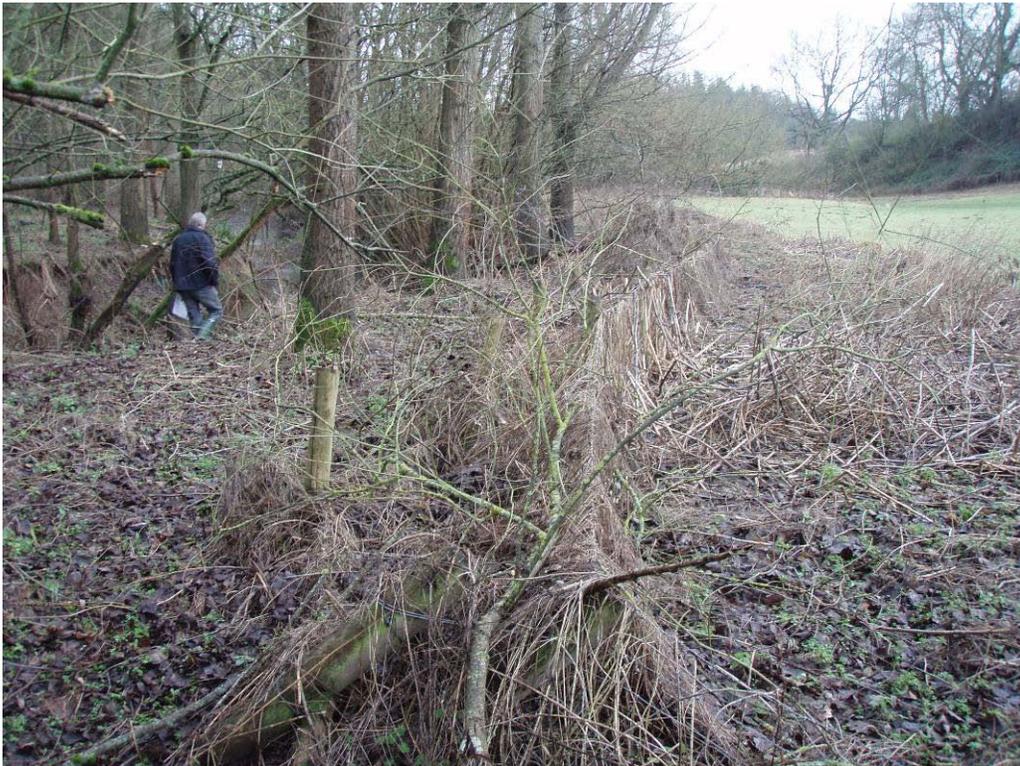
Photo 6 Land use – wooded LHB and pasture on the RHB with a fenced margin, but with lots of Himalayan balsam

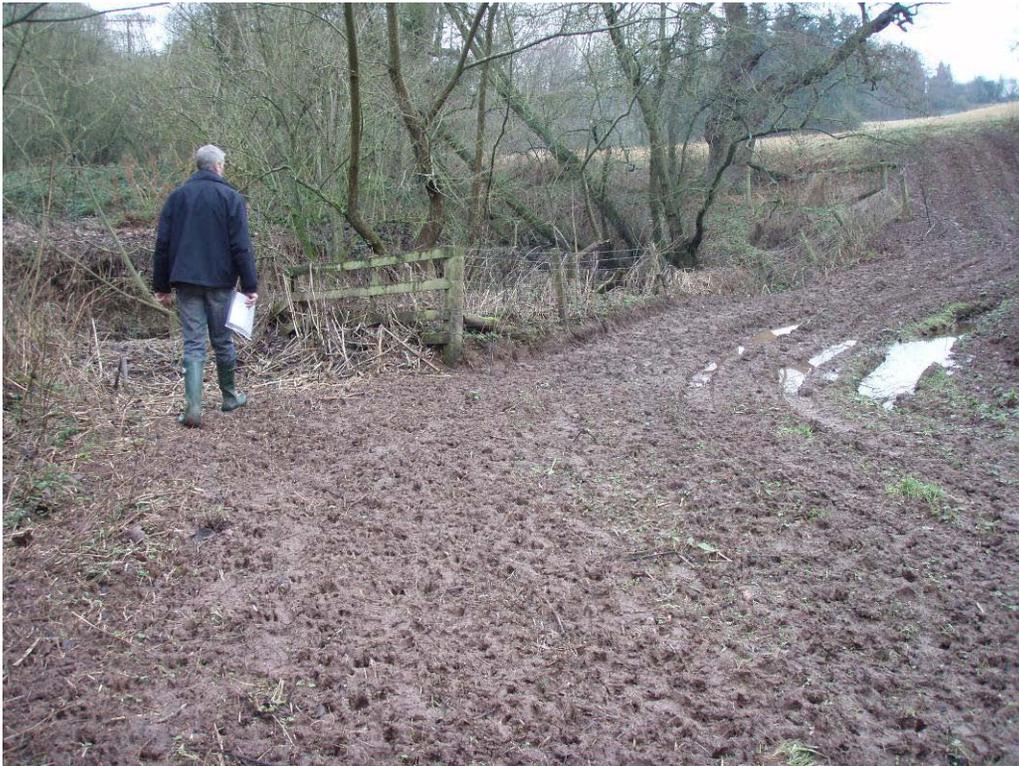
Photo 7 Area close to the brook heavily poached by livestock

- Tackle the bank poaching problem shown in Photo 7. Re-aligning the riverside fence or re-locating the gateway between the fields could be options to discuss with the land owner / manager.
- Maintain the current fenced buffer zone between the river and fields.
- Address the non-native, invasive Himalayan balsam problem, preferably within the context of a catchment-wide control program.
- Influence the manager of the riverside woodland plantations to replace the poplar plantation adjacent to the brook (downstream of A451) with native, deciduous woodland. Keep coniferous forestry well away from the watercourse, as is currently the case.
- Continue the current hands-off approach to management of in-stream woody debris. If it falls in – leave it there!

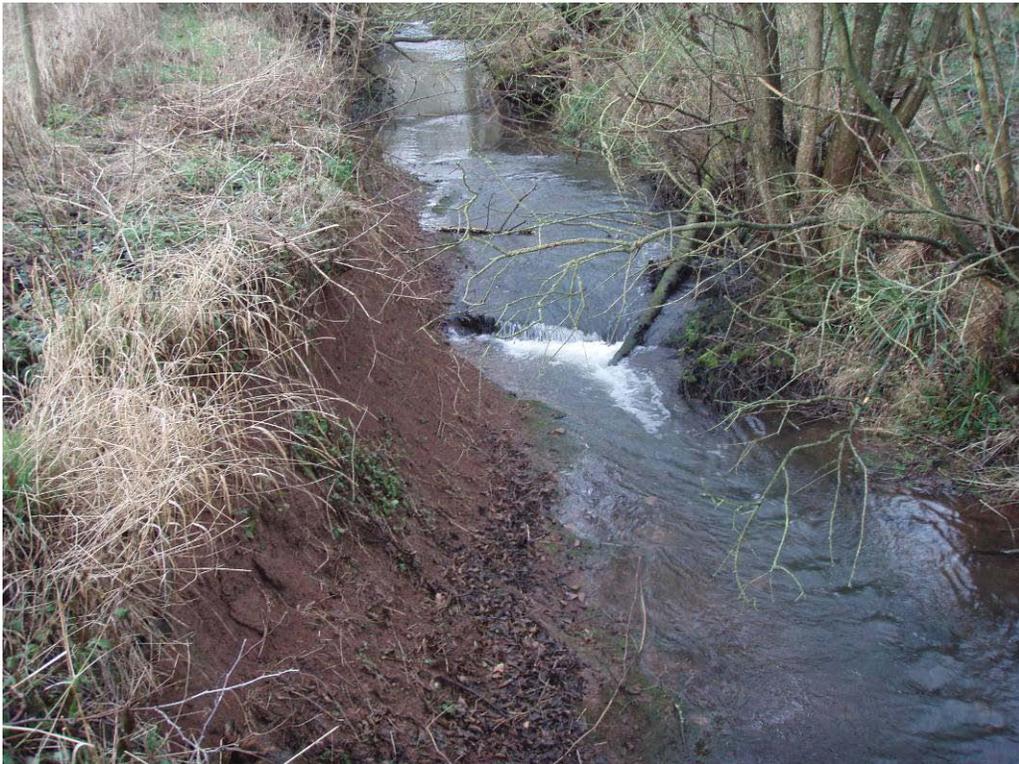
A bedrock outcrop creates two low bed-level checks (like low weirs) about halfway along this section (Photo 8), then downstream of this point the brook becomes slow, wide and canal-like (Photo 9). This is because of the impoundment of the brook behind a huge weir (approximately 5-metre head difference) at Priors Mill (SO7826167403). There is a channel around the weir on the right bank (dry at the time of the visit) to take higher flows. The mill (converted to private residence) is on the left bank and discussion with the owner revealed there is an automatic water level-controlled sluice incorporated into the weir structure (Photo 10). The presence of such a large structure is obviously a barrier to fish migration and it is surprising that the Dick Brook is currently classified as good ecological status because of this.

Photo 8 Outcrops of natural bedrock

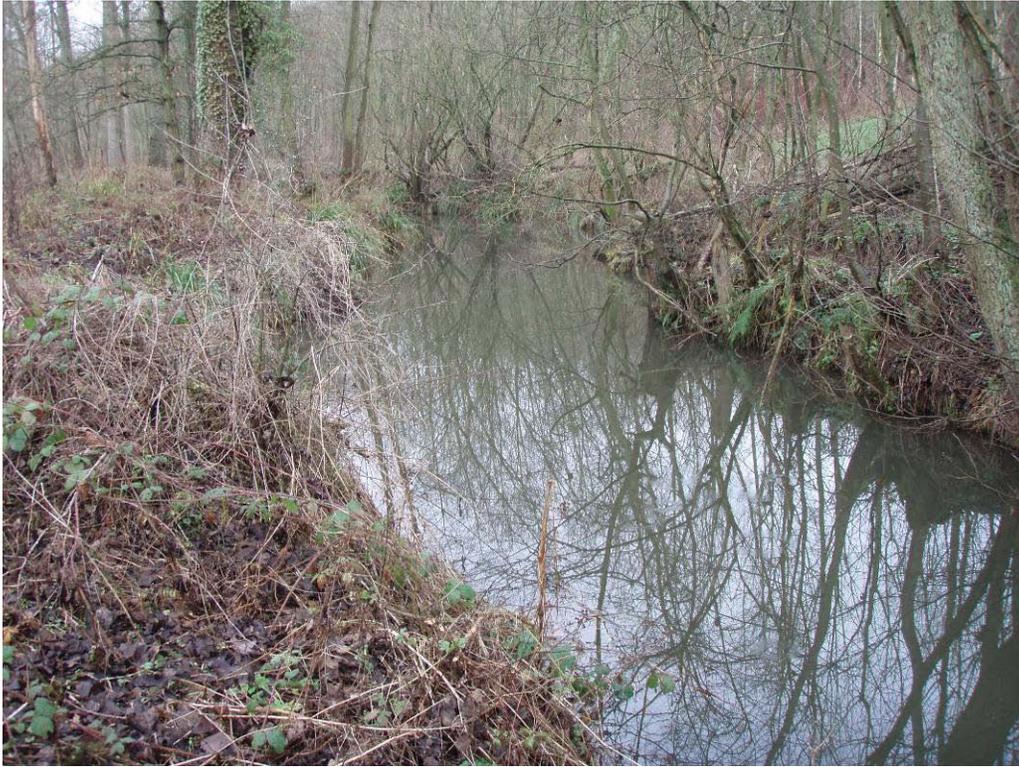
Photo 9 Slow, wide and canal-like: the effects of the weir impoundment

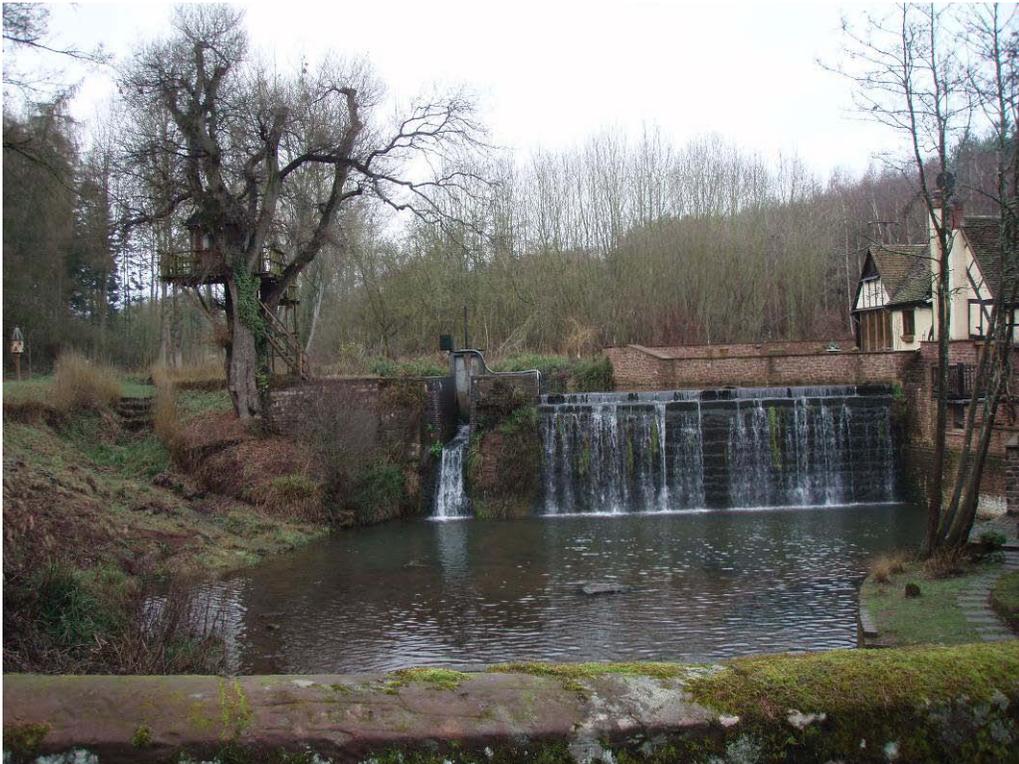
Photo 10 The weir at Priors Mill, with automatic sluice (left of centre) and dry overspill channel (left of picture)

This weir has a very large head difference across it and is undoubtedly a total barrier to upstream movement of fish such as trout, coarse fish and lamprey; it will also significantly impede juvenile eel migration. It is recommended that options to improve fish passage across this structure are investigated and if possible the reduction of the impounding effect upstream. Creating a permanent flow in the overspill channel on the RHB may be an option at this site. The Environment Agency should be consulted to check if this site has been looked at previously with respect to improving fish passage and to determine its priority in relation to other barriers.
