Habitat Advisory visit to Moanmore  
Lough, Co.Clare, Eire  
Undertaken on behalf of Patrick  
Hartigan, by Vaughan Lewis,  
Windrush AEC Ltd  
April 2006

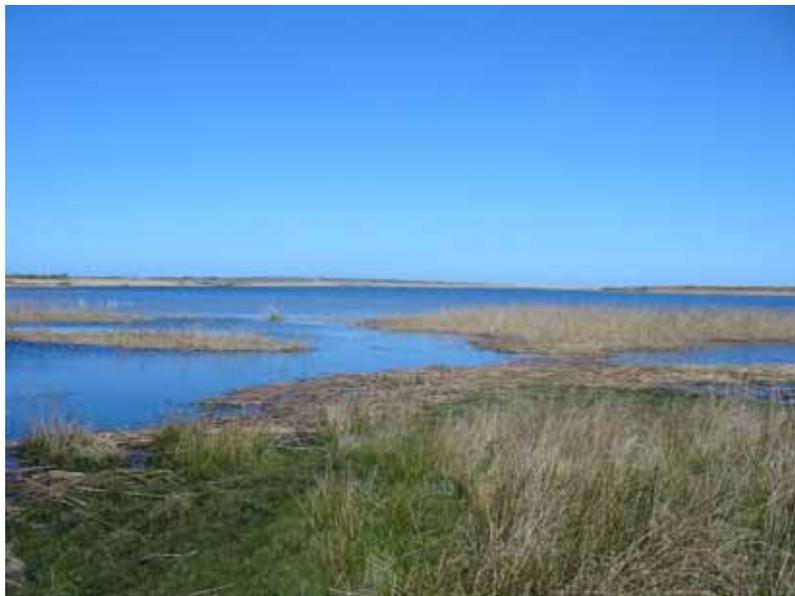
**Moanmore Lough from the south east**

The lough had an extensive marginal growth of emergent vegetation, including bulrush *Typha arundinacea*, and common reed *Phragmites australis*. Submerged vegetation included willow moss *Fontinalis antipyretica*, white water lily *Nymphaea alba* and pond weed *Potamogeton* Spp.

Water quality in the lough was a concern, with the Environmental Protection Agency identifying its water quality as 'failing'. There were no indications as to which parameters were causing the failures, although the presence of blue-green algal blooms during the summer would suggest that over-enrichment is an issue. The land to the east of the lough had been intensively grazed by cattle. This practice was expected to cease in the near future, with tree planting planned for approximately 4 Ha of pasture land in the south east corner of the lough.

- The proposed tree planting should ideally be comprised of a large percentage of deciduous trees. The benefits of hardwood tree belts are manifold and include:
  - Interception of surface water run-off
  - Detention of nutrients that are helping to feed algal blooms in the lough
  - Release of calcium salts via leaf break down (birch *Betula* Spp. is a particularly good genus for this), helping to buffer acidic flushes

- The presence of blue-green algae in the lough is of great concern. This group of algae flourishes in high nutrient water bodies when soluble nitrate becomes limiting, generally during the mid/late summer months. They are able to fix their own nitrate and hence have a selective advantage over competitive species at this time of the year. More generally, phosphate is the limiting nutrient in freshwater systems. Management of the area surrounding the lough should concentrate on reducing run-off of nitrate and phosphate. The cessation of grazing and planting of broadleaf woodland on the grazed area are both positive steps. Whilst land use adjacent to the inflow stream is outside of the lough owner's control, it would be worth attempting to influence it, in an effort to further reduce nutrient inputs.

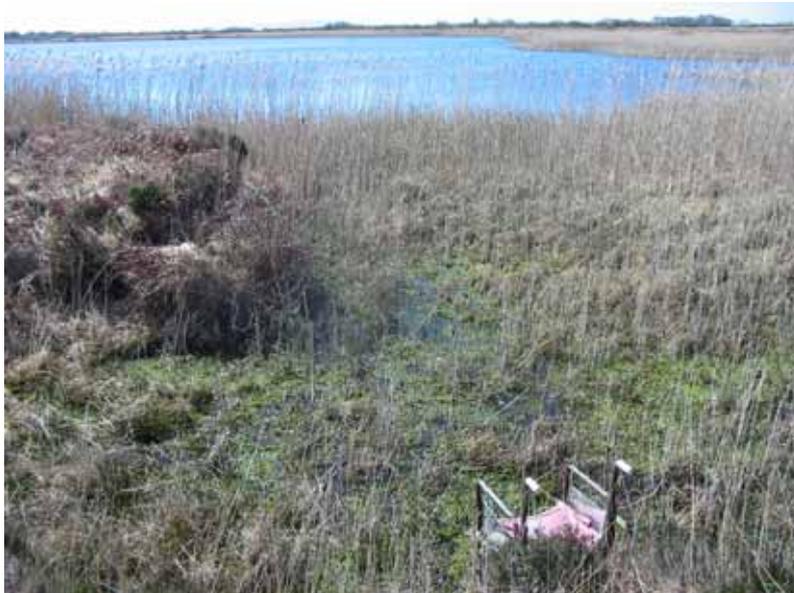
Land surrounding the north east and north west sides of the lough was not in the control of Patrick Hartigan. It appeared very likely that large scale peat extraction would take place over this land in the period leading up to 2015 when the rights of turbuary would be extinguished. Drainage ditches cut for peat extraction had the potential to dry out the local area, significantly affecting both its hydrology and associated vegetation. There was a considerable amount of rubbish strewn around this area, including old vehicles.

**Rubbish deposited at north end of lough**

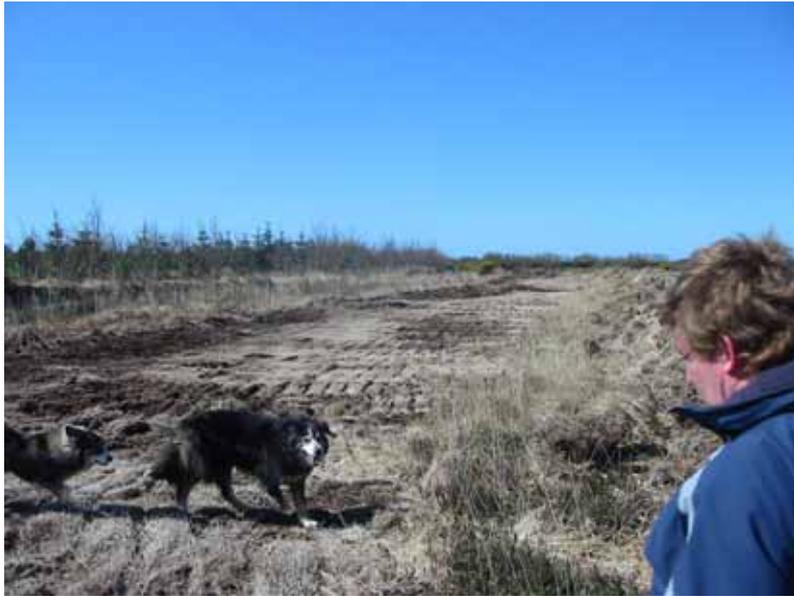
The outfall from the lough was on the western shore, alongside a newly excavated track presumably constructed as part of the peat extraction. The channel was very overgrown with sedge *Carex* spp., hard rush *Juncus inflexus* and mixed grass species, making access for fish along it difficult.

**Newly excavated track with outfall from the lough to the left of the picture**

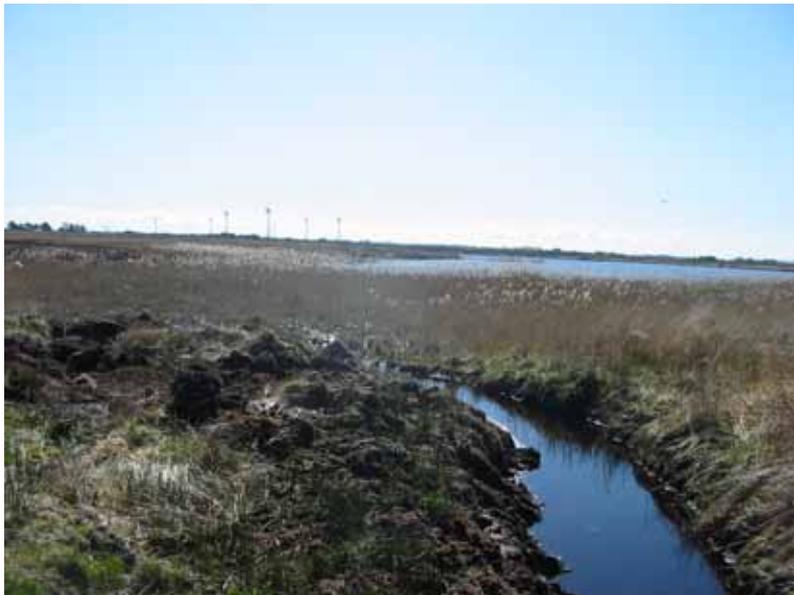
**Drainage channel through peat bog**

Similarly, the forthcoming peat extraction has the potential to cause significant mobilisation of metal salts and fine sediment into the lough. Ideally, a buffer strip should be established around the lough and alongside any drainage ditches with a view to reducing the impact of this damaging activity.
