Advisory Visit to the South Wey, near  
Bordon, Hants  
Undertaken on behalf of Mr  
P. Whitfield by Vaughan Lewis,  
Windrush AEC Ltd

May 2006

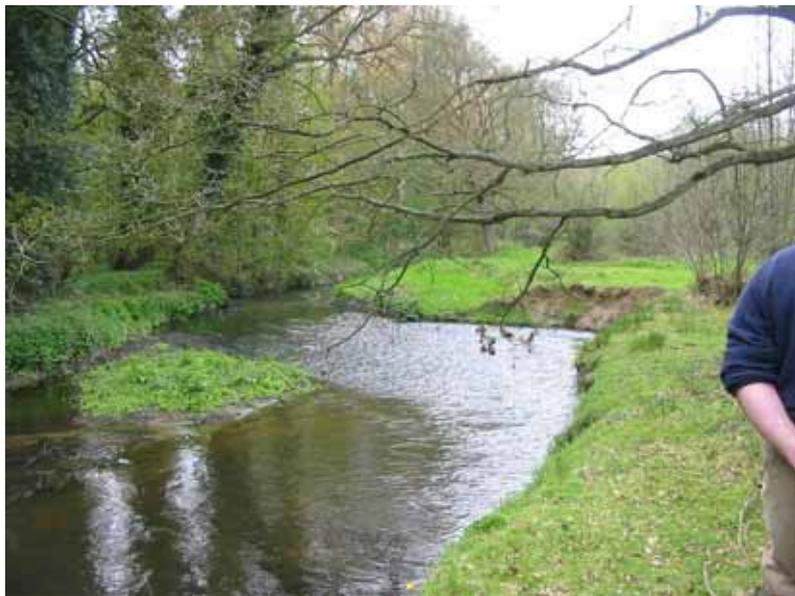
The downstream reach of the fishery had generally good instream habitat, with a mix of deeper slow glide, interspersed with shorter sections of shallow glide and riffle habitat, potentially suitable for spawning and juvenile brown trout *Salmo trutta*. However, the high volume of fine sand and sediment present entrained within and on the gravel was likely to have significantly reduced the hatching success of any trout eggs deposited. Environment Agency (EA) fishery surveys undertaken in this reach generally failed to produce any trout less than one year old, reinforcing this hypothesis of poor spawning success.

The channel was lightly shaded by riparian trees particularly on the RB. Despite their presence, Large Woody Debris (LWD) was underrepresented within the channel, with only limited amounts of fallen timber present.

### Typical section of the downstream reach

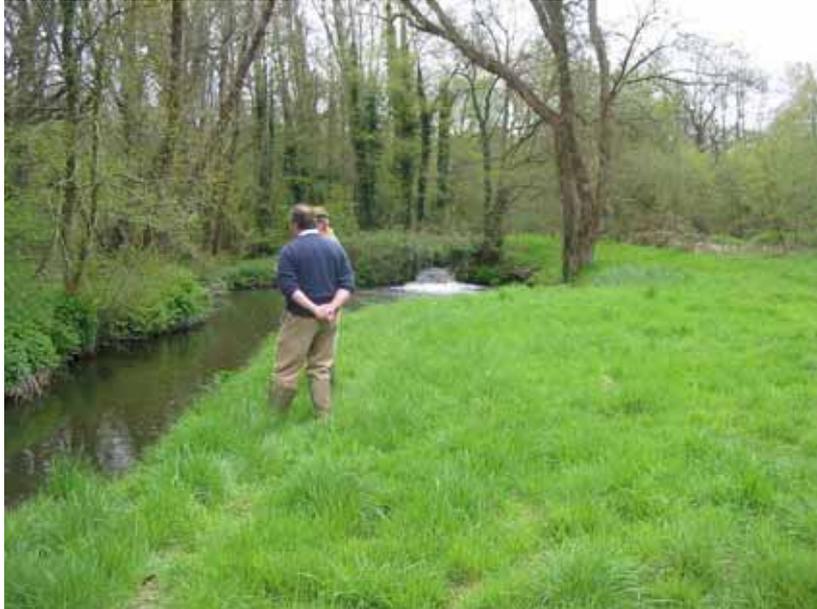
Habitat quality in the upper end of the reach was poorer, with deeper water and little spawning gravel present. The top of the reach was delineated by a weir with a head loss of perhaps 1m.

**Weir marking upper limit of downstream reach**

downstream drift of fry from upstream spawning sites is of significance. If this is the case, the presence of the weir may prevent upstream migration of adult fish and reduce downstream drift of fry, perhaps accounting for the poor fish stocks below the weir.

It may be possible to bypass this potential spawning bottleneck by the use of a deep substrate incubation box set up below the weir. Basically, these are gravel filled boxes, approximately 0.6m in each dimension, that are filled with suitably sized gravel and seeded with trout eggs obtained from native South Wey trout. A water feed at the bottom of the box allows the eggs to incubate and hatch. Once they reach the swim-up fry stage, they leave the box via the overspill pipes, stocking themselves into the river. In effect, they are naturally reared fish without the unhelpful behavioural modifications associated with hatcheries. Such a system could be established using the head of water retained by the weir. More details on incubation boxes can be found on the Wild Trout Trust web site [www.wildtrout.org](http://www.wildtrout.org) or in Volume 2 of the Trust's magazine, *Salmo trutta*.

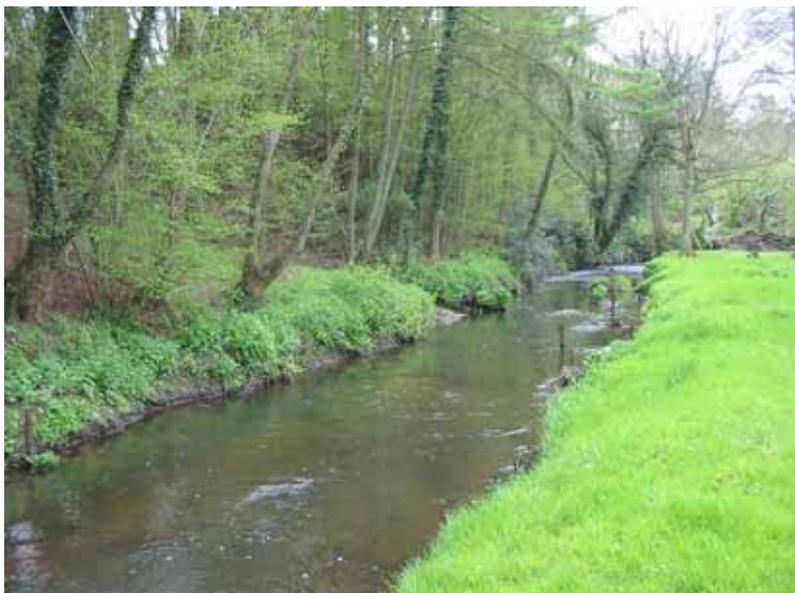
There was abundant good habitat for adult fish, including undercut banks and tree root systems. There was a good mix of shaded and more open sections of channel, allowing good growth of instream and marginal weed. There was once again a dearth of LWD in the channel, with a consequent lack of substrate sorting and scouring. Lengths of unconsolidated sediment were present on the inside of some of the bends, with the channel often overwide for the river's flow at these locations. Attempts had been made to narrow some of these sections in the past, evidenced by a line of stakes remaining in the river.

**Overwide section of river**

- It is recommended that faggot bundles are installed where the channel is overwide and where there are banks of unconsolidated fine sediment on the inside of bends. Interwoven with vertically driven untreated stakes, these can be used to form a new, soft river edge. The void space between the faggots and the existing bank can be backfilled using timber brushings (brushwood) securely fixed to prevent washout.

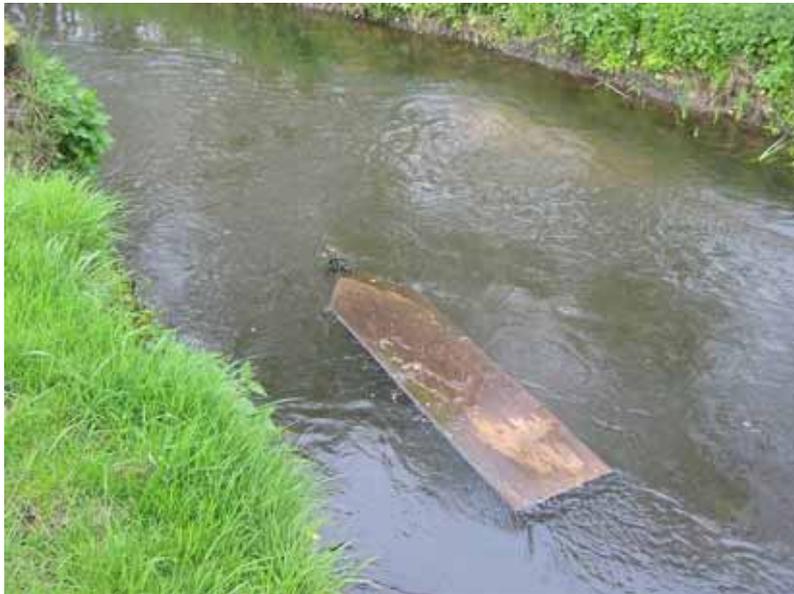
Upstream of the main access bridge crossing, the river had a relatively steep gradient, with good instream habitat. Flyboards had been installed in the channel. These had become well colonised with a variety of macroinvertebrate larvae. An automatic Environment Agency water quality monitoring station was present in this reach as a result of a number of past pollution incidents. A short length of gravel riffle had been installed by the EA in the past.

### **Flyboard**

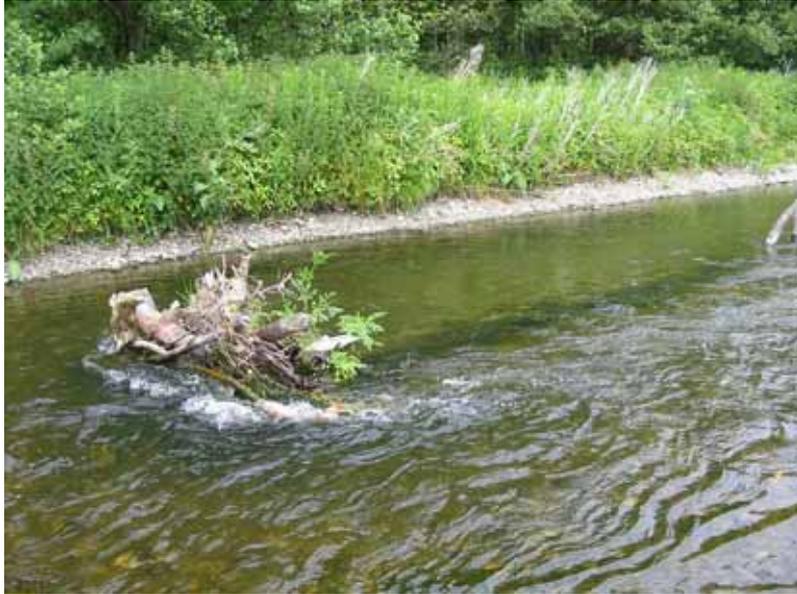
- More generally, the lack of significant LWD throughout the fishery reduced the habitat quality significantly. In low energy lowland streams, the presence of LWD is one of the few habitat features that can increase local flow velocity enough to cause scouring and sorting of the bed. Without LWD in the channel, instream habitat will remain relatively homogeneous, with a uniform layer of fine sediment present over much of the bed.

**Stabilised tree root system causing localised scour in a river**

Practical management options to increase LWD include making use of fallen timber in order to create simple flow deflectors by wiring/staking these to the bank. These can be used to scour relatively homogeneous riffle areas in order to sort potential spawning gravel and create deeper pools used by adult fish. These small pools can provide shelter areas adjacent to riffles during spawning periods, increasing the numbers of spawning fish. Provided that the LWD is adequately secured in the channel, there is very little risk of it posing an unacceptable local flood risk.

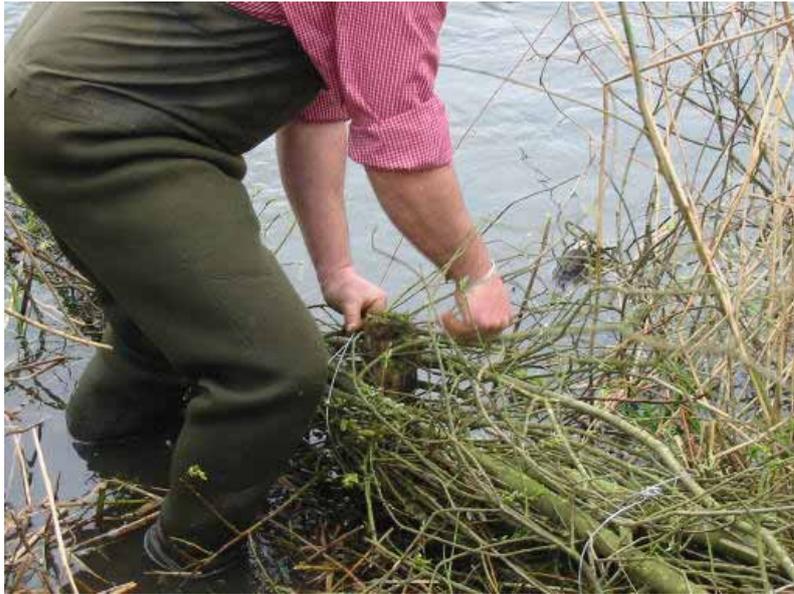
**Installing faggot bundles**

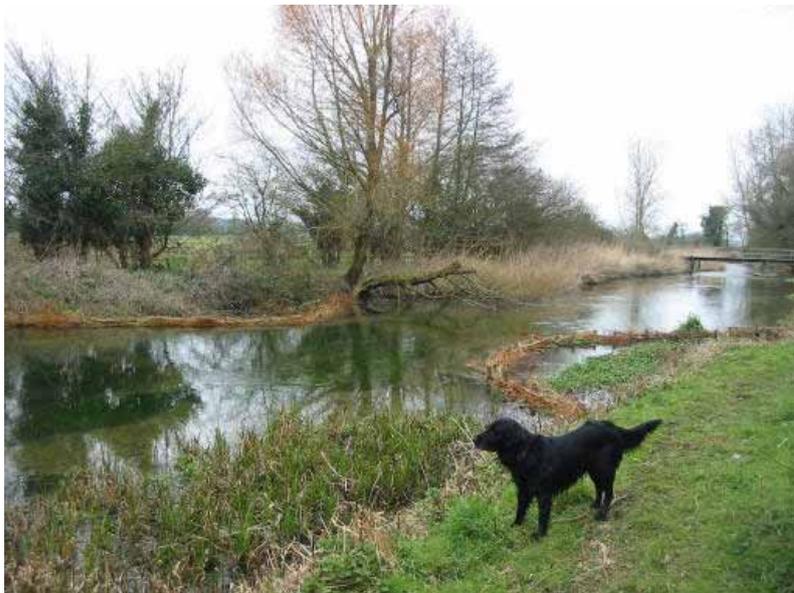
**Soft edged bankline constructed from faggot bundles. Note partial backfill with emergent vegetation**
