WILD TROUT TRUST

Loch Ard tributaries

Aberfoyle Angling Protection Association

15/05/2023

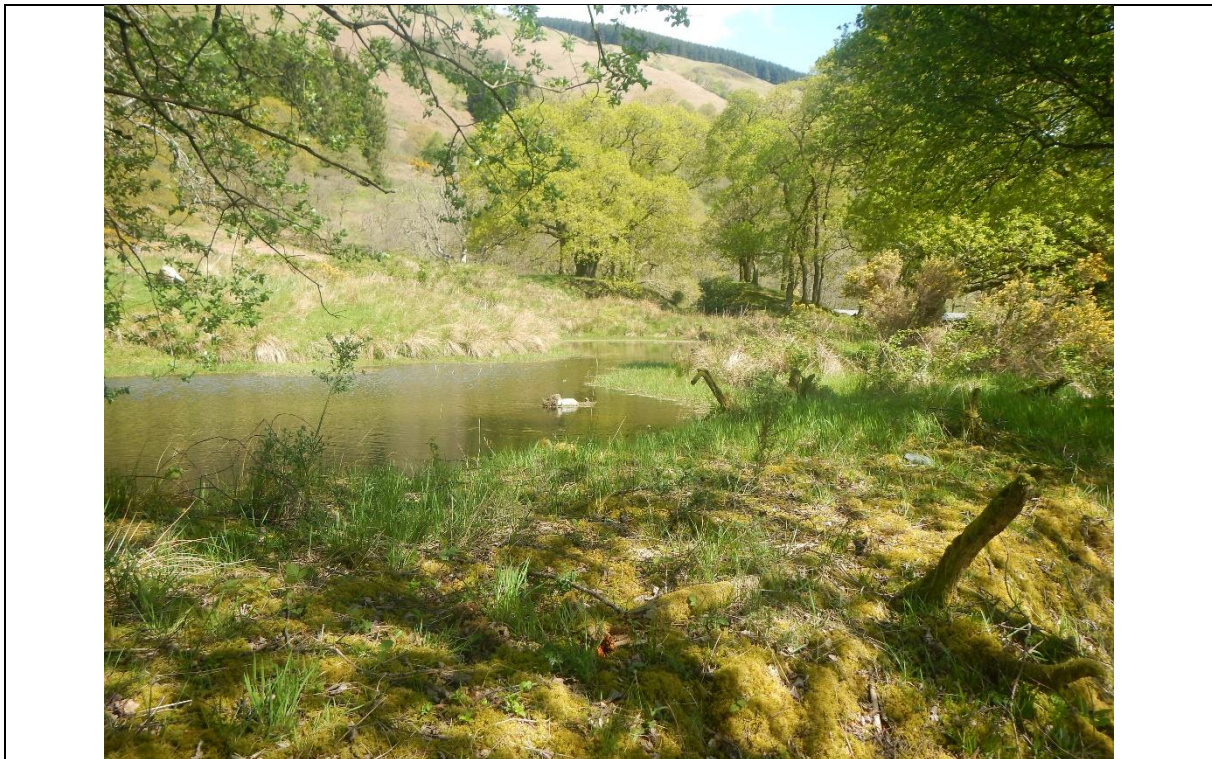
Figure 1. The pond and large dam that form the upstream limit of fish movement on the RB burn.

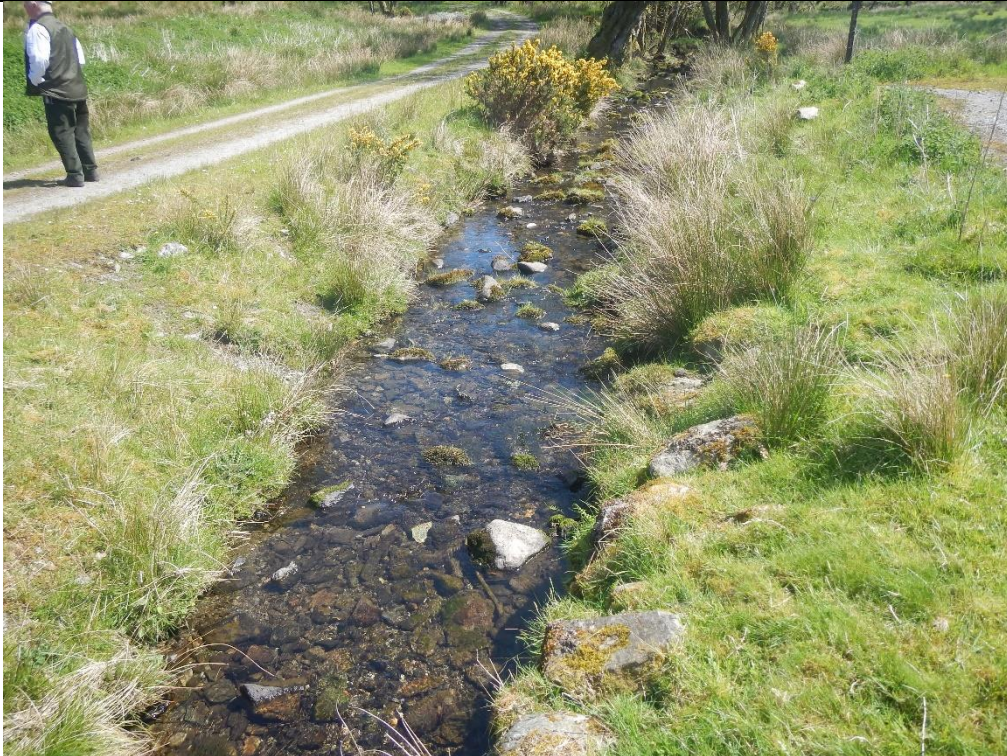
As a consequence of the steepened channel and the reduced gravel supply, the substrate of the burn is much coarser than would occur in a more natural course. The combination of poor accessibility and reduced substrate quality reduce the potential of the RB side burn but, amazingly, it still contained juvenile trout in all of the pools observed, even if in lower numbers than could be achieved in a natural burn. This is testament to the tenacity of brown trout.

Figure 2. Unnaturally coarse bed, owing to the straightened and steepened channel and a consequent limited capacity to retain finer gravel.

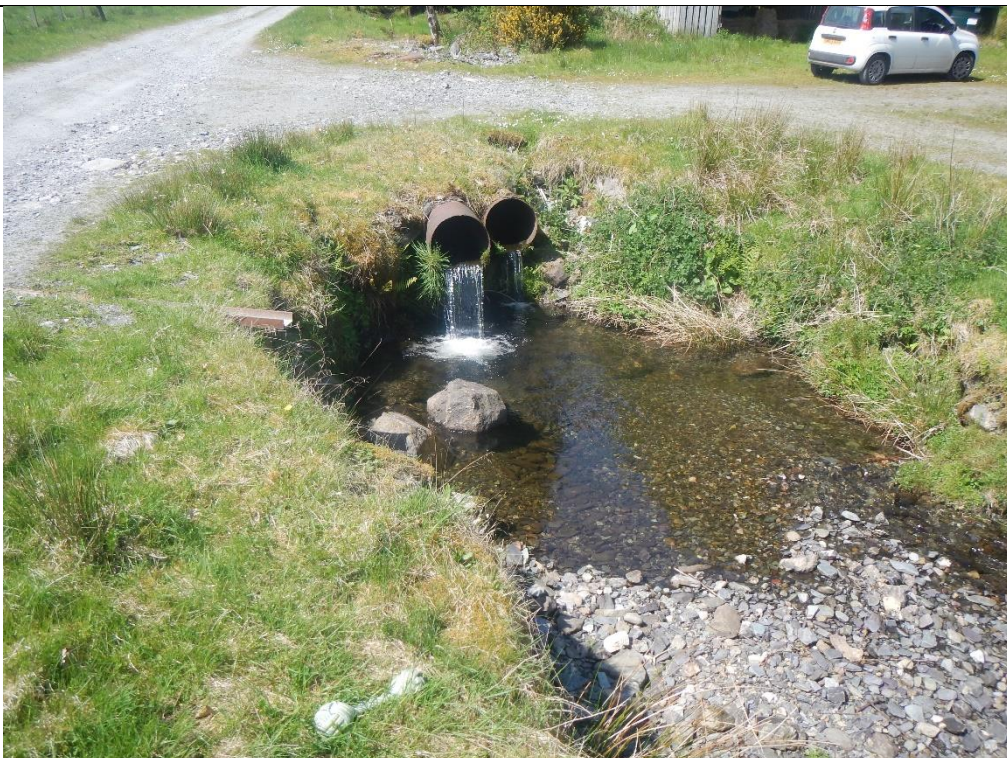
Figure 3. Perched culvert pipes created a series of major barriers for fish. The energy dissipation at the fall did facilitate some retention of the gravels that passed through, but these structures are highly detrimental and should be replaced with much larger, partially sunken structures to facilitate free passage of fish and sediment.

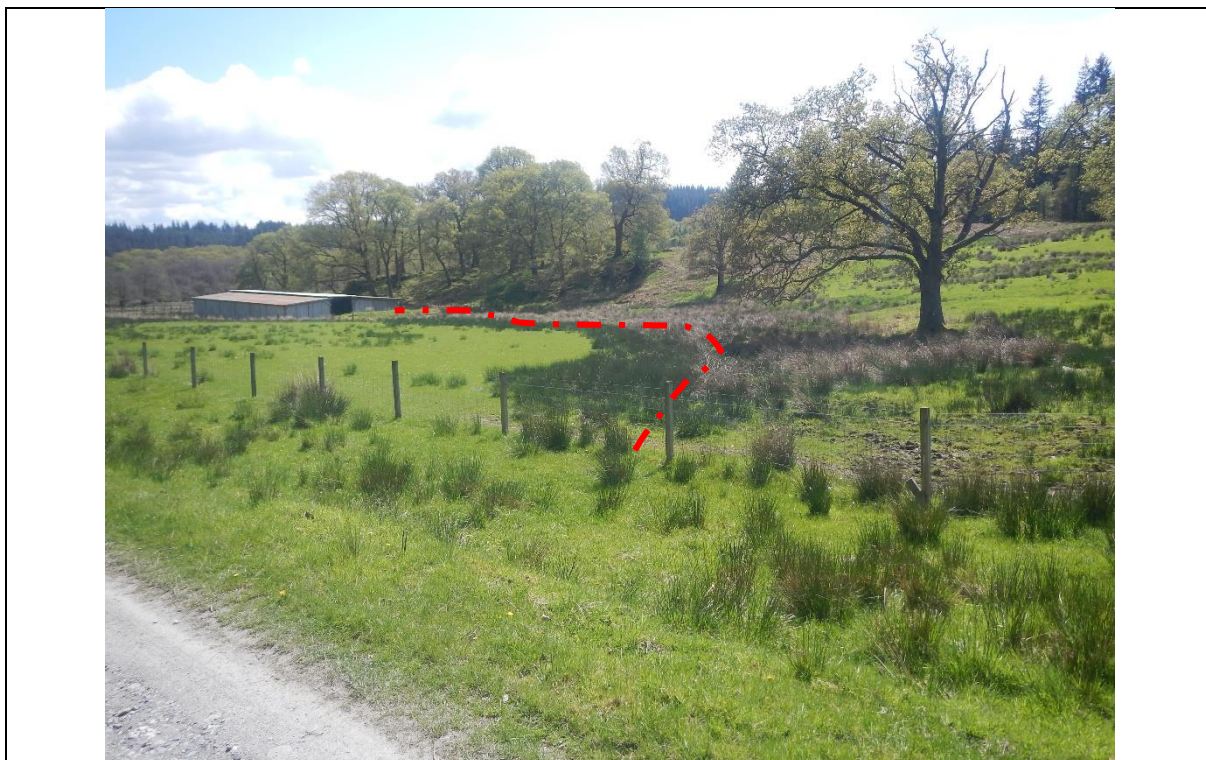
What appeared to be the former natural course of the RB side burn channel crosses the field to the RB side of the track, opposite the pond and still appeared to take some flow/water (as evident by damp ground covered by rushes), which progressed downslope to a livestock shed - located unsuitably close to the watercourse (*Figure 4*). This runs the risk of nutrient inputs to the watercourse (however small/low flow) if livestock are housed there. Livestock housing should be located well away from any watercourse, which should be a requirement under the General Binding Rules, to reduce the risk of pollution. Without the building, it could even be possible to reinstate the original watercourse.

Figure 4. The old course of the RB tributary burn, clearly visible from the low, damp ground and rushes, which flows parallel to the current straightened course. Note the proximity of the sheds.

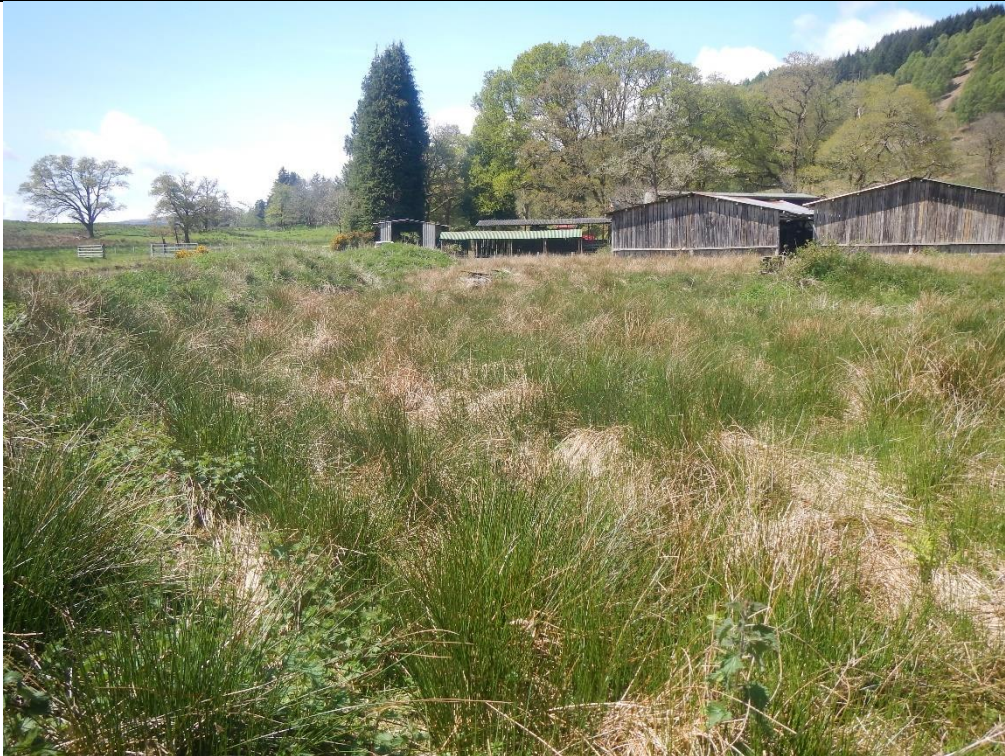
Figure 5. Further sheds adjacent to another area of low-lying wet ground, probably also a paleochannel, with suspected yard/building runoff and elevated nutrients.

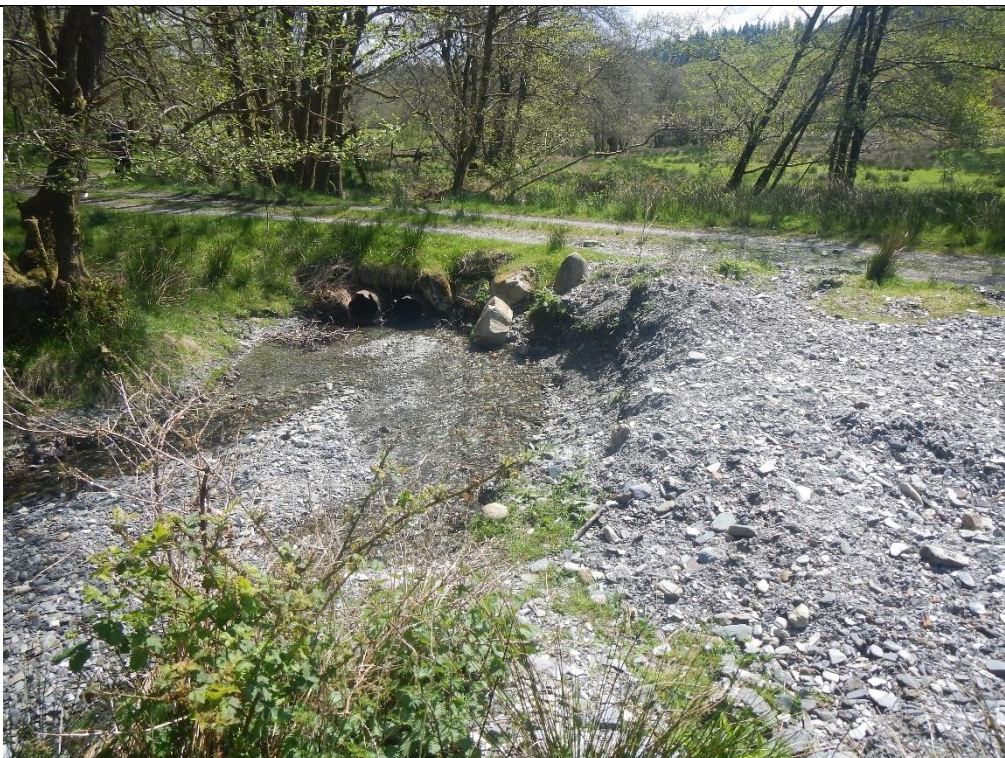
Figure 6 (56.187853, -4.44035). Another undersized and now significantly perched culvert. Note the ongoing sediment maintenance burden created by inappropriate watercourse crossings, with the entrained coarse sediment having to be regularly excavated.

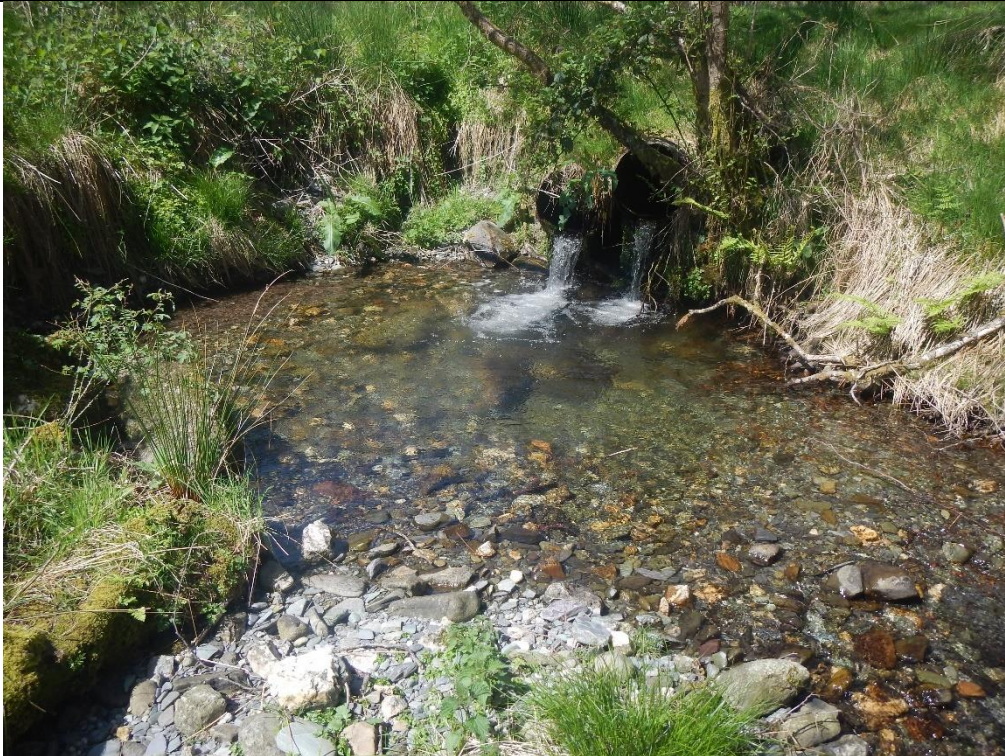
Figure 7. Perching at the d/s side of the culvert pipes.

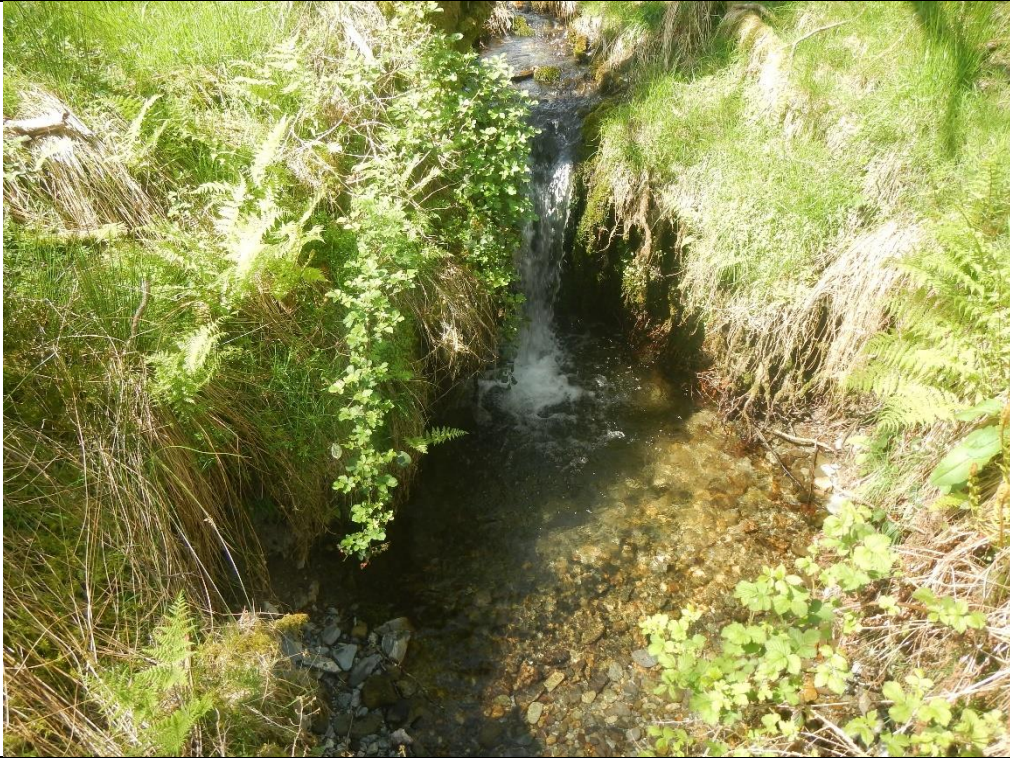
The situation worsened further downstream, where the combination of reduced sediment supply (and almost certainly channel dredging d/s), had created a major step in bed level (head cut) which has worked its way upstream (*Figure 8*) – a feature that is also impassable to fish. With the step at the track crossing pipe and the head cut, the downstream bed level of the channel appeared to be >1m below that of the channel upstream. This fact was also evident by the extent of channel incision downstream, with the bed now located well below the adjacent land and bank top (*Figure 9*). This issue also affected the RB tributary, which joined the LB tributary a short distance downstream, after flowing over the several significant steps.

Figure 8 (56.187878, -4.440153). The head-cut nick point in the channel d/s of the culvert – created by starvation of sediment supply to the channel and, almost certainly, dredging d/s.

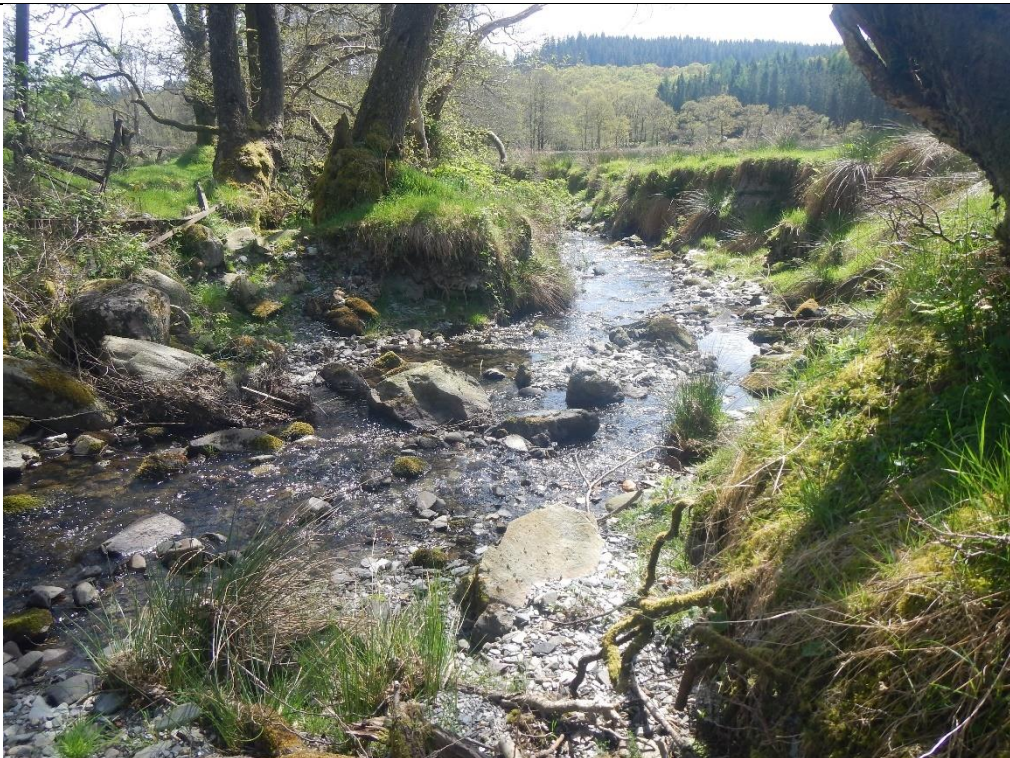
With high flows less able to dissipate onto the floodplain, the incised nature of the main burn downstream further reduced the channel's ability to retain gravel – an issue that compounds itself over time as the bed lowers. The ideal solution here would be to re-meander the channel and reintroduce natural coarse sediment, raising the bed to a more natural level.

Figure 9. The incised channel of Drumlean Burn, with limited ability to retain finer gravel bars and riffles.

In the short term, benefit could be gained through the installation of diffuse *Woody Material* structures, to dissipate flow energy and increase the deposition and retention of gravel. The bankside trees through this section could provide valuable anchor points for such structures (*Figure 10*).

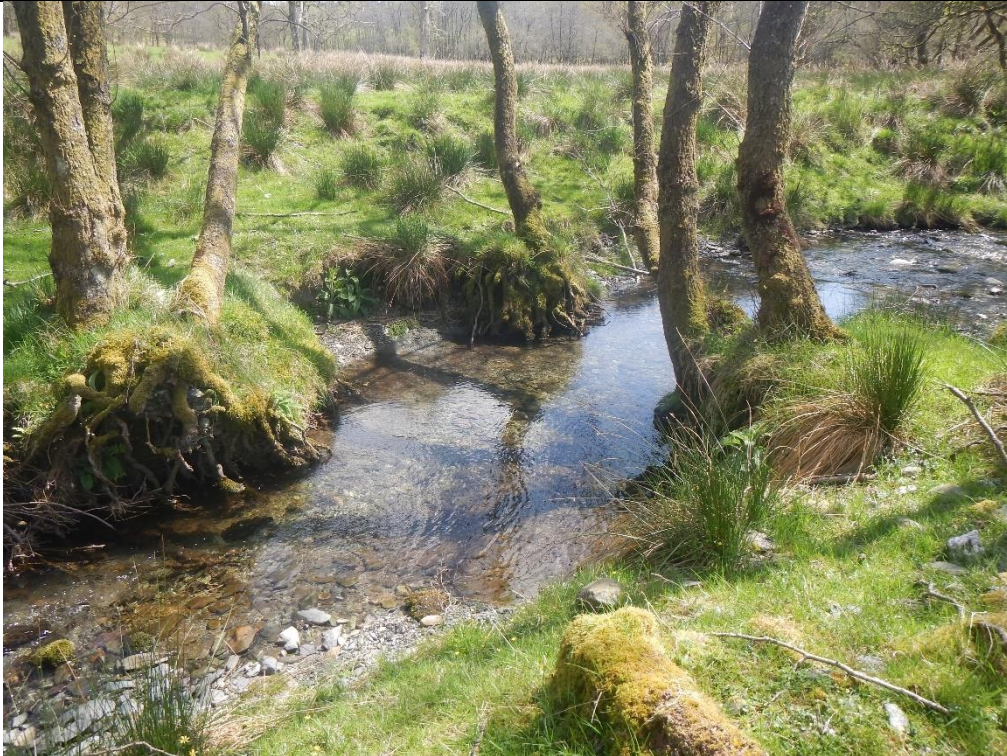
Figure 10 (56.187045, -4.439325). Bank stability from trees provide some in-channel features and could provide valuable anchor points from which to secure woody material that could increase coarse sediment deposition.

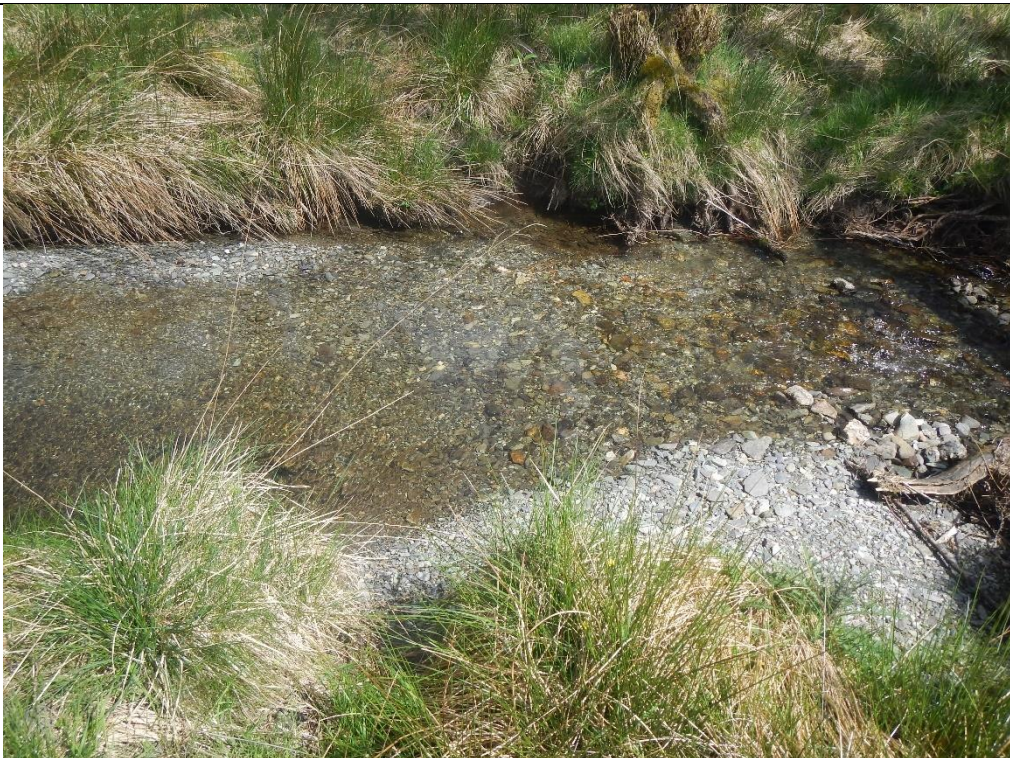
Figure 12. Gravel deposition in wider, lower energy areas of the channel. More of this material could be retained in other areas through the installation of woody material.

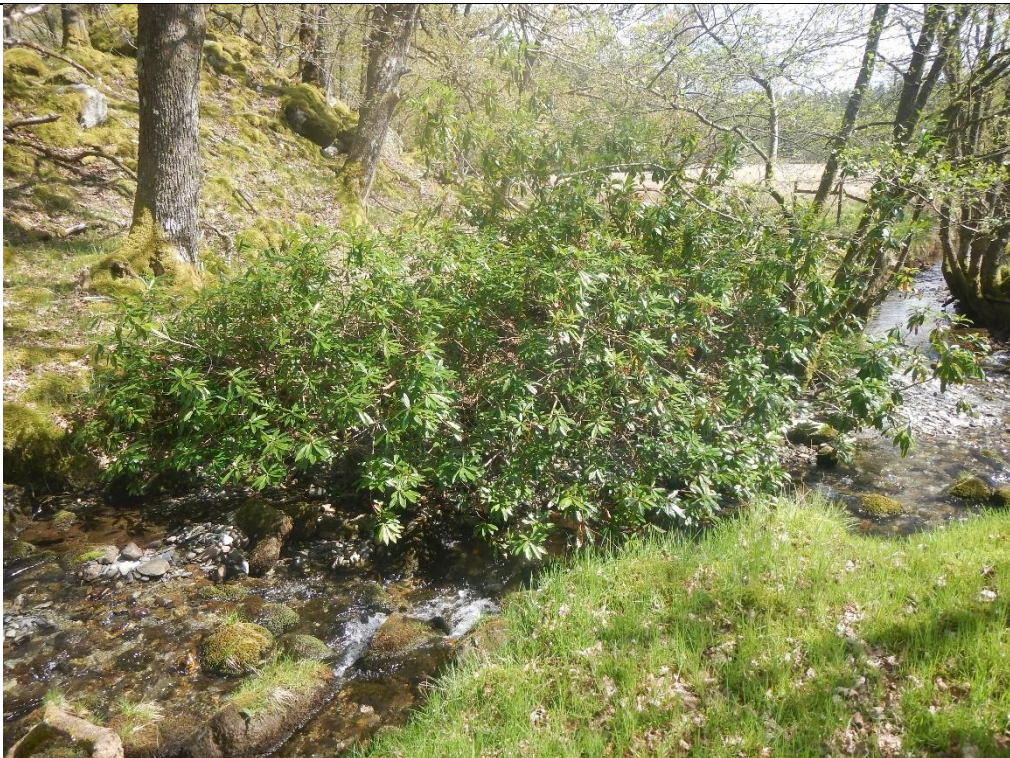
There was a general issue with livestock access denuding bankside vegetation and preventing natural tree regeneration in all areas upstream of the B829 road. Only one particularly problematic non-native species was observed during the visit, that being rhododendron (*Figure 14*). While this is not considered to be as invasive as some, it creates significant issues of overshadowing, out-competing most native species - its eradication is advisable.

Figure 14. Rhododendron – an invasive, non-native species that should be eradicated to prevent further spread.

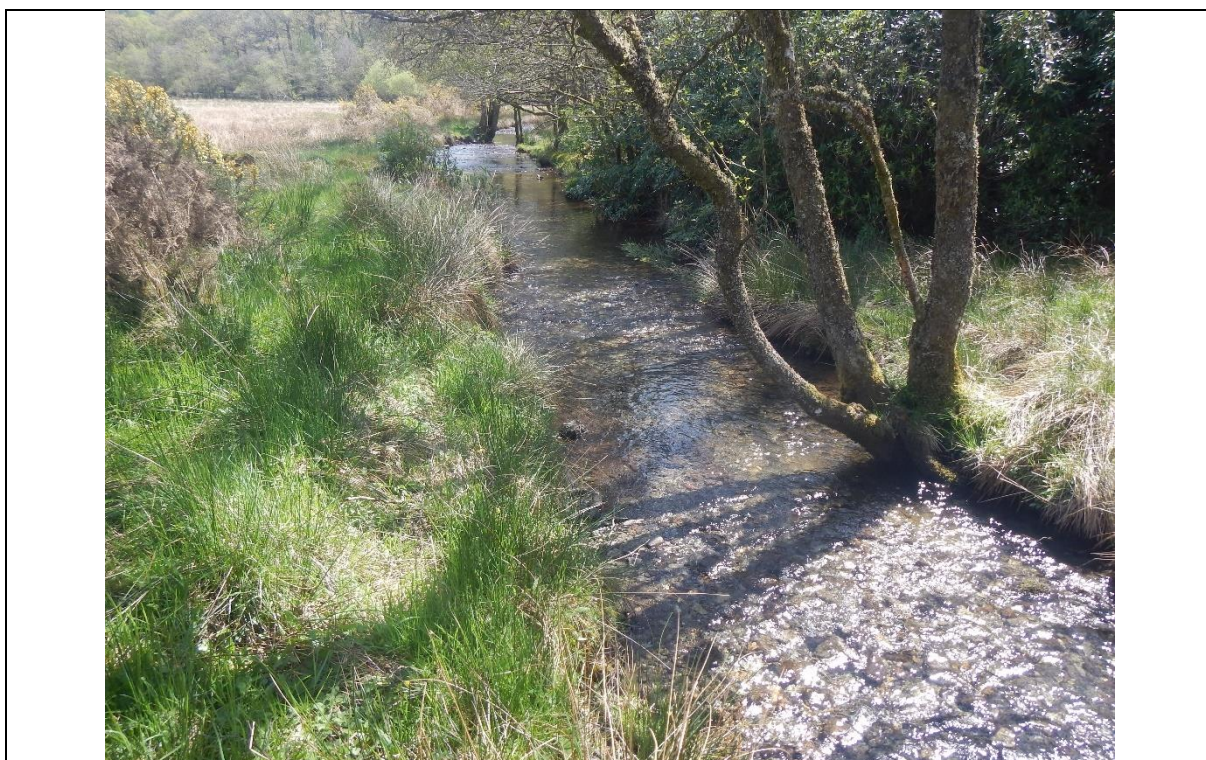
For ~200m upstream of the B829 road, the channel was significantly realigned and straight, with correspondingly uniform riffle and glide habitat, lacking pools and providing greatly underperforming habitat. Although a negative, this situation does at least create a great opportunity to quickly and easily improve the habitat quality. As for further upstream, the presence of bankside trees offers scope to install various types of *Lodged Woody Material*, and the stable banks with gravel substrate are perfectly suited to *Pinned Woody Material* type structures (*Figure 15* & *Figure 17*). These could significantly improve habitat in the short-term.

*Figure 15. The uniform width, uniform depth 200m u/s of the B829 road. Greater occurrence of structure and pools could be created through the installation of various types of *Woody Material*.*

- Prime location (the ~ 200m u/s of B829)
 - **56.1853, -4.438458 to 56.18356, -4.436975**
 - D/s of pipe culverts, to aid coarse sediment retention within the channel

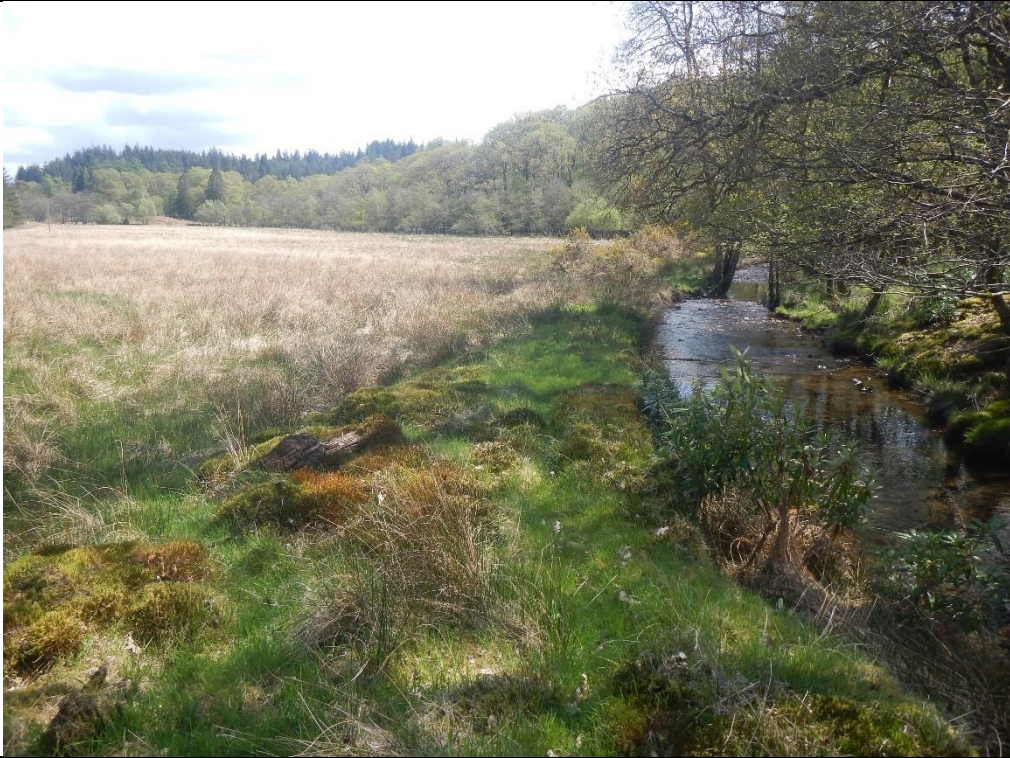
Figure 16. The low ground to the left of shot offers an opportunity to improve habitat quality and naturalise flows by reinstating a more sinuous channel across the field, if the landowner were amenable to the idea.

In the longer term, options could be explored to undertake more major channel restoration through breaking the current burn out of the LB embanked channel and creating a new re-meandered watercourse through the low-lying, adjacent LB land (*Figure 16*). The already wet nature of that ground makes it relatively low grade for agriculture and moving the watercourse to a lower point in the valley may even improve the general drainage, while also allowing more regular use of the floodplain to 'temporarily' store flood water that can then recede back into to the channel more easily as flows decrease. This could create a positive impact upon flood storage with little or no detriment to land drainage, possibly even a positive one.

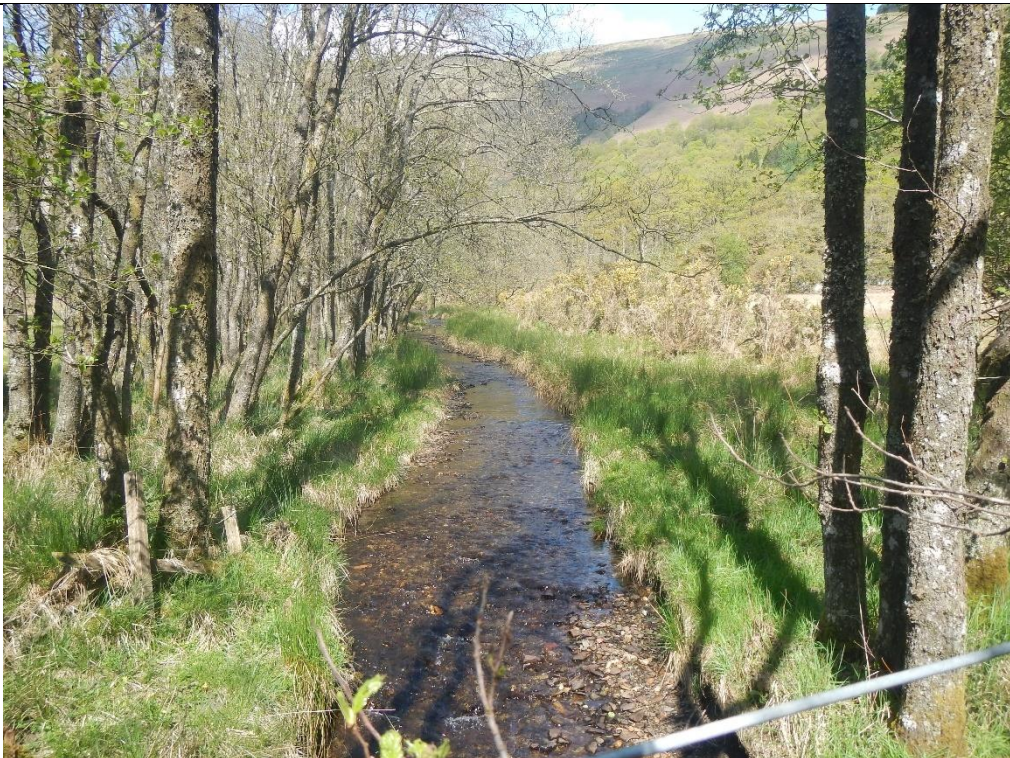
Figure 17. Looking u/s from the B829 road: continual glide, with no in-channel structure or deeper holding water.

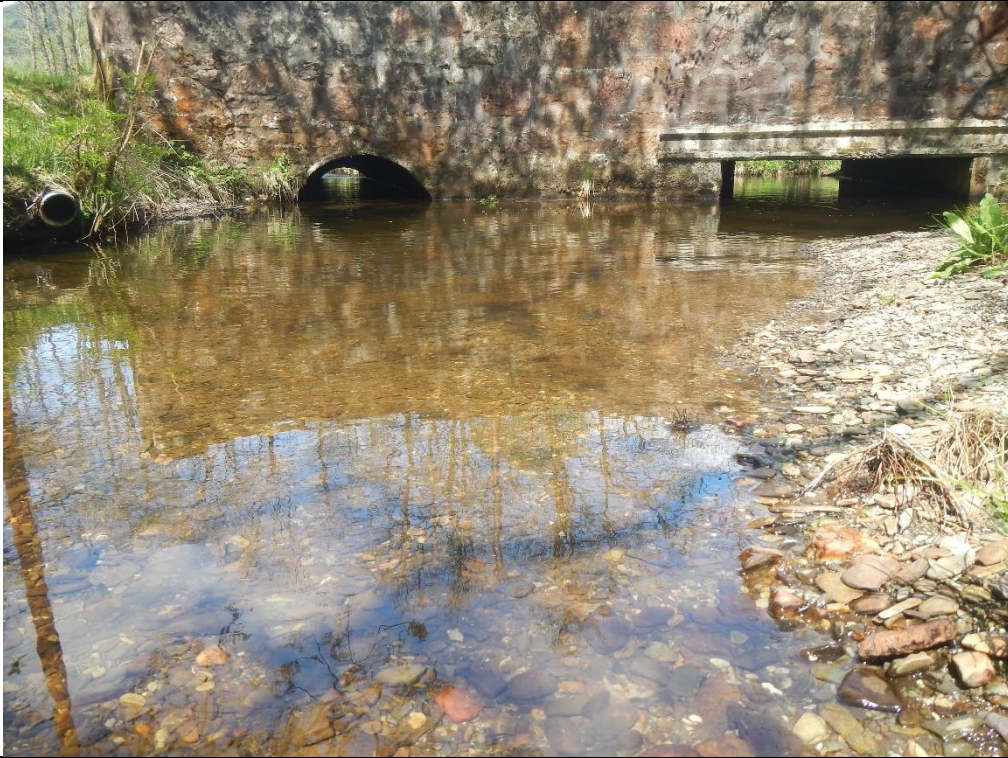
After ~300m alongside the road, the burn turns beneath the road, through an undersized culvert (*Figure 19*), although it appeared to be maintaining itself (or being maintained) in a clear state and affording free fish passage at the time of the visit. It would be worth monitoring this structure to ensure that it always provides free fish passage as, unimpeded, fish will move around a catchment throughout the year to use various habitat.

Figure 19. The somewhat undersized road culvert. This should be maintained clear to ensure free fish passage at all times – not just during spawning times.

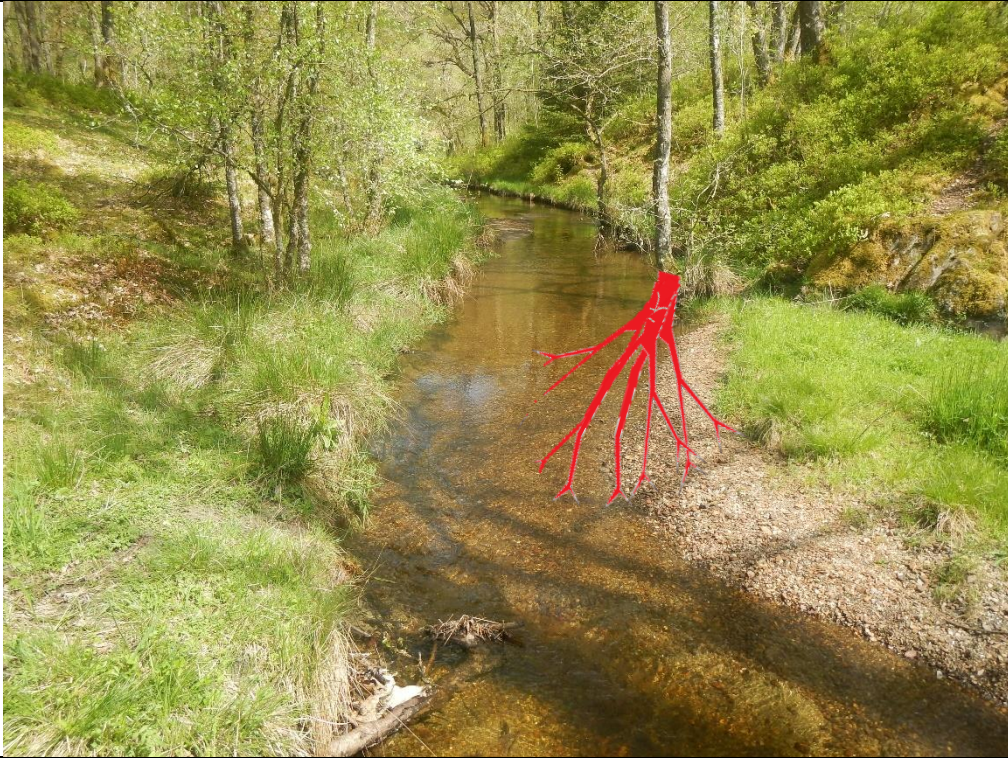
Figure 21. The natural sinuosity of the channel and fish cover could be enhanced here with the addition of woody material. The bankside trees provide a great anchor point for *Pinned Woody Material* (red diagram).

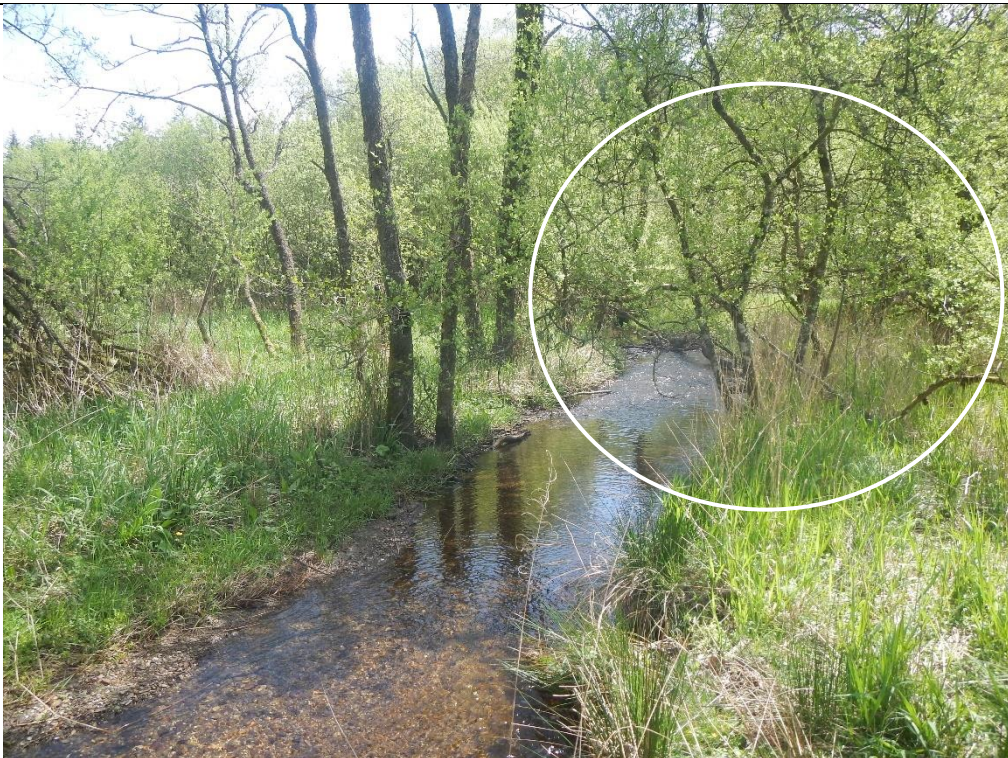
Figure 22. One or more trunks of the RB willow (white circle) could be laid down into the channel by *Hinging*, to increase structural diversity.

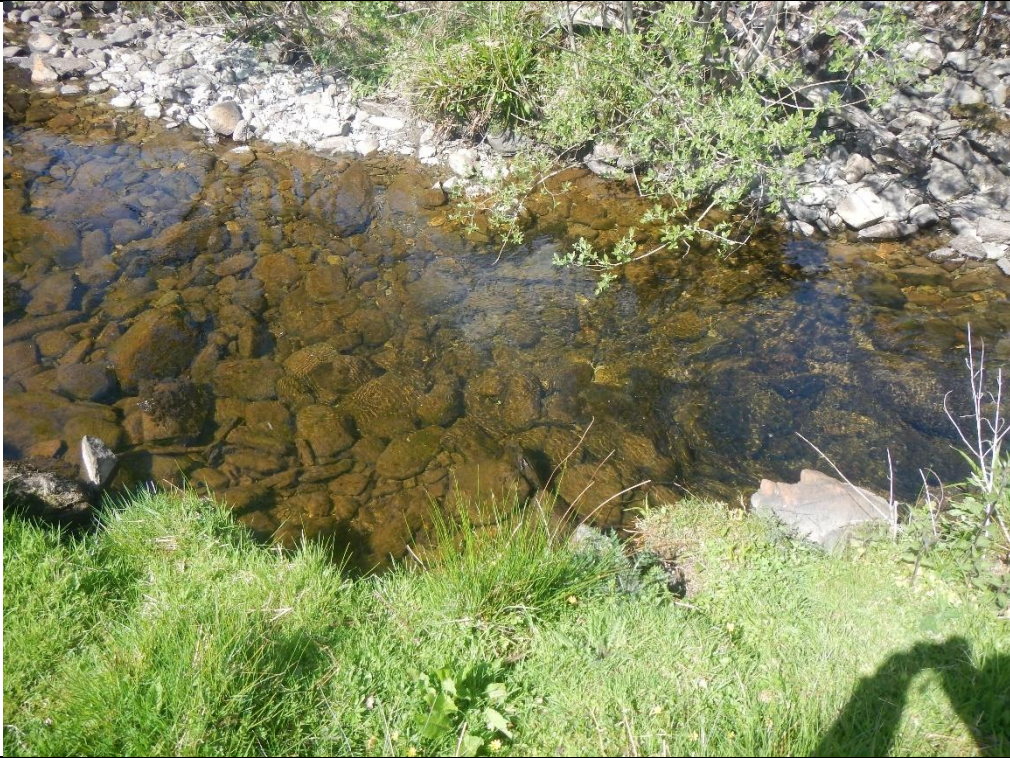
Figure 26. In many areas, the substrate of the channel was too coarse for salmonid spawning. Modified channels upstream and increased land drainage could contribute to this through increased peak flows and associated coarse sediment transport. Equally, barriers upstream could also starve the burn's supply of gravel.

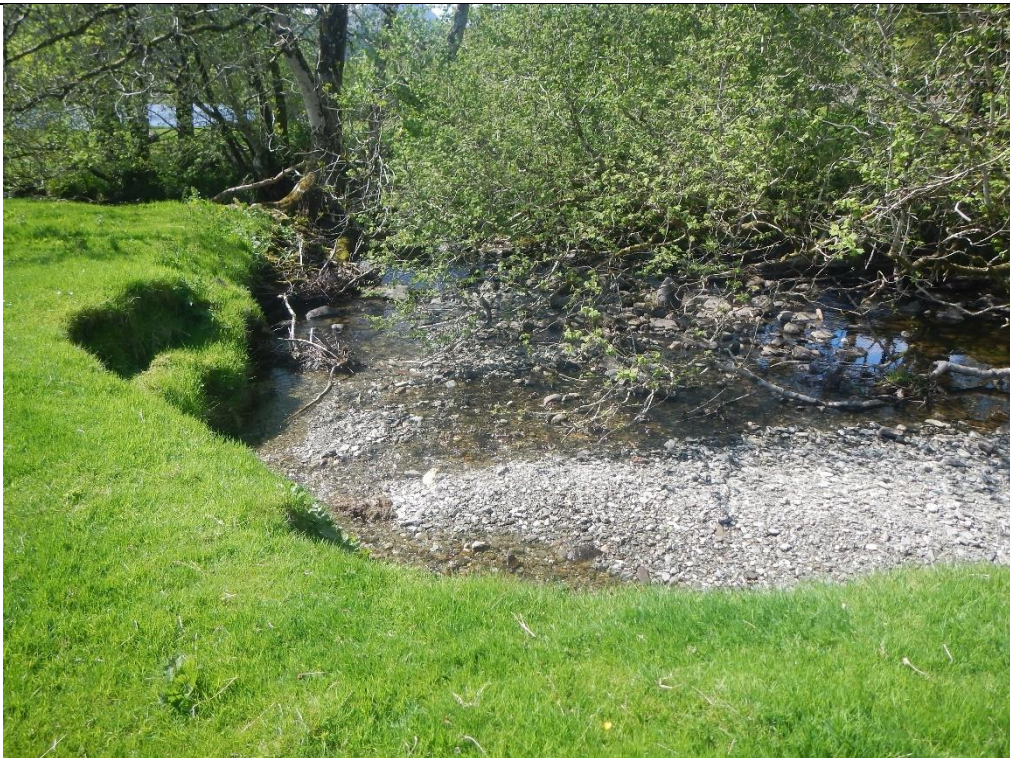
Figure 27. Some gravel was retained at bends, where trailing vegetation was also likely to dissipate high flow energy, but the channel generally lacked gravel.

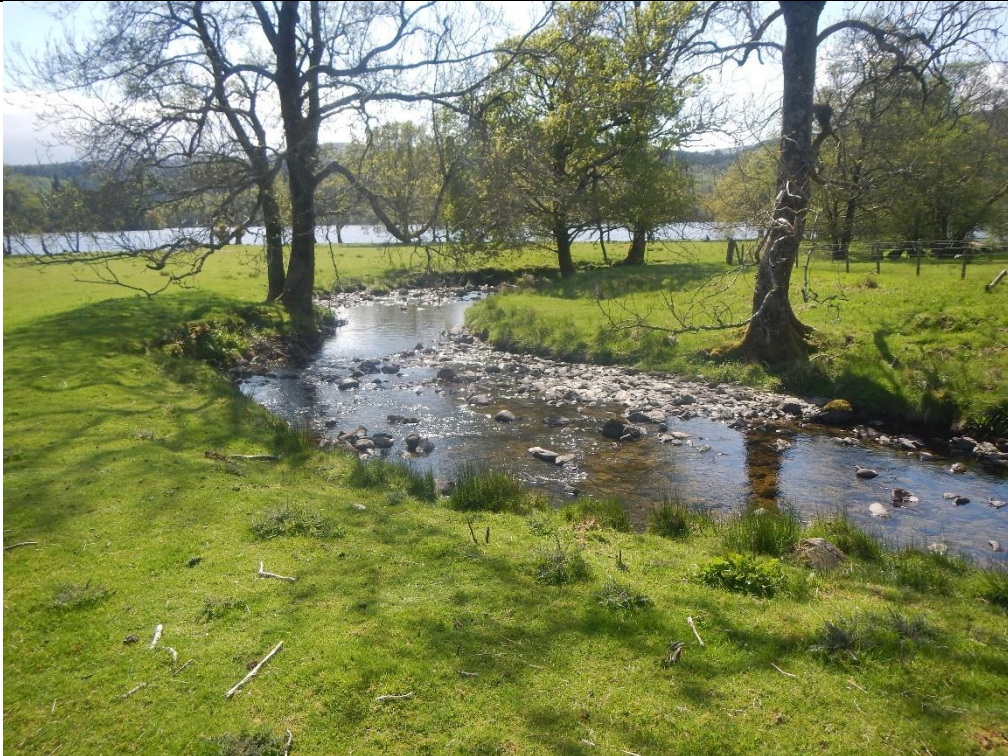
The potential for more structure to become established (particularly from the LB side) was reduced by livestock access to the banks, restricting tree growth and bank stability. Associated historic erosion was almost certainly contributing to the channel appearing overwide and shallow, although relatively stable in most places now (*Figure 28*). Grazing of bankside vegetation reduces species diversity and natural tree regeneration, along with causing more of the plants' energy to be diverted into replacing lost foliage than maintenance of diverse root systems. For this reason, grazed banks are generally far more susceptible to erosion than un-grazed/buffer fenced banks.

Figure 28. The overwide and generally shallow channel, lacking deeper pool habitat.

- Install buffer fencing wherever livestock have access to the watercourses (predominantly the upper part of Drumlean Burn and lower reaches of Ledard Burn).

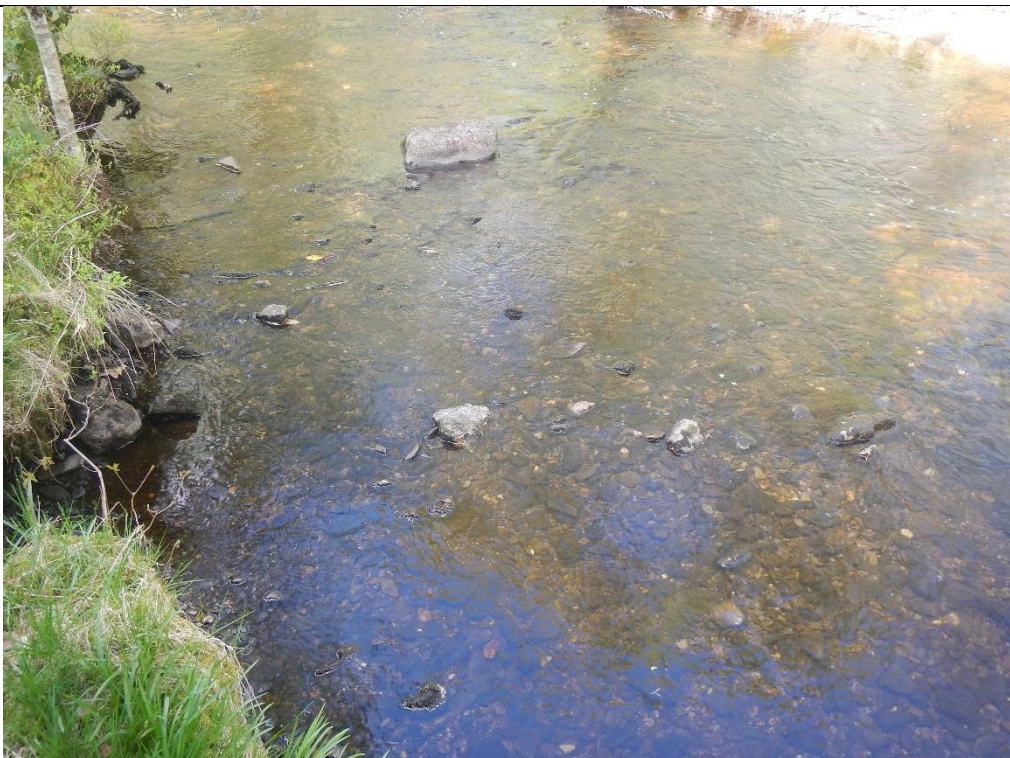
Figure 30. Limited bed sorting reduced the potential for salmonid spawning, but it remained reasonably good quality.

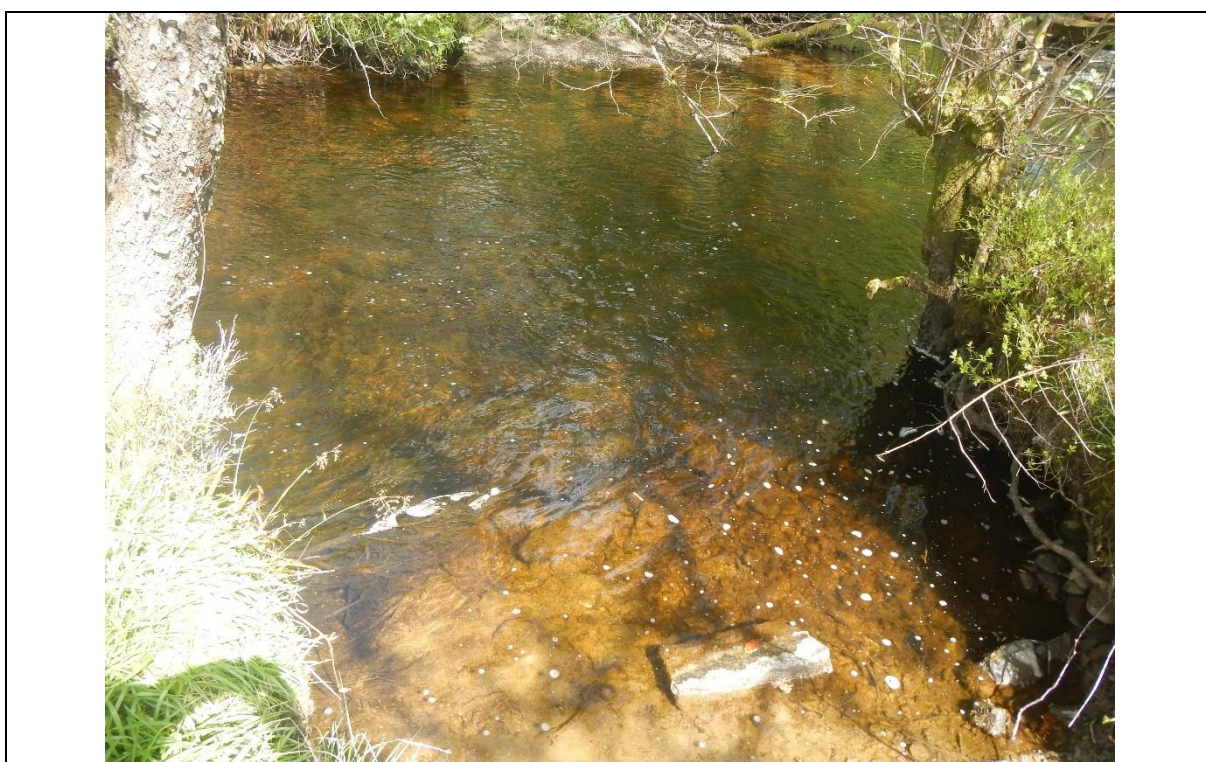
In wider areas of the channel, there were signs of fine sediment accumulation (*Figure 33*). While this would be expected to an extent in such areas, there is usually scope to limit anthropogenic inputs of fine sediment on most catchments and it may be worth undertaking inspections further upstream to identify sources such as livestock access/erosion, forestry drains, and track crossings and roads.

Figure 33. Fine sediment deposition in the margin at a wider section. This may indicate elevated inputs further upstream and further inspection would be beneficial.

- Investigate potential fine sediment inputs further upstream on the Water of Chon. This could be simple visual inspection of forestry drainage discharges, track crossings and land use (e.g. grazed fields/erosion).

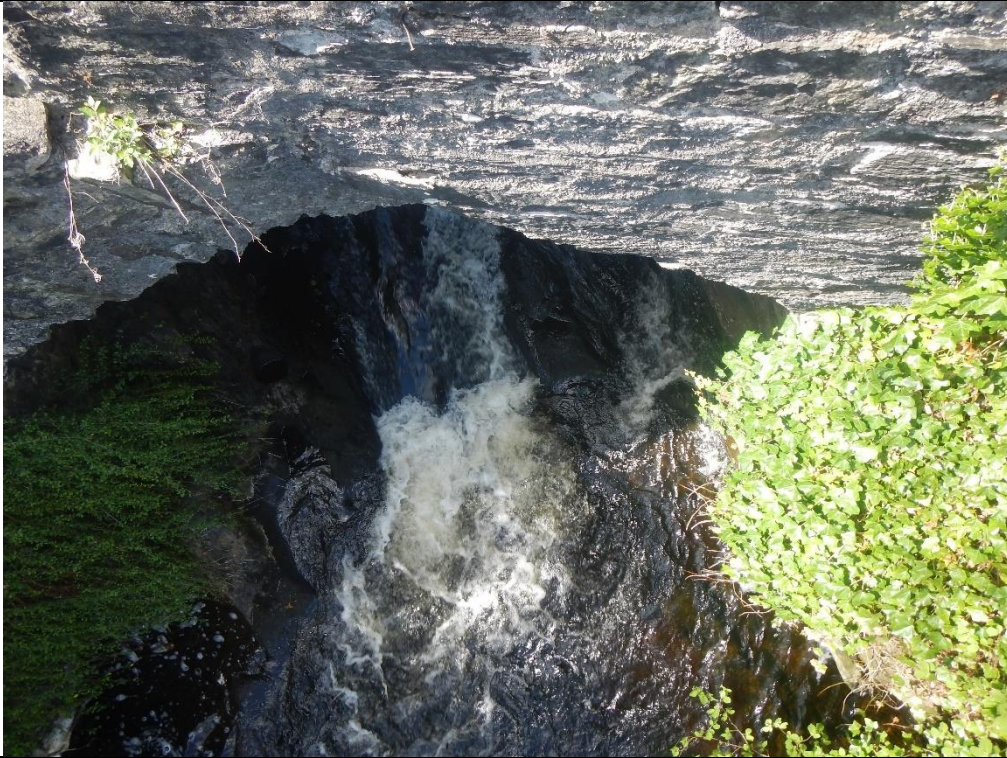
The bridge of the road crossing in Kinlochard appeared to be built on a natural bedrock feature, which creates a chute/fall that is a small obstacle to fish passage but will be passable in a range of flows (*Figure 34*). There is a general presumption against altering natural obstacles within watercourses, so the limited impediment that it does cause should simply be accepted as a consequence of naturally diverse habitat.

Figure 34. The road bridge in Kinlochard created no additional impediment to the already rugged bedrock outcrop on which it sits.
