WILD TROUT TRUST

Advisory Visit

Cound Brook, Shropshire

June 2020

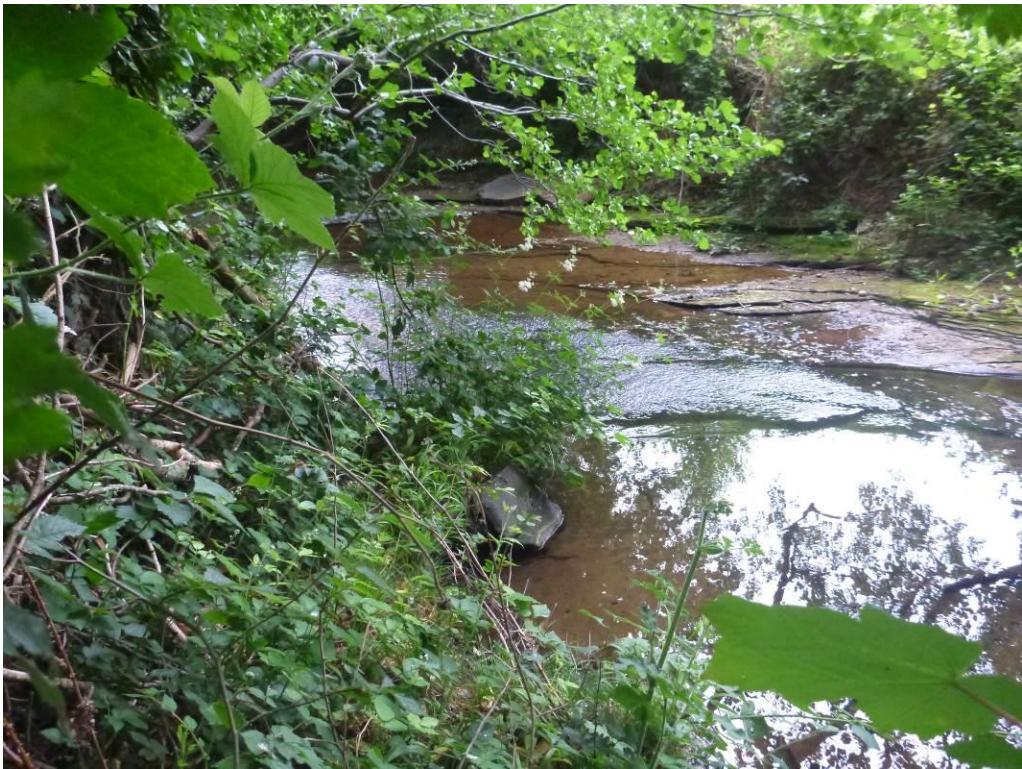
Photo 1 Exposed bedrock on the Row Brook.

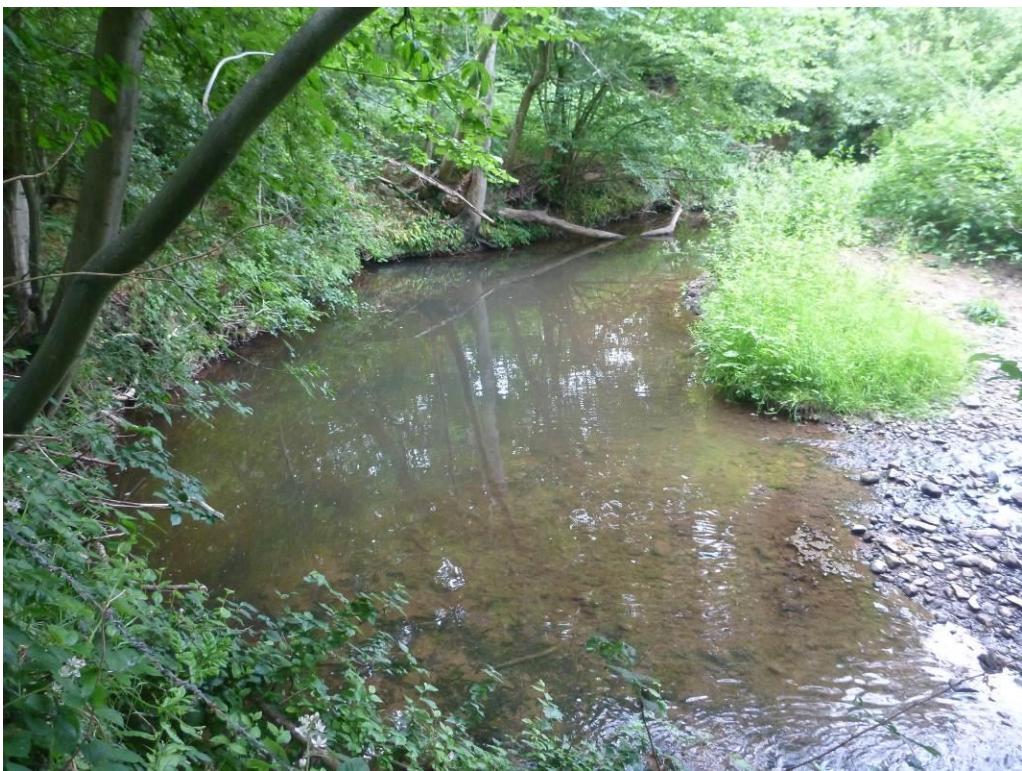
Photo 2 A deep corner pool on the Row Brook. The combination of depth, low cover and an undercut bank provide good adult trout habitat.

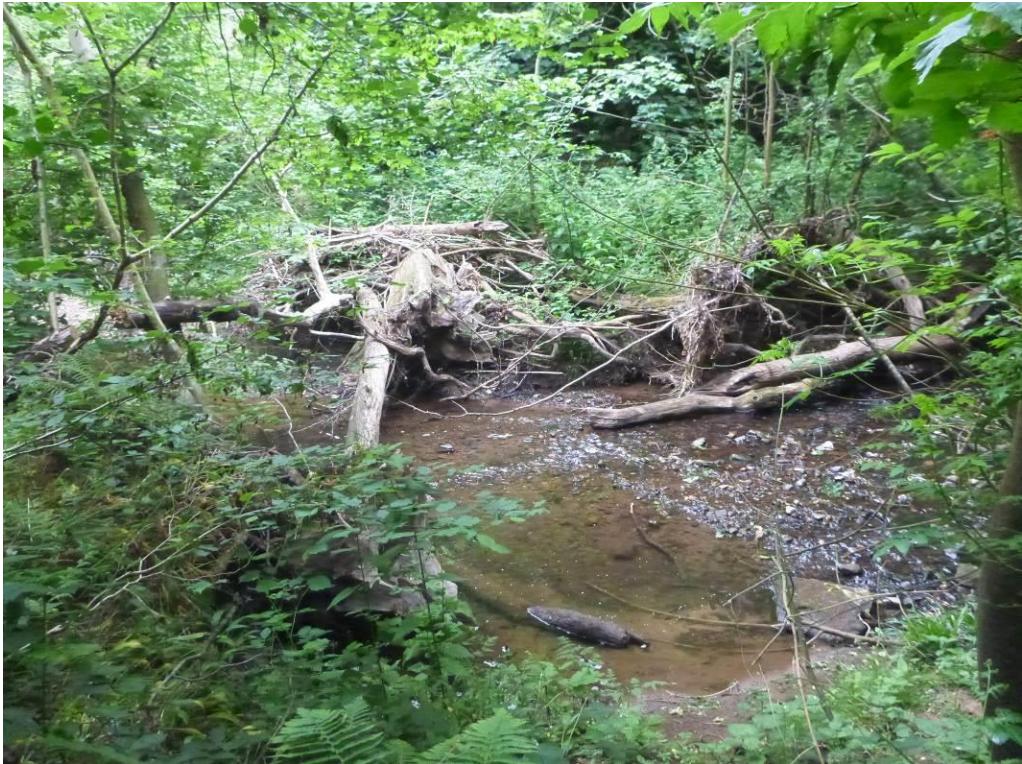
Photo 3 Large woody material accumulation – valuable habitat.

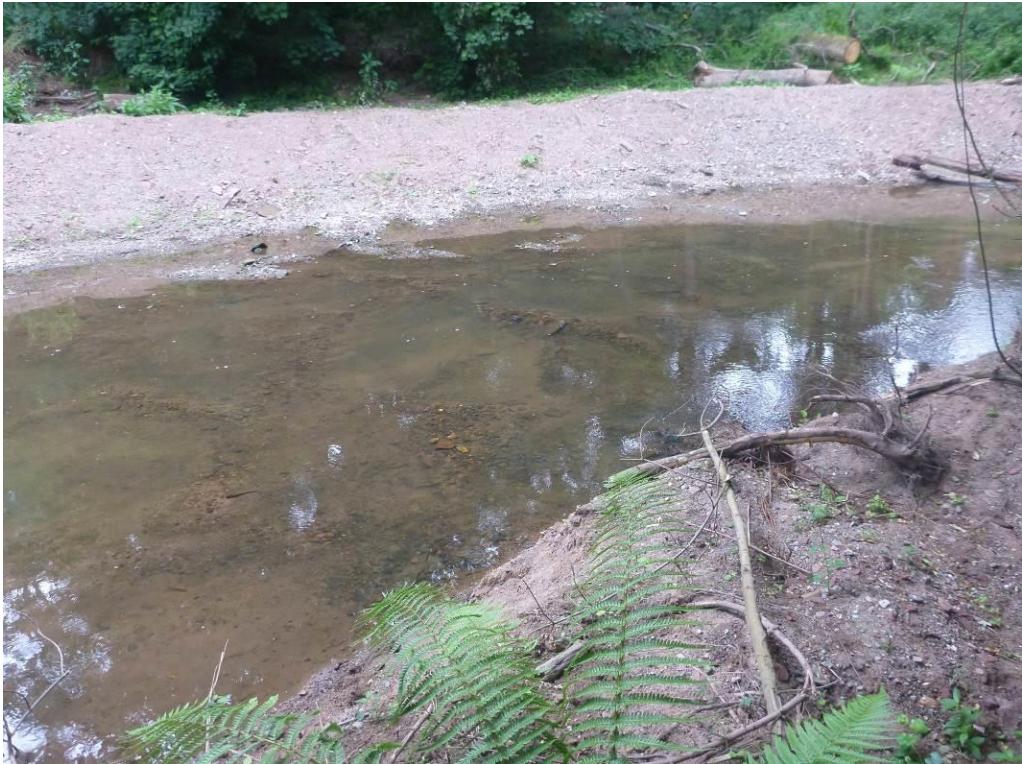
In one part of the brook an accumulation of large woody material has recently been removed from the channel with an excavator (Photo 4). In most circumstances, such removal is detrimental to the river habitat and the presumption should be to leave it in place. The guidelines here www.wildtrout.org/assets/files/library/Woody_Debris_Apr2012_WEB.pdf provide a helpful guide to decision making. It is useful to remember that the 'log-jams' are dynamic structures, forming and breaking down over varying timescales. In locations such as this, they rarely present an obstacle to fish movement and any increased bank erosion doesn't threaten valuable land or assets. In this context, the processes promoted by log-jams should be thought of as valuable and habitat-forming rather than detrimental.

Photo 4 Site of large woody material removal

If woody material really is causing a problem, a less disruptive intervention would be to make selective cuts with a chainsaw to cross-members within the log jam, then wait for higher flows to naturally move the material.

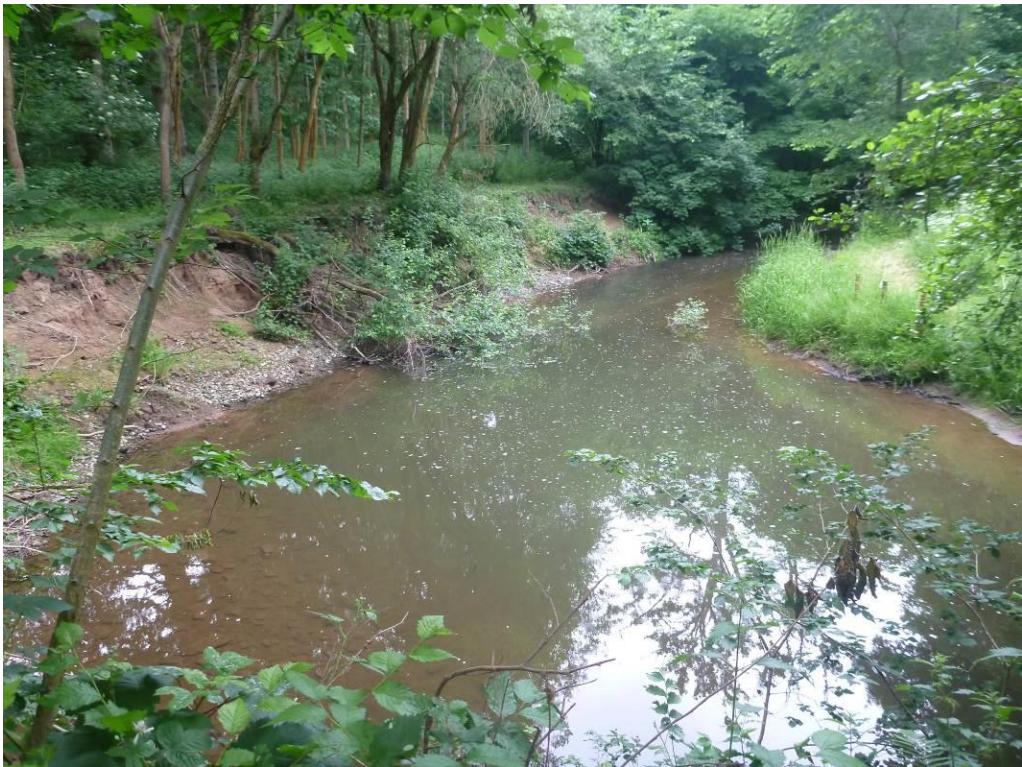
Photo 5 A deep pool with good low cover provided at the neck of the pool by a slumped tree. The crease between differing current speeds on the outside edge of the tree is an ideal lie for a trout and one was observed rising there.

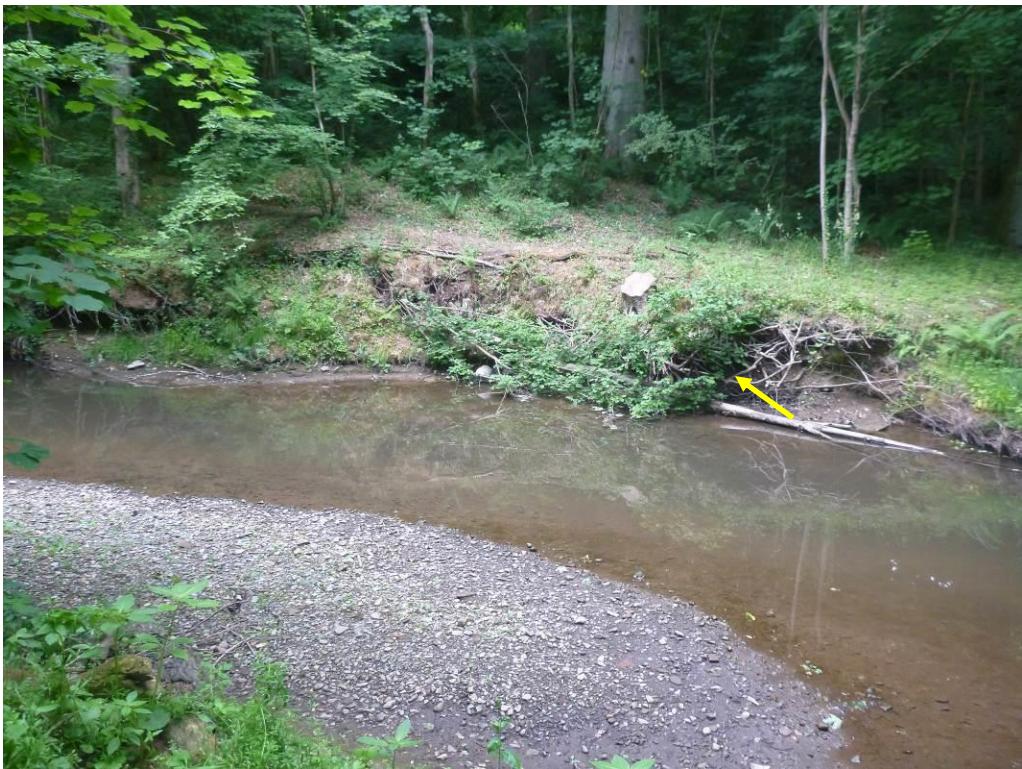
Photo 6 A small hazel tree has naturally folded along the far bank here adding good low cover to what would otherwise be an exposed pool. A larger tree was removed here (stump) to retain the roots within the bank. Arguably, allowing the tree to fall into the river and the outer bank to erode would have contributed to greater habitat diversity. However, retaining some of the cut branches and wedging them into the roots (arrow) could provide good fish-holding cover. Any re-growth from the coppiced stump could also be laid into the river margins for the same purpose (see recommendations).

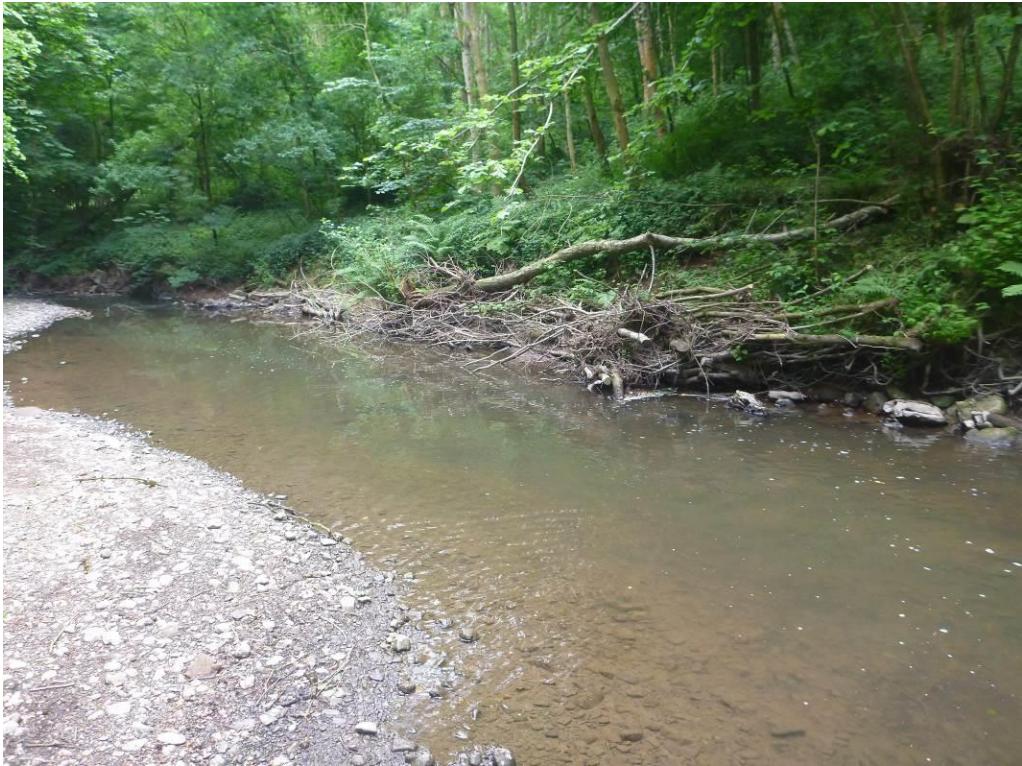
Photo 7 A pool with an accumulation of woody material along the far bank providing very good cover and enhancing the fish-holding potential.

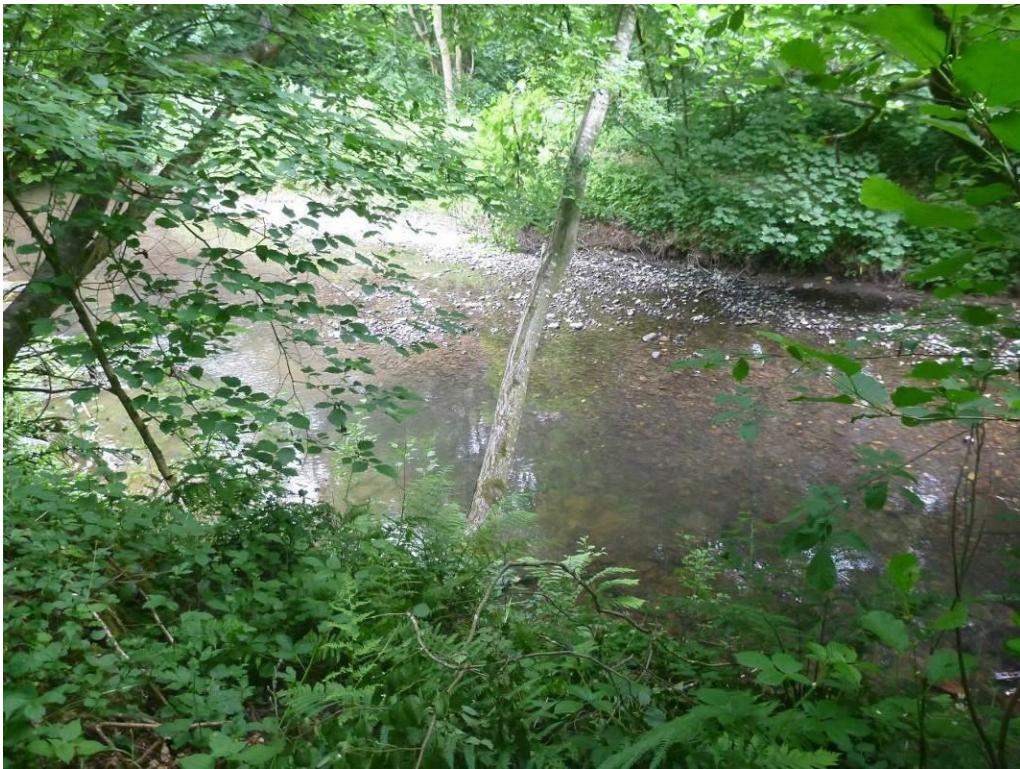
Photo 8 A leaning 'leggy' sycamore that could usefully be coppiced and subsequent re-growth used to hinge and lay into the margins.

- Leaning trees can either be allowed to fall into the river as large woody material or coppiced, depending upon their position (as discussed above). The re-growth from coppiced stumps can be laid over in the future (Photo 17).

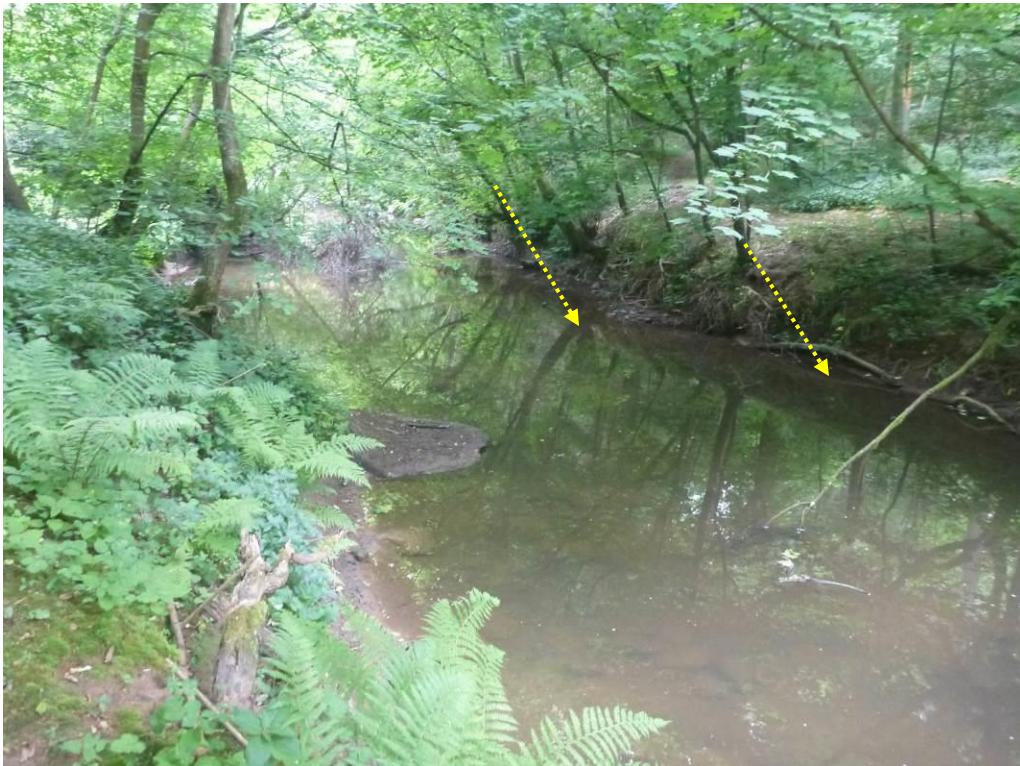
Photo 9 More branched leaning trees that could be hinged and laid (or cabled) into the margins to provide cover.

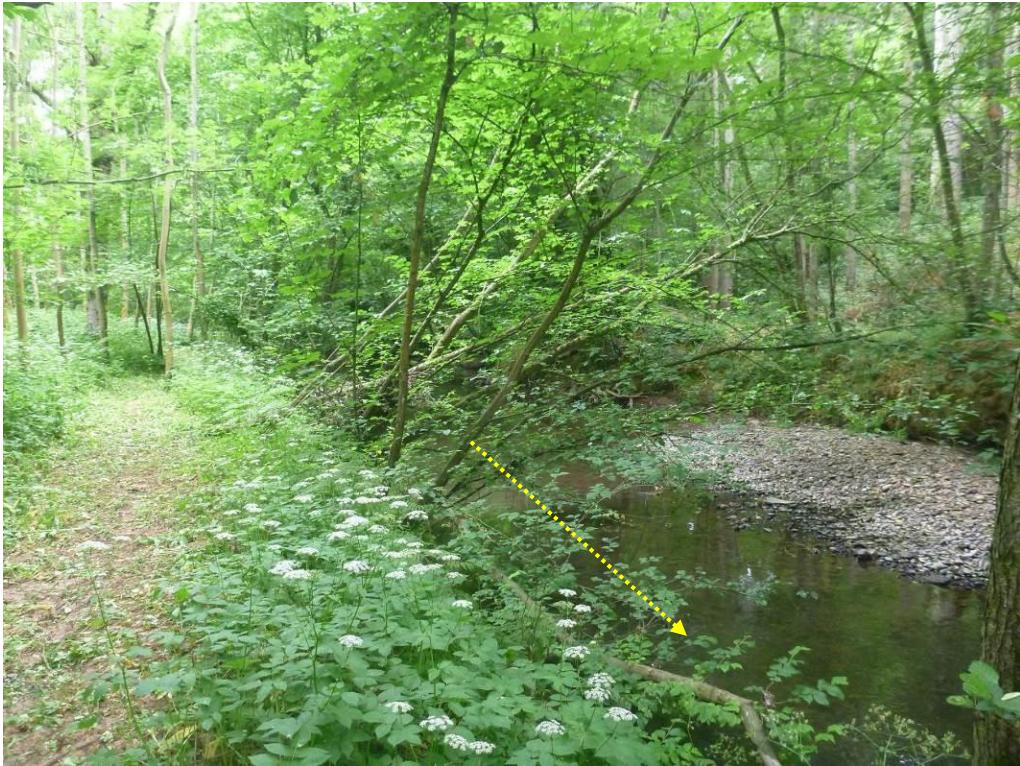
Photo 10 Smaller leaning trees (or coppice re-growth) ideal for laying into the margins.

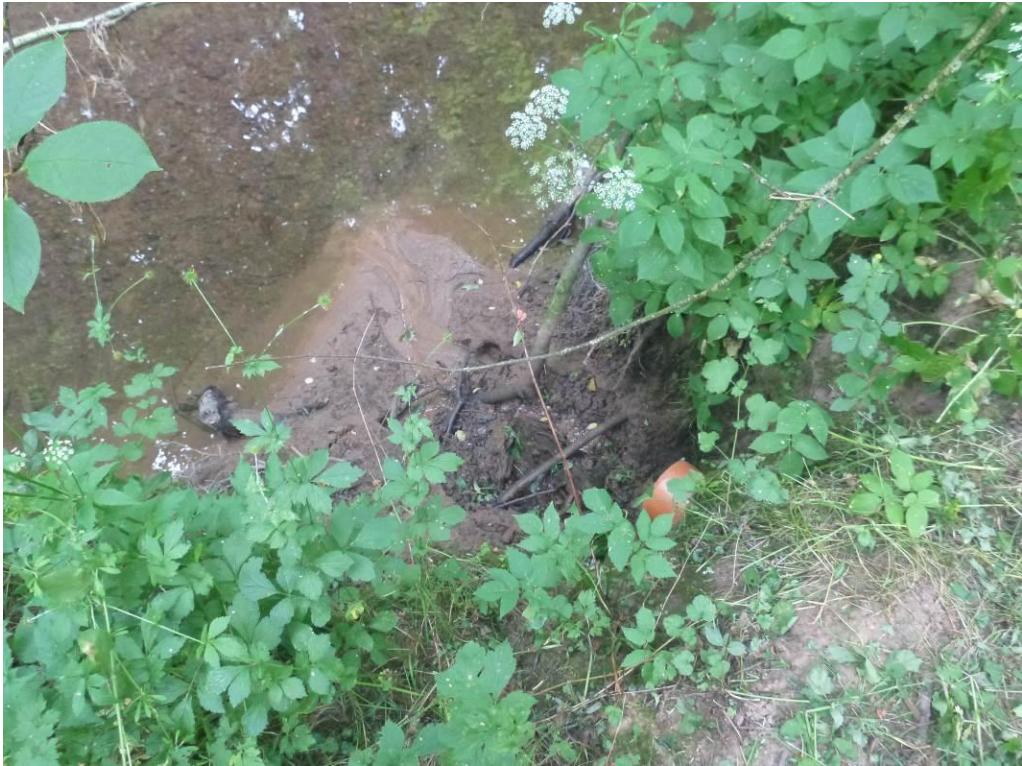
On the right bank towards the upstream end of the reach, there were some drains leading from a track which were supplying fine sediment to the river (Photo 11). Fine sediment clogs spawning gravels, decreases trout egg survival and impacts upon invertebrates. Measures should be implemented to reduce fine sediment inputs like this, such as cross-drains on tracks leading to swales, silt traps or field margins rather than the watercourse (<https://www.gov.uk/countryside-stewardship-grants/cross-drains-rp5>).

Photo 11 Fine sediment input from a pipe draining a nearby farm track.

- Address the fine sediment inputs from the track and elsewhere on the estate wherever possible to minimise the amount reaching the watercourse. The pathways for fine sediment reaching the river are often the same as those for nutrients such as phosphate (the reason for the *poor* ecological status of the watercourse noted in section 2.0), hence there is a double benefit from improvements.

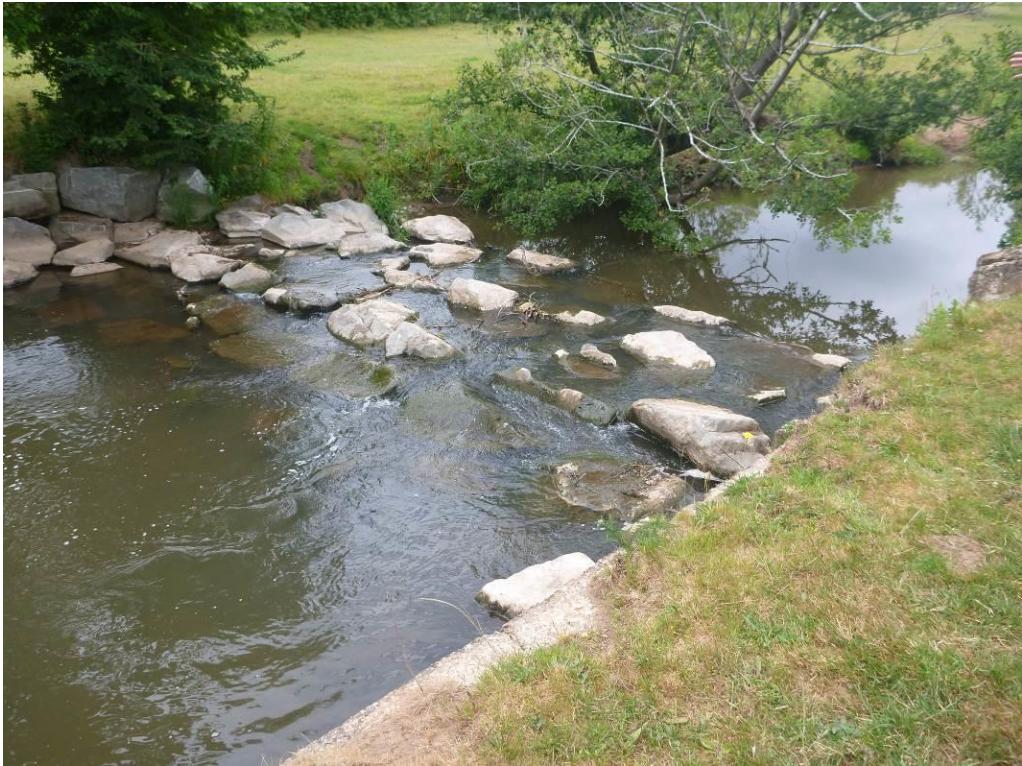
At the upstream end of the Cound Brook reach is a farm bridge and the site of a former concrete weir which supplied a hydraulic ram pump (Photo 12). In response to the weir breaking down, it was replaced first with gabion baskets which failed and more recently with boulders. The reason for repairing the weir is aesthetic rather than functional, as the ram pump is no longer used.

Photo 12 Former concrete weir replaced with boulders.

Weirs are detrimental to river habitats, interrupting fish migration and natural sediment transport, and raising upstream water levels which 'drowns' natural in-stream habitat (Figure 1). In the specific case here, there is little negative impact: the impoundment is small and does not extend a significant distance upstream; there is also no impediment to fish movement because of the open structure of the boulders. However, if there is no longer a need for the raised upstream water levels it would have been simpler and more beneficial simply to remove the old weir.

- Consider removal of the boulders upstream of the farm bridge and possibly the also the weir.
- The bank erosion upstream of the weir could be tackled by protecting the toe of the bank with brushwood staked and wired in place. The bank could also be re-profiled back to shallower angle. A wide buffer zone should then be fenced off from livestock to allow vegetation to colonise and stabilise the bank.

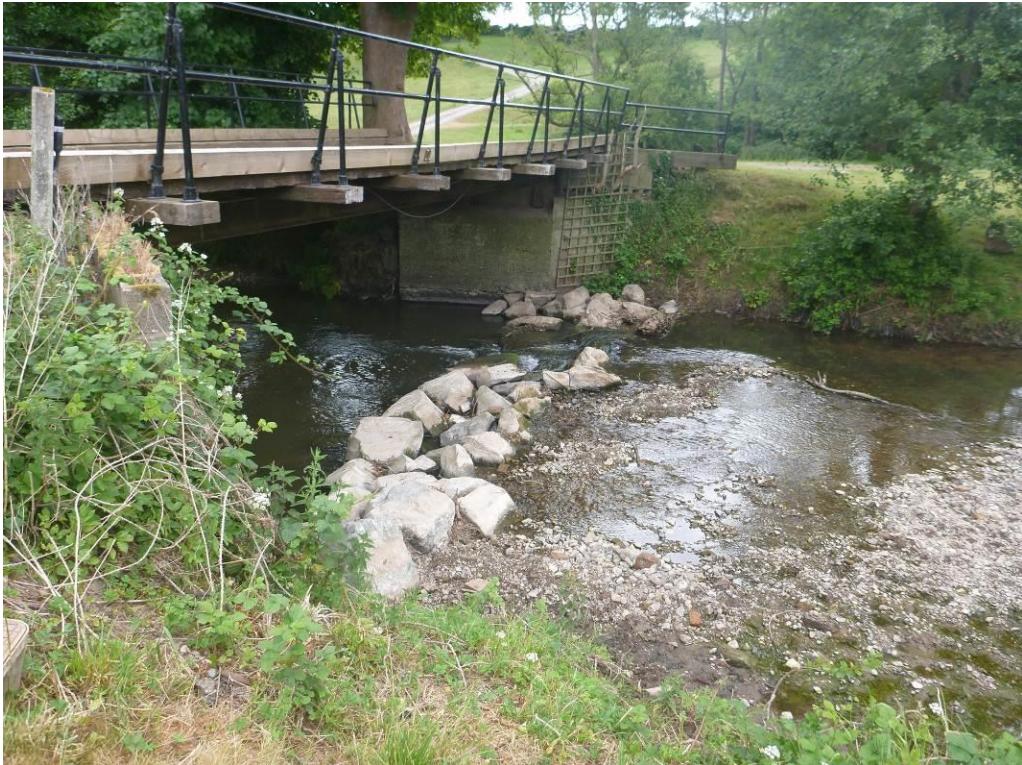
Boulders have also been placed just upstream of the farm bridge (Photo 13) a short distance downstream of the weir. Again, the impact on fish movement and habitat is minimal, but it could be a problem for the bridge in the future. Scour pools form downstream of weirs (due to the focus of flow energy and net loss of sediment). Here the scour pool will develop beneath the bridge adjacent to its footings, potentially undermining them. Removing the boulders would allow a more even distribution of sediment (gravel) protecting the footings.

Photo 13 Boulders placed upstream of the bridge. The effect of sediment accumulation upstream of weirs can be clearly seen here. High flows over the boulders may lead to scour underneath the bridge which could be problematic if it affects the footings.

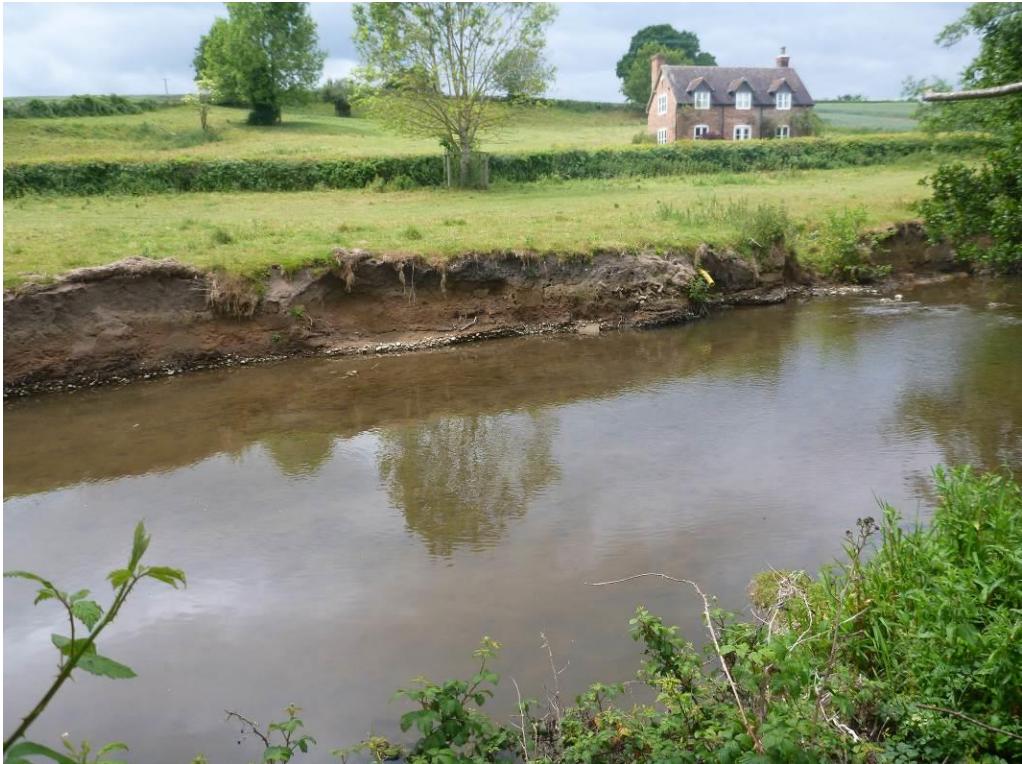
Upstream of the weir, accelerated rates of bank erosion were evident on the right bank (Photo 14). This is occurring through 'block failure', where the toe of the bank is eroded by river flow and the block of earth above, usually when saturated, falls into the river. The lack of trees or other deep-rooted vegetation here (grazing right up to the river) means the bank is less resistant. Some techniques for slowing the rate of erosion are described in the recommendations.

Photo 14 Accelerated rates of bank erosion.
