River Crane – Cranford Park

A Project Proposal by the Wild Trout Trust December 2015

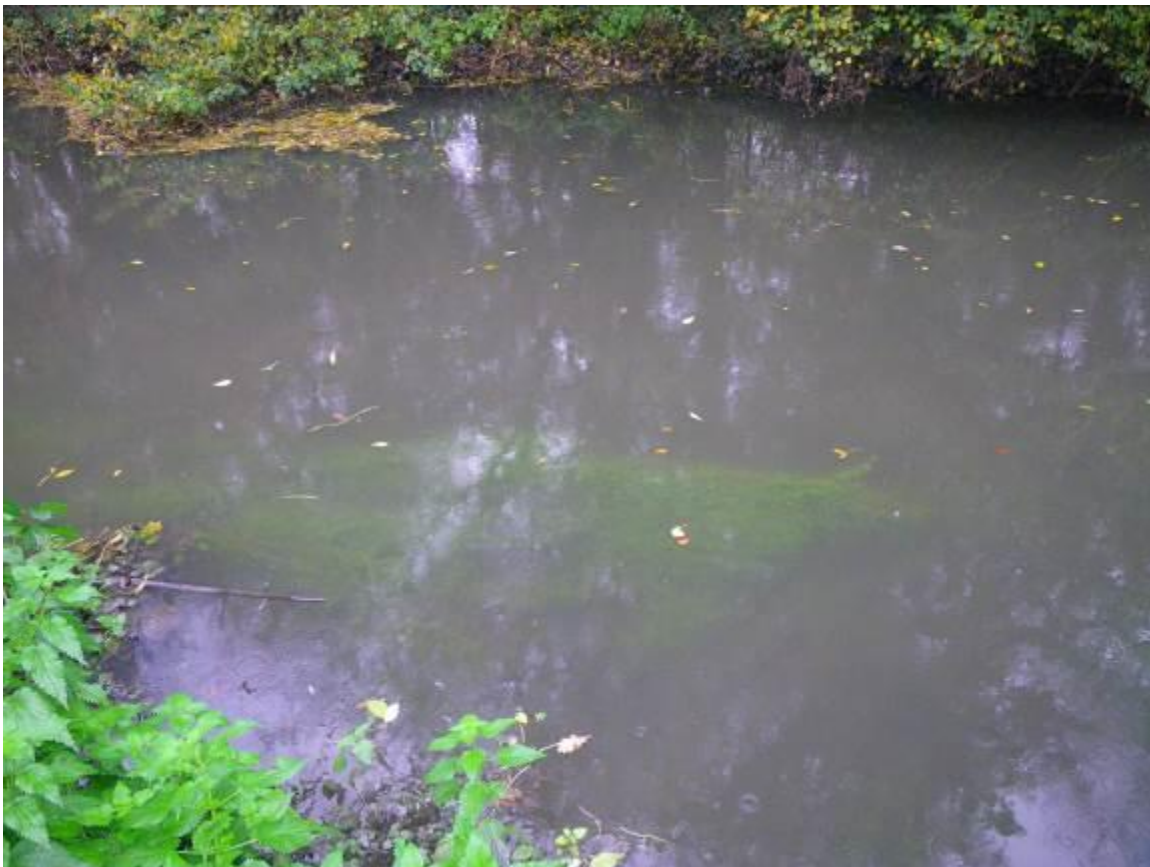
The LB (eastern bank) is comparatively heavily tree-lined. Where pockets of light hit the channel some beds of starwort *Callitche sp* (Photo 1) and fennel pondweed *Potamogeton pectinatus* were evident.

Photo 1. The odd bed of starwort was present in areas of direct sunlight.

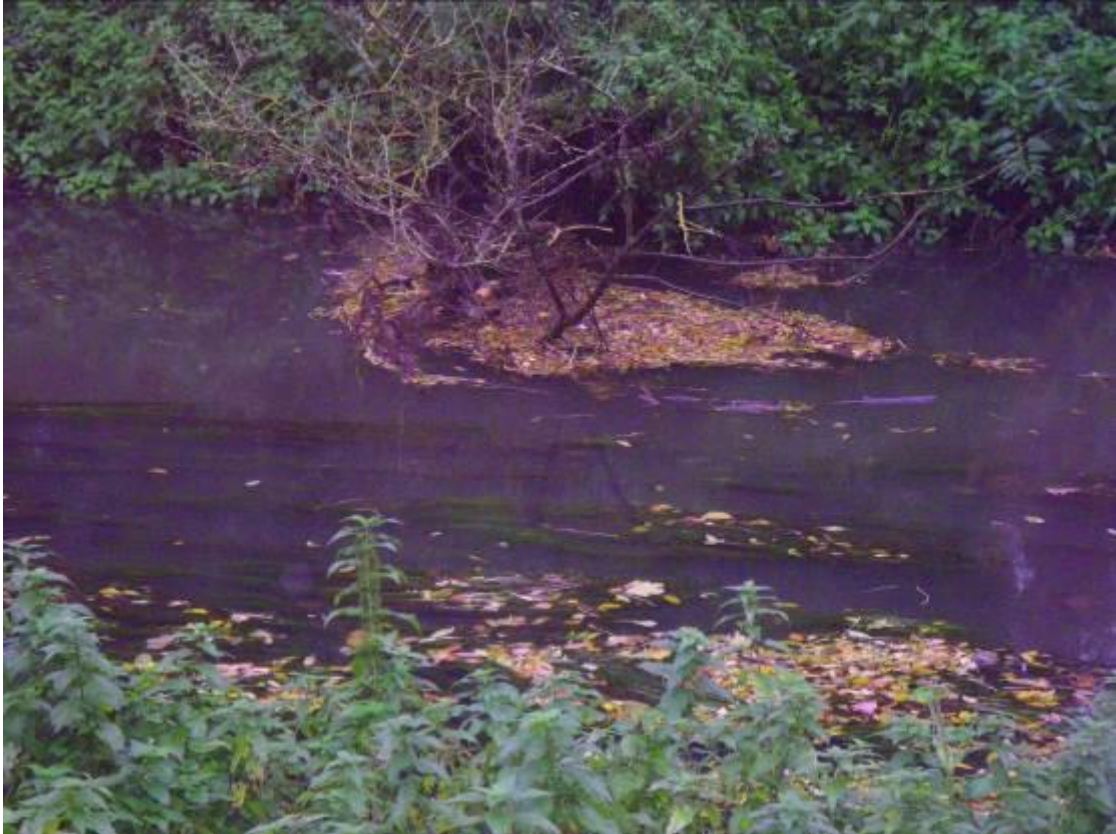
The river margins were generally well covered and “rough” providing some good habitat for both invertebrates and fish. Some good examples of coarse woody debris (photo 2) providing excellent refuge areas for fish, habitat for grazing invertebrates and nesting opportunities for birds could be seen.

Photo2. Coarse woody debris providing good quality habitat adjacent to beds of fennel pond weed.

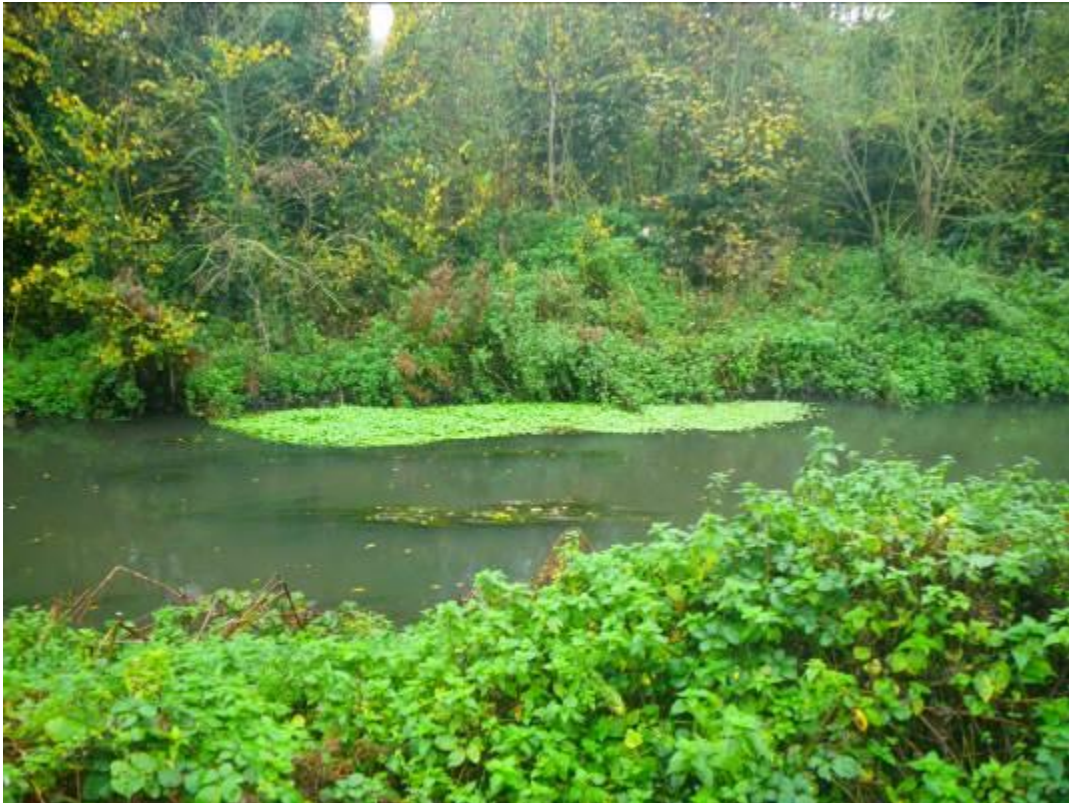
Of particular concern was the presence of several small beds of floating pennywort *Hydrocotyle ranunculoides* (photo 3). This highly invasive non-native plant is known to cause huge problems on water courses where it spreads rapidly, shading out the river bed and clogging up channels with potentially huge rafts of floating leaves.

The presence of this particular plant on the Crane system may well drive future management options. The plant is known to thrive in slow flowing, open systems with plenty of available sunlight. Opening up the canopy in an attempt to improve macrophyte communities may simply provide new opportunities for this unwanted visitor to establish. In addition to this plant failing to thrive in shaded areas, it will also struggle when flow velocities pick up. Hence any reach upstream of a weir or structure that slows down water velocities will be more vulnerable to colonization than un-impounded sections with a more natural channel form.

Photo 3. An established bed of floating penny wort in a sheltered margin with access to plenty of direct sunlight.

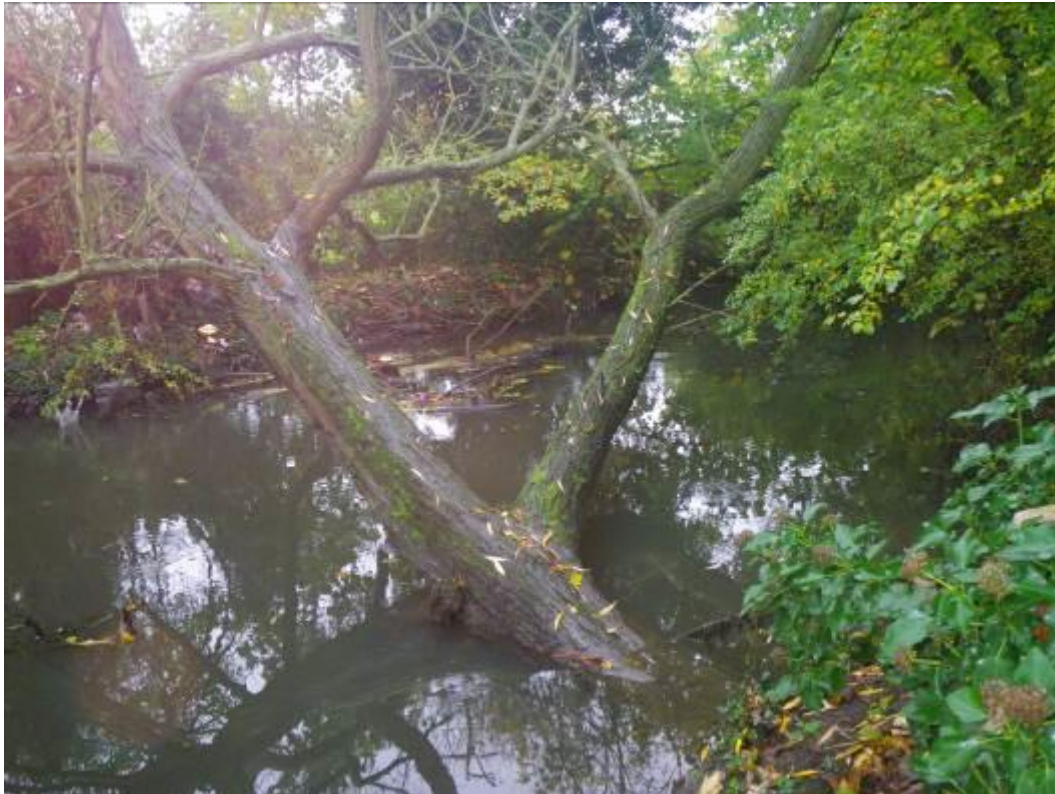
Fallen and partially fallen trees (photo 4) were relatively abundant, providing ample quantities of valuable woody debris within the channel. Most of these were considered to be relatively stable and posing no unacceptable risks, however, care must be taken to ensure that full channel width debris dams do not quickly build up adjacent to large, partially fallen trees. Retaining the partially submerged and valuable trunk sections and reducing the bulk of material above the surface will help to retain the features, as well as reduce their capacity for forming debris dams, thus reducing local flood risk.

Photo 4. A large, partially fallen tree still attached to its root plate. Cutting the main trunk and right hand branch will ensure the feature provides valuable habitat but without the risks associated with the root plate pulling a large chunk of the bank away and forming a blocking dam.

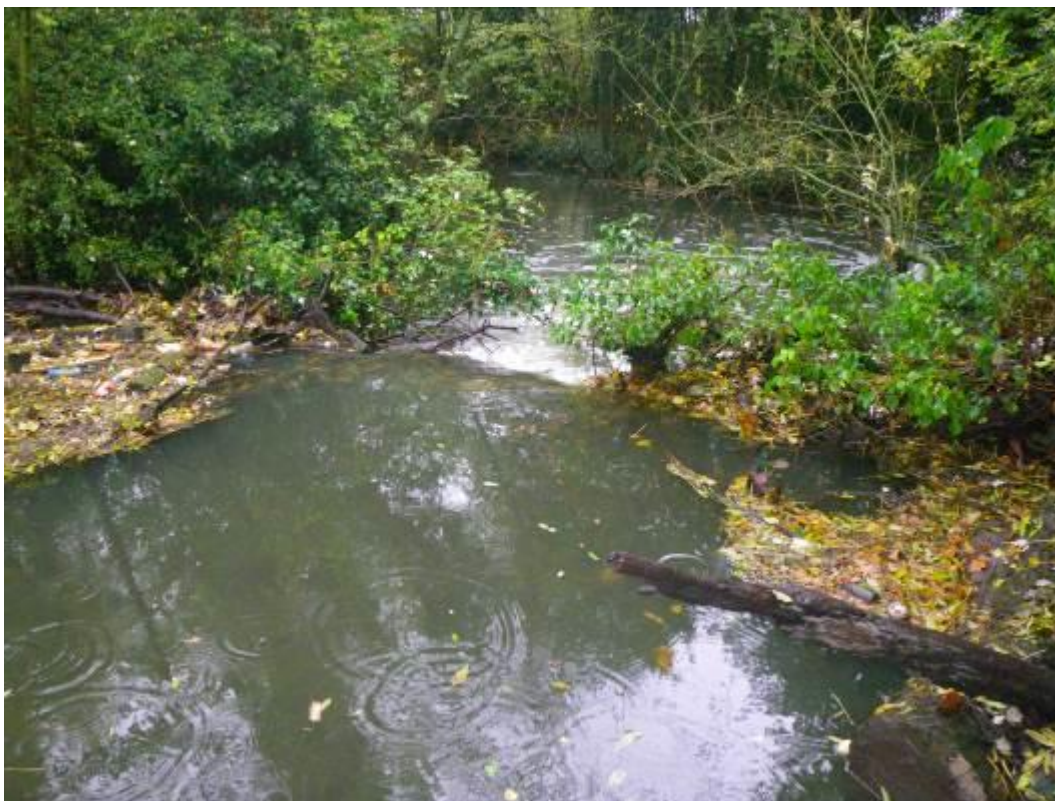
One such dam has already formed (photo 5) and is starting to impound the channel. It is recommended in cases like this that a watching brief is kept to ensure the dam does not collect further woody material. In this particular case it is recommended that a section of the blocking trunk is cut away to avoid the full width dam rapidly becoming occluded with more debris.

Photo 5. Full channel width debris dams should be notched to reduce flood risk and avoid excessive deposition in the reach above.

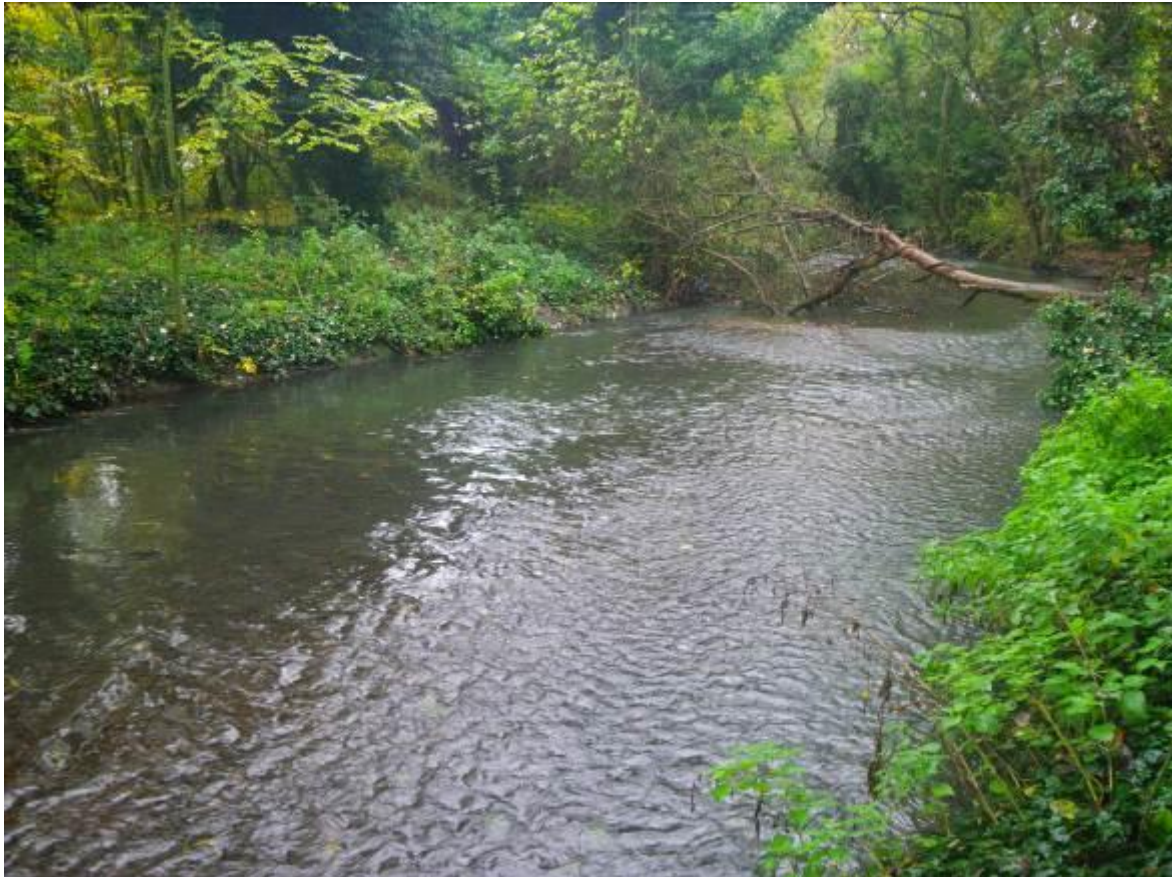
Several excellent examples of riffle habitat were evident on the lower reaches (photo 6). The whole area is gravel rich and where the channel has a modest gradient some excellent shallow riffles have formed, possibly in response to previous fallen trees scouring out bed and bank material. These sites are particularly valuable for a range of specialized plants, bugs and gravel spawning fish species. When selecting sites to allow more light penetration to the channel, shallow riffle sites respond well with the added benefit that there will be no additional risk of penny wort becoming established in these locations.

Photo 6. Shallow riffle habitat over a gravel bed. Dropping the upstream tree and securing it into the channel to form a half-channel width deflector will further sort and improve the quality of the gravels and create a valuable spawning habitat for a range of fish species.

Pieces of large woody debris could be secured onto shallow gravel riffle sections to help sort and clean gravels to optimise conditions for fish spawning.

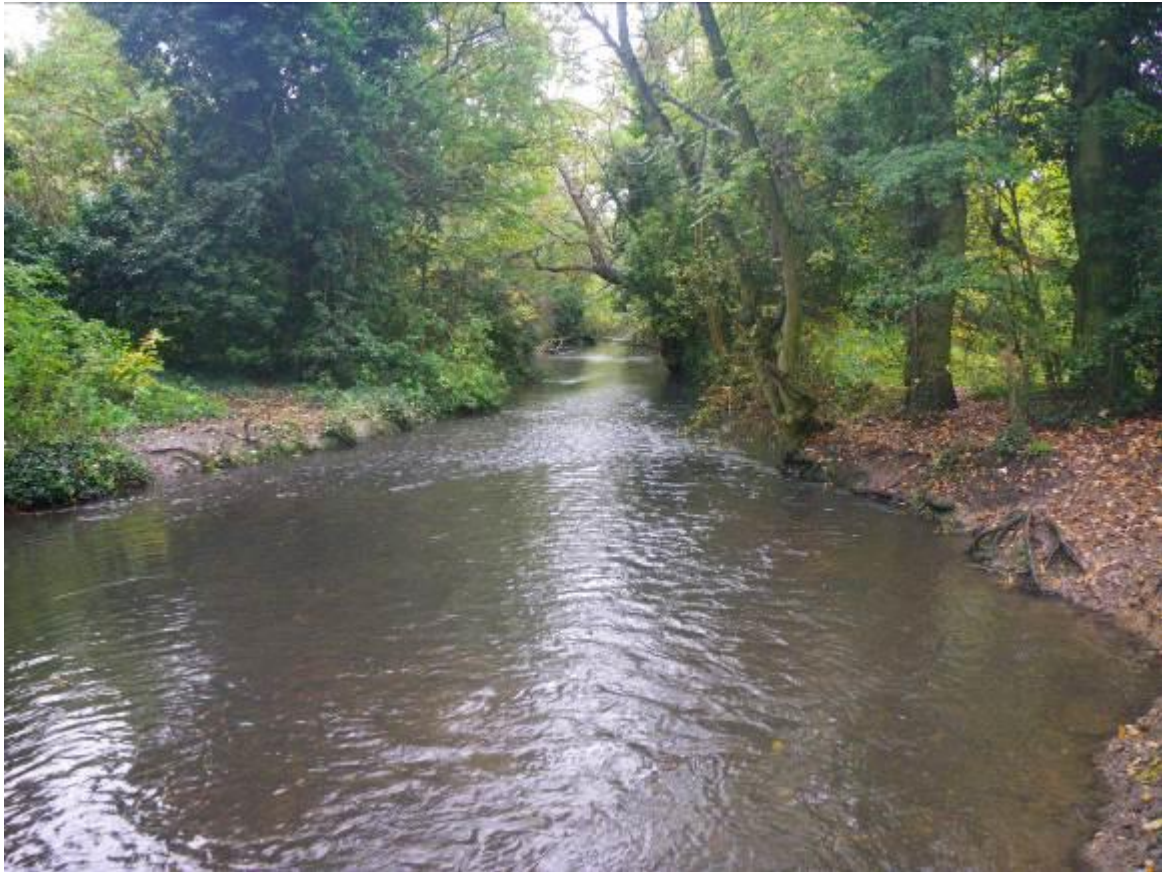
One or two of these areas are obviously being heavily used for dog paddling (photo 7), which is potentially putting pressure on the banks and is almost certainly responsible for the channel becoming wider and shallower than it naturally should be. There is a point when the channel becomes so wide it results in the gravels becoming heavily infiltrated with deposited sediment. Some defensive planting, or the installation of brushwood berms in the margins will help to deter too much dog and walker activity and allow the channel to be slightly squeezed in selected areas, thus energizing flow and keeping in-channel gravels relatively silt free.

Photo 7. A potentially valuable spawning site adjacent to heavily trampled banks. Strong tree root systems are giving the banks some protection although some brushwood pegged into the margins will also help protect the banks, deter dogs and provide habitat for bugs and small fish.

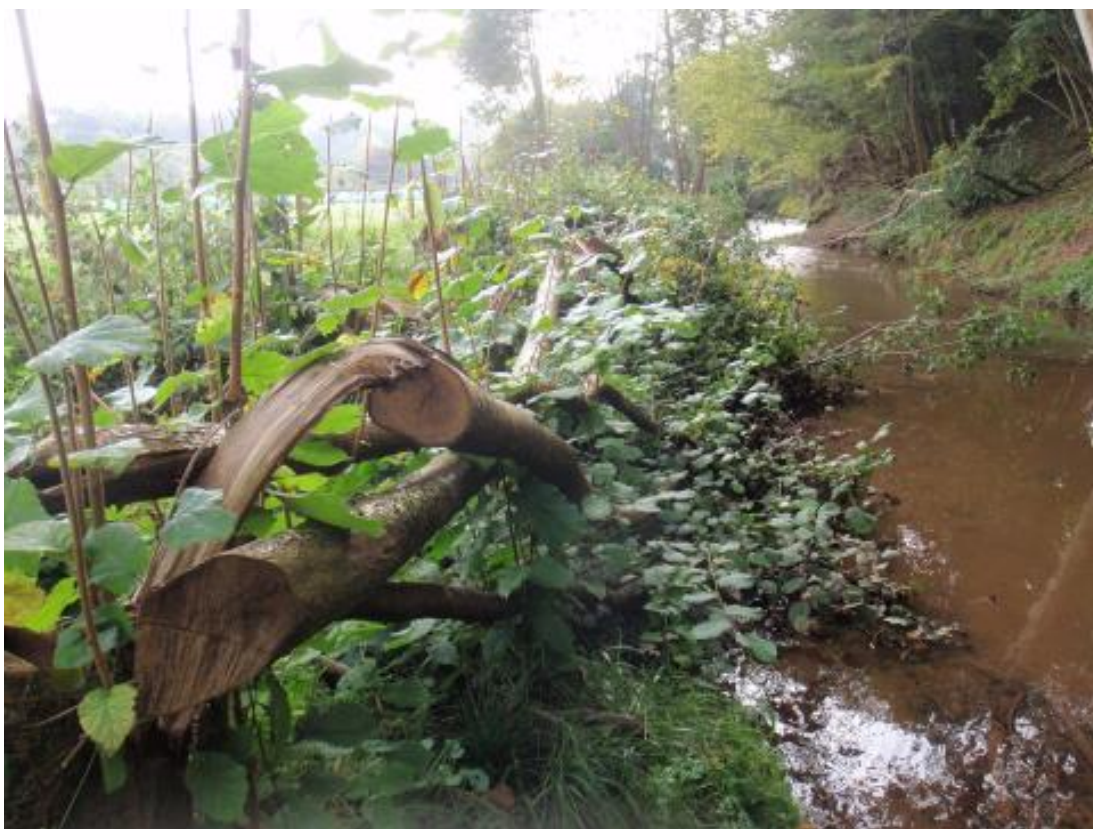
Photo 11. An example of hinging live alder into the river margins.

The odd tree in this reach is suitable for hinging/laying into the margins (photo 11). This might be an option on sites where there is currently heavy footfall and dog dipping to help protect the banks. An alternative is to again install brushwood berms but only where there is sufficient light to promote regeneration of either live willow or marginal emergent plants.
