# WILD TROUT TRUST

## Minstead Stream, West Sussex

A Project Proposal June 2023

By A. Thomas

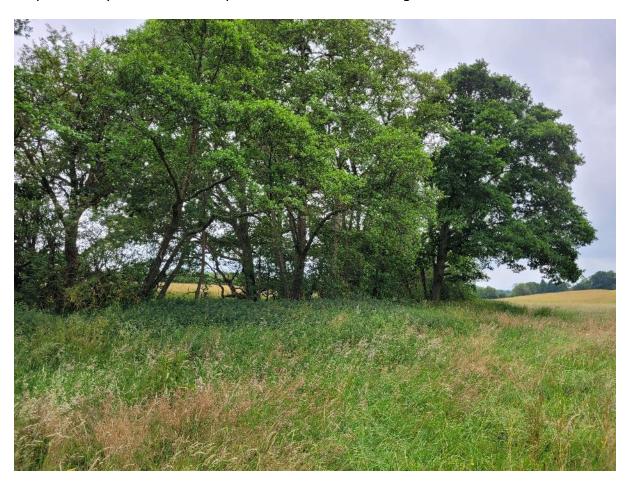
An overview of the map confirms that long sections of this stream have in all probability been heavily modified. The target 500m reach at Brook Farm appears to have been straightened and moved south, with the channel deeply incised, in all probability to facilitate improved local land drainage.

Photo 1. A view looking upstream of the tree-line channel. Note the bank height appears to be significantly higher than the lower sections of the adjacent northern meadow to the right of the photo.

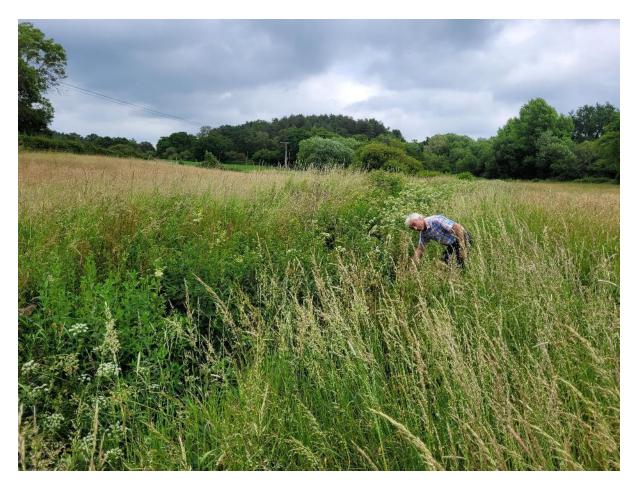
Currently the meadows to the south of the stream are still in arable production, with the low-lying northern meadow now in permanent pasture and annually cut for hay. This long strip of meadow has historically been drained and towards the bottom half of the meadow an additional channel (photo 2) picks up ground and surface water and runs parallel to the Minstead Stream before discharging into a pond at NGR SU84892063.

Photo 2. Additional drainage channel running parallel with the Minstead Stream, eventually feeding into a small wildlife pond near the tree line.

Additional inundation and the creation of new water vole habitat could be achieved via digging two new ditch lines perpendicular to the existing stream, one towards the top end of the reach and a second towards to lower end.

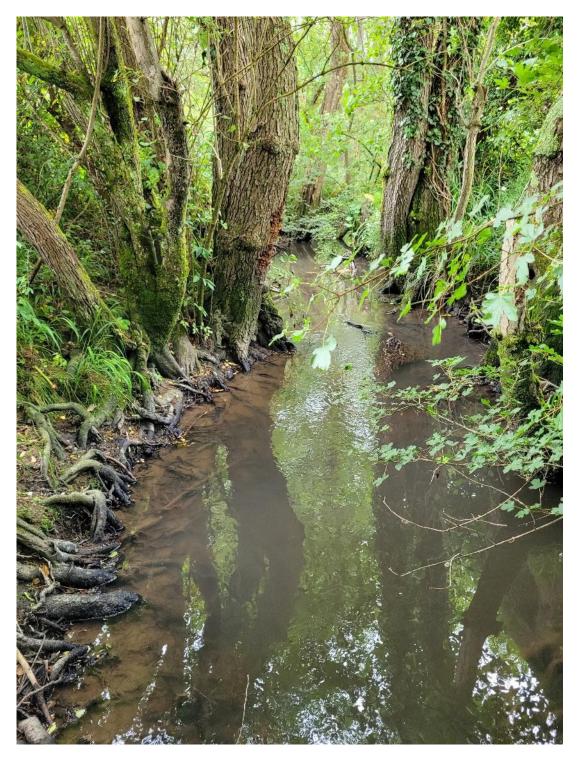
The stream channel is heavily shaded with a valuable mixture of bank-top native deciduous trees and shrubs, however, some of the alder (*Alnu glutinosa*) and Ash (*Fraxinus excelsior*) are showing signs of serious disease. The alder trees provide excellent complex habitat with their roots trailing extensively into the water (photo 3). Ash tree roots retained bank strength as they spread laterally along the banks.

Photo 3. Trees with complex root systems adjacent to a deep pool habitat.

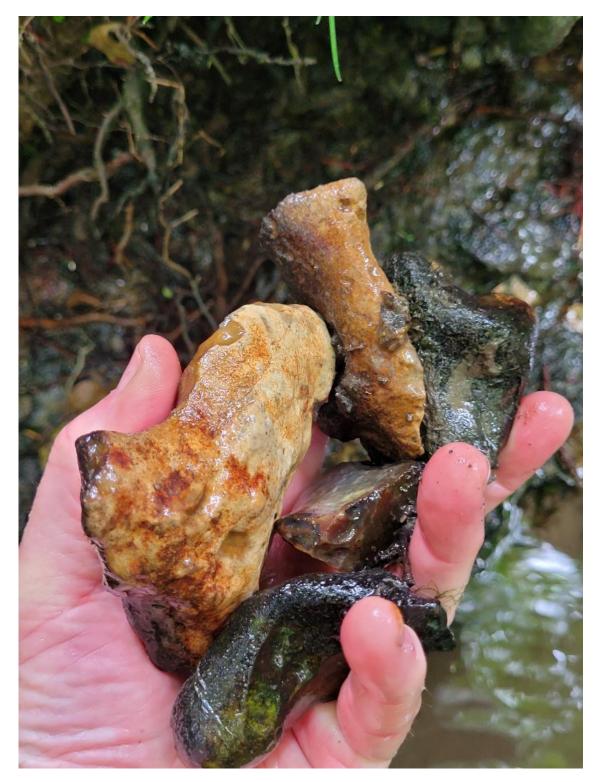
At the time of the visit, the stream had a modest flow, with the majority of the reach flowing over a shallow and mainly bare, sediment laden stream bed. Macrophytes were scarce, mainly due to the heavy shading and incised nature of the channel, however the odd clump of sedge (*Carex sp*) was evident where there were ledges for a toe-hold and sufficient sun light. The occasional deeper pool was seen, often created where adjacent root systems were meeting to create a narrow pinch point in the channel width and a corresponding flume of faster water (cover photo), creating some bed scour downstream. The occasional outcrop of bed gravels (photo 4) were observered and were a mix of ironstone and sandstone chips, with occasional areas of eroded greensand. Some flint gravel was also seen and may have gradually trundelled down the stream from the foot of the downs, rather than being eroded out of the stream bed or bank toe. Some of the gravels were glued together with calcium carbonate deposit (tufa). Even with the tufa deposits, the presence of these small gravel riffles is significant and is likely to be a critically important habitat utilised by the trout population for spawning.

Photo 4. Mixed gravels from the stream bed. Note calcium carrbonate deposite, reflecting the calcium rich source water eminating from the chalk springs at the head of the system.
