**Walkover Assessment**

**River Wear – Frosterley Angling Club**

**July 2014**

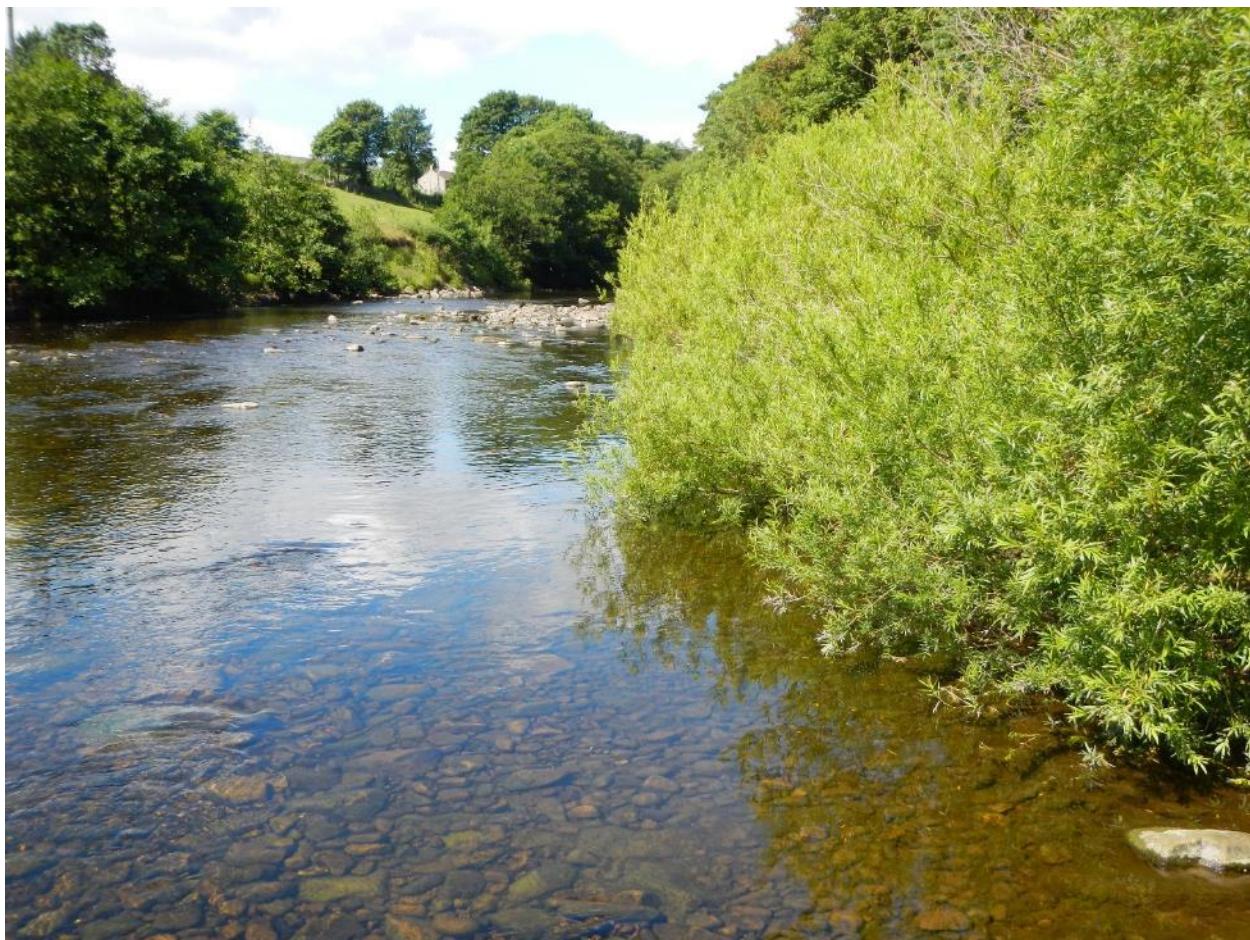
The first area visited is a relatively wide, open reach of river with an abundance of juvenile salmonid habitat provided by shallow glides and riffles (Fig. 1). The coarse gravel and cobble substrate also provides potential spawning habitat for larger sea trout and salmon. Overhanging trees on the RB provide valuable low-level cover, and overhanging and trailing willows (*Salix* spp.) on the left bank (LB; defined when looking downstream) provide cover and shelter for fry from high flows and predators.

**Figure 1. Aerial cover on the RB (left of shot) and trailing willow in the RB margin (right of shot)**

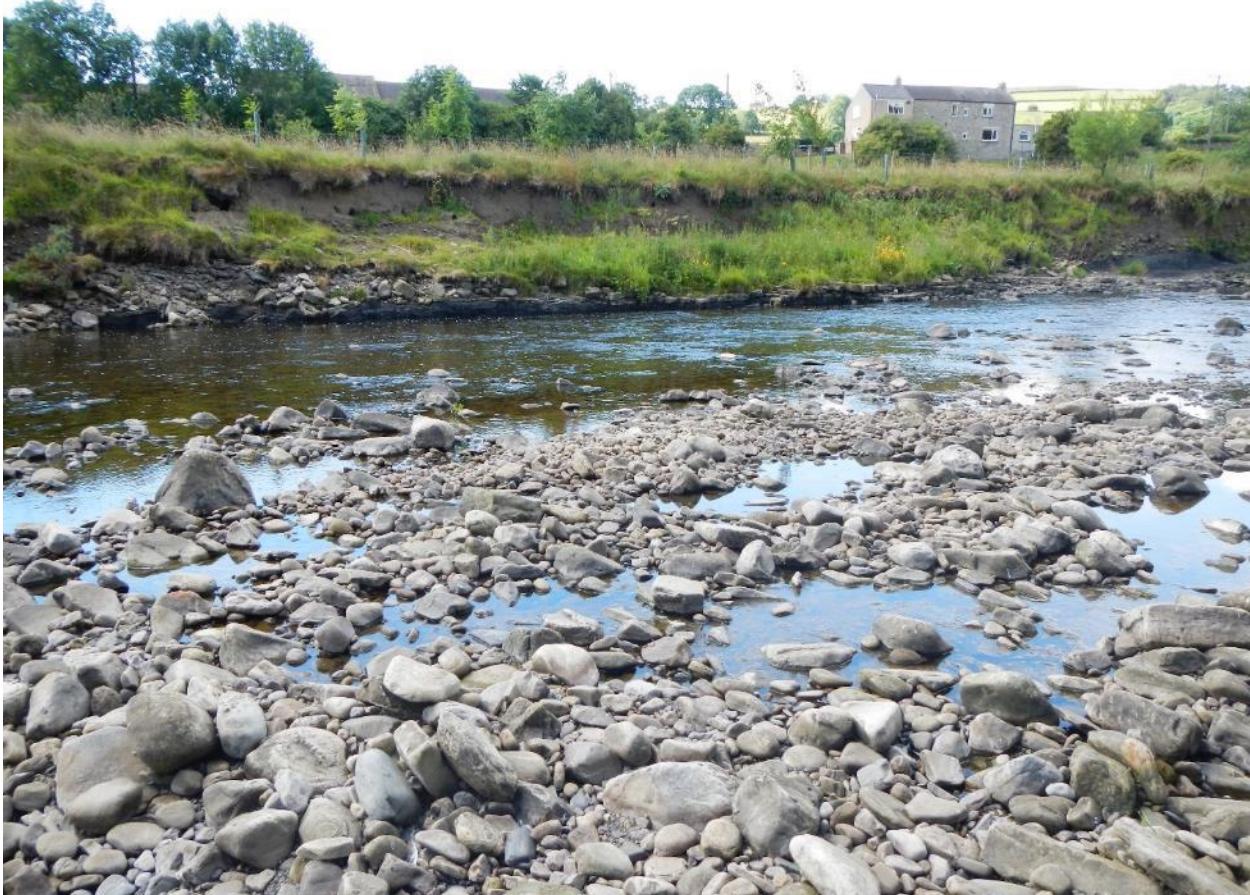
Active hydrogeomorphology and substrate supply in this wide section of river has led to the formation of large gravel and cobble bars (Fig. 2 & 3). This process occurs as the channel naturally adapts its capacity to the flows it receives, depositing material in the lower velocity. The narrowing effect created by deposited materials then helps to maintain deeper channels and pools that will form the low flow, summer channel (Fig. 2).

In the absence of trees and herbaceous vegetation, the right bank (RB) face is suffering from excessive erosion (Fig 2 & 3). The high proportion of grass along the bank suggests a history of grazing, which reduces plant species diversity and the extent of root structure it contains, increasing bank erosion. A seam of bedrock along the bank toe (Fig. 2) has assisted in stabilising the bank by holding some slumped bank material in place long enough to re-vegetate. The lack of trees and shrubs along the bank face mean that it remains at risk from erosion. The area in Figure 3 is also unstable and, without attempts to stabilise it, the bank is likely to continue to erode; widening the channel and potentially leading to shallowing. This is an important consideration as pool formation is often reliant upon stable banks forcing scouring flows into the bed to create depth, rather than laterally into the bank and increasing channel width.

**Figure 2. Low flow channel (background) created by gravel and cobble deposition (foreground). The**

**area of bare bank face (background) also shows how material has slumped and is now sitting on a bedrock shelf, where it has begun to re-vegetate**

- Planting would be particularly beneficial in areas with bank stability issues:
  - RB upstream of Bridge End (Fig. 2 & 3: NGR - NZ 02185 36826), throughout the unstable areas
  - RB upstream of old pumping station (Fig. 4: NGR - NZ 0331936744) along the unstable bank face
  - LB downstream of existing willows in sandy deposition (Fig. 11: NGR - NZ 0378836890)
  - RB, around the Kingfisher caravan park (Fig. 13: NGR - NZ 04452 36856) – this treatment would be even more beneficial if undertaken in conjunction with some coppicing to let light in

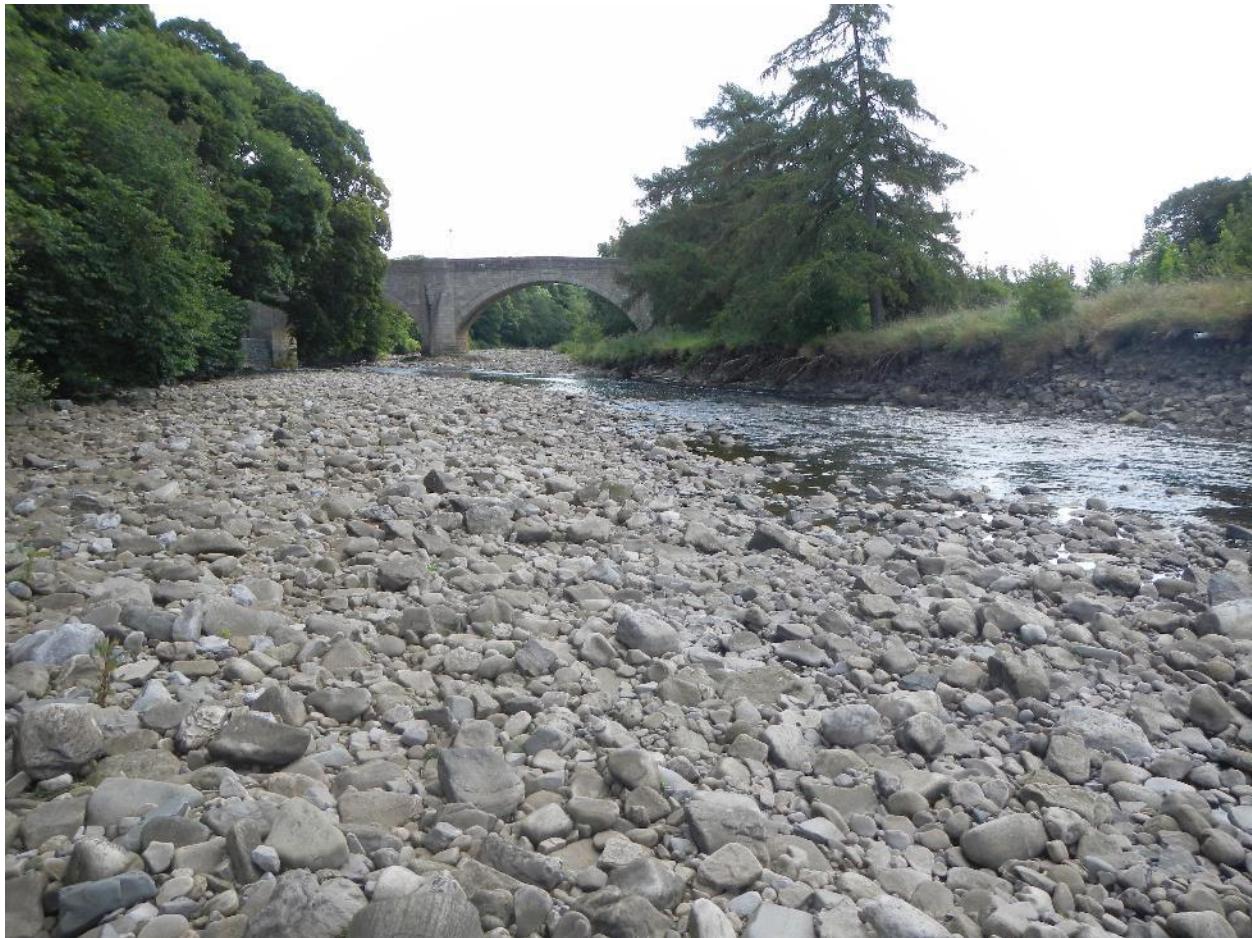
**Figure 3. Large gravel deposition (foreground) and unstable, eroding RB (background)**

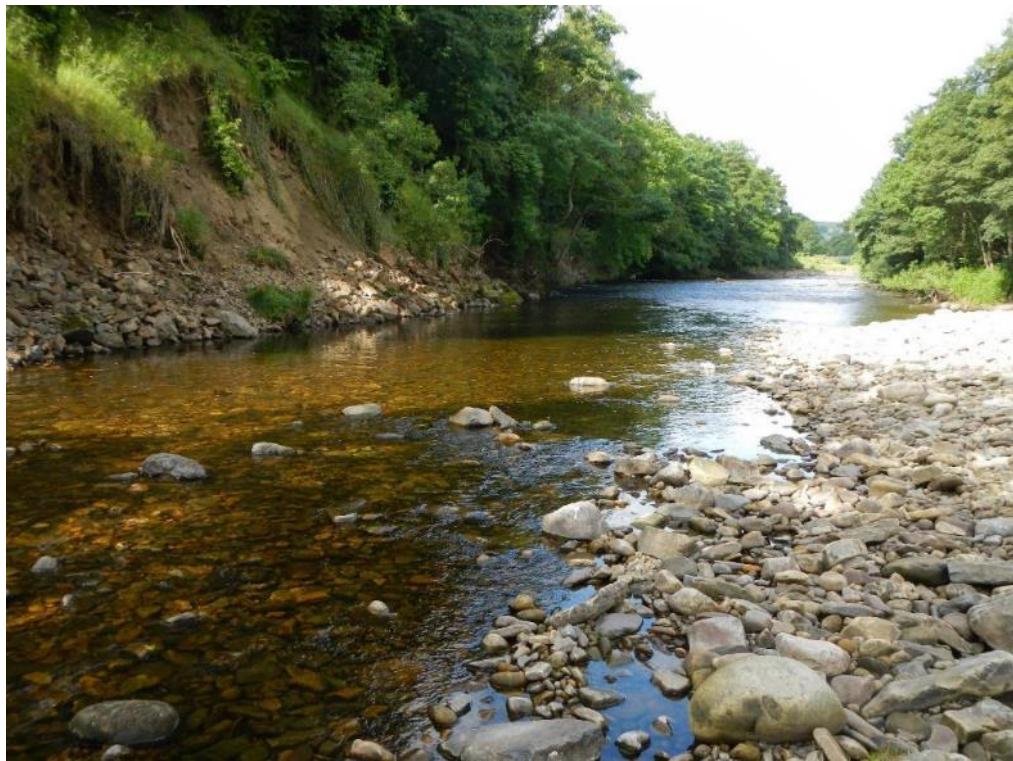
The large eroding area of the RB upstream of the old pumping station (Fig. 4) may be attributable to removal of a weir at this location. This will have lowered the bed and water level as material stored upstream is liberated on subsequent high flows, destabilising the un-vegetated bank. Leverage created by the weight of mature trees (now washed out) above the destabilised bank will have eventually caused them to slump into the channel. A current lack of tree root protection within in the bank is allowing further erosion and slumping of materials, and contributing to shallowing of the pool. Erosion immediately downstream is also likely attributable to the weir, as a legacy of the limited sediment supply from upstream while the weir was in situ. Bankside trees are still present here (Fig. 5) but significantly undercut and susceptible

**Figure 4. Destabilised bank and erosion upstream of the old pumping station**

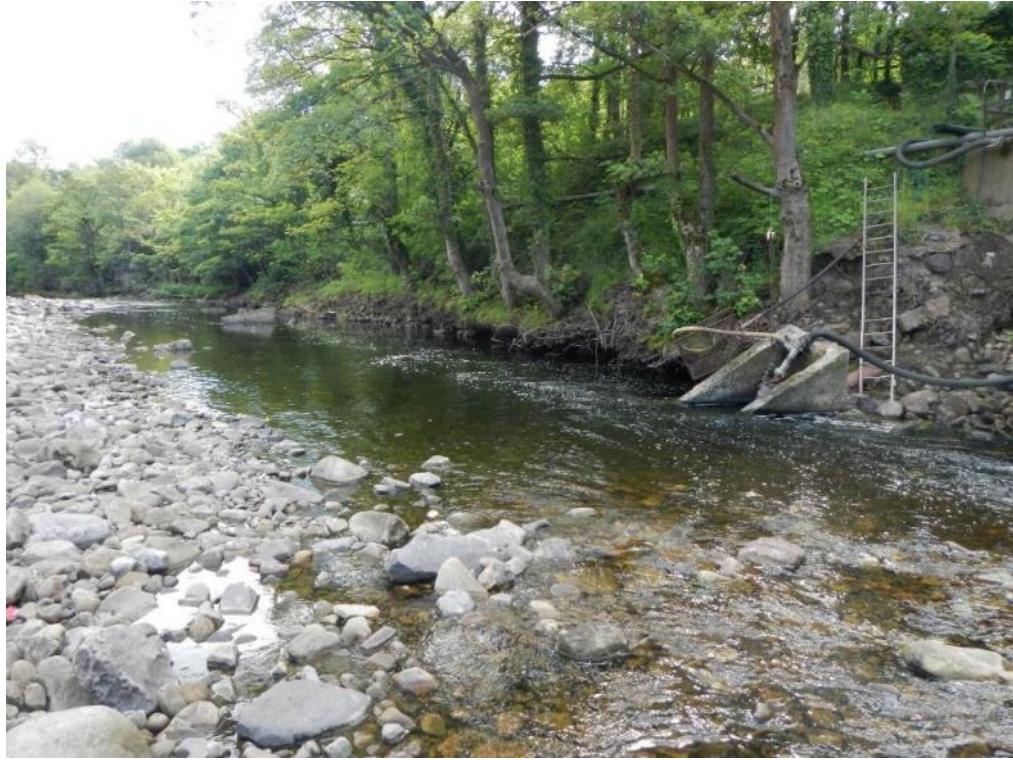
to slumping which will further destabilise the bank. Back-eddying created by the remnant concrete wing-walls will also be increasing erosion.

**Figure 5. Undercut bank, probably a result of reduced sediment supply while the weir was in situ and back eddying d/s of the concrete wing-wall**

- This treatment would be beneficial on the perched sycamores around the old pumping station (Fig. 5: NGR - NZ 03346 36749) to relieve pressure from the undercut bank and reduce the chance of the bank collapsing.

- Once the weight has been taken out of the perched sycamores near the old pumping station by coppicing (Fig. 5: NGR - NZ 03346 36749), it may also be worth installing some brash bank protection into the undercut

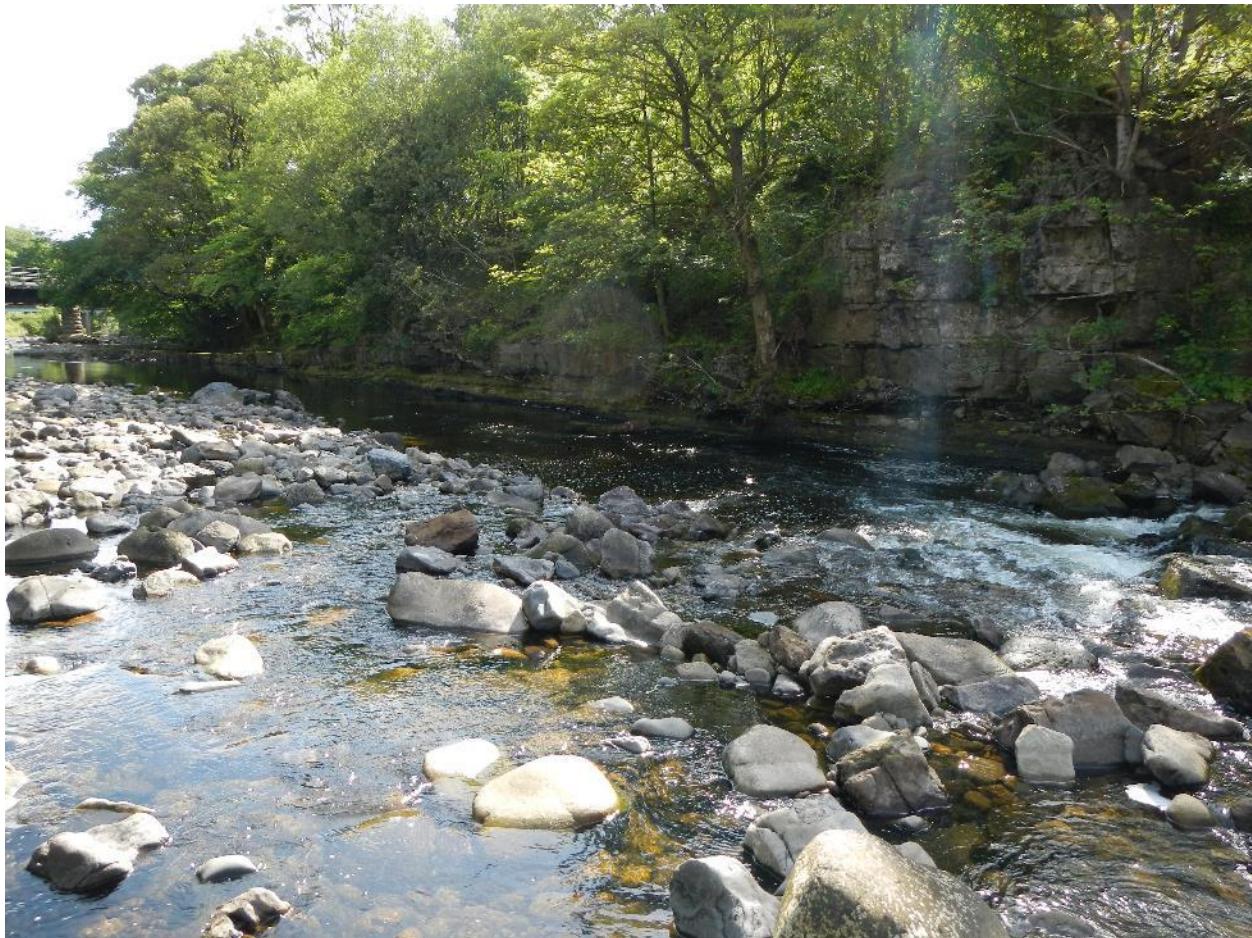
Downstream, bedrock protects the bankline and has forced bed scour to create and maintain a deep pool along the toe of the bank (Fig. 6). In contrast to the juvenile habitat provided by the many shallower riffle and glides, these natural deeper areas provide a vital holding habitat for adult fish, both resident and migratory. There is a lack of aerial cover in this area so pruning of any overhanging branches should be avoided to retain cover.

**Figure 6. Deeper pool area along a bedrock cliff (background) with shallow juvenile habitat (foreground)**

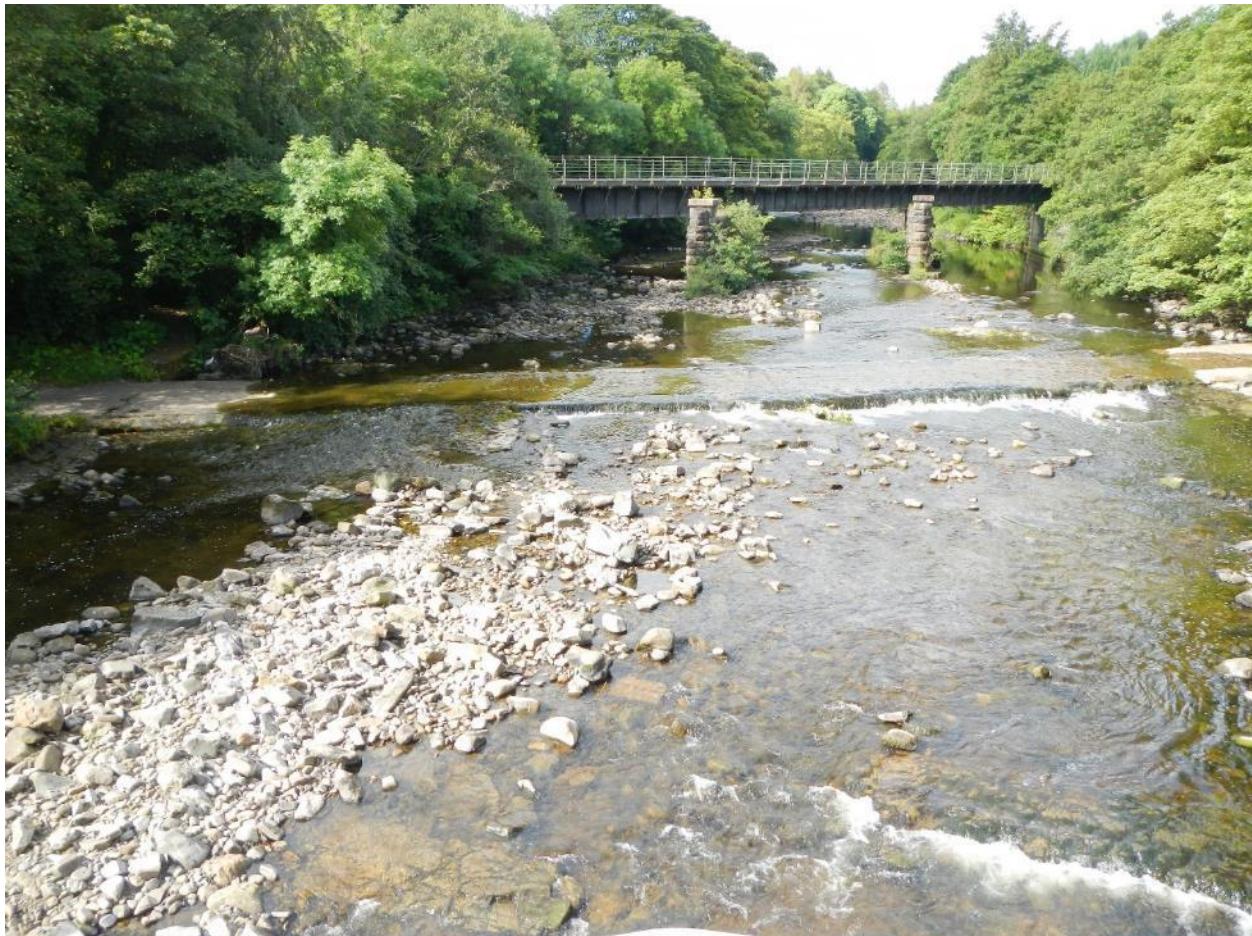
Where a concrete ford crosses the river downstream it poses an obstacle to the free transport of bed materials, and for fish passage. While the structure is small, the vertical step from shallow water, and shallowing effect of spreading river flows across the full width of the ford, make it an obstacle that will inhibit fish movements, especially in low water conditions. Any delay to fish movements is likely to increase stress levels and place them at increased risk of predation. The fixed bed level across the full channel width is also likely to be limiting bed scour upstream and leading to sediment from upstream in-filling and shallowing the pool.

**Figure 7. Concrete ford that poses an issue to fish movement and sediment transport**

- It is recommended that the concrete ford (Fig. 7: NGR - NZ 03536 36876) between the two bridges, downstream of the pumping station is removed. It is currently acting as sediment trap and raising the bed level in the pool upstream. The structure is also an obstruction to fish migration (particularly juveniles), hampering progress of fish, placing them at greater susceptibility to predators and preventing optimal habitat utilisation.

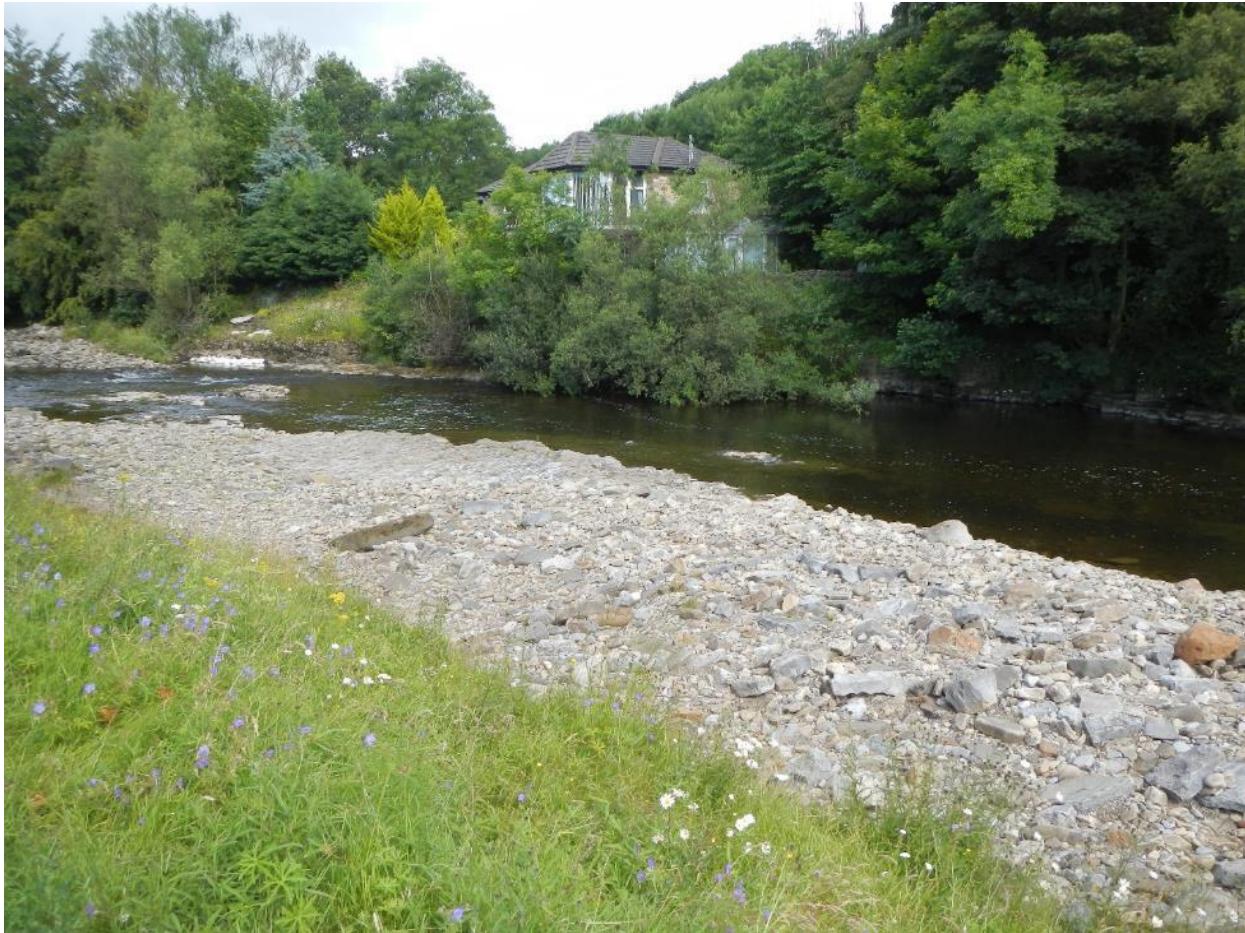
Downstream of the ford another bedrock pool provides excellent deep-water adult trout habitat, and is further enhanced by the presence of a trailing willow shrub on the LB (Fig. 8). This not only adds to flow disturbance in the pool (promoting greater physical diversity and associated benefits to flora and fauna) but also provides valuable shade, cover and structure in which fish can shelter and evade predators. The shrub is also a valuable source of terrestrial invertebrates and a great refuge for emerging aquatic insect species.

**Figure 8. Excellent pool habitat, enhanced by overhanging/trailing willow**

- Buffer fencing would be highly beneficial in reducing the rate of erosion along the cattle-grazed field upstream of the Kingfisher Caravan Park (Figs. 8, 9 and 10: NGR - NZ 0378836890).

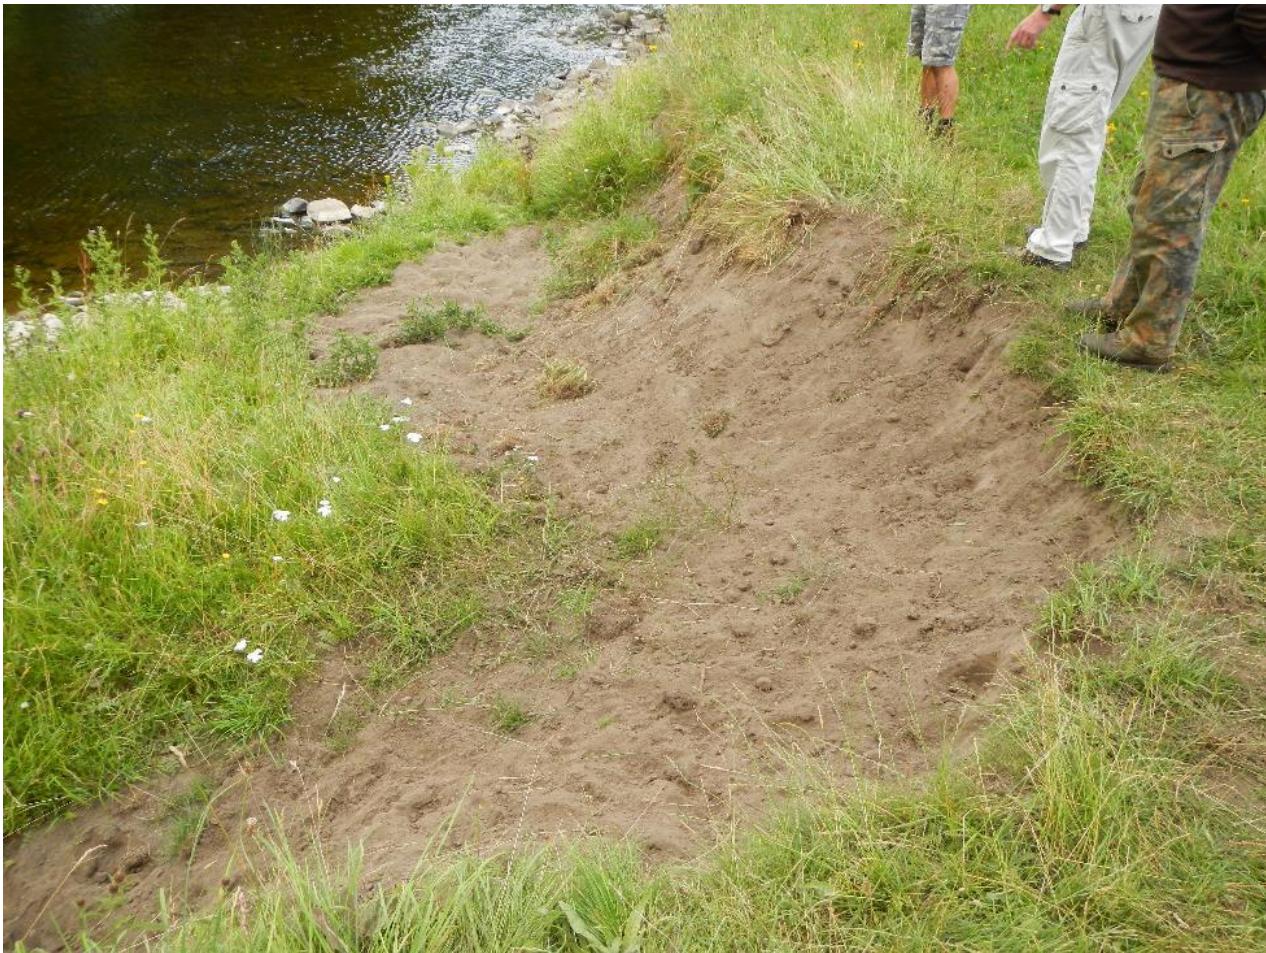
On the LB, livestock access is leading to increased bank erosion. While stock density appears to be extremely low, the physical damage of the cattle climbing in and out of the channel is denuding the bank of vegetation and causing areas to slump (Fig. 9). This leaves open, bare sections of bank that are placed at greatly increased risk of erosion in high flows, especially on the sandy, friable soils present.

**Figure 9. Even low density grazing can be a cause of increased bank erosion**

- Laying would be particularly beneficial on the LB, laying one or several of the large leaning willow trees (Fig. 9: NGR - NZ 0378836890). They could be laid along the riverside of the smaller willow shrubs to increase the low cover extending out into the channel and provide valuable flow disruption.
- Similar treatment would be beneficial on the larger willows on the LB in Figure 13 (NZ 0378836890) (back right of shot).

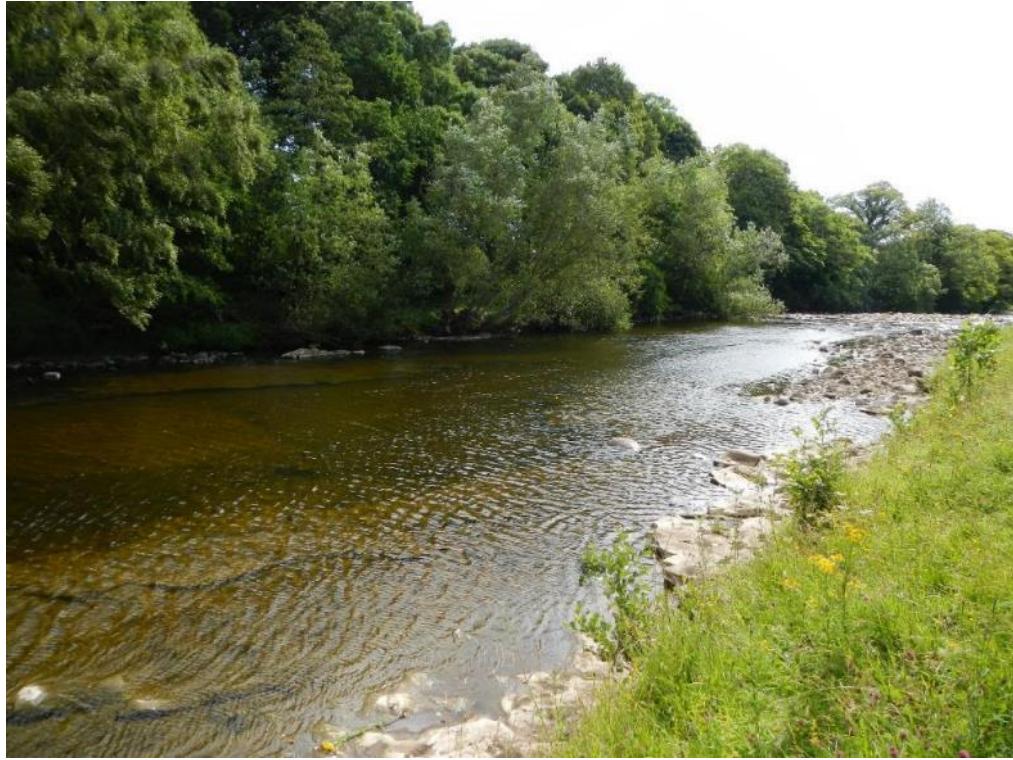
On the LB downstream, bankside willows provide a potential source of woody debris to the channel. The larger species, such as crack willow (*Salix fragilis*) are likely to collapse into the channel under their own weight over time Fig. 10; they will then provide valuable flow disruption, cover and shelter within the channel. Smaller shrub species also enhance the river margins through increased low cover and structure, and having a denser structure, they slow marginal flow velocities, creating refuge areas and increasing marginal sediment deposition (Fig. 11). This not only helps to store materials but also allows the river to adapt its width to the flows it receives and facilitates channel narrowing where required. This in turn maintains a channel width that creates scouring of the bed to maintain pool depth.

**Figure 10. Tail of a pool where LB willows provide a source of woody debris and cover**

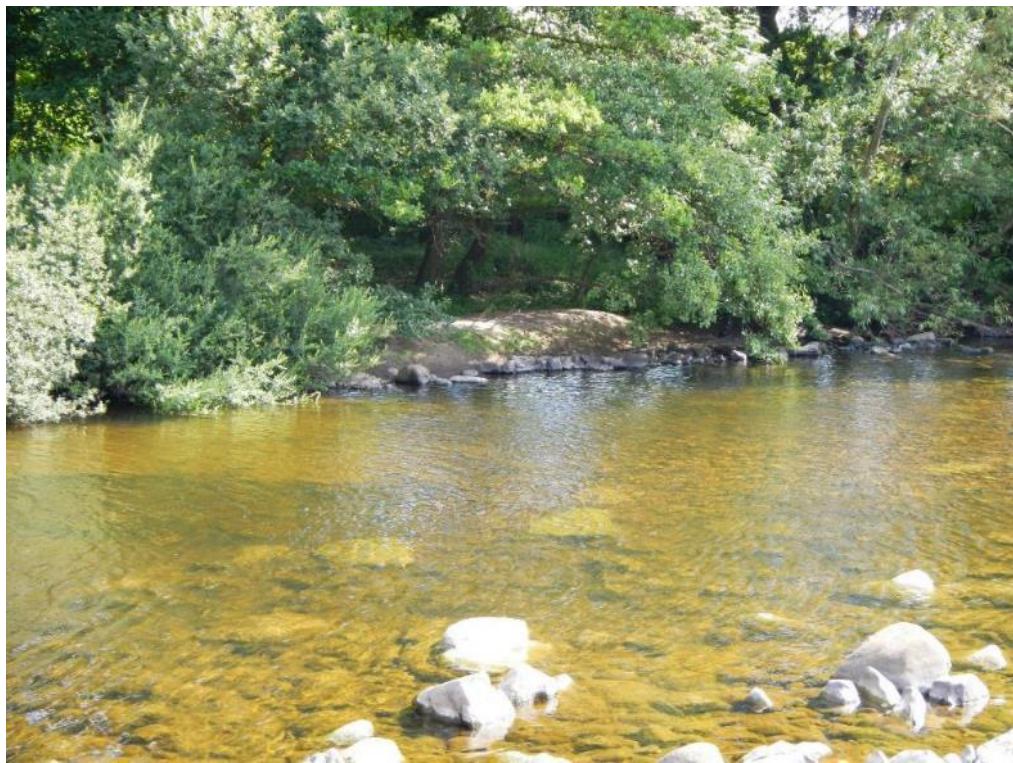
**Figure 11. Dense marginal vegetation provided by the willows provide valuable cover, shelter, flow disruption, and facilitate sediment deposition, helping to maintain channel widths**

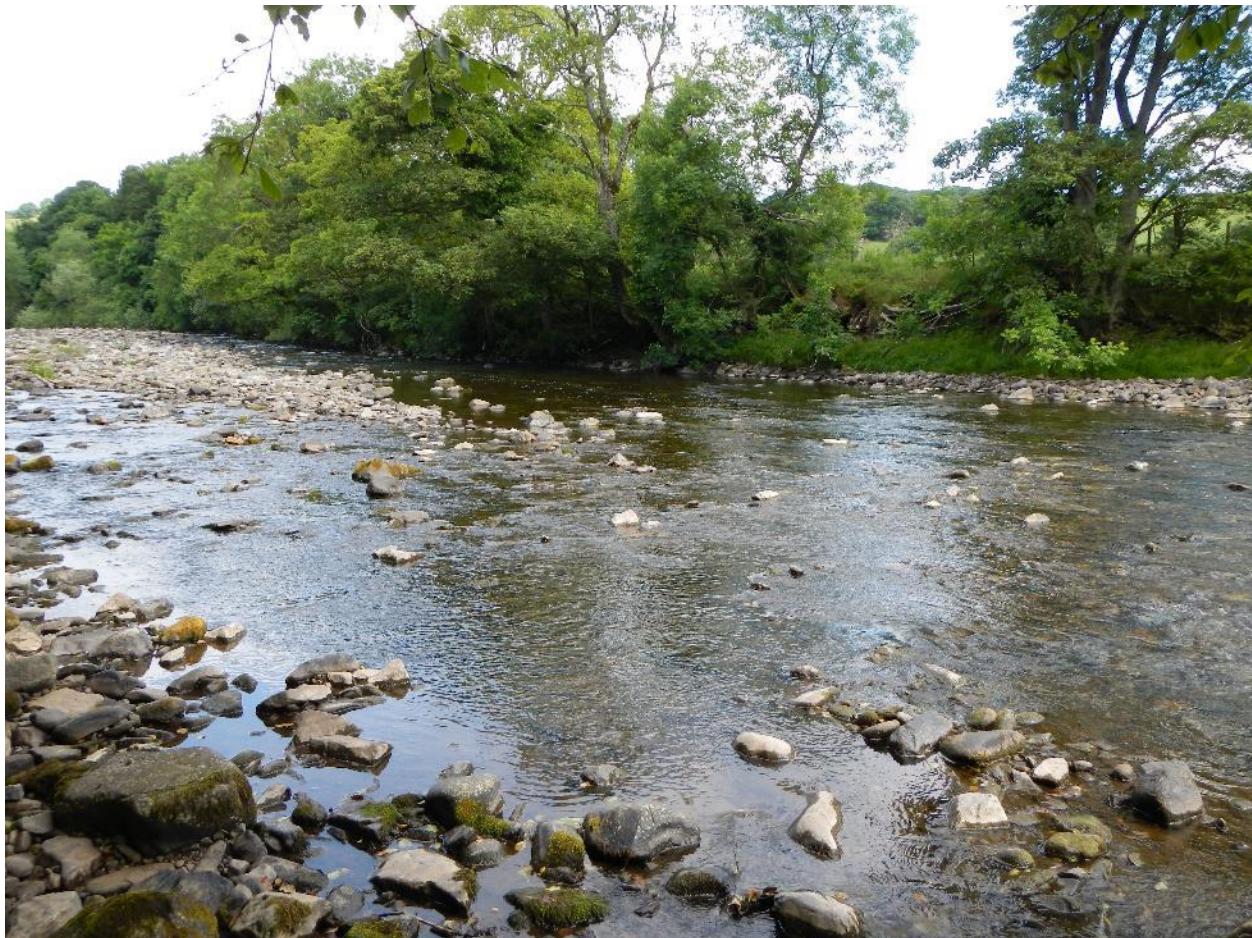
Juvenile habitat is abundant throughout Frosterley AC waters, providing good on-growing areas for all salmonid fry and parr (Fig. 12). While these areas are unlikely to hold many adult trout, particularly in low flows, they are vital to the health of fish stocks through juvenile production. Trailing and low-level cover was in relatively short supply in many such areas, predominantly due to the wide cobbly nature of the channel and margins, but would be a valuable addition if marginal trees could be encouraged over the channel.

**Figure 12. Good juvenile habitat where a greater level low-level and trailing cover would be beneficial**

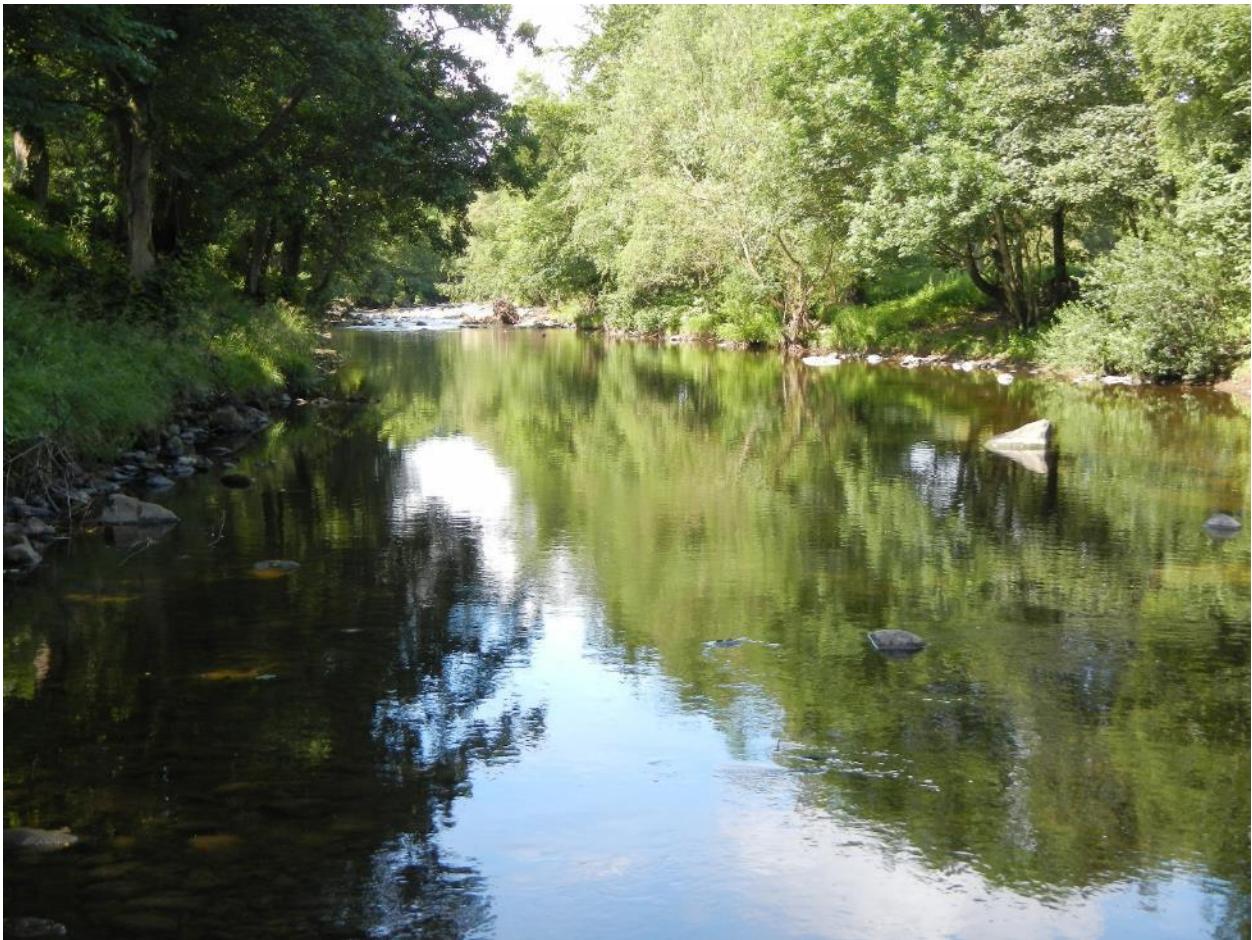
Moving downstream, the lack of low-level and trailing cover along the bank continues, probably a consequence of past tree maintenance (Fig. 13). Some willow shrubs are colonising the LB (right of shot), which, in time, should enhance the shallower margin area for fry; however, the deeper water along the RB (right of shot) is significantly lacking in any low cover which greatly decreases its carrying capacity, especially for larger fish.

**Figure 13. A notable lack of low-level and trailing cover along the RB (left of shot)**

- Coppicing should also be undertaken along any areas where the tree canopy has been lifted by past pruning and maintenance, but would be particularly beneficial along the Kingfisher Caravan Park section (Fig. 13: NGR - NZ 0378836890).

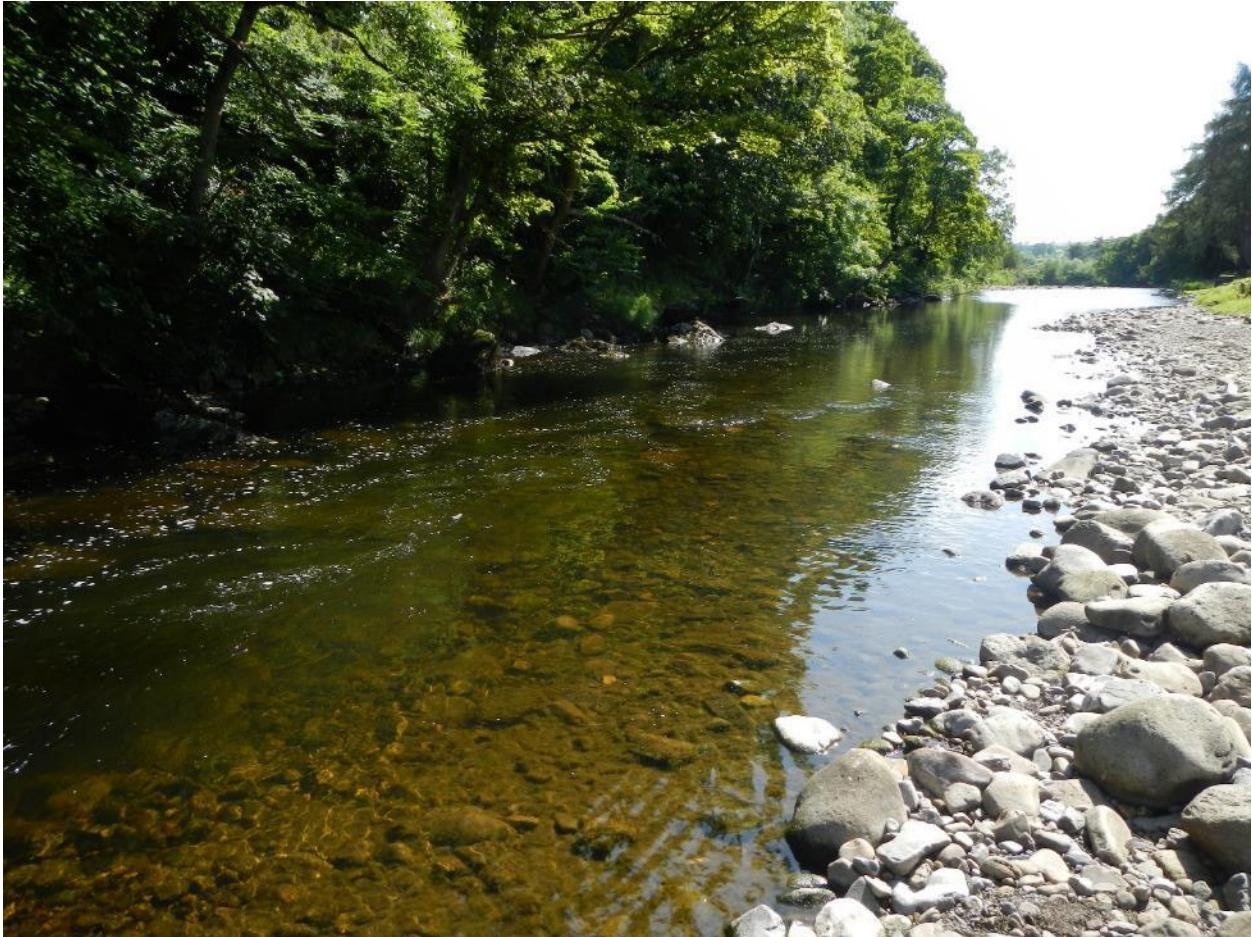
At the very downstream end of the section walked a long, deep pool provides more good adult holding habitat, but again, has a lack of low-level and trailing cover (Fig. 14). It is likely that some low branches will be broken from the tree trunks during high flows, particularly from brittle sycamores (*Acer pseudoplatanus*), but the pronounced lack of such branches suggests a history of pruning and maintenance.

**Figure 14. Good quality adult holding habitat, again lacking in low cover**

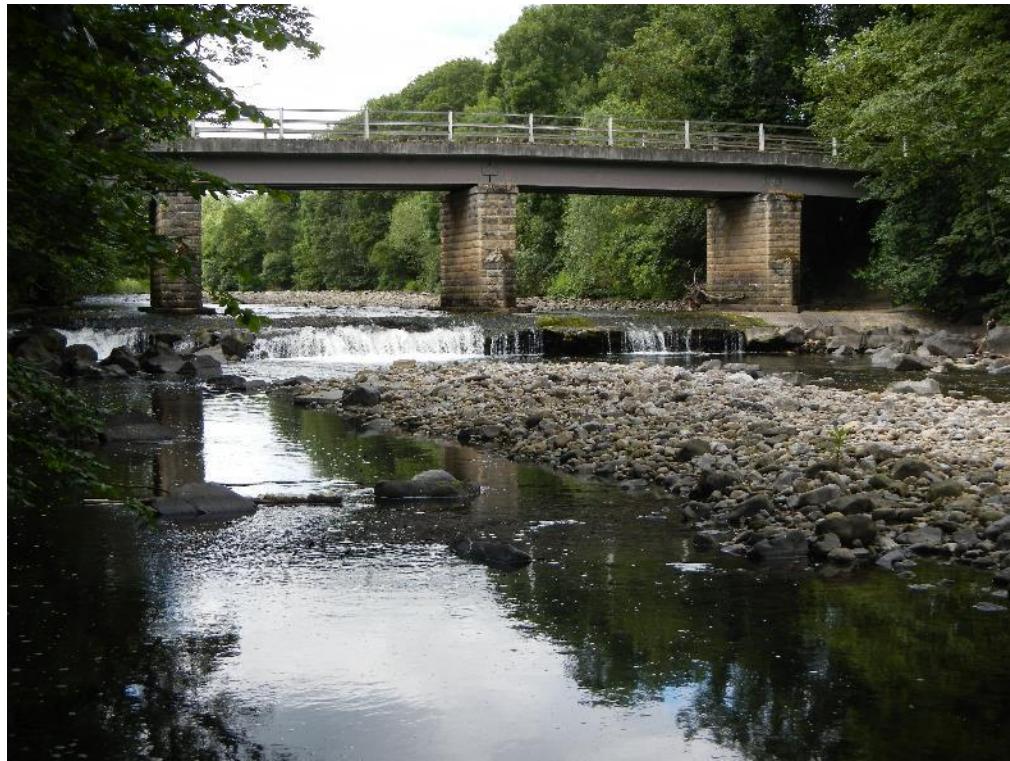
A short distance downstream of Frosterley AC waters is a significant barrier to fish migration caused by Harelaw Bridge footings (Figs. 17 & 18: NGR - NZ 05519 36868). This structure was probably once much less of an issue as bed check weirs downstream are likely to have maintained the bed level downstream. However, the weirs have now washed away, allowing bed material d/s of the bridge to wash out, leaving a perched apron that is a significant barrier to fish passage. Attempts have been made to improve fish passage with a rock-ramp type fish easement but subsequent high flows have washed out most of the structure and the bridge again poses a challenge to movement of both adult and juvenile fish.

**Figure 17. Looking upstream at the obstacle posed by Harelaw Bridge footings**

It is recommended that Frosterley AC pursue the issue of fish passage with local Environment Agency fisheries staff and Wear Rivers Trust to ascertain if a more permanent solution can be found. Pressure and support from a local AC on this issue is likely to encourage more action to be taken.

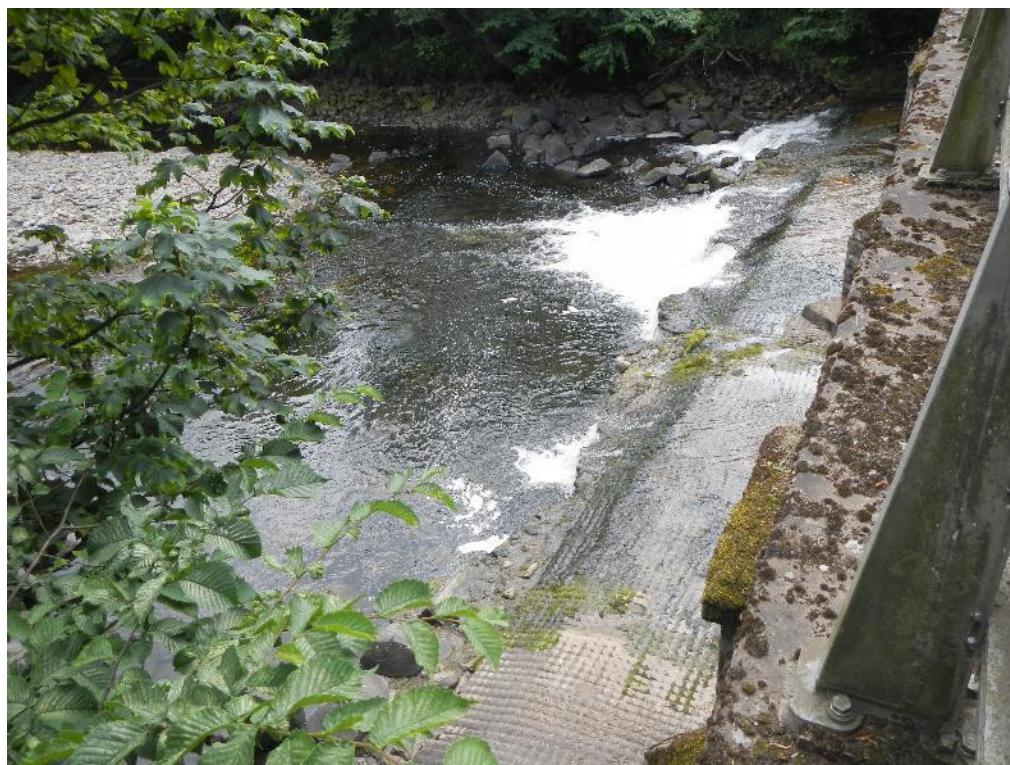
**Figure 18. Harelaw Bridge footings, with rock-ramp remains in the background**
