Walkover Habitat Survey
Welton Beck, Lincolnshire
November 2016

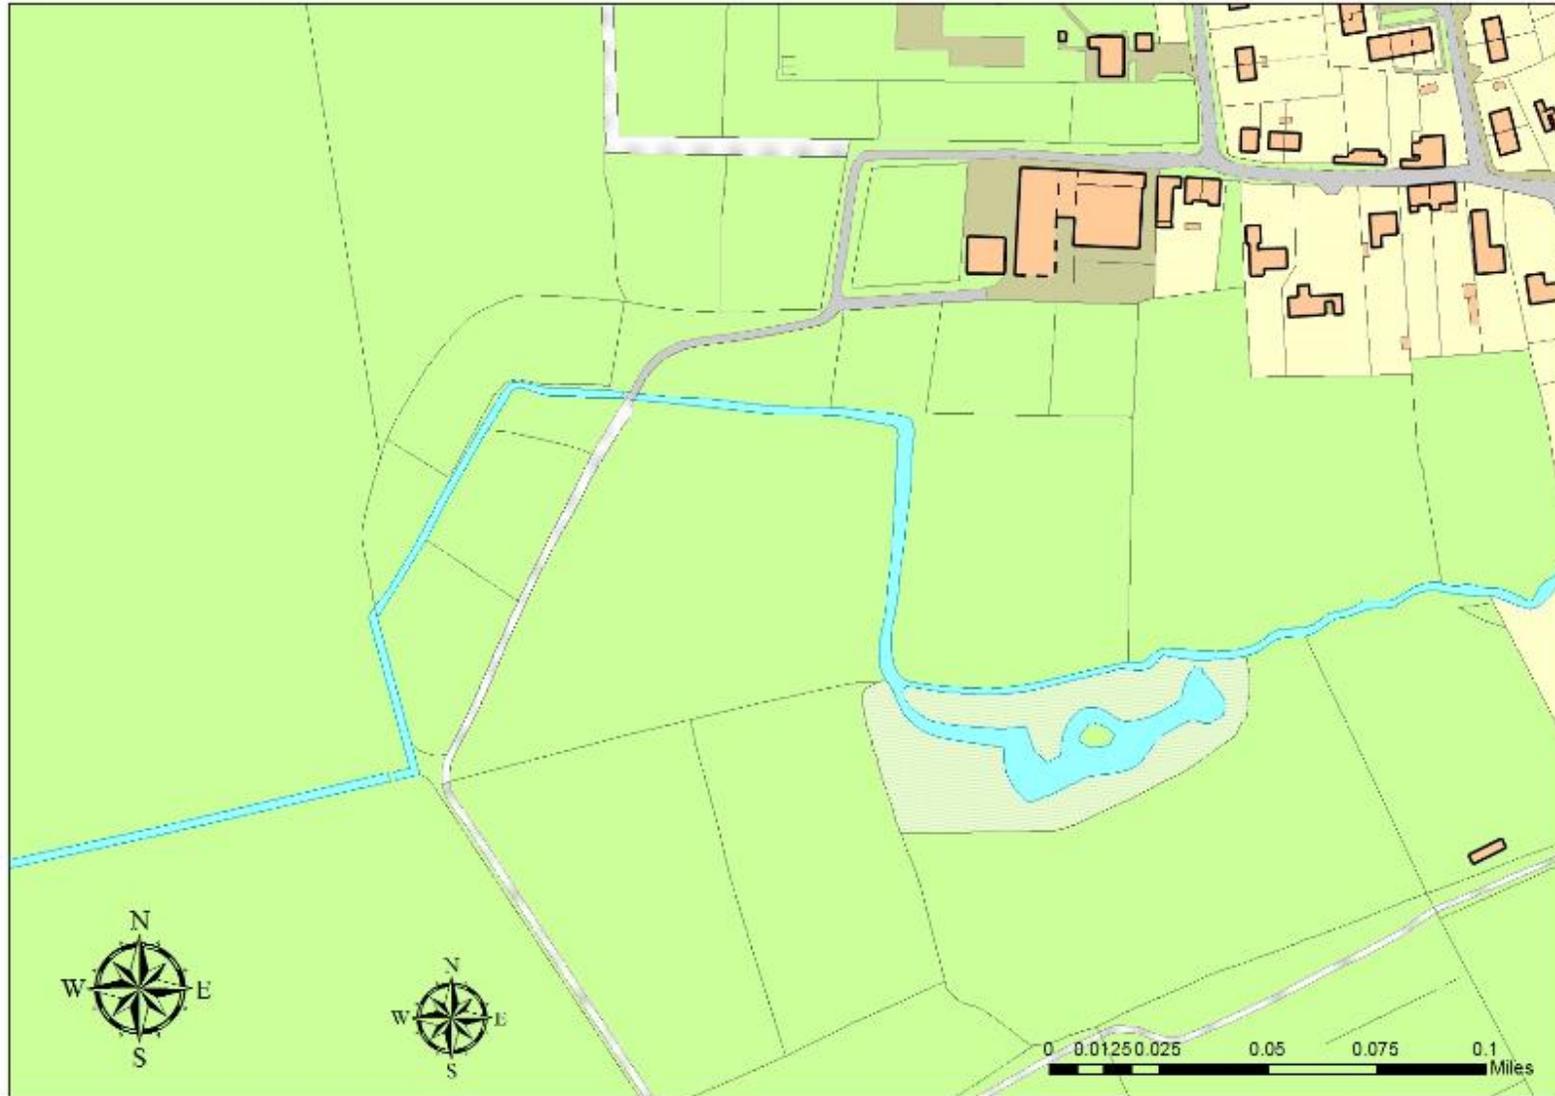
Figure 1 Plan of beck upstream of Welton village, near Norbeck Farm. The pond here appears on the 1966 Ordnance Survey 1:2500 map, but is absent from the 1956 1:10560 map indicating its approximate construction date. It is sited over two springs marked on the latter map.

Figures 1 and 2 show a section of the Beck upstream of the village near Norbeck Farm. The river has evidently been straightened and possibly re-routed at some point in the past, although this was prior to the 1886 Ordnance Survey 1:2500 map. Map dates also show the pond was constructed in the late 1950s / early 1960s. The LiDAR map (Figure 2) shows some lower-lying areas that may indicate a former meandering course of the beck. Subject to scoping work and landowner agreement, there is potential to carry out a river re-naturalisation project in this vicinity; this could involve re-meandering the river course and re-connecting the floodplain, which would provide benefits both wildlife and potential flood protection benefits to the village (slowing the conveyance of water into the village and providing upstream floodwater storage).

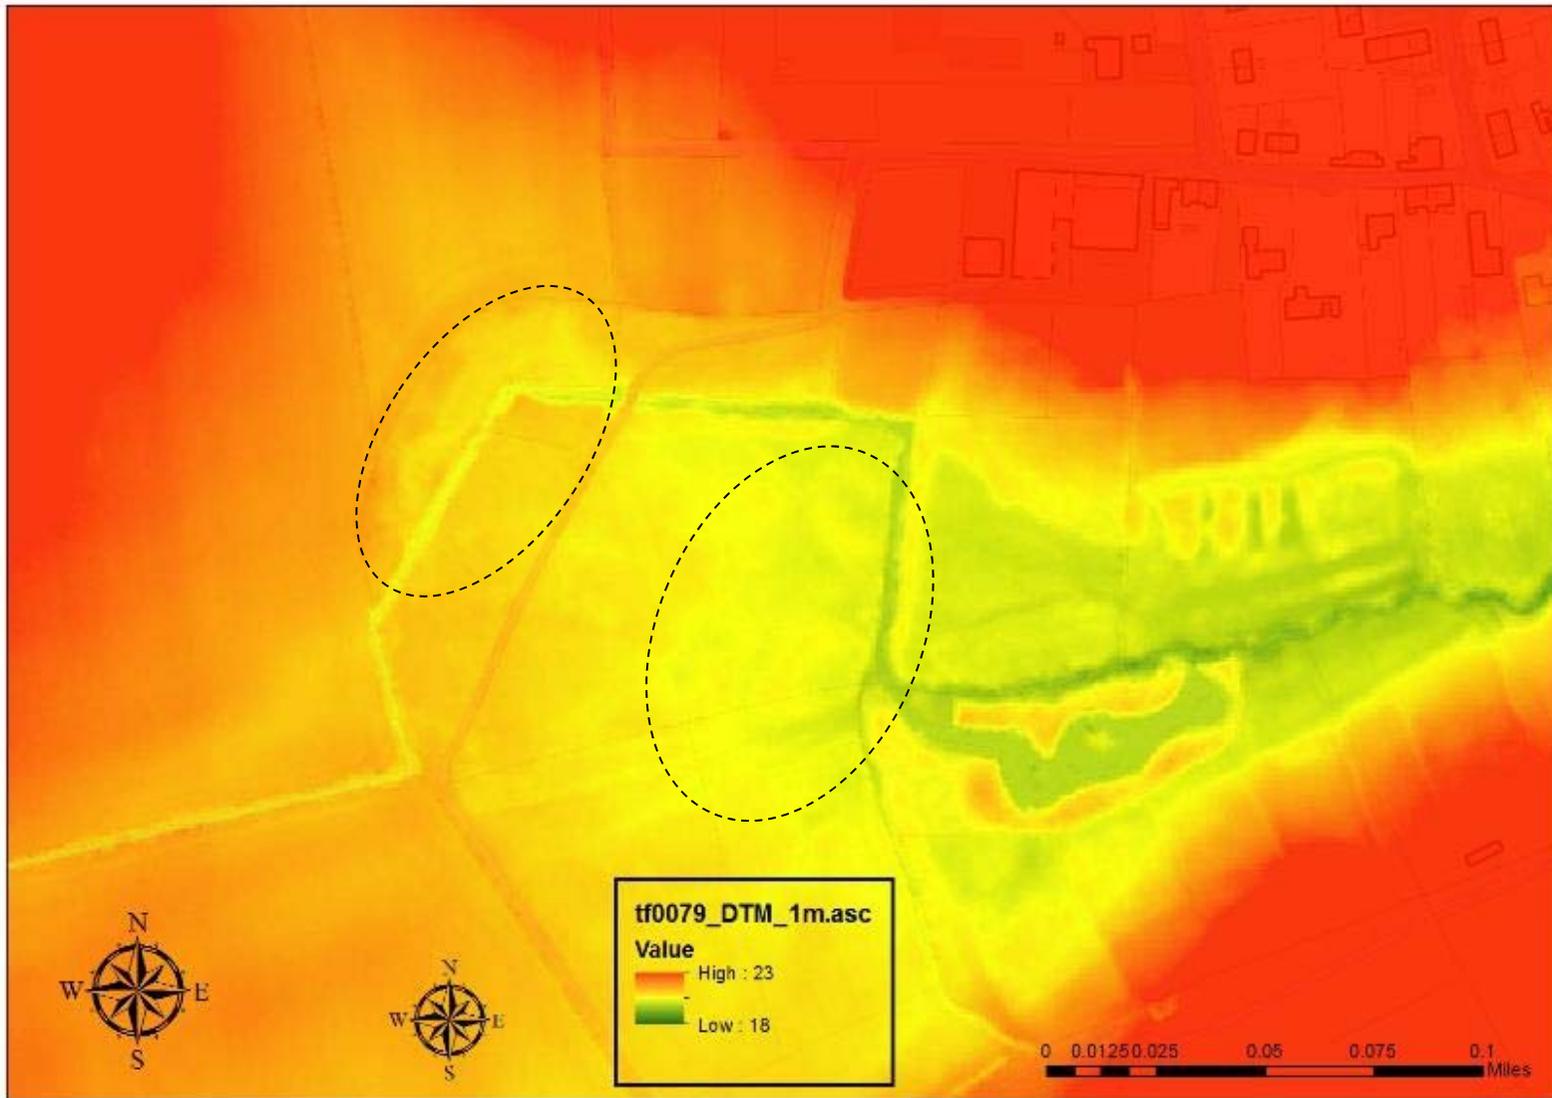
Figure 2 LiDAR map of same area as Figure 1 showing relative land levels. The spoil banks from the pond excavation can be clearly seen around its edges. There is some evidence of a former meandering beck course (within dashed ellipses), pre-dating the obviously straightened and re-routed existing course.

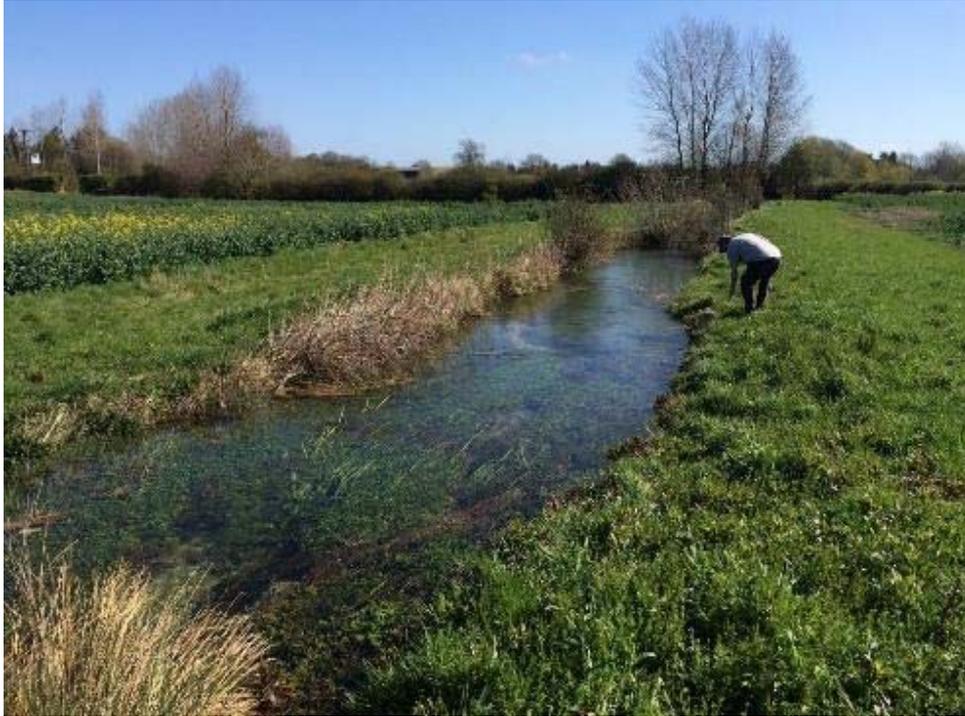
The very upstream part of this section was not inspected during this visit, but was visited by Environment Agency staff in summer 2016 (Photo 1). Downstream from the spring head the channel runs through a pond, then appears to have been recently cleared of vegetation. The channel is straightened and has a uniform depth and width, but is not deeply incised.

Photo 1 Upstream of Welton village, summer 2016 (Picture: David Hutchinson)

There are opportunities here to create variation in the instream habitat using the “dig and dump” technique, berm creation and bank re-profiling.

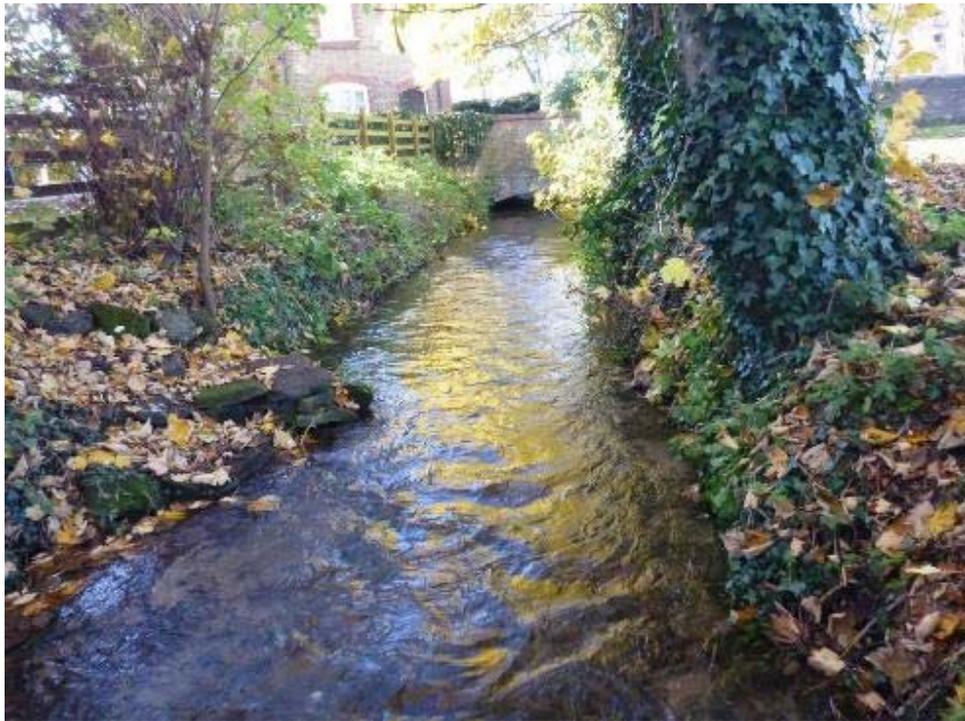
Photo 2 View upstream from Lincoln Road bridge (TF 01124 79624) towards Vicarage Lane bridge. Note the low bridge.

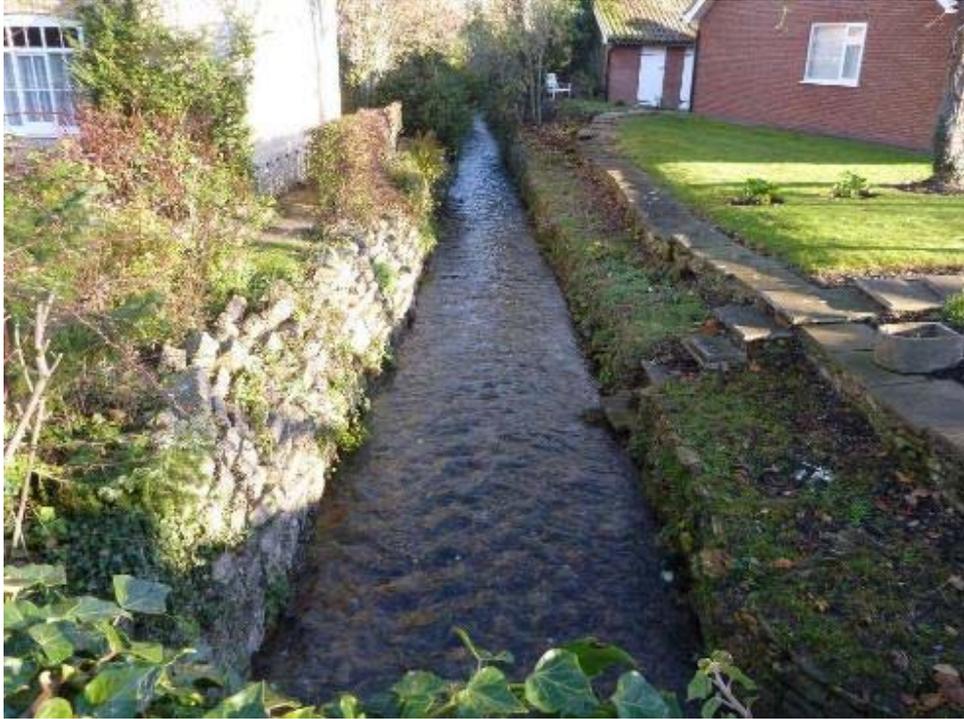
Photo 3 View downstream from Lincoln Road bridge. A very straight, relatively steep river channel.

From Vicarage Lane downstream past the church to the recreation ground, the beck is straight, relatively steep and bordered by private residences (Photo 3). The instream habitat here is poor, being uniformly shallow and lacking deeper pools. The habitat could be greatly improved here by constructing pools using various types of low weirs from timber or stone. It is important to note, these are specialised structures set at a low level to create bed scour downstream of the structure, not impound water upstream. Their use is

limited to straight, heavily-modified stream channels like this and they are not recommended for meandering or low-gradient channels.

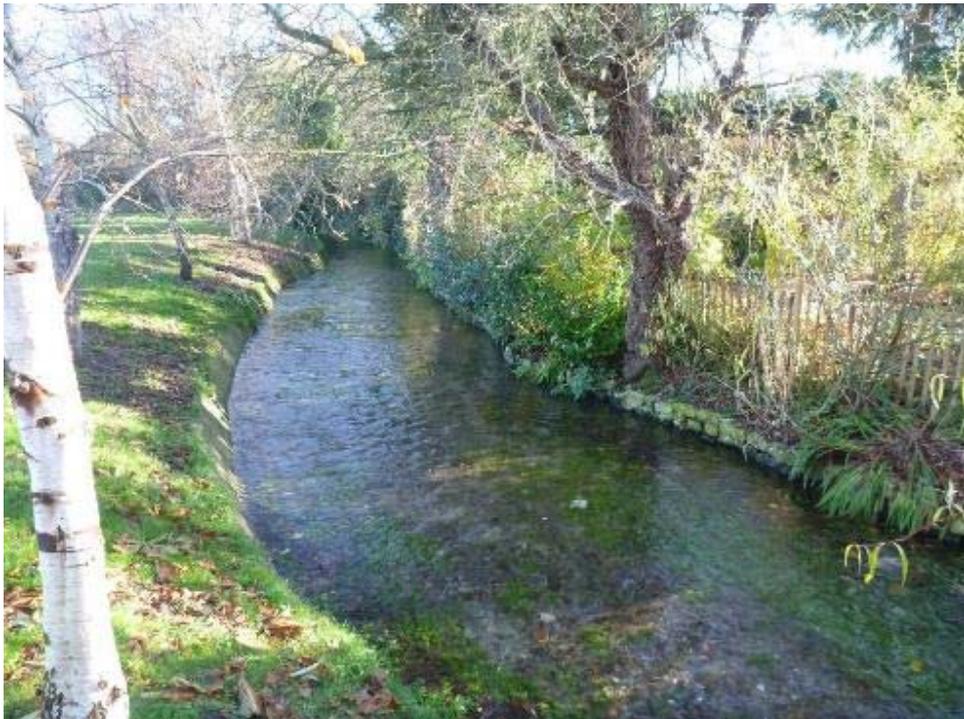
Photo 4 Recreation ground area (TF 01315 79742)

At the recreation ground the beck widens (Photo 4) and remains uniformly shallow with poor instream habitat. The left bank has been armoured with paving slabs which give way to a natural earth bank with progress downstream. There is potential here to narrow the channel and re-profile the left bank to a shallower angle (removing the slabs); this would create a two-stage channel, retaining conveyance for flood flows but improving habitat in the narrower, summer flow channel.

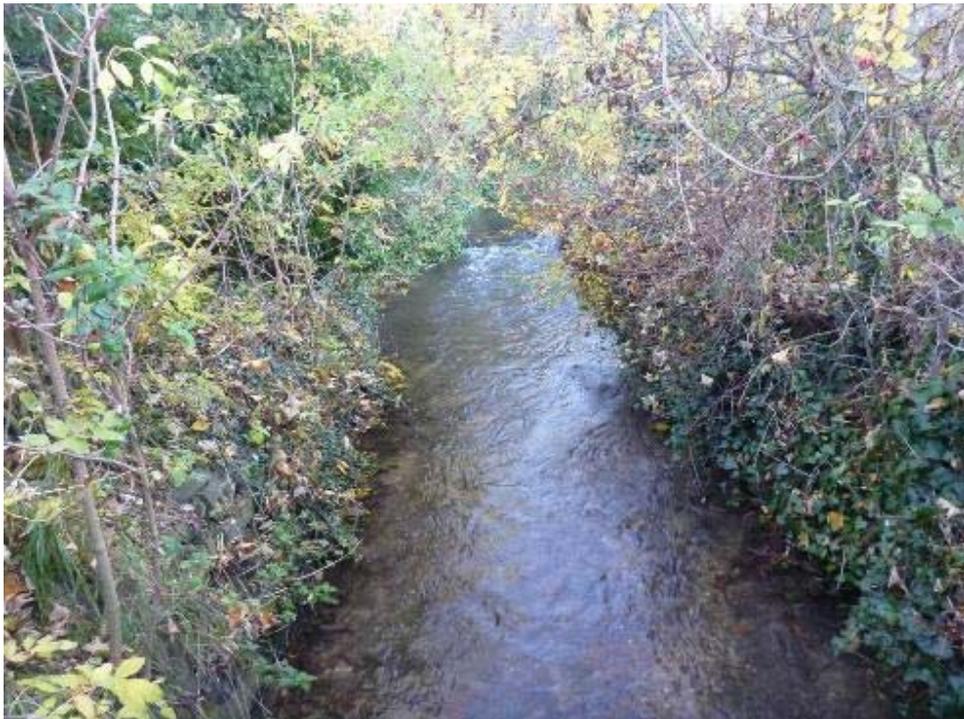
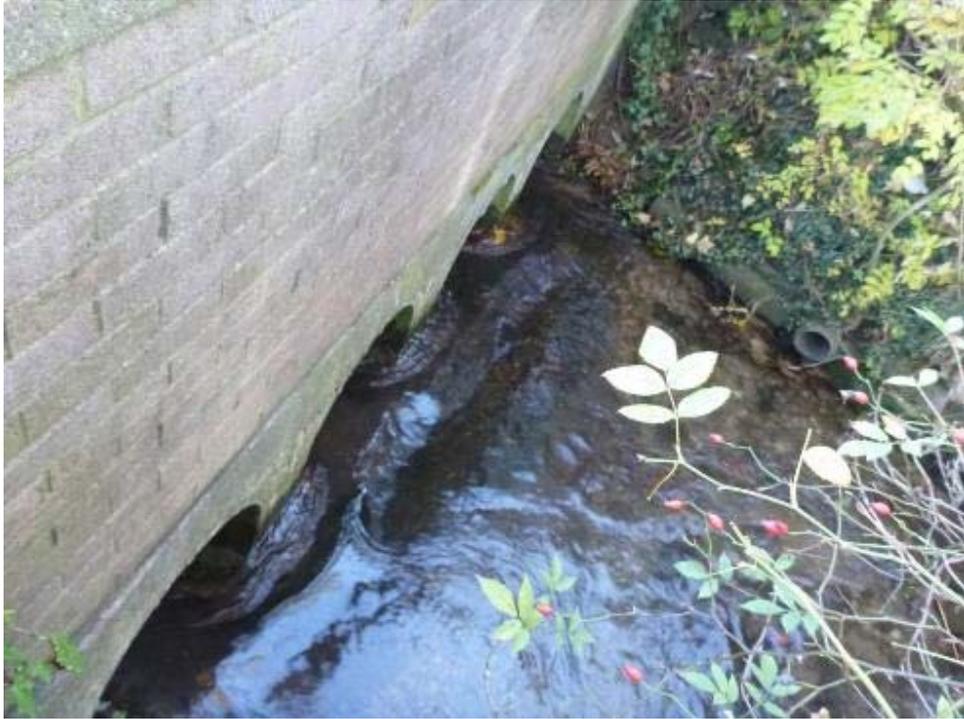
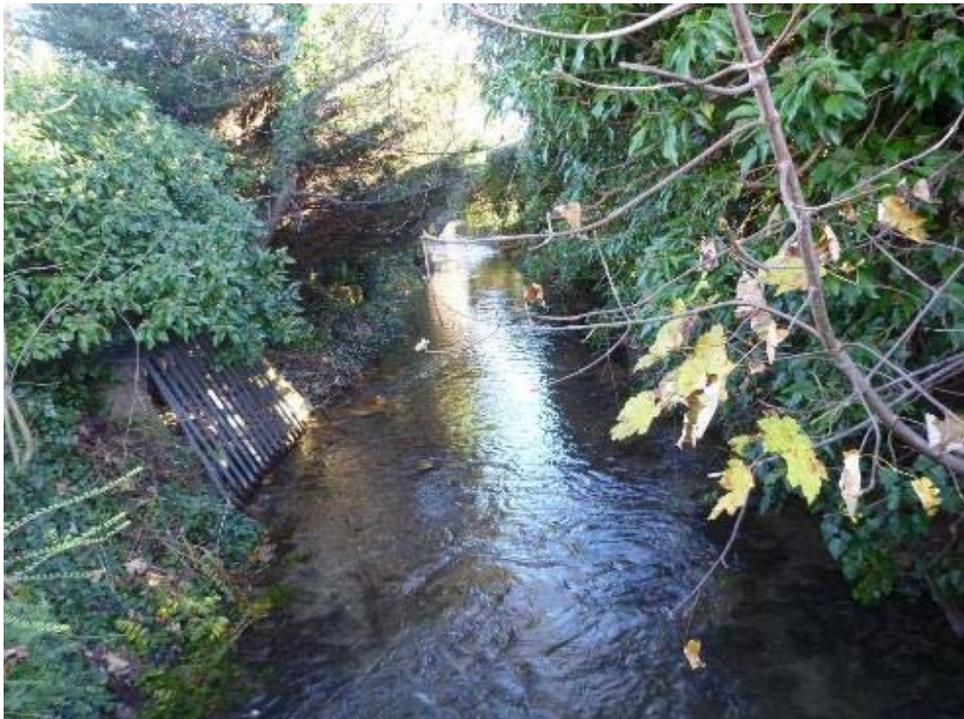
Photo 6. View upstream from bridge on The Grove (TF 01494 79852)

Photo 7 Culvert pipes under bridge on The Grove.

Photo 8 View downstream from bridge on The Grove (TF 01494 79852), with a deeper scour pool area immediately below the culvert.

Downstream of the recreation ground the beck is confined alongside gardens again, then passes under a road culvert at The Grove (Photos 6 – 8). The flow conveyance capacity of this culvert appears quite small and this is a common theme of other bridges over the beck. There is a deeper scour pool present downstream of the culvert created by the funnelling effect of the flow through the culvert; this is similar to the effect that would be created by the weir structures mentioned above.

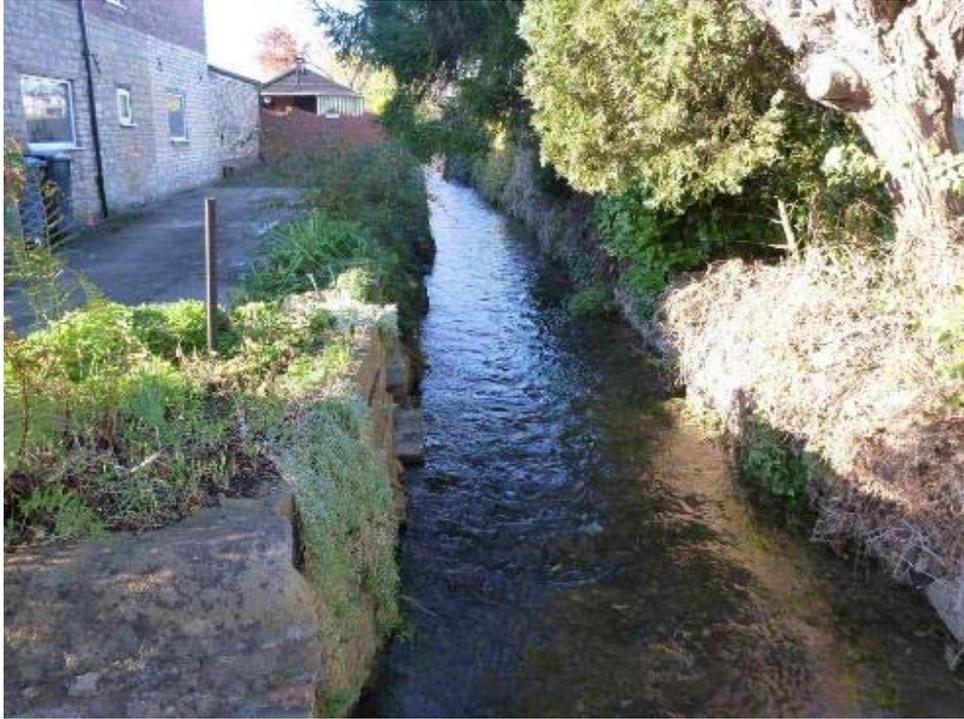
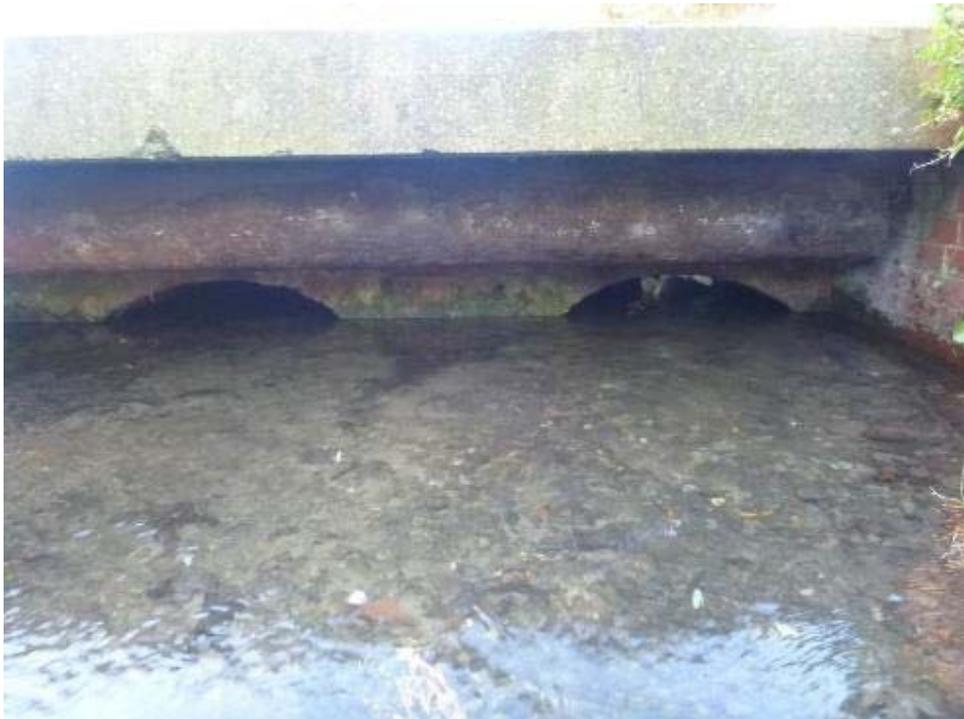
Photo 9 View upstream from Ryland Bridge, Dunholme Road (TF 01889 79953)

Photo 10 Limited conveyance capacity through the culverts under Ryland Bridge.

About 500m of the beck was inaccessible between The Grove and Ryland Bridge, flowing through private residences. Looking upstream from Ryland Bridge (Photo 9), there appears to be scope for introducing constructed pools as mentioned above, if landowners were willing. The bridge has particularly limited conveyance capacity in the culvert underneath (Photo 10).

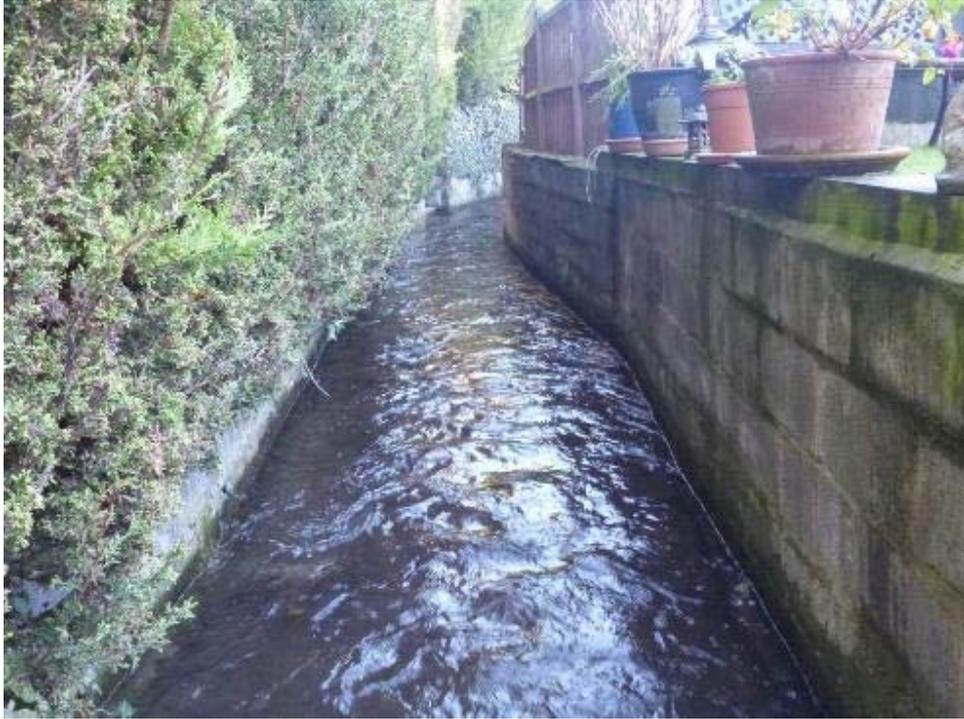
Downstream of Ryland Bridge, the beck is largely confined between walls of gardens (Photo 12) before reaching a more meandering section in a wooded area alongside a pond on the left bank (Photos 13, 14). The pond is fished by Scunthorpe Pisces Angling Club; there may be scope for fishery improvements here, such as peg refurbishment, via rod licence income streams (Photo 14). The instream habitat in the beck is better through the short meandering section, with deeper scour pools located on the outside of bends adjacent to mature trees.

Photo 12 Downstream of Ryland Bridge, the channel is mostly confined between walls alongside gardens of residential properties.

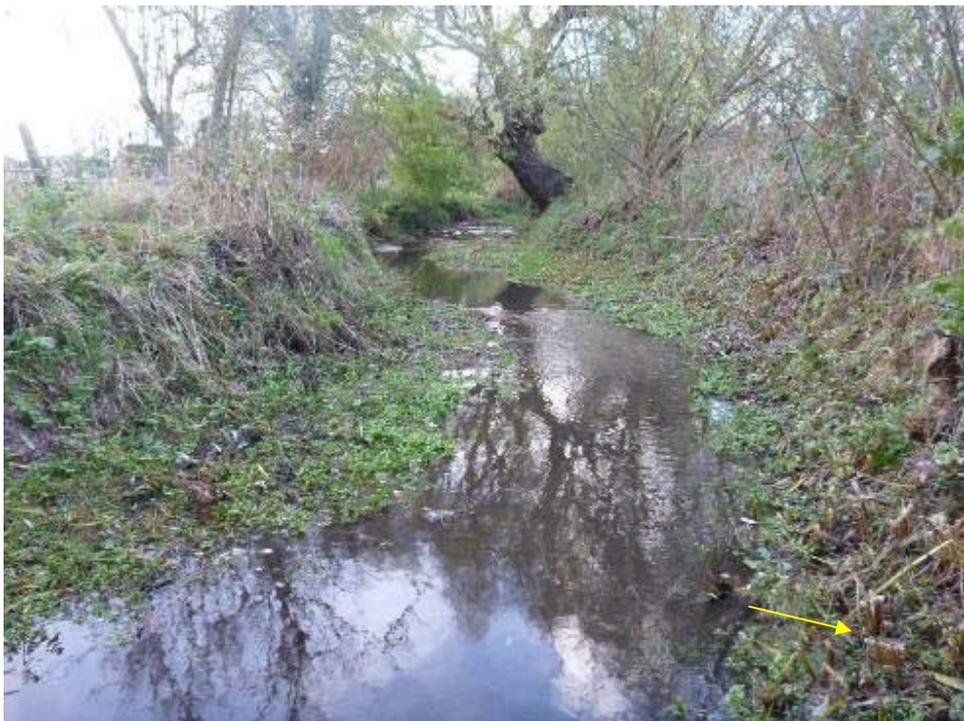
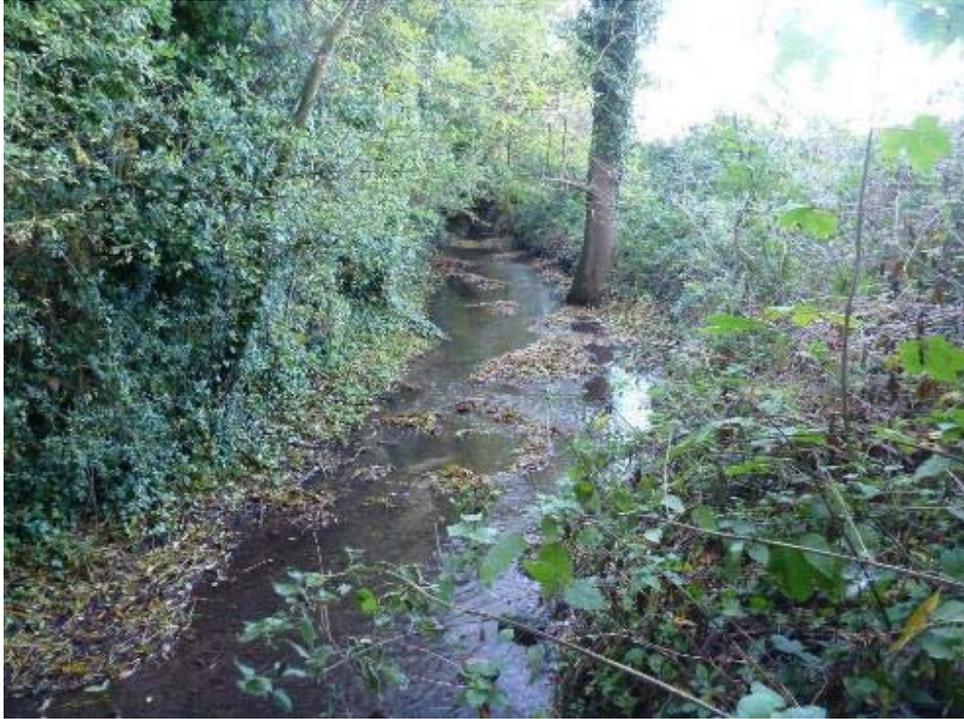
With progress downstream, the bank-full channel has evidently been widened and deepened (Photos 15 – 17) creating a large capacity for higher flows. As further upstream, the brook is uniformly very shallow and has poor in-stream habitat. The gradient in this section is however lower, hence it is not suitable for constructed pools as recommended further upstream. Low-level flow deflectors on alternating banks, to mimic the natural channel dimensions is the best approach here. In some areas the beck has begun to re-establish its natural dimensions within the larger channel, depositing sediment on the inside of bends which has become vegetated to form berms (Photo 15). The channel maintenance carried out within this section has retained the berms, trimming only the taller vegetation such as rushes. In more shaded area, berms have not developed, presumably because of the lack of light preventing growth of aquatic vegetation.

Photo 15 A greatly widened and deepened bank-full channel, with in which the beck has begun to re-establish its natural width and some sinuosity, creating vegetated berms on the inside of bends. Sensitive channel maintenance here has retained the low berms, trimming back just taller vegetation such as reeds and rushes (arrow).

Photo 16 In more shaded sections, vegetated berms have been unable to develop because of lack of light.

Building upon the natural processes of low-level channel narrowing is recommended here. The outside edges of the berms could be defined with brushwood bundles, then back-filled with material excavated from the river bed and/or reprofiling the banks to a shallower angle. The overall capacity for containing high flows would be retained, whilst greatly improving instream habitat.

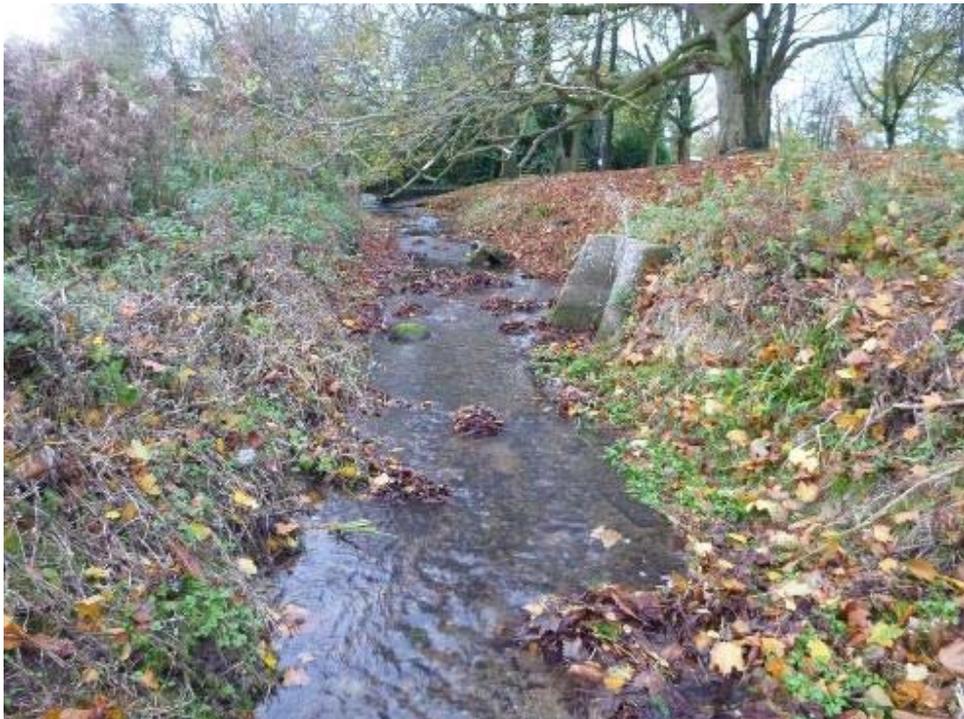
Downstream of Beck Lane ford there is a short section of steeper channel, with much coarser bed substrate than elsewhere (Photo 23), then an approximately 200-m section down to the A46 which is lower gradient and has been widened and deepened creating a large capacity for higher flows, similar to the section alongside the pond mentioned above (Photos 24 – 25). As further upstream, the brook is uniformly very shallow and has poor in-stream habitat. Some natural vegetated berms have been allowed to develop and cutting of taller vegetation has been carried out (similar to the previously mentioned section). Low-level flow deflectors on alternating banks, to mimic the natural channel dimensions is again the best approach here, back-filling with river bed and/or bank re-profiling material.

Photo 23 Steeper section of channel downstream of Beck Lane, with a coarser gravel substrate.

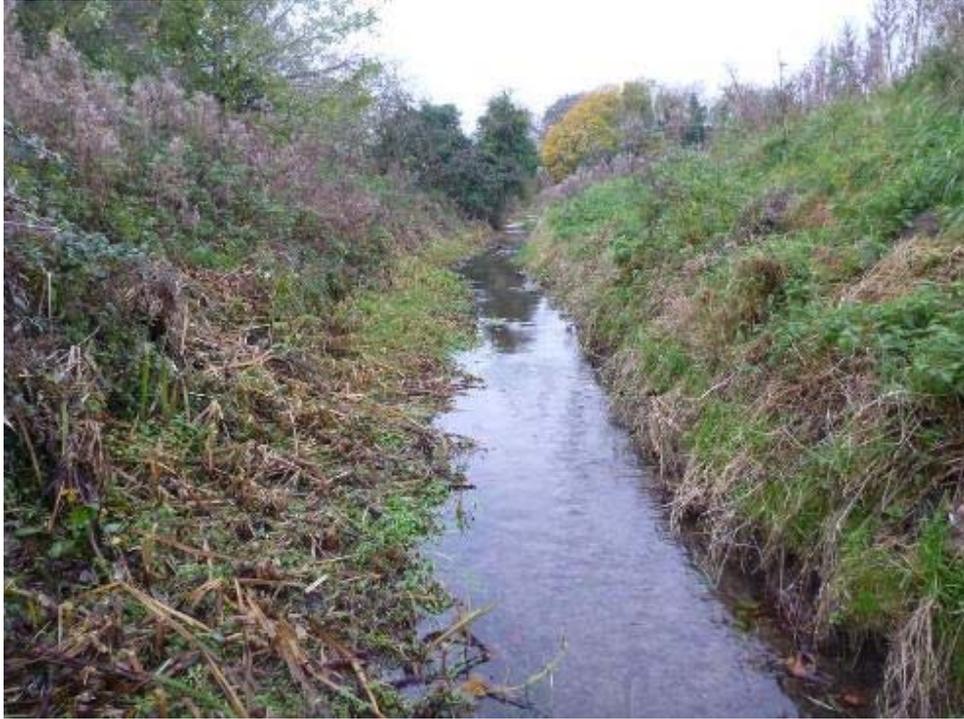
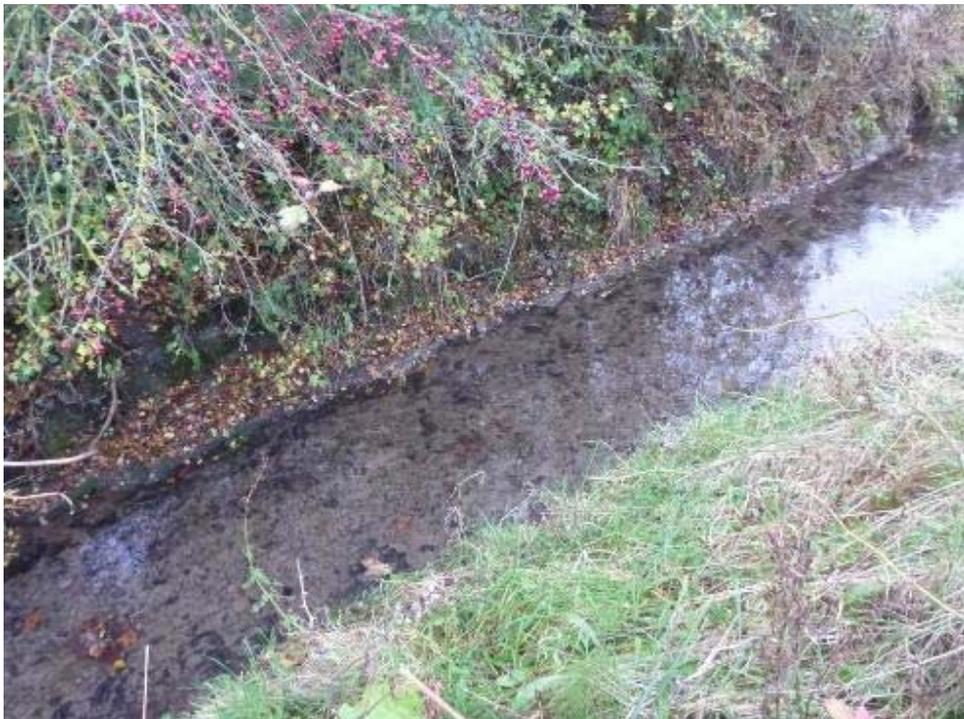
Photo 24 TF0287379467 between Beck Lane and the A46. A maintained, large capacity bank-full channel within the beck has begun to re-establish its natural width via vegetated berms, largely against the RH bank (left of picture). Sensitive channel maintenance here has retained the low berms, trimming back just taller vegetation such as reeds and rushes.

Photo 25 As above, illustrating the very shallow uniform habitat.

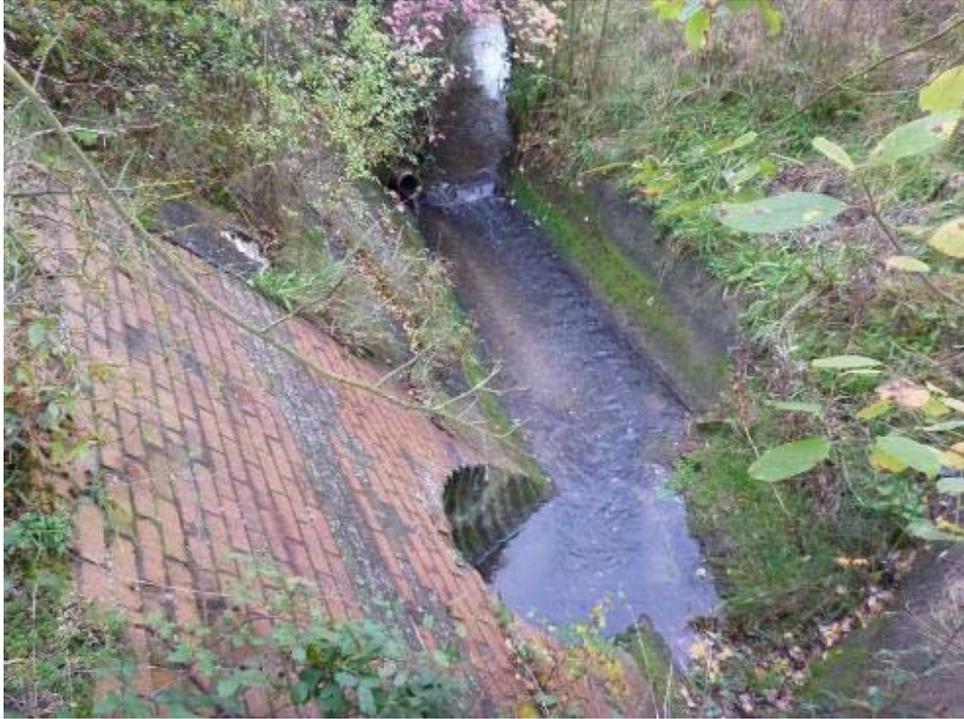
The beck runs through a concrete-bedded culvert under the A46 (Photo 26) with a small step on the upstream side and very shallow water. This is a barrier to fish passage at low flows and simple notched low wooden baffles downstream of the step would improve this.

Photo 26 Upstream end of culvert under A46 (TF0294979512). Short length of concrete –lined channel with a low lip. One or two notched baffles downstream of the lip would make it more passable by fish.

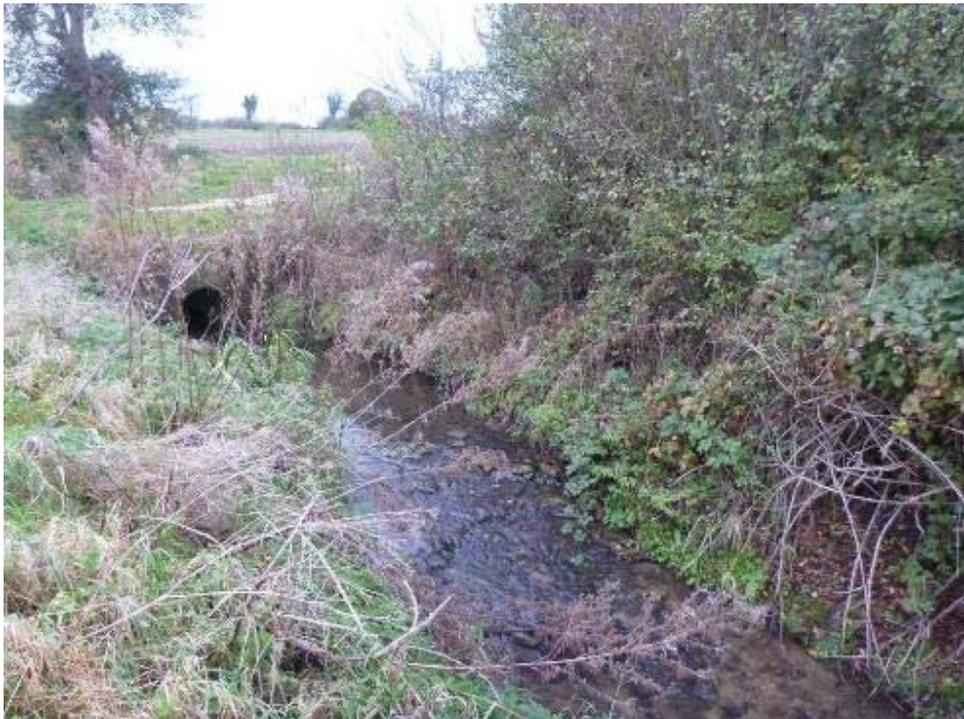
Photo 29 Culvert at farm track crossing (TF0337779647). No obstruction to fish passage. A deeper pool has formed below the culvert and sticklebacks were observed here.

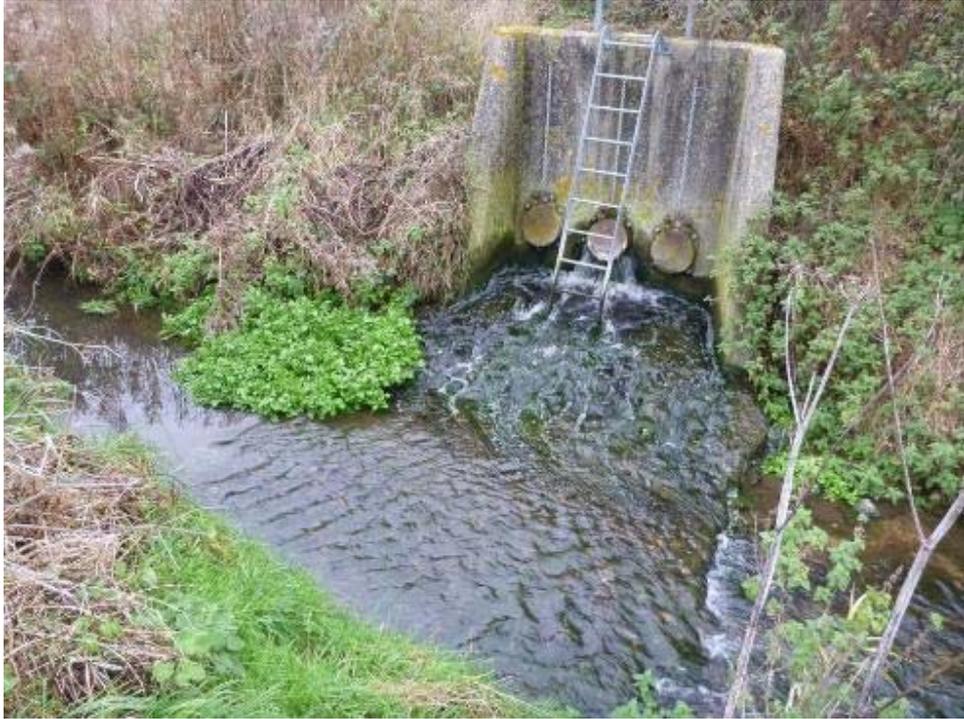
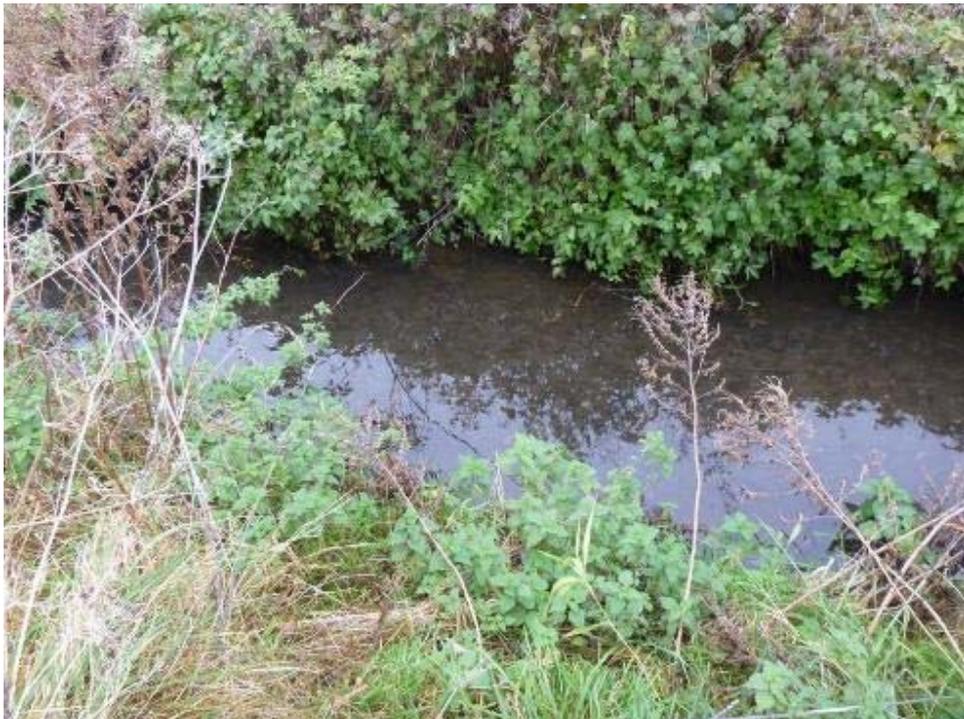
Photo 30 Sewage works discharge (TF0343879630) onto a concrete pan on the river bed.

Photo 31 Fine silt accumulated upstream of the slight impoundment at the STW discharge.

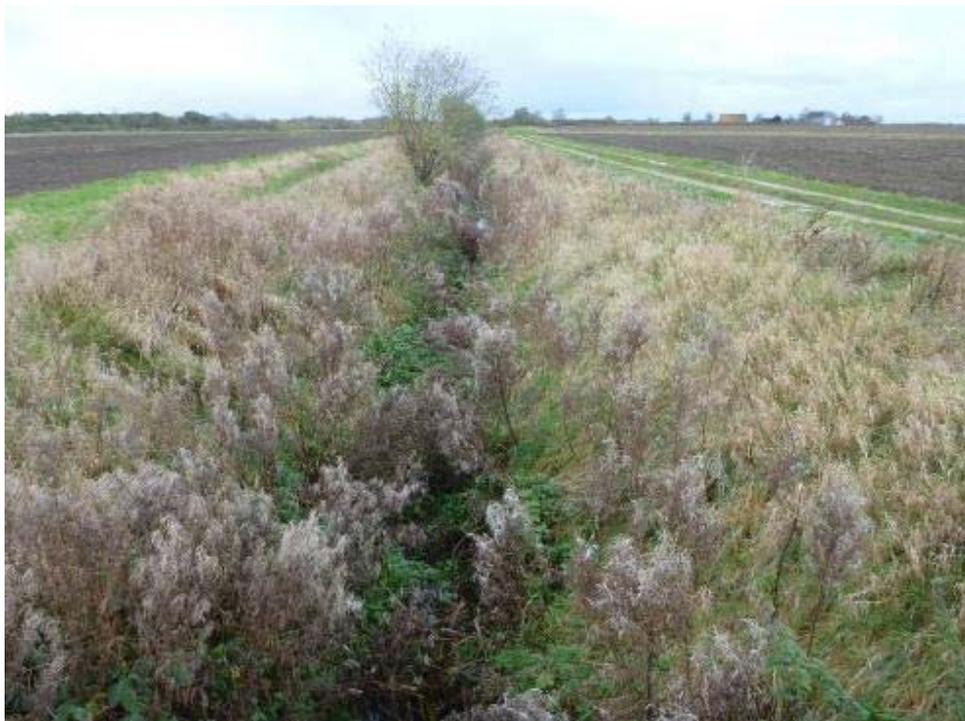
Photo 35 Typical view of the Welton Beck in the lower reaches; slightly impounded upstream of a culvert leading to sediment accumulation and emergent vegetation encroachment.

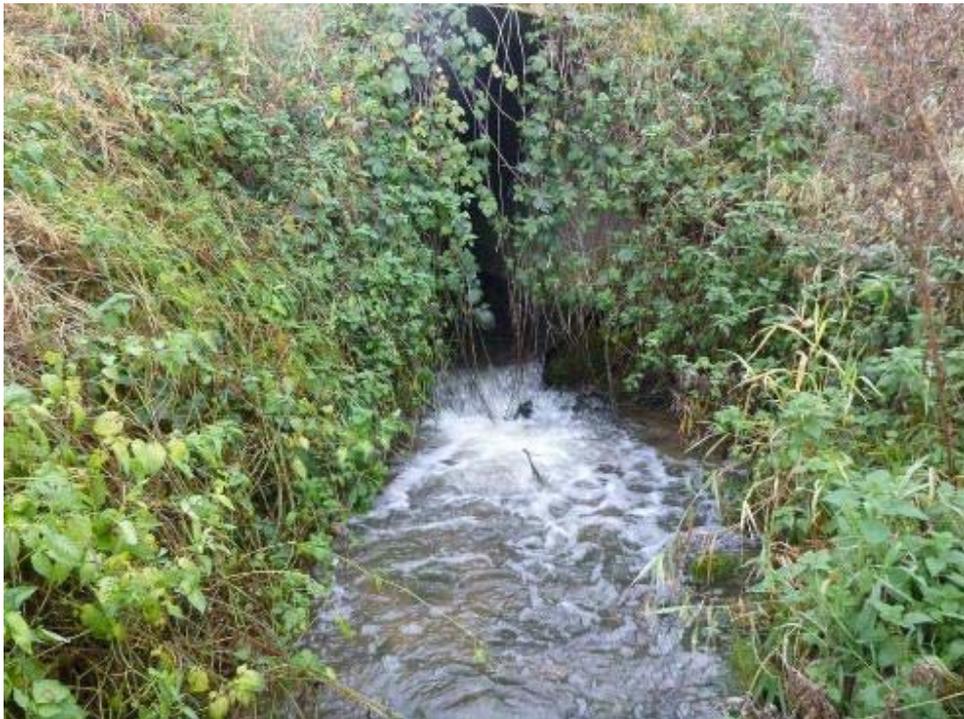
- The gradient of the beck within Welton village is relatively steep, lessening in Dunholme and east of the A46. There are no significant impoundments (weirs, sluices, etc.) along the course which would impede fish passage. There is a culvert under a track crossing near the Barlings Eau which requires minor modification to allow fish passage (Photo 37).

The Barlings Eau is known to have a reasonable fish population, including trout, so ensuring a free pathway for fish to migrate upstream through the Welton Beck is important. The route is relatively free of obstructions, but the occasional culvert under farm tracks (Photo 37) has become perched above the downstream water level. Raising the bed level and hence water level of the beck immediately downstream of the culvert by introducing a mat of cobbles/coarse gravel would overcome this quickly and easily.

Photo 37 Farm track culvert which is perched and a barrier to upstream fish movement, potentially restricting fish movements from the Barlings Eau up into the Welton Beck. (TF 04807 79385).

Where culverts have become perched and a drop between upstream and downstream river bed and water levels has occurred, this can impede free movement of fish and natural sediment transport. To rectify this, the culvert could be replaced with a larger diameter structure (larger pipe or box culvert, Photo 45) set well below bed level. Alternatively, the river bed downstream of the culvert can be raised by introducing stone/gravel to raise downstream water levels (Figures 5 – 6). On the lower reaches of the Welton Beck towards Barlings Eau, the culvert (Photo 37) could be modified in one of these ways.
