Fish Passage Appraisal

Lumb Mill Weir, Eastburn Beck

Report title: Fish Passage Appraisal: Lumb Mill Weir, Eastburn Beck

Report reference: RRCL.FPA.20161006.1

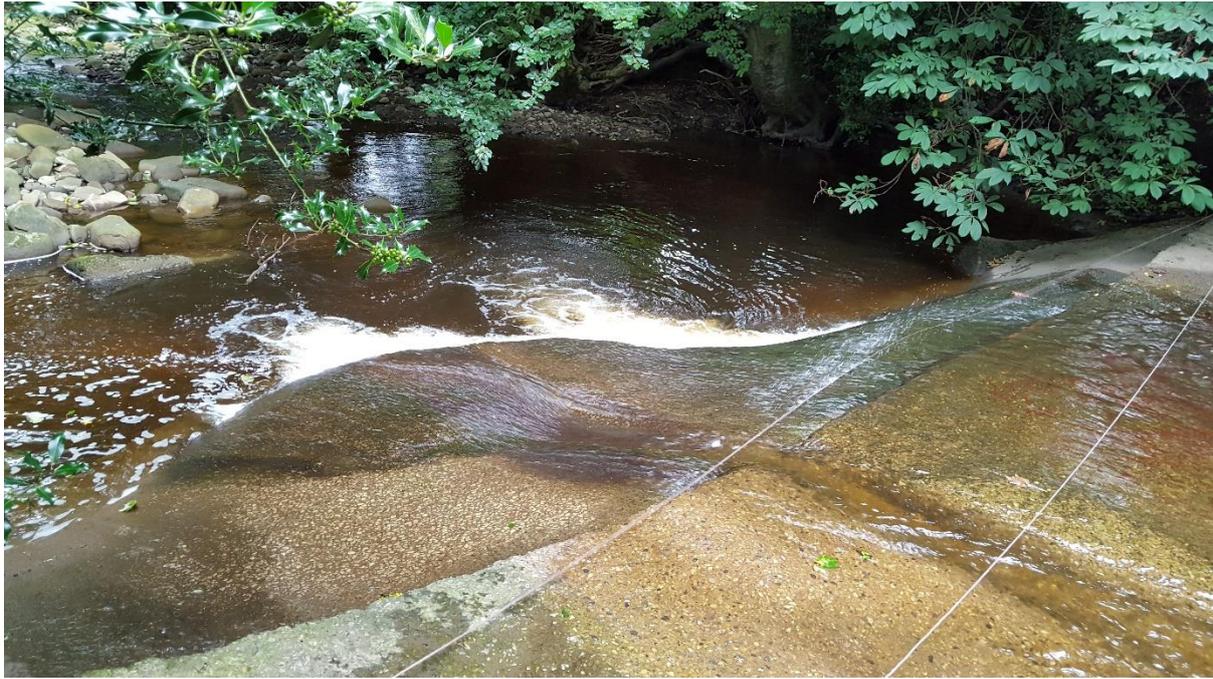
Figure 2. Lumb Mill weir as viewed from the top LHB of the weir.

Lumb Mill weir is located at SD 98796 44462, just west of Glusburn, North Yorkshire (Figure 1). The structure is located underneath a road bridge with its purpose being to protect the footings of the bridge from erosion. It is a two-part structure consisting of a low-head weir (Figure 2) with an 8-10 m concrete apron (Figure 3) upstream that passes the stream under the bridge. The weir pool downstream is *ca.* 1-1.5 m deep, giving some fish species a chance of leaping on to the apron. Due to the width and profile of the apron, water depths over it at base flows are shallow (< 0.2 m) with depth varying slightly where channels have been eroded by the stream. The head of the weir is \sim 0.75 m with the weir and apron combined being \sim 1-1.25 m.

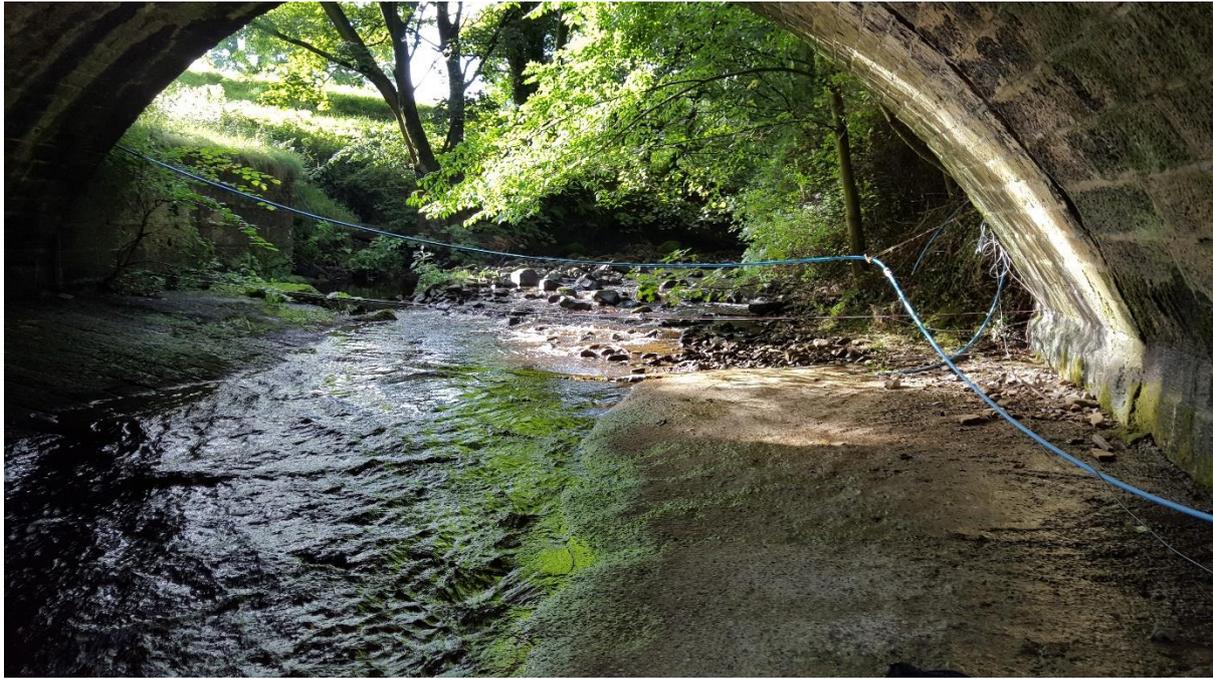
Figure 3. Upstream apron of Lumb Mill weir with PIT antennae in-situ below the blue water pipe.

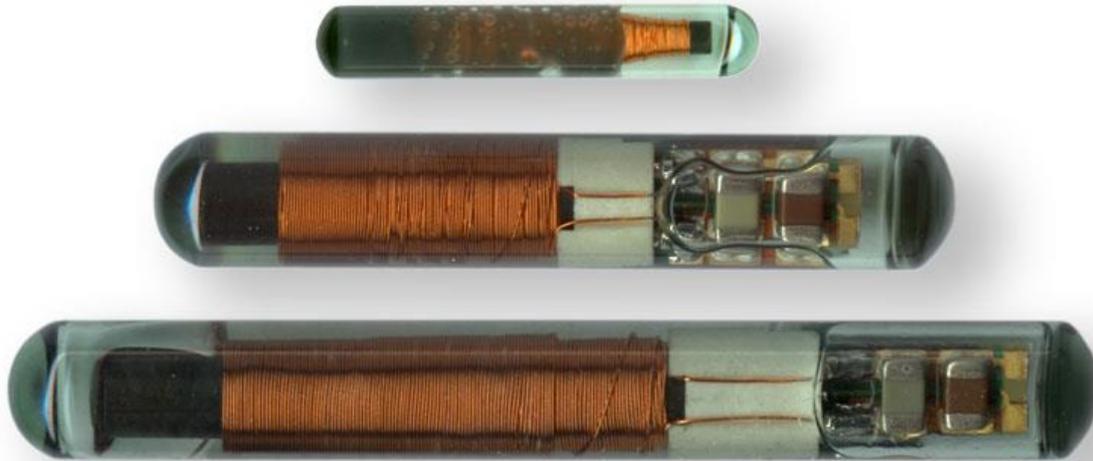
Figure 4. 12 mm, 23 mm and 32 mm PIT tags (not to scale). Source: Oregon RFID.
