## Notes of visit to Stroud Rural SuDS project – April 16

On 13<sup>th</sup> April 2016 I visited the Stroud SuDS project with project officer Chris Uttley. I was very impressed with what I saw and heard and so, given that the project is currently focussing very much on getting on and doing natural flood management work on the ground, rather than lots of monitoring and report-writing, I thought it would be useful to those interested in the subject to hear what the project has achieved in a short space of time. The data and information in this report are derived through *pers comm* with Chris Uttley himself and the photos are a combination of his and mine.

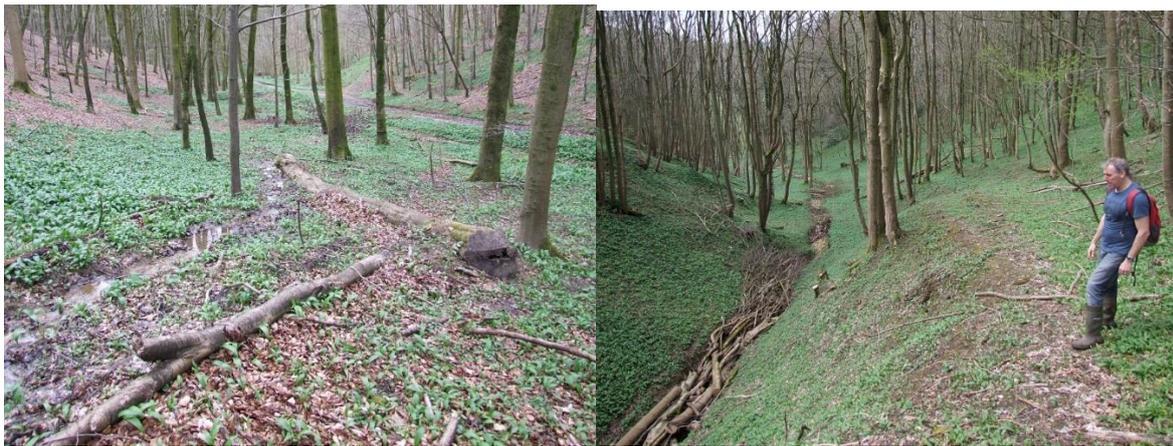
**Use of woody debris to deflect seasonal spring flows back into the ground and to slow instream flows in seasonal headstreams**

5. The use of woody debris in seasonal spring-fed stream courses was particularly interesting to me – I had not come across that type of intervention before.

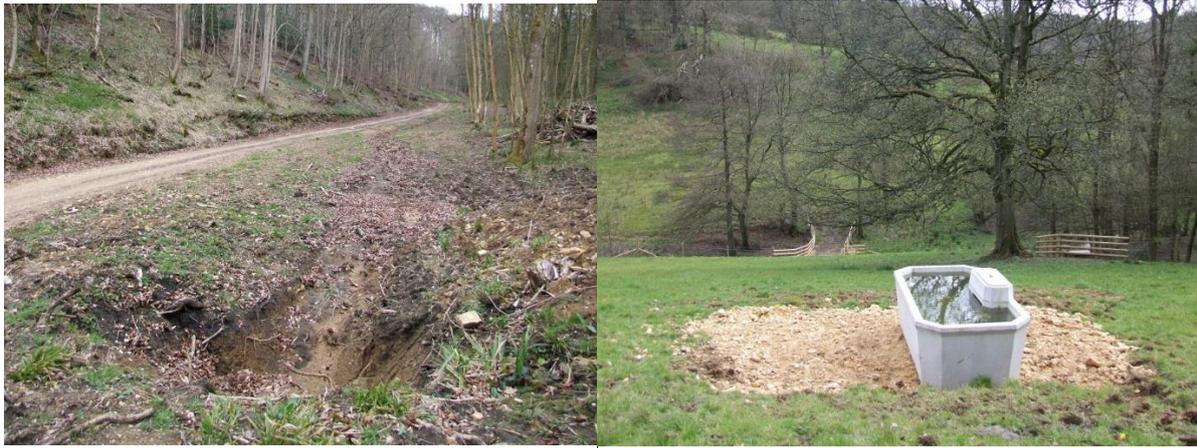
**Forest tracks diverted into soakaways and spring-fed drinking troughs to keep livestock out of watercourse**

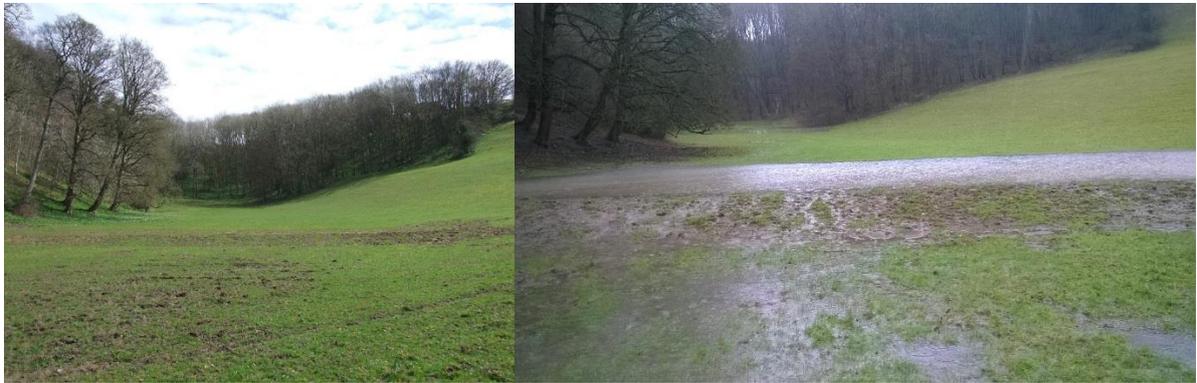
**Upper Painswick Valley field bund in normal and flood flow conditions**

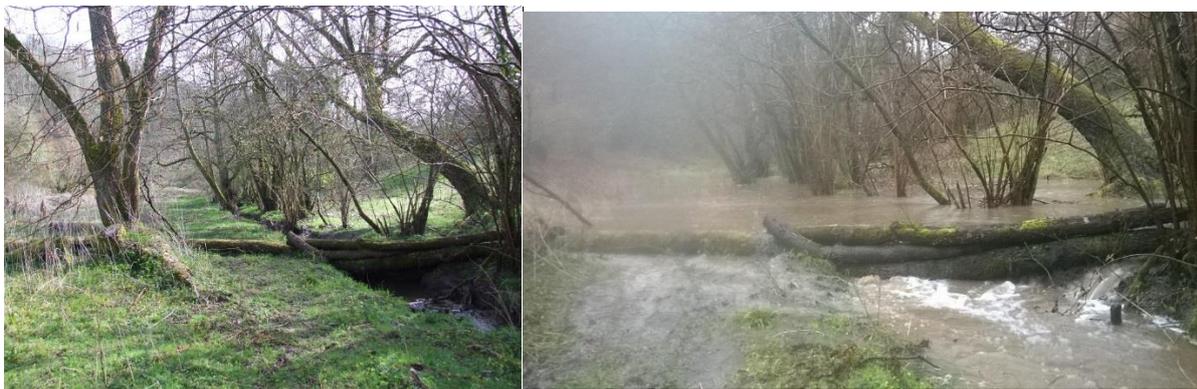
**Dillay Brook (Slad Valley) debris dam in normal and flood flow conditions**

4. It is clear that some reaches of these watercourses had completely lost contact with small areas of floodplain due to long-term artificial deepening, resulting in storm flows being contained within channel and rushing rapidly on downstream. These woody debris dams enable the utilisation of these narrow areas of upstream floodplain just as they would have been used pre-man-induced deepening.
