Test and Itchen River Restoration Strategy Projects completed in 2017.

Bossington Estate structure removal, River Test – T102/T103 – Restore – SU 33875 30768

Southington House, Overton, River Test – T008/T009 – Rehabilitate – SU 50953 49769

**Wherwell Estate, River Test – Restoration of Beat 3, 4 and 5 - T053 – Rehabilitate
SU 39876 41370 (middle of site).**

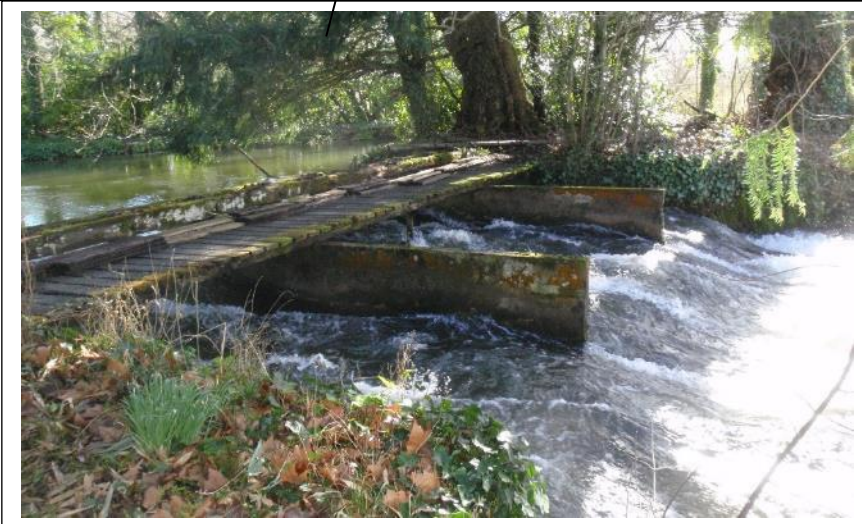
Location and image of the large impounding structure at Bossington Estate

The above map shows the extent of the major restoration at Bossington Estate carried out by Cain Bioengineering. The darker area shows the length of river that was in poor condition due to the impounding effects of the two large structures. The largest of which is shown above.

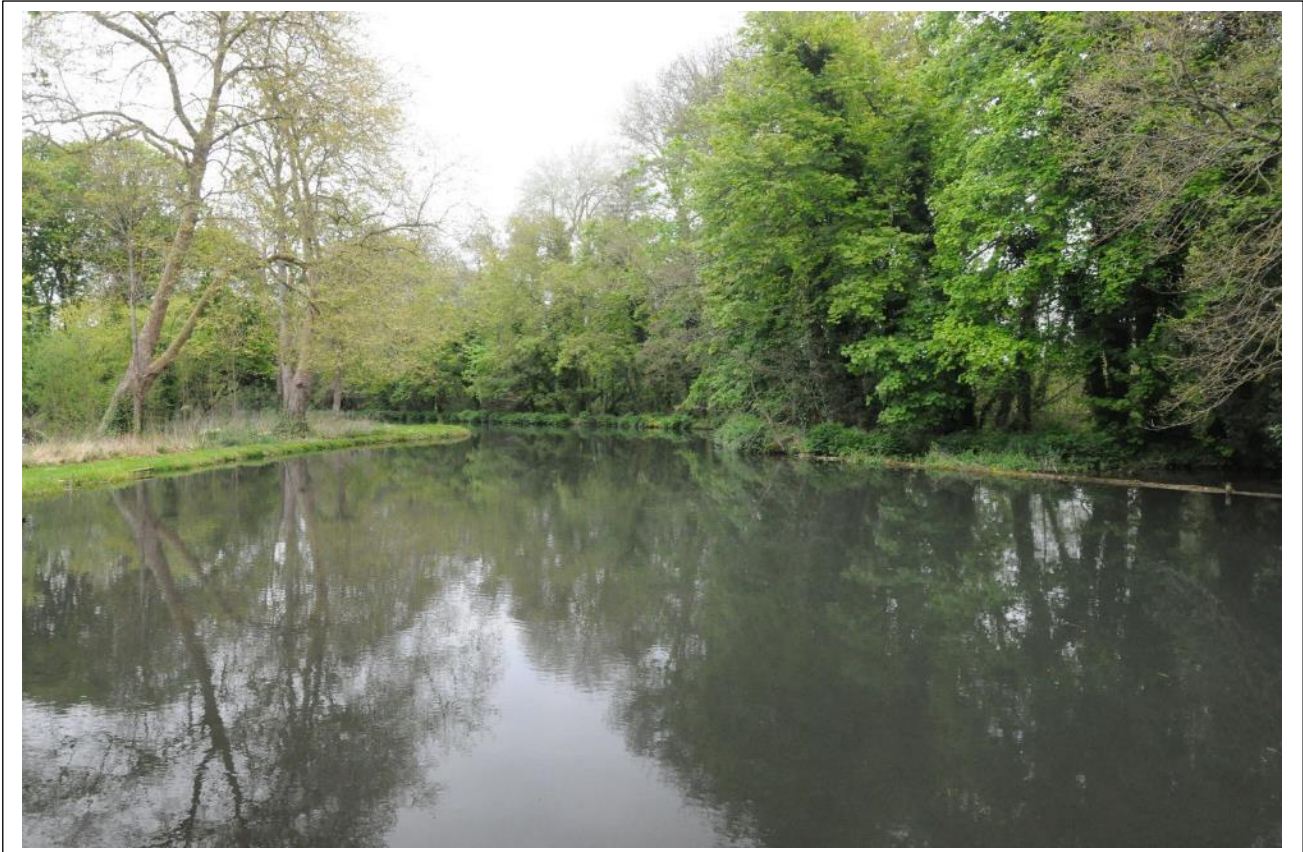
Impounded river upstream of the structures at Bossington

The above photo shows the impounding effect upstream of the structures when they were still in place. While this may be an extreme example of an impounded section of the River Test it is representative of the negative effect impoundments have. A large portion of the Test and Itchen River Restoration Strategy is to encourage river keepers and fishery managers to promote the benefits of river restoration to anglers as some may like the above image and it's ability to hold large stocked fish. Stocked fish can still be caught in restored sections but importantly wild fish can also flourish in the newly created habitats. Numerous surveys have also proved that increased velocities also provide the correct conditions for increased numbers of Chalkstream invertebrates and promote the growth of macrophytes (weeds) such as *Ranunculus*. While river restoration is improving the SSSI status of the river it can at the same time provide anglers with a more natural fishing experience and a wider variety of challenges in a setting more appropriate and characteristic of a world famous Chalkstream. The removal of an impounding structure can also potentially reduce flooding to nearby at risk properties.

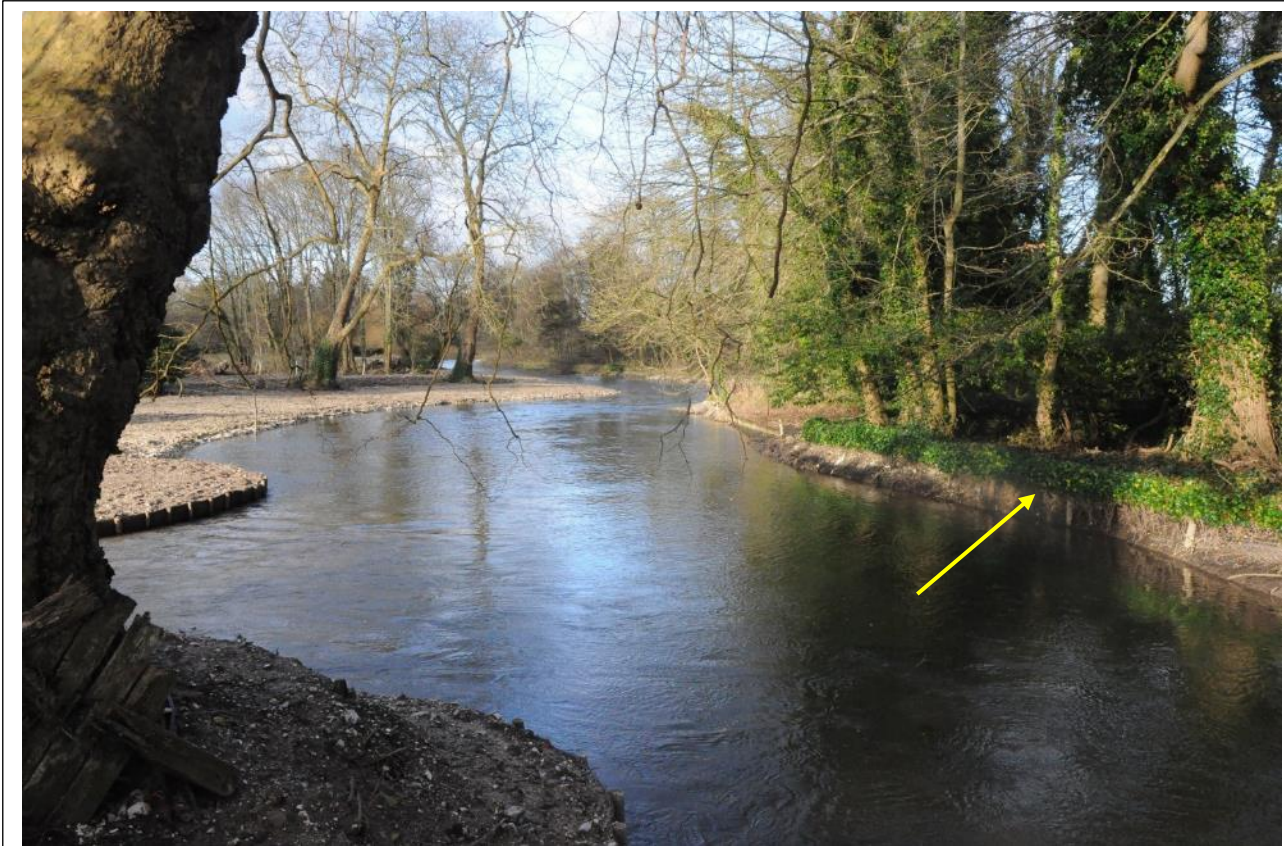
Structures removed and river restored

This is the same stretch of river once the structures had been removed. On removal the level dropped by nearly one metre, see arrow. The channel was then narrowed and sinuosity created by bank re-profiling and the introduction of woody material. The bed was then raised using locally-won gravel. The 'new' gravel bed was deliberately contoured to provide high velocity points for wild fish and deeper slower areas for stocked fish. Once finished the excavation hole for the gravel was re-profiled and will be used as a small beginners fishing lake. The silt that had accumulated upstream of the structures was also used in the narrowing process and also spread along the banks. This image was taken soon after the completion of the works in the autumn of 2017 and in-channel and bankside vegetation has yet to establish. Based on previous restoration projects this process will be quick now that the key ingredients of light and increased velocities are now present. Along with the already present seed base the margins will also be planted up with appropriate plants. In-channel weed growth can expect to change dramatically from ribbon weed to a wide variety of Chalkstream macrophyte species. Small shoots of *Ranunculus* were already growing only weeks after completion. In time this will provide excellent habitat for invertebrates and juvenile and adult fish species, though whether the river keeper will appreciate the extra work during the weed cut periods is yet to be seen!

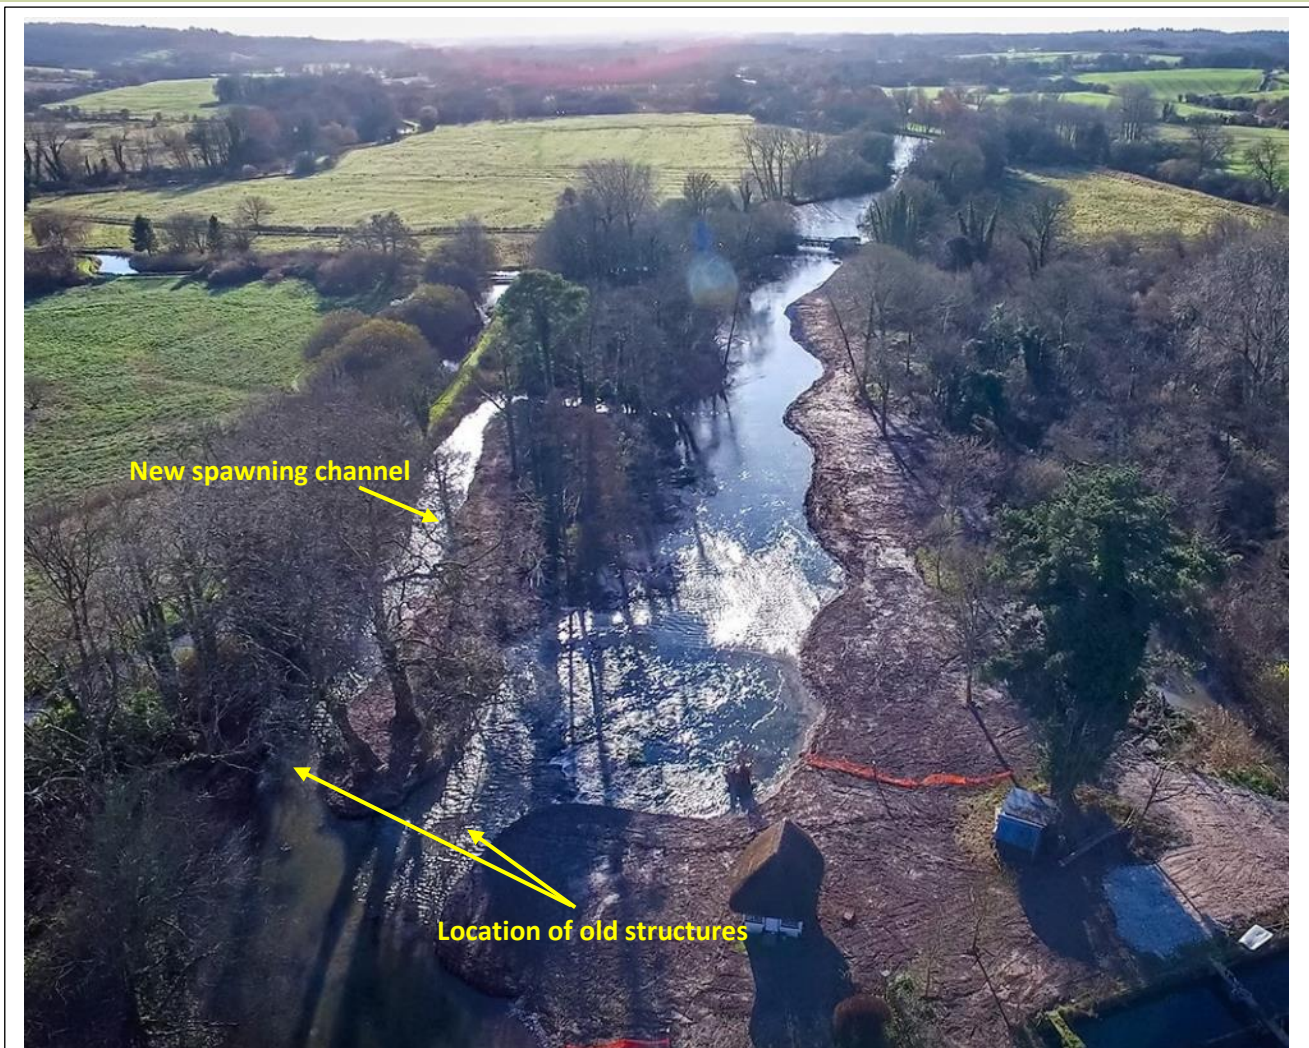
Photo showing location of the old structures, the new spawning channel and the restored section downstream.

A total of 800m of channel was restored at Bossington Estate. Reducing the water level by removing the structures also allowed the banks to be lowered. In many places these had historically been built up with dredged material from the river, creating a ridge along the bank top. Removing this ridge and re-profiling the banks to a more natural gradient has reconnected the river with the flood plain and created an additional area of flood storage.

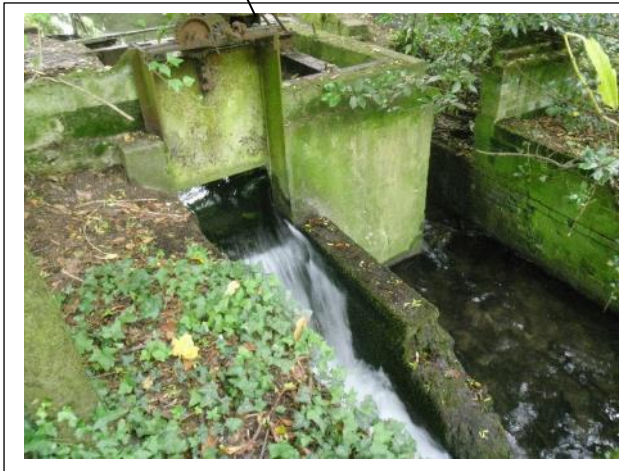
Location and image of historic impounding structure.

The above map shows the extent of the 400m long restoration, the location of the Silk Mill, and the historical impounding structure at Southington House. The shaded area shows the extent of the in-channel siltation.

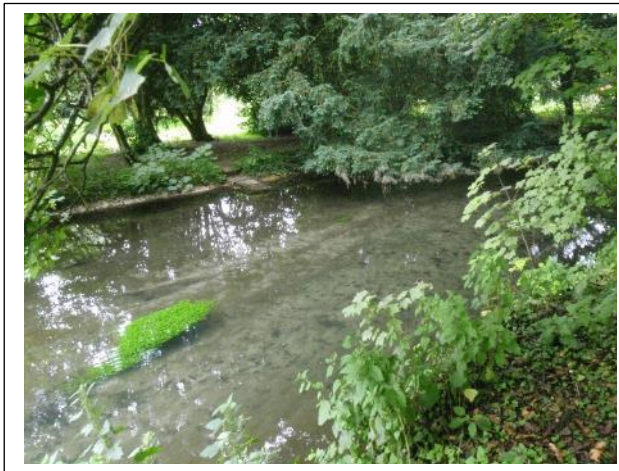
Siltation upstream of structure.

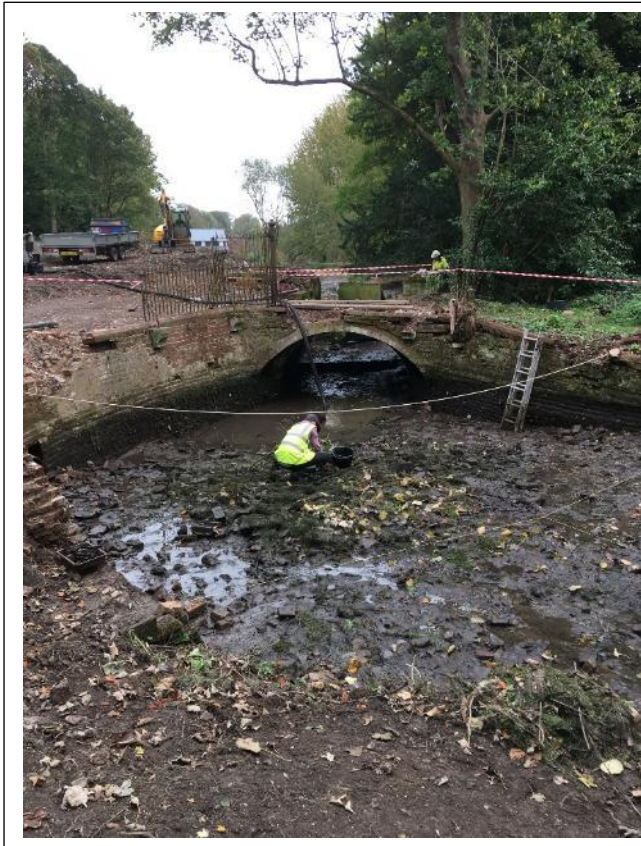
Archaeologist working in the drained pool downstream of the structure.

Before any works could start the site had to be cleared of a large number of sycamore trees to create access and light. A coffer dam was then installed at the first bend, see map. Prior to draining the works area, a small number of trout and eels were caught and relocated downstream of the works area. The river was then diverted through a series of pipes and pumped to downstream of the works area so that work could take place in a dry river bed. This also allowed the archaeologists the opportunity to search the river bed prior to the start of the works.

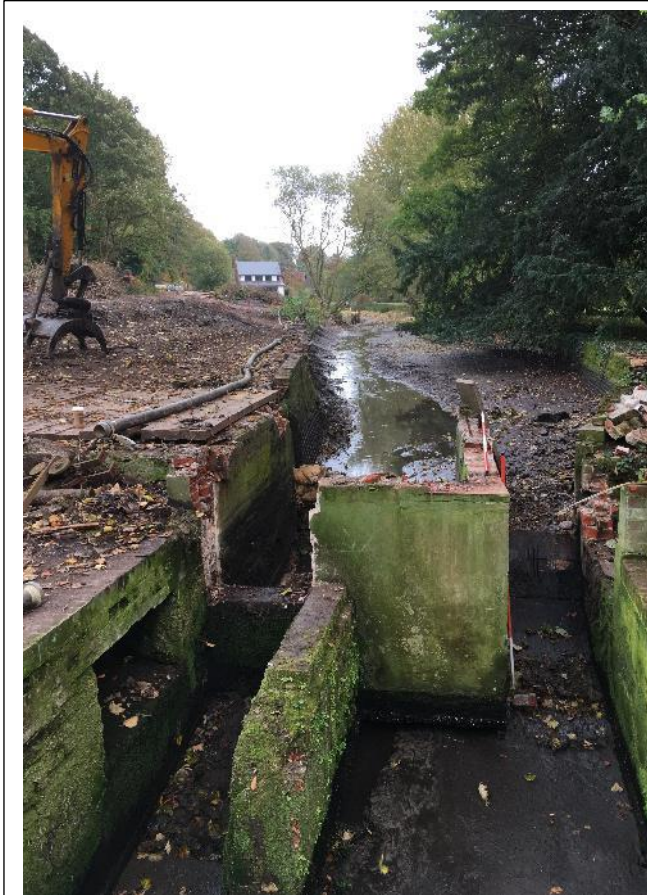
Before - River diverted and structure partially removed.

Dismantling the structure had to be done sympathetically so as to retain as much as possible of the original historic brickwork. During this process a large oak beam was uncovered under the silt lying across the width of the channel. A core sample was taken and carbon dated which revealed the beam was from 1769 the date the Silk Mill started.

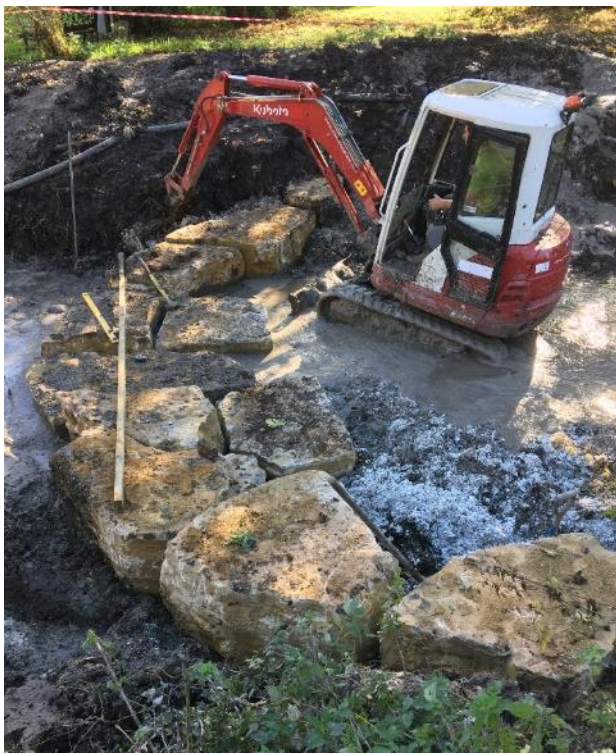
One of the biggest problems to overcome during this project was to maintain a flow of water through an upstream SSSI offtake channel once the structure was removed. To regain the head lost, two crescent rock ramps were constructed upstream of where the structure once stood (see map). Each of these had to be designed to allow up and downstream fish passage for all species. With technical advice from fish pass colleagues 1.5 tonne blocks of Portland stone were positioned and angled to make up this difference.

One of the two rock ramps being installed. Notice the spirit level!

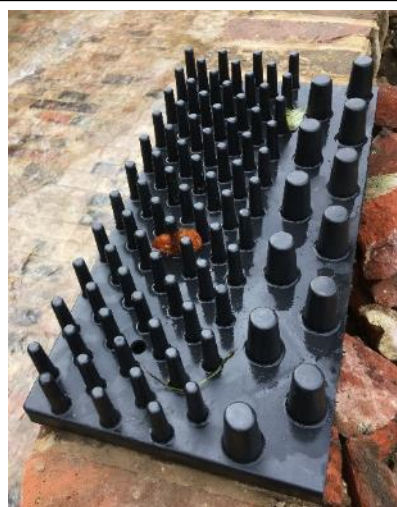
Eel tile

Providing up and downstream fish passage for all species was a major part of this restoration. Fish had not been able to get past the structure for maybe centuries. Once removed and the river reinstated trout and grayling were seen swimming up and downstream immediately, even the 'Brickies' were impressed. The image on the left shows an eel tile. Eels are not good at swimming against higher velocities and use these tiles by twisting through the nodules. To keep with the aesthetic of the brick work the eel tiles will be made of oak not black plastic. These will then be secured to the brick work on the bed running alongside the true right bank wing wall.

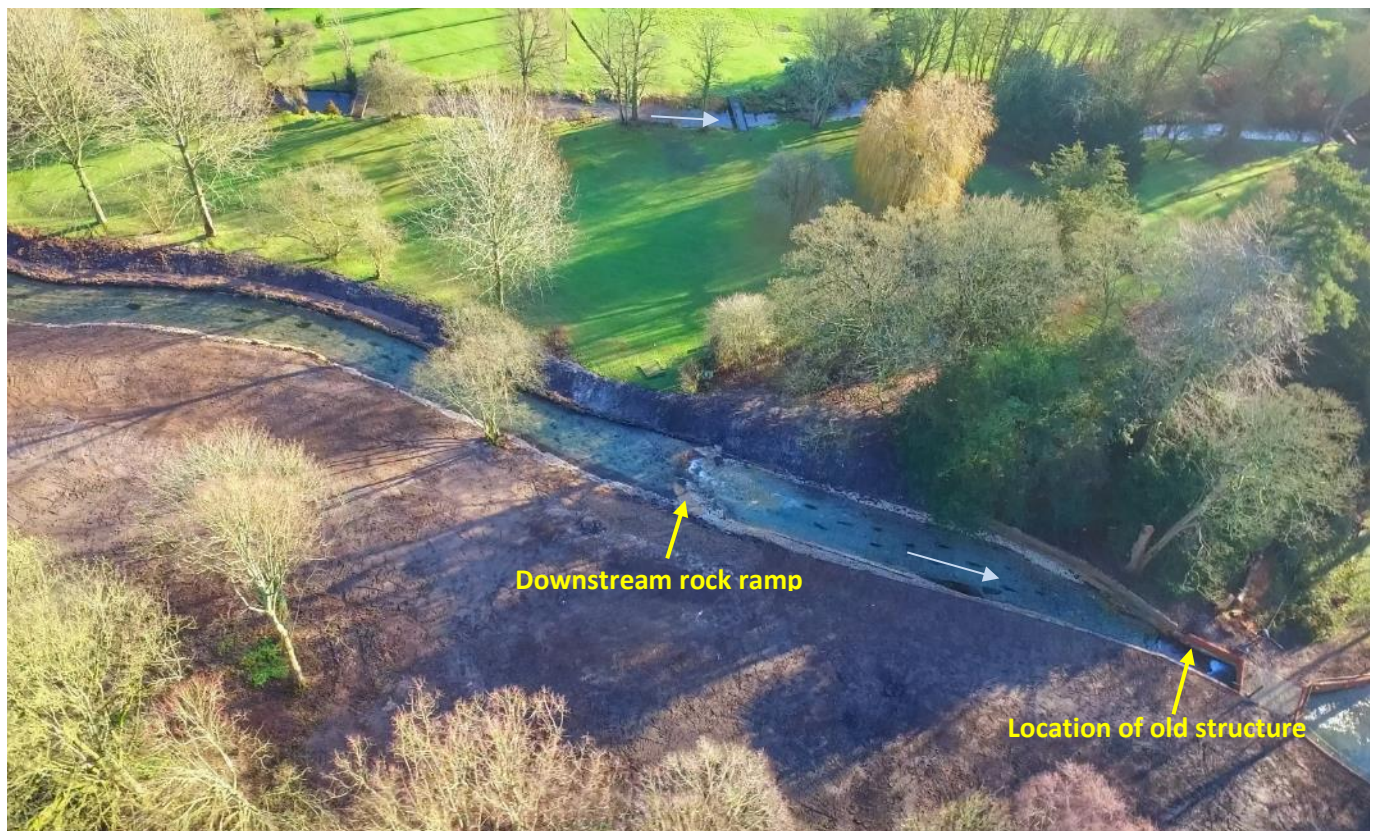
Aerial photo showing the downstream end of the restoration. The second rock ramp is just out of shot to the left and the SSSI offtake channel can be seen at the top.

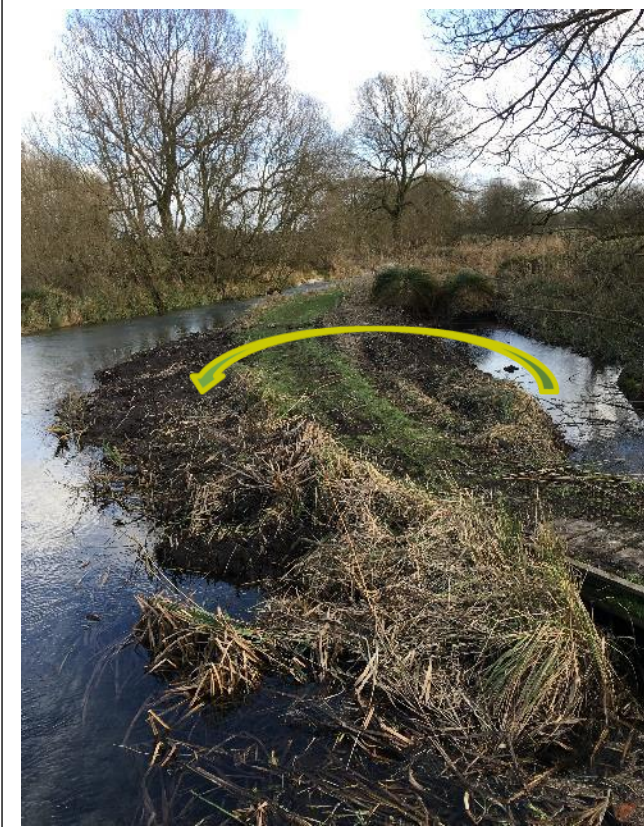
Bankside woody material was used in the wide sections to create meanders and provide cover and habitat for a variety of chalkstream species. In time these will also fill in with silt and help narrow the river. Another technique used for building meanders was to use locally-won bankside material. Where appropriate shallow scrapes were dug just back from the bank and the material gained used to build meanders in to the channel. This technique provides an excellent source of material and also creates a shallow pool for a variety of amphibians, insects and plants.

Inside meander created using locally-won material.

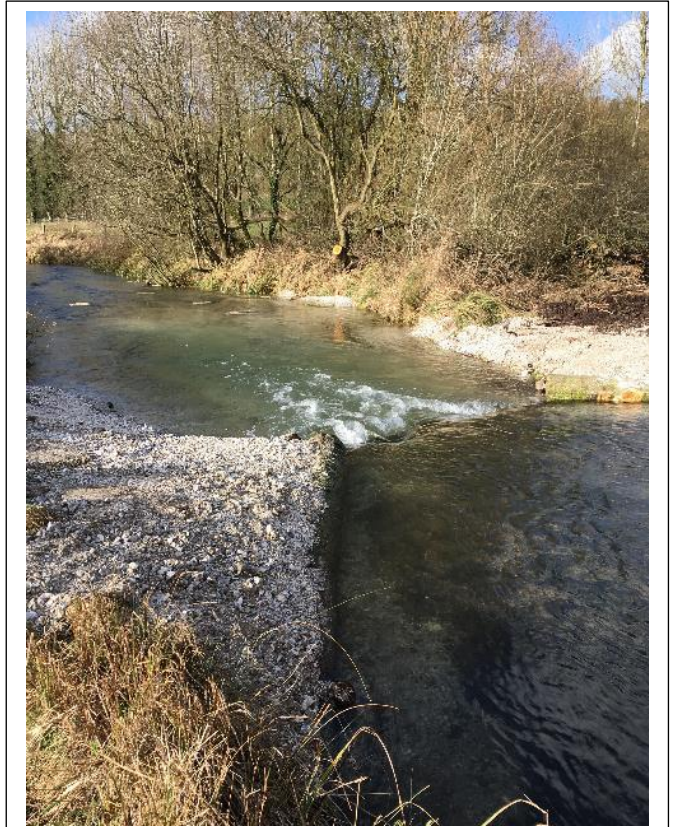
Pinch point

To add variety to the uniform channel a couple of Pinch points were also incorporated into the restoration. These are built at an appropriate location by making a shallow scrape in the bed and using the material to create 'shoulders' from each bank. This then increases velocities, provides potential spawning and juvenile habitat and provides shallow pools for adult fish. When building pinch points there is always the danger that you are impounding the river upstream. Consequently they have to be positioned in areas with good gradient and not be made too narrow.

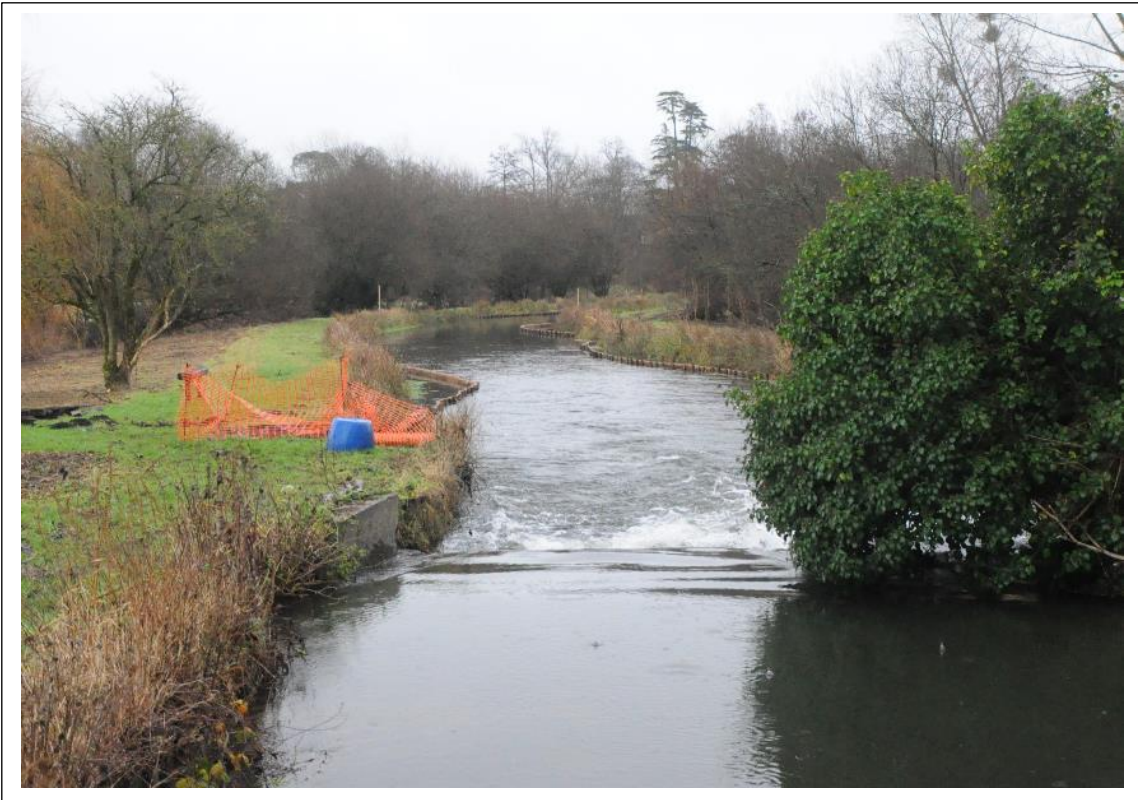
The new meanders staked out and the structure in the foreground.

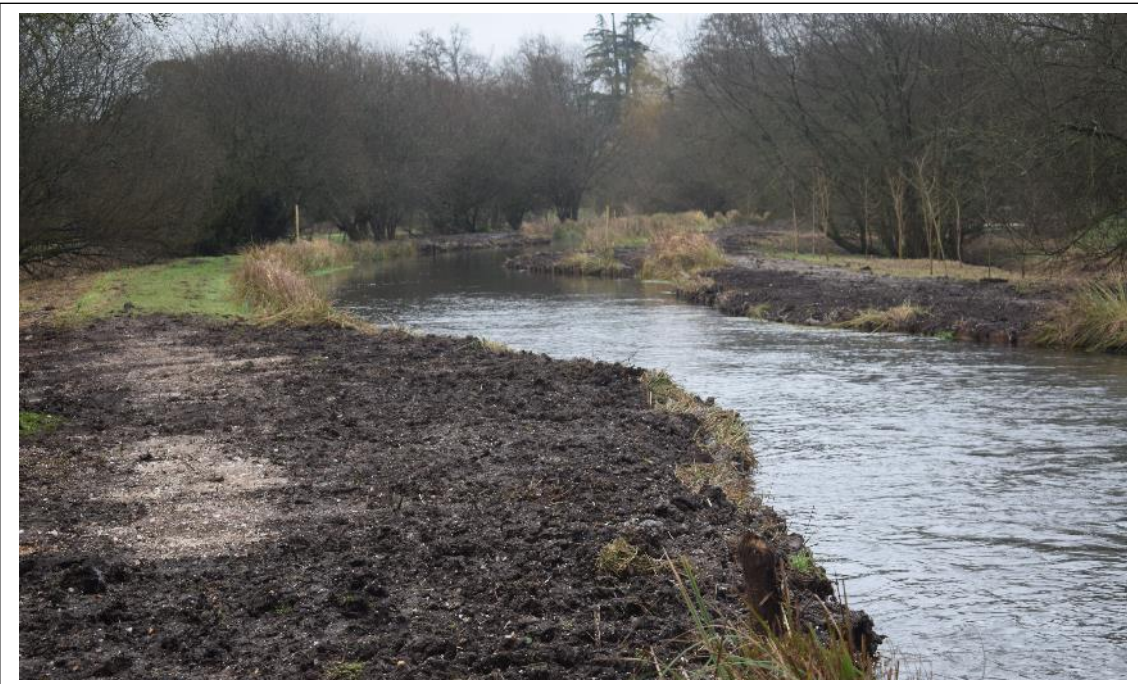
The meanders recently completed and the banks re-profiled.

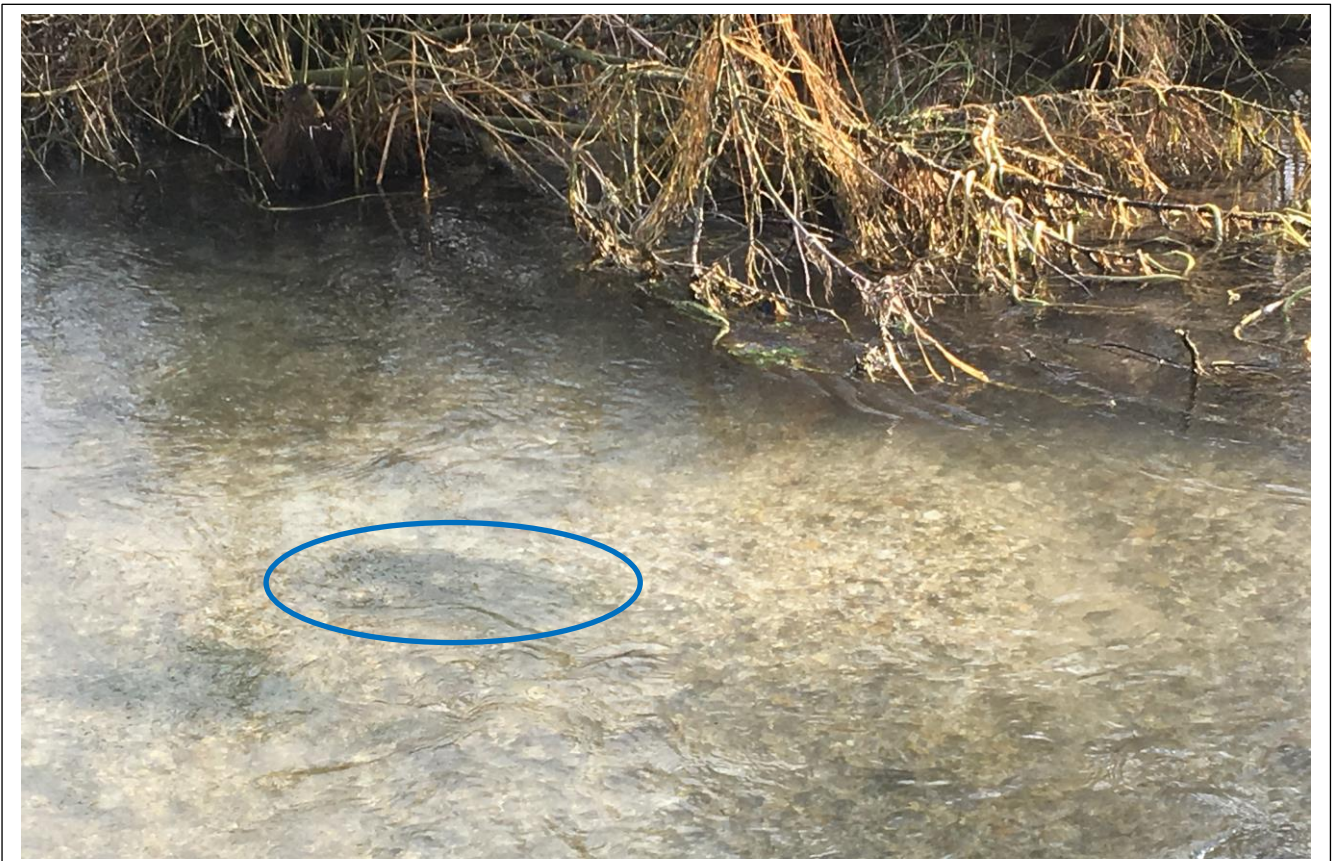
Suspected salmon cutting a redd on the newly introduced gravel at Bossington. This is upstream of the recently removed structure and only two weeks after the completion of the project.
