Test and Itchen Restoration Strategy 2014 collaborative projects between the Environment Agency, Natural England and landowners.

The Test and Itchen restoration Strategy is collaboratively involved in seven projects this year, five on the Test and two on the Itchen. We are also carrying out feasibility reports on three structures, two on the Test and one on the Itchen. The works are a mixture of narrowing, bank protection removal, the creation of islands, and altering and removing structures for the benefit of fish passage, upstream habitat and re connecting the river with the flood plain. All works have had input from Environment Agency geomorphologists, fish passage and flood risk experts and Natural England. The designs at Tufon, Chilland and Twyford are by Nigel Holmes, who is sadly no longer with us and will be missed by all. As of writing, three projects are under way and the rest are due to start soon. Please see below a brief description of each project and the reach number.

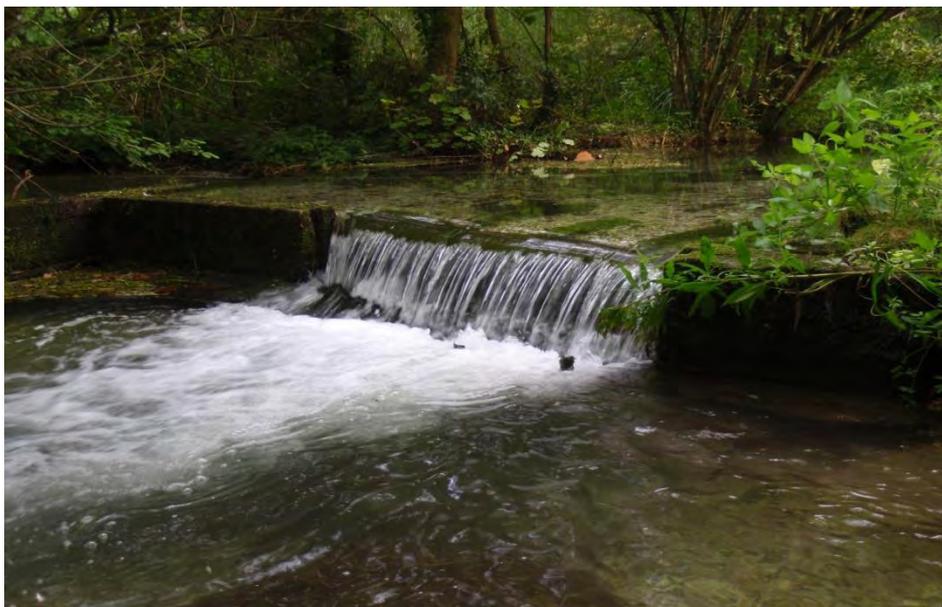
Polhampton.T003 – Rehabilitate.

Presently there is a 3m wide structure which has a 35cm drop. This is impounding upstream and preventing fish passage. Unfortunately the structure cannot be completely removed. The works will reduce the height of the structure, create a rock ramp on the downstream side and a rock crescent on the upstream side. This will reduce the upstream impoundment and increase velocity. The rock ramp and crescent have been designed to focus the flow and thereby improve up and down stream fish migration to this previously unreachable section.

Structure at Polhampton to be improved

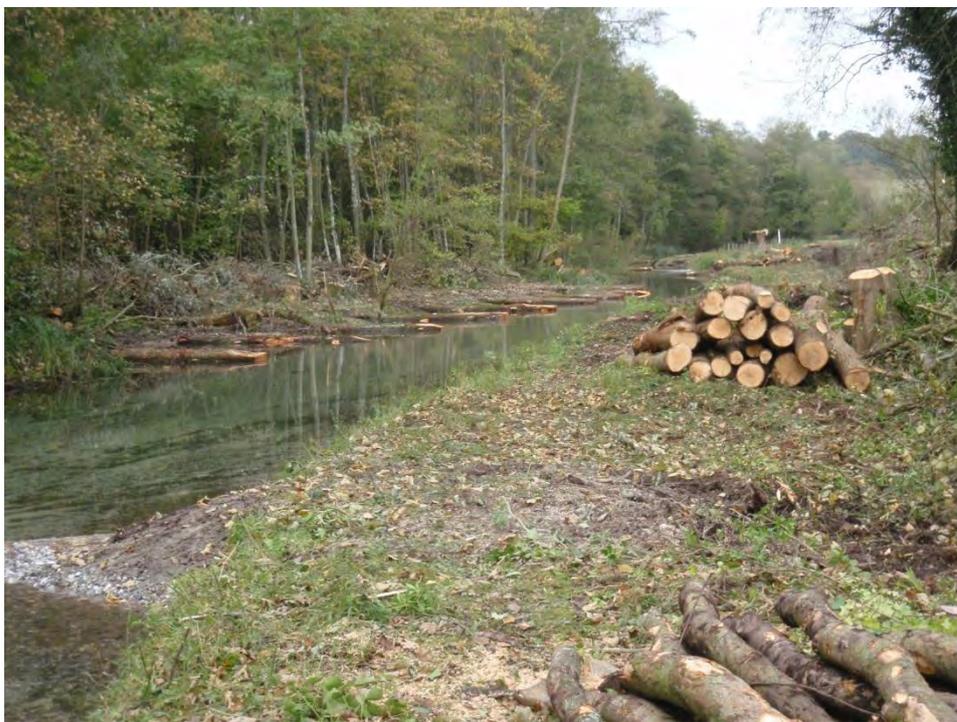
Tufton (phase 2). T025, T026, T028 – Rehabilitate.

Work on the main channel was completed last year and this year's work is focusing on the by stream. Previously this was a straight, heavily shaded channel with little in channel or bank side habitat. Restoration involves pinch points, creating shallow scrapes to hold fish, meanders, re-profiling the banks at various locations, removing a structure and tree work to allow more light into the channel and provide woody debris for re-profiling . The section is approximately 600m long and works is taking place on both banks. Works have started here and are going well. Last year's finished works give a good idea of how this will improve and mature with age. Future management will be more subtle than in the past as is already being seen on lasts years restored section. Once this work has been completed units T023, T025, T026, T027 and T028 will all have been finished.

Tufton phase 2 – work in progress

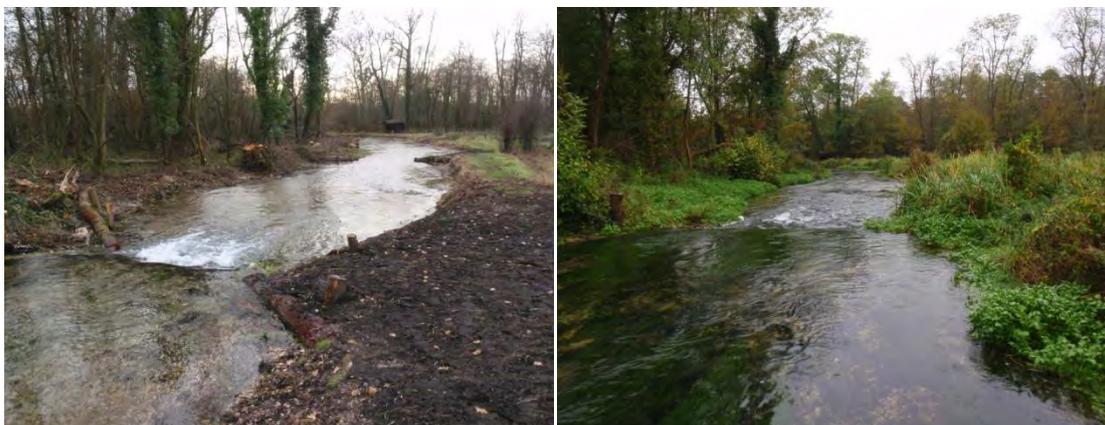
Before and after shots of Tufton phase 1.

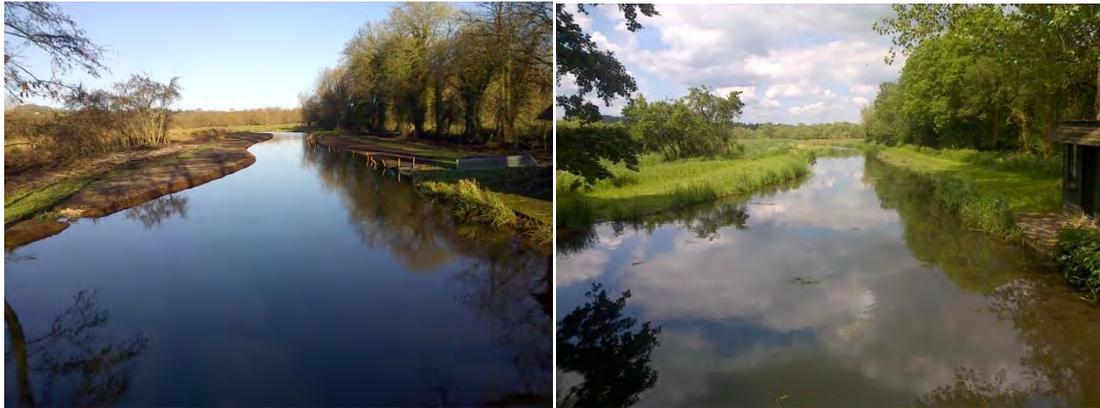
Houghton Club (phase 2). T089 – Rehabilitate.

This is a continuation of last year's work and will improve both banks in a 100m section upstream of the previous works. The restoration will create meanders in a presently straight and historically dredged section using previously dredged material to create the meanders. Small trees along the true left bank will be thinned out to allow more light in so as to encourage bank side marginal vegetation. If gravel can be won locally bed raising will take place to help further improve in stream velocities and therefore habitat. As on the previous site, bank side management will also be more subtle.

Before and after shots of last years work.

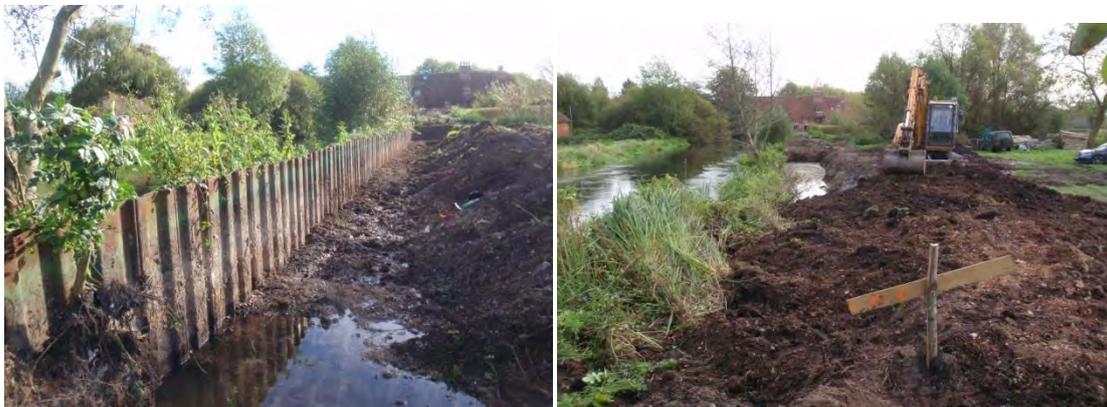
Upstream of Saddlers Mill. T148 – Rehabilitate.

Work will involve various types of restoration techniques to the true right bank to improve bank side habitat and re connect the river with the flood plain. The total length to be improved is approximately 100m. On one section 40m of steel piling is being completely removed and the bank re graded to improve bank side habitat for water voles and marginal vegetation. The front will be protected initially using heavy duty, large diameter faggots planted up with the vegetation already on site. Due to the sensitivity of flooding here colleagues from flood risk advised on the feasibility and construction. Other sections are being narrowed due to historic cattle poaching. The removal of the steel pilings has started, see below.

Steel piling exposed prior to removal. Piling removed and bank being profiled

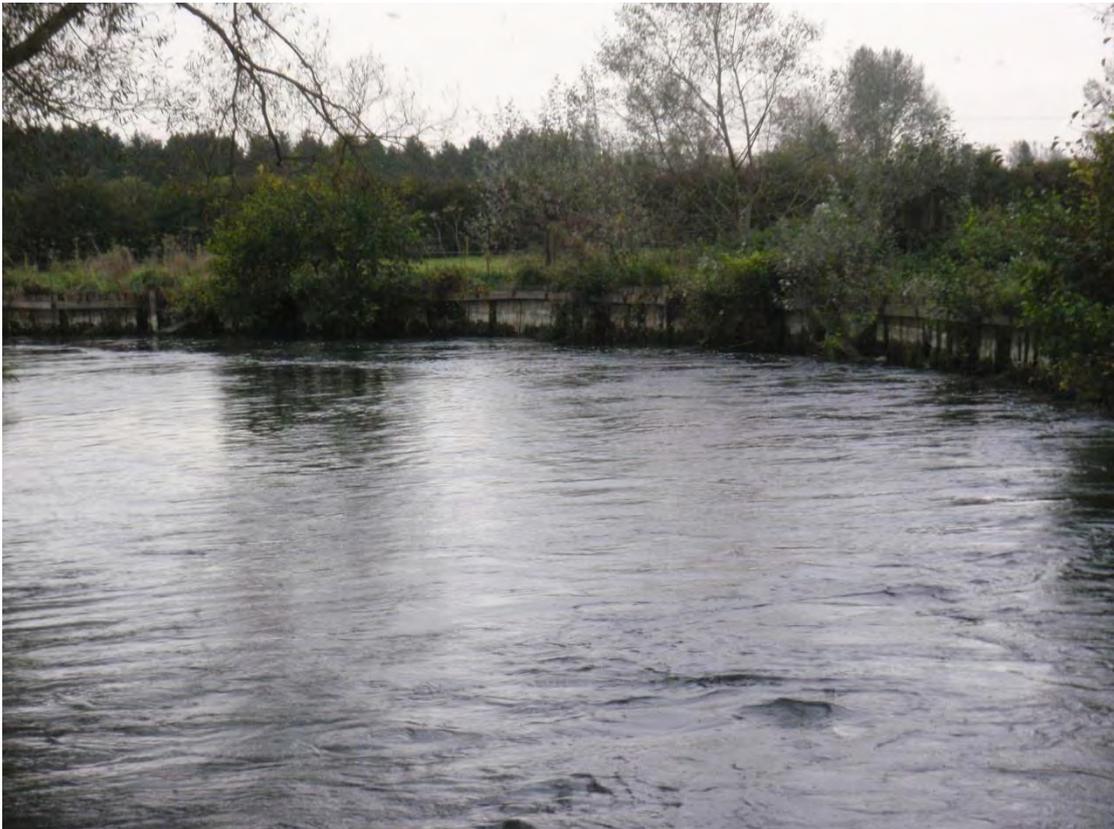
Broadlands. T150 – Conserve and Enhance.

Although this section is down as conserve and enhance within the Strategy, this particular area is highlighted as 'remove bank protection'. The work will involve removing 110m of wooden piling from the true right bank and re grading the banks to form a shallower gradient. This will increase channel capacity, re connect the river to the flood plain and help natural river processes take over for the benefit of the opposite bank which has suffered due to the presence of the piling.

110m of wooden piling true right bank

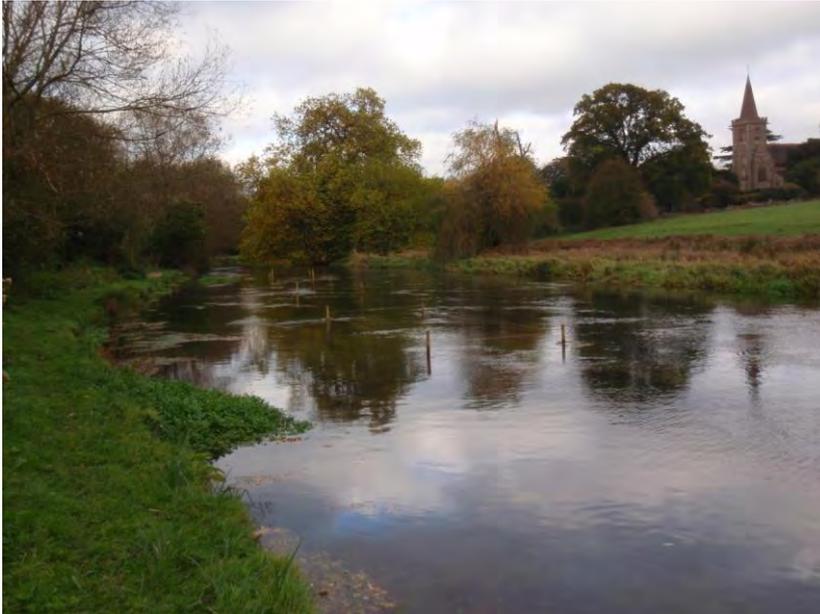
Twyford, Bishopstoke Angling Club. I65 – Rehabilitate.

This is an ambitious project to build 3 islands in an overly wide and historically dredged section of river. Work has just started here. The islands will be constructed in limestone rock and planted up with locally won woody debris and vegetation. Due to the sensitivity of flooding in this area colleagues in flood defence were consulted and were happy for the works to go ahead as the historic flooding in Twyford occurs from runoff from the north not the actual river. The club have asked for a small single span bridge to one of the islands to access fishing. While not absolutely necessary it was agreed for the good of the project and will not detract from the overall improvement to this stretch.

Looking upstream – view of over wide, slow, dredged section with islands staked out.

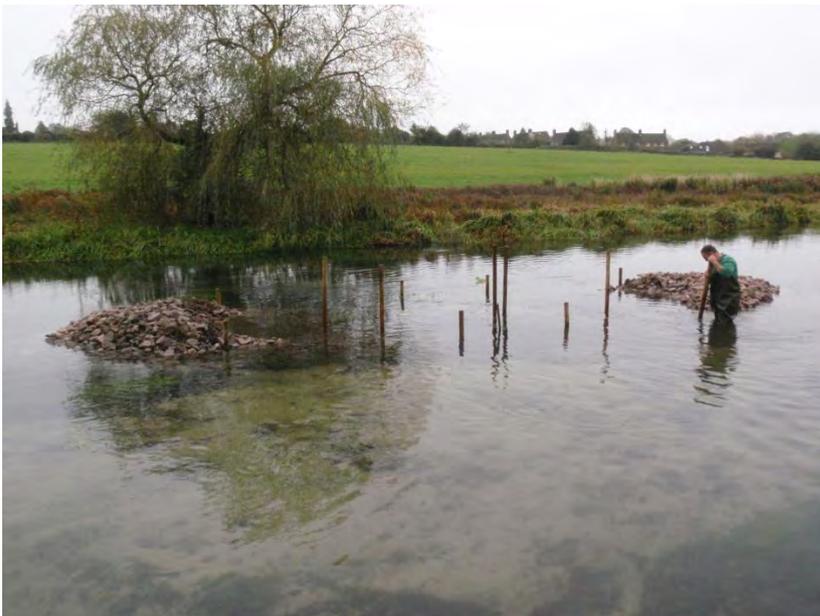
First island being built – notice near bank mobilisation of silt already due to increased velocities.

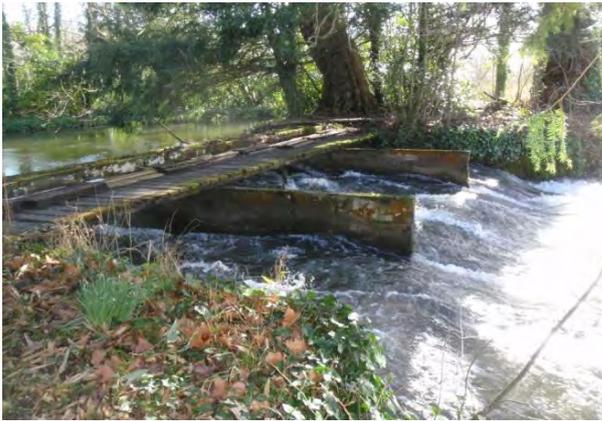
Bossington structure

Once contractors have been chosen three structures are to be surveyed to assess their suitability for either removal or alteration to improve fish passage, flood risk, salmonid spawning and upstream habitat in general for the benefit of the SSSI. The three structures are at Bossington, the Houghton club on the Test and at Winchester College on the Itchen. The owner at Bossington is very keen to have the structure removed/alterd which will improve in-channel conditions up stream. We will have to see what the report says before the Houghton club or Winchester College are 100% on board but the floods at the beginning of the year have highlighted to them the need that something needs to be done.

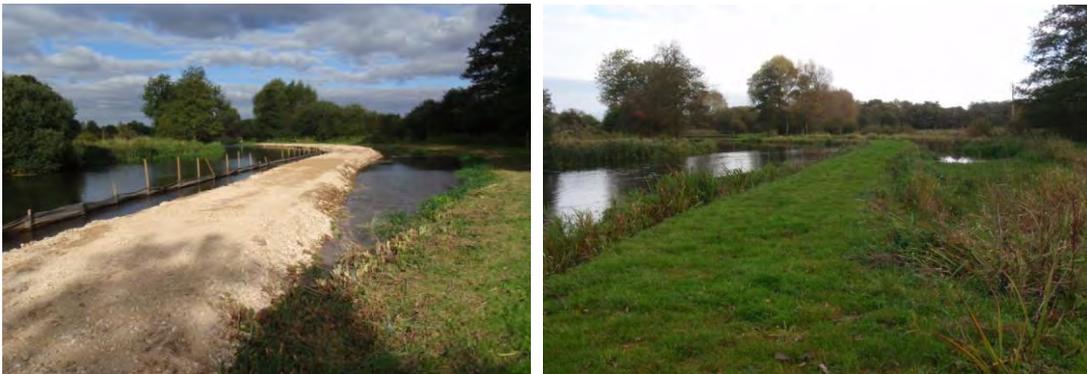
All the works from last year are maturing nicely with evidence of water voles, *Ranunculus* growth and an abundance of adult and juvenile brown trout. All those collaboratively involved with last year's work are also very happy with the outcome of the various projects. As agreed with owners and keepers, a more subtle style of management has allowed margins to grow which is providing excellent habitat for plants and invertebrates. Unfortunately not all anglers appreciate this style of management and there have been a few complaints at some locations over the difficulty of access to the water's edge. The restored sites also, as would be expected, have faster velocities. While this is ideal for wild fish it is not the preferred habitat of large stocked fish and again anglers have complained about the difficulty in fishing some of these restored sections. To date keepers have created gaps in marginal vegetation to provide better access or built fishing platforms. Keepers are also being encouraged to inform/educate anglers as to the importance of the wider environment they are fishing in and the SSSI designation and what that means.

Before and after, 1 year old – Houghton, river Test, Blackbridge

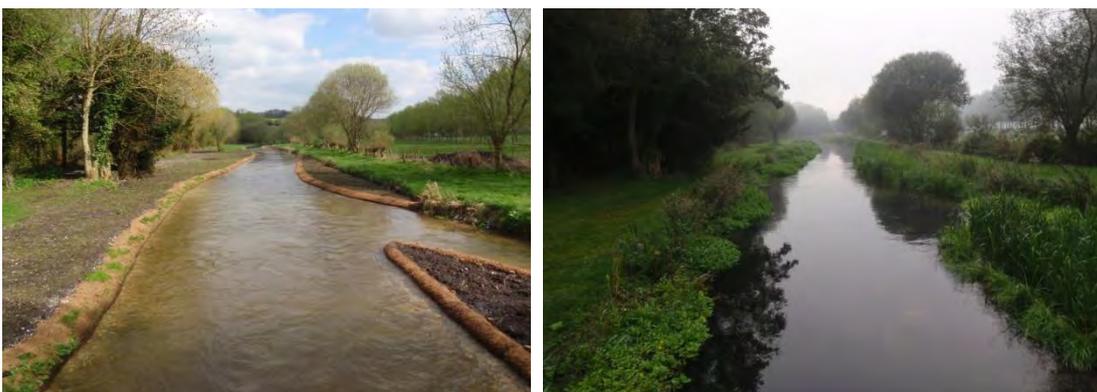
Before and after, 7 months – Compton, river Test, upstream of 'swimming pool'.
