## Bank Protection

## Brash Bank Protection

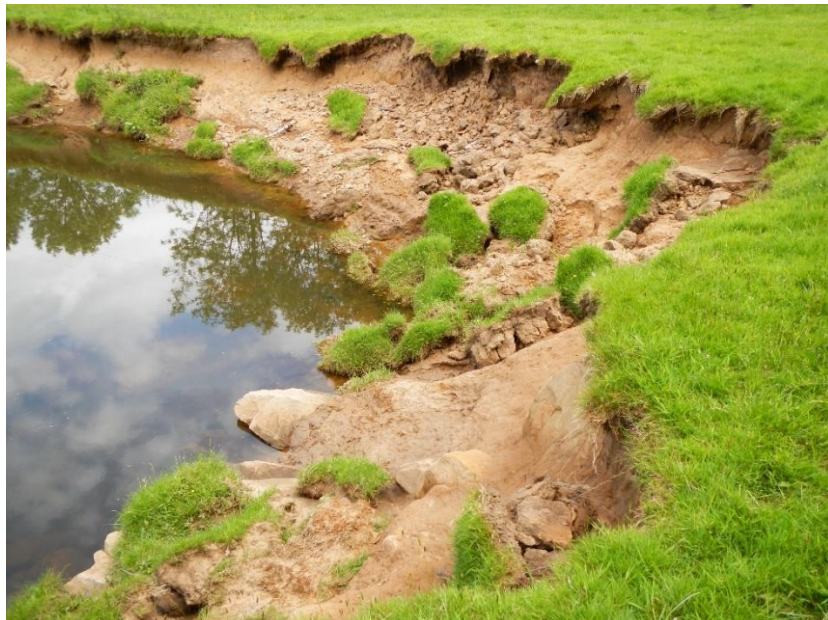
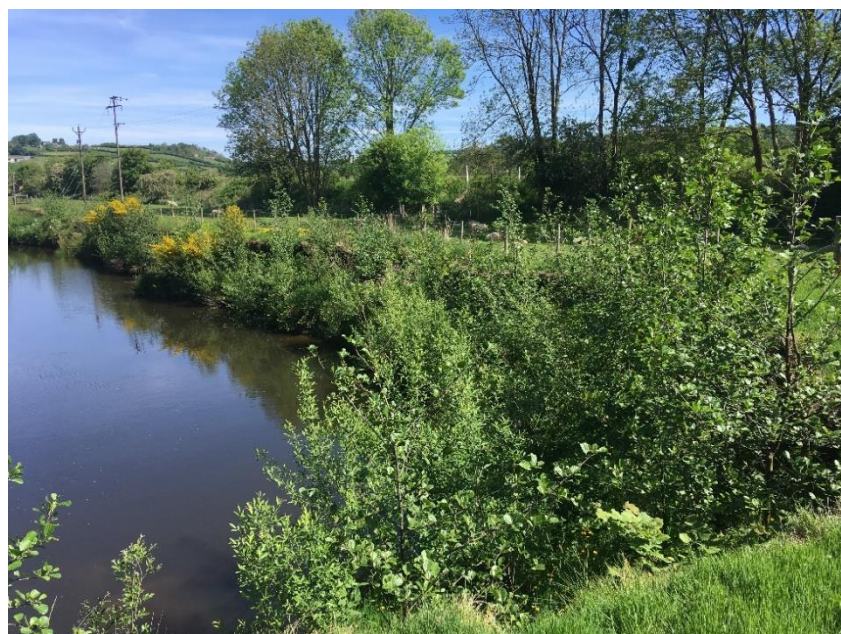
In the following example, fencing to exclude livestock, tree planting and light regrading by hand with spades is all that was required to restore bank stability.

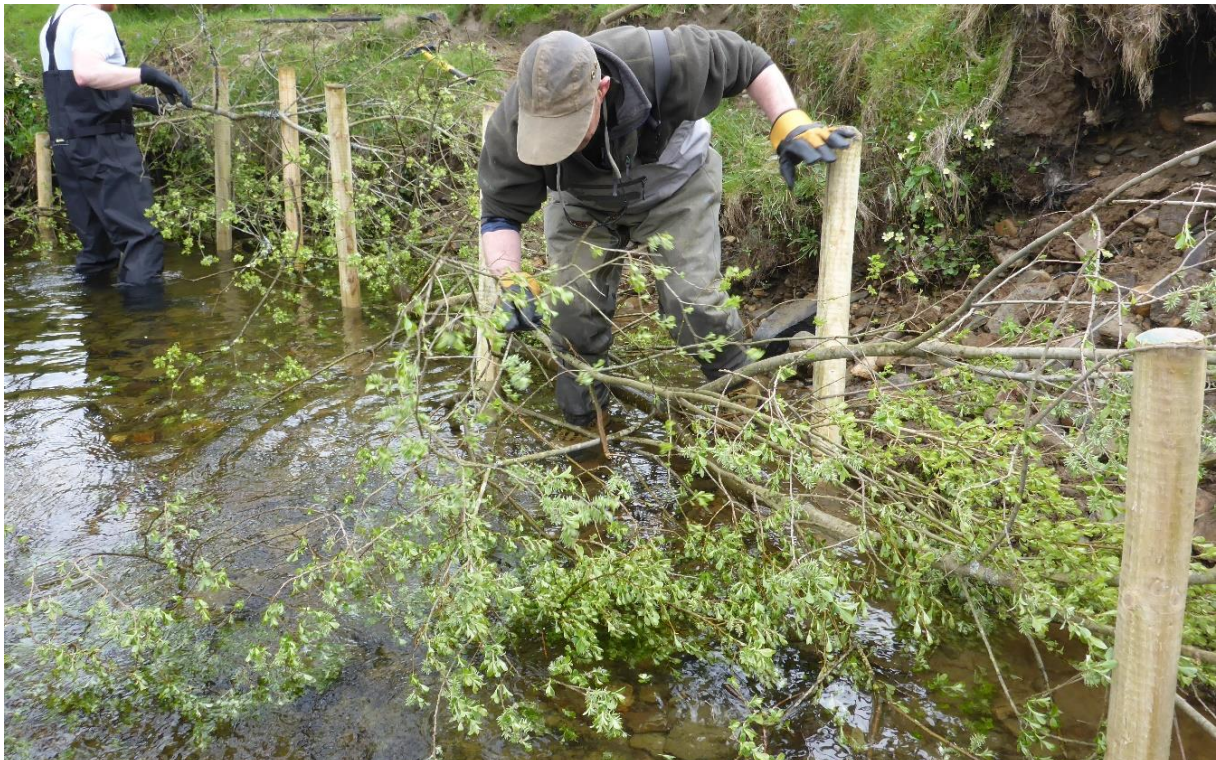
*Above - Live willow being loosely woven between the posts of the bank protection – unlike the hard, tidy line of traditional tight willow spiling (or rock or wood revetment), this provides diffuse protection from day 1, and is far less likely to create erosion issues elsewhere. Also note the valuable in-channel structure created for fish and invertebrates.*

Brash bank protection entails installation of brushwood/branches to protect the bank face and/or toe, prevent undercutting and retain any slumping material *in situ* long enough for vegetation to establish. The brash is pinned down with further branches over the top as batons, which are secured at either end with posts and sometimes a length of low-tensile wire. It can be beneficial to include live willow within the matrix, as it will usually take root and grow if in contact with damp sediment. Additional grass seed and tree planting can help, but are not always necessary. This method also requires livestock exclusion to treat the issue as well as rectifying the symptoms.

Contrary to popular belief, the hard, tidy lines of many bank protection measures, including willow spiling, can be counterproductive, and often simply deflect flow energy onto other areas of the bed or bank – much as harder, artificial bank protection does. This is why willow spiling can often fail in its first year or two, after which the bushy growth can begin to protect the bank. It is usually far better to protect a bank from the start, leaving a scruffy, brashy edge that baffles flow and encourages deposition of fine sediment. That deposition can even help to rebuild the bank line, providing a nutrient-rich growing medium for the vegetation that will ultimately colonise and stabilise the bank. A nice scruffy margin is also far better for fish and invertebrates, which will utilise the structure as refuge.

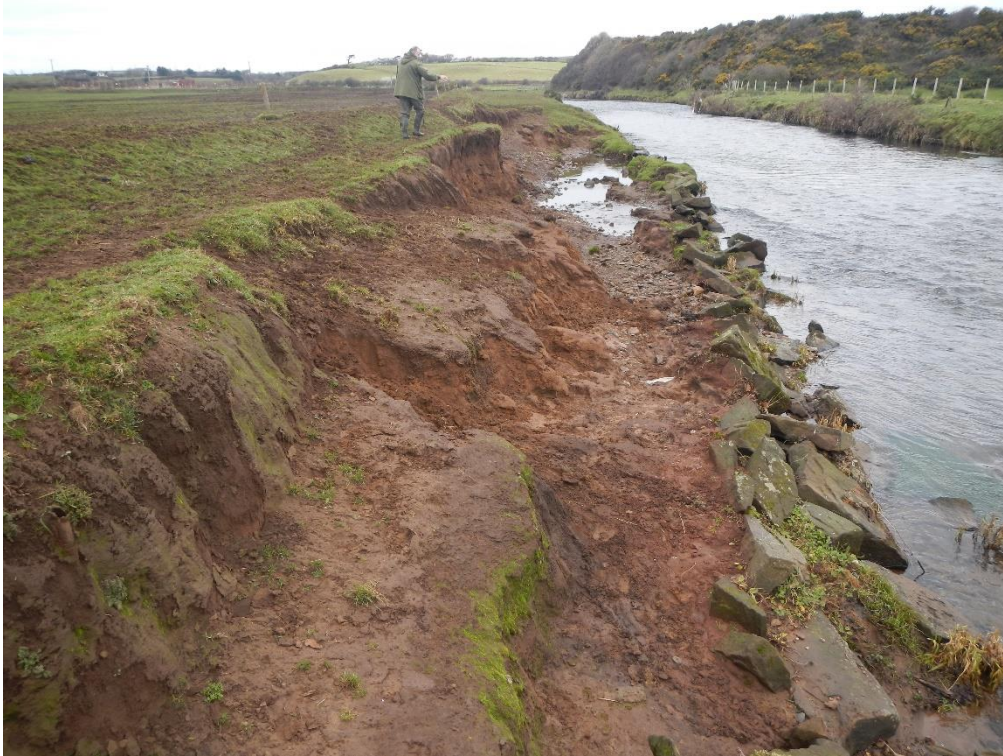
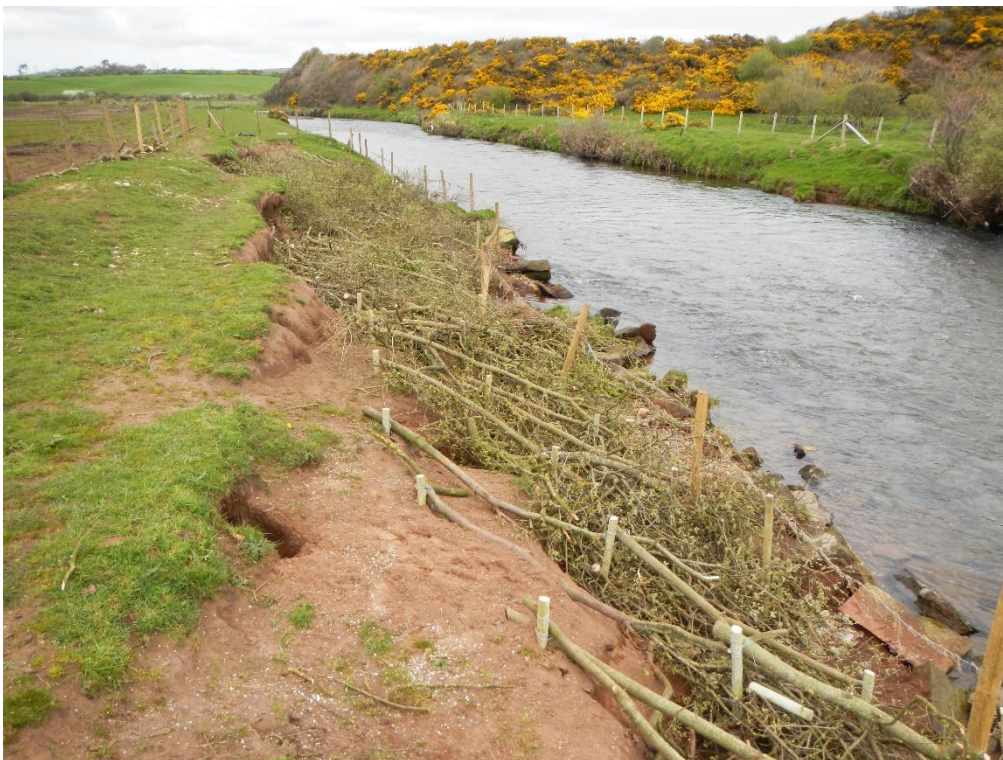
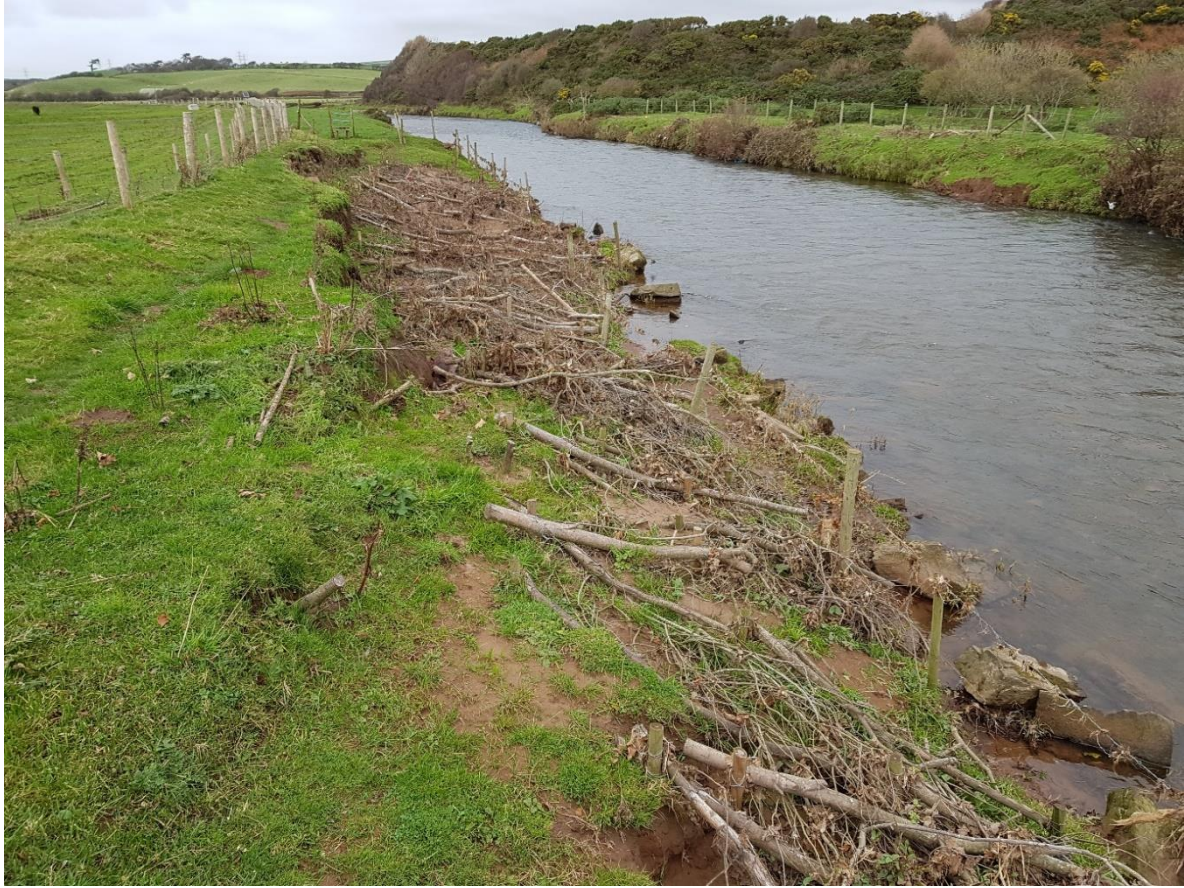
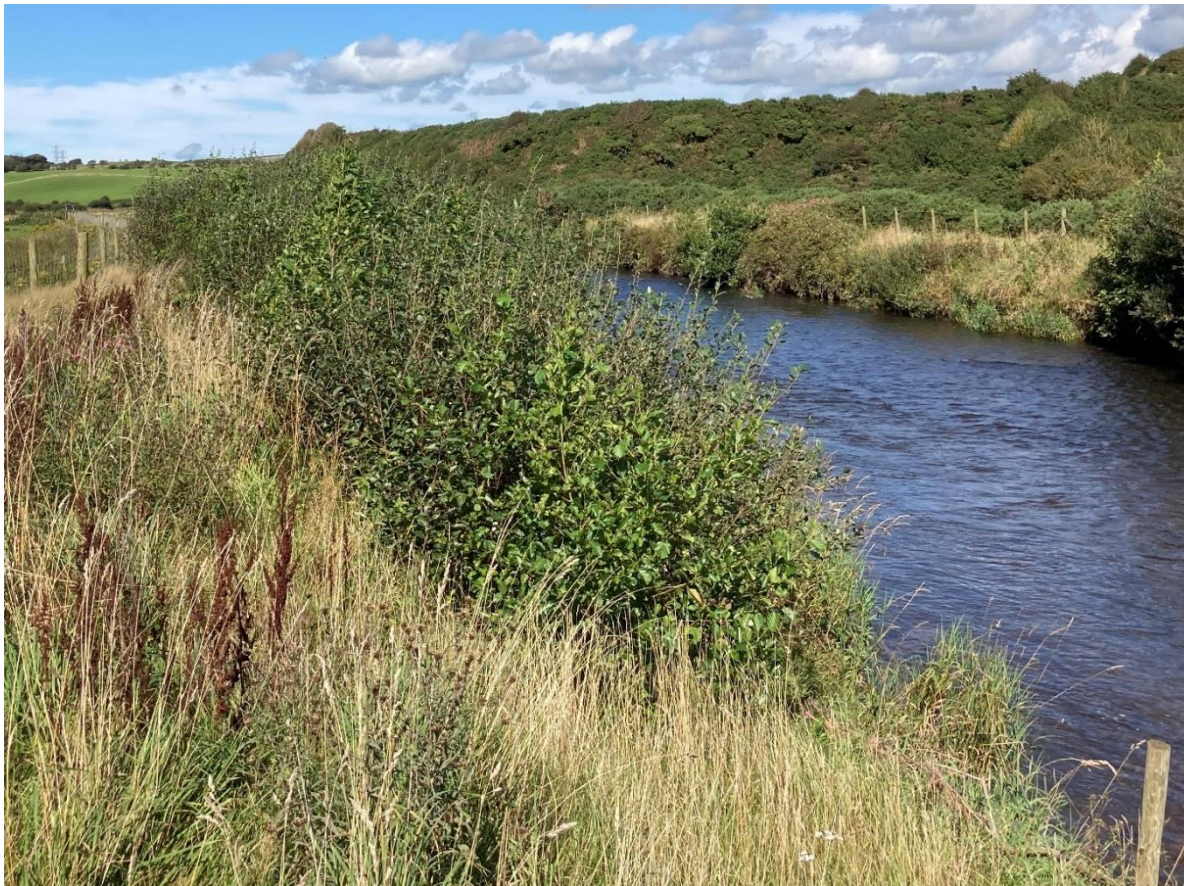
The following sequence shows how the installation of a brush mattress not only halted further erosion but dissipated flow energy sufficiently to facilitate deposition of river sediment that filled the erosion void - in less than one winter. Several years down the line, the area is now a stand of willow and regenerated alder. The contribution fencing made should not be underestimated, as although the brush fixed the erosion scar, the fencing prevented livestock from perpetuating the issue.
