Langley Mill fish pass design, River Erewash

Tender Invitation

Advisory Visit

River Erewash, Fish Passage Appraisal, Langley Mill, Derbyshire

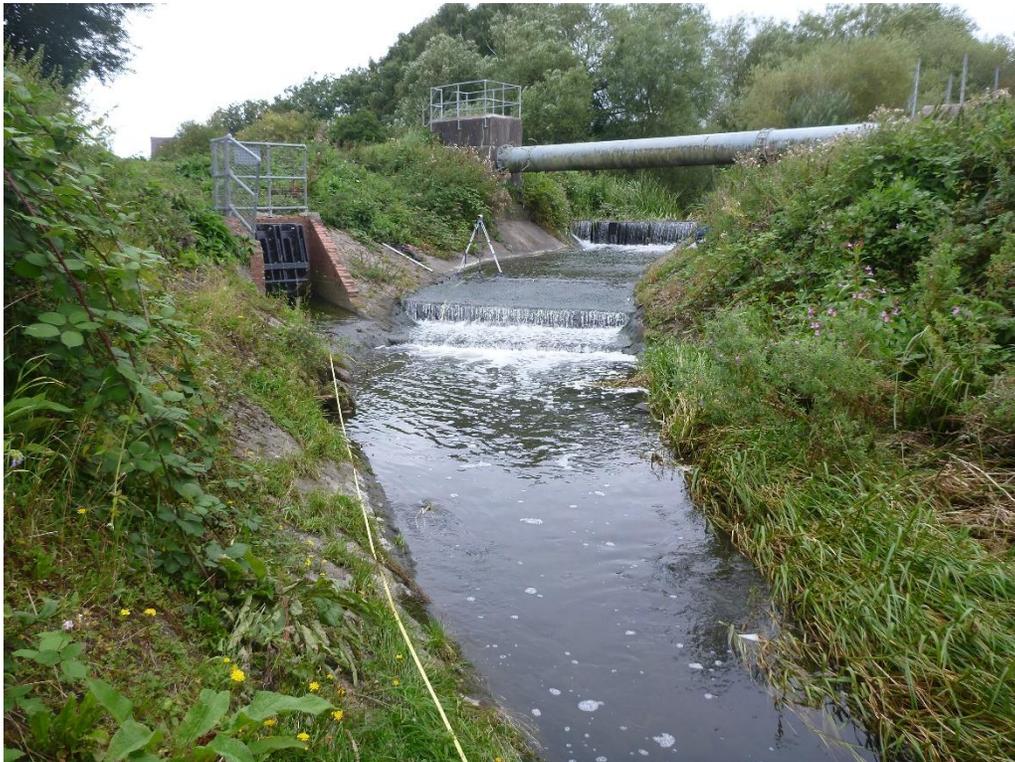
Photo 1 Langley Mill weir

The weir structure consists of a crest at the upstream end, 9.5m wide across the channel with a vertical drop of 0.925m onto an extended concrete apron (water level difference also 0.925m). The apron extends approximately 15m downstream at a gradient of 1.2%, then a further 3.6m at 5.3% to a vertical step 0.34m high. The apron continues a further 1.7m downstream of the step, to another vertical step of 0.4m to the downstream riverbed level (water level difference across this downstream step was 0.14m). Water level difference (head loss) across the entire structure was 1.805m over 20.7m (Photo 1).

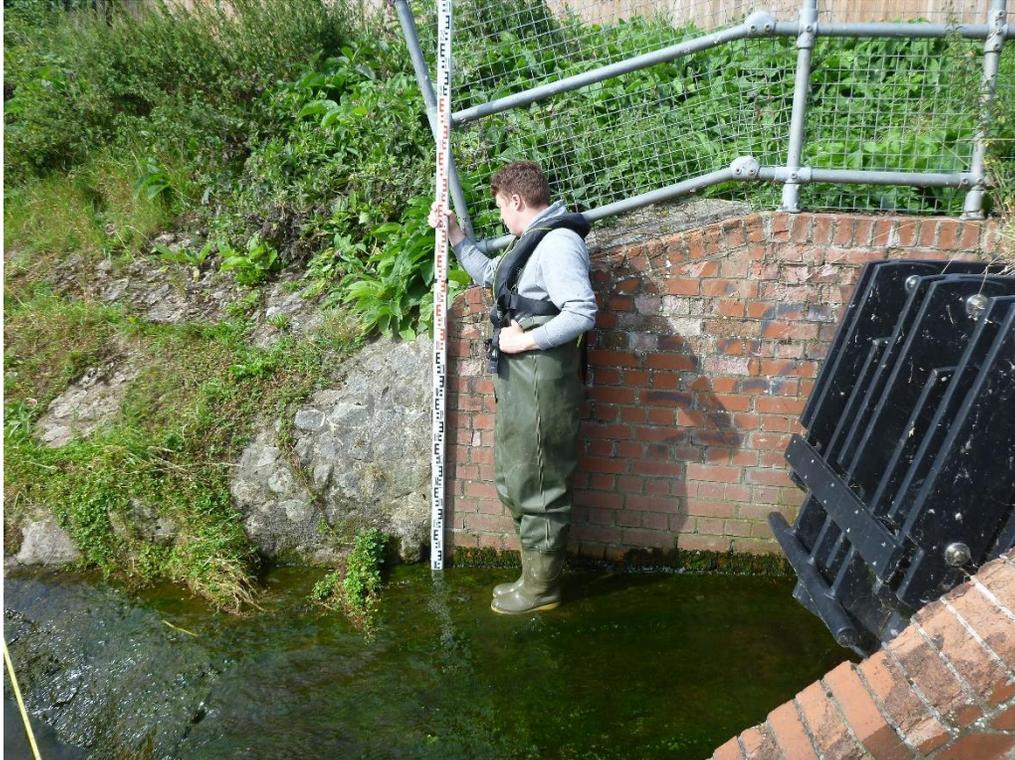
During the site visit, a levels survey of the weir structure (including the 20.7-m long apron) and the riverbed levels upstream and downstream was carried out using a dumpy level. The levels quoted in this report are relative to a temporary benchmark taken on the concrete base of the combined sewer overflow (CSO) at the edge of the brick wall (Photo 2), located at the downstream end of the weir apron.

Photo 2 Temporary benchmark position, NGR SK4528247570, nominal level 3.3m

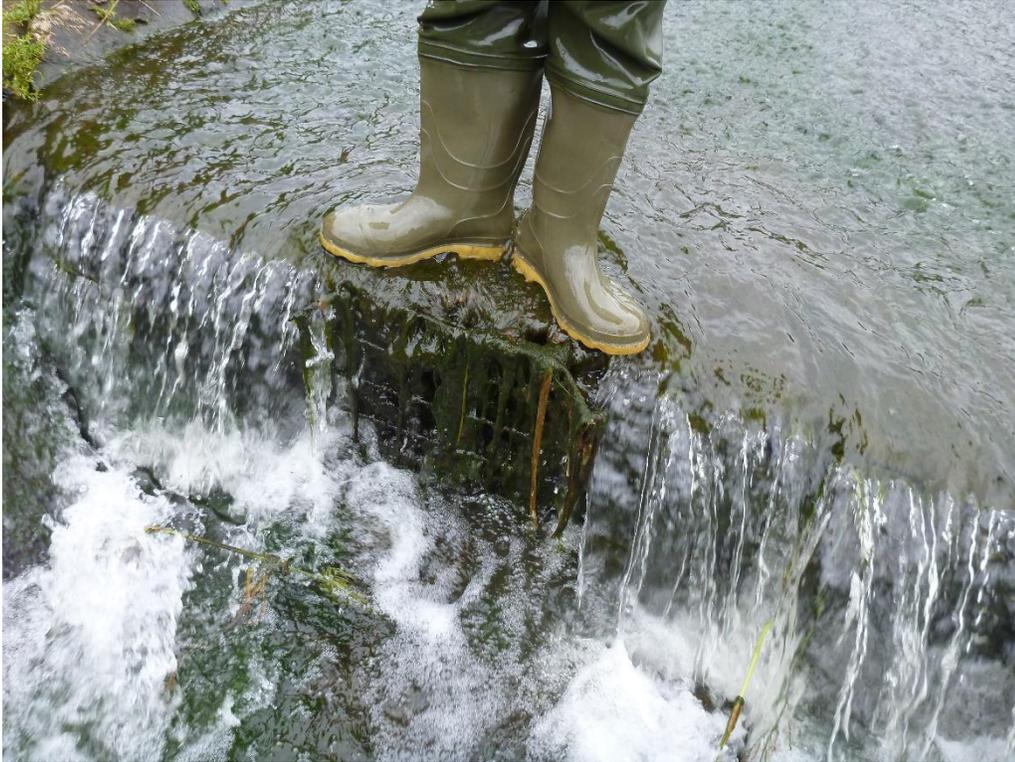
- The steps in the concrete apron appear to be constructed from gabion baskets with a concrete skim above (Photo 3). The main weir appears to be constructed of sheet piling with a concrete crest (needs confirmation) and there is considerable undermining of the crest – possibly the reason the concrete apron was installed downstream in the 1980s.

Photo 3 Gabion construction of steps in weir apron.

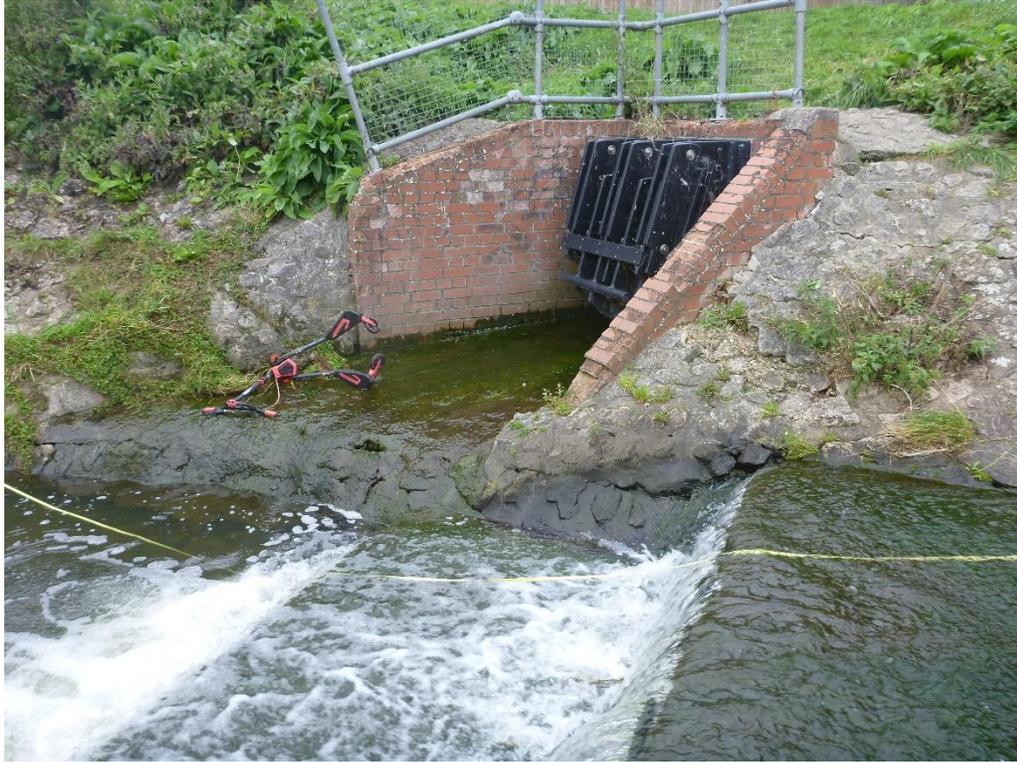
- The combined sewer overflow pipe (with flap valve) outfalls to the river on the RHB, immediately downstream of the steps at the downstream end of the concrete apron (Photo 4). The invert level of the concrete base of the outfall is 3.3m.

Photo 4 Combined sewer/surface water outfall

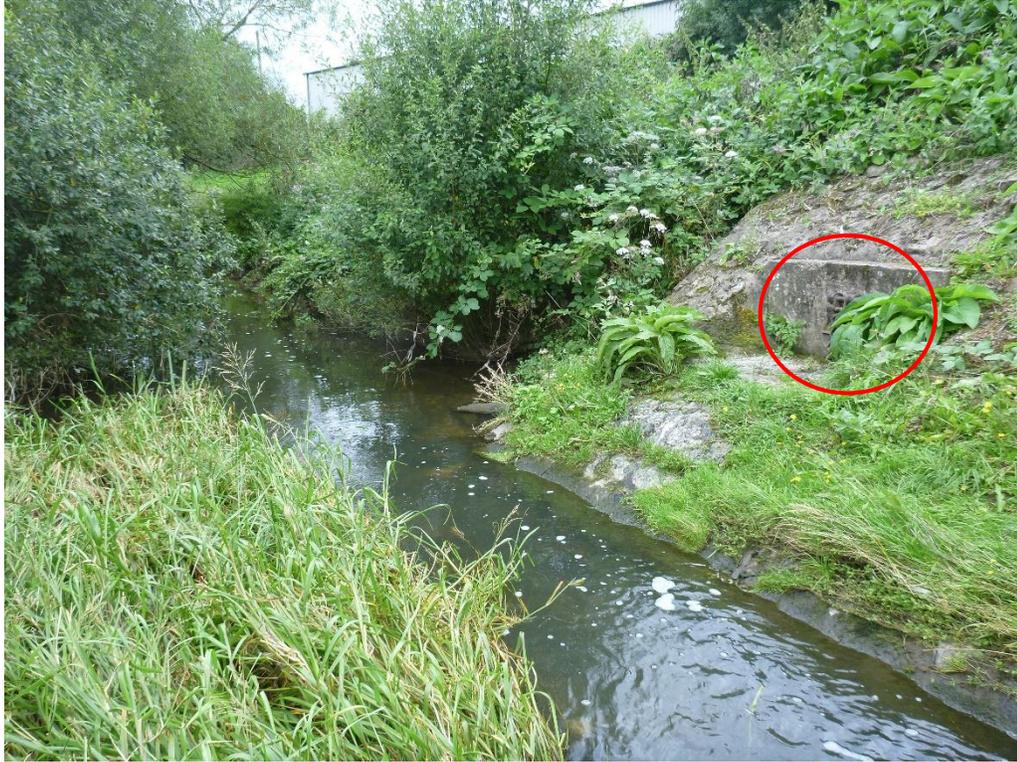
- Downstream of the steps there is a natural river bed; the RHB consists of stone cemented in place, extending to approximate chainage 42.5m where there is a small flapped surface water drain outfall (Photo 5). The LHB was overgrown with brambles at the time of the visit, but is thought to be an earth rather than stone bank. A low berm of sediment consolidated with emergent aquatic vegetation was present against the LHB, narrowing the low-flow channel.

Photo 5 Downstream end of site (chainage 42.5m), end of artificial stone bank on RHB and flapped outfall (red circle).
