# THE RIVER YARROW & TRIBUTARIES

Advisory Visit Report  
Undertaken on behalf of the Wild Trout Trust

By Ron Holloway MIFM  
7<sup>th</sup> December 2001

## River Yarrow Visit 7<sup>th</sup> December 2001

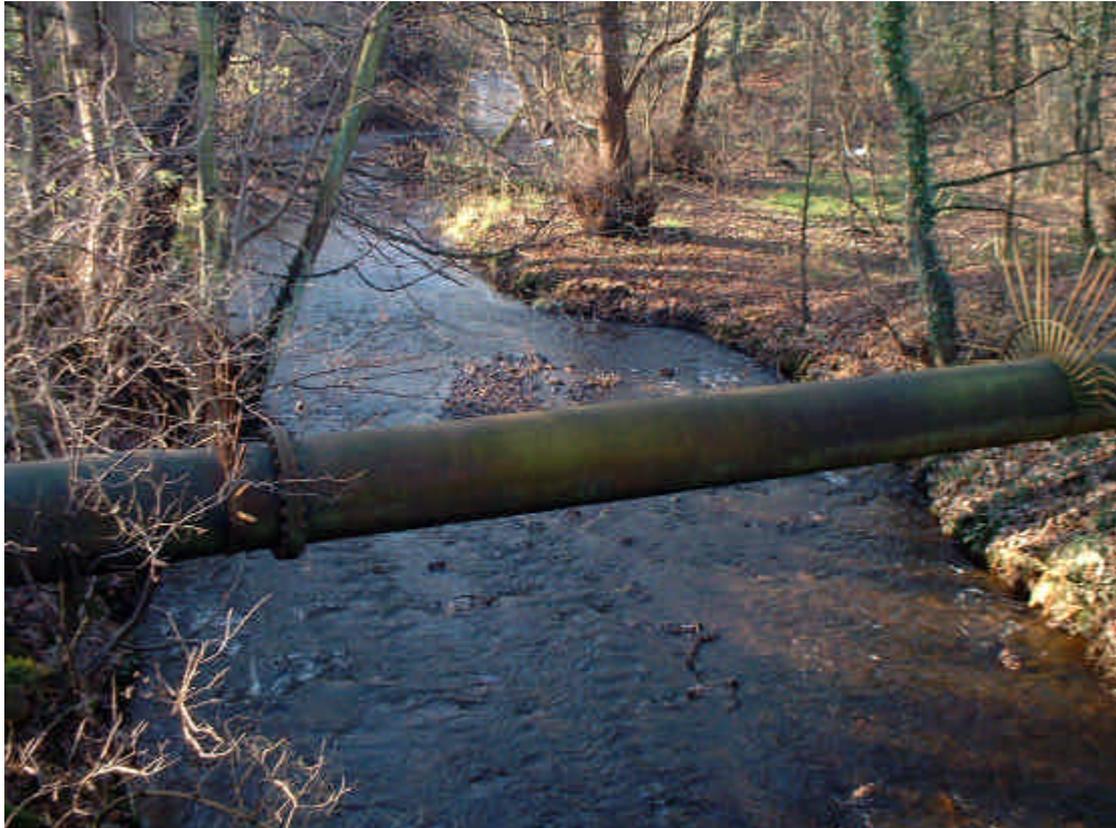
**Blackbrook – Fig.2**

Water quality is good (see EA report) the substrates as viewed from the bridge are suitable for salmonid spawning and the quality of substrates improve as one progresses further up the Blackbrook. Recent EA surveys (Oct.2001) indicate good survival of 0-1 young of the year trout and some numbers of 1-2 year class. The spawning potential is excellent and the Blackbrook offers good nursery facilities for trout once access is made available by the removal of the weirs downstream.

Recommendation: Protect as is and continue to monitor spawning and young of the year survival.

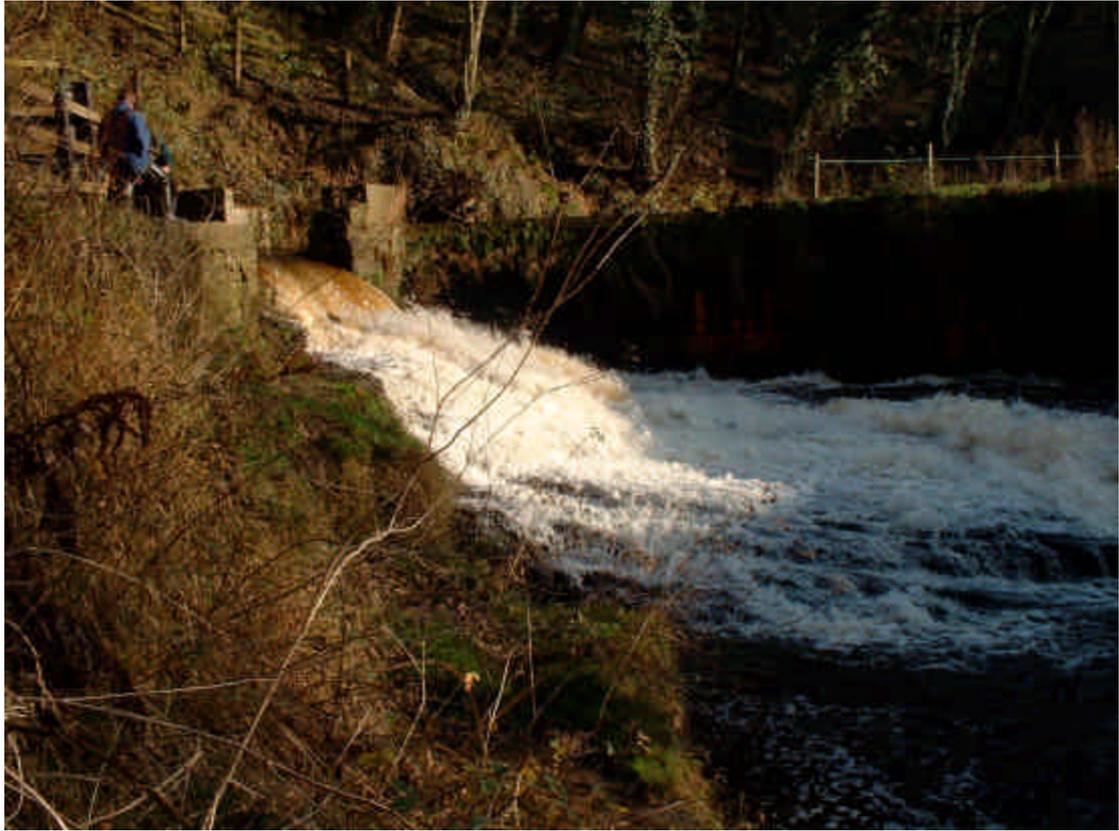
**Fig. 3. – Birkacre Weir**

This weir, (see Figs. 3 and 4) is also an impassable obstruction for most species of fish. The requirement for maintaining the height of the head of water above this weir which allows water to feed the two ponds (lodges) via a 6" pipe by gravity flows precludes the removal or lowering of this weir. The most realistic option to follow which would allow access for migratory fish to the substantial and excellent fish habitat upstream, would be for a fish pass to be constructed. The geology of the natural substrate below the weir and the construction and geomorphology of the weir itself, precludes contemplating the siting of a fish pass through or over the main weir sill. The one, if not only option, would be to construct a stepped fish pass around the weir on the far side of the weir, through the private property of the neighbour. Besides being the most practical option, this siting of the pass would also protect any running fish from the unwarranted attention of members of the public! The construction of a fish pass through or over the weir sill would attract the attention of passers by on the footpath only a few feet away.

Recommendations: History states that there has been a by-pass channel constructed and used around this weir in recent times which allowed the water take-off mechanisms to supply the ponds to be installed. It has been suggested that some numbers of migratory fish did use this temporary by-pass channel when it was in use and what seatrout have subsequently been observed trying to negotiate the almost impossible part of the weir, are the descendants of those fish which used the bypass channel and made it upstream to the excellent spawning gravels.

It is suggested that permanent fish pass is designed and constructed along the same historic bypass channel which was previously used by the engineers. Careful consideration to the design and incidence, size and depth of the steps of the pass has to be made, allowing for suitable standing waves in each step to assist fish to propel themselves up the pass.

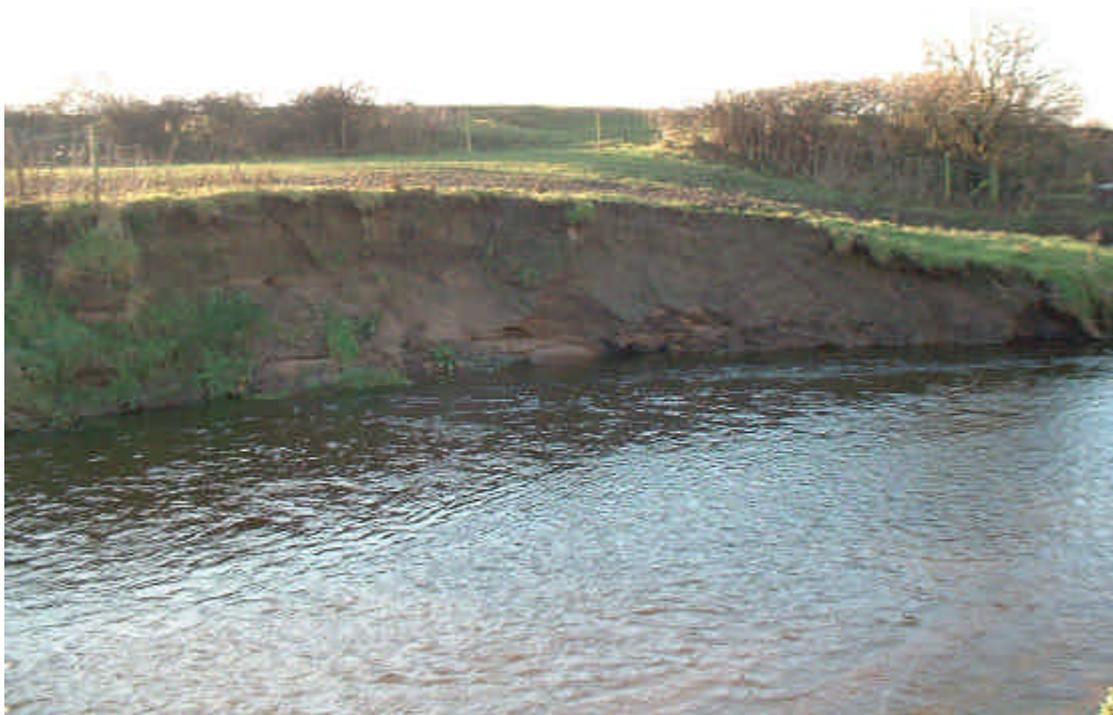
**Fig. 5 - Erosion**

**Site Four:** The Banks of the Yarrow from Eccleston Bridge downstream to Croston Weir –See Fig.5.

Although there are one or two major erosion points along this reach, the general structural condition of the river bank is good. Where erosion is occurring, the suitable use of willow spiling is suggested along with some reprofiling of the steep banks which would then allow for replanting with indigenous tree species and native occurring bankside vegetation. This will naturally stabilise the vulnerable soft banks. To complete the protection of this stretch suitable stock fencing along the whole length is intended, but allowance should be made to leave suitable and acceptable stock watering access for livestock.

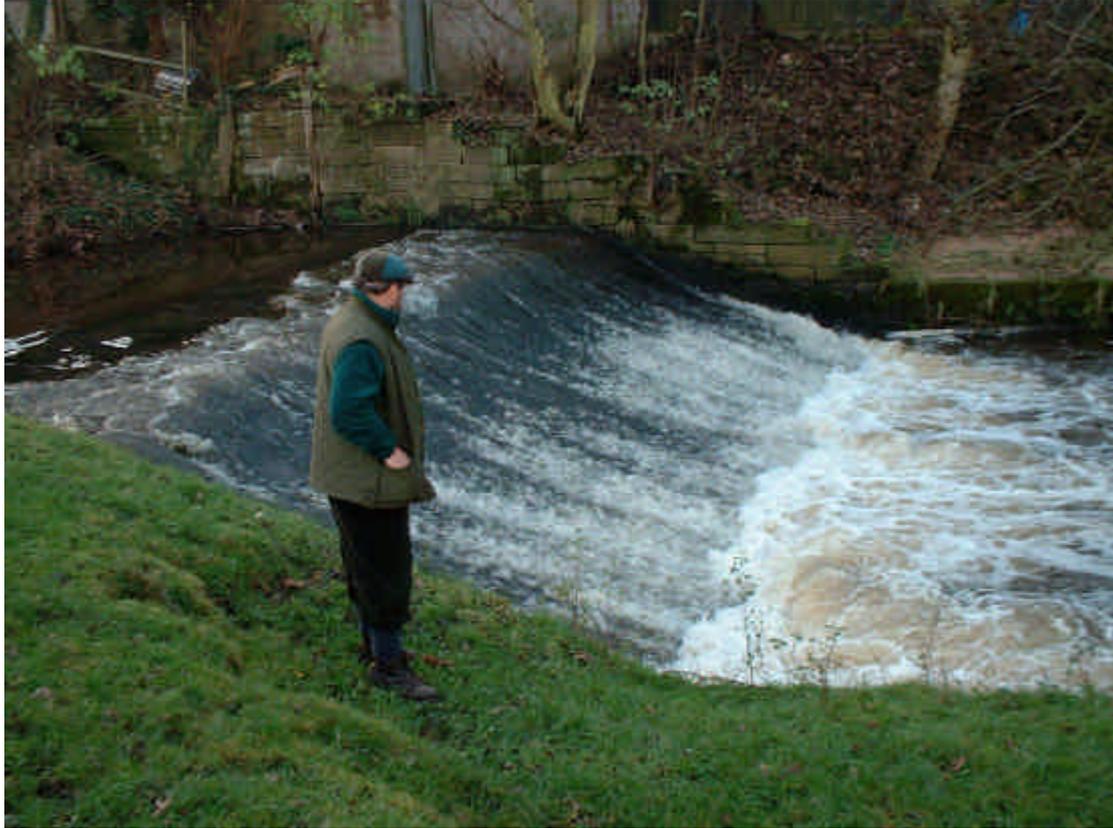
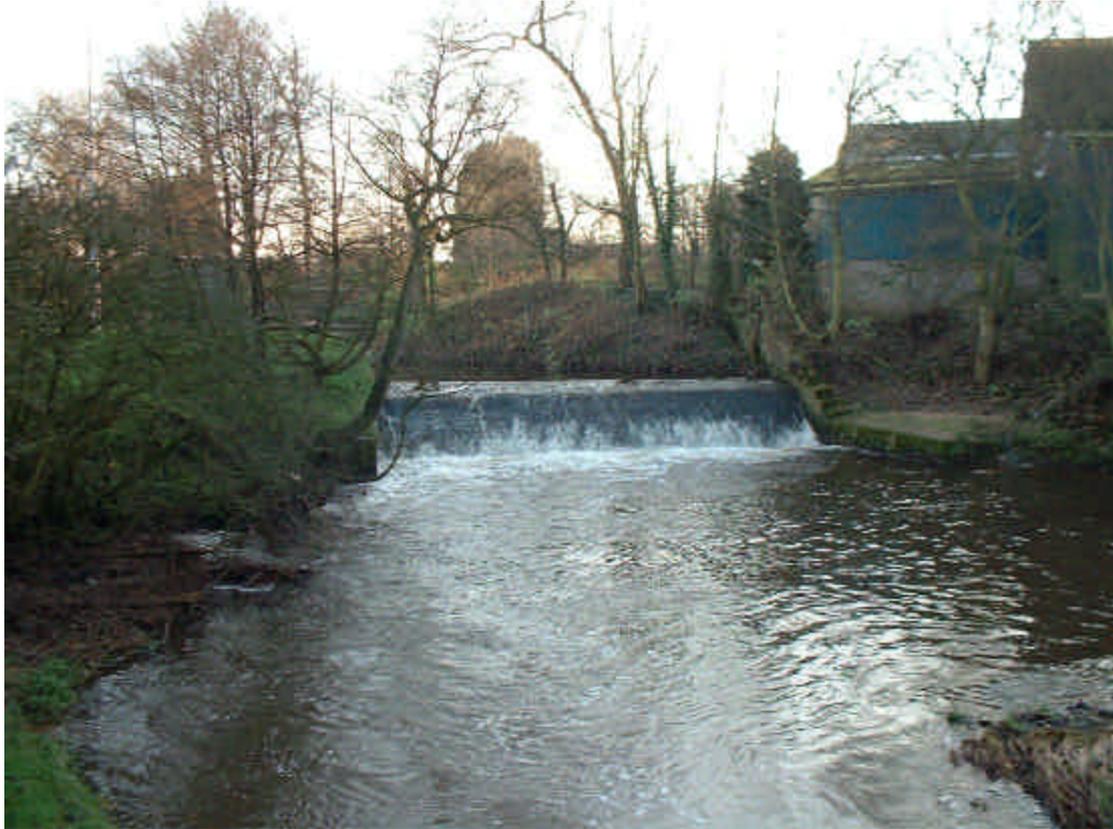
**Fig. 6 – Croston Weir**

For some years, it was thought that Croston weir presented an insurmountable obstruction to all species of fish seeking to attain the ever improving aquatic habitat upstream of this obstruction. It has, however, been accurately documented that migratory salmonids (seatrout) have been observed and counted either scaling the sloping weir face or at times when flows are suitable, actually clearing the weir completely (using the Fosbury Flop technique I believe!) However, it has been noted that it was predominantly small seatrout who have been most successful in this feat. This poses the question whether the weir is actually selecting mainly for these agile young seatrout and precluding the older and larger adults from reaching the upstream quality spawning areas.

Recommendations: It is suggested that serious consideration be given to installing a fish pass around (preferably) or through or over this weir. The ideal option would be to construct a shallow three step pass around the weir on the mill side. The alternative is to construct a denil pass through the centre of the weir which would be more difficult and more expensive to construct.

large numbers of late run big mature hen fish. Therefore, it is suggested that although the Croston Weir allows small migratory trout access at certain flow conditions, the construction of a suitable fish pass that allows for ALL sizes of fish at ALL states of the river flows, easy access upstream, is strongly recommended.
