THE RIVER ALUN (aka ALYN)

**Advisory Visit Report Undertaken
On behalf of the Wild Trout Trust
By Ron Holloway MIFM
22nd April 2002-04-25**

The River Alun – The Rossett & Gresford Fly Fishing Club

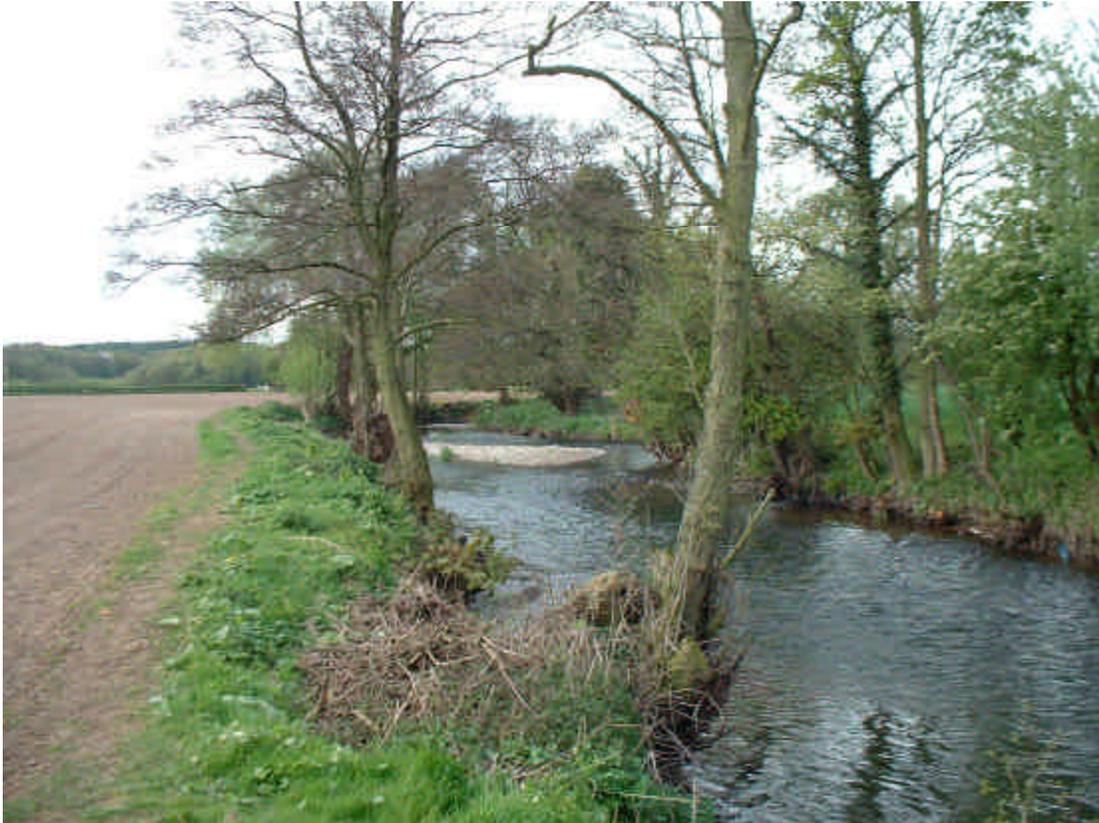
1. Swimup fry habitat is excellent as there are sufficient shallow riffles which make favourable habitat, however I fear that what natural spawning does occur is negated by the sediment loading of the river at the critical incubation and alevin stages.

Spawning Area.

As and when access to the stretch above is finalised, it is suggested that this new area is used as an experimental site to enable the EA to assess the survival rates of eggs and alevins and swim up fry after in-gravel egg incubation boxes are used to monitor survival in natural river conditions. Not until the suspected controlling factors of the natural survival at these life stages are pinpointed and identified, can any meaningful mitigation work be implemented. During these assessments, it will be necessary, therefore, to continue to stock the R & G FFC waters but it is recommended that no stocking of the upper beat be undertaken during this research work.

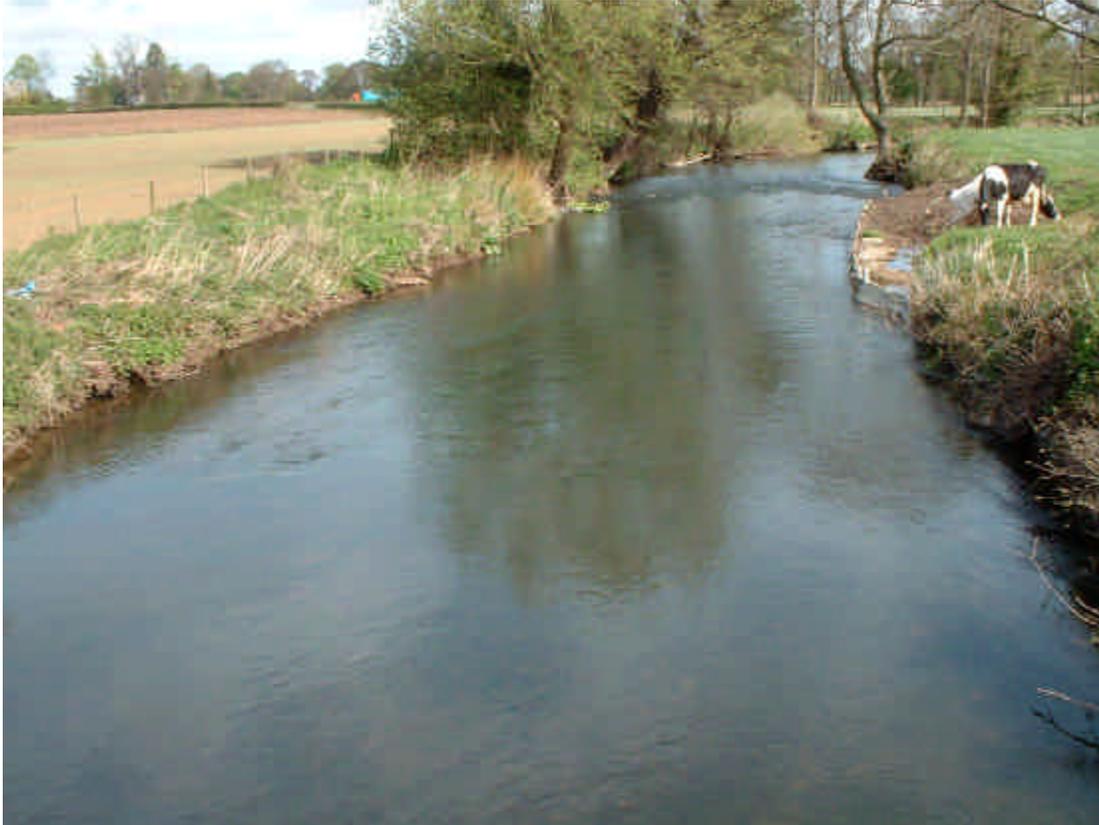
2. For fingerling and for the stocking size of trout (8” to 10”) there appears to be little instream/midstream cover other than the few deeper undercut pools and within the impounded waters above the lower weir.
- 3 Anecdotal evidence states that historically the aquatic weed life was quite strong and regular. This being the case, this growth would have provided excellent summer cover for fingerlings and two plus and three plus adult trout in those areas that now provide little or no natural holding habitat.

No Instream cover

2A. In the areas which offer little instream/midstream cover, the random placement of single and groups of large rocks and stones would help to break up the water

surface and provide better cover, holding and feeding lies for the trout. The placement of these rocks to be set 4 to 6” out of water at summer mean base flow. These rocks will then be submerged during the higher levels of winter and would utilise the flow energy at that time to scour the river bed of sediments.

4A Where bank re-instatement is contemplated be sure to use natural materials which are on site – i.e. logs from fallen trees and stone and cobble from the river margins, or larger rocks which may be available from the nearby quarry. Avoid at all costs the use of manmade materials unless these can be fully covered by natural materials. Whenever bankwork is completed, it is essential to plant up as soon as possible with naturally occurring bankside vegetation which will help to stabilise the new bank which must then be fenced off to protect from grazing animals (See Picture “No Instream Cover”)

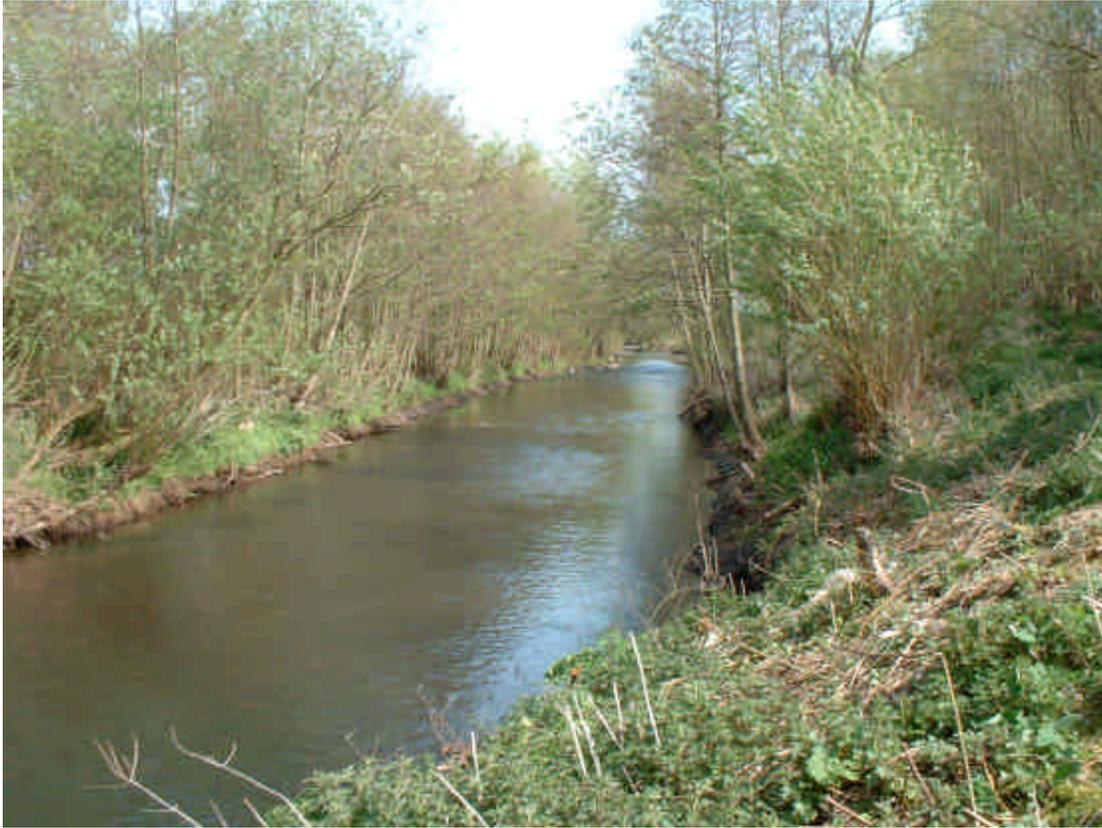
4. Although some serious bank erosion did occur in the 2001 flood event which will entail some heavy re-instatement work, the general overall effect of these floods has not dramatically affected the quality of the trout habitat within the river.
5. Tree cover is adequate along most reaches though the one year class growth of alder along the channelised stretch does need attention.

Over treed Channelised Stretch

6. This channelised stretch is virtually characterless and except for an ineffective rock structure, midway, consideration should be given to introducing some instream meanders to provide more diversity of fish habitat

5A Where the river is completely shaded, serious consideration should be given to instigating a systematic pollarding programme of the mature trees to allow more sunlight into the river. For example, the new channelised stretch needs attention very soon, as all the marginal, self seeded trees, are single stemmed and, if left, will totally shade the entire stretch. These single stem trees need pollarding, which will remove top weight, thus reducing toppling during gales. Once pollarded the trees will sprout from the base and provide a more stable growth, whilst allowing light into the river

but still stabilising the river bank with stronger root growth. When pollarding, take note of the direction of the sun in summer and aim for 60% light and 40% shade.

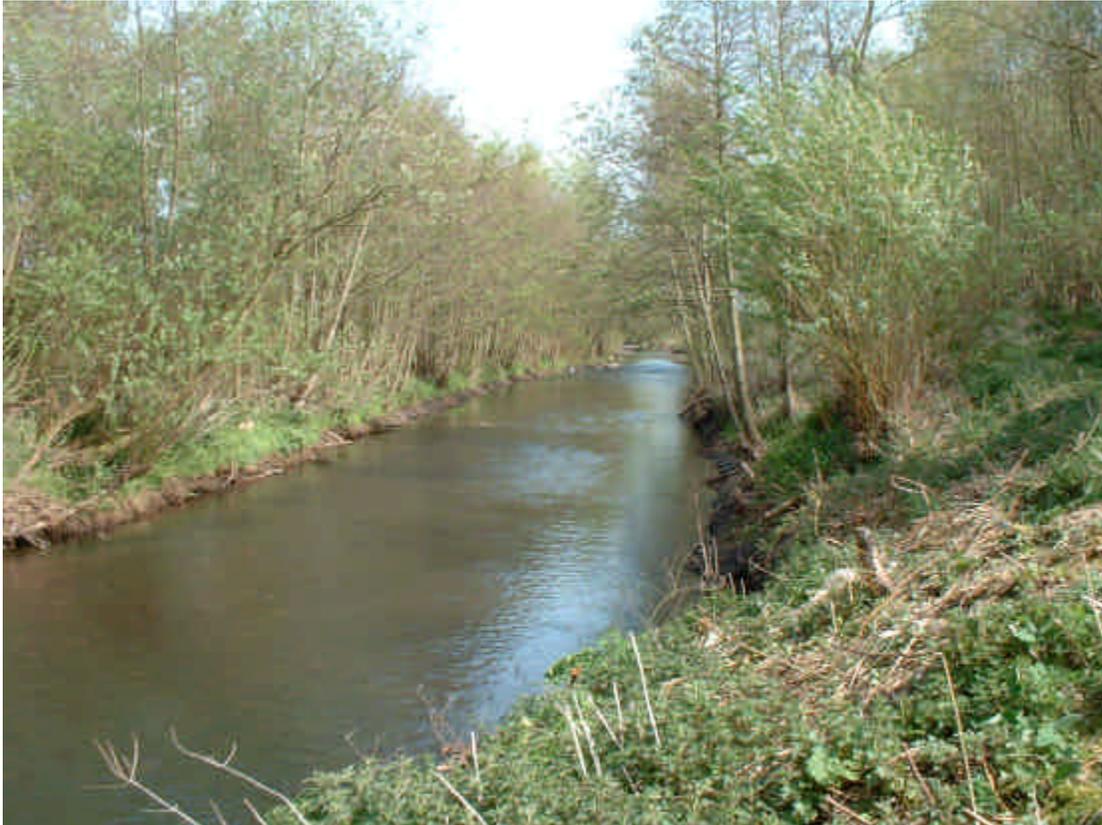
Triangular Deflectors

6A Still in the channelised stretch, to instil more character and improve habitat, it is recommended that an alternating series of triangular rock deflectors be constructed to nudge the flow of the river from side to side – (See picture with drawing).

Where the old stone structure is still visible, it would be useful to construct a pair of triangular deflectors, one each side of the river, and the action of this would scour a deep pool just downstream. Placement and construction of this is critical – the rocks should be so placed that the points of the triangle are 6” out of the water at summer mean base flow level and, ideally, the construction should gently slope up from this point to the river bank. This construction will ensure that when submerged at high flows, the current is still directed away from the river bank, thus reducing the possibility of bank erosion.
