THE RIVER COVER – COVERDALE, YORKSHIRE

**Advisory Visit Report Undertaken on behalf of
The Wild Trout Trust
By Ron Holloway MIFM
(R H Associates)**

Upper River Cover – Advisory Visit Report
18th September 2002.

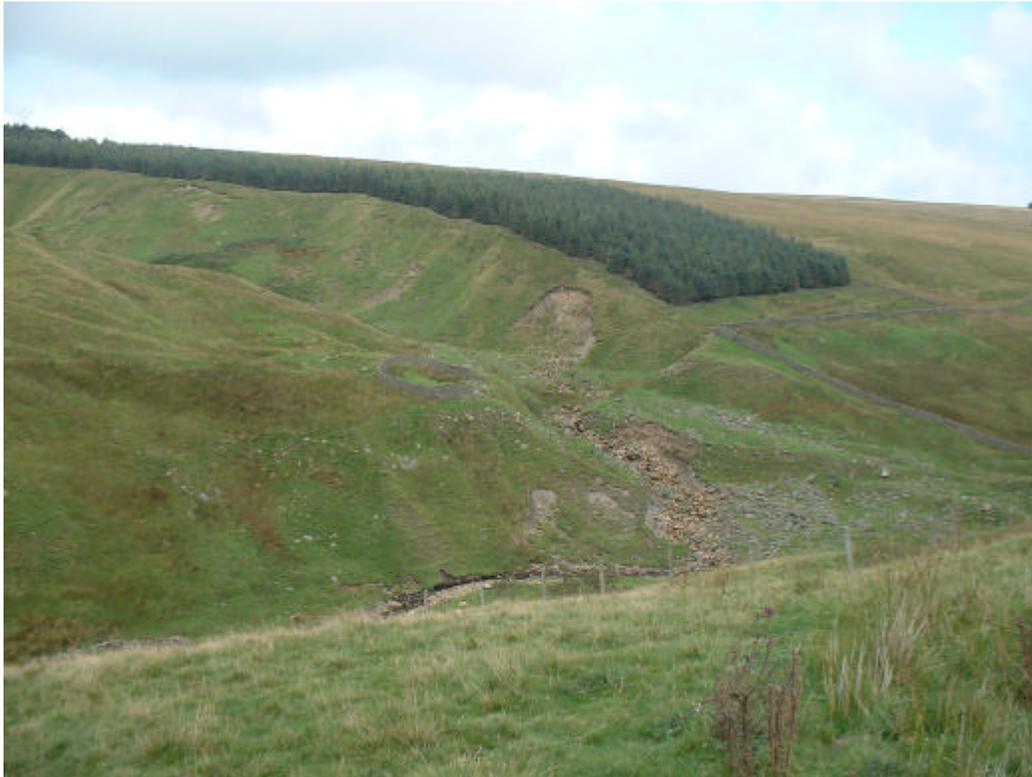
No.3. Problem Tributary.

There is one major tributary which enters the River Cover from the North Moor and which appears to have seriously re-profiled much of the river downstream of its confluence. This problem may be resolved if the proposed hydro scheme is implemented which will significantly reduce the effects of storm events impacting on the main stream. Until this scheme is implemented, it must be understood that any

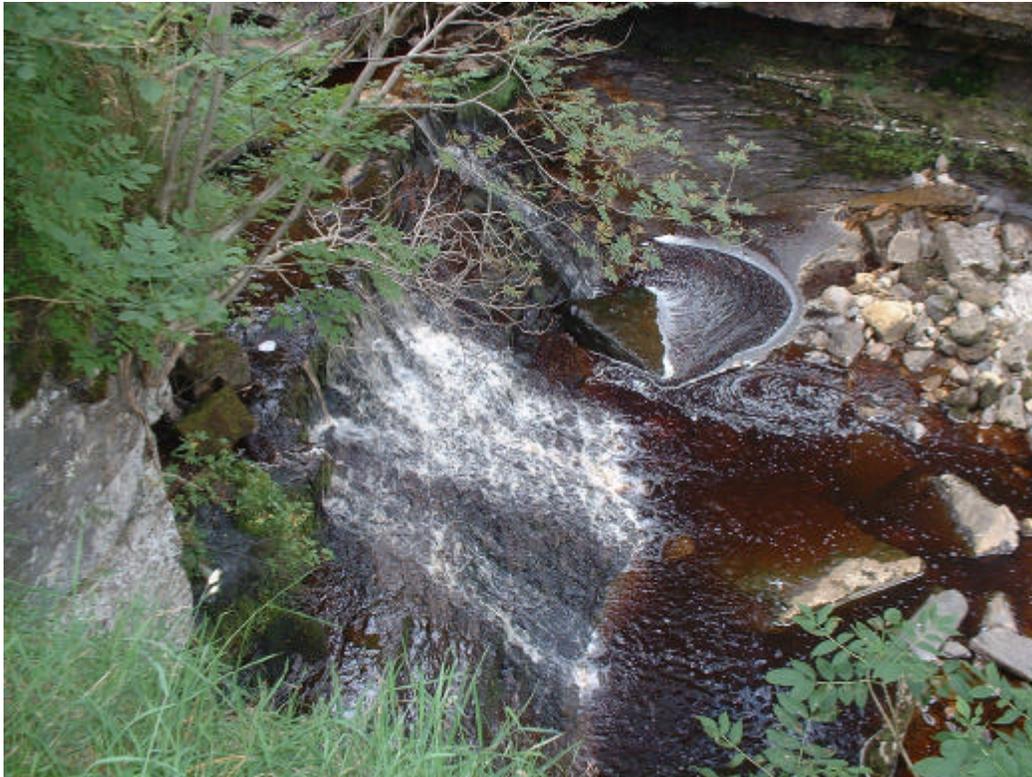
No.4. Problem Falls!

Although there are a few resident trout above the falls and those which are there suggest that the almost impassable falls and lack of spawning gravel are the main controlling factors in this area. What resident fish there are would originate from parents that managed to negotiate the falls only when water levels allowed and which coincided with their spawning run. This is a happening that may only occur once in five or ten years.

1. Construct a rock weir, or two if necessary, below the foot of the falls but within the rock gorge. This weir(s) will raise the level of the water below the falls which will allow more spawning fish to ascend upstream throughout a wider range of river flows. It should be noted that a good plunge pool is retained below the foot of the falls which will provide a constant standing wave in the flow which, in turn, assists leaping fish to negotiate the obstacle.
2. Consideration should be given to creating several weir pools upstream of the falls by constructing several upstream pointing V weirs with substantial rock. The upstream V shape of the construction will help to maintain its stability in high flows (pictures 5 and 6 to illustrate).

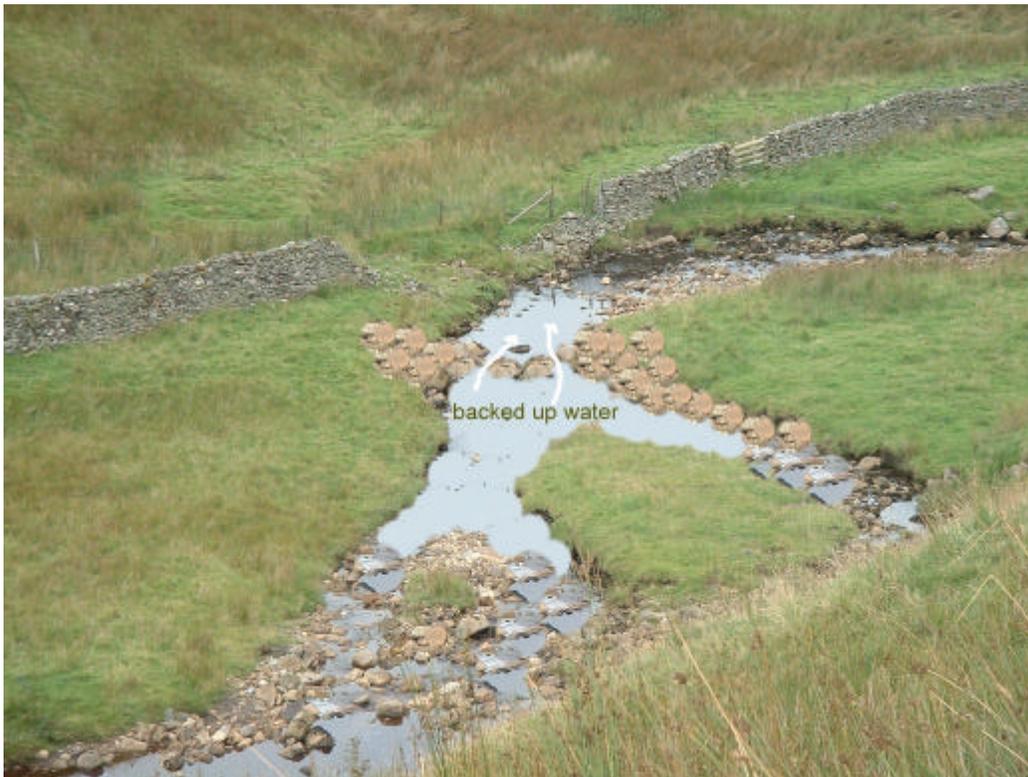
No.7. Weir Pool Construction.

It is suggested that below the main falls, the main controlling factor is the lack of adult fish holding pools. The heavy spate flows have re-sorted large quantities of substantial rock and cobble and has infilled most of the original deeper holding pools and created a more lamina stream bed of large rock and cobble.

1. Create a further series of rock weir pools from the large quantities of natural rock available. Care should be given to the construction of these weirs with substantial rock being used which will remain stable and which will withstand the most powerful flows. Along this stretch these weirs should be over engineered rather than under engineered and sufficient rock be used to provide adequate protection from erosion around the weirs when overtopped in high flows. (See illustrations)
2. Where necessary, further planting of suitable spawning gravels should be considered.
3. Provide fencing for protection from livestock.
4. Continue tree planting programme with indigenous, deciduous trees, as before.

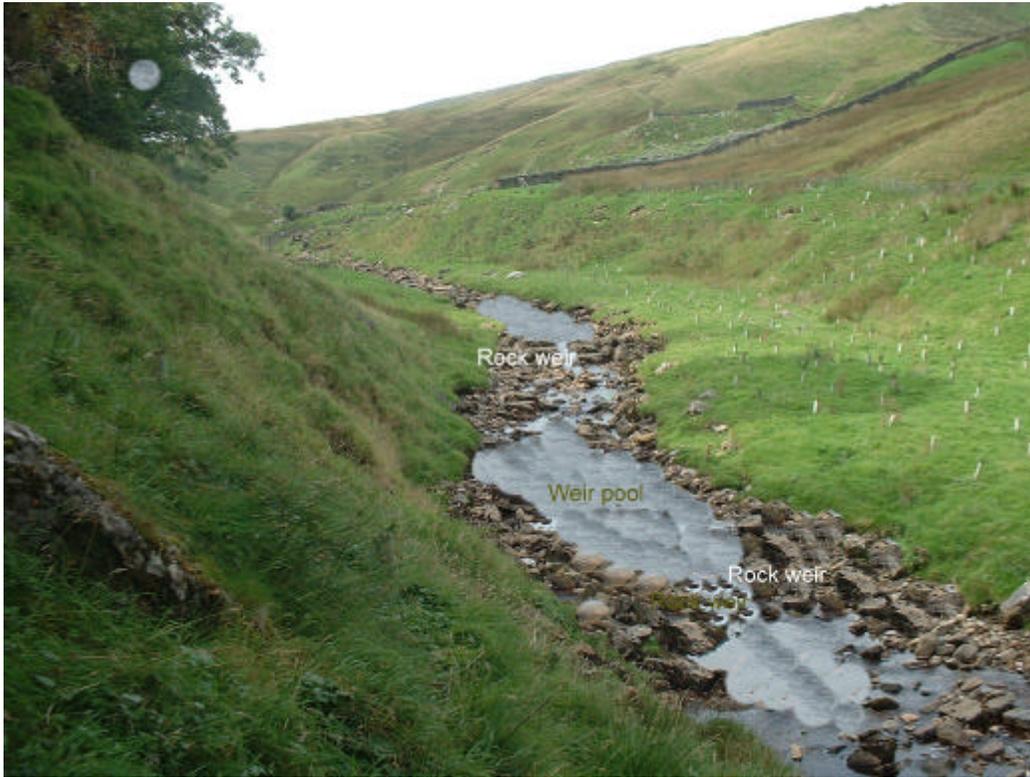
Suggested weir pool construction
