# **RIVER FYNN FISHING CLUB**

ADVISORY VISIT REPORT  
Undertaken on behalf of the Wild Trout Trust

## **RIVER FYNN ADVISORY VISIT**

**13<sup>TH</sup> MARCH 2002**

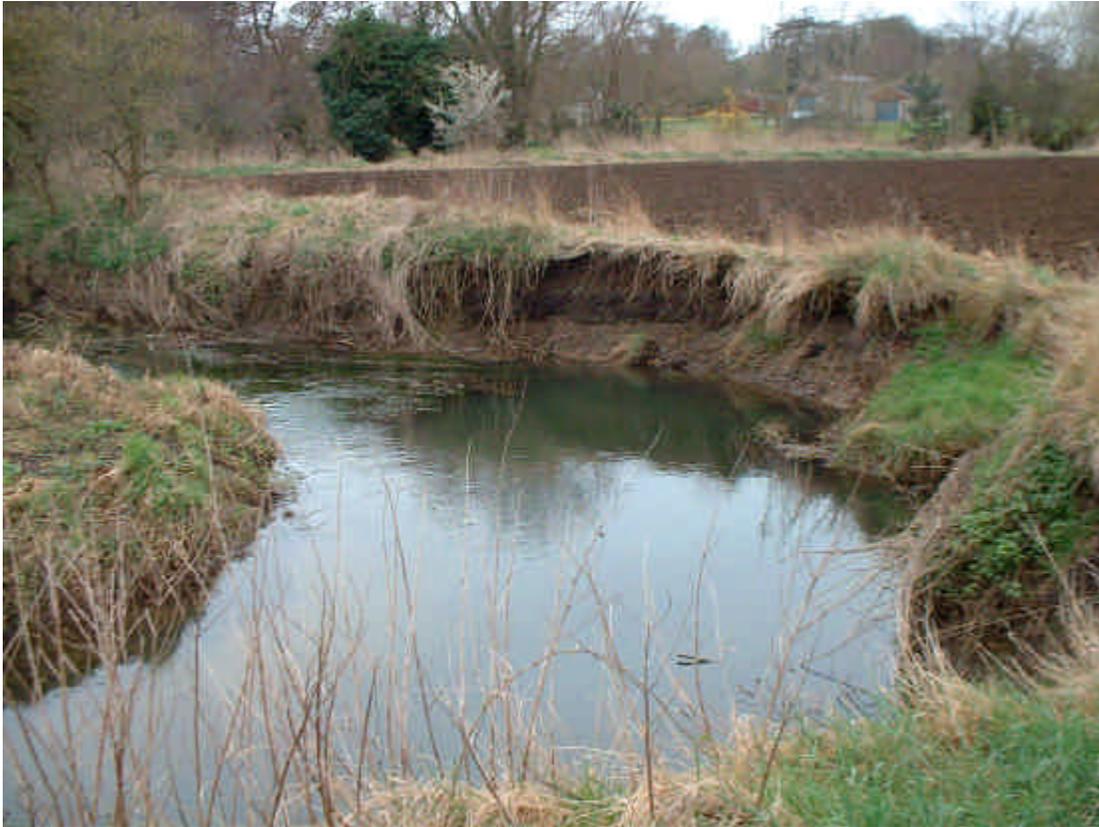
**Fig.2 Erosion**

incubation of trout eggs. Channel width is fine, though there is one area of serious erosion which needs attention (Fig2).

It is suggested the foot of the eroding bank is protected with a line of faggots (brushwood bundles) that are firmly fixed to the river bed, tight in under the erosion point. Alternatively, a line of substantial tree trunks be pegged in, in a similar fashion, both these methods would protect the vulnerable bank from further erosion. Other than this, trout holding habitat is reasonably good along this stretch. Serious consideration however, should be given to protecting the river from the surface run-off from the arable activity in the field adjacent to the river. The river is suffering from large inputs of sediment that originates from these adjacent land-use practices. It is suggested that the Club liaise with the farmer/landowner, to agree to fence off a strip of land along the field edge ( see Fig.3) to create a natural buffer zone of vegetation. The strip of land should be between eight and ten metres in width and once established this would filter out a substantial amount of surface run-off which is

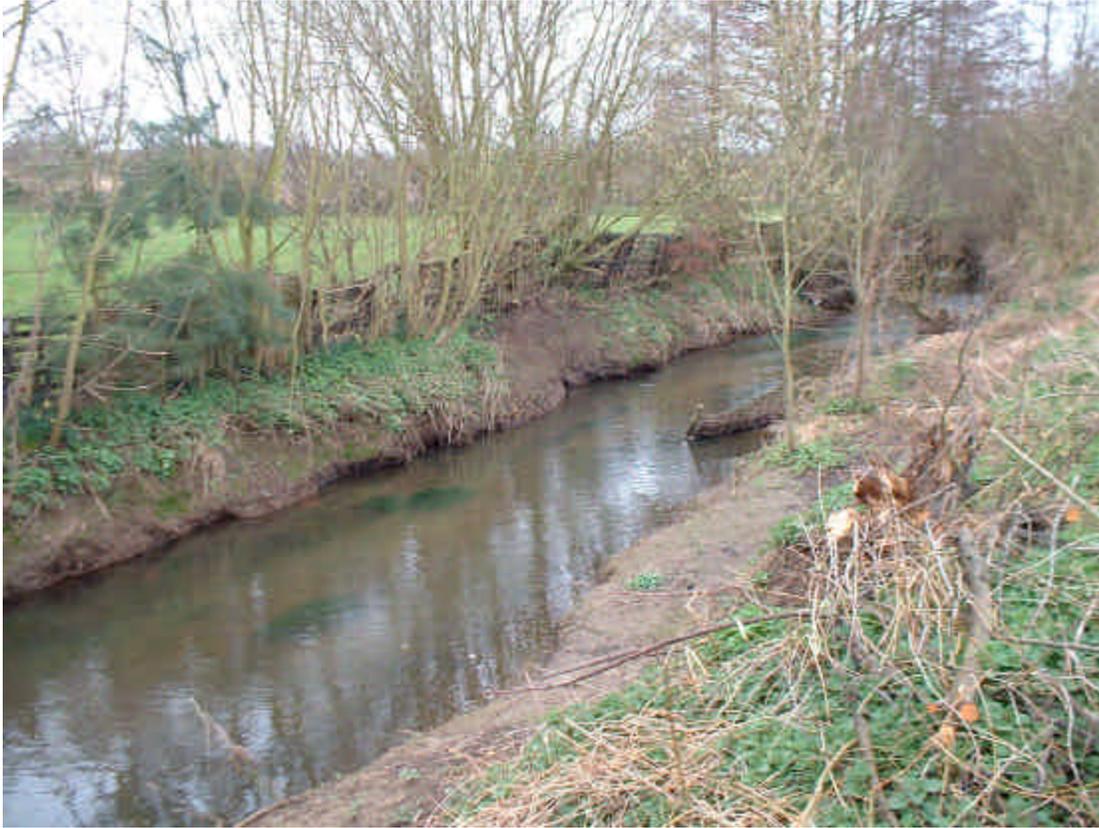
**Fig.4 - Groynes**

Several of the hurdle flow deflectors along this stretch are disintegrating or being washed out by high flows. These need to be removed and replaced by more substantial structures of a triangular shape which should then be infilled with chalk, gravel or soil and then planted with natural vegetation. The triangular shape of these structures will help to reduce bank erosion downstream by directing the current towards the centre of the river. It is also suggested that several pairs of these groynes are installed opposite each other thus creating a channel restriction and speeding up the flow which will scour the river bed and create useful trout holding habitat downstream of the structure. (See Fig.4)

Whatever instream structures are decided upon, it is essential that the Club discuss the project with the Environment Agency Fisheries Officer who has to consider consents for the installation of any structure and he will give further advice on the siting and construction.

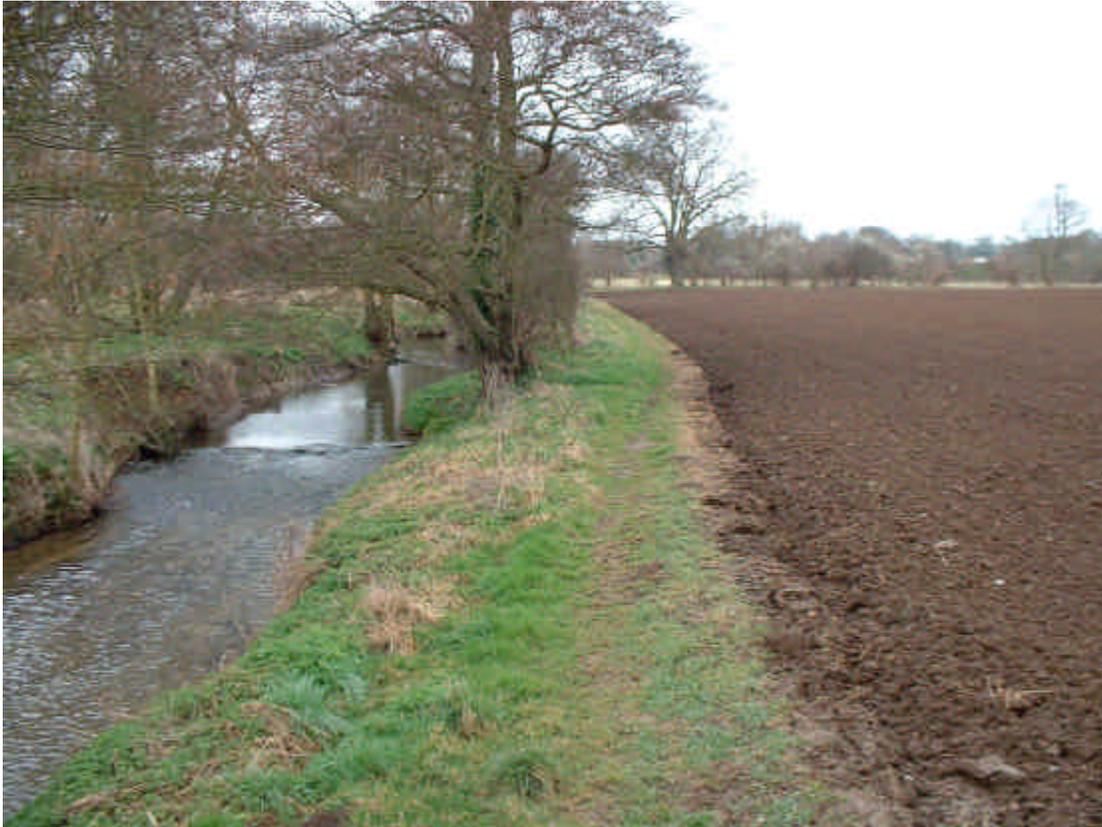
**Fig.5 Instream Weirs and Buffer Zone**

The programme of thinning out the tree cover along this stretch should be continued. It is suggested that a 60/40 ratio between cover and light be aimed at, i.e. cut 60% and leave 40%. This will allow sunlight into the river and encourage instream weed growth in a stretch that has very little juvenile, or adult, trout holding capacity. There

are very few places where a young, or adult, trout can hide from predators such as herons (and anglers!).

It is strongly recommended that this stretch is NOT stocked until sufficient trout holding habitat has been installed, or has been naturally formed by annual strong weed growths. Furthermore, to improve holding capacity, a series of weirs constructed from logs or imported stone, be built which would create deeper holding areas above and useful, well aerated, scour pools below, which would be attractive to trout. Again, in this instance, plans and designs for such weirs and the materials recommended for use in construction can be obtained from your local EA Fisheries Officer with whom on site discussions are most essential.
