THE RIVER GLAVEN FISHERY ASSOCIATION

Advisory Visit Report

Undertaken on behalf of the Wild Trout Trust

11th March 2002-03-17

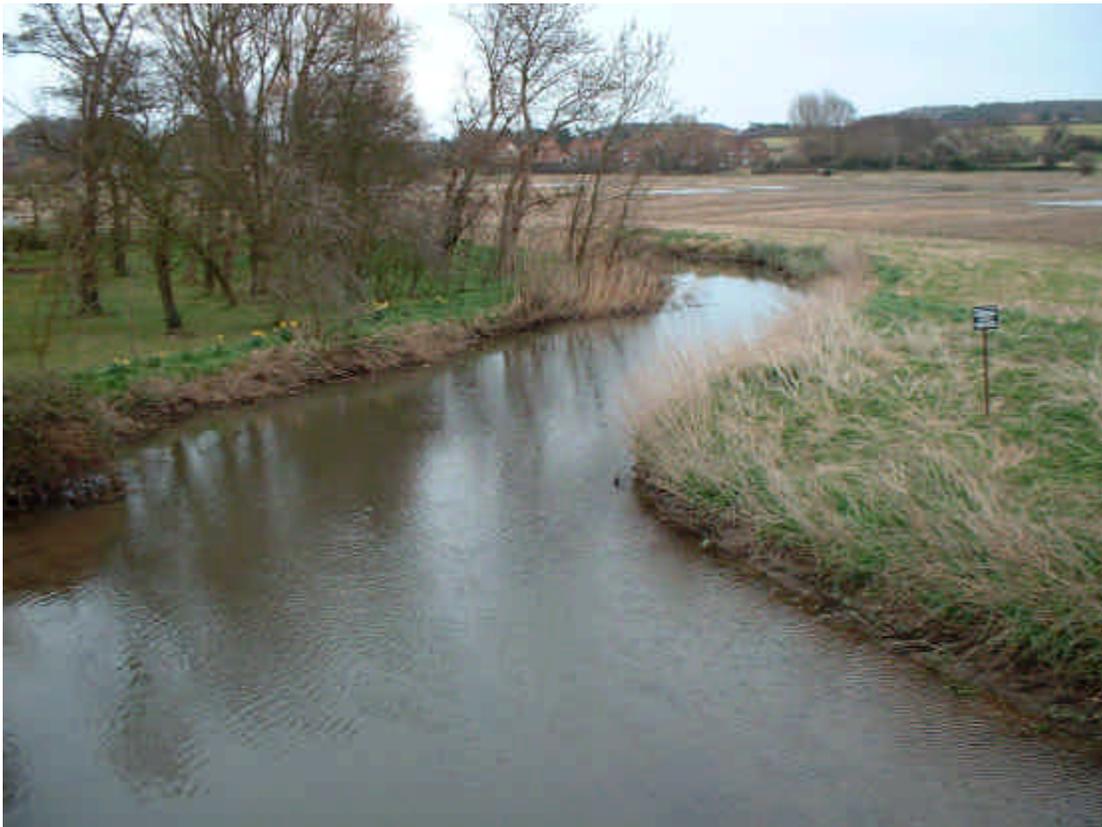
Fig.1. River Glaven at Wiveton Bridge

Anecdotal information indicates that the last electro-fishing survey revealed that there is a healthy and reasonably large population of quality roach in the river below Wiveton Bridge – i.e. Upper Ramm down to Lower Kendall and below. Few, if any, resident trout were found in this stretch though migratory seatrout have been taken in the past. The slow flows here are not conducive to encouraging resident trout. The flow is controlled by a downstream weir/sluices.

The river channel from Wiveton Bridge downstream has been heavily dredged in the past so the natural channel profile has been grossly overwidened and overdeepened. The river here is trying hard to naturally narrow itself and this should be allowed to continue by allowing the vegetation that is colonising the deposited silt along the edges of the overwidened channel. The slow flow and overwide silted channel makes for ideal coarse fish habitat and, as seen, does not allow for any quality trout holding habitat.

In my opinion, it would be a waste of good trout and money to stock this area – at least until such time as the channel has narrowed and the flow speed increased, but unfortunately, flow speed on this beat is controlled by the sluices downstream so this does not appear to be a likely scenario. Consideration, therefore, could be given to raising some extra revenue for the fishery by allowing a selected group (say six rods)

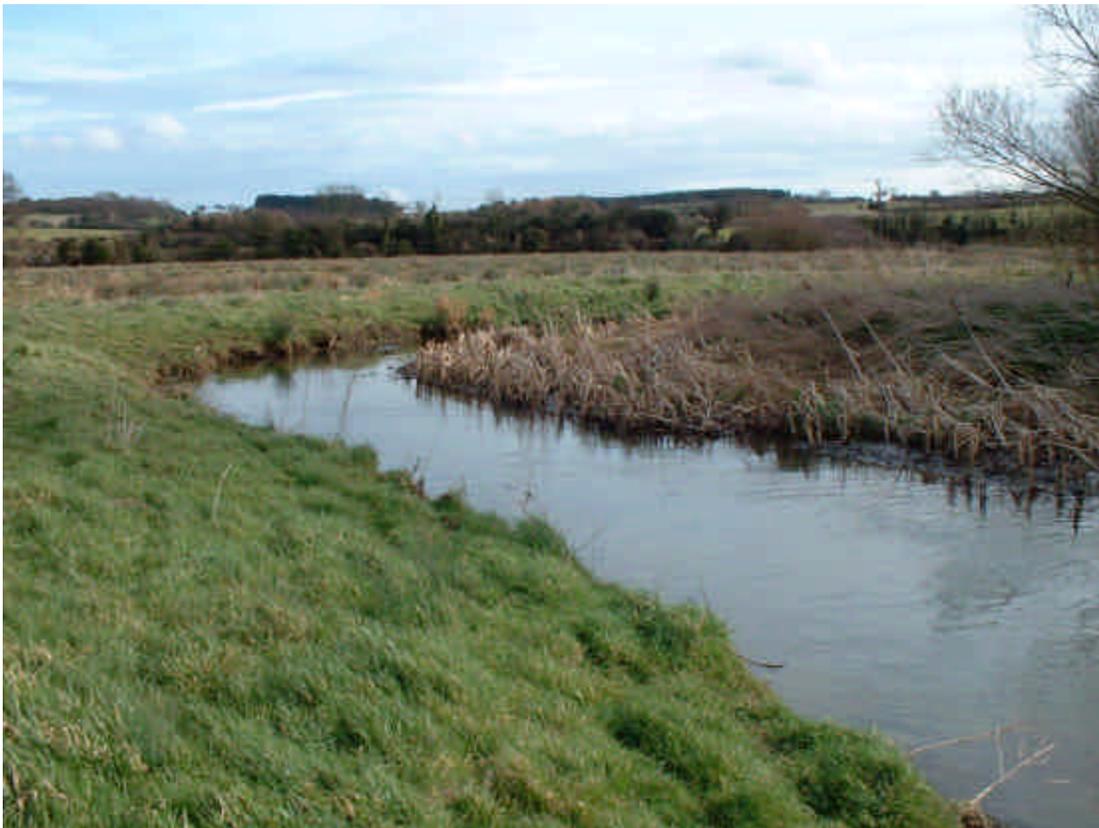
Fig. 2 “S” Bend Blount’s Marsh.

The stream flow speeds here are reasonably good though the channel has been overwidened and deepened. Aquatic weed is evident and does grow well in the summer. Silt deposits have been colonised on the point of the “S” bend and this growth must be encouraged as it locks up these silt deposits. Middle to late summer trimming may have to be undertaken here to maintain fly fishing access to the attractive pool on the “S” bend.

To create some juvenile trout habitat and to encourage adult trout to hold in this stretch it is suggested that two, or more, gravel riffles are installed and at least one sited just upstream of the “S” bend and one just downstream of it. Once installed, these will increase flow speeds, keep suspended sediments on the move and offer juvenile habitat and spawning facilities for overwintering trout. For the exact siting of these riffles and quantities of gravel required consult Simon Johnson and his staff who have excellent experience in the installation of gravel riffles in Norfolk streams. At this site, the arable field bordering the far bank is cultivated almost to the river edge. Suggest the Club open discussions with farmer (landowner) to either fence off or retreat operations away from bank edge to allow nature to grow a natural buffer zone between the river bank and the cultivated land. This would help reduce sediment input to the river during heavy winter rainfall.

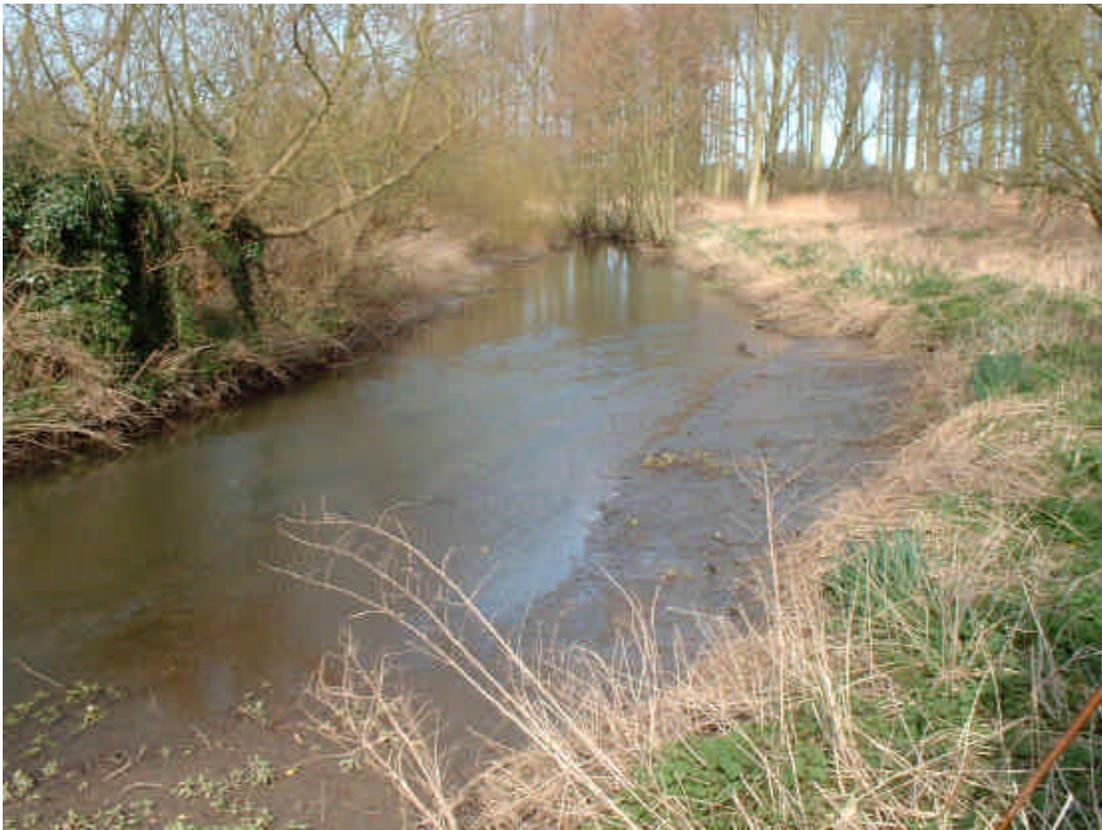
Fig. 4 Upper Buxton Silt Beds.

Here the river channel is overwidened, amply illustrated by long banks of deposited silt along river margins and bays. These silt banks could well be beneficial to the river in the long term, once they have been stabilised and vegetated with natural growth of indigenous plants. This eventual narrowing of the channel will help to increase flow speeds and reduce further silt deposits and encourage a more stable and hardened river bed that will be more attractive to trout.

Suggest replace existing groynes/deflectors with more substantial triangular groynes. Suggest several pairs placed opposite each other at intervals to create a scour pool downstream of the structure that will become attractive to trout. Furthermore, place a series of alternating triangular groynes/deflectors to direct the current to meander from bank to bank. Suggest consult with Simon Johnson on siting and numbers of structures to be built and which materials to be used.
