# **TURRIFF ANGLING ASSOCIATION**

## **The River Idoch (or Burn of Monquhitter)**

Advisory Visit Report Undertaken on behalf of **The Wild Trout Trust**  
And  
**The Deveron, Bogie and Isla Rivers Trust**

By Ron Holloway MIFM  
On 19<sup>th</sup> May 2002

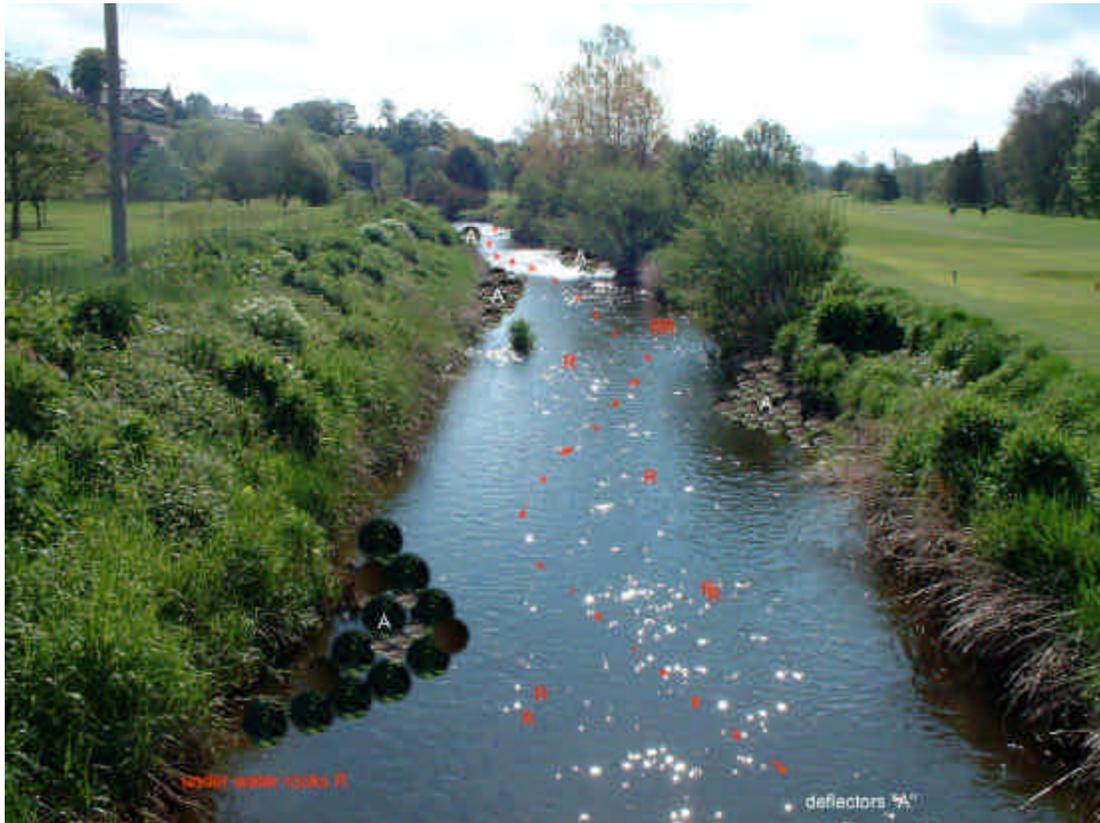
#### **Site One – (Picture One)**

This reach below the old railway bridge has been dredged into a trapezoidal shaped channel and although the quality of the substrate is good and there are a couple of riffles for juvenile fish, the reach is too canal like. There is little, if any, adult fish cover or holding capacity. It is suggested that an alternating series of triangular deflectors are installed which will create a meandering effect and gently energise the flows to create scour pools just below each structure.

**Picture One – Meanders.**

These structures as illustrated to function correctly need to be triangular and constructed with substantial rocks able to withstand high flows and yet to be positioned so that they are only 4 to 6 inches above water level at mean base flow heights. The shape of these constructions will also continue to direct the current towards the centre of the river at all flow heights. To further improve adult fish holding capacity a number of randomly placed singles and clusters of rocks should be positioned along the reach.

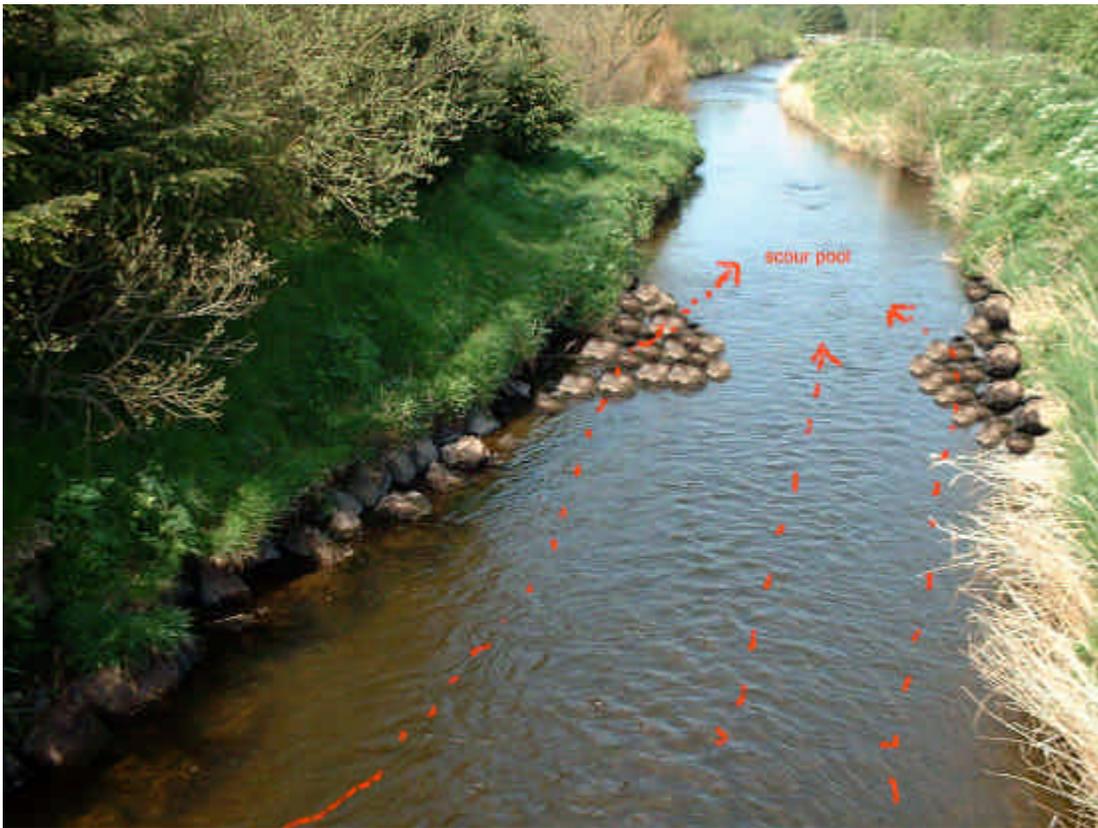
### **Site Two (Picture Two)**

Looking downstream from the footbridge, this again is a featureless stretch which offers little, or no, adult fish cover. Swimup fry habitat is fine along the stream margins but that is all. The remedies suggested are similar to that in Site One and the structures placed as illustrated in the overdrawn picture

### **Picture Two – Deflectors**

Again, singles and clusters of instream rocks should be placed randomly along this stretch above and below the main structure. The effect of these will further energise flows and naturally create more adult holding habitat and help to keep the river bed cleaner.

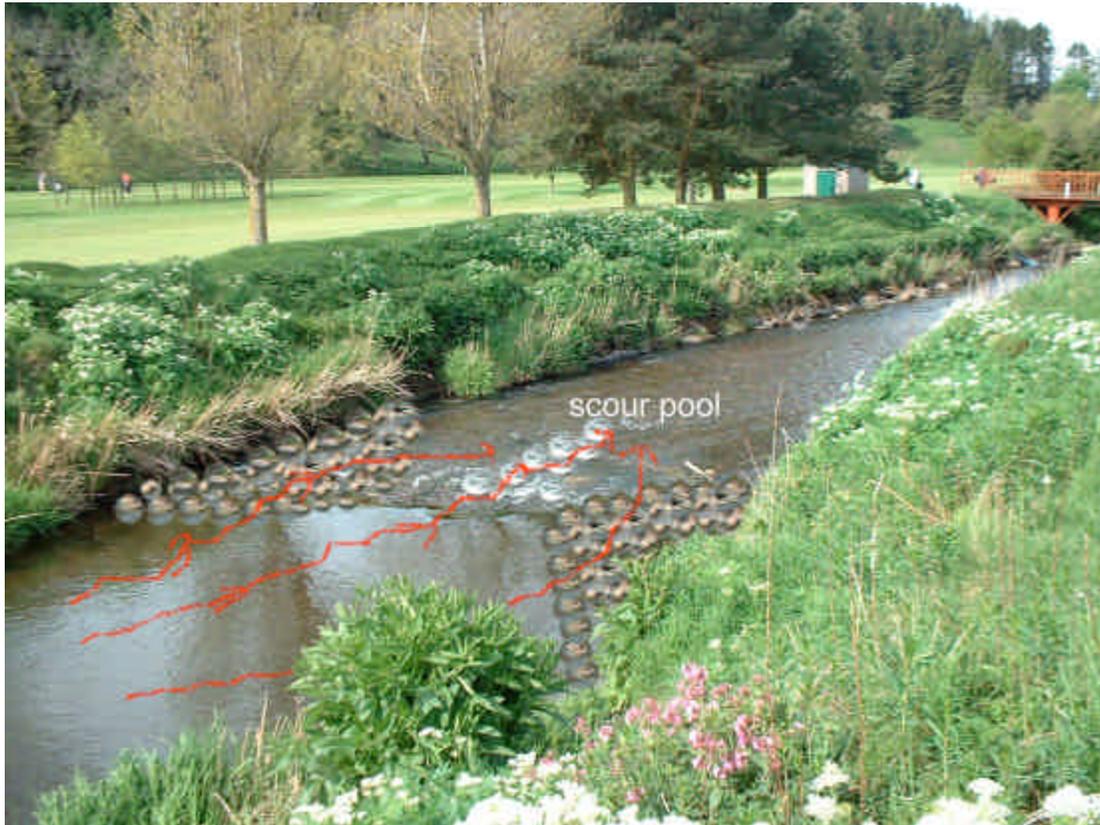
### Site Three (Picture Three)

Here, upstream of the footbridge is another ideal spot to instal a channel deflector and it is advised to instal them as in picture three below.

**Picture Three – Scour Pool**

Again, some randomly placed rocks up and downstream of this construction will help to improve habitat and break up the featureless surface of the river along this stretch.

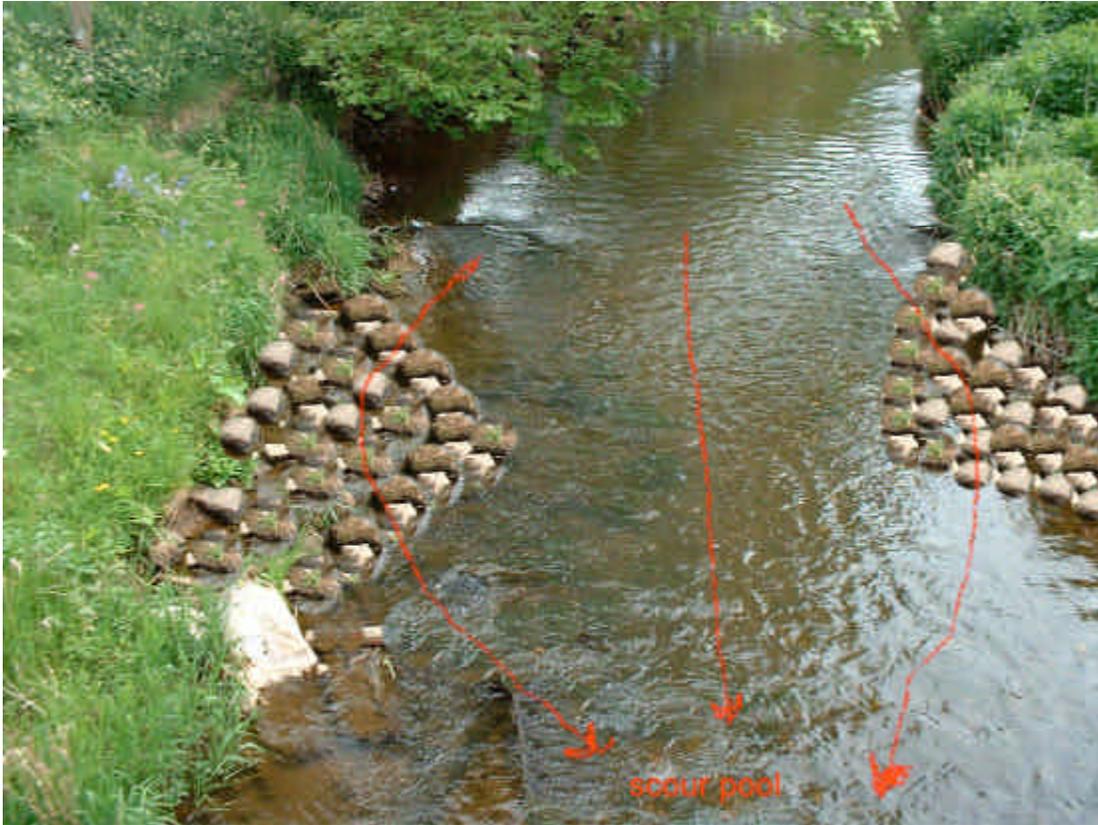
### Site Four (Picture Four )

Here is an ideal illustration of the size, shape and placement of boulders to construct a good flow deflector – this idea can be used beneficially at sites throughout the entire river system.

Picture Four – Rock Deflectors

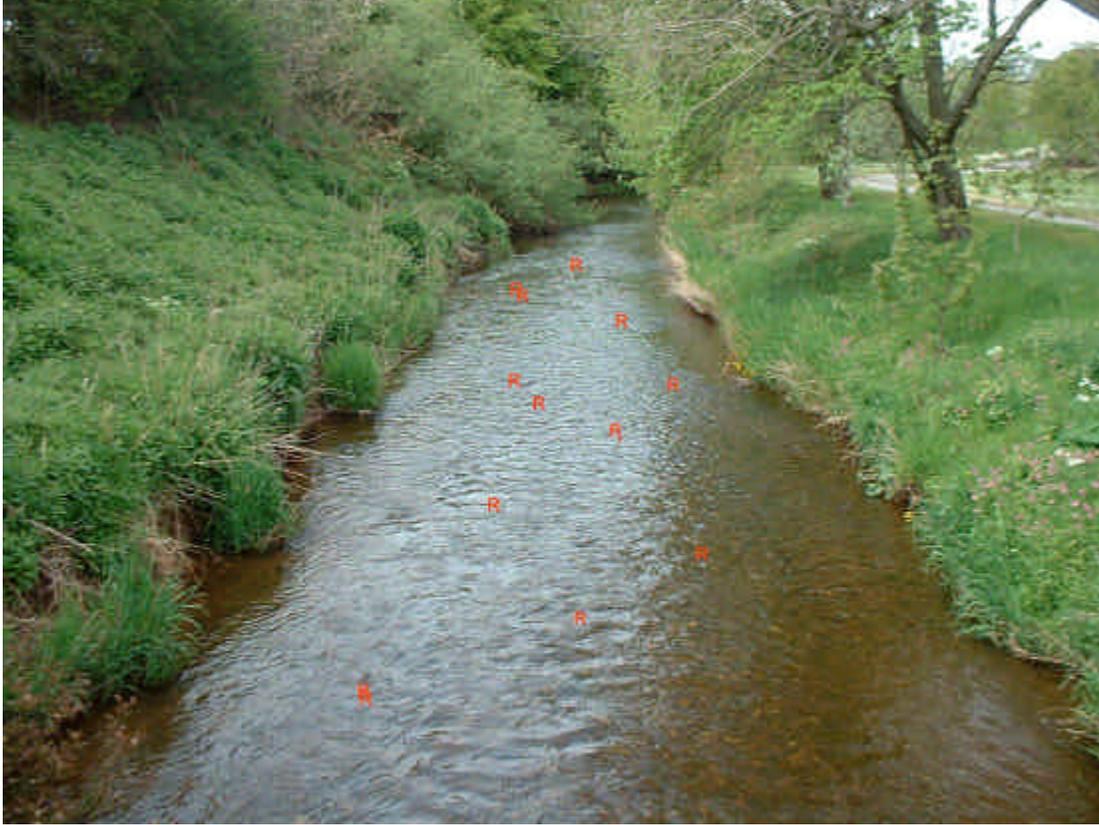
### **Site Five (Picture Five)**

At this site, just the use of randomly placed rocks would break up this featureless river bed and the resultant broken water would afford habitat for young of the year and fingerling salmonids.

### **Picture Five – Random Rocks**

The subsequent re-energised flow would not only help to keep silt deposits on the move but also create areas of viable clean spawning gravels for resident brown trout.

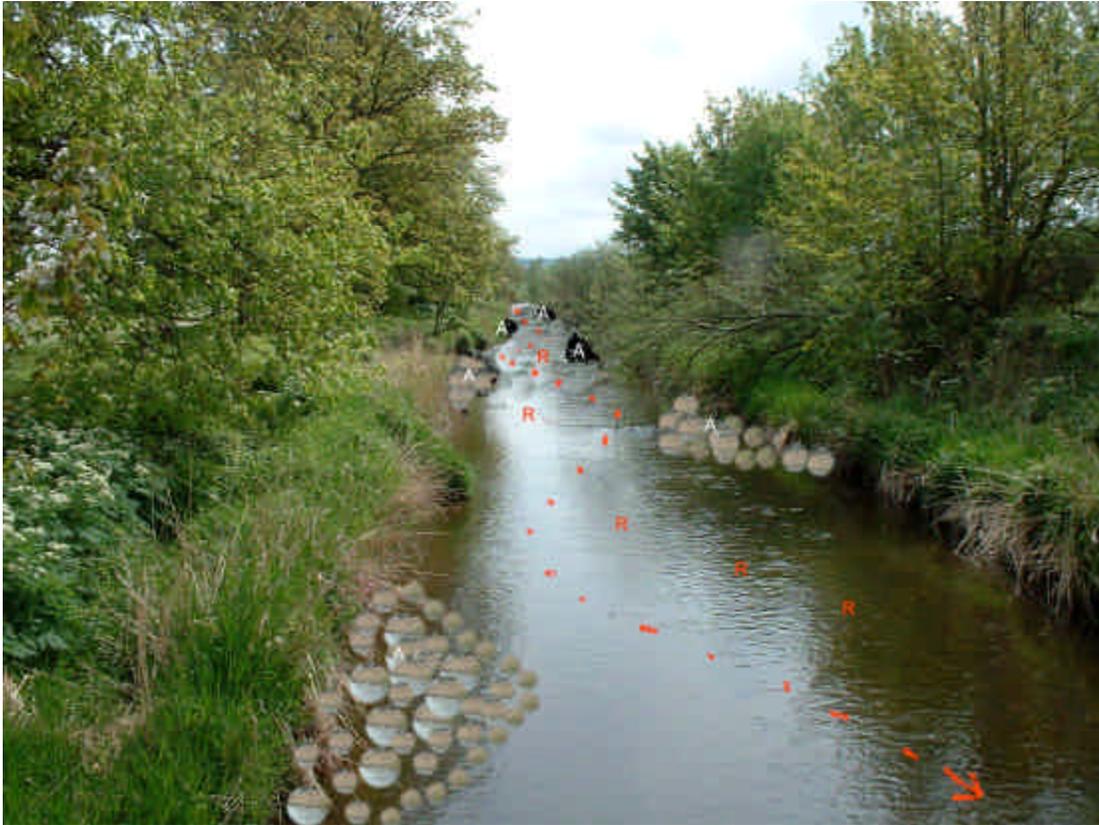
### **Site Six (Picture Six)**

This site provides an excellent opportunity to create some meanders within the stretch that were lost in the dredging operations. It is recommended that an alternating series of triangular rock deflectors, as illustrated in the picture, would encourage the river to develop some natural meanders. It is important to remember that all these deflectors should be set at the right levels – i.e. 4 to 6 inches out of water at mean base flow heights.

**Picture Six – Meanders**

Again, some random rocks can be placed along this stretch to improve holding habitat.

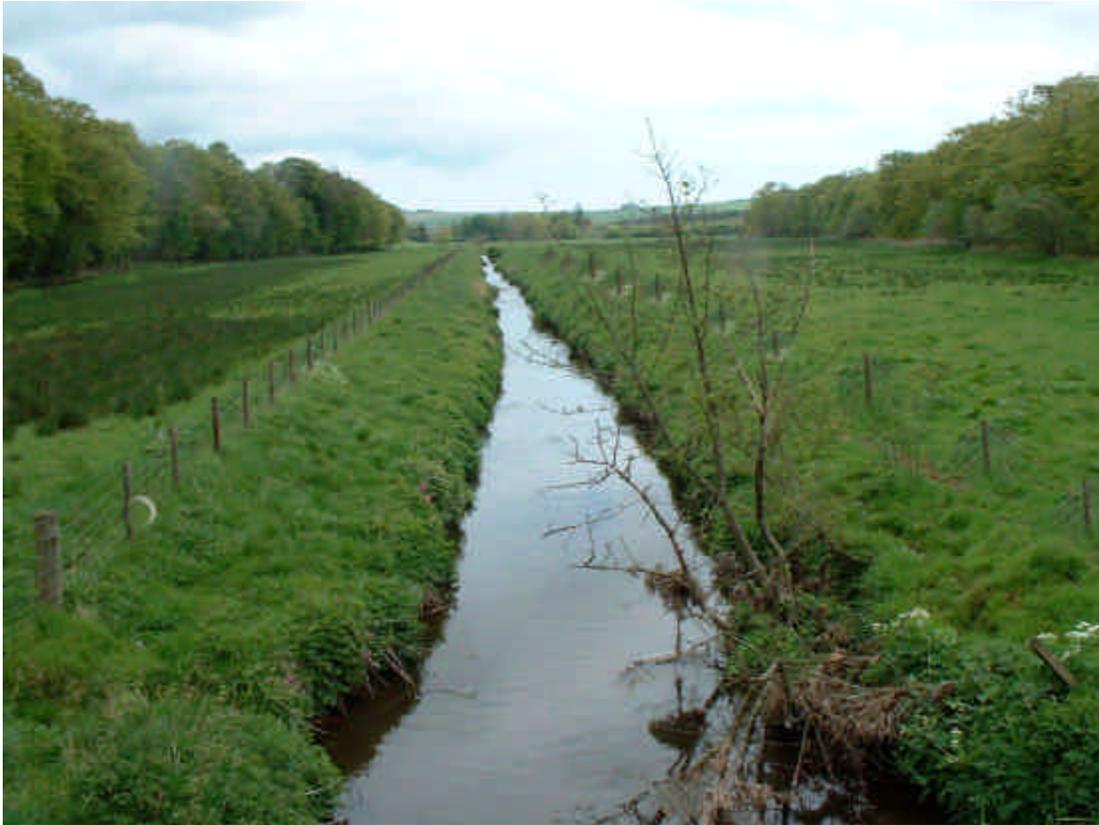
### **Site Seven (Picture Seven)**

This partially fenced, canal like, stretch needs to be fenced off completely as illustrated in picture seven, furthermore some instream placement of boulders to break up the featureless aspect of the stretch would provide juvenile and fingerling holding habitat. The bankside vegetation should be allowed to grow and in high summer would almost cover the water surface which would help control water temperatures and release terrestrial insects into the water.

**Picture Seven – Fencing**
