Wild Trout Trust Advisory Visit

AJ's Fly-fishers'
River Nidd
North Yorkshire

Alistair Maltby MSc. MIFM

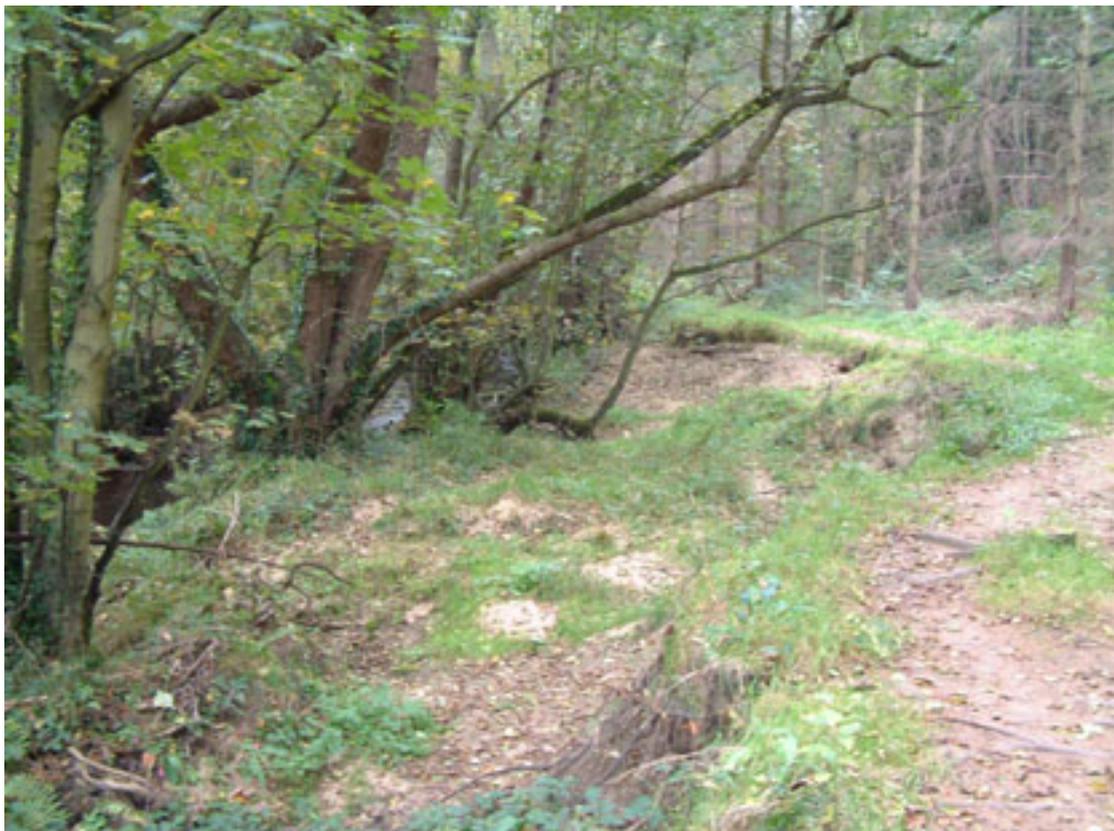
The erosion is of particular concern throughout this section because of the extremely sandy nature of the soil. Once vegetation is lost, the soil is particularly mobile. The eroded sandy soil is depositing in very high quantities in the pools. This will undoubtedly result in a loss of invertebrate habitat in the pools. The coarse nature of this sediment means it will not have an impact on potential spawning areas unlike finer sediments.

Multi-stem trees characteristic of historic coppice and displaying high erosion of the sandy soil typical of overshadowed river banks.

There is a real need to instigate cyclic coppicing throughout this section of the river. Coppicing will not result in long-term loss of the trees, or more importantly the roots that provide bankside habitat for trout. Following coppicing, the risk of collapse of the tree is immediately removed, vegetation begins to recover between the trees and provides increased levels of habitat between the remaining root structures. There is also more chance of in-stream vegetation beginning to recover and the process of the river over-widening is stopped and can be reversed. This work could increase adult and juvenile fish habitat considerably. The age of the trees means that this will be a considerable task for club volunteers and the club should investigate carrying this work out in partnership with the Woodland Trust. There may be options for including the work in existing conservation schemes operated by the Trust. The Trust should be made aware that erosion to the bank caused by the overshadowing is beginning to threaten the footpath and attempts to reduce this erosion will not be successful without changes to the shading regime. It is unlikely that the shaded nature in this section is a natural characteristic but due to unsympathetic management. Once a better shading regime is achieved, further habitat improvements may be possible.

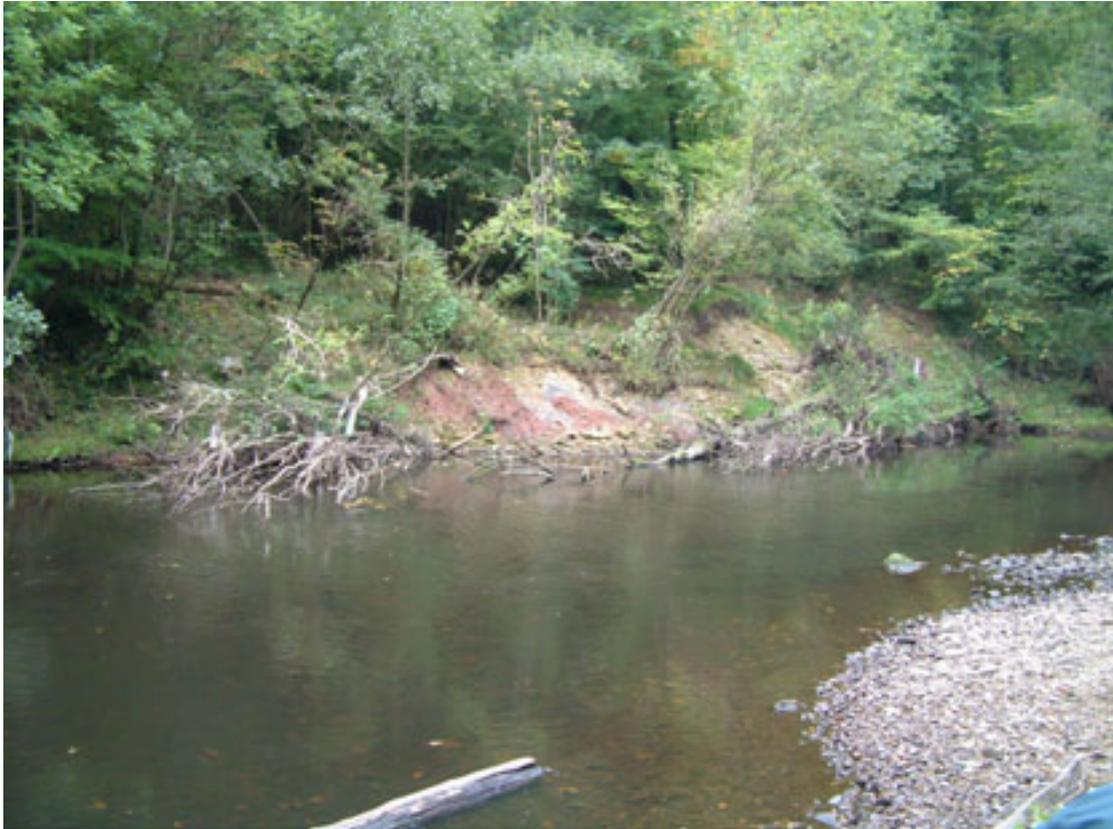
There are a number of fallen trees throughout the bottom section of the beat and these are providing excellent habitat, food production and in some places protection from erosion of the bare banks. Any management works involving large woody debris should consider the fisheries value of the debris

Large woody debris are the only bankside features providing habitat and erosion protection in the absence of adequate sunlight.

before considering removal. If removal is necessary, the club should consider moving the debris to a location where it will be beneficial before complete removal from the river is considered.

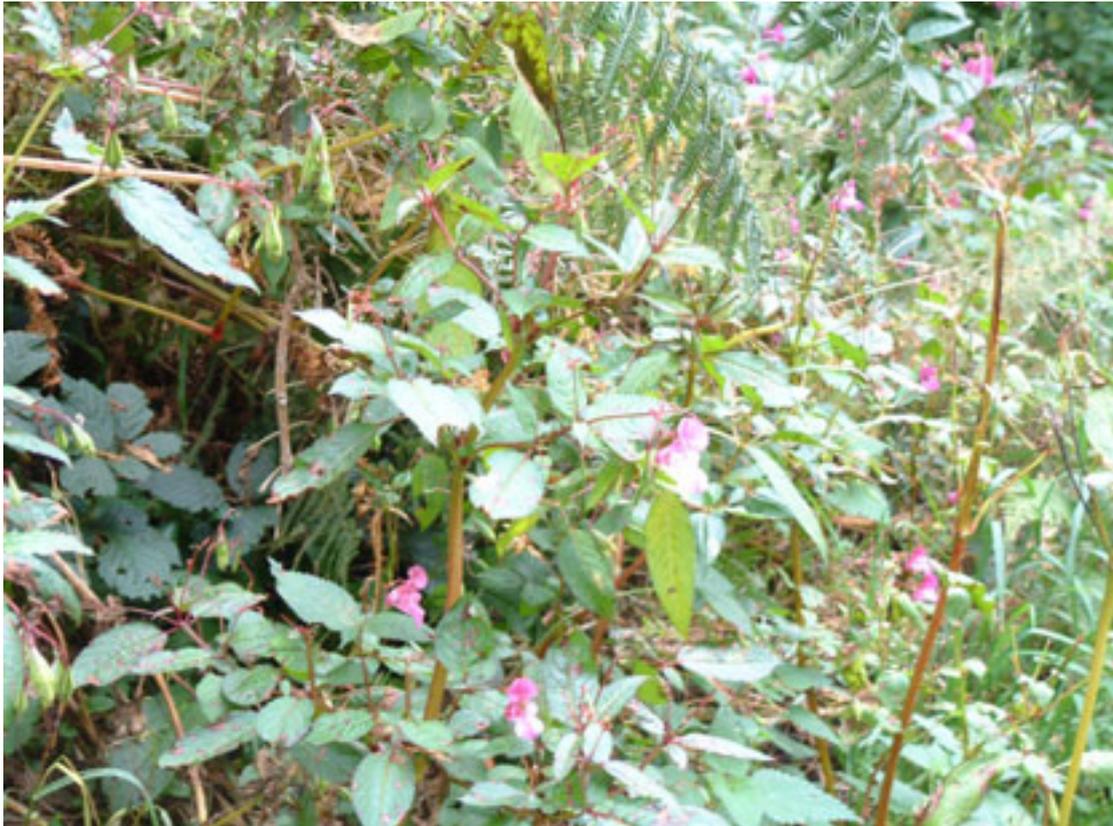
A common problem for many UK rivers, is the invasion of an exotic plant, Himalayan Balsam. This attractive plant, first imported as an ornamental, competes for bankside habitat and colonises in large stands. The plant dies back in winter leaving a bare exposed bank which is prone to erosion and provides little habitat. The Nidd has extensive colonies, however, it is apparent that someone has been keeping a check on the plant throughout the gorge by pulling it. The plant is an annual and can be eradicated by removal starting at the top of the river catchment. As the plant has not established in large colonies yet on the beat, it would be prudent to advise anglers to assist in the manual removal of the plant as they come across it until such a time as there is a catchment-wide eradication programme. No other exotic invasive plants were seen on the visit, but an eye should be kept open for Japanese Knotweed which can cause considerable problems. If it does occur, specialist advice should be sought on removal techniques in order to prevent the spread of the plant.

Himalayan Balsam does occur within the beat but has been controlled up to now.

1. Before undertaking any tree management or operating chainsaw equipment, take advice from the riparian owner and professionally trained individuals for obvious legal and safety reasons.
2. Meet with the Woodland Trust representative to bring the river corridor into the conservation or management plan for the gorge and offer assistance from the club where possible.
3. Produce a coppicing plan for the beat to increase light levels in some of the heavily eroding sections (particularly where multi-stem alder dominates).
4. Investigate the cost of marking stocked fish and run accurate catch return project, even if only for a couple of seasons, to try out various new stocking regimes.
5. Recommend to fishermen that they assist in the removal of Himalayan Balsam in order to prevent large stands developing.
