MYDDLETON ANGLING CLUB

The River Wharfe, Ilkley, Yorkshire

Advisory Visit Report Undertaken on behalf of the **The Wild Trout Trust**
By Ron Holloway MIFM

8th May 2002-05-14

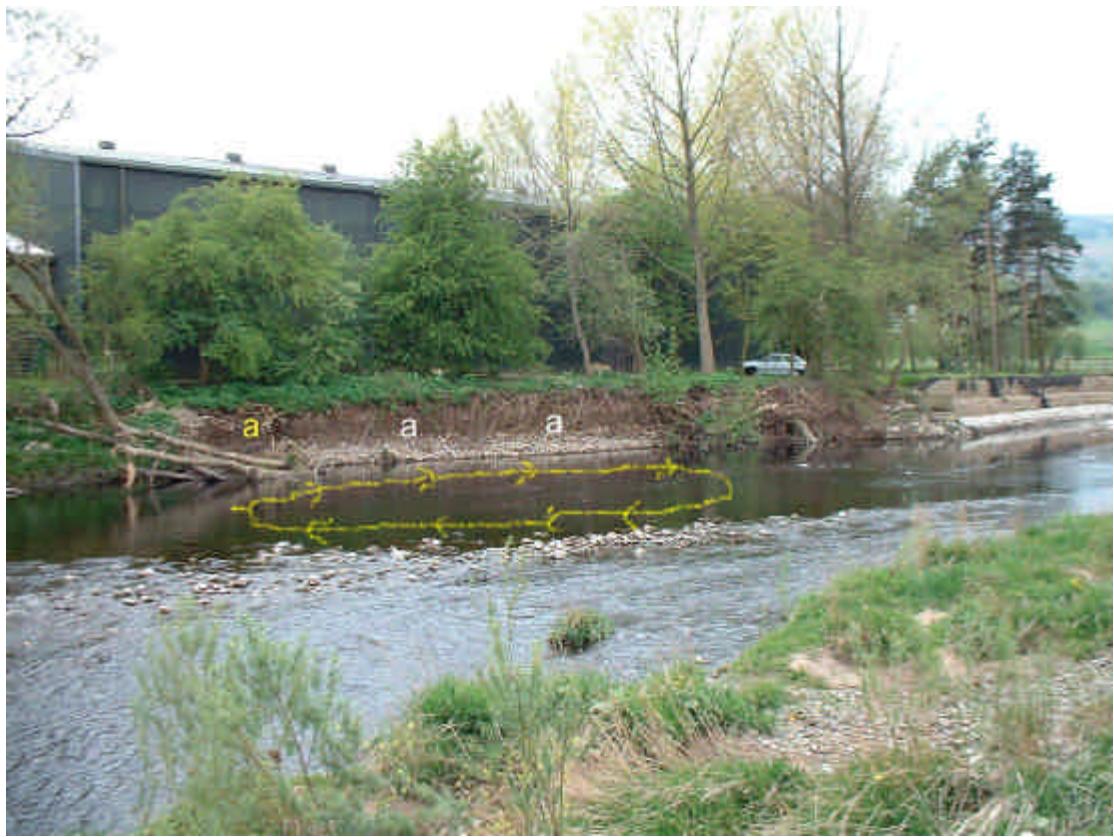
Site One: At the rear of the Tennis Club Courts – Illustration Two. The protection work recently carried out has protected the land directly behind this new structure but due to its morphology (shape) it has inadvertently created a major problem just downstream of the structure by encouraging a back eddy to form which has already caused considerable erosion in the area directly behind the grey building. (See area indicated by letter A in Illustration No.2) Serious consideration should be given to protecting this vulnerable bank from further erosion which could threaten the structure of the grey building, particularly in any above normal high flows.

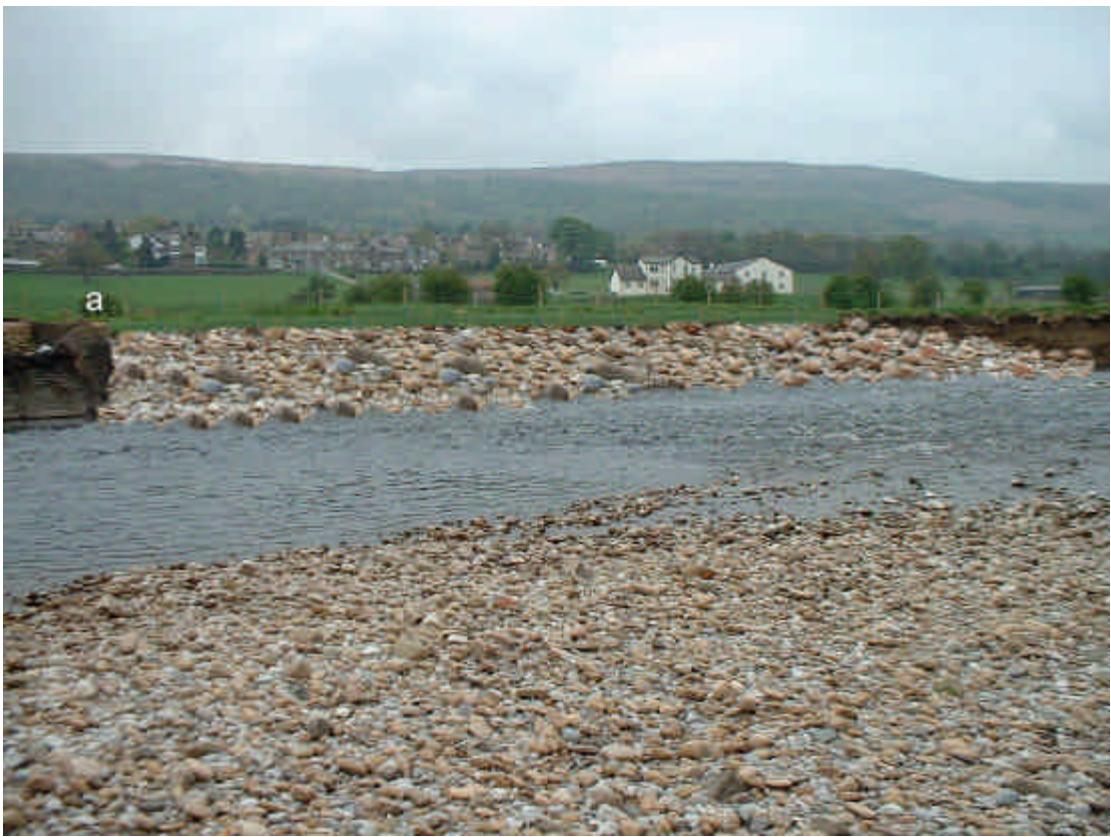
Illustration Three.

Site Two – Upstream of Tennis Courts. The protection work recently carried out has protected the land directly behind but its upstream limit has, and is, encouraging the river at any level to erode the unprotected bank upstream and also the indications are that the river will erode behind the upstream end of the new construction (see A in Illustration No.3)

Consideration should be given to protecting this very vulnerable bank by extending the work upstream and by deflecting the current away from the foot of this soft bank. Large rock riprap could be considered as illustrated. However, larger rock than illustrated should be used. There will, however, be problems with planning and conservation consents as sandmartins have now colonised the face of this bank.

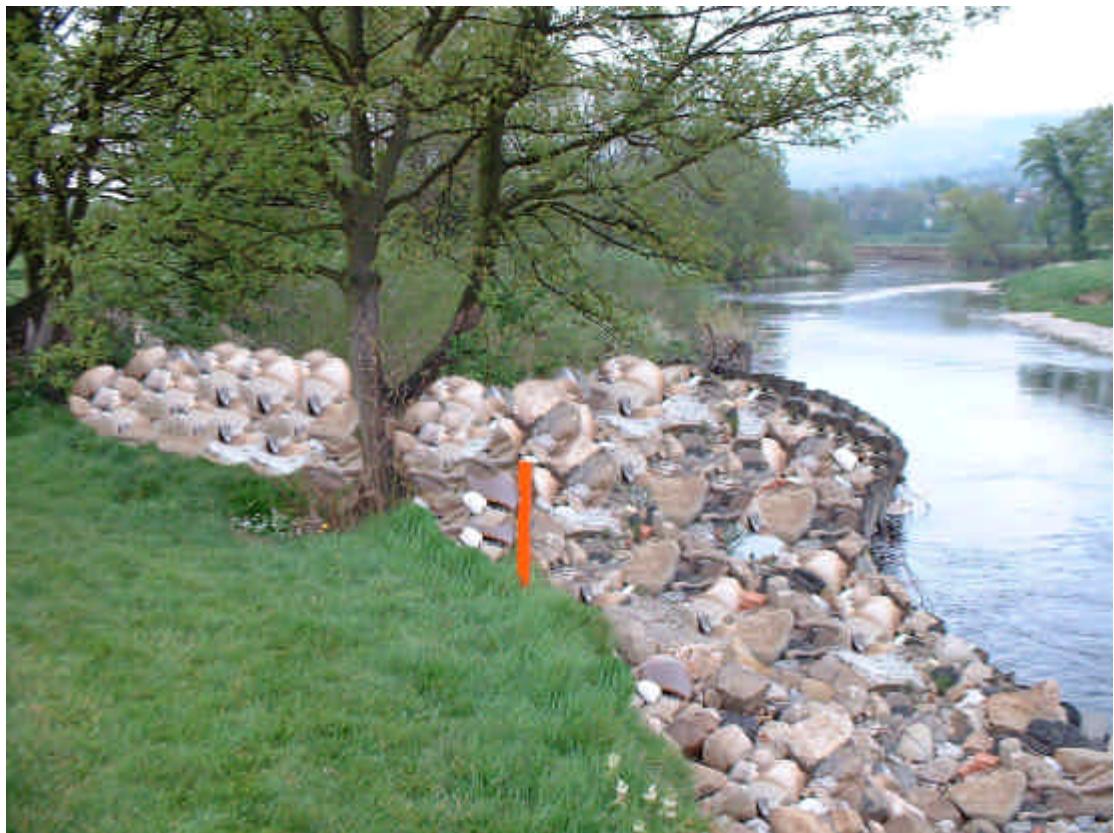
Illustration Four.

Site Three: Hawksworth Island.

The area behind the sheet piling is very vulnerable to further erosion at high flows and any further erosion could seriously compromise the golfing area of the island. Any remediation will be expensive and will require expertise from a fluvial geomorphologist who will be able to recommend and design a suitable structure to prevent further serious damage. Consideration could, however, be given to the importation of big rocks to back fill the entire area behind the damaged piling and for this to be re-profiled back, as illustrated (Illustration No.4.). When sufficient rock has been placed consider removing the damaged piles. Part of the rockfill could be

infilled with gravel and soil and replanted. However, it is advisable to take professional civil engineering advice on this site.

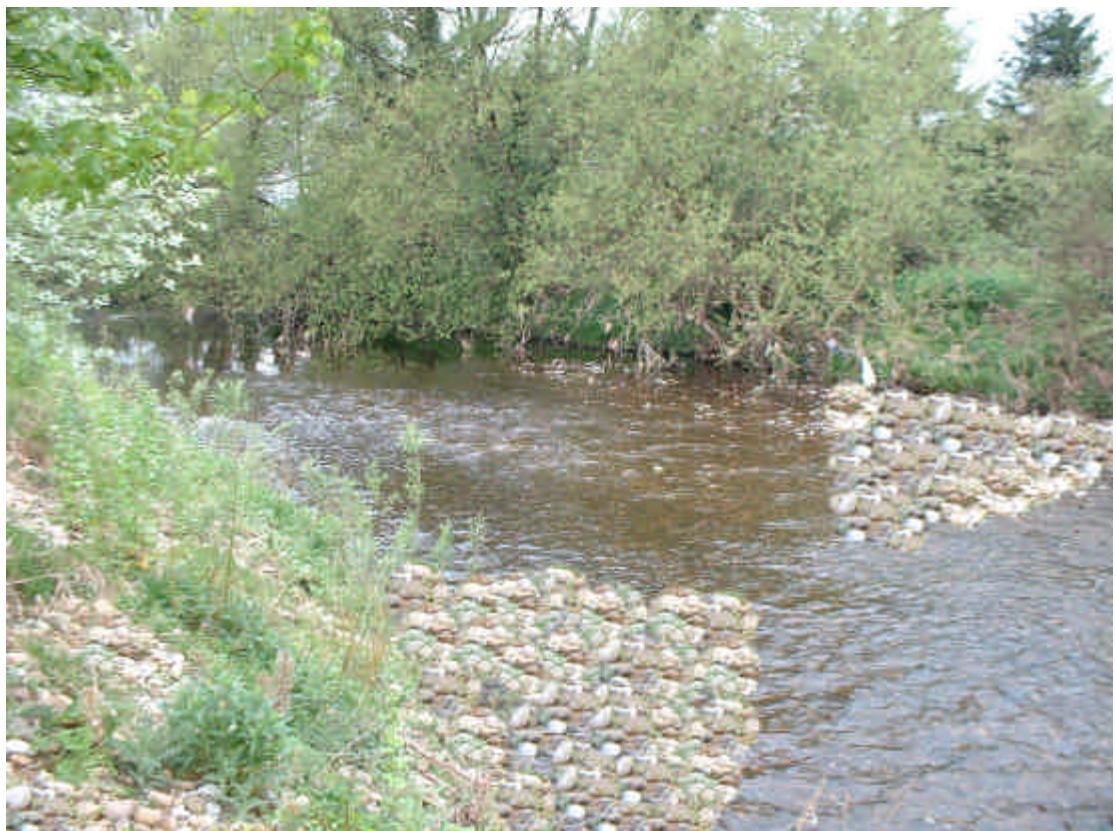
Illustration Five.

This reach, which runs round the back of Hawksworth Island has excellent wild trout holding potential. To improve this capacity it is suggested that a double rock structure be placed on the shallow riffle – this to be built of rocks of sufficient size which will withstand high seasonal flows (Illustration No.5).

The shape of the constructions will scour a trout holding area just downstream. The rock used in the illustration may be on the small side but were all that was available but it gives some idea of the shape. It is suggested you consult with the EA on the precise siting of these structures. Fishing access may be improved with some judicious pruning of overhanging branches, otherwise this stream is a perfect example of quality trout habitat.

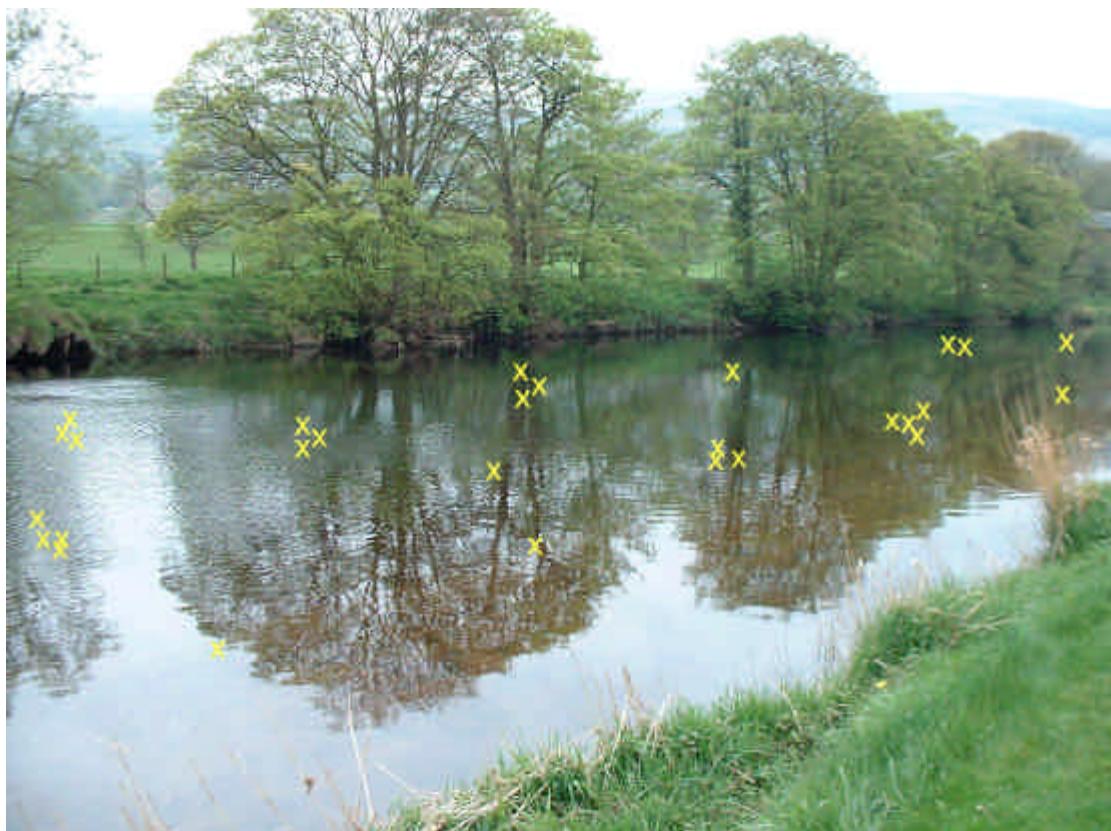
Illustration Six.

This wide, shallow, featureless stretch needs livening up with some randomly placed clusters of rocks throughout the entire area. The placement of these clusters will not only create excellent trout holding areas but will also produce more surface activity into the stretch and generate more energy into the flow which will help to keep sediments on the move and, therefore, maintain a cleaner river bed.

These clusters of rock should be placed to be just below the surface at mean base flow heights and be substantial enough to withstand any high winter flows. Random placing of rock clusters – see Illustration No.6.
