Habitat Advisory Visit to the River Wissey (Norfolk) By
Simon Johnson on behalf of the Foulden Lattimer Estate.

1.0 - Introduction

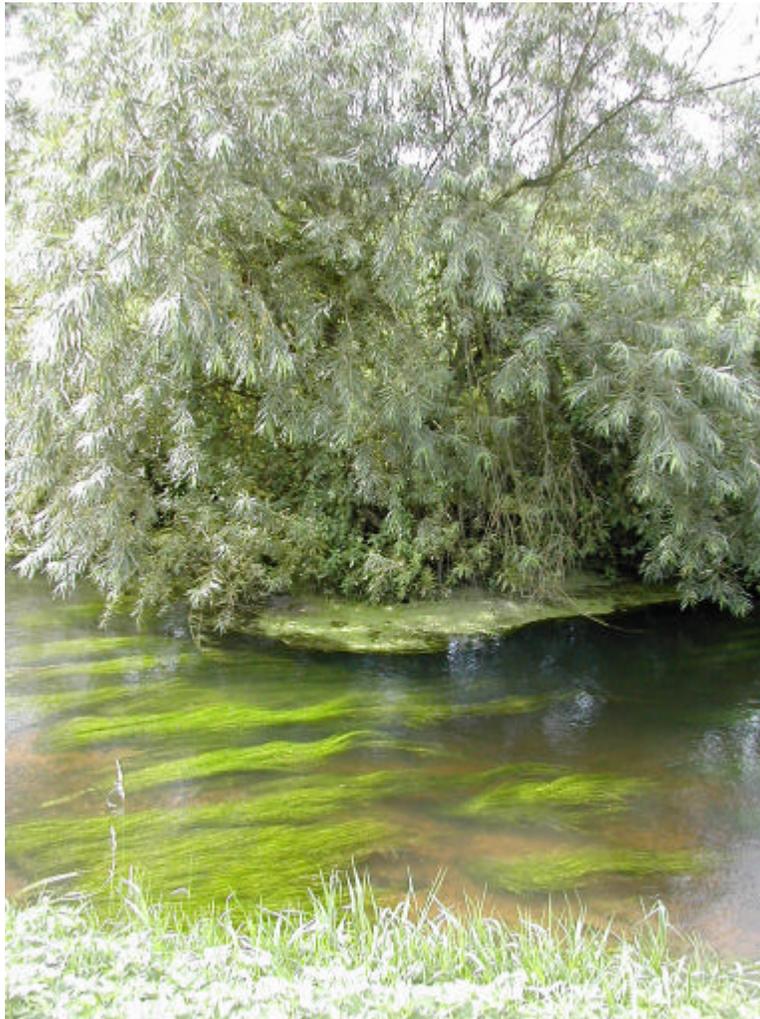
There appears to be a relict area of shallower gravel riffle habitat here, although the stretch has been deepened. Exiting the bend the stretch through to Pool A is characterised by shallow gravel runs and good aquatic weed growth (water crowfoot). The banks are steep due to spoil from previous dredging operations. There is a natural berm forming on the inside of the bend which is speeding up flow velocity nicely. The willow trees at the exit of Pool A provides excellent cover for adult fish. (cover picture)
