Wild Trout Trust Advisory Visit

Urswick Tarn Angling and Conservation Society

1st September 2003

Urswick Tarn Angling and Conservation Society (Urswick Tarn and Gleaston Beck)

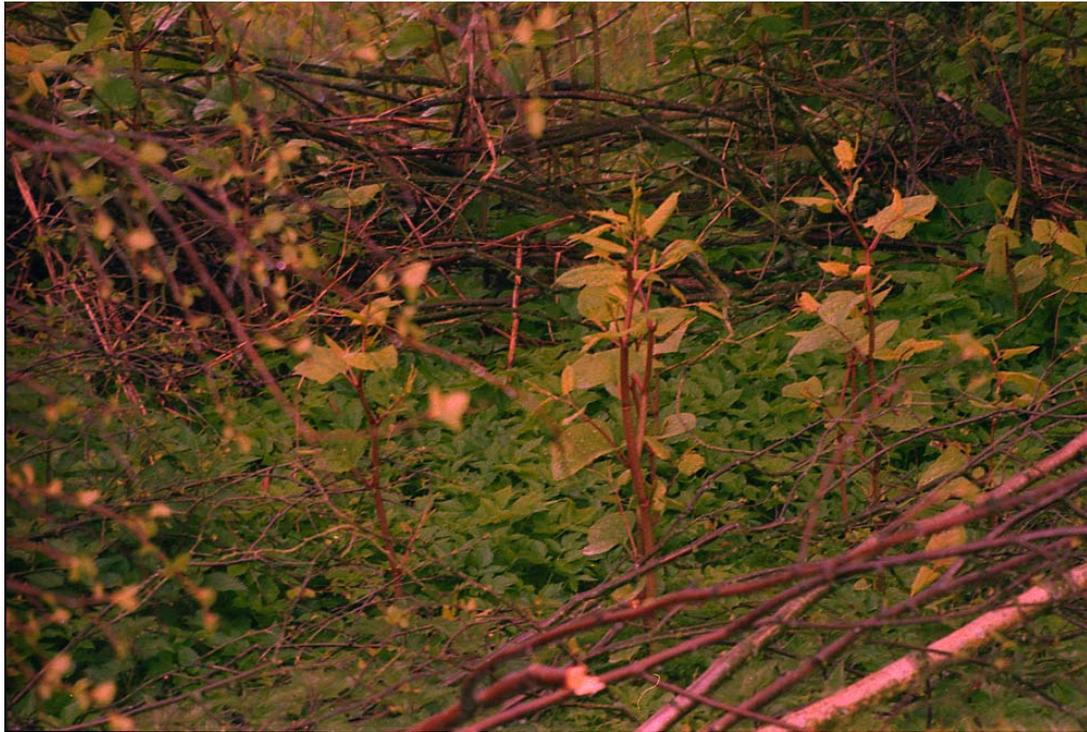
Only the female plant is present in the UK and will not produce fertile seeds. All spreading has been carried out by manual means. A single node on the stem is capable of travelling down waterways and establishing a new plant elsewhere and this is a real threat to habitats all the way down Gleaston Beck. In the case of the small stand beginning to develop adjacent to the tarn, it appears that some rhizome (root) has been imported during the creation of the new track down to the area know as the "Landings".

Figure 1: Isolated patch of Japanese Knotweed beginning to establish at the Landings.

Eradication of Japanese Knotweed is difficult and should not be attempted without thorough research. The plant cannot be removed by pulling, as this breaks up the rhizome into small pieces that re-grow vigorously. The plant tops must be disposed of as "Special Waste" if cut. The best approach for this small stand would be to take measures to prevent spreading of the plant and individually treat individual stems with a translocated herbicide such as glyphosate (trade name RoundUp) twice a year, in Spring and Autumn when the growth is most vigorous. This approach may still take up to 3 years to work. If this approach does not work, the rhizome root system is already well established and much more aggressive measures need to be used. If this is the case, seek specialist advice.

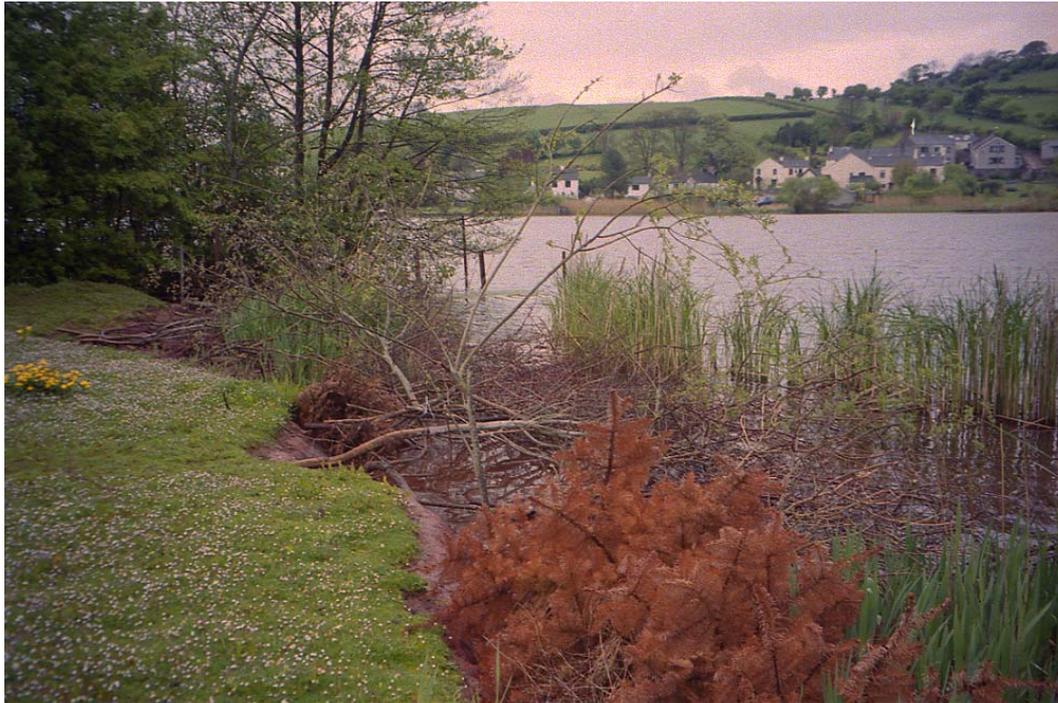
Urswick Tarn is typified by some fantastic reed beds. These have been lost in parts of the tarn. This has been recognised by residents and some attempts to protect remnant reed beds have been quite rightly taken using randomly placed brushwood. Where there are breaks in the brushwood, erosion of the tarn bank by wave action has been concentrated.

Figure 2: Breaks in the recovering reed bed allow wave action to cause excessive erosion behind the recovering reed bed. Note grazed bank.

Restoration of reed beds has been successfully carried out elsewhere in the country, by protecting the recovering vegetation and exposed bank, using continuous lengths of brushwood faggots. These are either pinned into the tarn bed using long road-pins or willow stakes, or can be strung along a wire line attached to the tarn bank at either side of the length of bank being restored. It is important that there are no breaks in the protection for waves to pass through while the reed beds are recovering.

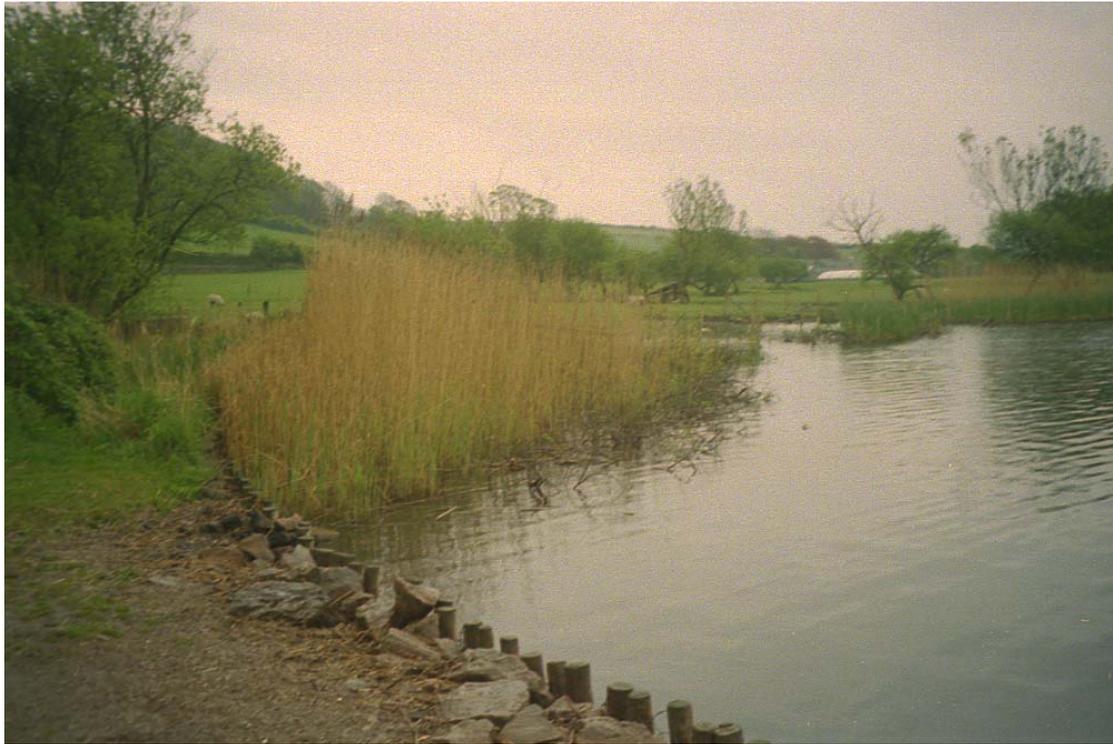
It is obvious that wave action did not cause the original deterioration and loss of reed beds, in fact, the reed beds are probably the best protection for the tarn bank against wave action. The most direct physical damage to the reed beds is likely to have been caused by grazing animals and waterfowl. Steps have already been taken to protect reed beds from animals in some parts of the tarn and appear to be very successful. It must be recognised that reed beds in other parts of the tarn will not recover without appropriate fencing. Where land is part of an agricultural holding, protection work (fencing, planting etc.) may form part of a Countryside Stewardship or other agri-environment scheme for which the farmer is paid on an annual basis.

Figure 3: Fenced reed beds in the background, and those naturally sheltered show much better recovery.

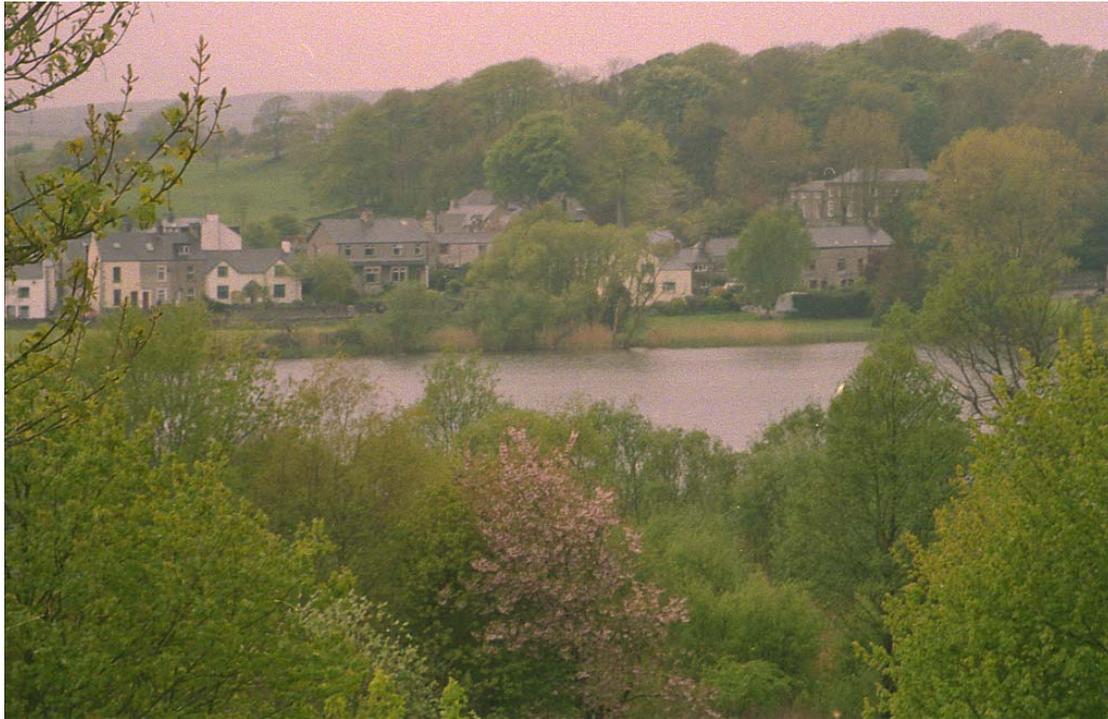
This appears to be behaviour associated with predatory birds resulting in fish taking refuge in a shoal. The tarn historically had large beds of floating marginal vegetation that has been lost due to intensive management for angling in the past.

Figure 4: Restoration of floating vegetation close to residential areas, where angling is not favoured, will create important conservation areas for the fishery.

It is important to increase daytime refuge within the tarn in order to prevent the shoaling behaviour of the fish, which is not contributing to the long-term health of the population. It is recommended to try and restore some marginal floating vegetation in parts of the tarn where there is limited public access and treat these areas as conservation areas.

There are details of floating vegetation that was historically present in the tarn in the Cumbria Wildlife Trust conservation strategy for the tarn. Efforts should be made to try and restore some of these. The labour offered by the UTACS will be essential to help achieve this.

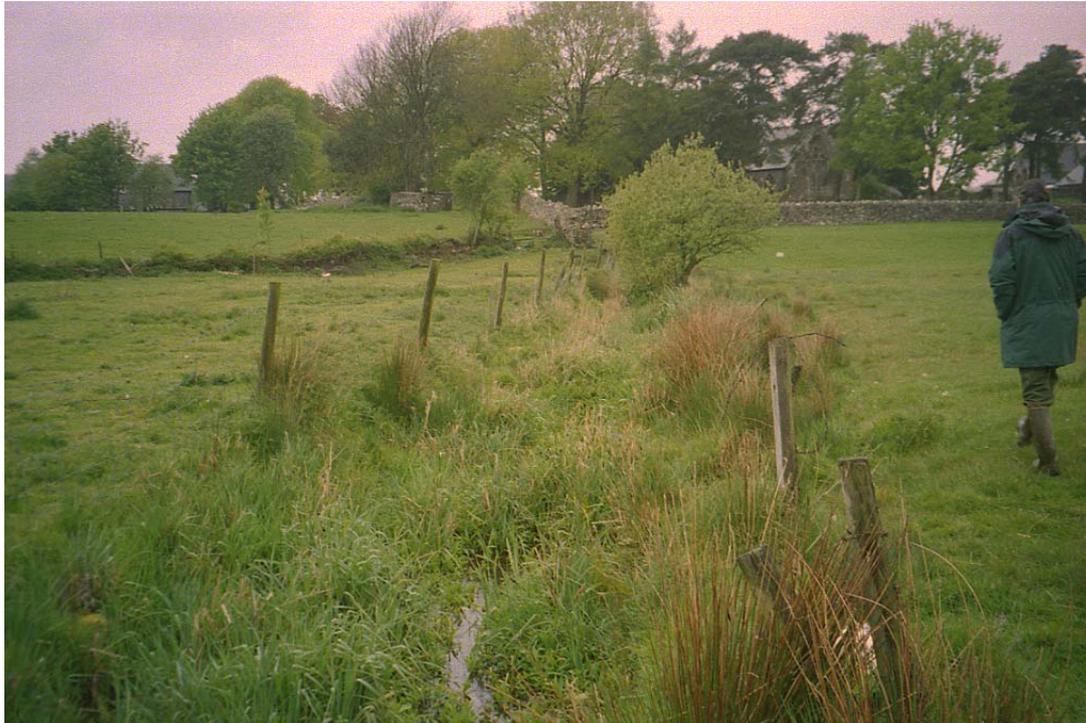
The reed beds are an extremely important component in the Urswick Tarn ecosystem and this has been recognised by the TA and UTACS in their recent conservation work. There appears to have been significant loss of reed beds by reclamation of wetland at the rear of adjoining gardens, whether to enhance views or increase property size, and this has probably had some detrimental impact, but is certainly understandable. There must therefore be an objective to re-establish reed beds in other places where they have been lost, to make up for the losses on private property that cannot be restored. There have often been problems with restoration of reed bed systems where they have been lost completely due to the loss of the natural protection that reeds offer each other. One technique that has been used successfully is where the root ball of individual reed plants is bound in hessian with suitable compost, and sometimes a stone as weight. These are planted where there is access, but also can be thrown from the shore or dropped in from a boat into deeper water. This must be carried out at the beginning of the growing season in order to allow them to root. Reeds that are in the process of establishing may also be cut right back at the end of the growing season, in order to avoid the growth causing the plant to be uprooted by severe weather. Great care must be taken not to compromise existing reed beds, to establish new ones. Removal of plants from one may enable wave action, or birds to cause a long-term decline in the bed. It may be extremely helpful to establish some reeds in one of the drains at the top of Gleaston Beck, and use these to re-establish new reed beds in the tarn. This would also help with water quality issues in any of these watercourses. It must be remembered that all new or

Figure 5: It may be safer to establish reeds for replanting in one of the drains rather than compromise reeds in the tarn. This will also assist with water quality improvements (drains should also be fenced).

recovering reed beds must be protected with fencing as the beds are on the Eastern side of the tarn.

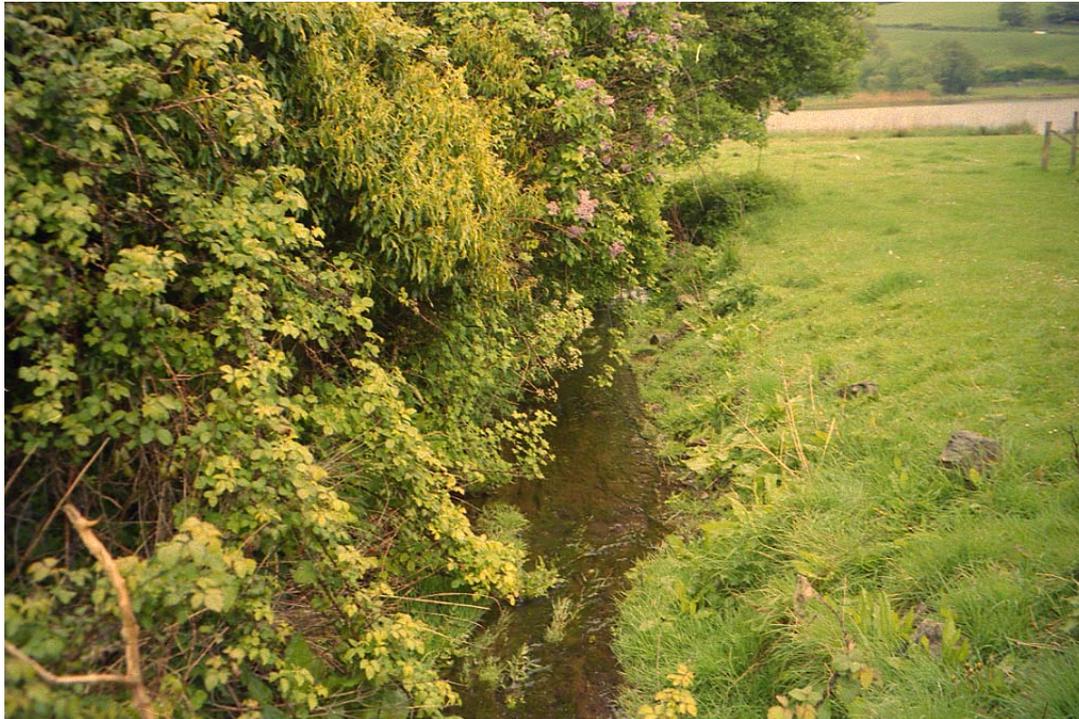
The tarn is probably mostly fed from groundwater sources, hence its rich limestone character. The only visible tributary that feeds the tarn is the small beck that enters on the West side.

On inspection, this beck displayed a very poor range of invertebrates, implying water quality that is below standard. The cause of this poor water quality is unknown and an attempt to trace any negative inputs into this beck should be made. This could, for instance, be due to septic tank leakage or similar inputs, but suggestion has also been made of a historic mine leakage into this watercourse. The EA water quality department should be asked for their opinion and the potential risk to the tarn assessed.

Figure 6: The beck entering from the Western side carries water of questionable quality. Natural treatment of this beck offers potential for some remediation.

Failing treatment of the cause of the poor water quality, some protection to the tarn may be afforded by increasing the amount of vegetation on the beck. This can act as a sediment trap for noxious substances, and vegetation will help clean the water. First step should be to increase the light that gets to the beck; this will increase in-stream vegetation growth. The beck should also be fenced to allow bankside vegetation to establish, and prevent stock from disturbing any trapped sediment. The reeds in the tarn are ideal for treatment of poor quality water, establishing these along the length of the beck would also be helpful.

In an ideal world, the beck should be increased in length, turned into the field, a couple of ponds created to really slow water and allow sediment to drop out and be treated by vegetation, before entering the tarn. The landowner will probably be resistant to this, however, if they are an agricultural holding, this work may form part of a Countryside Stewardship or other agri-environment scheme, that would also pay for some of the tarn improvements over this piece of land.

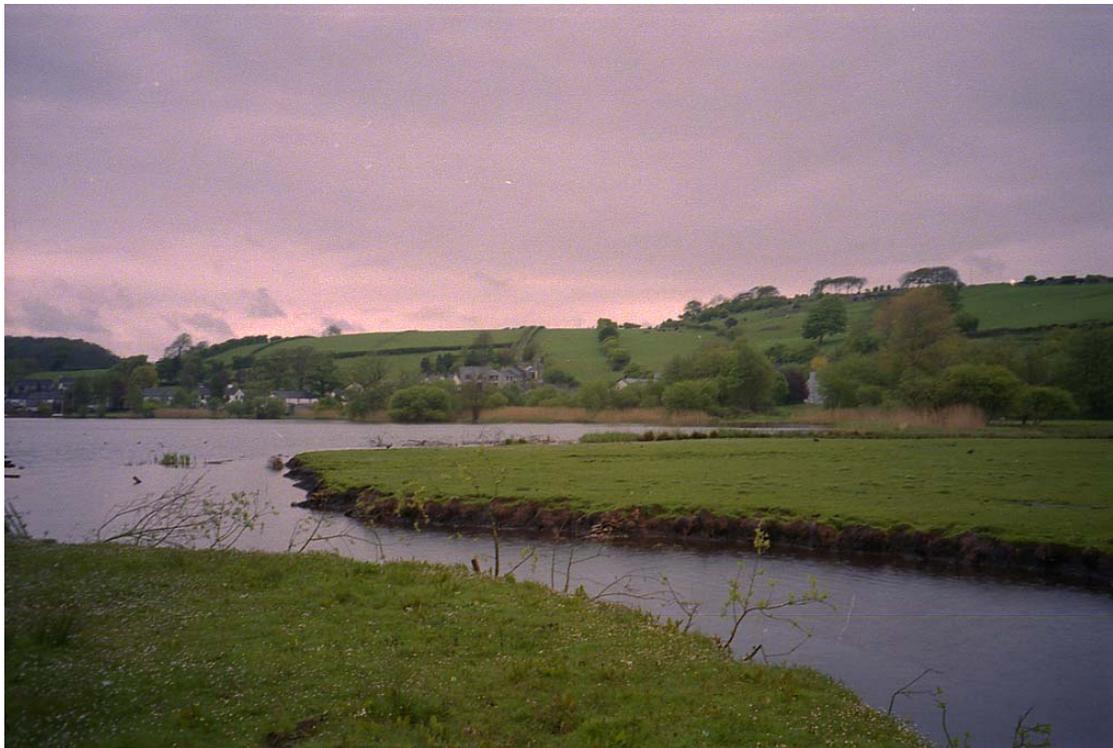
The flood defence concern is that a high rainfall incident will raise the water level in the tarn and flood Great Urswick, so vegetation has been cleared from Gleaston Beck and it has been straightened to allow water to get to the sea as quickly as possible. The flood risk is exacerbated by the very low gradient of parts of Gleaston Beck.

Figure 7: Gleaston beck has been cleared of vegetation from where it leaves Urswick Tarn. This has left a watercourse with very little conservation value. New policies should allow restoration of a low flow channel and allow a certain amount of agricultural land to flood without compromising residential areas.

New policies on flood defence should allow the creation of a low flow beck of high conservation interest, while also allowing a high flow channel (two stage channel) with additional unpopulated areas serving as flooding zones.

It is important that all improvements are carried out in partnership with the EA flood defence department and this may also lever some restoration funding. Even large rocks throughout Gleaston Beck have been removed, and these are essential for providing trout habitat, especially where no vegetation is allowed, and do not significantly affect the ability of the channel to move water in high flows. In fact, sediment that builds up in these straightened channels does reduce ground infiltration and can increase flood risk in some situations.

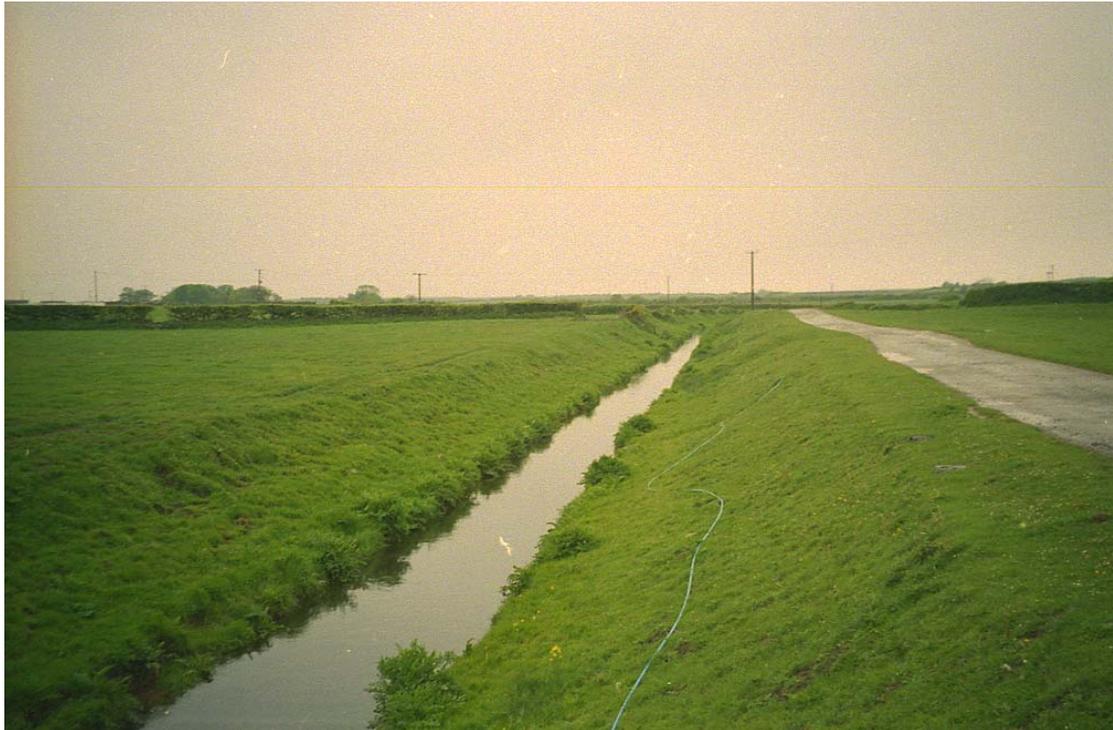
Figure 8: Gleaston Beck is characterised by a straight featureless flood defence management routine and is probably not relative to its flood risk.

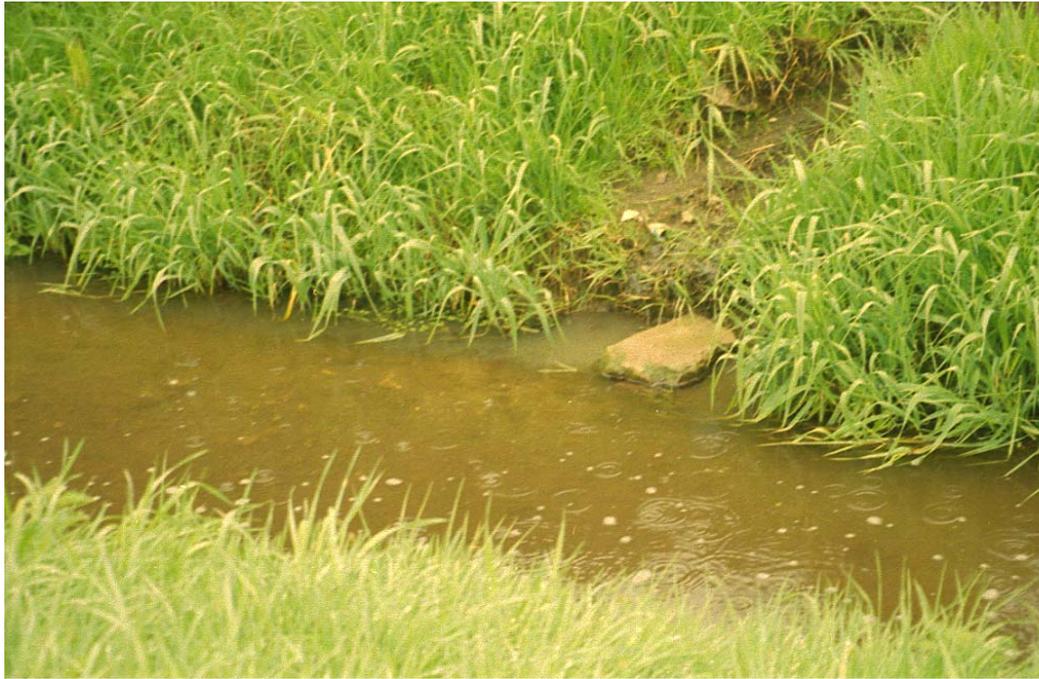
Water quality in Gleaston Beck should echo the water quality of the tarn, however, there is evidence of small pollution inputs and a history of acute agricultural problems.

Figure 9: This grey coloured discharge from a clean water drain was definitely sewerage related and by the deposit on the vegetation was high flow at some point. This could have come from a number of sources, both acute and diffuse, but either way will contribute to long-term problems in the beck.

The statutory agencies can only respond to events reported by the public, so continue to monitor suspect areas, take samples and photos and report the incident to the Environment Agency as it occurs. Talk to the local water quality officer about how to take a sample, and ask to be provided with some sample bottles, if time constraints make it difficult for the authorities to catch the event.

UTACS (and the TA) should as a matter of urgency join the ACA (www.a-c-a.org) in order to legally protect their interest in both the tarn and beck, especially where pollution is concerned.

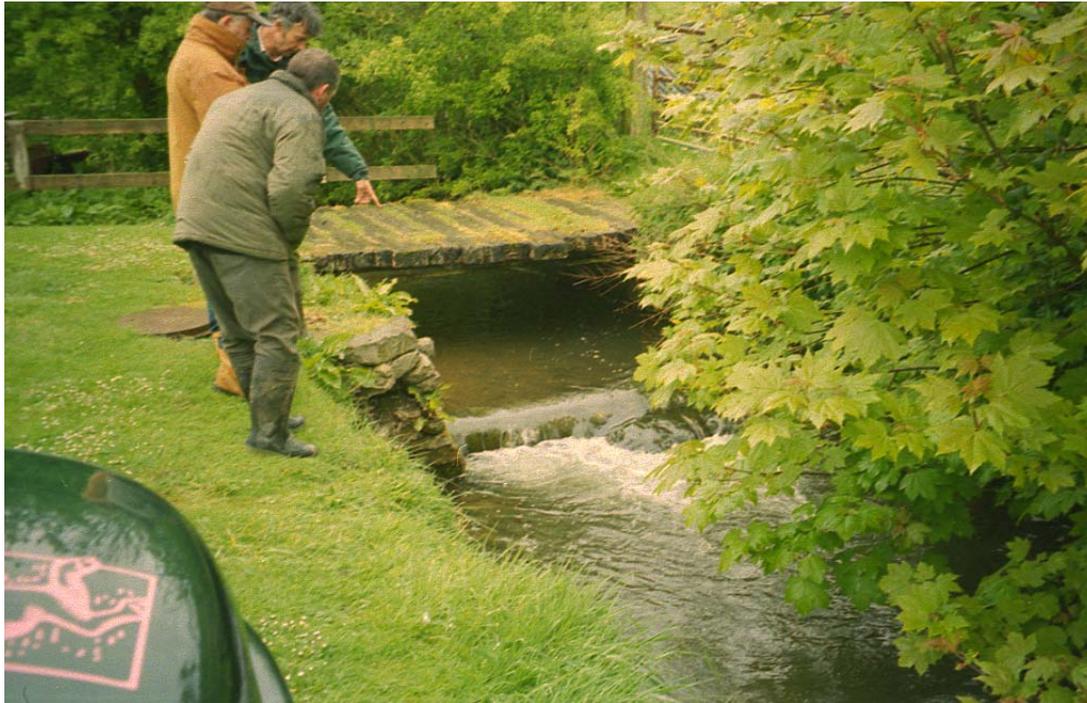
The transformation of Gleaston Beck where a single pool has been allowed to form is outstanding and provides considerable evidence of the potential for the beck where habitat and water disturbance is allowed to increase. In this location, mayfly was observed hatching and a single trout was seen. The landowner reported the mortality of a very large hen trout earlier in the year, which lends more evidence to the argument that Gleaston Beck should be supporting a migratory trout population, and that they may recolonise without assistance from artificial stocking.

Figure 10: A simple structure has created a pool that now supports salmonids and a far increased range of invertebrates.

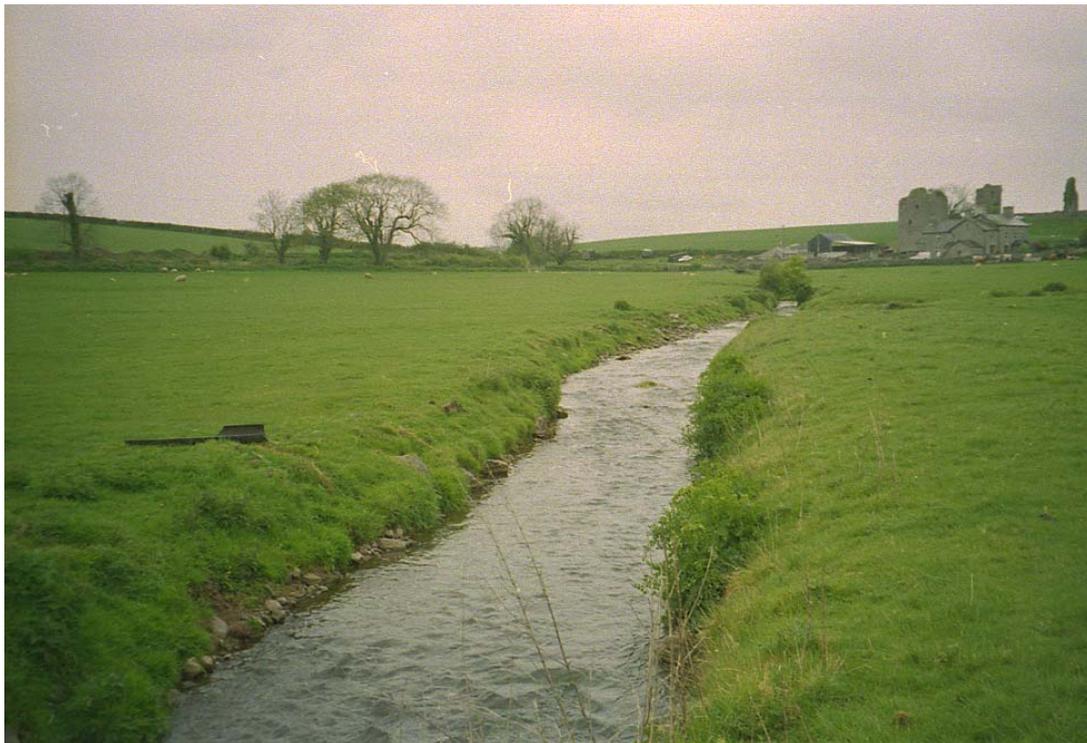
Figure 11: Pool – riffle creation, return of large stones, and fencing to promote vegetation will restore Gleaston Beck from the featureless drainage channel above to a point where it can support a healthy salmonid population in a surprisingly short time.

Where landowners approve, recreation of pool – riffle habitat will transform the ability for Gleaston Beck to support trout. Examples of techniques needed were recently observed by members of UTACS at a visit to a WTT demonstration event and may also be seen in the Game Conservancy Trust publication, “Helping fish in lowland streams”. Of particular interest in Gleaston Beck is the upstream V-shaped weir, which is easy to construct, does not necessarily need much height (not affecting flood risk), and keeps river flow central so not losing the straight channel where it is essential for flood defence. Where possible, other techniques could be used to produce a meandering channel on flood plain land where it can safely flood, or flood within a second flood channel. These plans should be discussed with the EA, but may well be possible to include within agri-environment schemes with landowners.

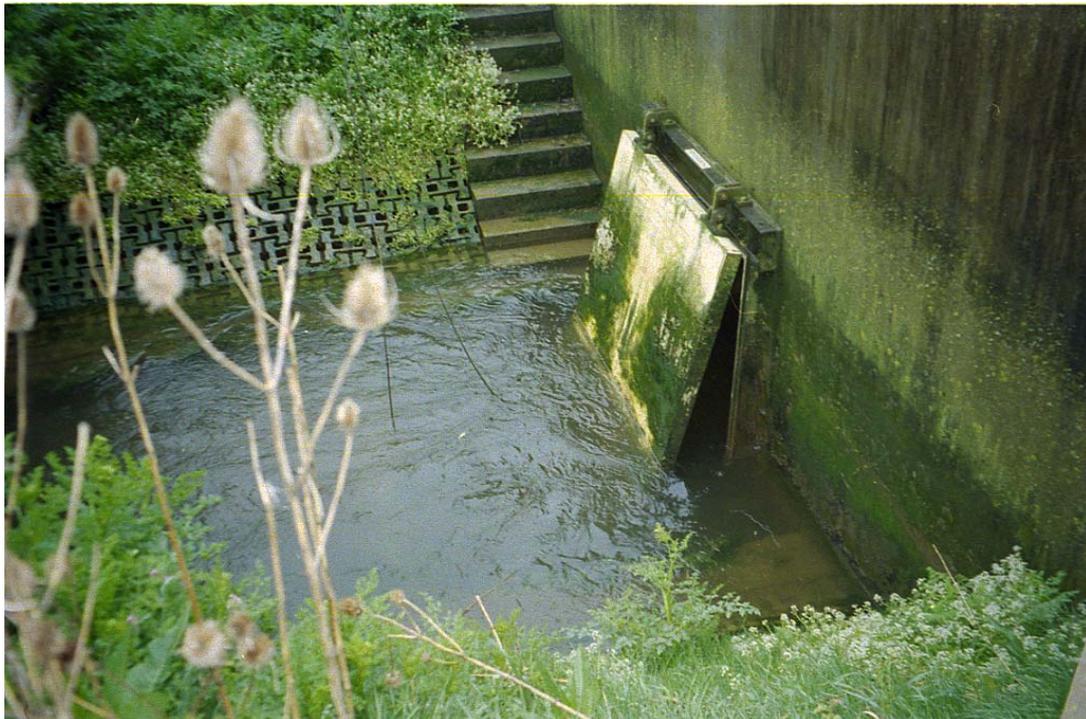
Where Gleaston Beck meets the sea, a tidal flap has been constructed, which presumably acts to prevent flooding of agricultural land by saline water in very high tides. Tidal water will close the flap at exactly the point when migratory trout are likely be wanting to enter the beck. This structure, and the culvert that carries water under the road and out to sea, may appear to be very unattractive to fish, however, trout were observed below the tidal flap and seemed to enjoy the little bit of disturbance and in-stream feature that the flap has produced, much like the small weir upstream.

Figure 12: The tidal flap and pool supports trout, but probably is a barrier to migratory fish populations.

This feature has the potential to severely impact on any migratory fish population and negotiation with the EA should identify a means to enable access by fish without compromising the flood defence purpose, if this purpose is still required. The flap may either be controlled so that it is only operated on extreme tides (either manually, remotely or automatically) or a fish pass structure constructed.

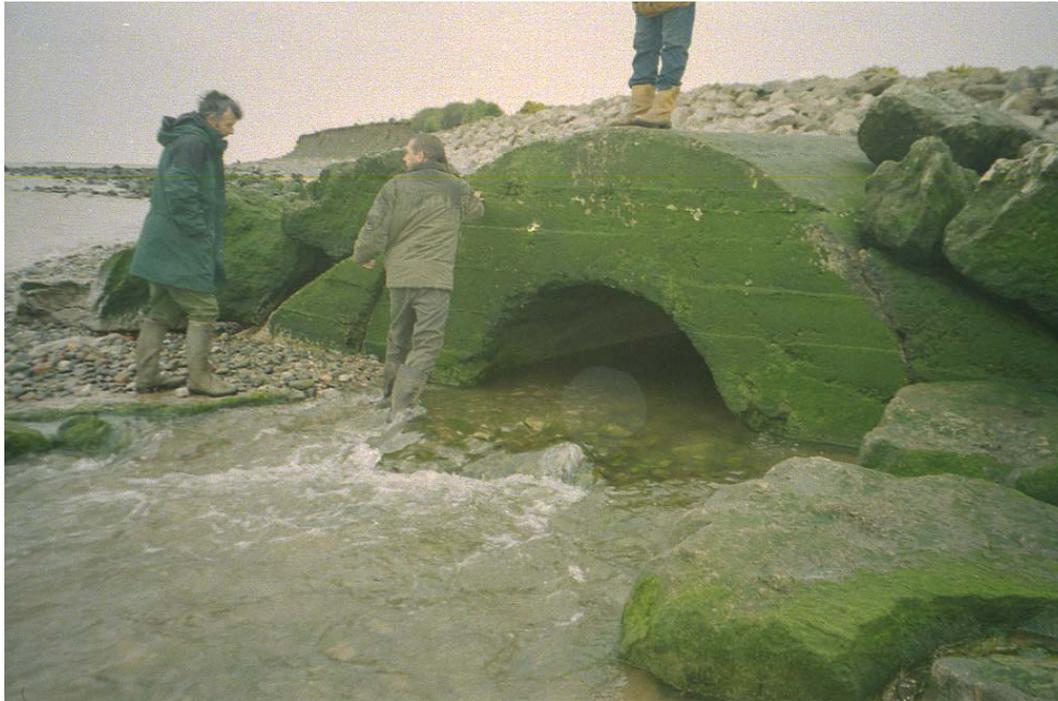
One other concern is that the flap and culvert has destroyed any “estuarine” habitat where migratory trout may slowly adapt to increasing saline levels. Ideally, this could be recreated upstream of the flap within a two stage channel if necessary. Whether this may compromise survival of sea trout in Gleaston Beck is unknown. Restoration of this point of the beck may be achieved in partnership with the Morecambe Bay Partnership.

Figure 13: Where Gleaston Beck meets the sea, is heavily modified, but does not appear to be a barrier to fish.

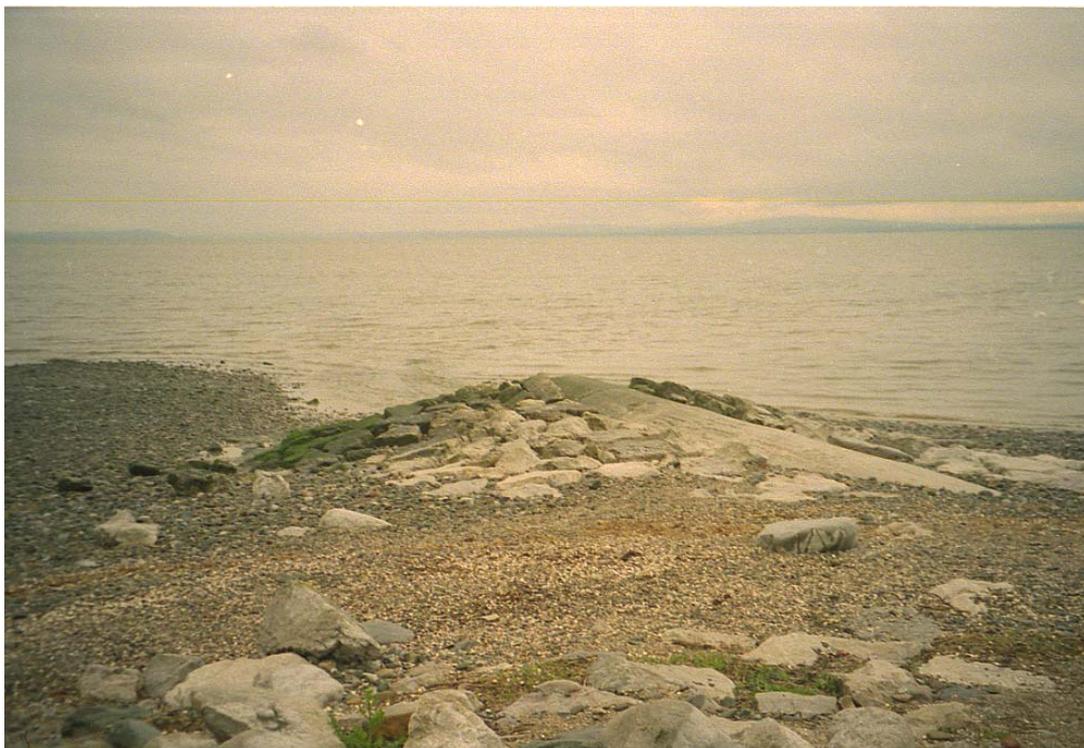
Figure 14: A big wide world for a Gleaston Beck sea trout, but Morecambe Bay is ideal habitat and supports other migratory trout populations.
