**HABITAT ADVISORY VISIT,
AMPNEY BROOK**

**UNDERTAKEN BY VAUGHAN LEWIS,
WINDRUSH AEC ON BEHALF OF
CHARLES NEWINGTON-BRIDGE
FEBRUARY 2004**

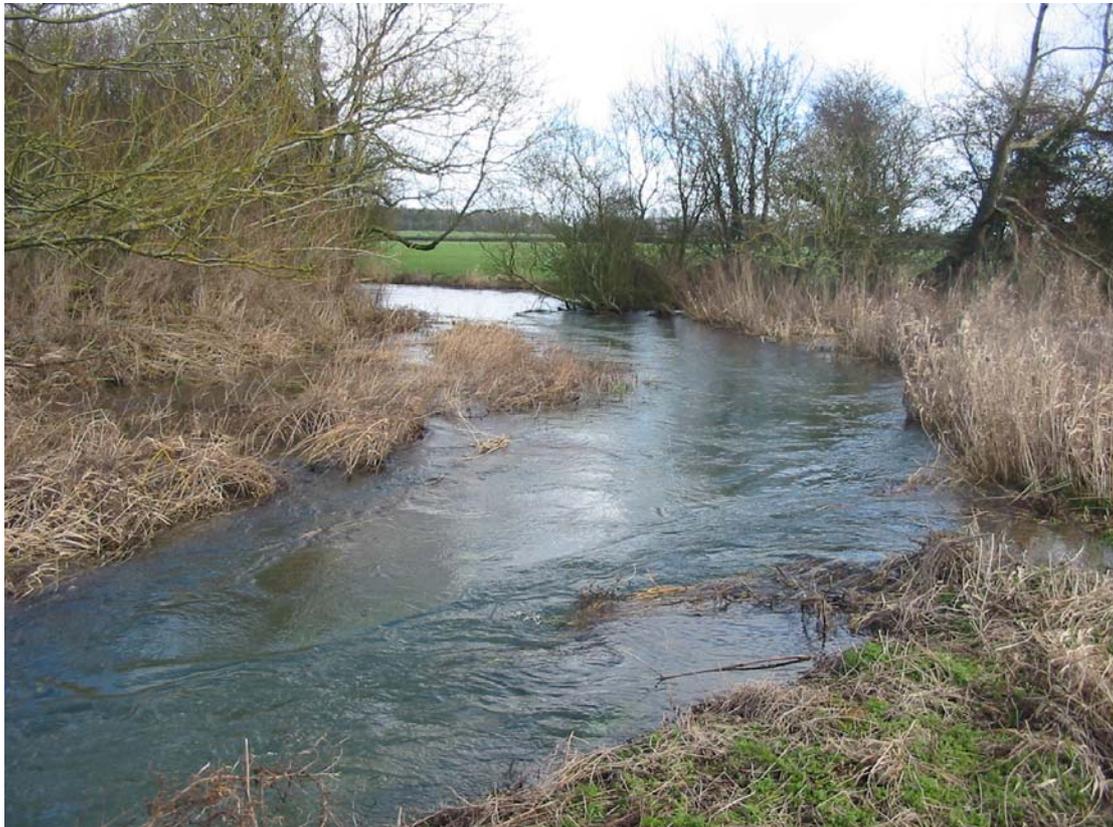
Upper section of the AV reach

The upper fishery was fringed with deciduous trees casting a generally dappled shade. Some short sections of the channel were however, heavily shaded. There was some large woody debris (LWD) present in the channel at discrete locations.

There was evidence of some localised overshadowing of the channel. This shade is restricting the growth of marginal vegetation, with associated damaging impacts on the rate of erosion, the provision of marginal cover for fry, and water flow velocity. In order to reduce overshadowing whilst retaining the valuable erosion protection provided by tree root systems, thinning of the riparian tree canopy at selected locations could be undertaken..

Rotationally coppicing can be undertaken in order to create an overall dappled shade over the river. Cutting on the south side of the channel is particularly beneficial, as light incidence is greatest from this direction. The conservation value of the existing trees should not be under-estimated and great care should be exercised in the selection of trees to be cut. A felling licence is required from the Forestry Authority for all significant tree felling, including coppicing. Timber arisings from the coppicing could be utilised to create stick pile otter holts. These are used by otters for temporary lying up or in exceptional circumstances, for breeding.

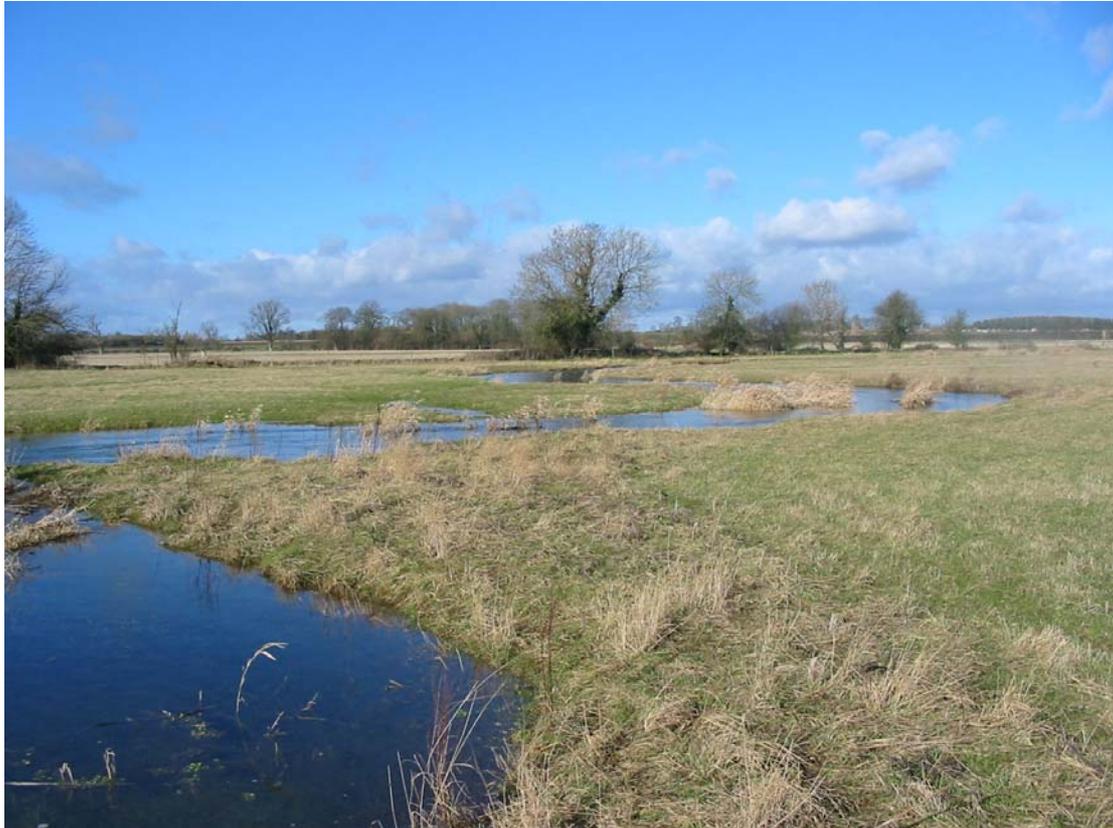
Middle section of the AV reach.

Below the ford, the river ran through semi-improved pasture/old water meadow, with light to moderate grazing pressure from sheep. This had resulted in a reduction in the growth of emergent and riparian vegetation and some local bank erosion due to block failure.

The present grazing regime is having some adverse impact on the middle reaches of the fishery, with ploughing close to the bank edge similarly affecting the lower fishery.

It would therefore be of great benefit to enter the riparian fields into an agri-environment scheme such as the new Environmental Stewardship scheme, in order to

reduce both the poaching of banks by stock and ploughing too close to the river. Agri-environment schemes provide farmers with payments to manage land for general environmental benefit, with specific payments available to fence riverbanks against stock grazing and to create un-cultivated buffer strips alongside arable cultivation. Information on these schemes is available from the local DEFRA office.

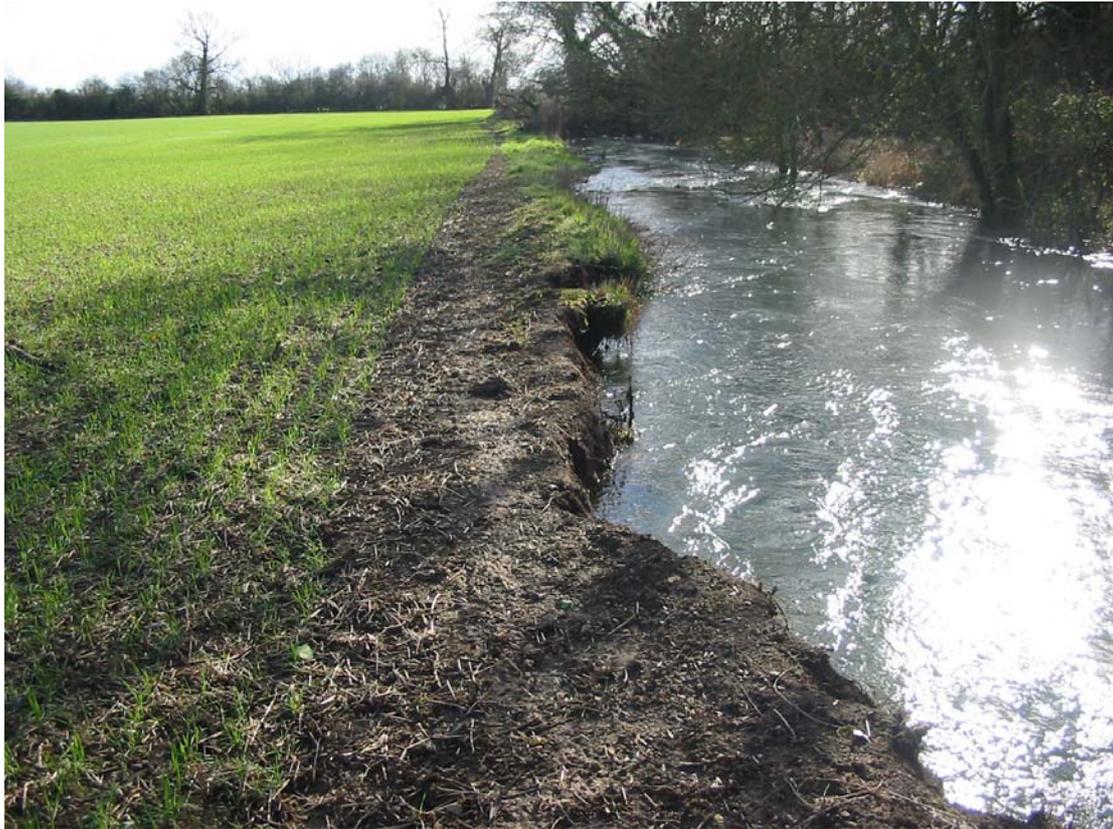
Below the grazed fields, agricultural usage changed to arable cropping. There was clear evidence of ploughing very close to the edge of the Brook, with associated erosion of its banks.

Ploughing to the edge of the Brook and associated erosion towards the lower end of the fishery
