Advisory Visit to the River Coln,
Ernest Cooke Trust, Glos.
Undertaken on behalf of the Wild
Trout Trust, by Vaughan Lewis,
Windrush AEC Ltd

September 2004

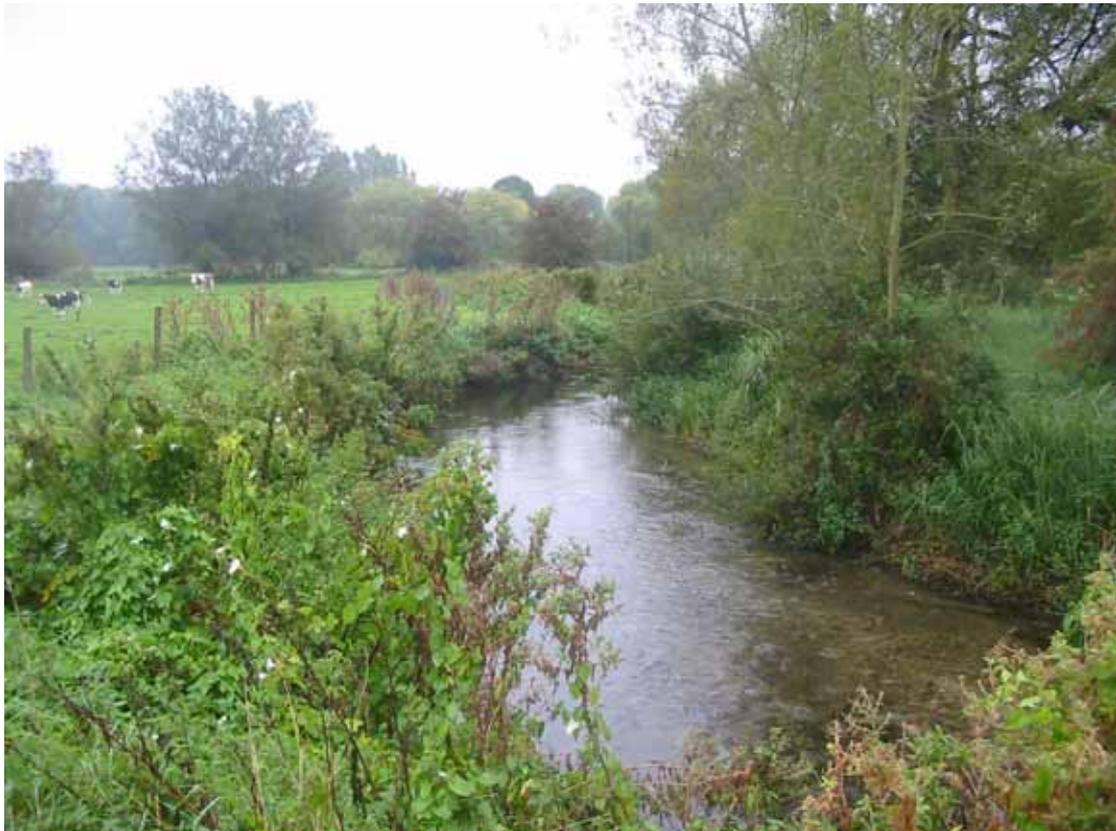
This section of the river had an extensive and dense growth of water crowfoot *Ranunculus spp.* during the early part of the 2004 fishing season. This was lightly cut in July by the river keeper in order to create a 'checkerboard' pattern. Subsequent to this, the crowfoot failed to re-grow with virtually no weed present on the day of the site visit. This had resulted in lower than usual water levels in the river.

River Coln downstream of Netherton Bridge. Note LB fencing and associated well developed marginal growth

- The marginal vegetation downstream of Moss Bridge should be allowed to grow laterally in order to encourage narrowing of the channel.
- The present policy of winter cutting of the marginal vegetation should be modified, in order to protect habitat for water voles and invertebrates. The presumption should be that no cutting should routinely take place.

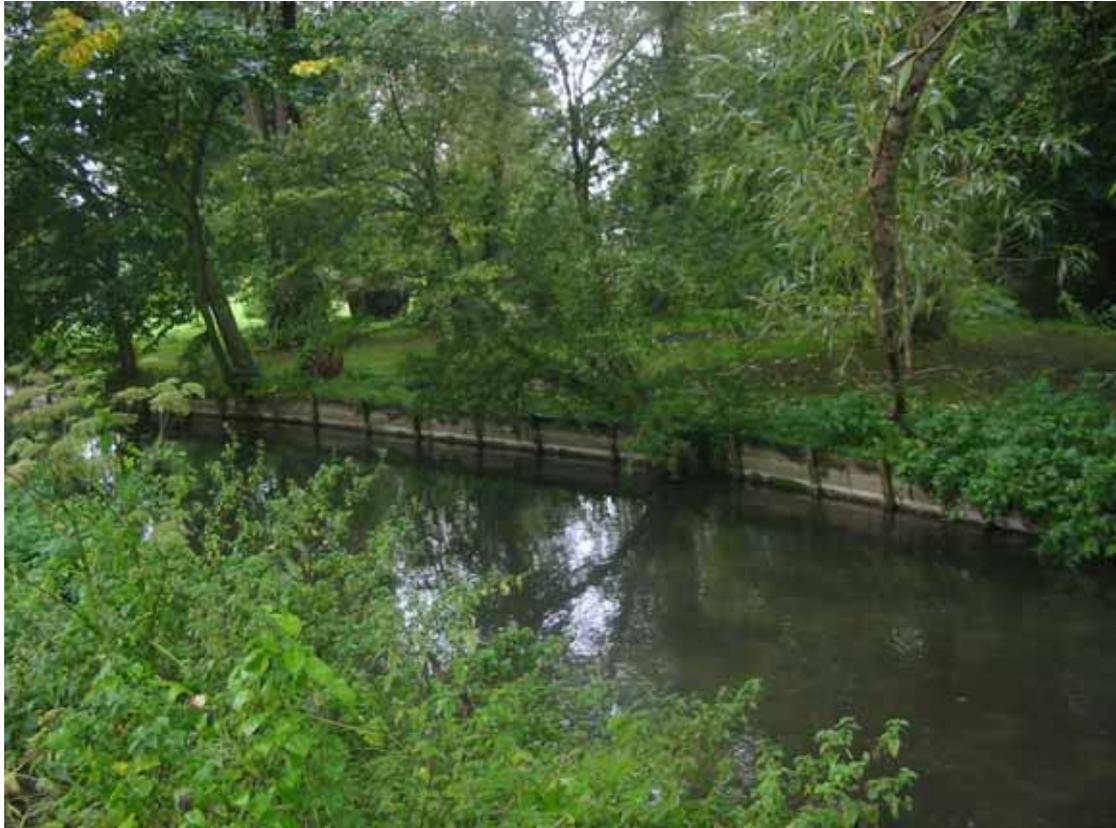
Sections of the RB were not owned by the Estate and formed the gardens of individual residential properties. These banks were heavily cut to the detriment of the fishery, reducing fringing cover valuable to a range of fish species. Sections the bank had also been reveted in places

Heavily cut and reveted RB outside Estate control

- In order to reduce the need to cut bankside vegetation for angler access, the use of careful wading should be encouraged. The impact of thoughtful wading during the fishing season is minimal compared to the very significant impact of regular and heavy bankside cutting

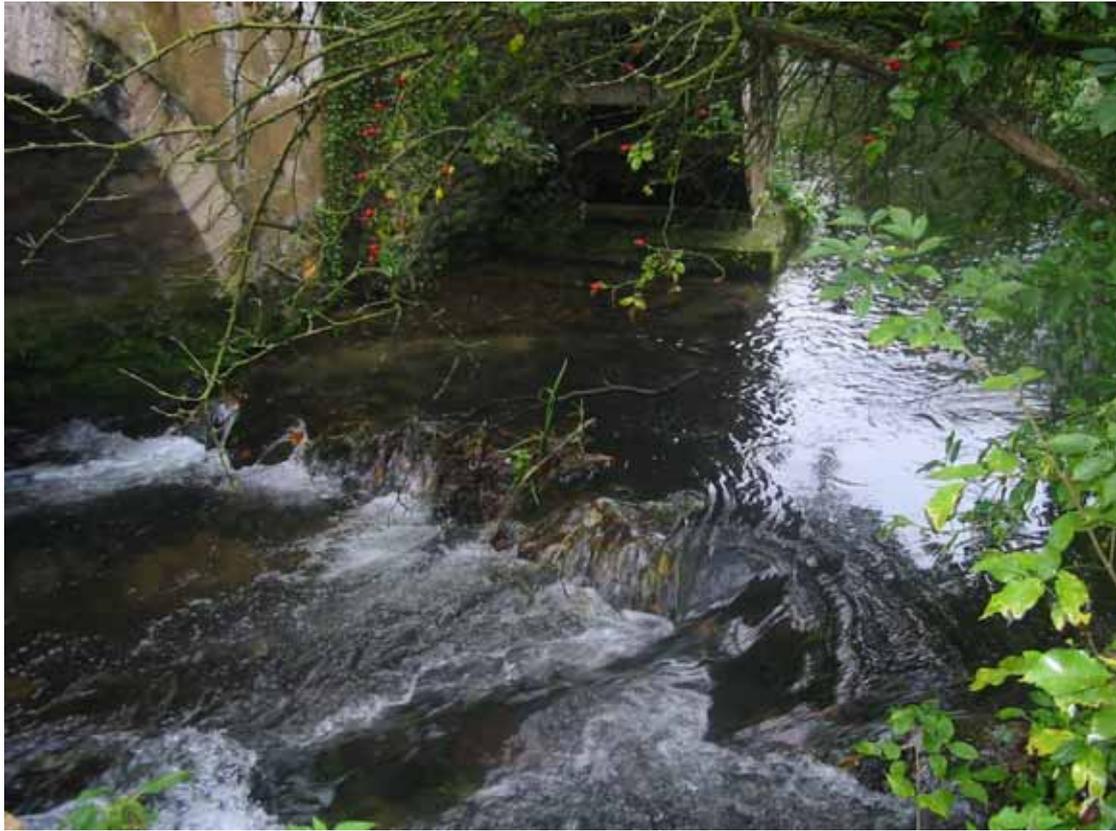
At the downstream limit of this reach, a small impoundment had been built up from stone adjacent to Quenington Bridge. This was retaining a head of water in the low level channel, increasing its width and encouraging the deposition of fine sediment.

Impoundment upstream of Quenington Bridge

- The impoundment above Quenington Bridge could usefully be removed, reducing the retained head of water and the cross sectional area of the low level channel upstream. This would both reduce silt deposition and allow marginal growth to flourish, further narrowing the stream's width.

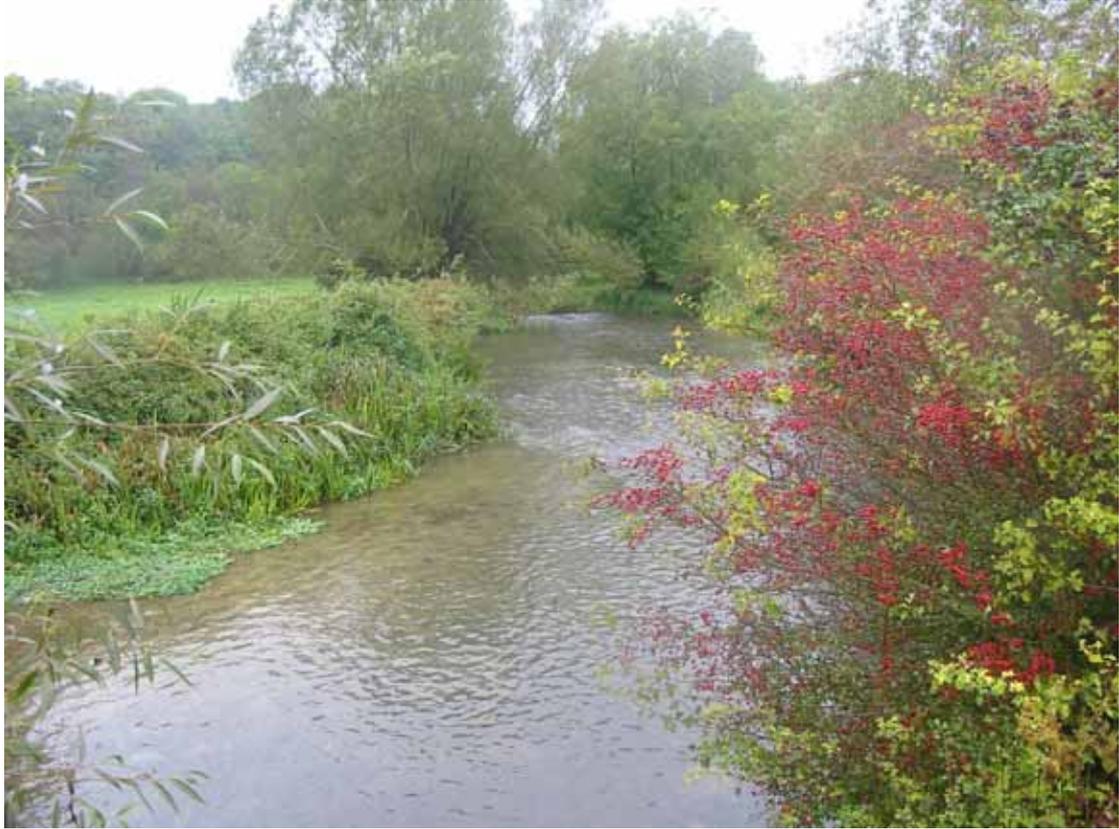
Downstream of Quenington Mill, there was an abundance of flow dependent spawning habitat, dominated by moderately well-sorted gravel substrate. There were some small stands of water crowfoot present in this reach. Despite this, overall coverage of submerged weed was poor, with the result that there was an almost total lack of instream cover in the over-wide and shallow channel.

Reach downstream of Quenington Mill. Water level very low due to lack of submerged weed

- The reaches below Quenington Mill and Moss Bridge both suffer from being over-wide, with uniform bed profile and a lack of submerged vegetation cover. As a result, it is recommended that more Large Woody Debris is introduced to the channel, either in the form of constructed wooden deflectors or felled, stabilised and secured trees trunks. Fallen branches and tree trunks are important components of river systems, helping to provide cover and trap fine sediments. Of particular importance to the Ernest Cook fishery is their part in shaping and forming bed profile. Fallen timber act as groynes, helping to scour out the bed, and sort substrate, removing fine sediment from spawning gravel.

- The encroaching marginal growth below Quenington Mill should be encouraged. This growth is a direct response by vegetation to the previous heavy dredging of this reach. Faggot bundles can be staked into the soft marginal fringe to speed up the rate of colonisation. Alternatively, simple walkways to the water from the path can be constructed using willow stakes and willow bundles. Above all, the temptation to dredge the river should be resisted. This would be a short term palliative with serious long term consequences for the recovery of the Coln.

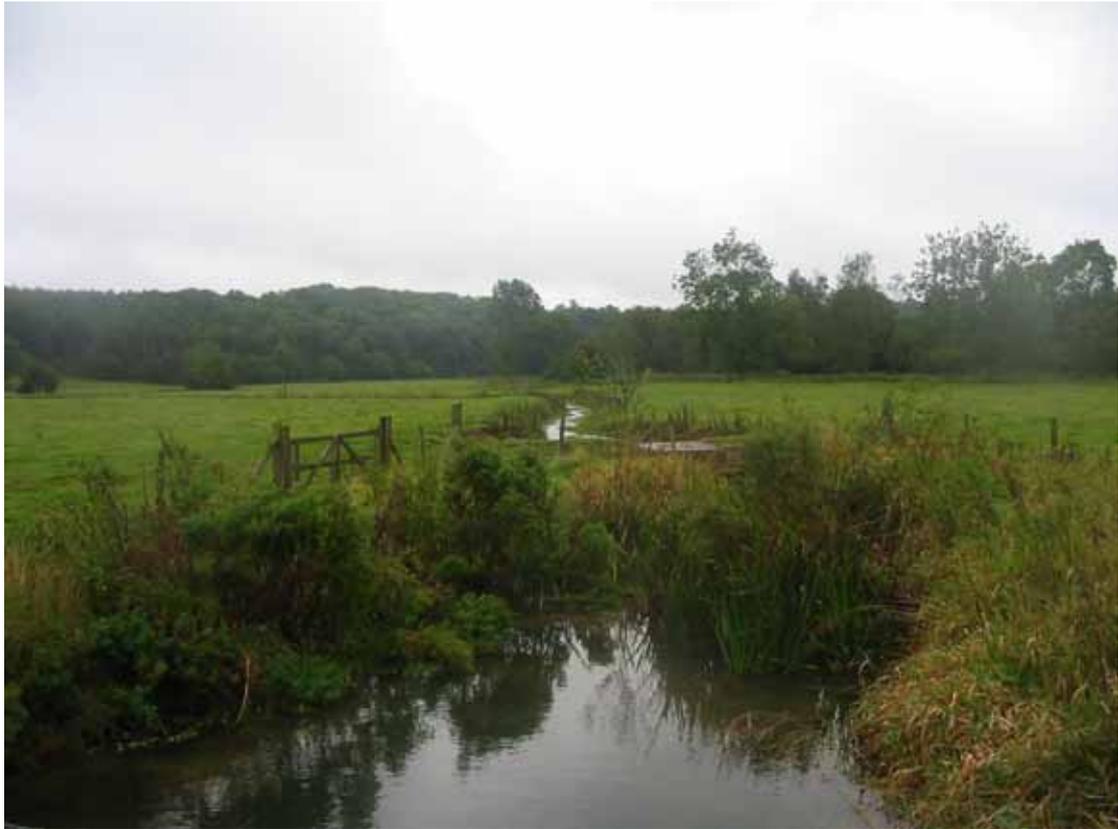
A relic water meadow carrier diverged from the LB of the main river, providing a potentially excellent nursery area for juvenile brown trout.

Water meadow carrier with potential as juvenile trout nursery stream

These boxes have been used very successfully at Williamstrip Estate where they could be viewed in operation. The small water meadow carrier downstream of Quenington Bridge provides an absolutely ideal location for one of these boxes. If such an idea is adopted and shown to be successfully working, it should allow the Estate to significantly reduce its reliance on introduced hatchery reared fish, with an associated cost saving. Note that a consent in writing is required from the Environment Agency prior to the introduction of any fish or fish eggs.

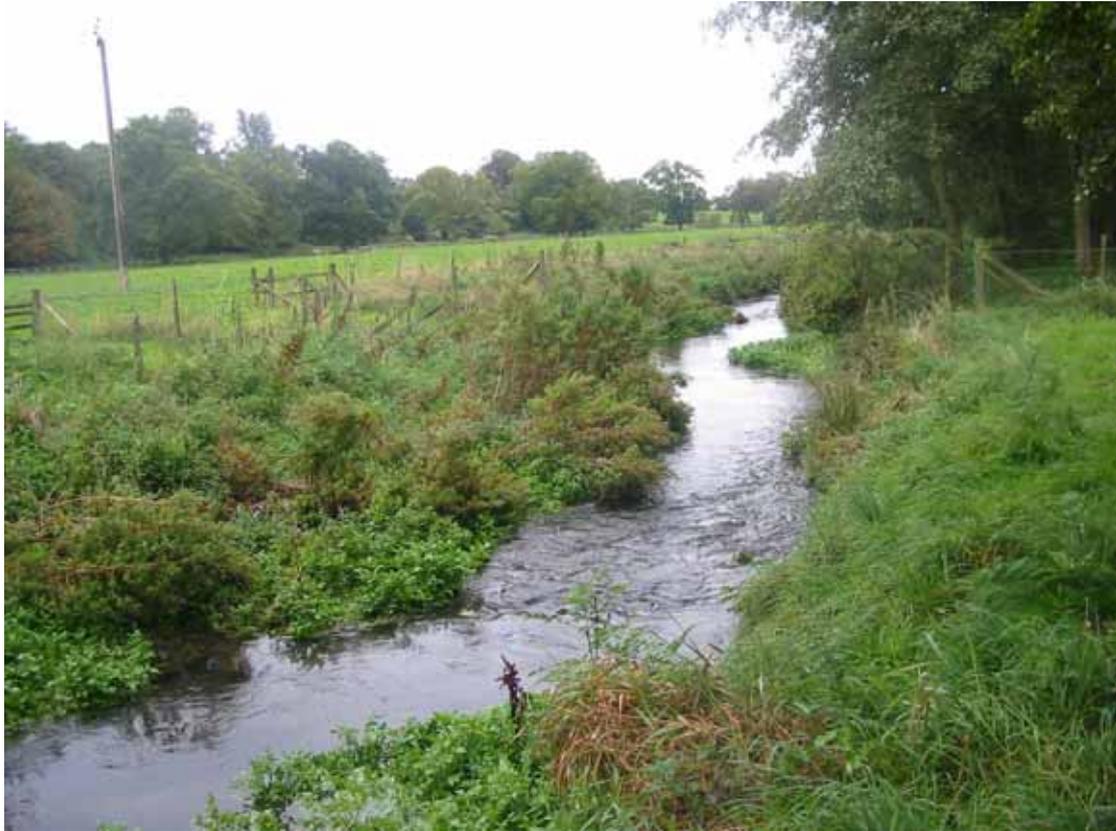
The New Cut was constructed in the early-1980's by Thames Water as mitigation for increased borehole abstraction in the Cotswolds. It was fed via a cut from the main river and a spring fed stream on the RB of the Cut. The channel was narrow (2m – 4m), with a largely gravel dominated bed. A series of small groyne had been used to manipulate flow and increase diversity. Stands of starwort *Callitriche* spp. were

abundant. Marginal growth was extensive and lush. Good numbers of small wild spawned brown trout were evident in the channel.

Typical section of the New Cut
