Habitat Advisory visit to the Killrow
Stream, Headford, Co.Galway, Eire
Undertaken on behalf of Headford and
Corrib Anglers by Vaughan Lewis,
Windrush AEC Ltd
August 2004

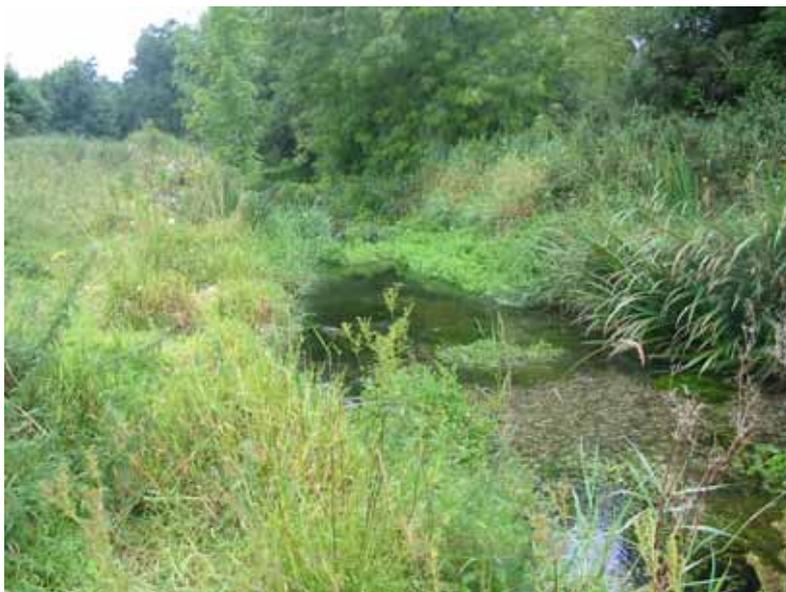
The channel at the upper limit of the reach had a wetted width of between 2m-4m, with a depth of between 20cm and 1m. Some enhancement work had already been undertaken by the HCA and WRFB, with small gravel riffles introduced to encourage spawning of brown trout and subsequent recruitment of juvenile fish. The gravel remained relative poorly sorted, with large stands of starwort having colonised some sections.

Introduced gravel riffle

Largely as a result of past land drainage activity, there is inadequate availability of suitable gravel dominated spawning and juvenile habitat throughout the reach. Where gravel has been introduced during previous schemes, it remains relatively unsorted, with little variation in bed morphology, reducing not only recruitment areas but also adjacent pool habitat vital as refuge for adult fish during spawning activity. This poor sorting is a direct consequence of the limited energy typically found in limestone streams such as the Killrow.

In order to improve the sorting of the hard bed material, and hence improve both the quality of the spawning gravel and the availability of deeper pool areas for adult fish below gravel shallows, a series of strategically located groynes should be constructed in order to increase energy locally.

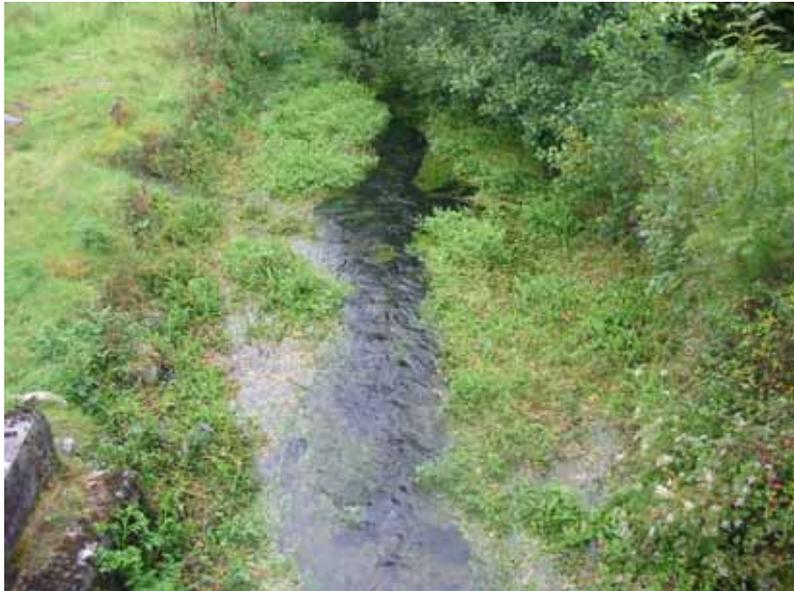
Some 500-600m downstream of the main road were the remains of an old mill. There was a minimal head loss across the invert of the associated bridge structure, with access for fish possible at all normal discharges. Gradient of the stream was good, with large stands of lesser water-parsnip *Berula erecta* and hemlock water dropwort *Oenanthe crocata* present below the old mill. Significant numbers of alder trees were present on the RB. Several large adult fish (>30cm length) were noted in this reach.

Strong growth of lesser water parsnip and hemlock water dropwort downstream of the old mill

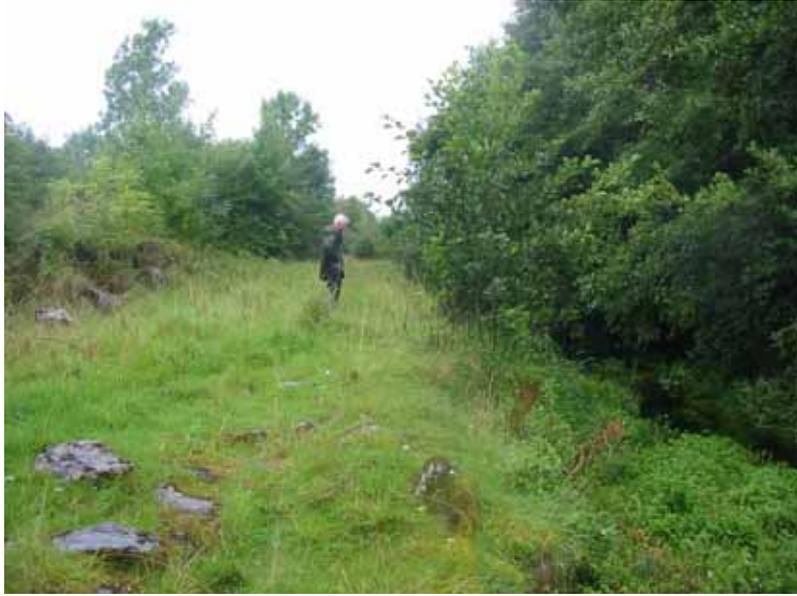
Elevated spoil heaps on left bank of the Killrow stream. Note height difference between water level and bank top.

There was clear evidence of past dredging of this reach, with large bunds of stony bed material piled on both banks, particularly the LB, leaving the elevated bank level significantly higher than the water level in the incised channel.

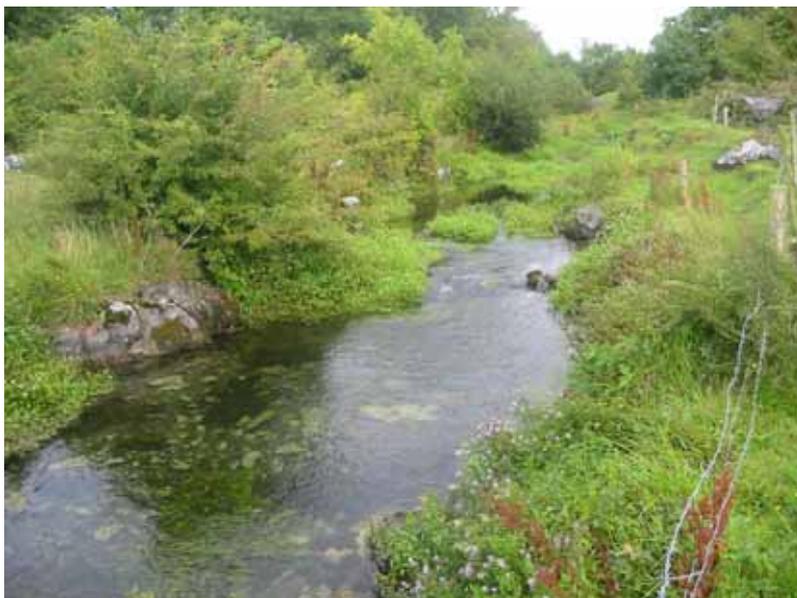
Further down the reach, the gradient of the channel reduced. The bed profile was relatively uniform, with the substrate dominated by silt covered, unsorted gravel, offering limited habitat for adult trout. Most of the stream was <0.4m deep with only a few deeper pools present where stone constrictions and gravel riffles (introduced during past enhancement schemes?) had increased velocity locally causing scour.

Pool and riffle formed by increased velocity caused by boulder constriction

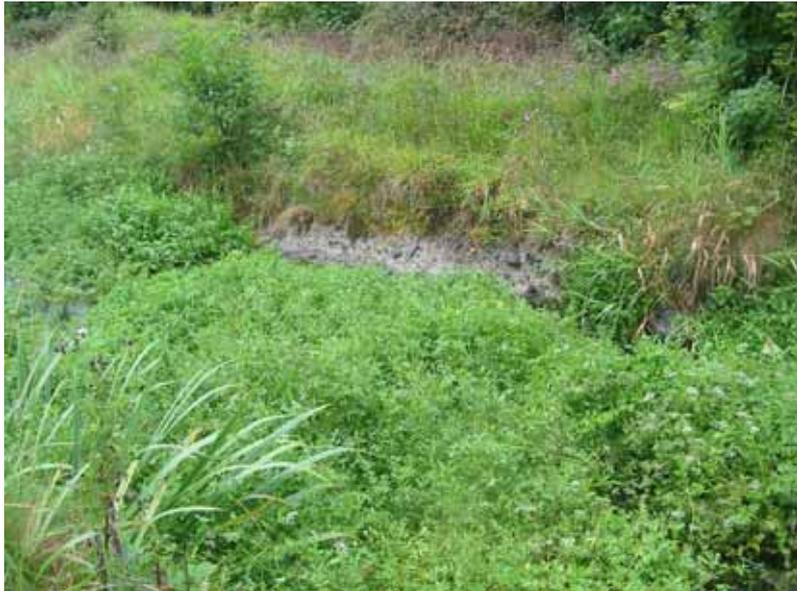
Much of the channel was over-wide (5m-6m) with respect to the flow in the stream. As a consequence, extensive beds of mixed emergent vegetation had grown across the channel. Exposed sections of bank clearly showed extensive deposits of stone and gravel that would provide a supply of hard bed material through the process of erosion.

Overwide channel, occluded with mixed emergent species. Note exposed gravel strata on far bank providing a ready source of potential bed material

Brief examination of bank sections in the Killrow stream clearly showed the presence of extensive gravel seams. Careful construction of groynes would allow the controlled release of this valuable material via the process of erosion. In the event that this is not acceptable to local landowners, then it is recommended that the sections of channel between the groynes should be seeded with local gravel of between 10mm-40mm diameter. The increased velocity resulting from the introduced groynes will aid sorting of this material.

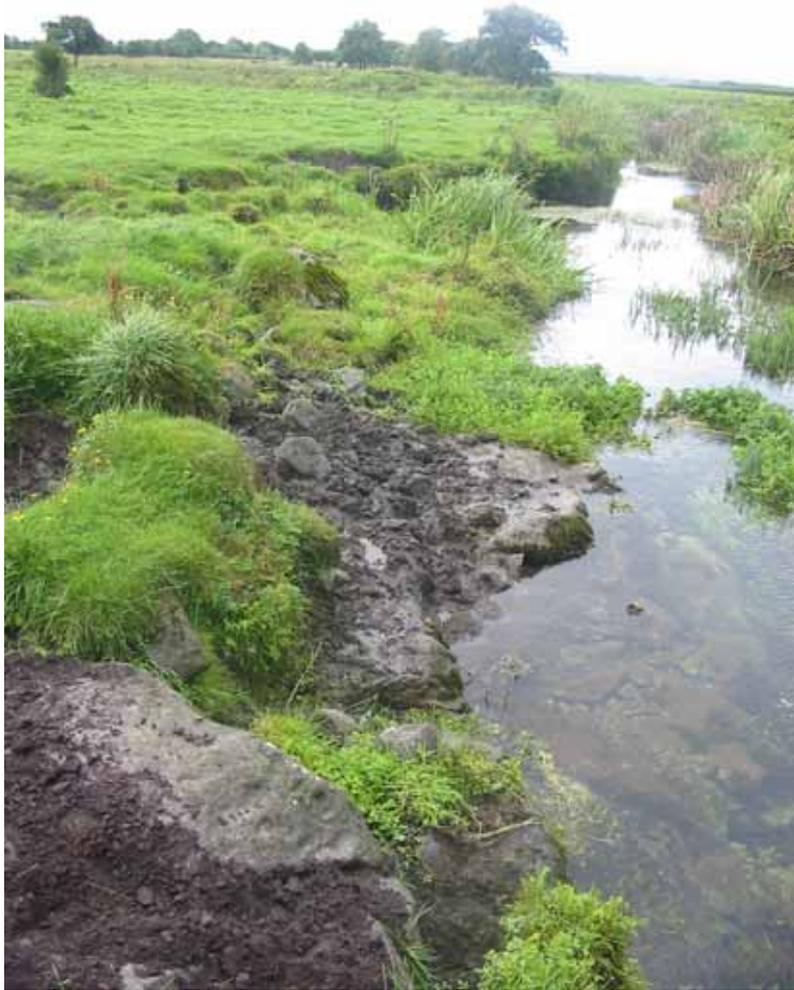
There were some sections of bank erosion caused by agricultural stock, resulting in the release of increased volumes of fine sediment, the further over-widening of the channel and a heavy local growth of emergent vegetation, including yellow flag *Iris pseudacorus*.

Bank overgrazed by agricultural stock at lower end of reach

Some bank erosion caused by trampling and grazing by agricultural stock was apparent at the lower end of the study reach. In order to prevent the excessive erosion, mobilisation of sediment and loss of marginal habitat associated with this damage, it is recommended that the affected areas should be securely stock fenced ideally leaving a buffer strip of >10m to reduce the impact of any sediment laden run-off on the stream.

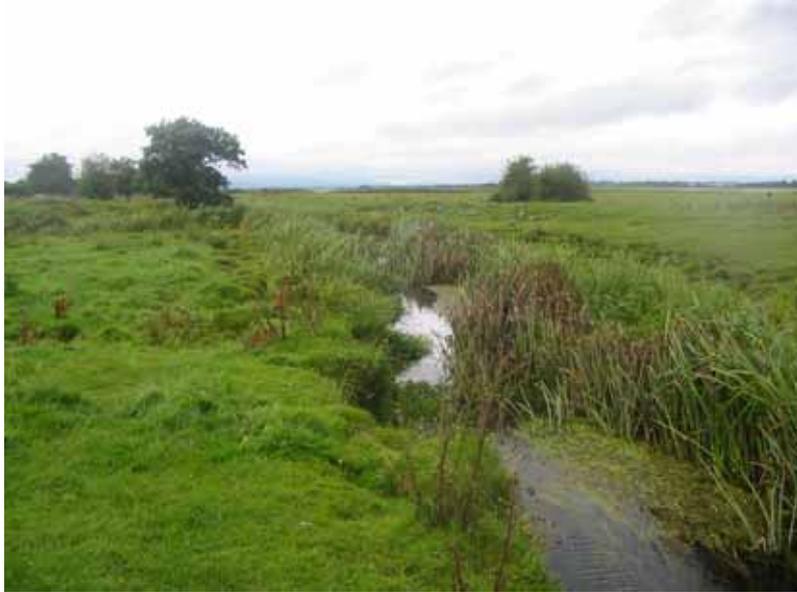
Downstream of the confluence with a major LB drainage stream, the water level was controlled by the backwater effect of Lough Corrib. As a consequence, opportunity for management work was minimal from this point to the stream's confluence with the lough in Ballindiff Bay, a distance of approximately 1km.

Lower section of reach. Note reduced gradient, with water level controlled by Lough Corrib, and extensive growth of emergent vegetation
